Attachment G: Cape Fear River Animal Feeding Operations Monitoring Study: Preliminary Report

CAPE FEAR RIVER ANIMAL FEEDING OPERATIONS MONITORING STUDY: PRELIMINARY REPORT

North Carolina Department of Environmental Quality
May 2020

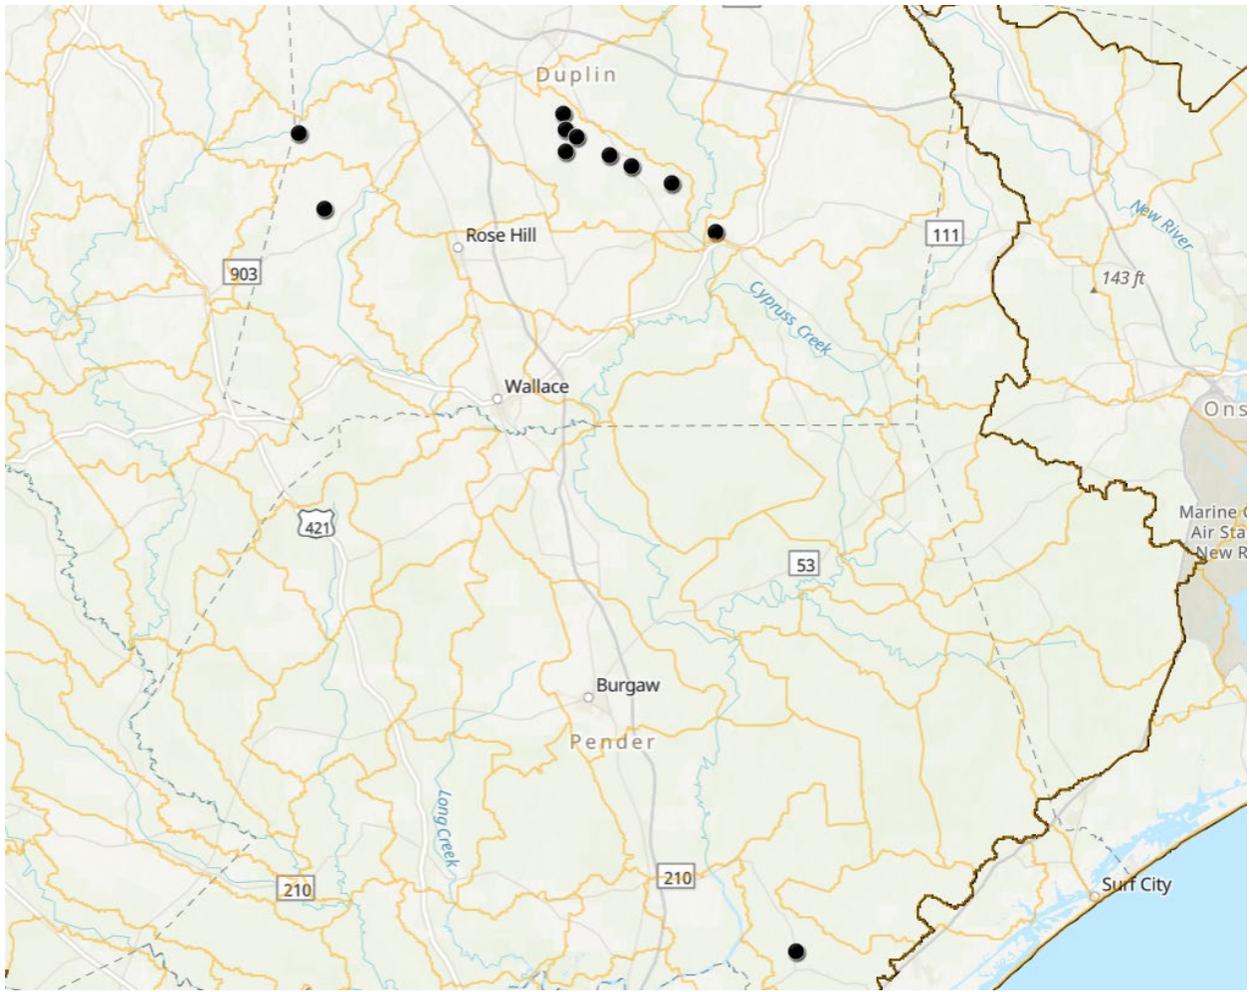
Figure 1. Map showing the watersheds and water quality monitoring sites.

The CFRAFOMS was designed to investigate potential water quality impacts in highly concentrated areas of AFOs. Ten (10) water quality monitoring stations and one reference/background station were included in this study (Figure 1). General information on the selected monitoring stations including their location, stream index number, and watershed characteristics can be found in Table 1. The station locations were selected to provide a picture of the surface water quality adjacent to animal feeding operations.

The Stocking Head Creek watershed has 22,353 acres of land mass and is located in the Cape Fear River basin. Seven of the eleven water quality monitoring stations are located in this watershed. Murphey's Creek monitoring site is located in Rockfish Creek watershed which has 30,981 acres. Muddy creek monitoring site is located in the Muddy Creek watershed with 30,718 acres. Sikes Mill Run monitoring site is located in Six Runs Creek watershed with 14,548 acres. The background monitoring site is located in Harrisons Creek watershed located in Pender county with 23,433 acres.

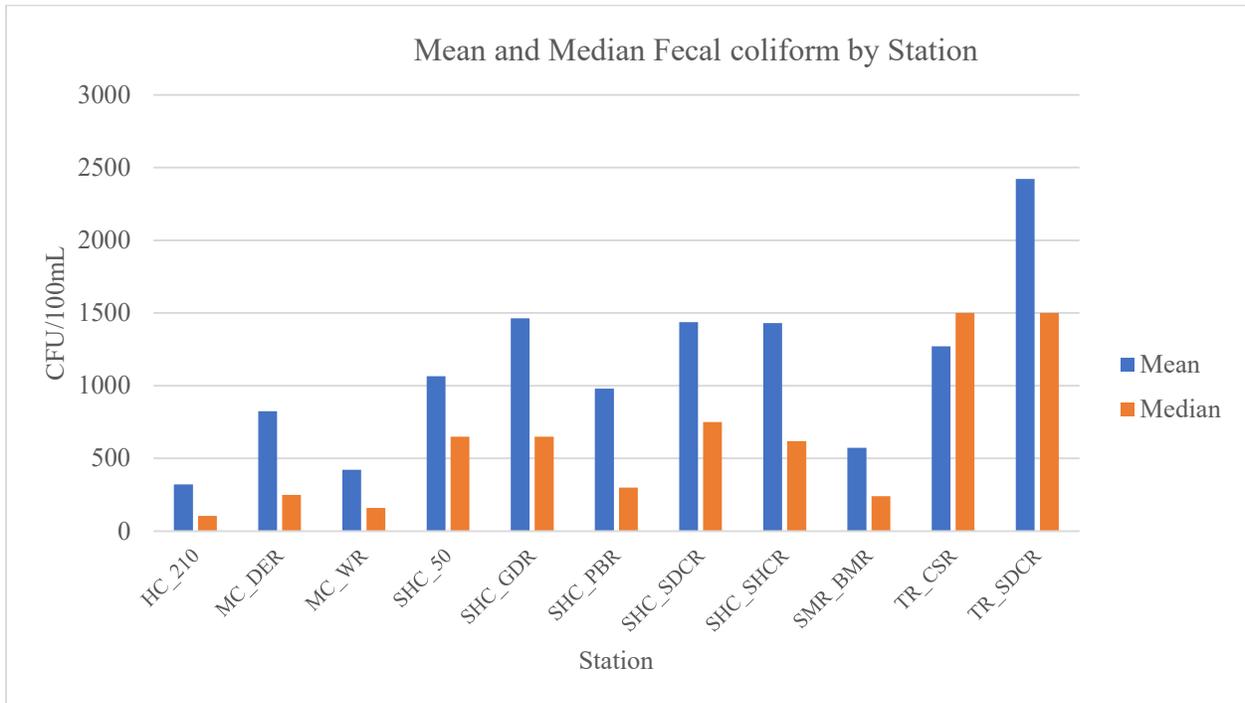
Figure 2. Mean and median concentrations for Fecal coliform (April 2018-October 2019).

The mean and median concentrations for nutrient parameters and pathogens were calculated for the data between April 2018 and October 2019. The results are shown below in Figures 2-6 by parameter for each monitoring station.

As shown in almost all cases in the tables above, the reference station (HC_210) had much lower mean and median concentrations by parameter than the test stations. To evaluate whether the parameter concentrations are significantly different in the test stations as compared to the reference
