Profile M - Cross Section at Station E18
 January 7, 2009 Bear Trail Debris Flow
 Maggie Valley, Haywood County, NC

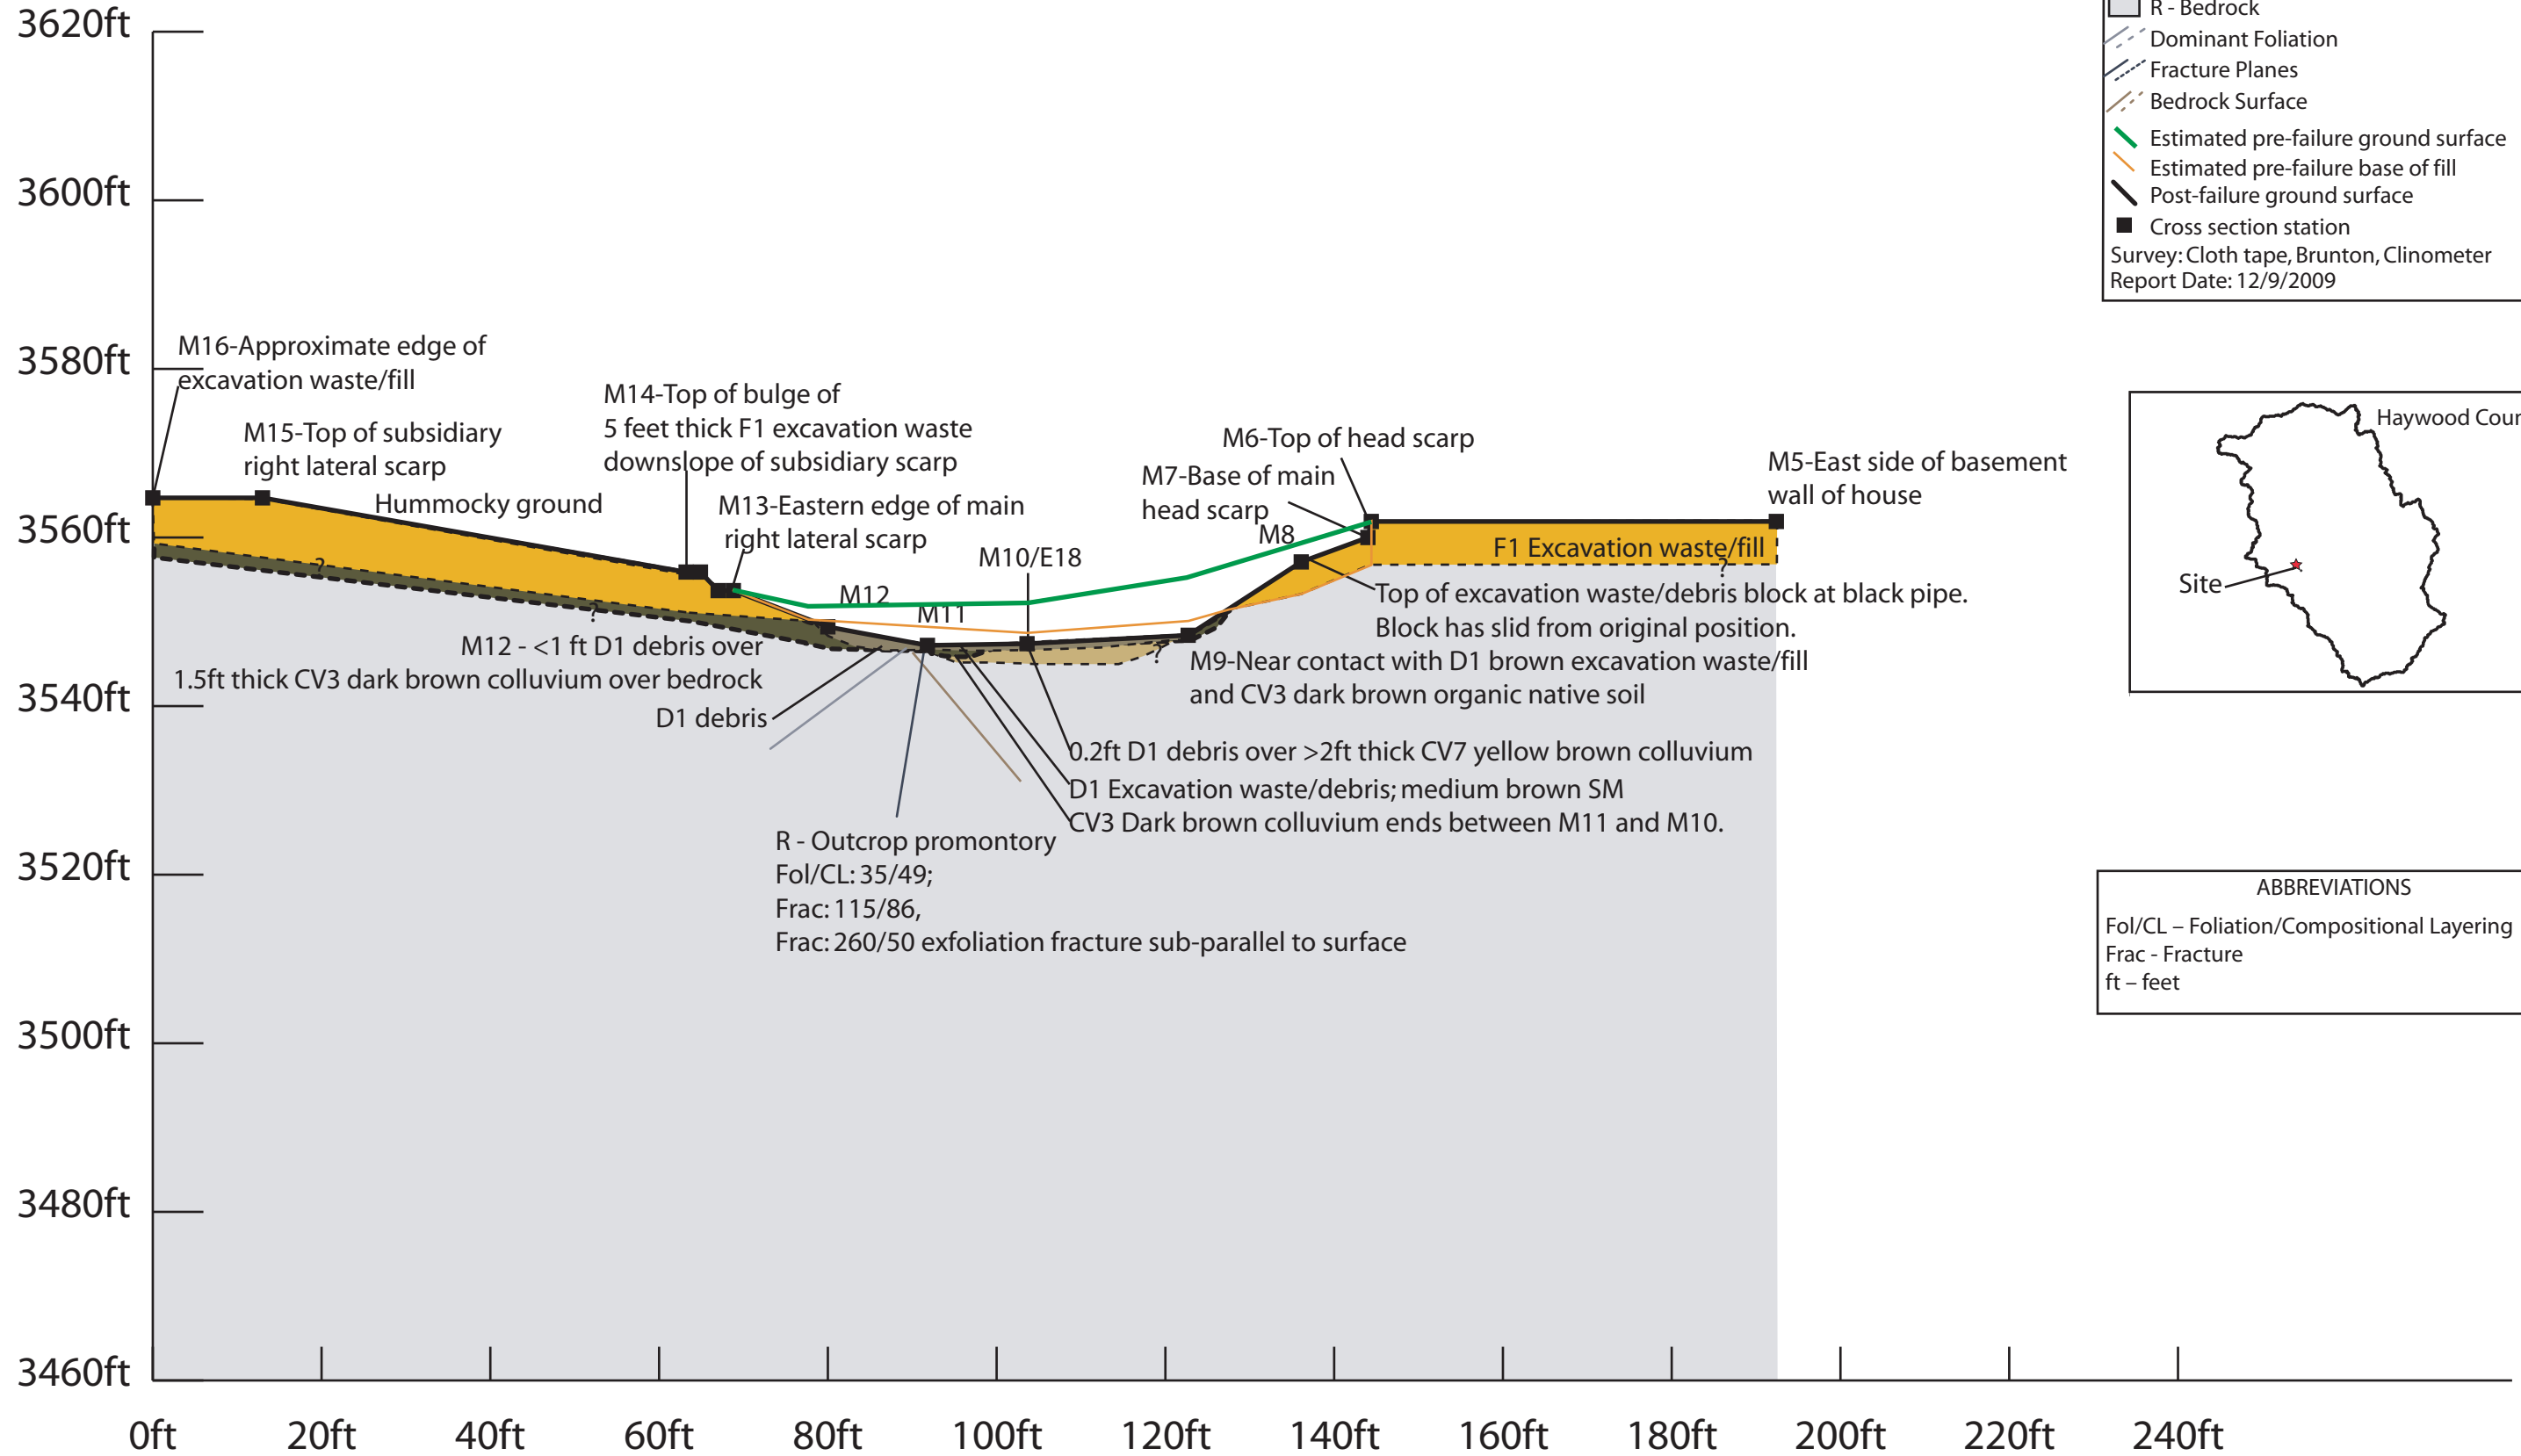
Bearing = 265 degrees
 View looking upslope
