MITIGATION PLAN
ABBAY LAMM
STREAM AND WETLAND MITIGATION SITE
Alamance County, North Carolina
Full Delivery Contract No. 5790

Cape Fear River Basin
Cataloging Unit 03030002

December 2014

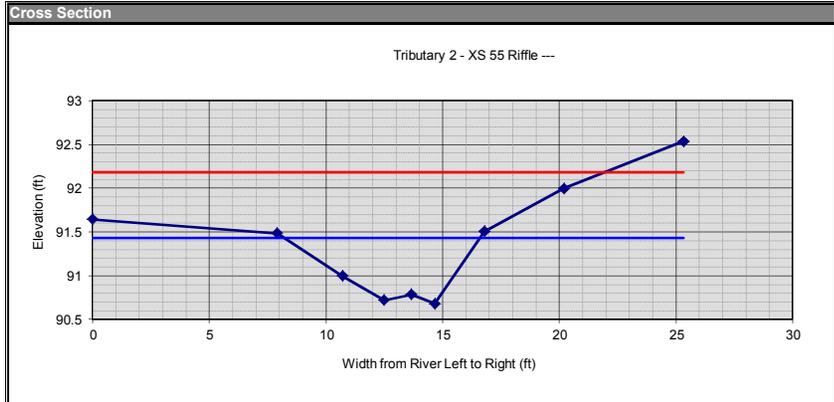
section: Tributary 2 - XS 55

Riffle

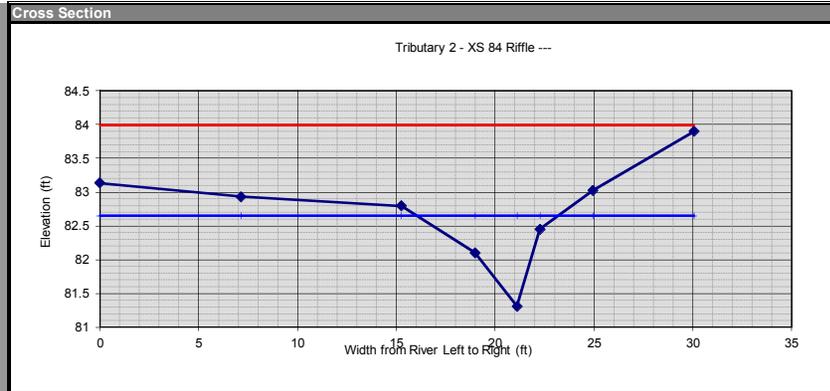
section: Tributary 2 - XS 84
Riffle

description: Tributary 2 - XS 84
height of instrument (ft): 100.00

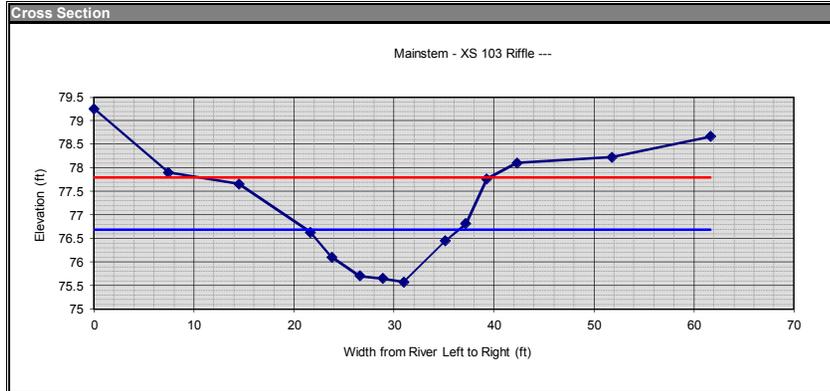
section: Mainstem - XS 103
Riffle

description: Mainstem - XS 103
height of instrument (ft): 100.00

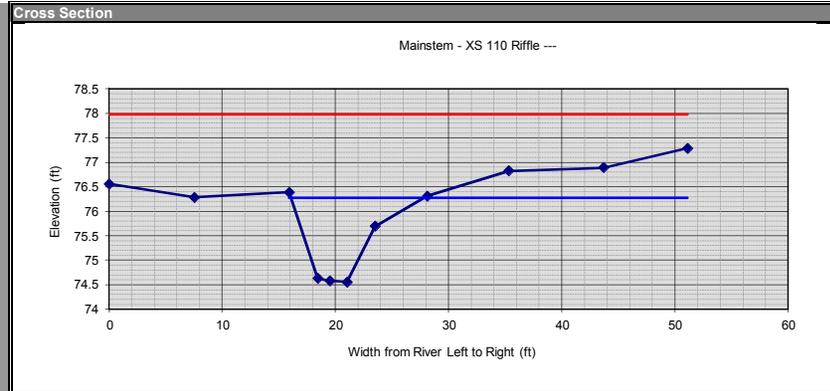
section: Mainstem - XS 110
Riffle

description: Mainstem - XS 110
height of instrument (ft): 100.00

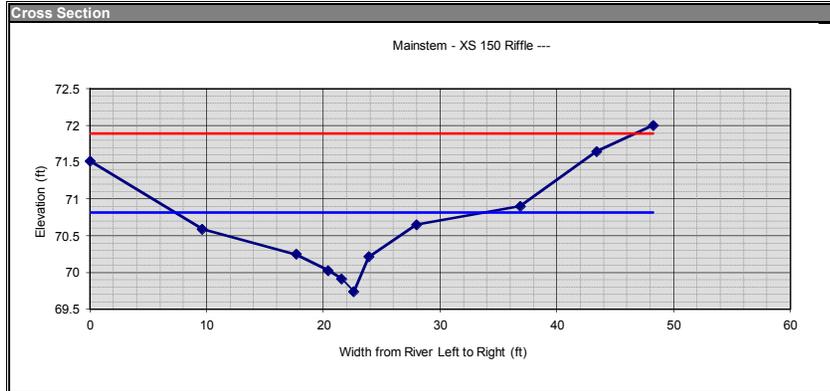
section: Mainstem - XS 150

Riffle

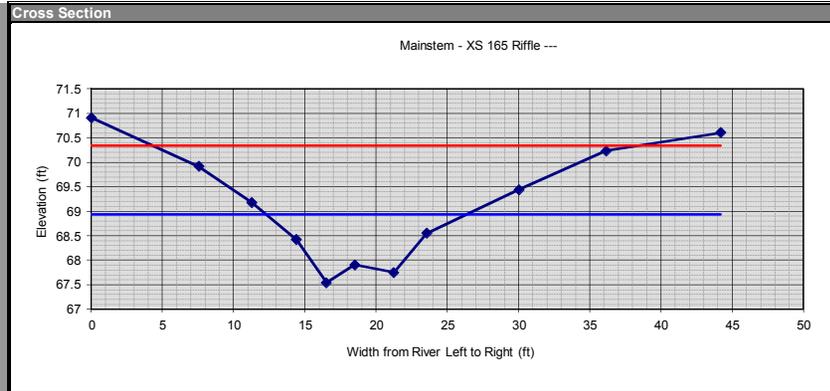
section: Mainstem - XS 165

Riffle

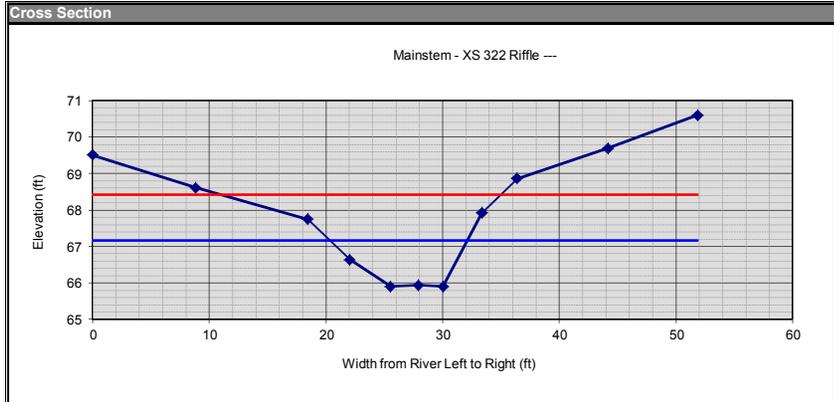
section: **Mainstem - XS 322**
 Riffle

description: **Mainstem - XS 322**
 height of instrument (ft): **100.00**

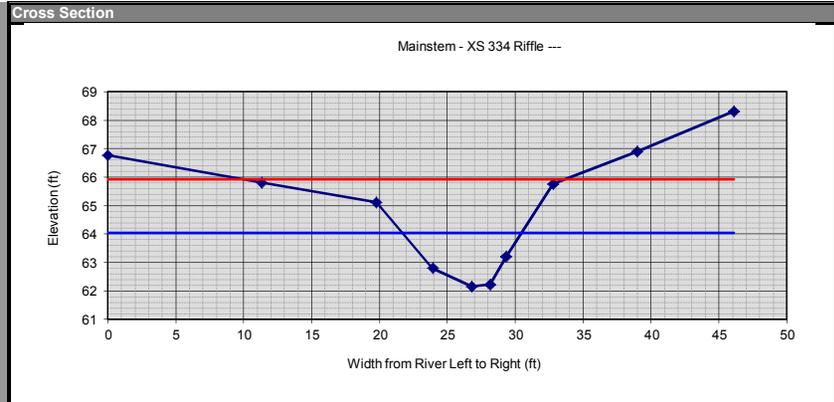
section: **Mainstem - XS 334**
 Riffle

description: **Mainstem - XS 334**
 height of instrument (ft): **100.00**

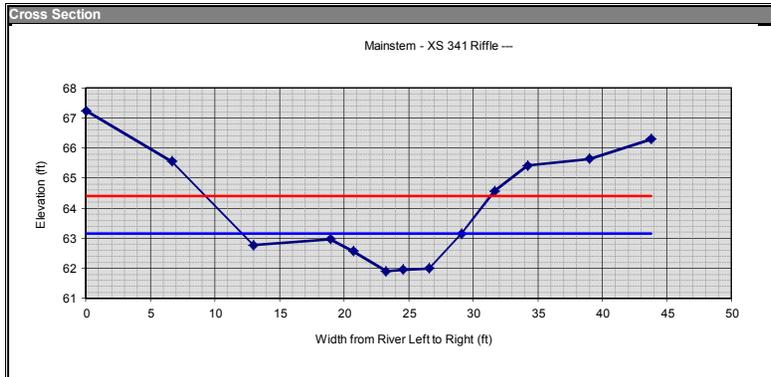
section: Mainstem - XS 341
Riffle

description: Mainstem - XS 341
height of instrument (ft): 100.00

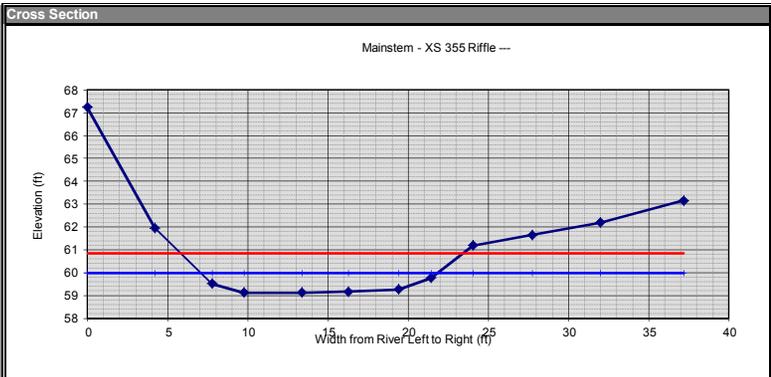
section: Mainstem - XS 355
Riffle

description: Mainstem - XS 355
height of instrument (ft): 100.00
