**FINAL**  
**AS-BUILT BASELINE MONITORING REPORT**  
**BEAR CREEK (PHILLIPS SITE) RESTORATION PROJECT**

Chatham County, North Carolina  
EEP Project No. 26 (Contract No. 5715)  
DWR Project No. 0713-94  
SCO No. 09-07726-01A

**Data Collection – March-April 2014**

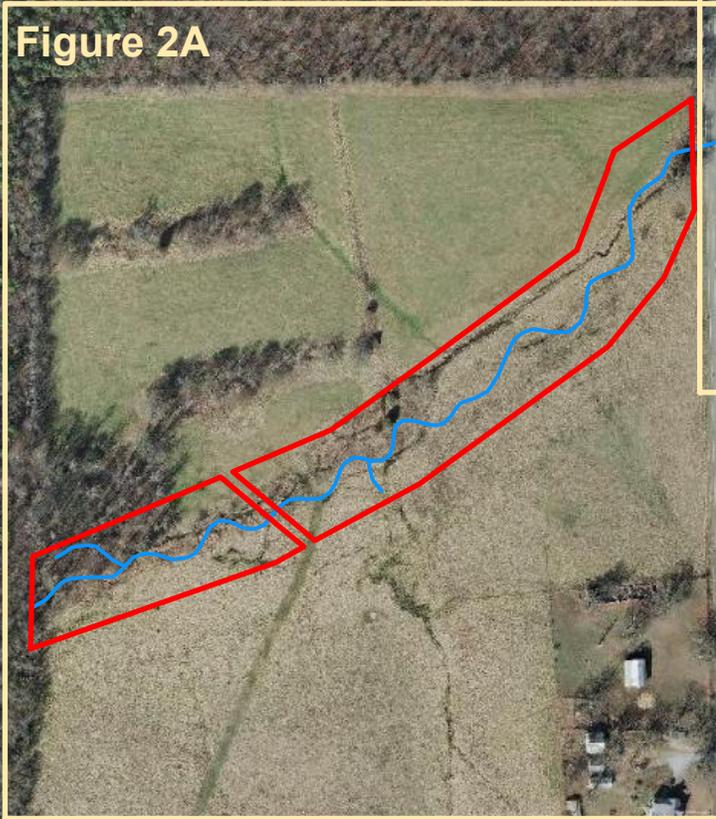
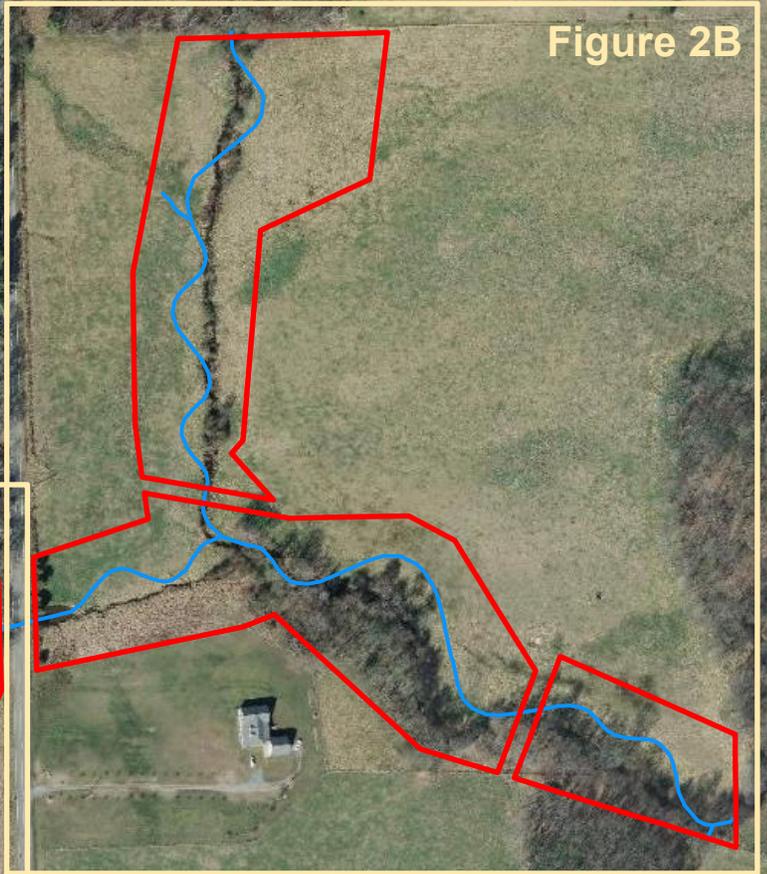
2

CURRENT CONDITIONS PLAN VIEW  
BEAR CREEK (PHILLIPS)  
EEP PROJECT NUMBER 26  
Chatham County, North Carolina

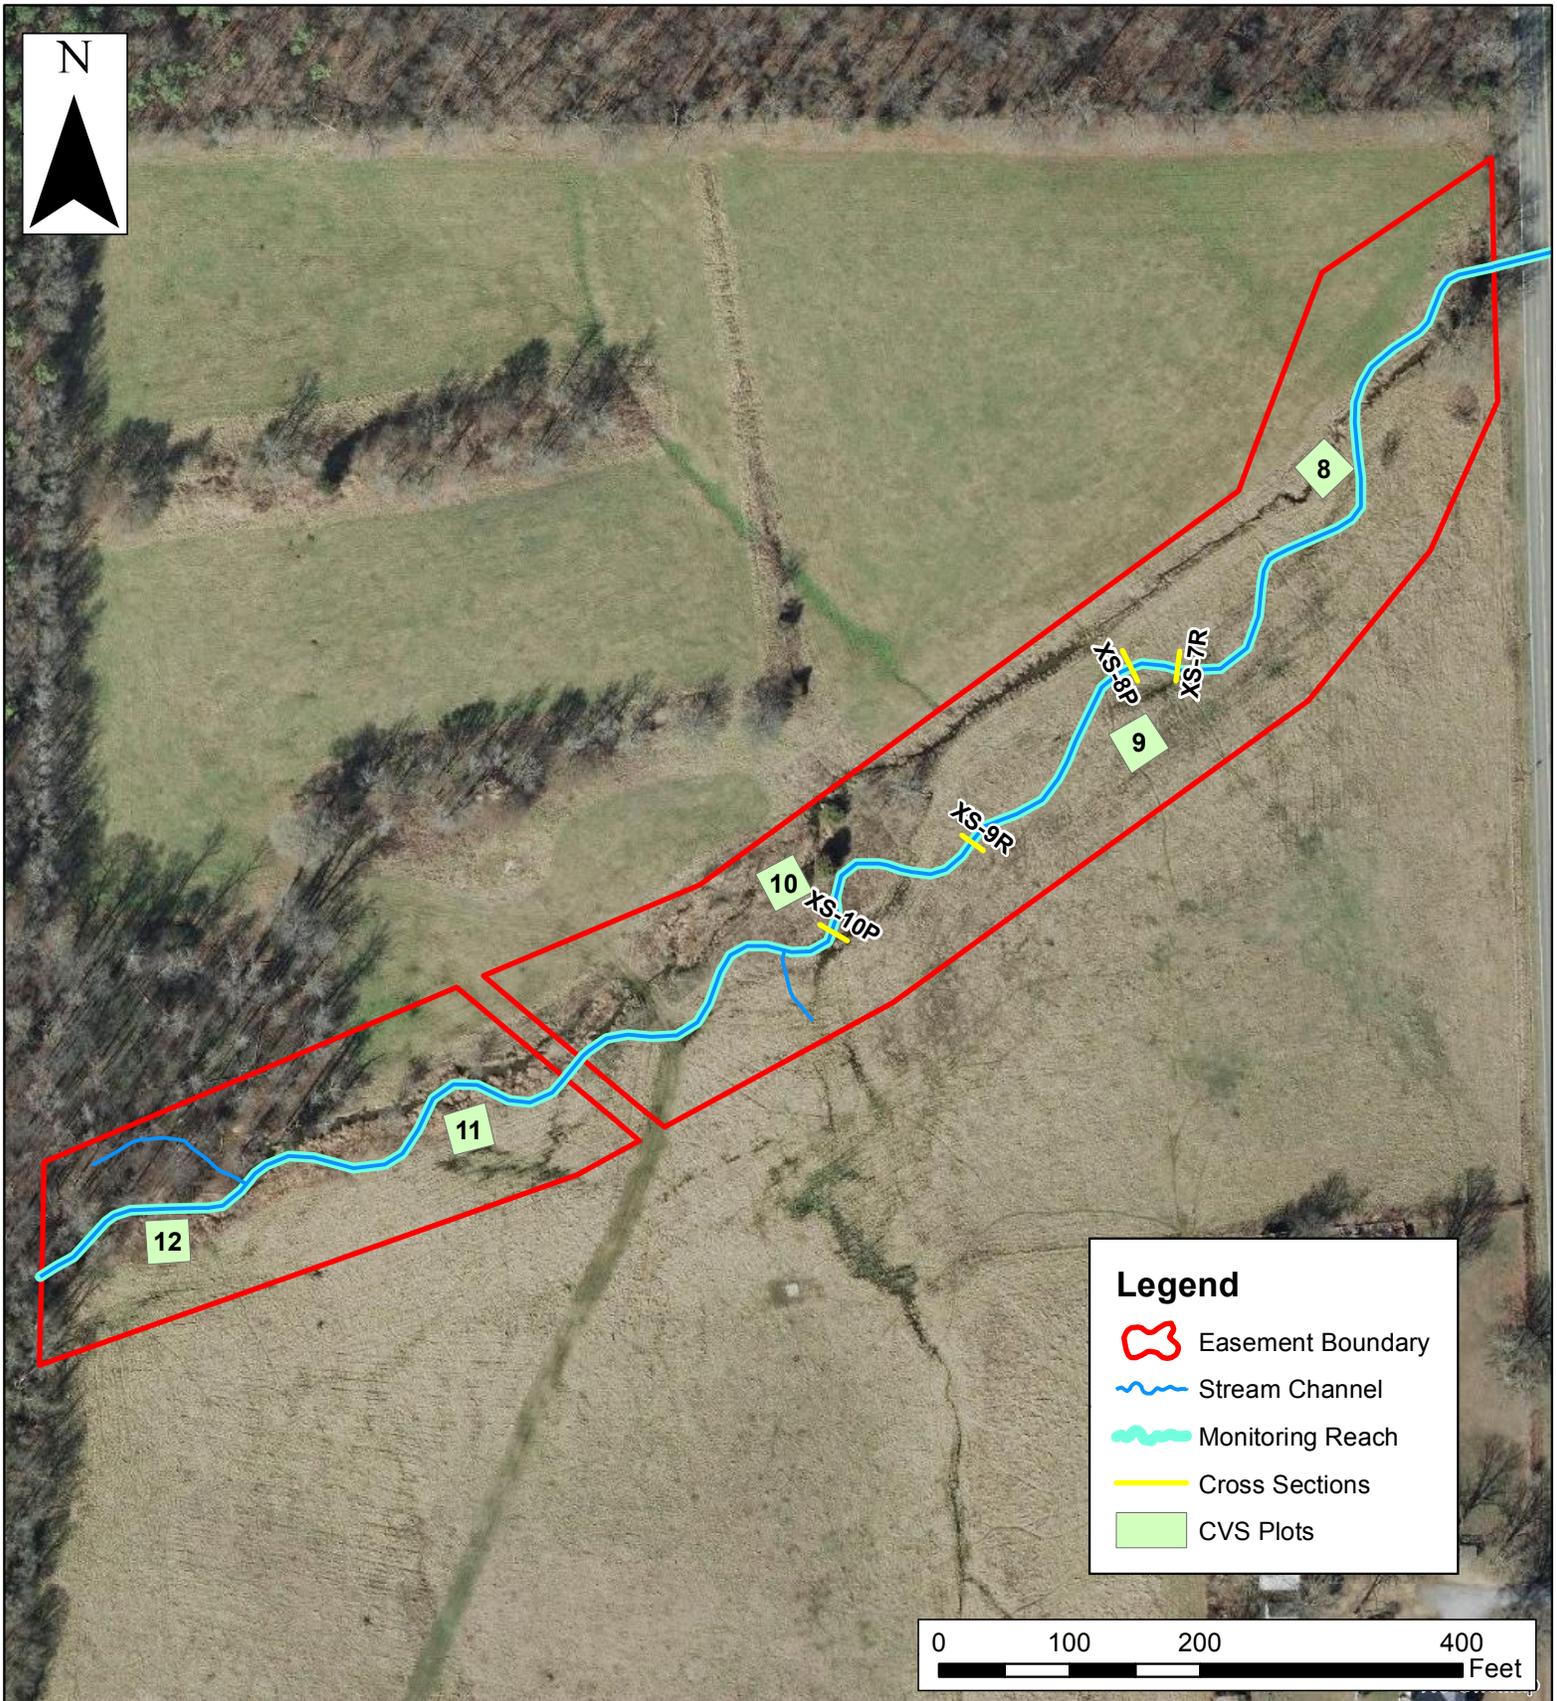
**2A**

CURRENT CONDITIONS PLAN VIEW  
BEAR CREEK (PHILLIPS)  
EEP PROJECT NUMBER 26  
Chatham County, North Carolina

Ten permanent cross-sections, six riffle and four pool, were established and will be used to evaluate stream dimension; locations are depicted on Figures 2, 2A, and 2B (Appendix B) Because riffle cross-sections are critical in determining bankfull design parameters, the number of riffle cross-sections established outnumber pool cross-sections. Each cross-section is marked on both banks with permanent pins to establish the exact transect location. A common benchmark will be used for cross-section comparisons from year-to-year data. The annual cross-section survey will include points measured at all breaks in slope, including top of bank, bankfull, inner berm, edge of water, and thalweg, if the features are present. Riffle cross-sections will be classified using the Rosgen Stream Classification System.

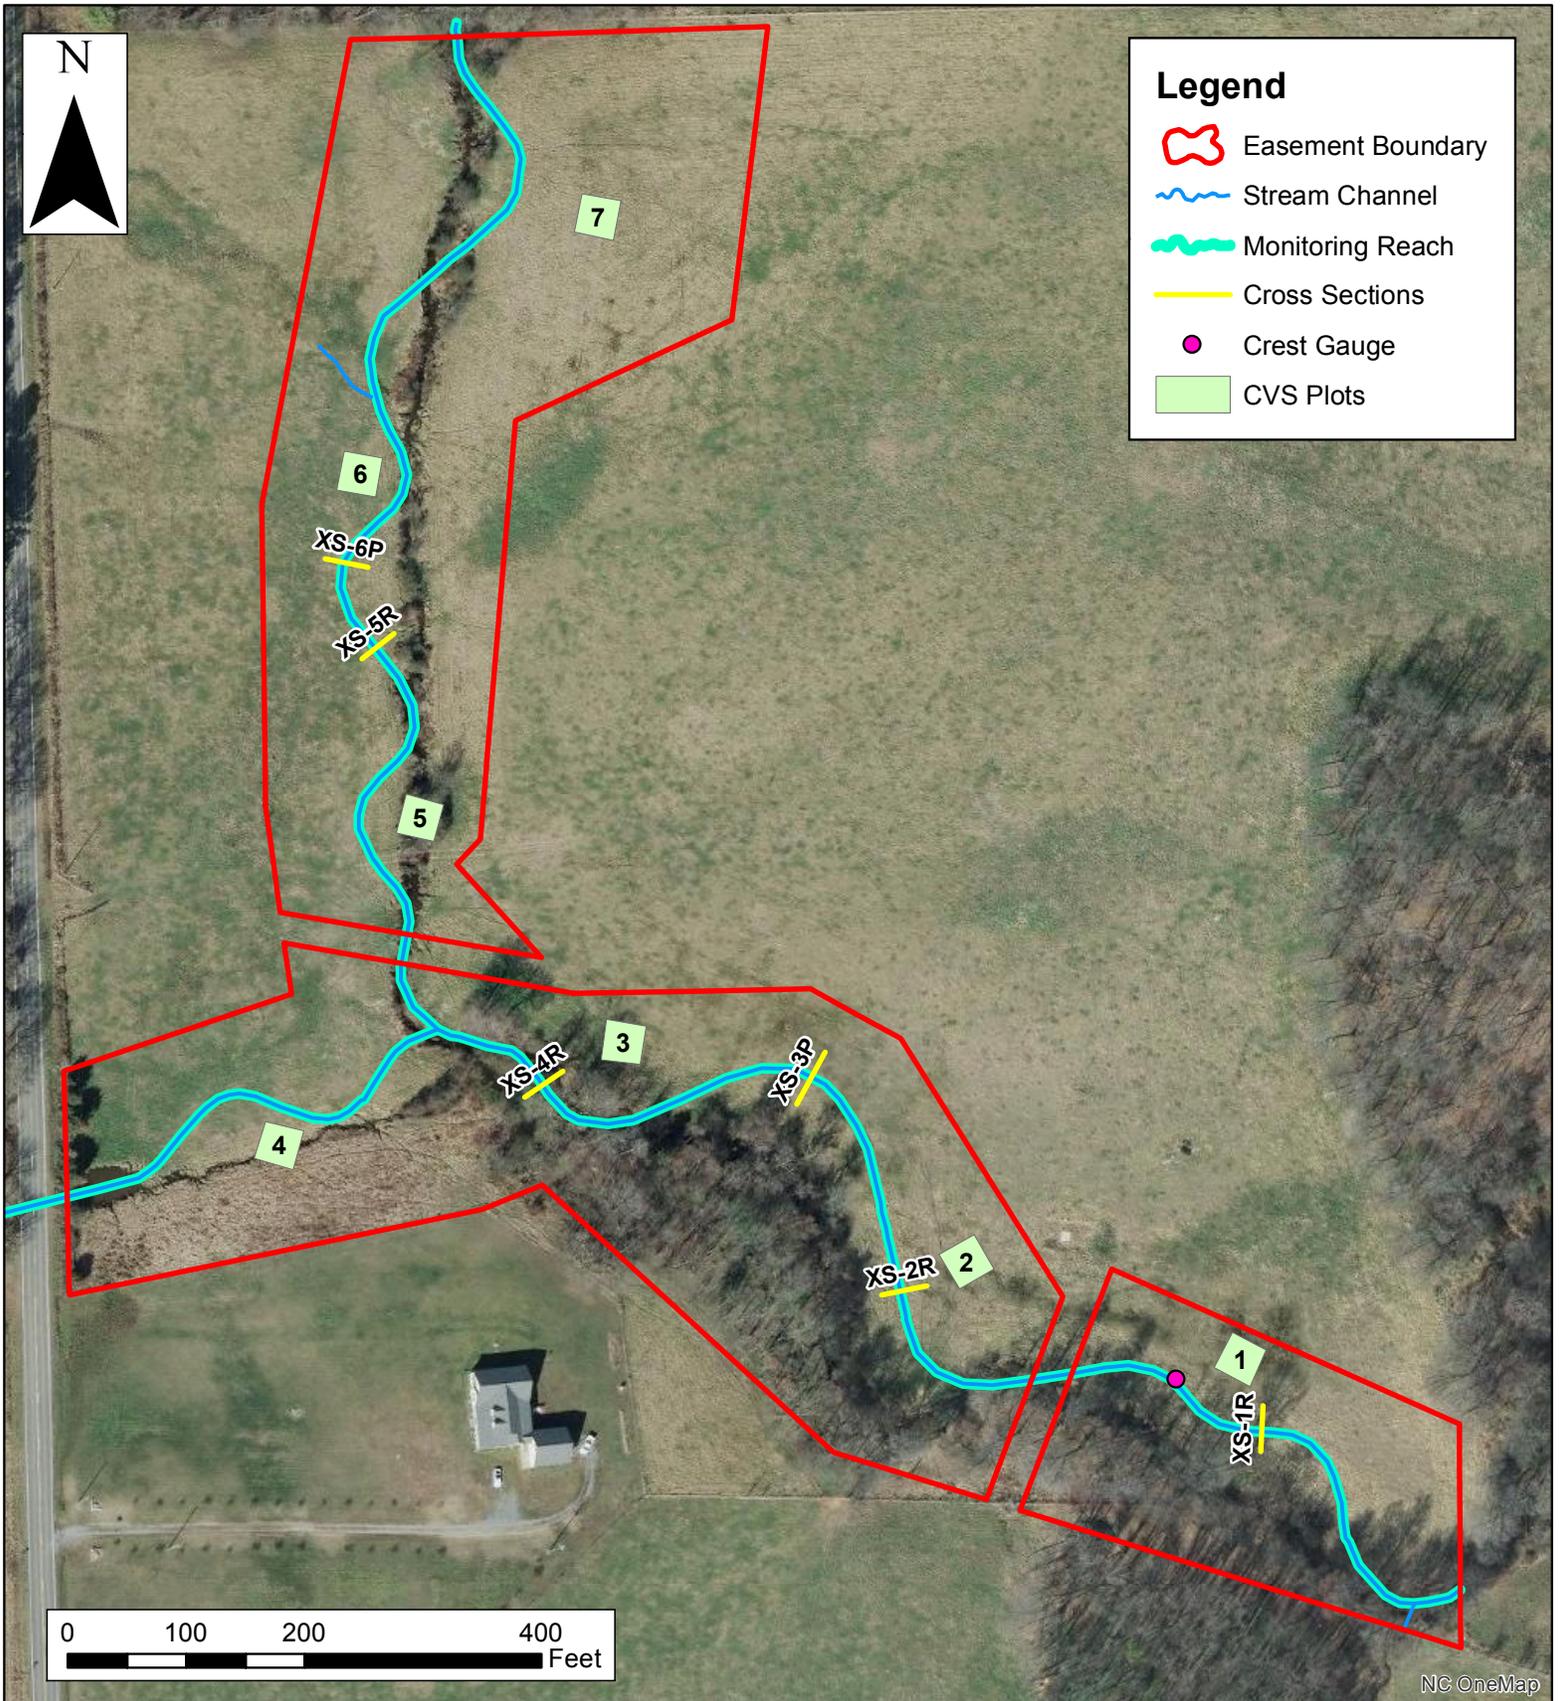
**2B**

CURRENT CONDITIONS PLAN VIEW  
BEAR CREEK (PHILLIPS)  
EEP PROJECT NUMBER 26  
Chatham County, North Carolina

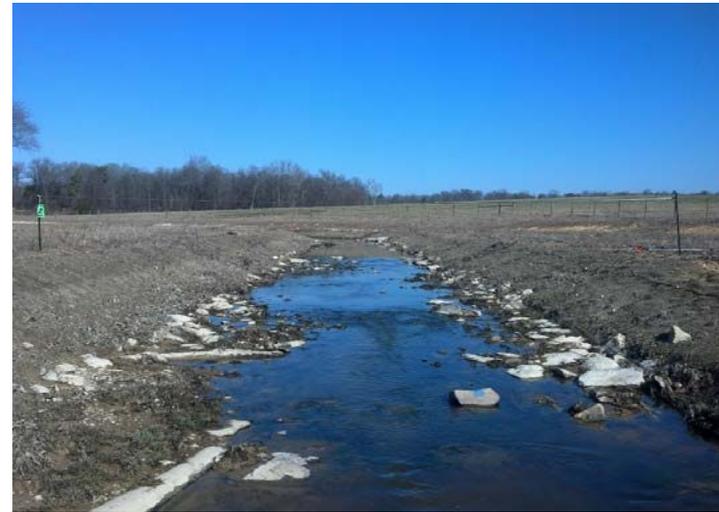
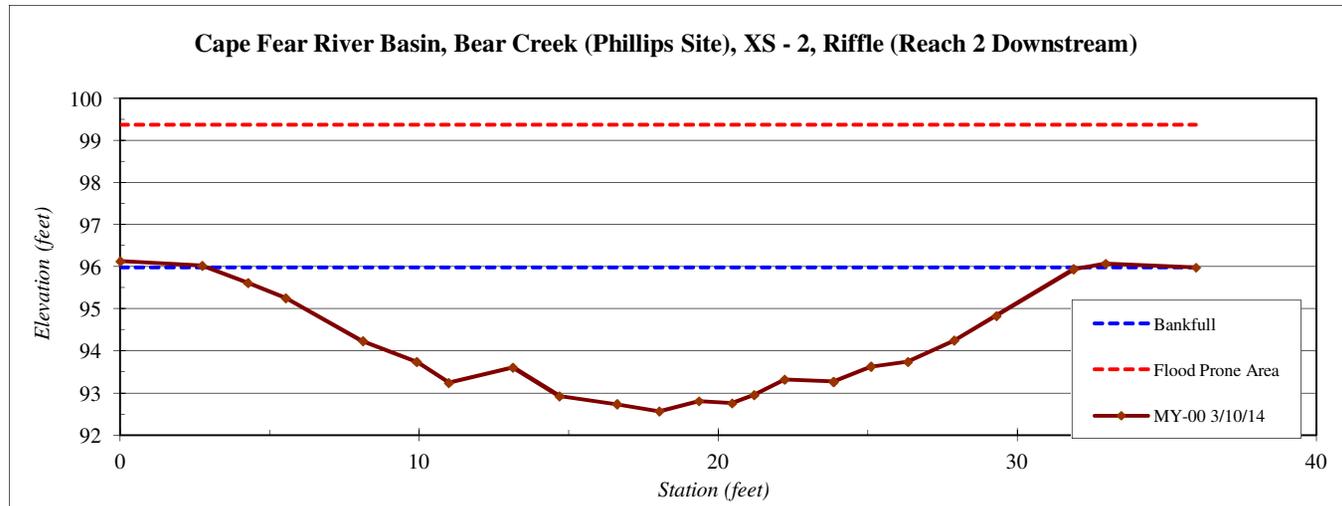
<b>River Basin:</b>	Cape Fear
<b>Site Name</b>	Bear Creek (Phillips Site)
<b>XS ID</b>	XS - 2, Riffle (Reach 2 Downstream)
<b>Drainage Area (sq mi):</b>	4.99
<b>Date:</b>	3/10/2014
<b>Field Crew:</b>	Perkinson, Jernigan

SUMMARY DATA	
<b>Bankfull Elevation:</b>	96.0
<b>Bankfull Cross-Sectional Area:</b>	61.1
<b>Bankfull Width:</b>	29.3
<b>Flood Prone Area Elevation:</b>	99.4
<b>Flood Prone Width:</b>	250.0
<b>Max Depth at Bankfull:</b>	3.4
<b>Mean Depth at Bankfull:</b>	2.1
<b>W / D Ratio:</b>	14.1
<b>Entrenchment Ratio:</b>	8.5
<b>Bank Height Ratio:</b>	1.0

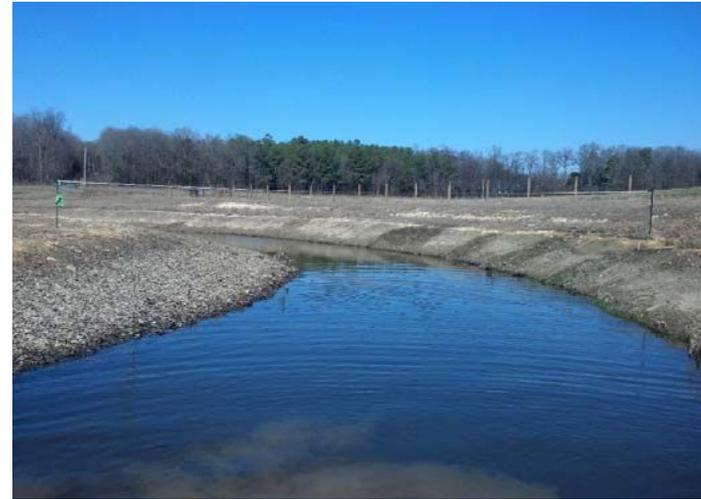
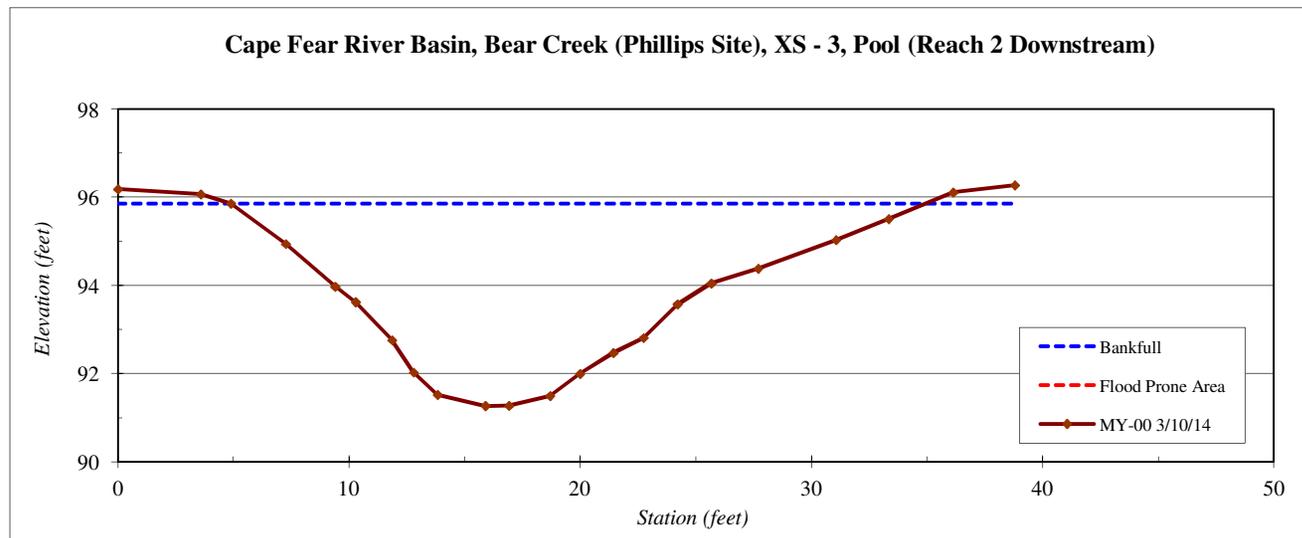
<b>River Basin:</b>	Cape Fear
<b>Site Name</b>	Bear Creek (Phillips Site)
<b>XS ID</b>	XS - 3, Pool (Reach 2 Downstream)
<b>Drainage Area (sq mi):</b>	4.99
<b>Date:</b>	3/10/2014
<b>Field Crew:</b>	Perkinson, Jernigan

SUMMARY DATA	
<b>Bankfull Elevation:</b>	95.9
<b>Bankfull Cross-Sectional Area:</b>	70.0
<b>Bankfull Width:</b>	30.1
<b>Flood Prone Area Elevation:</b>	-
<b>Flood Prone Width:</b>	-
<b>Max Depth at Bankfull:</b>	4.6
<b>Mean Depth at Bankfull:</b>	2.3
<b>W / D Ratio:</b>	-
<b>Entrenchment Ratio:</b>	-
<b>Bank Height Ratio:</b>	1.0

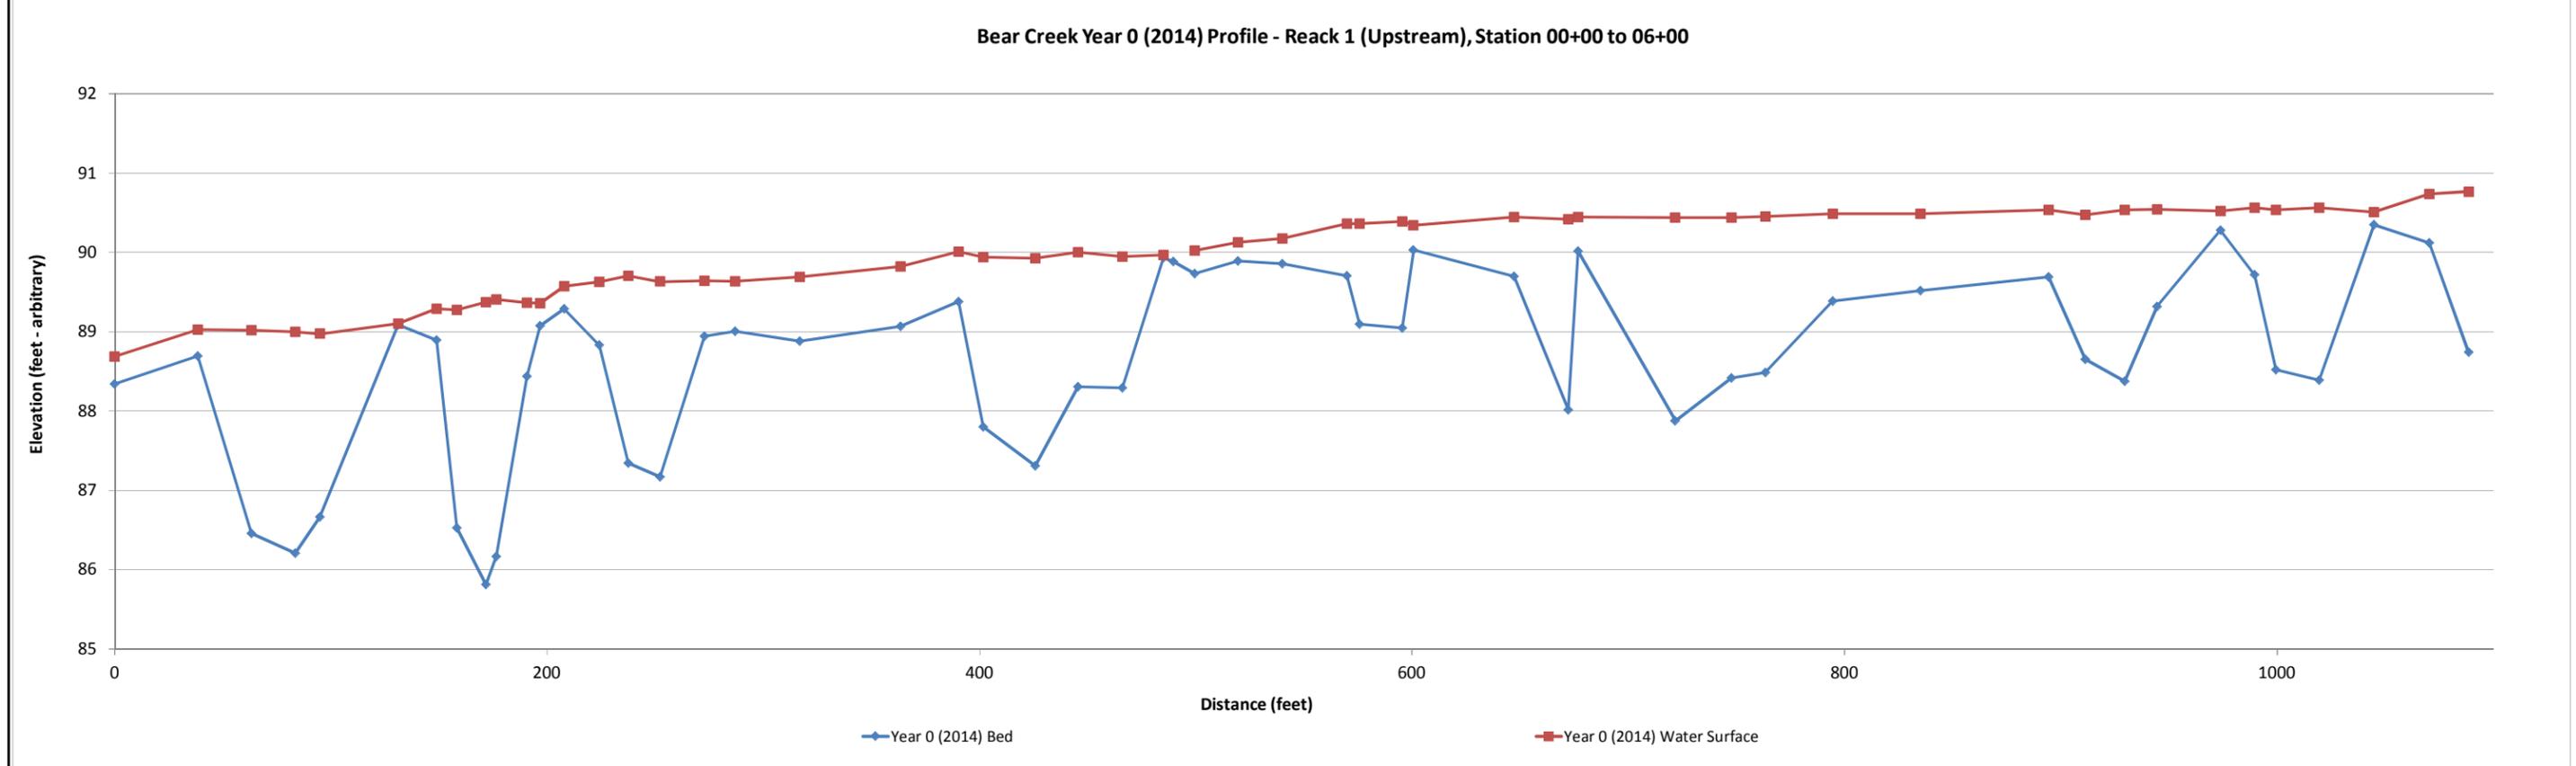
**Project Name** Bear Creek - Profile  
**Reach** Reach 1 (Upstream) Station 00+00 - 11+00  
**Feature** Profile  
**Date** 3/10/14  
**Crew** Perkinson, Jernigan

<b>Avg. Water Surface Slope</b>	2014	2014	2015	2016	2017
<b>Riffle Length</b>	0.0017				
<b>Avg. Riffle Slope</b>	57				
<b>Pool Length</b>	0.0053				
<b>Pool to Pool Spacing</b>	26				
	115

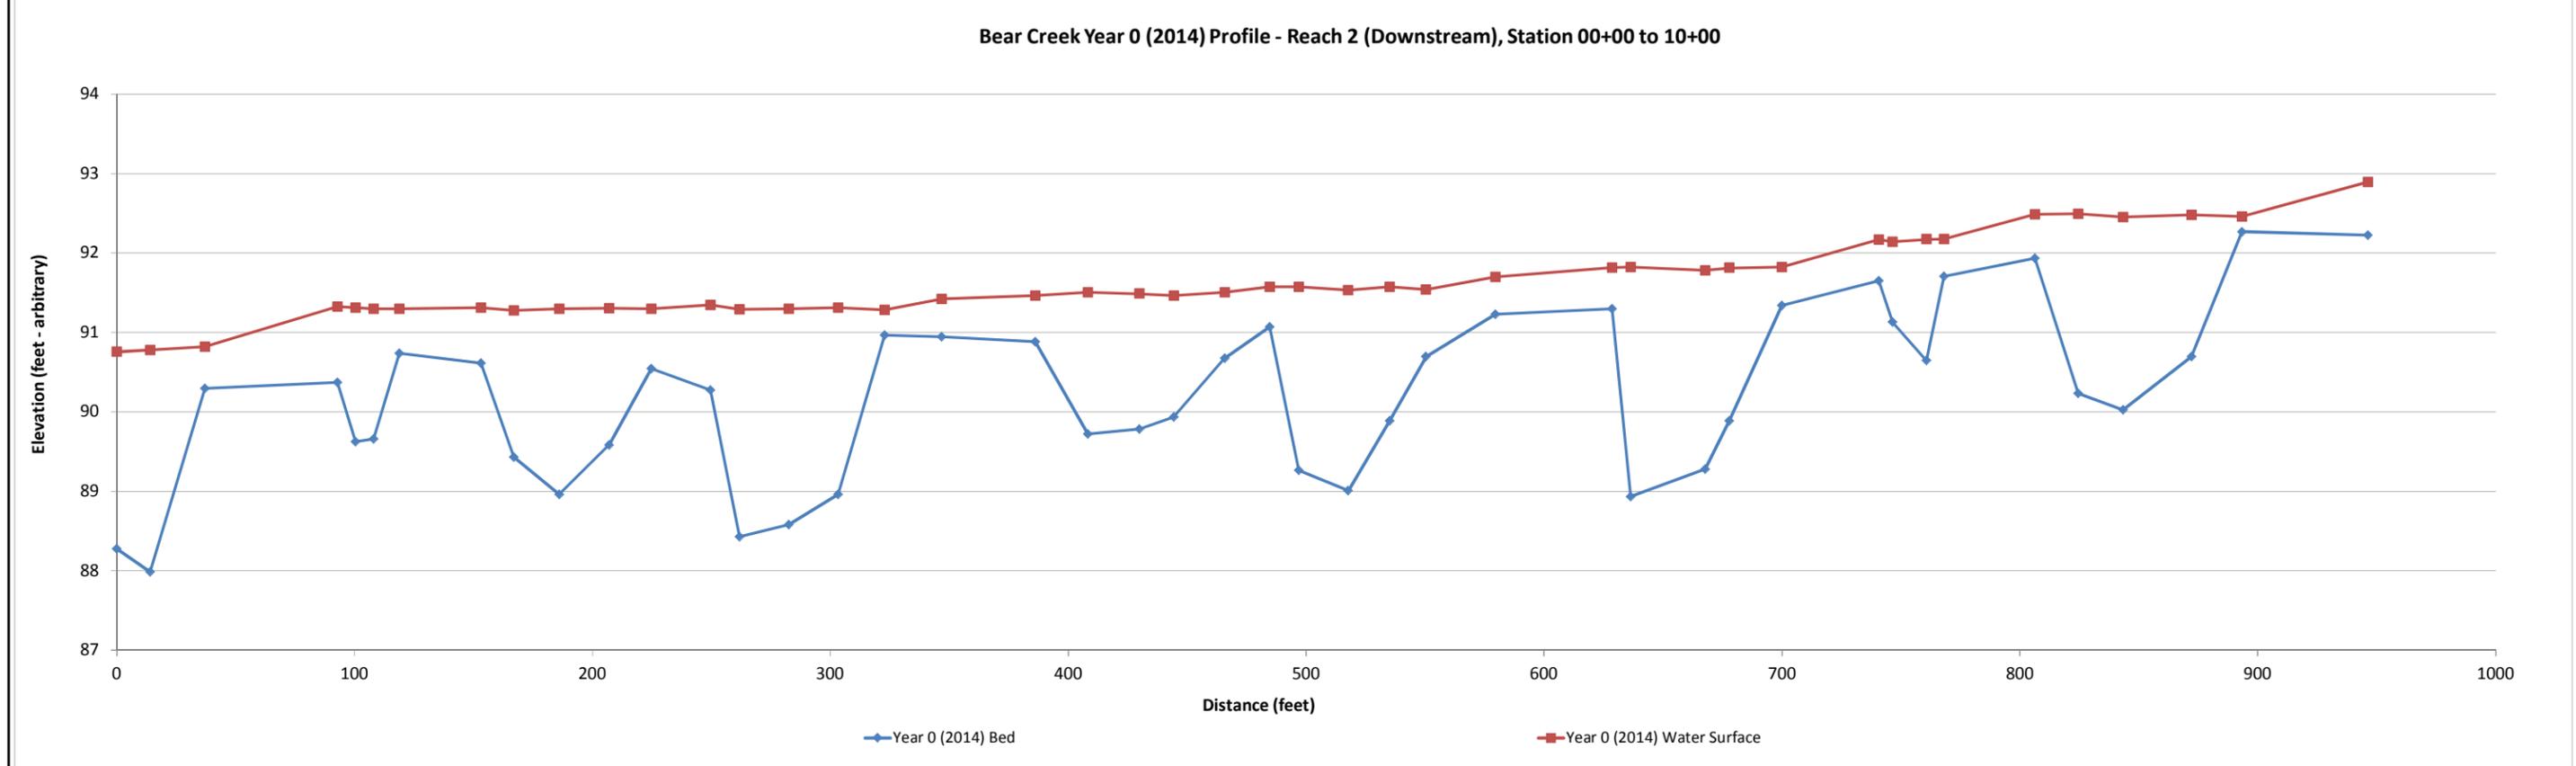
**Project Name** Bear Creek - Profile  
**Reach** Reach 2 (Downstream) Station 00+00 - 10+00  
**Feature** Profile  
**Date** 3/10/14  
**Crew** Perkinson, Jernigan

<b>Avg. Water Surface Slope</b>	2014	2014	2015	2016	2017
<b>Riffle Length</b>	0.0019				
<b>Avg. Riffle Slope</b>	45				
<b>Pool Length</b>	0.0052				
<b>Pool to Pool Spacing</b>	33				
	107

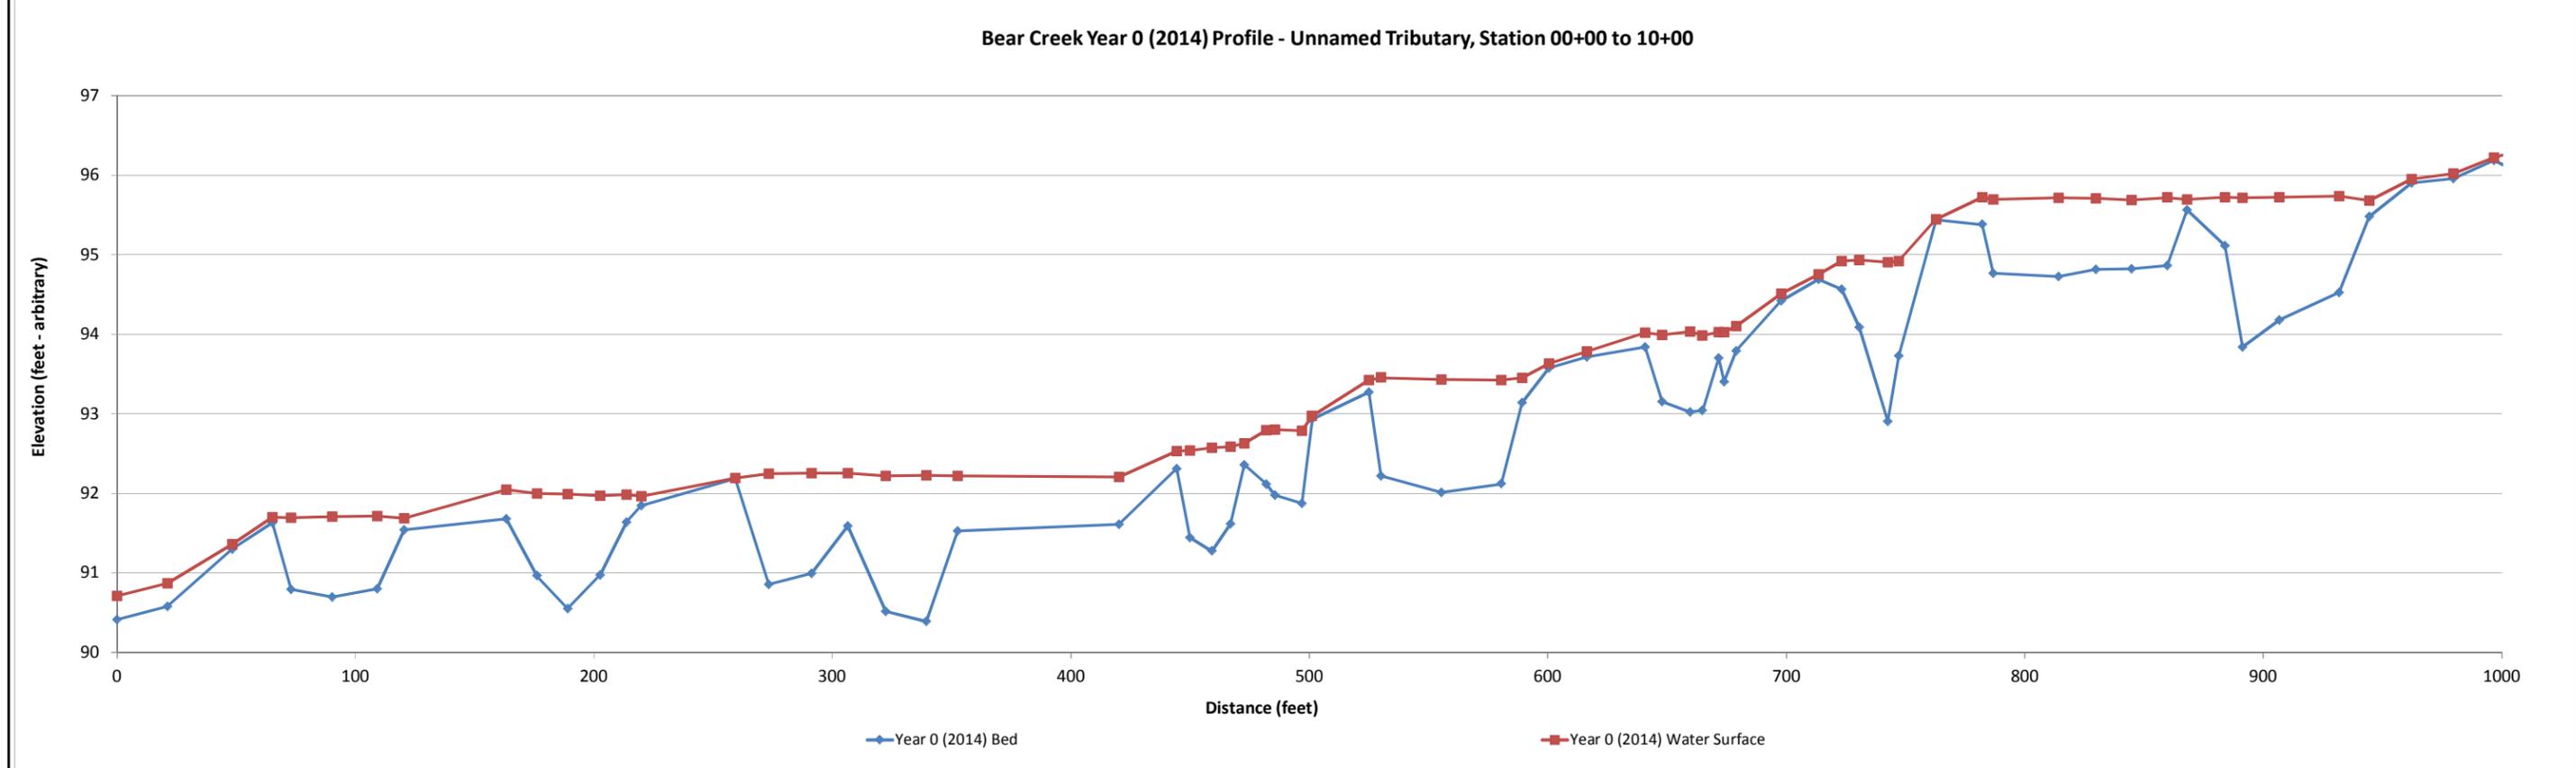
Project Name	Bear Creek - Profile
Reach	UT to Bear Creek Station 00+00 - 10+00
Feature	Profile
Date	3/10/14
Crew	Perkinson, Jernigan

Avg. Water Surface Slope	2014	2014	2015	2016	2017
Riffle Length	0.0041				
Avg. Riffle Slope	35				
Pool Length	0.0081				
Pool to Pool Spacing	23				
	69

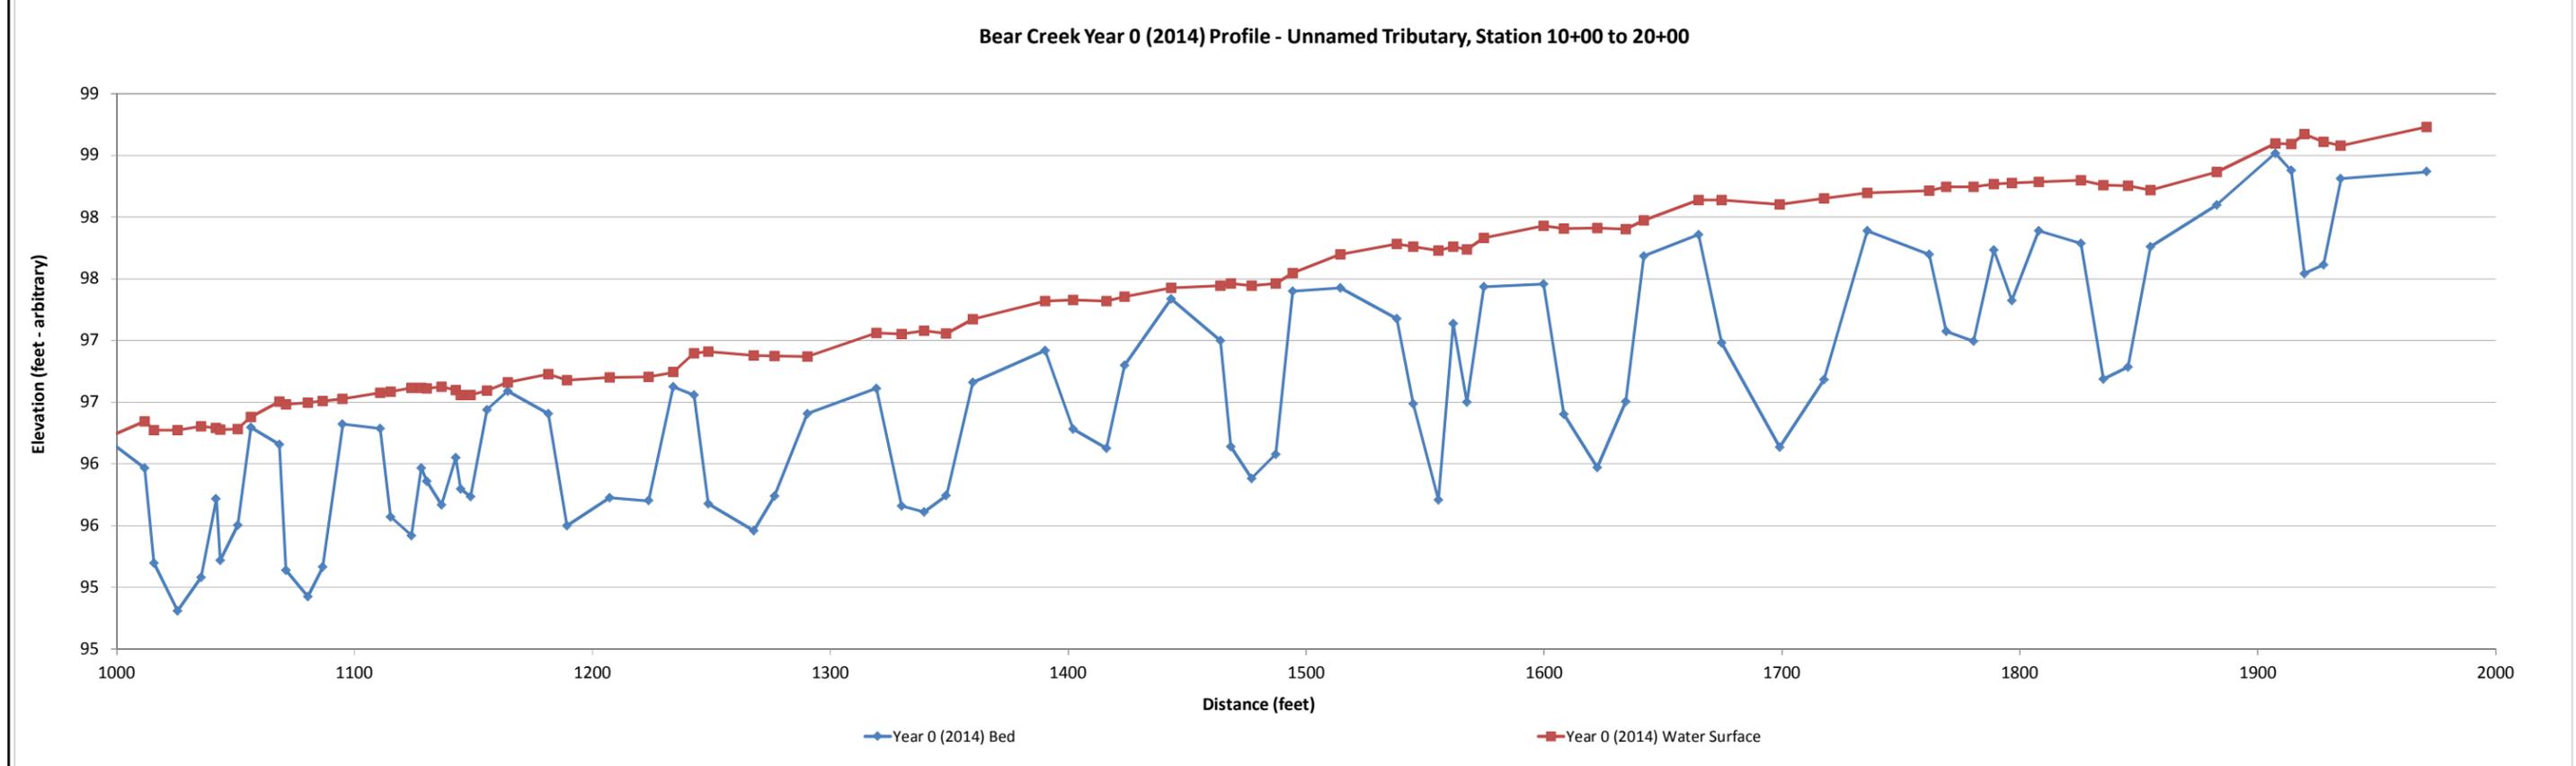
**Project Name** Bear Creek - Profile  
**Reach** UT to Bear Creek Station 10+00 - 20+00  
**Feature** Profile  
**Date** 3/10/14  
**Crew** Perkinson, Jernigan

<b>Avg. Water Surface Slope</b>	2014	2014	2015	2016	2017
<b>Riffle Length</b>	0.0041				
<b>Avg. Riffle Slope</b>	35				
<b>Pool Length</b>	0.0081				
<b>Pool to Pool Spacing</b>	23				
	69
