# FINAL MITIGATION PLAN

**The Best Site Stream and Wetland Restoration Project  
Duplin County, North Carolina  
EEP Project # 95353**

**Cape Fear River Basin  
CU 03030007**

October 2013

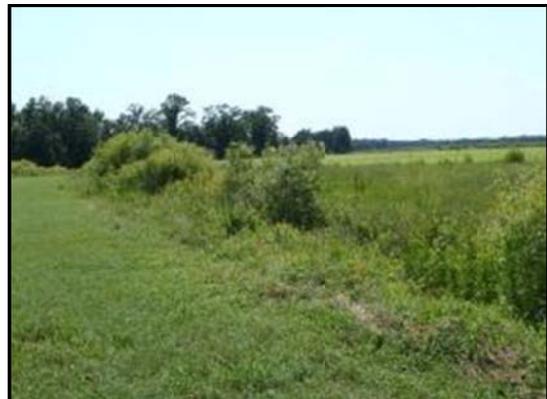
*Downstream view of UT 1.*

UT1 has a drainage area of 0.06 square miles (41 acres), and flows in a southerly direction through cultivated fields and pasture to the confluence with Muddy Creek. The planform of this G-type channel is generally straight and is entrenched throughout. The approximate bankfull cross-sectional area is 3.2 square feet with approximate dimensions of 5.1 feet wide and 0.6 feet deep, while the cross-sectional area of the channel at top of bank is 22.8 square feet. The existing length of UT1 is 1,854 linear feet, and the dominant bed material is fine sand. The gradient of the reach is approximately 0.0066 ft/ft. The reach is severely oversized and exhibits moderately unstable banks. The riparian buffer is primarily comprised of pasture grasses with some shrubby vegetation growing within the channel. The channel scored 32.5 points on the NCDWQ Stream Identification Form (Version 4.11).

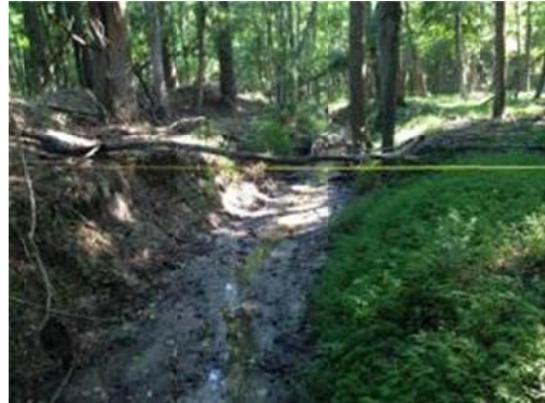
*Downstream view of UT4.*

UT4 is a stable to moderately stable channel located to the west of UT3 and discharges to Muddy Creek. This reach has a drainage area of 0.13 square miles (82 acres) and has a slope of 0.0042 ft/ft. The upstream of a farm crossing has been significantly altered by ditching and agricultural activities. The historic valley is present, but has been hydrologically isolated from the contributing watershed by ditching. In addition, cattle access has led to habitat degradation and sediment input to the downstream channel. This section is a G-type channel and has an approximate bankfull cross-sectional area of 6.4 square feet and an area of 26.8 square feet at top of bank.

The channel downstream of the crossing is relatively stable and exhibits a meandering pattern. UT4 has a fine sand bed and is an E5 stream type downstream of the culvert. The channel is typically 7.5 feet wide and 1.0 foot deep. Due to the stable nature of the downstream reach of UT4, Stream Preservation and Buffer Enhancement is proposed from just downstream of the crossing to the confluence with Muddy Creek. Headwater Valley Restoration is proposed upstream of the crossing. The channel scored 33.75 points on the NCDWQ Stream Identification Form (Version 4.11).

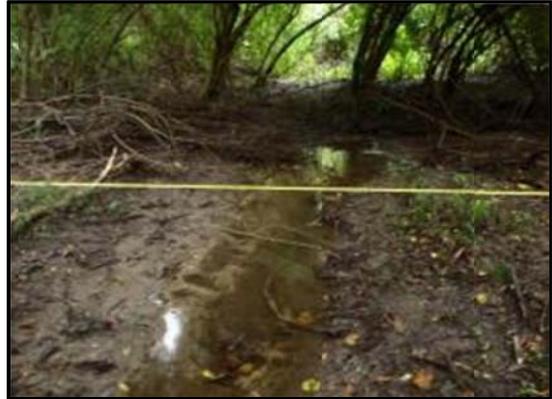
*Downstream view of UT7.*

UT7 is a stable, meandering channel that flows in a southerly direction east of Lyman Road down to its confluence with UT5 before discharging to Muddy Creek. UT7 has a drainage area of 0.60 square miles (387 acres) and has an existing length 3,183 linear feet. The riparian buffer is comprised of an intact hardwood forest with localized areas of privet and provides a variety of aquatic and terrestrial habitats. The reach is a C5 stream type, has an average cross-sectional area of 6.1 square feet, and a slope of 0.0040 ft/ft. The channel scored 38.5 points on the NCDWQ Stream Identification Form (Version 4.11).

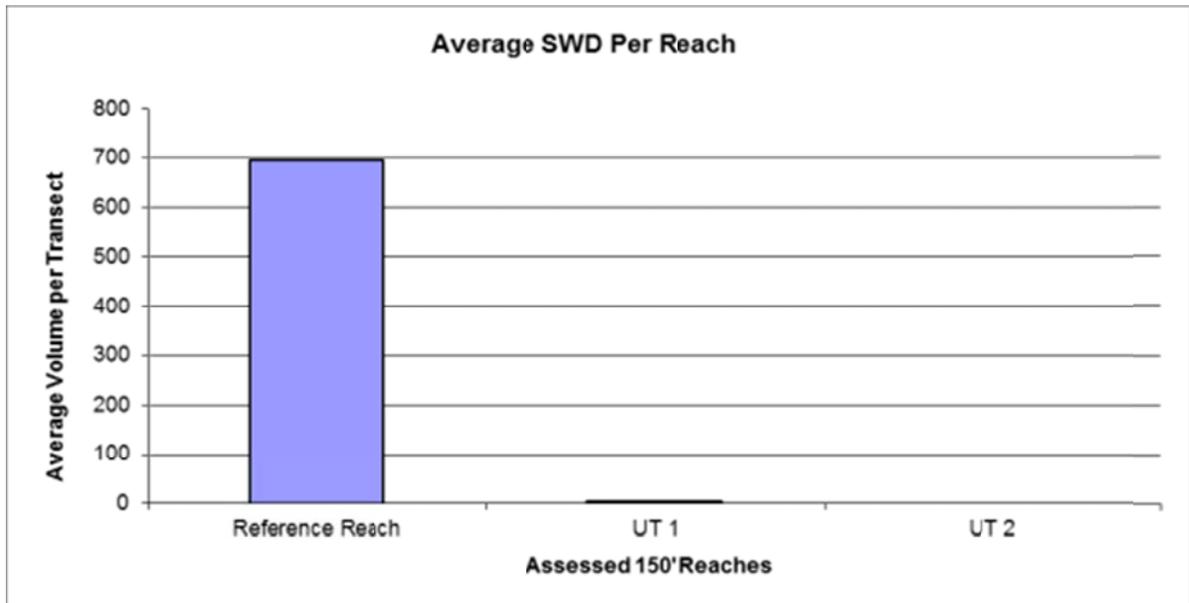
**Chart 1.** Average volume (cubic inches) of SWD per assessed reach. This chart represents existing conditions in all assessed reaches.

In addition to the habitat assessment conducted at the reference site, Reaches UT1 and UT2 of the project site were assessed in order to measure representative habitat gains over time post-construction. Based on these assessments, there is a large disparity of SWD volume between the reference reach and the design reaches (**Chart 1**). Small woody debris assessment results for Reaches UT1 and UT2 were very low compared to the reference reach results. Due to Reaches UT1 and UT2 flowing through open agricultural fields, no adjacent buffers are present to contribute woody debris. The only woody debris present is washed in from upstream.

Woody debris collected in streams provides habitat for macroinvertebrates, fish, and amphibians, and increases stream productivity by retaining carbon in the channel. While it would be difficult to replicate the volume and spatial distribution of SWD found in the reference channel, this quantitative habitat assessment provides guidance for improving habitat conditions through specifically placed and sized SWD structures, and provides a means for assessing functional gains over time. WK Dickson has included these structures in the design plans (**Appendix D**).

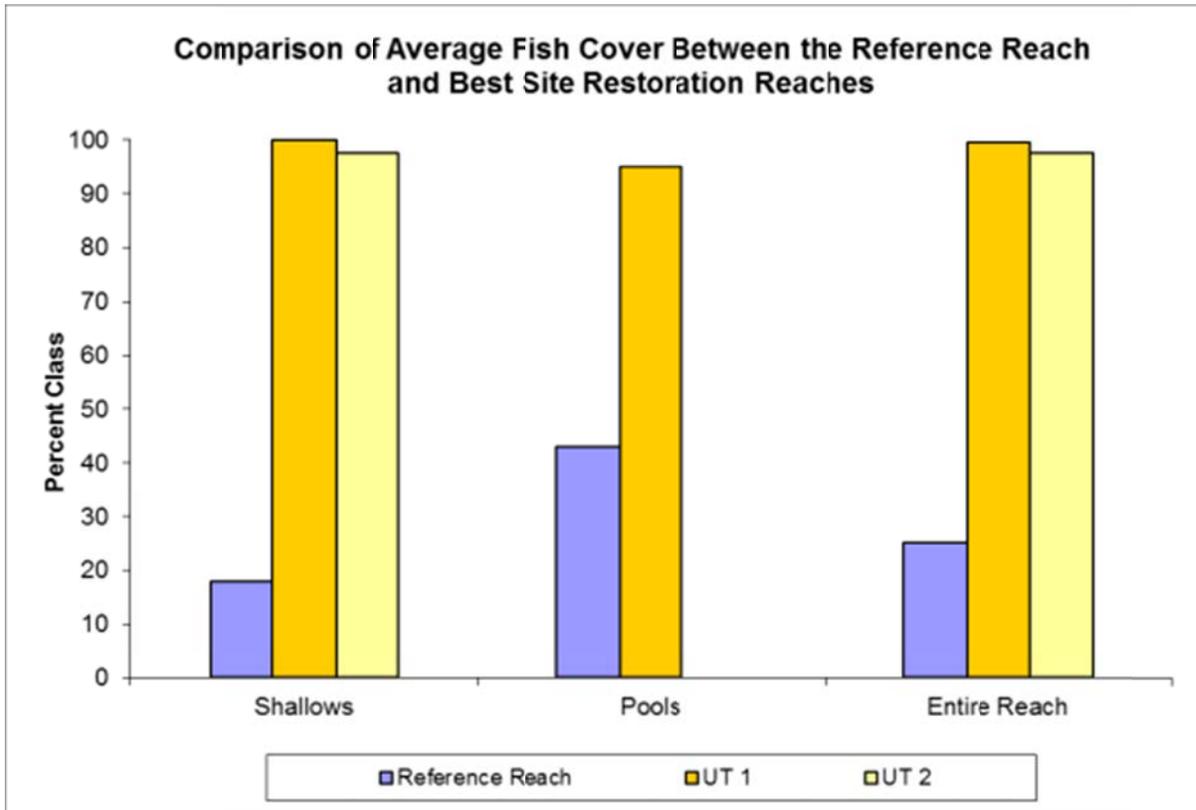
**Chart 2.** Average percent of fish cover per channel bed form type in the reference reach

Fish cover measurements were taken at each transect along the reference reach and Best Site Reaches UT1 and UT2. Fish cover area was visually calculated within the ten-foot transect length. Fish cover types include small woody debris and brush, aquatic macrophytes, overhanging vegetation, undercut banks, and boulders. For each transect a percentage of total fish cover and individual cover type areas were calculated (**Chart 2**). Location and general habitat data was recorded for each fish cover measurement to assess spatial distribution.

The fish cover analysis revealed that the average area of fish cover is nearly four times as high in Best Site Reaches UT1 and UT2 as in the reference reach. This is because the streambed along the assessed portion of Reach UT1 and UT2 was mostly covered by macrophytic vegetation and was devoid of any significant woody debris or undercut banks. Fish cover from low growing brush will increase in the restoration reaches after the riparian planting occurs. Woody debris structures will also provide additional fish cover habitat and resting areas for fish swimming upstream.

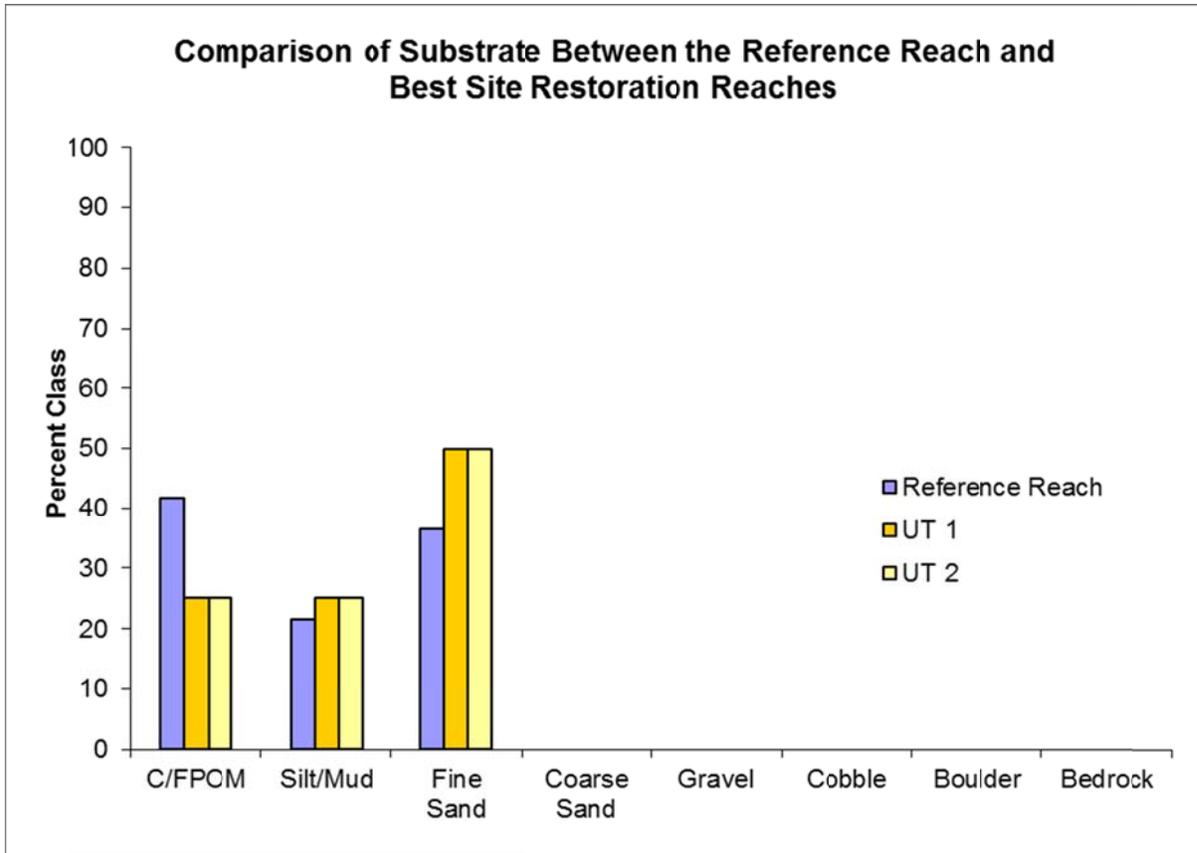
**Chart 3.** Comparison of substrate composition between the reference reach and the restoration reaches.

Substrates were divided into eight classes as follows: coarse/fine particulate organic matter, silt/clay/muck, fine sand, coarse sand, gravel, cobble, boulder, and bedrock (**Chart 3**). Channel width and water depth were measured at each transect in four equally spaced intervals from bank to bank. Substrate coverage was visually determined between widths measured at each major change in substrate type.

The substrate composition analysis revealed that the reference reach has slightly more organic matter substrate (C/FPOM) than UT1 and UT2. These differences may be attributed to a couple of factors, including the maturity and close proximity of riparian plants to the reference reach, and channelization of UT1 and UT2 which typically results in flushing of organic matter and a lack of carbon retention. Macroinvertebrate abundance and diversity has been tied to the ability of a channel to retain carbon. Several design structures and vegetation plantings can be used to increase organic substrate composition. Constructed leaf packs will be installed in select locations for immediate macroinvertebrate colonization. SWD bundles will serve to collect organic matter flowing downstream increasing carbon retention. By adding sinuosity and creating a better floodplain connection, adding SWD in select locations, and creating pool habitats, substrate composition will more closely resemble reference reach conditions.

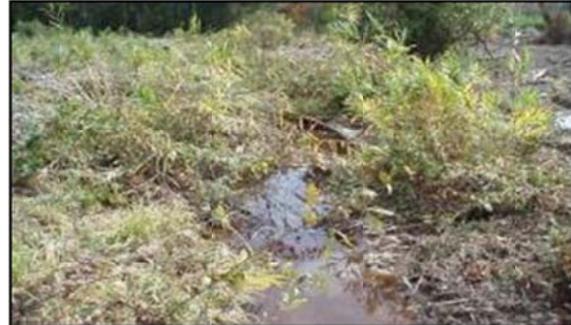
*Sod mats blanket the top of bank of this stream in Bertie County.*

Structures will be incorporated into the channel design to provide additional stability and improve aquatic habitat. Native materials and vegetation will be used for revetments and grade control structures where applicable. Additionally, woody debris will be placed throughout the channel at locations and at a frequency that is similar to those mapped in the analog reaches. The analog reach has woody debris throughout the length of the channel, providing grade control for shallows and forcing scour pools.

Woody habitat features installed will include leaf packs, dead brush, woody debris bundles, root wads, and wattles. Sod mats harvested onsite will be installed along stream banks during construction if and when feasible. Sod mats will only be harvested and used if comprised of appropriate vegetation. The use of sod mats that include aggressive turf grasses will be avoided. Sod mats (see photo above) are natural sections of vegetation taken from the banks when they were cut during construction, and are about nine inches thick. Before installation, proposed banks are graded lower than specified to accommodate the thickness of the mat. The mats are placed on top of the bank to act as a natural stabilizer of native species, and they grow much faster than the combination of coir fiber matting and seeding (see detail **Appendix D**). Other bank stability measures include the installation of cuttings bundles at three to five foot intervals along the tops of banks, live staking, root wads, and log toes. Typical details for proposed in-stream structures and revetments are in **Appendix D**.
