**FINAL**  
**MITIGATION PLAN**

**FLETCHER MITIGATION SITE**

**Henderson County, NC**

**Project No. 100004**

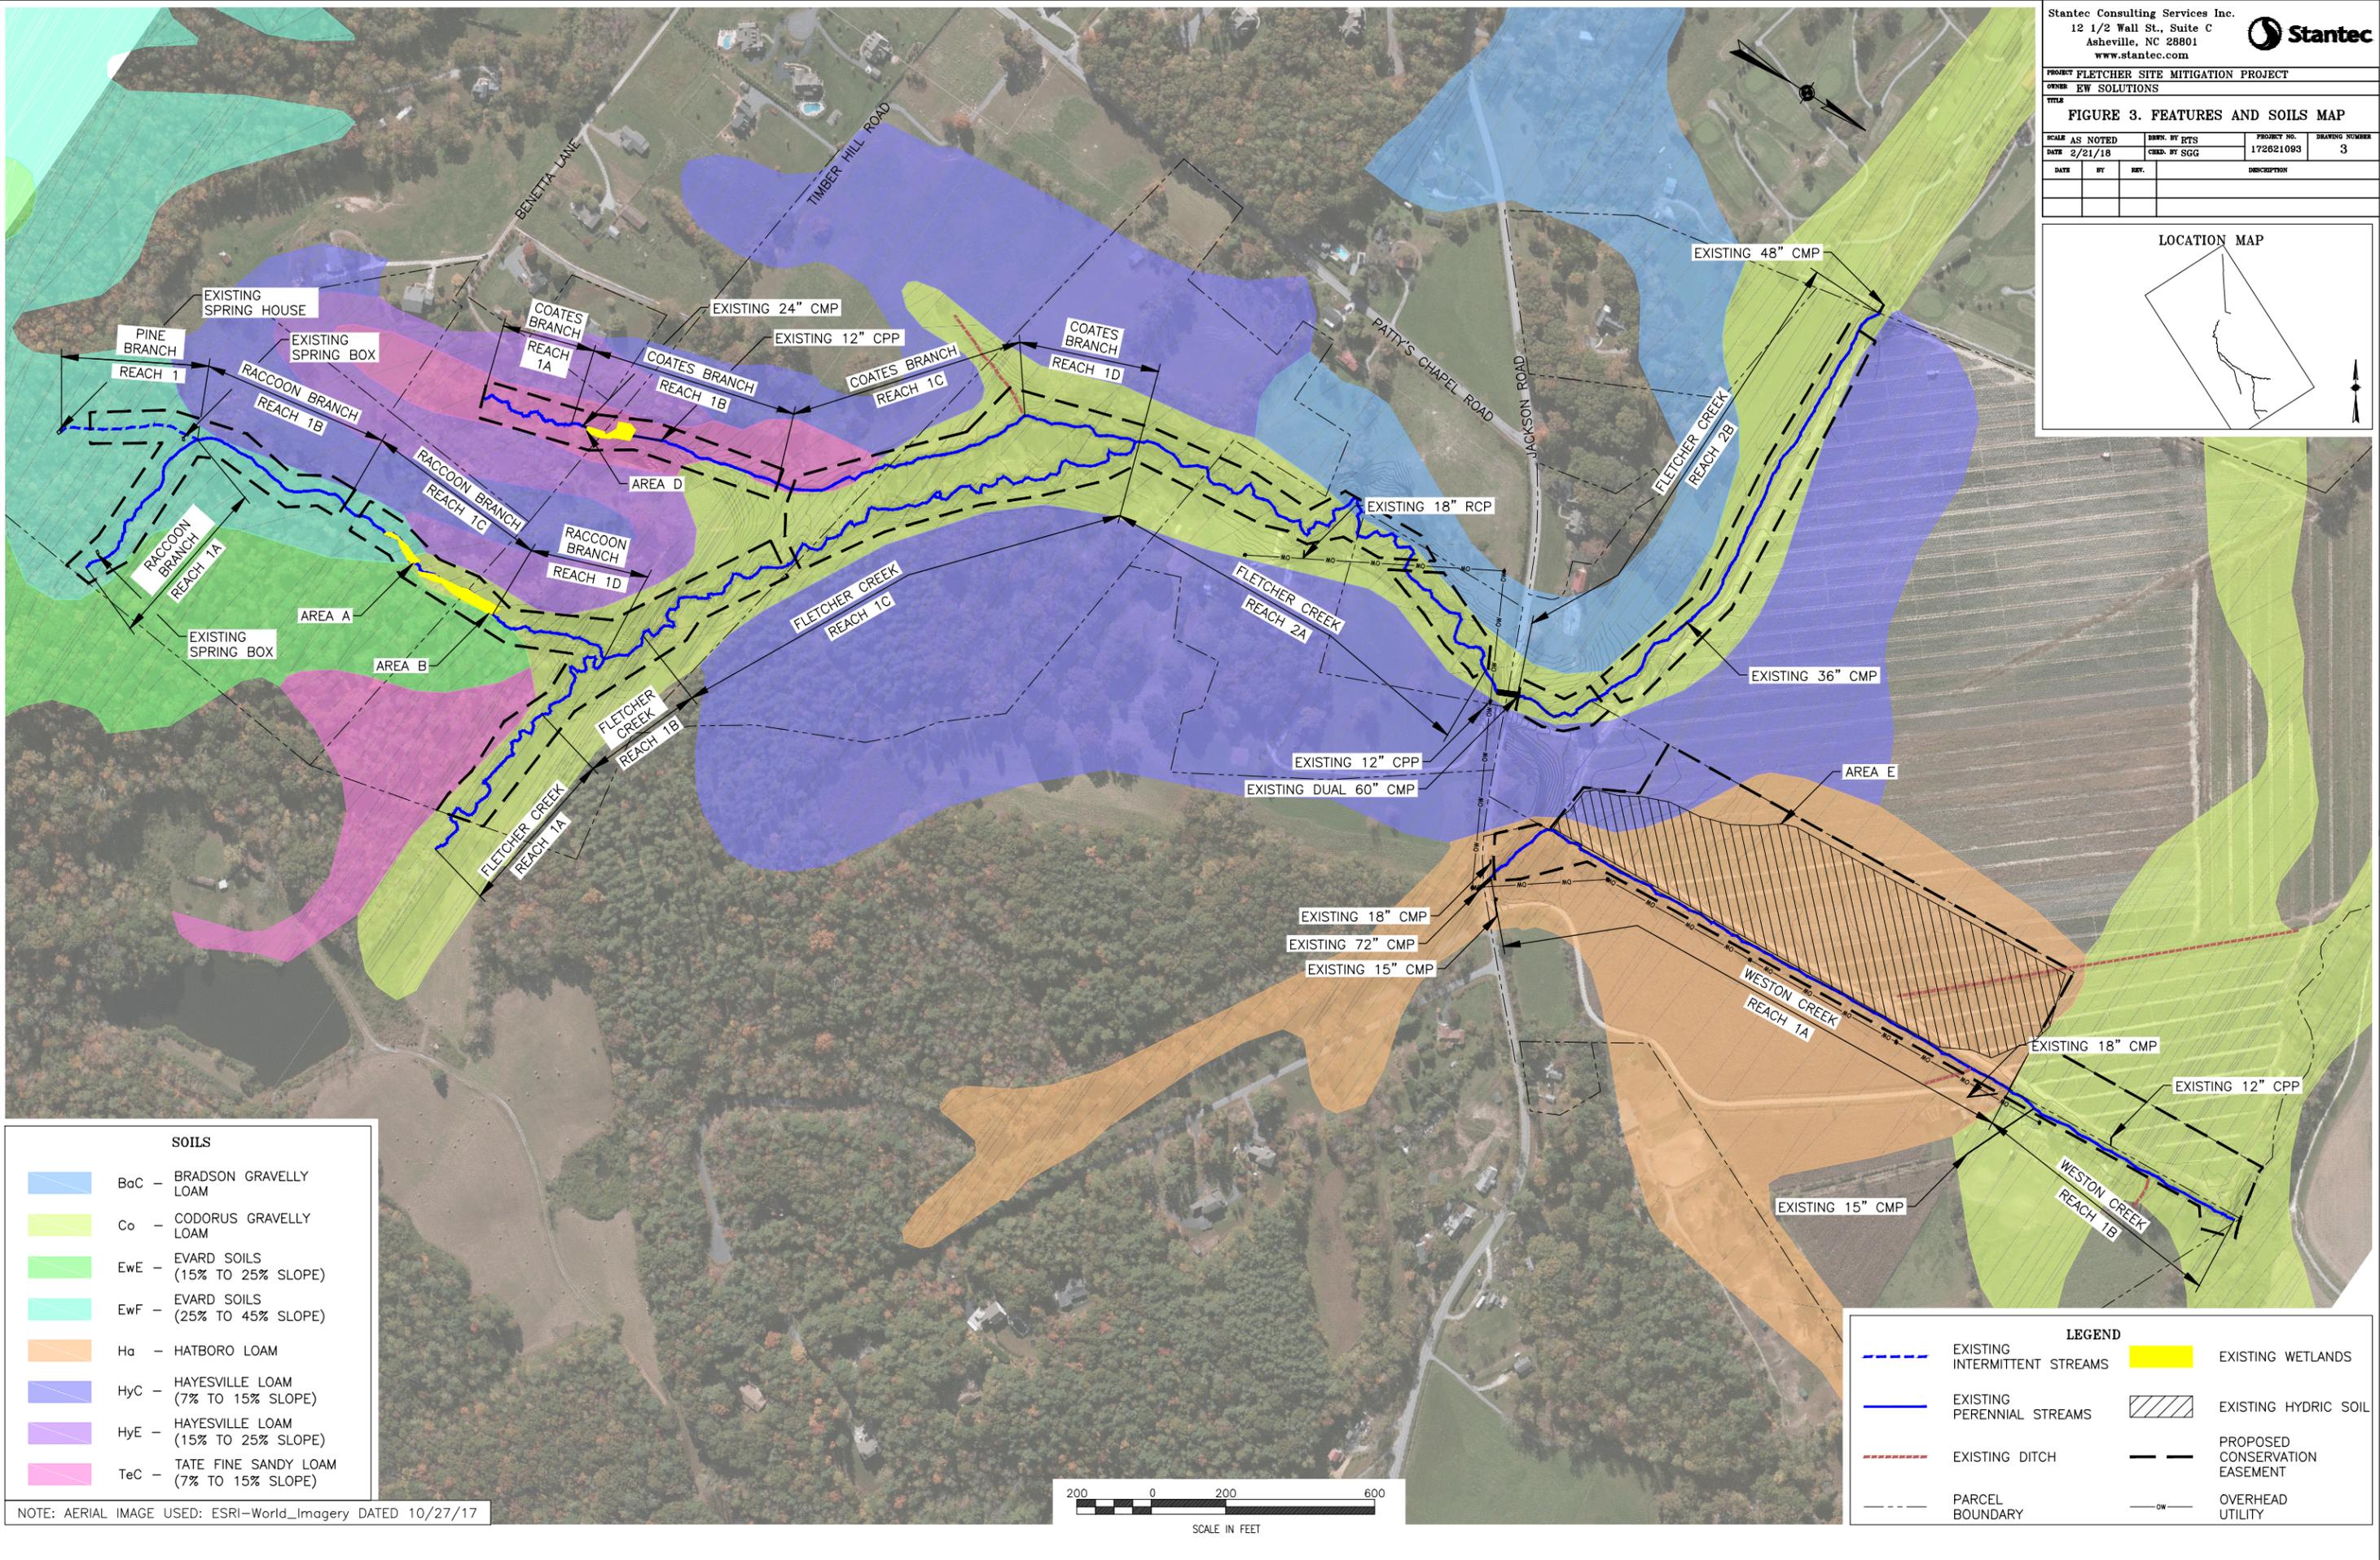
PROJECT FLETCHER SITE MITIGATION PROJECT			
OWNER EW SOLUTIONS			
TITLE <b>FIGURE 3. FEATURES AND SOILS MAP</b>			
SCALE AS NOTED	DRWN. BY RTS	PROJECT NO.	DRAWING NUMBER
DATE 2/21/18	CRD. BY SGG	172621093	3
DATE	BY	REV.	DESCRIPTION

SOILS	
	BaC - BRADSON GRAVELLY LOAM
	Co - CODORUS GRAVELLY LOAM
	EwE - EVARD SOILS (15% TO 25% SLOPE)
	EwF - EVARD SOILS (25% TO 45% SLOPE)
	Ha - HATBORO LOAM
	HyC - HAYESVILLE LOAM (7% TO 15% SLOPE)
	HyE - HAYESVILLE LOAM (15% TO 25% SLOPE)
	TeC - TATE FINE SANDY LOAM (7% TO 15% SLOPE)

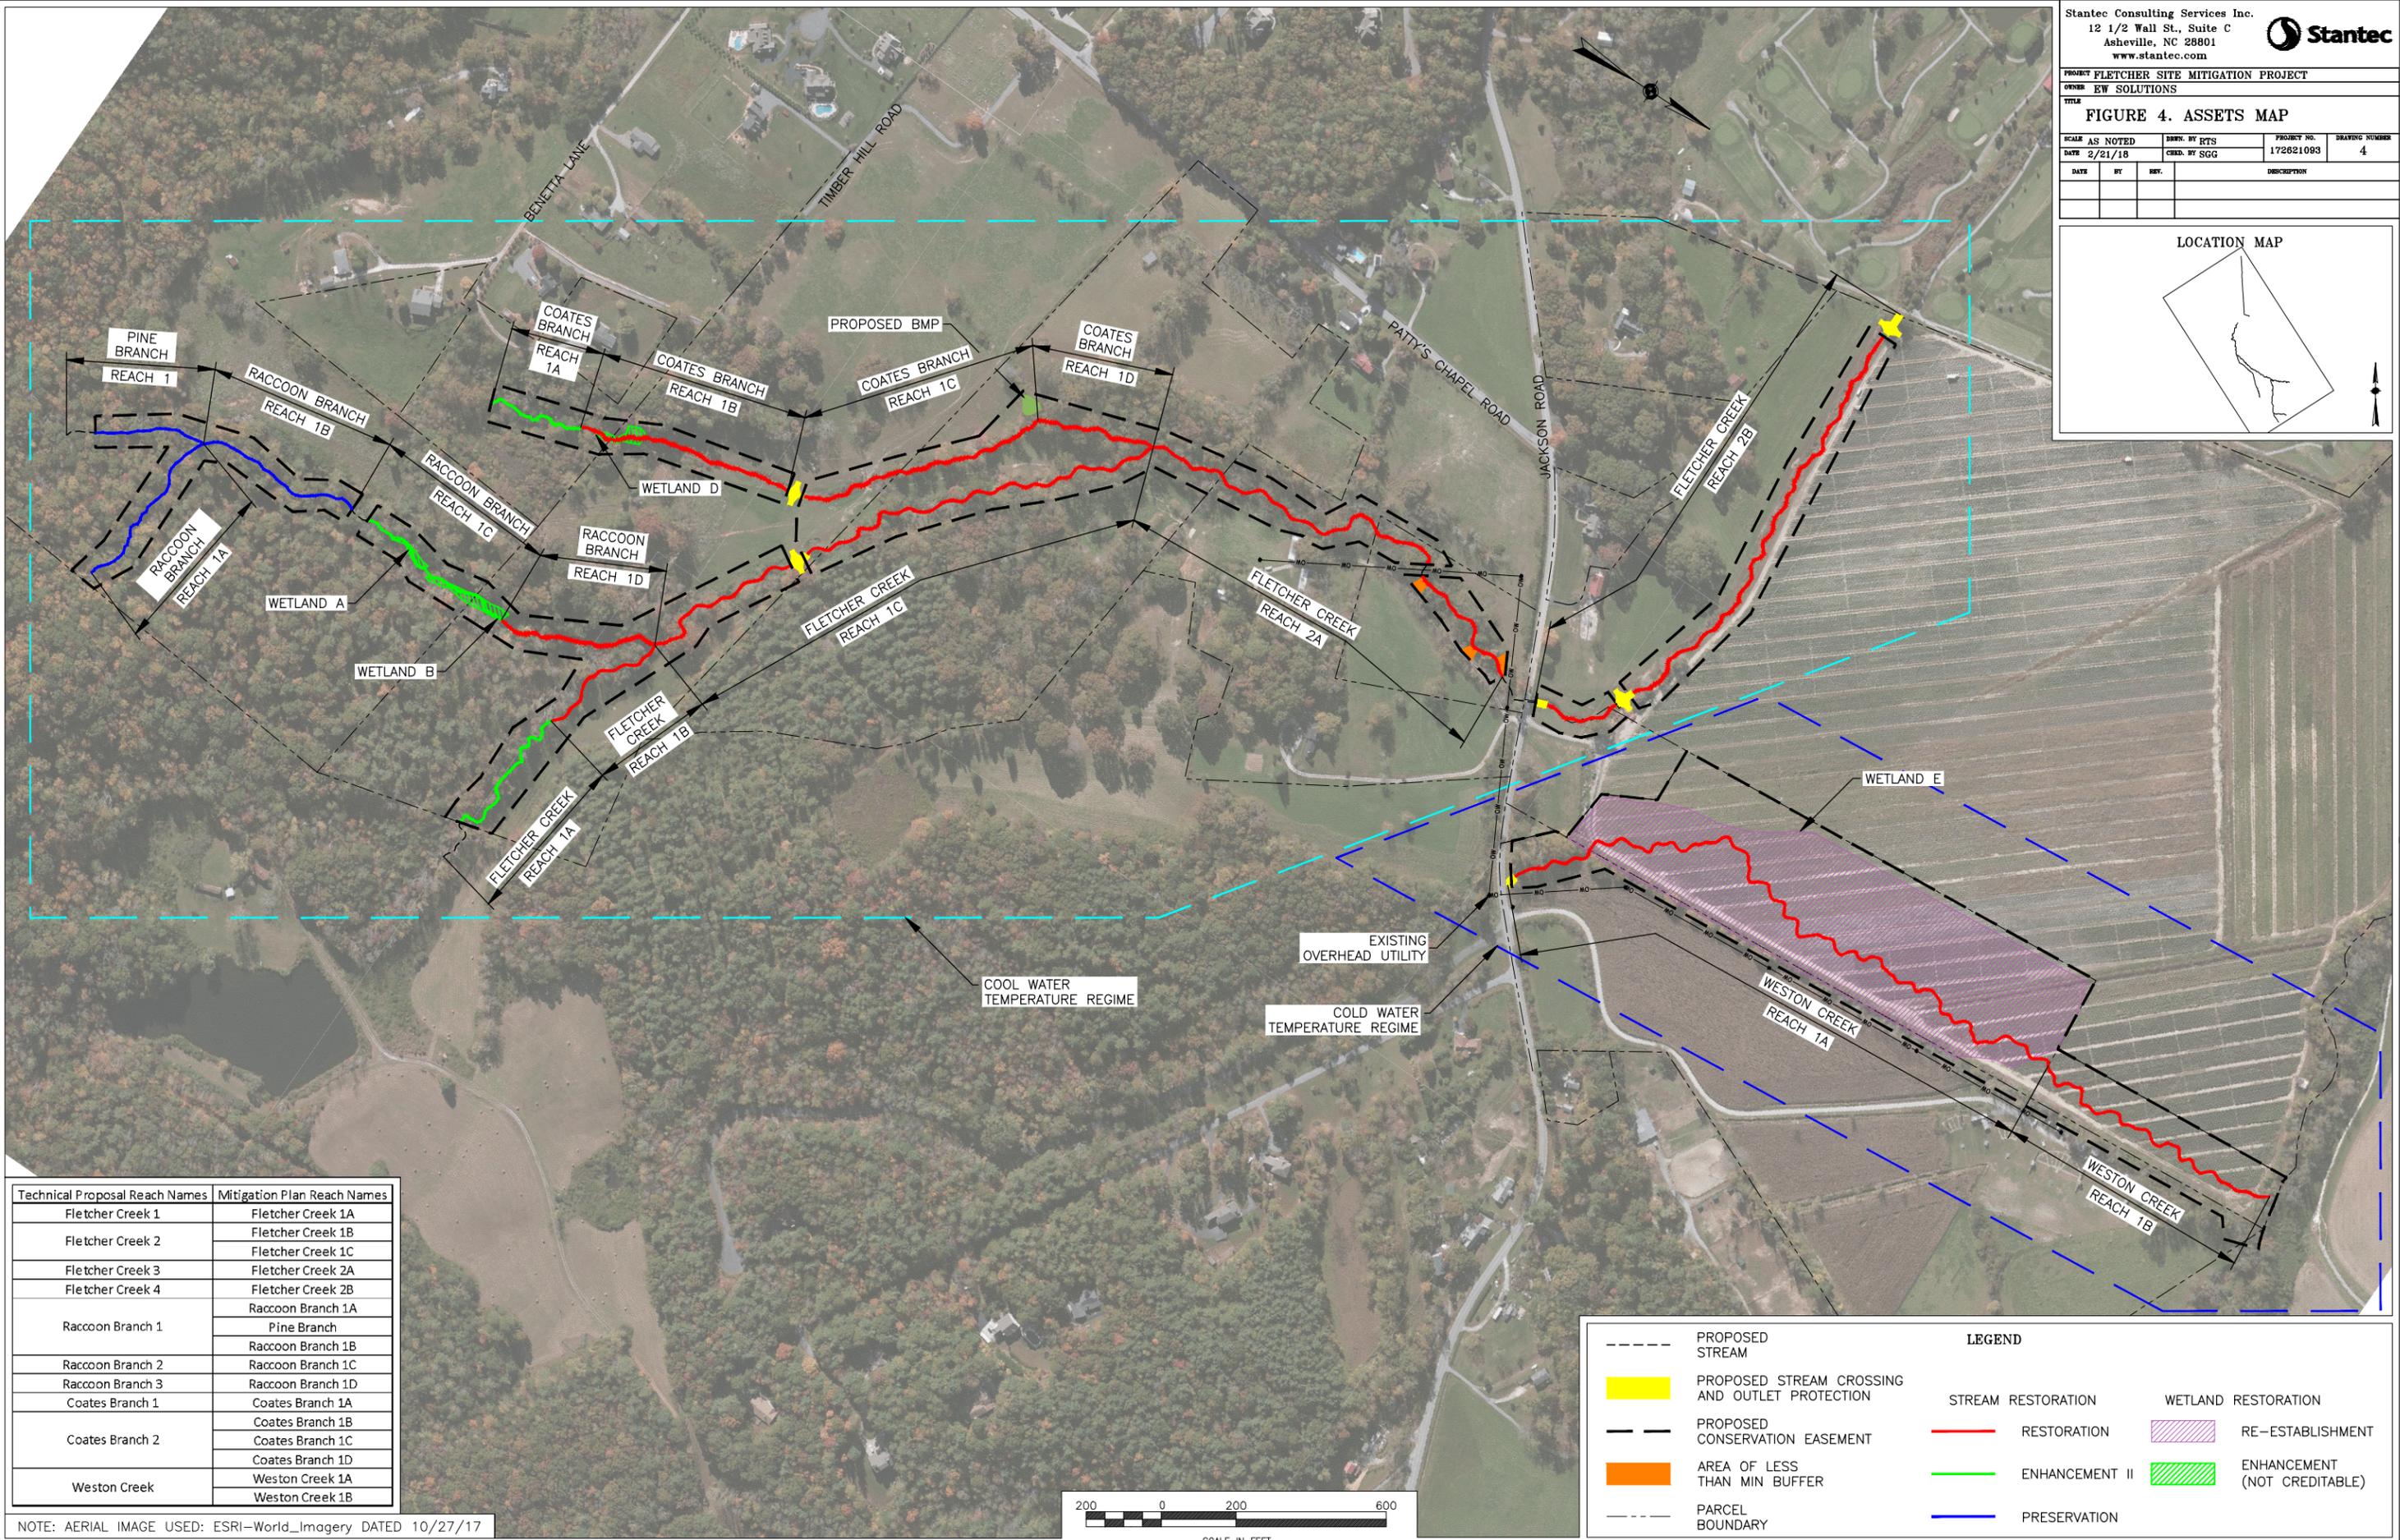
PROJECT FLETCHER SITE MITIGATION PROJECT			
OWNER EW SOLUTIONS			
TITLE			
FIGURE 4. ASSETS MAP			
SCALE AS NOTED	DRWN. BY RTS	PROJECT NO.	DRAWING NUMBER
DATE 2/21/18	CRD. BY SGG	172621093	4
DATE	BY	REV.	DESCRIPTION

Technical Proposal Reach Names	Mitigation Plan Reach Names
Fletcher Creek 1	Fletcher Creek 1A
Fletcher Creek 2	Fletcher Creek 1B
Fletcher Creek 3	Fletcher Creek 1C
Fletcher Creek 4	Fletcher Creek 2A
	Fletcher Creek 2B
Raccoon Branch 1	Raccoon Branch 1A
	Raccoon Branch 1B
Raccoon Branch 2	Raccoon Branch 1C
Raccoon Branch 3	Raccoon Branch 1D
Coates Branch 1	Coates Branch 1A
	Coates Branch 1B
Coates Branch 2	Coates Branch 1C
	Coates Branch 1D
Weston Creek	Weston Creek 1A
	Weston Creek 1B

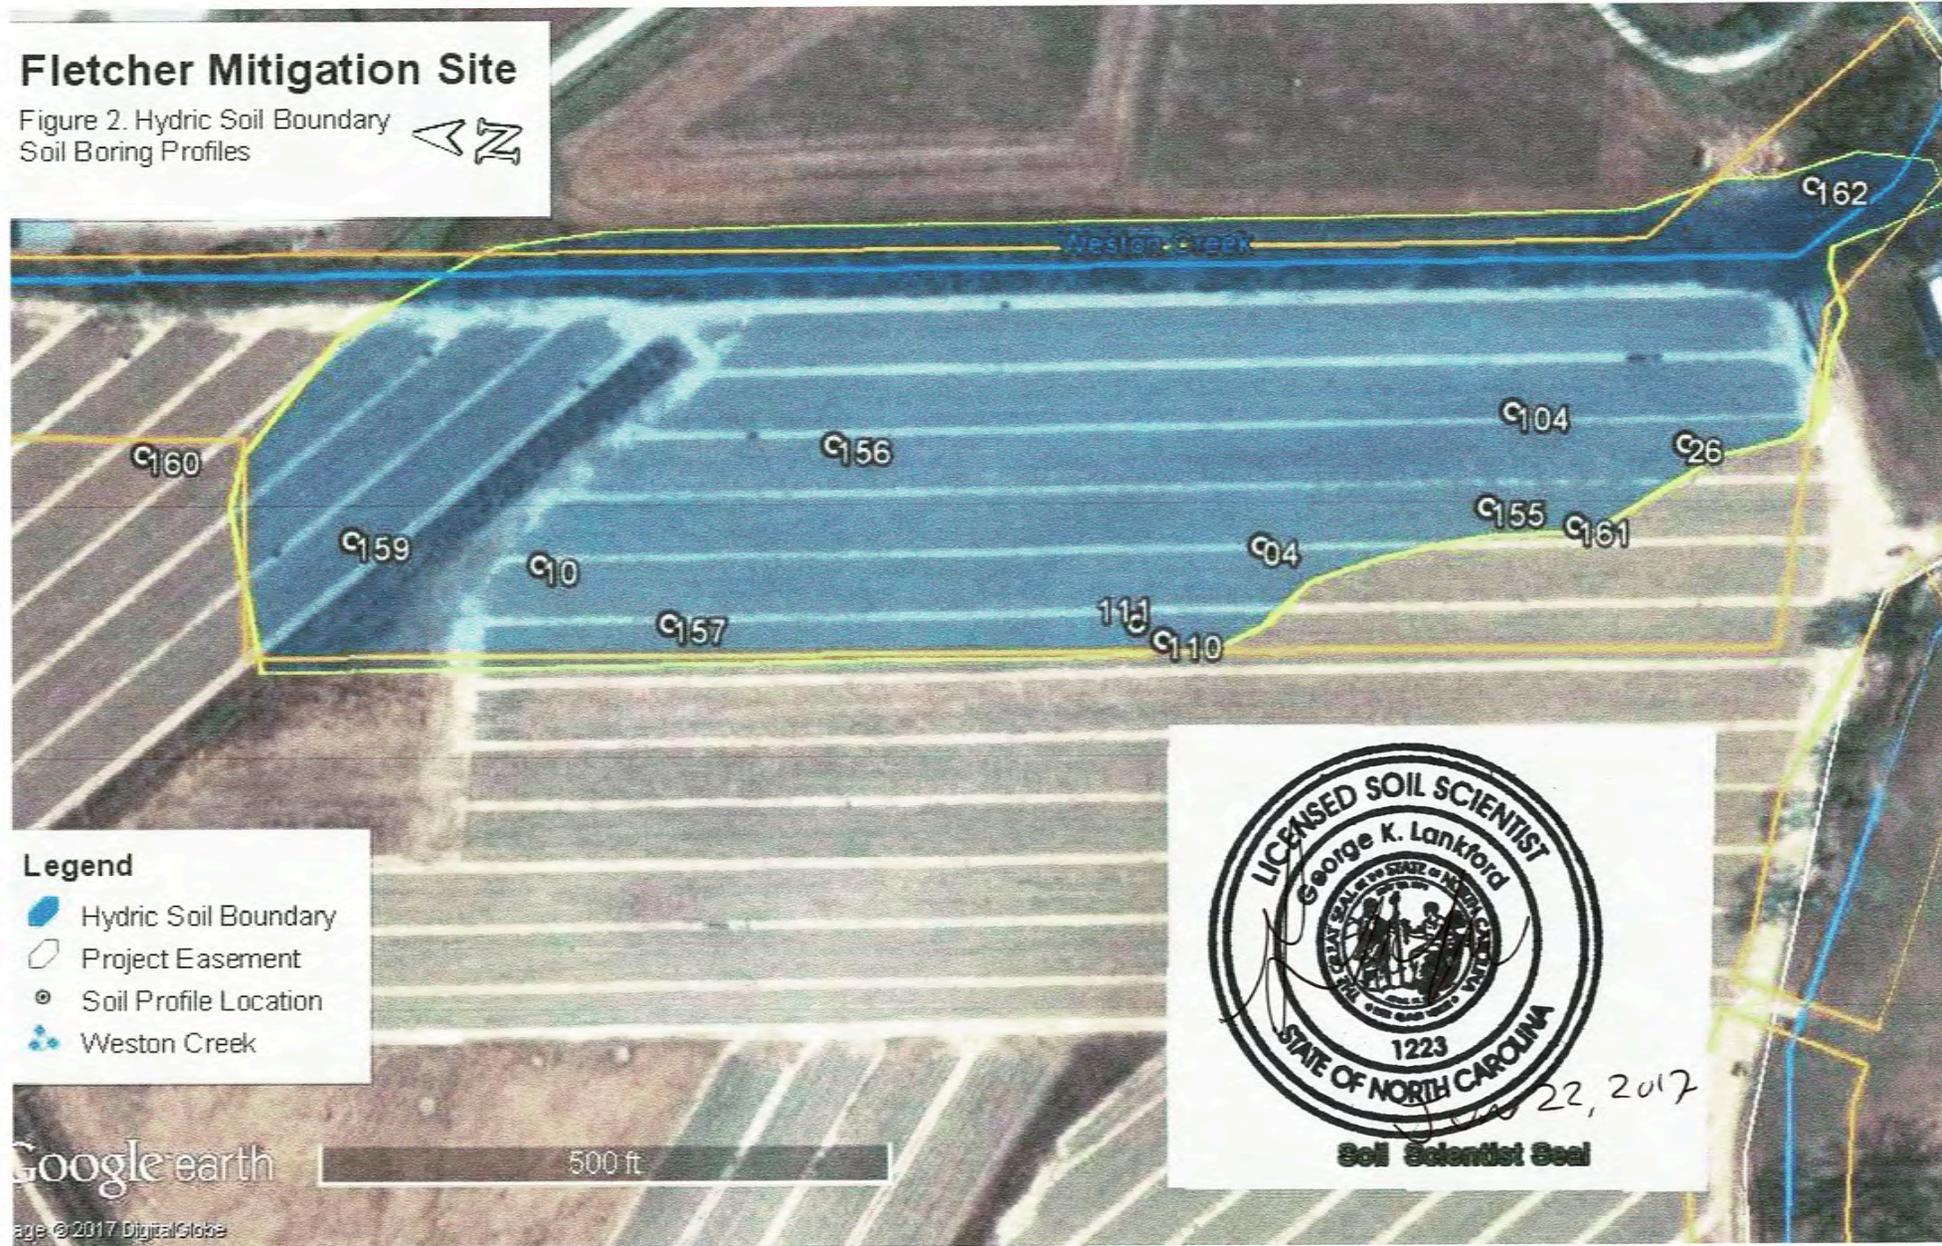
Figure 2. Hydric Soil Boundary  
Soil Boring Profiles

Dominant hydric indicator across the site is F3-Depleted Matrix. Redoximorphic concentrations having sharp features lacking a corona with a mottle color trending toward redder are characteristic of relict features. Some areas with a thicker or thinner horizon due to agricultural management. Cultivation depth across the site is variable with some areas with deeper cultivation. Recent evidence of deep ripping observed. Some areas may also be relict F6-Redox Dark Surface indicator, but destroyed due to mechanical mixing of surface during frequent cultivation.
