MITIGATION PLAN
GATLIN SWAMP WETLAND RESTORATION SITE
MARTIN COUNTY, NORTH CAROLINA

(CONTRACT #16-D05024)
FULL DELIVERY PROJECT
ROANOKE RIVER BASIN
CATALOGING UNIT 03010107

**GATLIN SWAMP WETLAND RESTORATION SITE
AS-BUILT MITIGATION REPORT
MARTIN COUNTY**

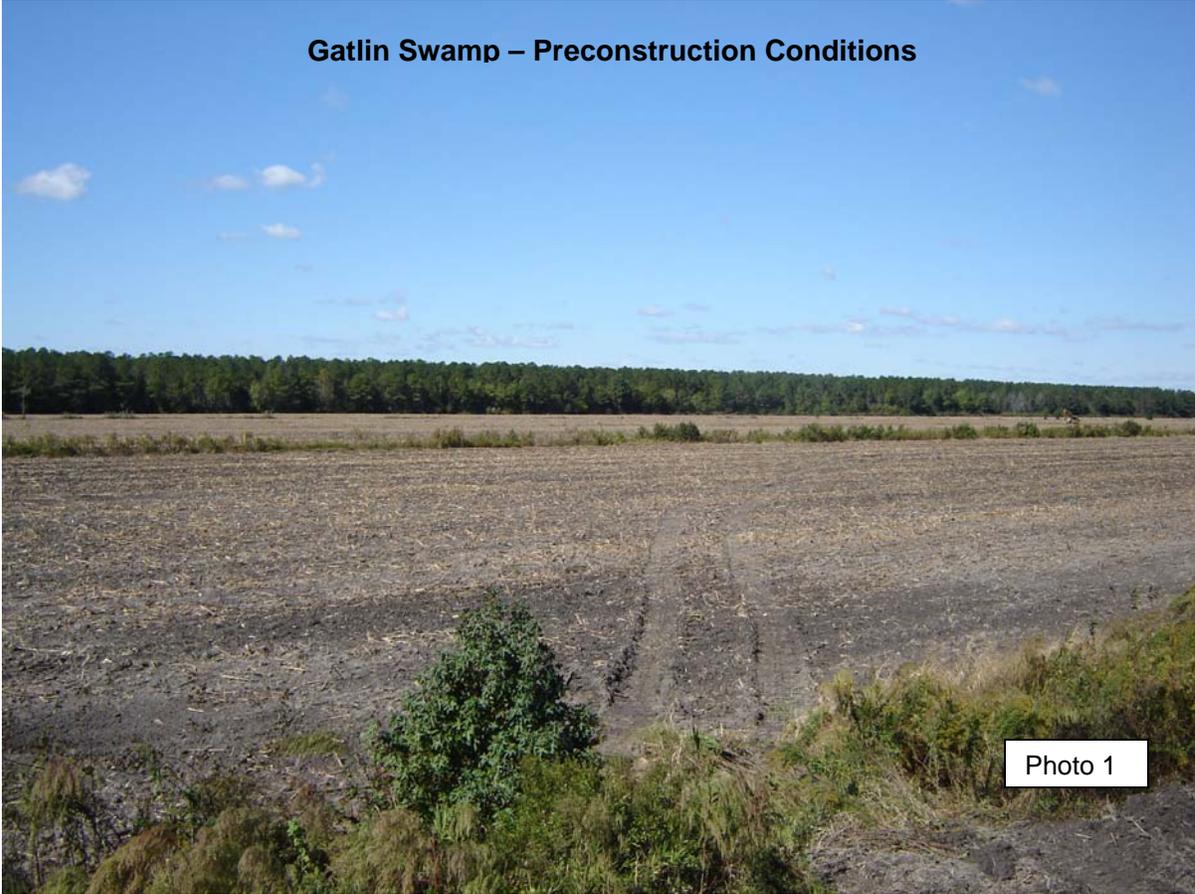
Photo 1

Gatlin Swamp – Preconstruction Conditions

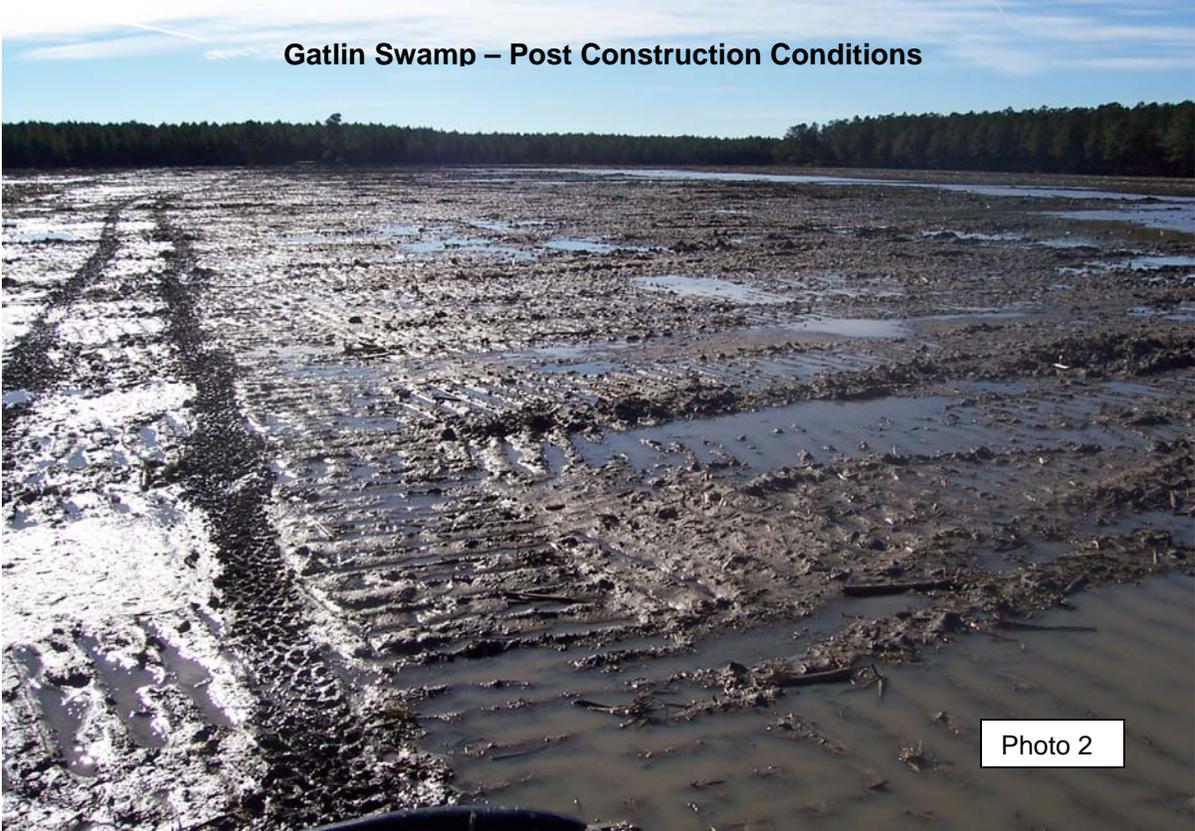
Photo 2

Gatlin Swamp – Post Construction Conditions

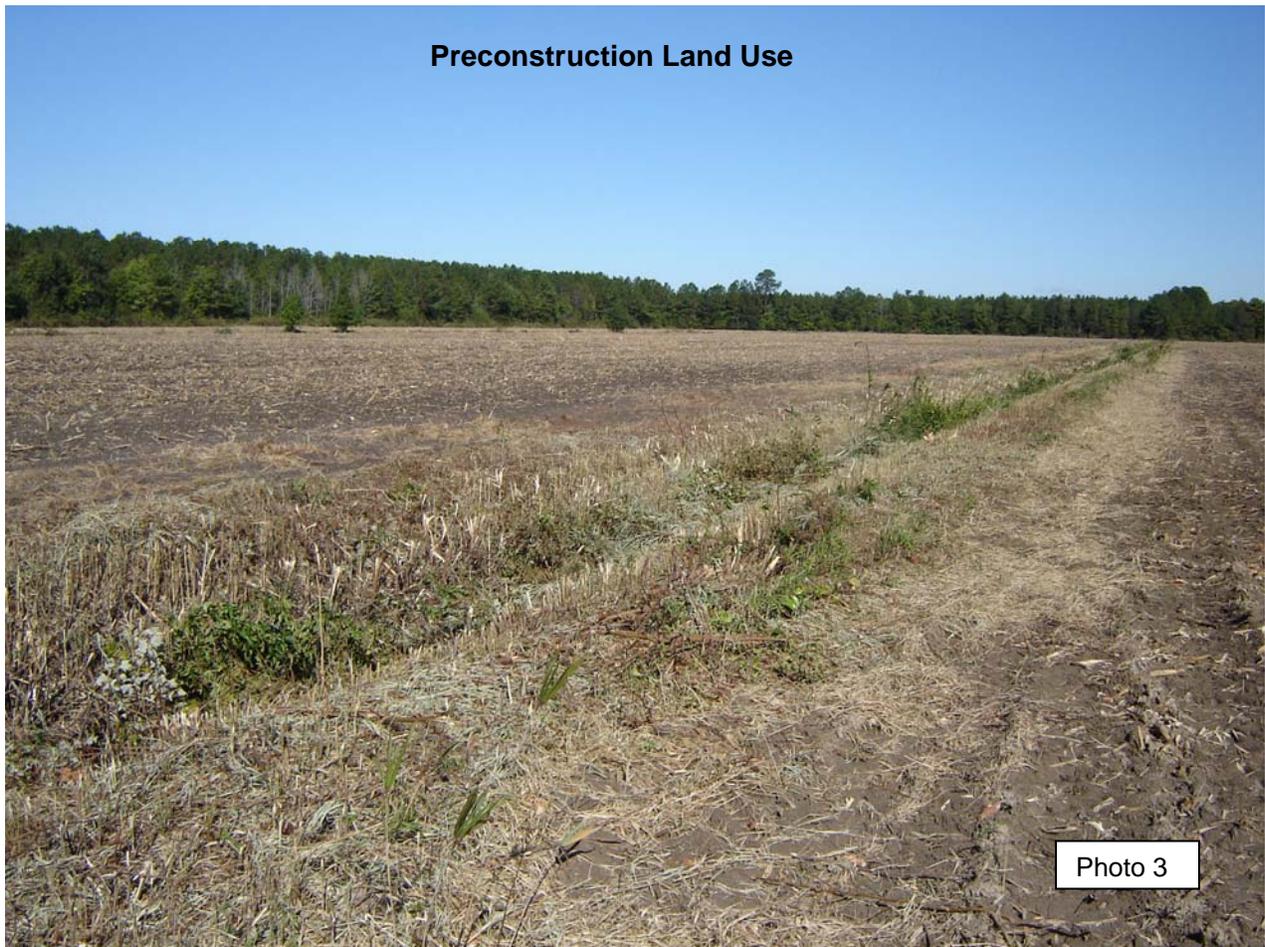
The Site includes 150.2 acres of land located in an expansive, nonriverine interstream flat. Prior to construction, the entire 150-acre tract was utilized for agricultural row crop production including corn, soybeans, and peanuts (Figure 3). The Site is surrounded by timber tracts approximately 20 years in age. An extensive ditch system had been excavated to drain the Site for agricultural land uses. These ditches were excavated to a depth of approximately 2 to 4 feet, oriented primarily in a north to south direction, and drained towards perimeter ditches which removed hydrology from the Site.

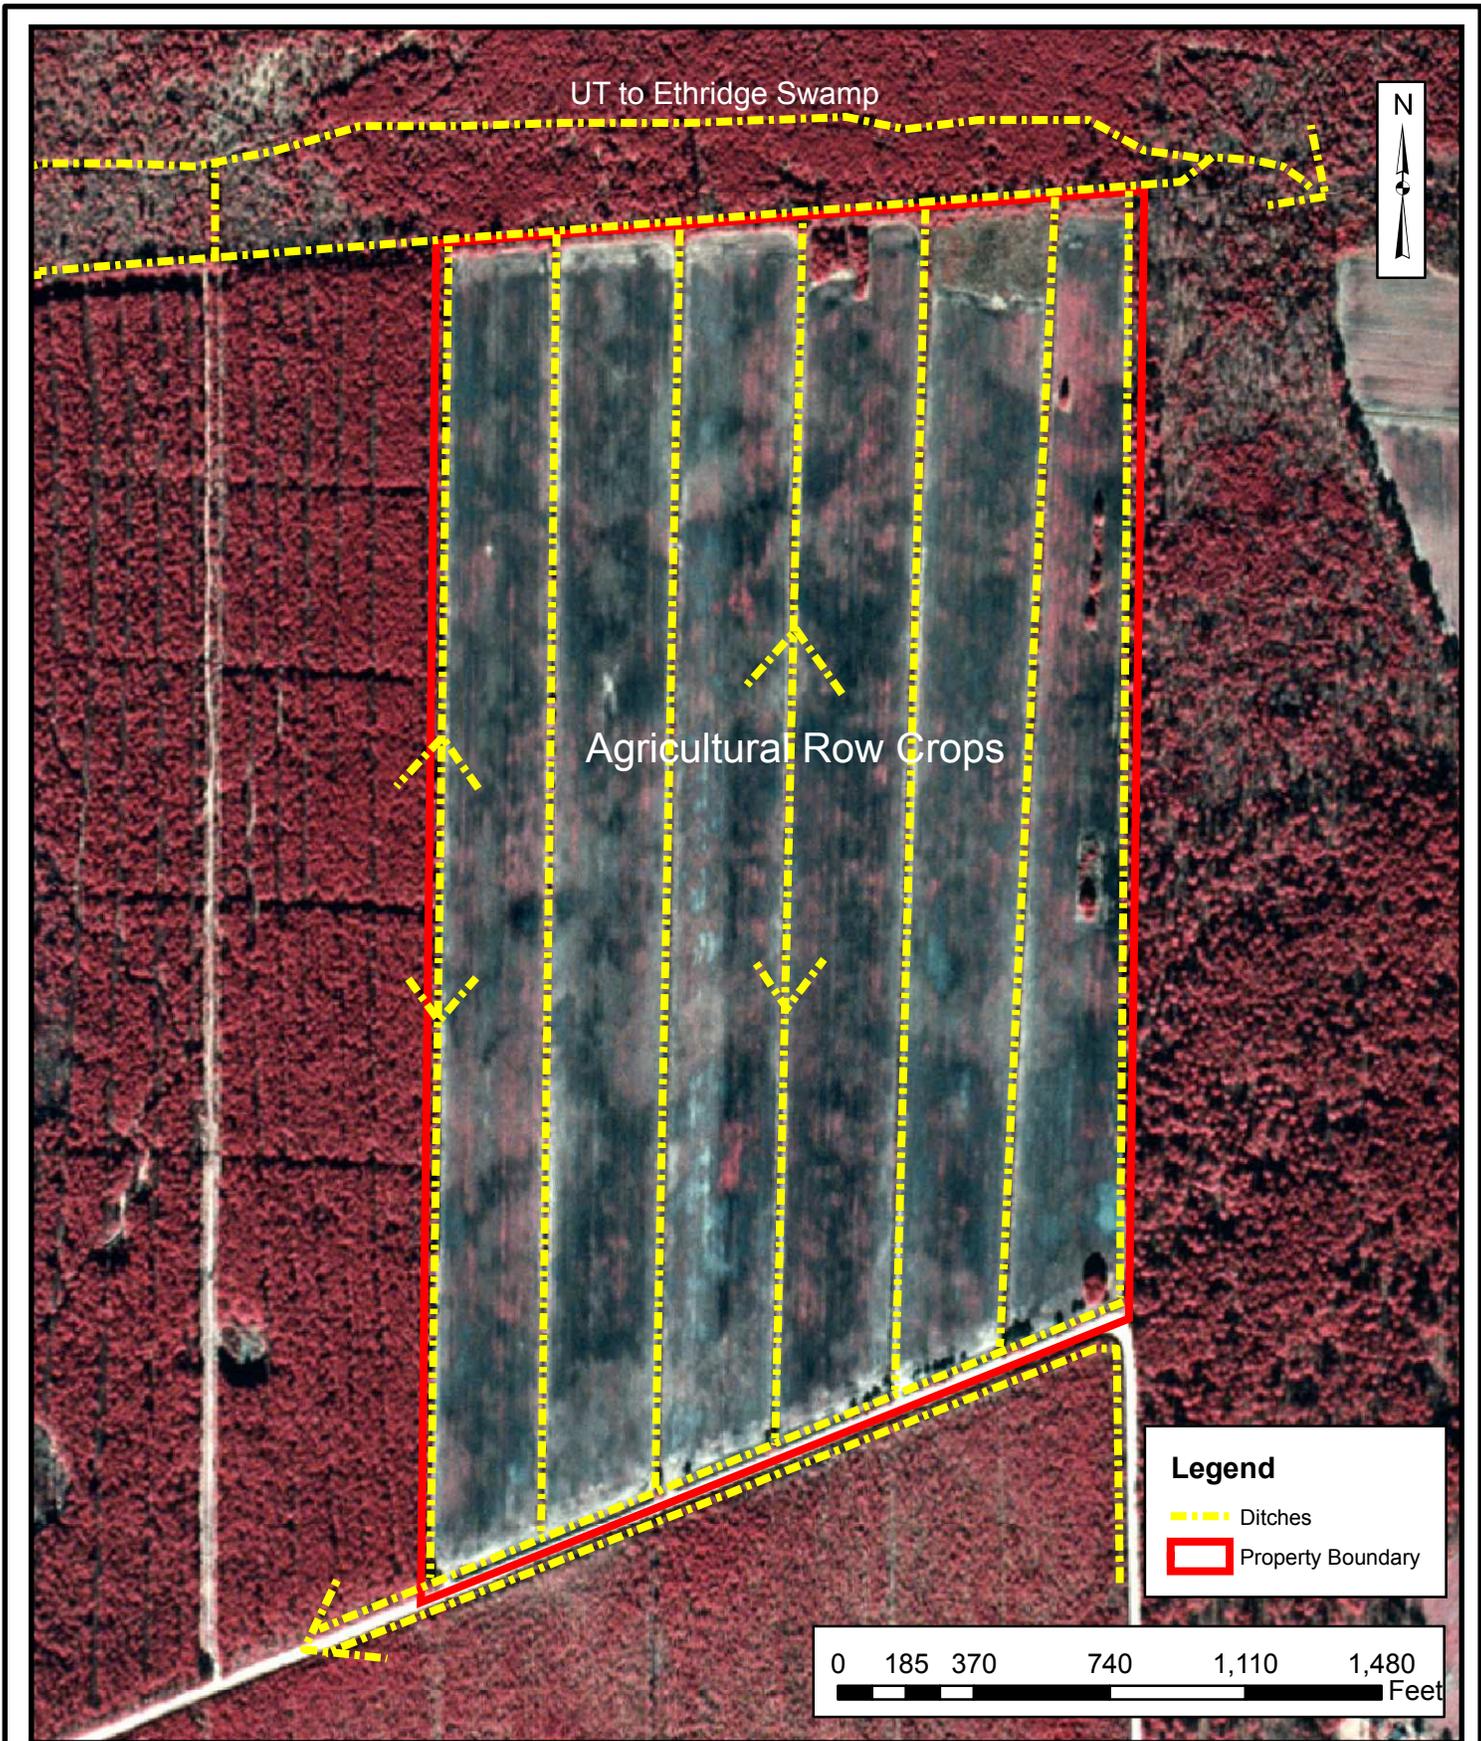
PRE CONSTRUCTION CONDITIONS
GATLIN SWAMP WETLAND RESTORATION SITE
Martin County, North Carolina

Prior to Site implementation, soil surfaces had been leveled, graded, and compacted as a result of agricultural practices. Typical of crop land with clayey subsurface horizons (ex: Rains series), approximately 9 inches of the Site soil surface (A horizon or plow layer) was characterized by loamy soils with relatively high permeability that were plowed annually. Immediately below this plow layer, a compacted clay layer or "pan" (upper portion of the B horizon) exhibited low permeability. Precipitation that infiltrated to the clay pan migrated laterally through the permeable plow layer into Site and perimeter ditches.

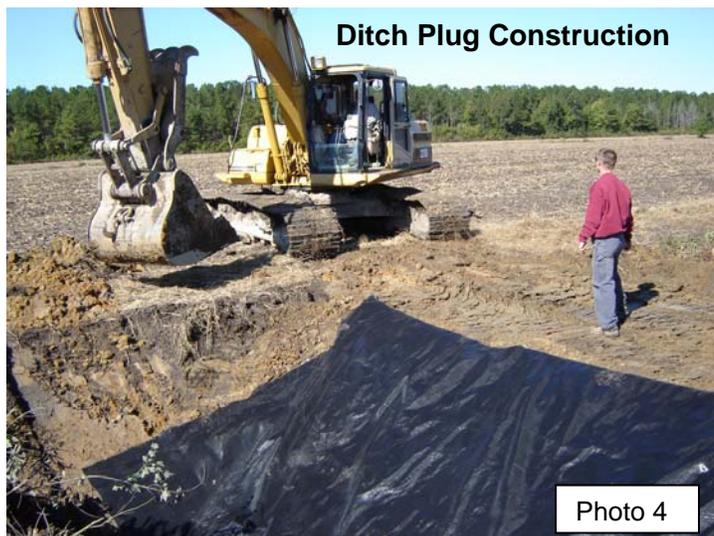
DITCH PLUGGING
&
DITCH BACKFILL

THE CONTRACTOR EXCAVATED MATERIALS FROM THE SITE BY REMOVING TOP SOILS (A-HORIZON) AND EXCAVATING SMALL (3'X3'X3') DEPRESSIONS WITHIN THE UNDERLYING (B-HORIZON) SOIL LAYERS. B-HORIZON MATERIALS WERE STOCKPILED IN DESIGNATED AREAS AND PROTECTED BY EROSION CONTROL MEASURES. ONCE THE DEPRESSIONS WERE EXCAVATED, THE DEPRESSIONS WERE COVERED WITH STOCKPILED TOP SOILS (A-HORIZON).

ON-SITE DITCHES WERE CLEANED, AS NEEDED, TO REMOVE UNCONSOLIDATED SEDIMENTS WITHIN THE LOWER PORTION OF THE CROSS SECTION PRIOR TO BACKFILLING. THE UNCONSOLIDATED SEDIMENTS WERE LIFTED FROM THE DITCHES TO EXPOSE THE UNDERLYING, RELATIVELY IMPERMEABLE CLAY SUBSTRATE ALONG THE DITCH INVERT.

DITCH PLUGS WERE INSTALLED ALONG ON-SITE DITCHES AT CRITICAL LOCATIONS SUCH AS SITE INFALLS AND OUTFALLS. EACH PLUG CONSISTED OF EARTHEN MATERIAL BACKFILLED IN 2-FOOT LIFTS OF VEGETATION FREE MATERIAL AND COMPACTED INTO THE BOTTOM OF THE DITCH. EARTHEN PLUGS WERE REINFORCED BY INCORPORATION OF FILTER CLOTH INTO THE PLUG TO MINIMIZE PREFERENTIAL FLOW OF GROUNDWATER THROUGH FILL MATERIAL.

DITCHES WERE BACKFILLED USING ON-SITE MATERIAL EXCAVATED FROM SMALL (3'X3'X3') DEPRESSIONS. DITCHES WERE BACKFILLED, COMPACTED, AND GRADED TO THE APPROXIMATE ELEVATION OF THE ADJACENT WETLAND SURFACE.

ON-SITE SOILS WERE RIPPED TO 21 INCHES IN DEPTH TO PROMOTE SOIL SURFACE AND SUB SURFACE MICROTOPOGRAPHIC VARIATIONS ACROSS THE SITE.

Ditches identified for backfilling (Figure 4) were cleaned, as needed, to remove unconsolidated sediments within the lower portion of the cross-section. Accumulated sediments within the ditches consisted of relatively high permeability material that could have acted as a conduit for continued drainage after restoration. The unconsolidated sediments were removed from the ditches to expose the underlying, relatively impermeable clay substrate along the ditch bottoms. The sediment material was placed on adjacent surfaces and later incorporated into top soils during soil preparation for planting.

Ditch plugs were installed along on-Site ditches at locations depicted in Figure 4. In addition, all Site outfall locations were effectively plugged to prevent migration of surface water to and from the Site. The plugs were constructed of low density material designed to withstand erosive forces associated with concentrated surface water or groundwater flows. Each plug consisted of earthen material backfilled in 2-foot lifts of vegetation free material and compacted into the bottom of the ditch.

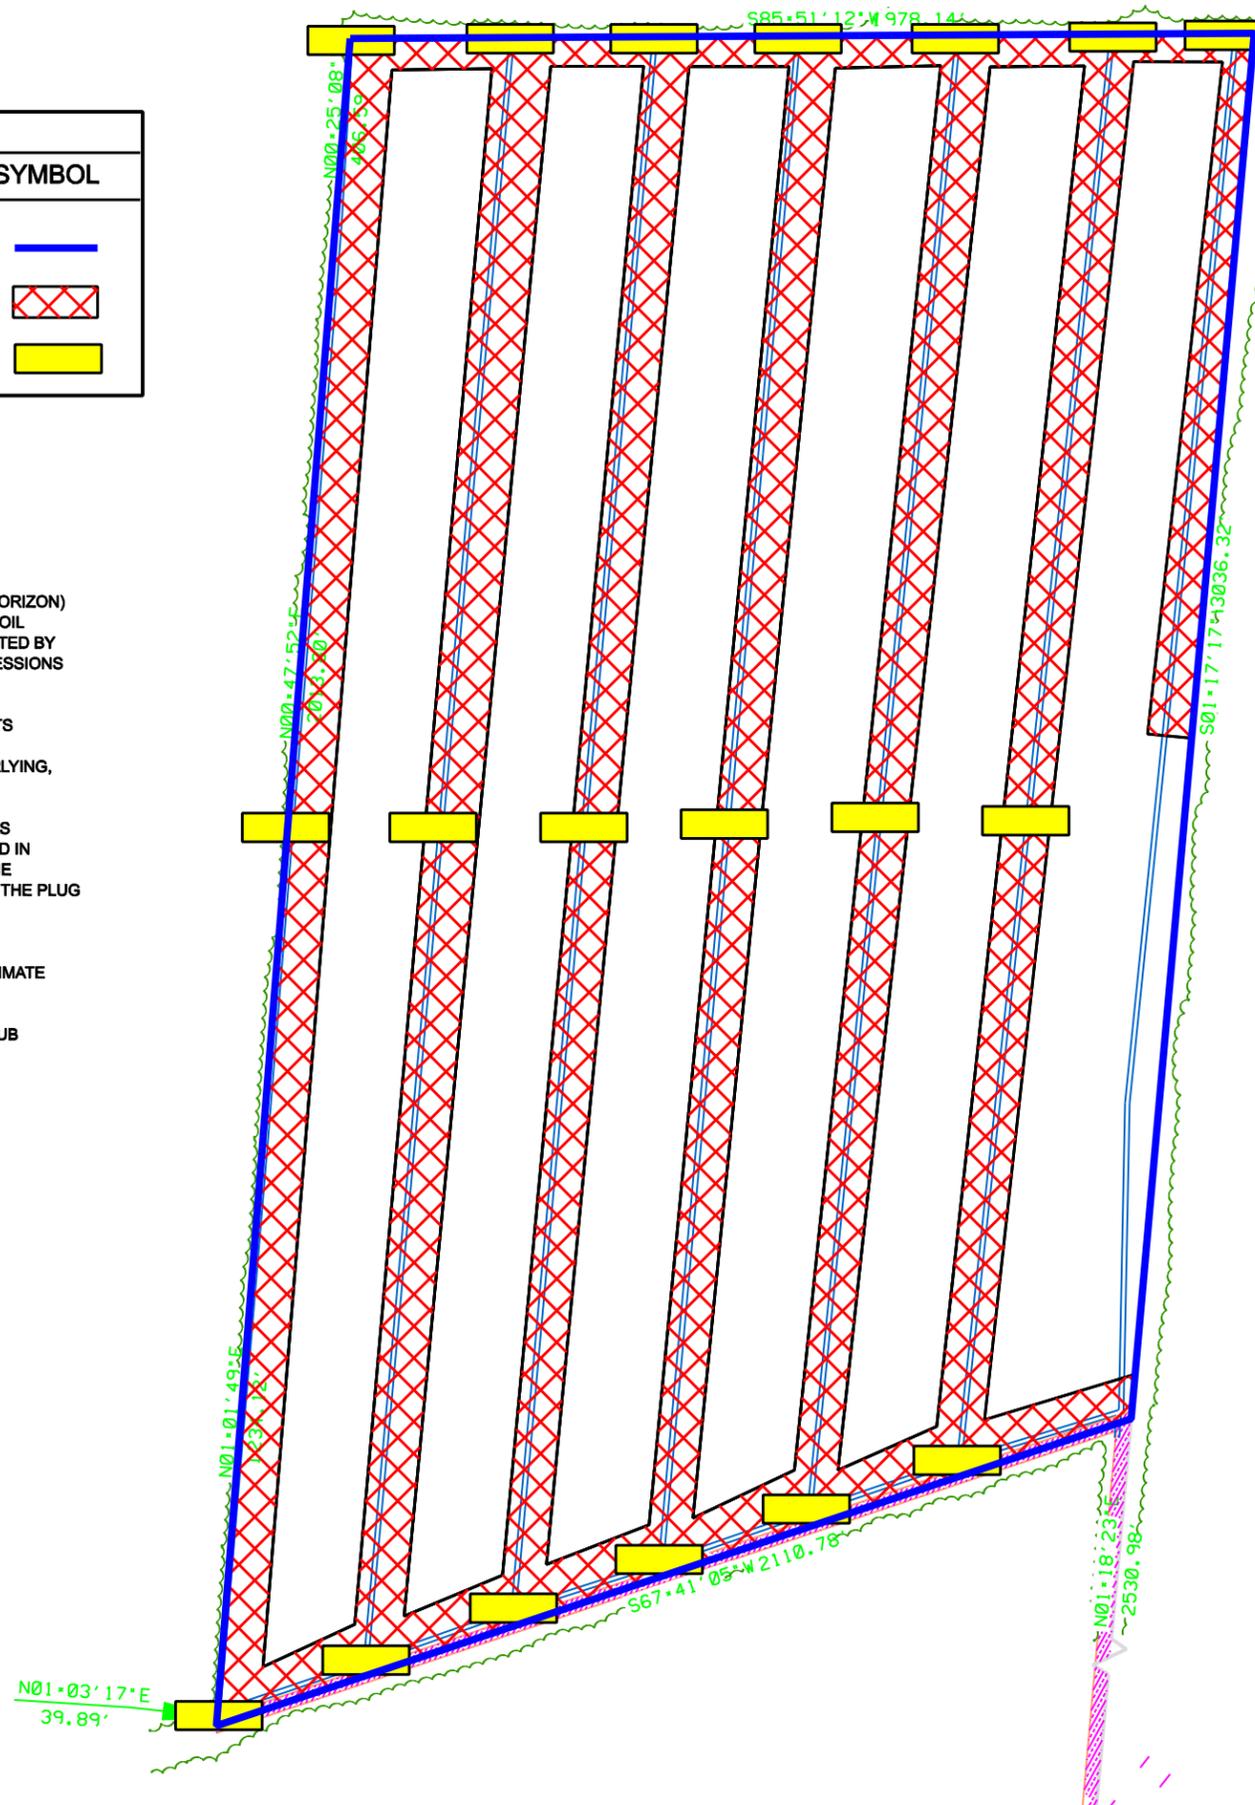
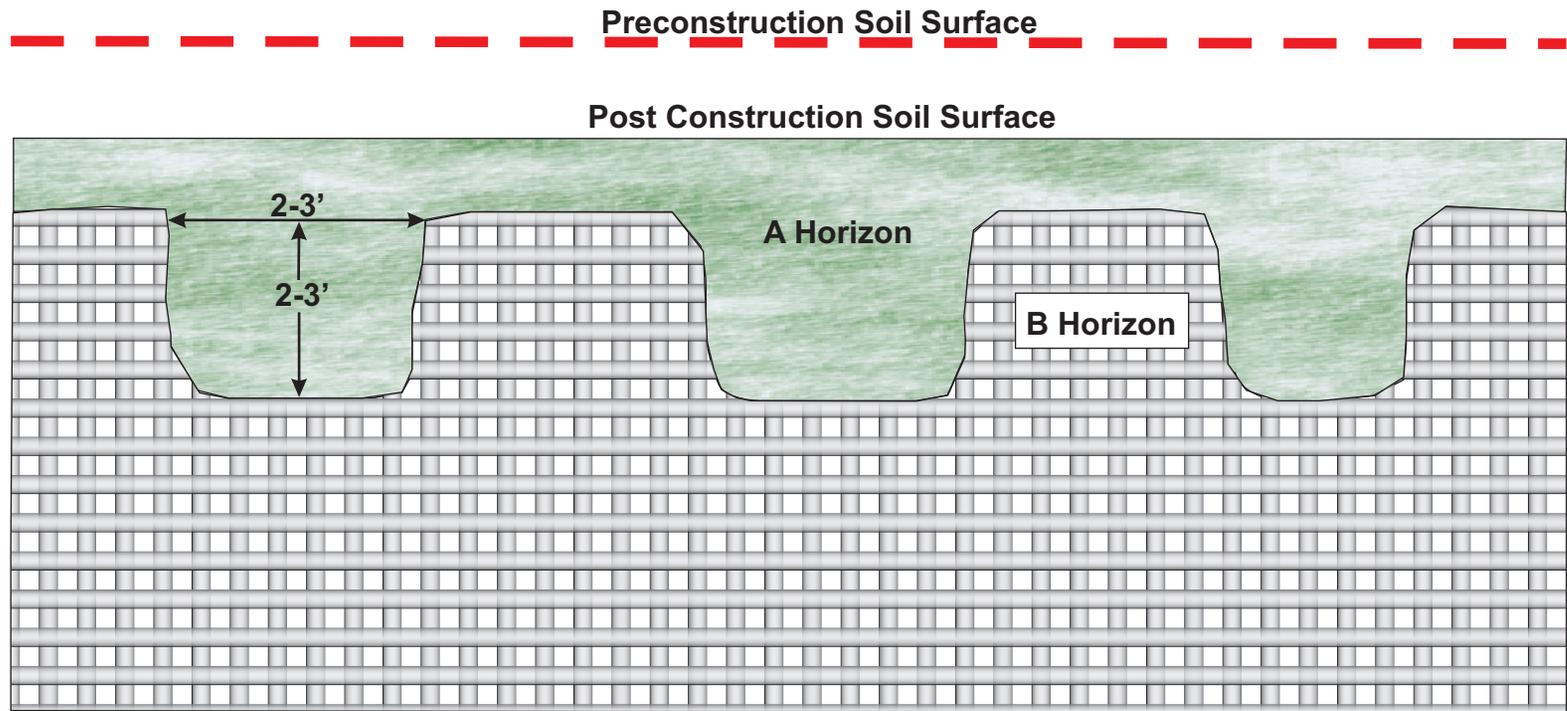
DEPRESSION CONSTRUCTION
 GATLIN SWAMP WETLAND RESTORATION SITE
 Martin County, North Carolina

Based on volume calculations for ditch-backfill material, approximately 24,375 cubic yards of material were borrowed from the Site. Borrow material was generated through excavation of groundwater storage depressions throughout the Site landscape. The primary purpose of these depressions was to provide suitable, low permeability material for ditch plugs and backfilling, to increase water storage potential within the wetland restoration area, and to increase potential for biological diversity within the complex.

The depressions were constructed by excavating and stockpiling top soils overlying the B horizon (clay layer). Subsequently, clay from the B horizon was excavated as individual pockets approximately 2 to 4 feet in width and 2 to 4 feet in depth, such that the landscape was “pockmarked” with small, groundwater storage depressions (Figure 5). Clays excavated from the depressions were utilized as backfill material on adjacent ditch sections. Top soils and sediment removed from ditch cleaning efforts were utilized to backfill the depression to within 0.3 foot of the surface.

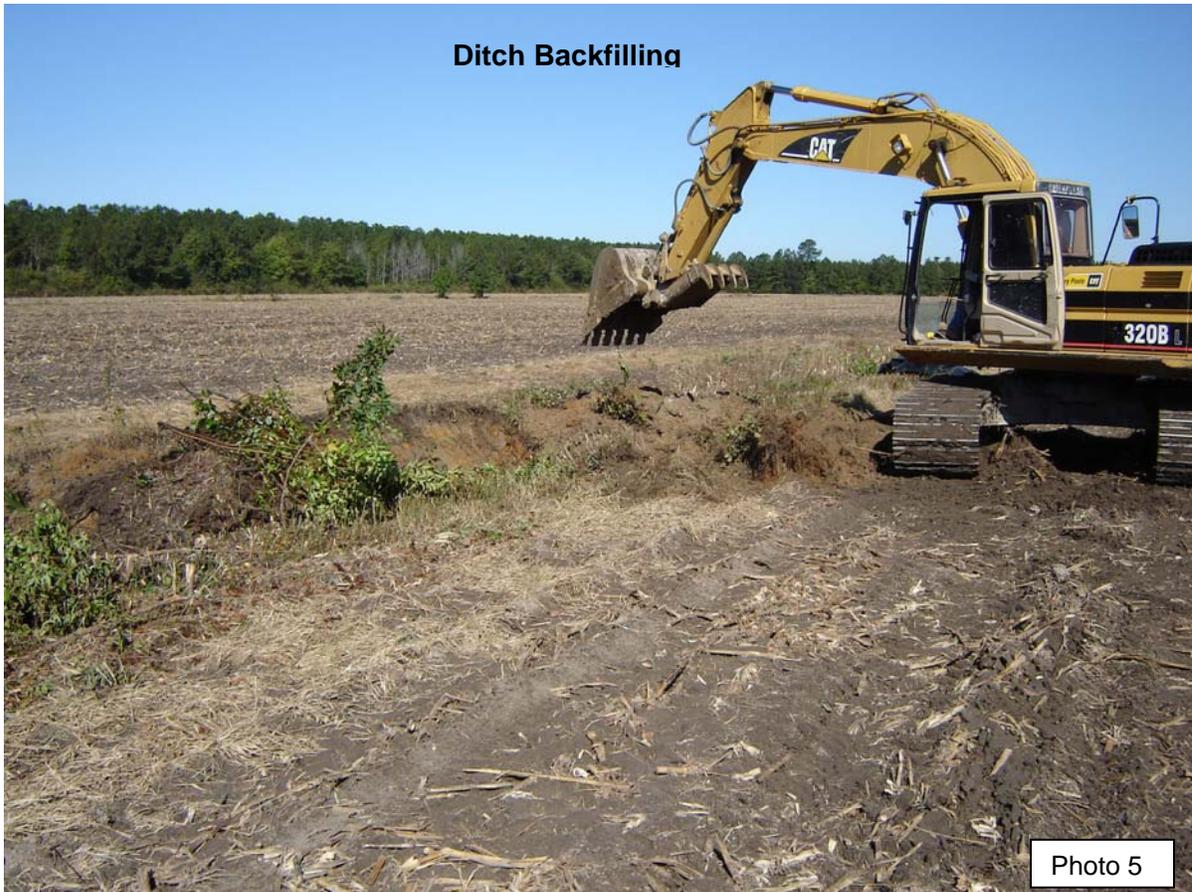
Ditches were backfilled using on-Site, earthen material from excavated depressions. Based on cut-fill estimates for this project, approximately 24,375 cubic yards of ditch backfill material was required to effectively fill all on-Site ditches. Material excavated from the groundwater storage depressions was stockpiled adjacent to the ditches to be backfilled. Ditch backfill locations were filled, compacted, and graded to the approximate elevation of the adjacent wetland surface.

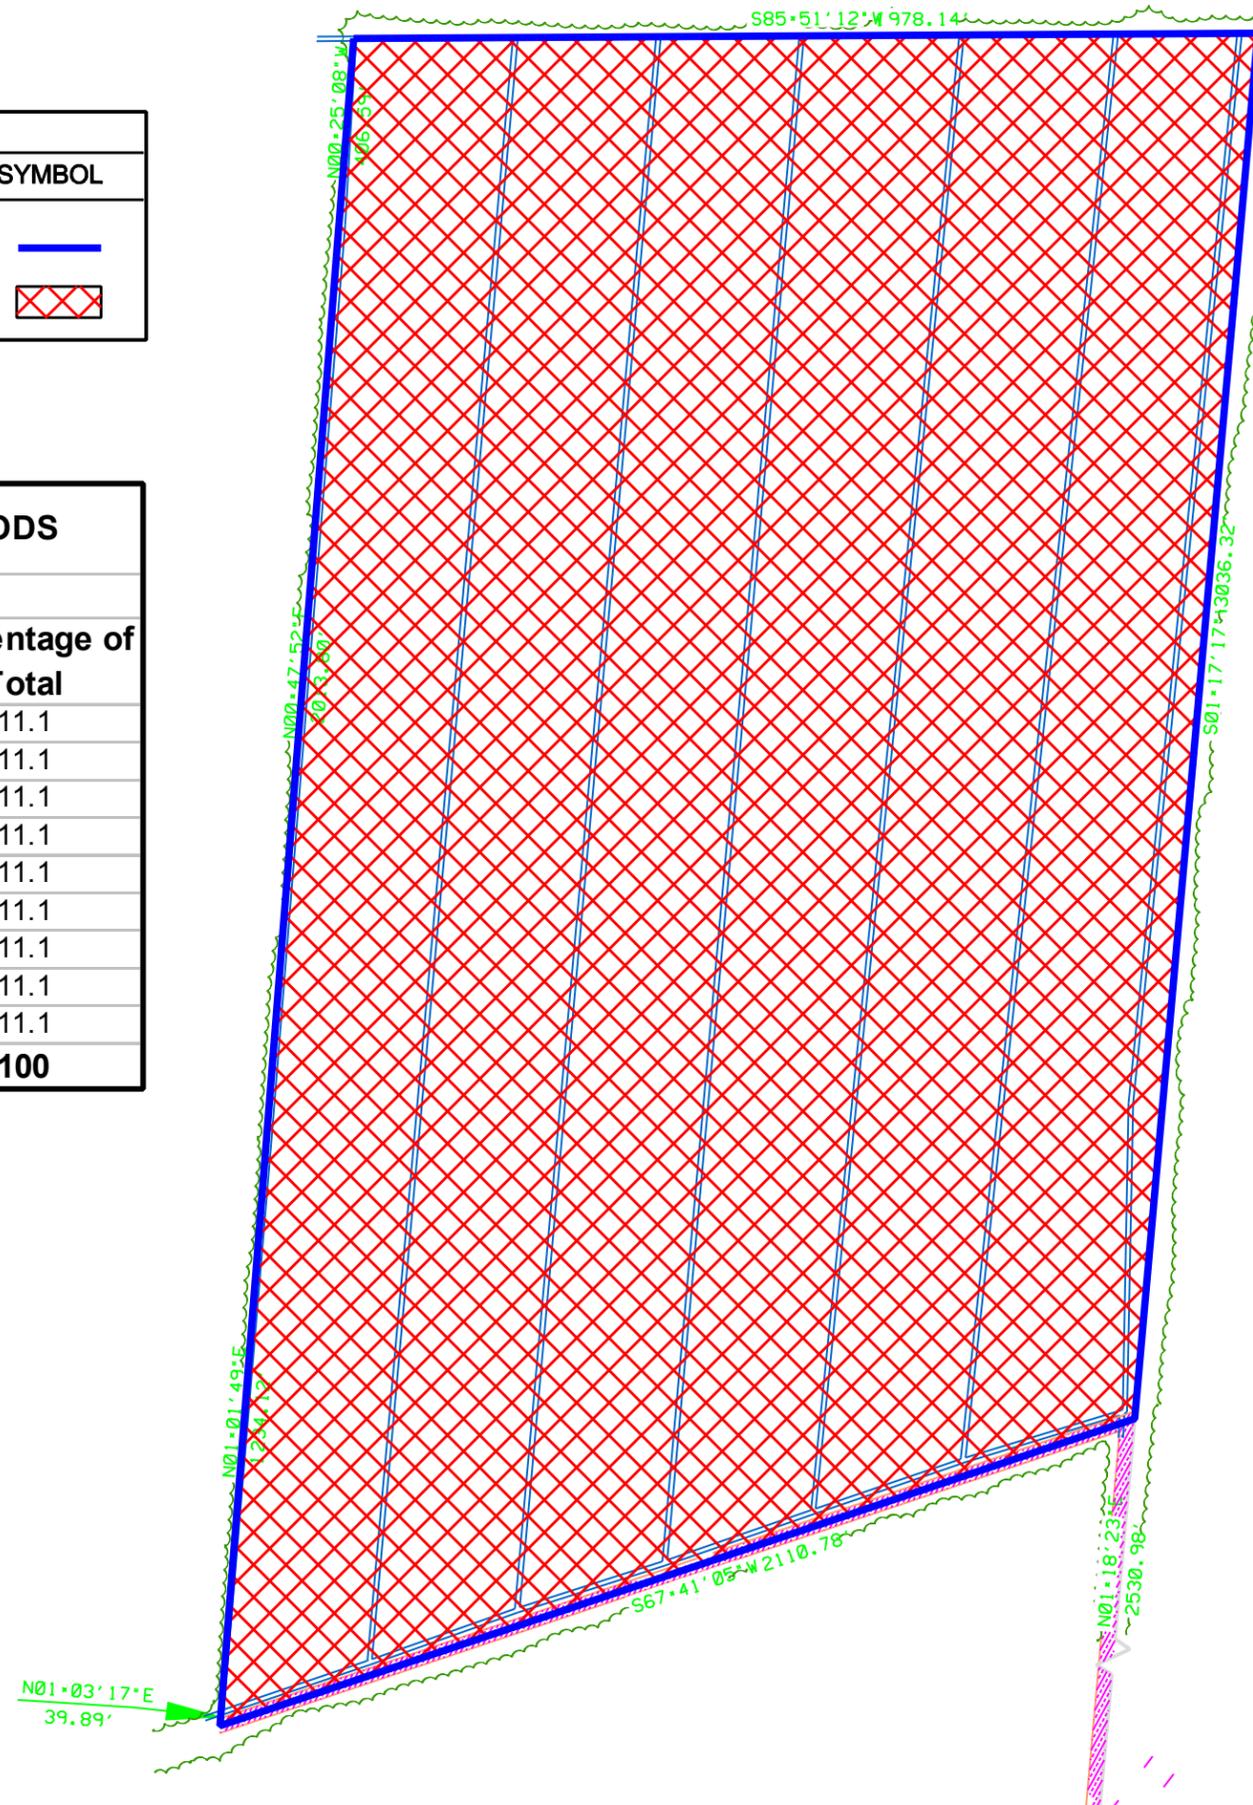
**PLANTING
PLAN**

In January 2006, the Site was planted with native, wetland-adapted tree species. On-Site observations and pertinent community descriptions from *Classification of the Natural Communities of North Carolina* (Schafale and Weakley 1990) were used to develop the primary plant community association promoted during restoration efforts. The entire 150.2-acre Site was planted with species characteristic of a Pine Flatwoods community (Figure 6).

VEGETATIVE ASSOCIATION (Planting Area)	PINE FLATWOODS	
Area (acres)	150	
SPECIES	Total Number Planted	Percentage of Total
Loblolly Pine (<i>Pinus taeda</i>)	16,667	11.1
Pond Pine (<i>Pinus serotina</i>)	16,667	11.1
Swamp Chestnut Oak (<i>Quercus michauxii</i>)	16,667	11.1
Cherrybark Oak (<i>Quercus pagodaefolia</i>)	16,667	11.1
Southern Red Oak (<i>Quercus falcata</i>)	16,667	11.1
Water Oak (<i>Quercus nigra</i>)	16,667	11.1
Willow Oak (<i>Quercus phellos</i>)	16,667	11.1
Sweetbay (<i>Magnolia virginiana</i>)	16,667	11.1
River Birch (<i>Betula nigra</i>)	16,667	11.1
TOTAL	150,003	100

Bare-root seedlings of canopy and understory tree species were planted within the Site at a density of 950 stems per acre (6.8-foot centers). Planting was performed during January 2006 to allow plants to stabilize during the dormant period and set root during the spring season. Bare-root seedlings were hand planted to minimize wetland soil disturbance. A total of 142,775 diagnostic tree and shrub seedlings were planted in support of Site wetland restoration. The entire 150-acre restoration area was re-vegetated during implementation of this plan.

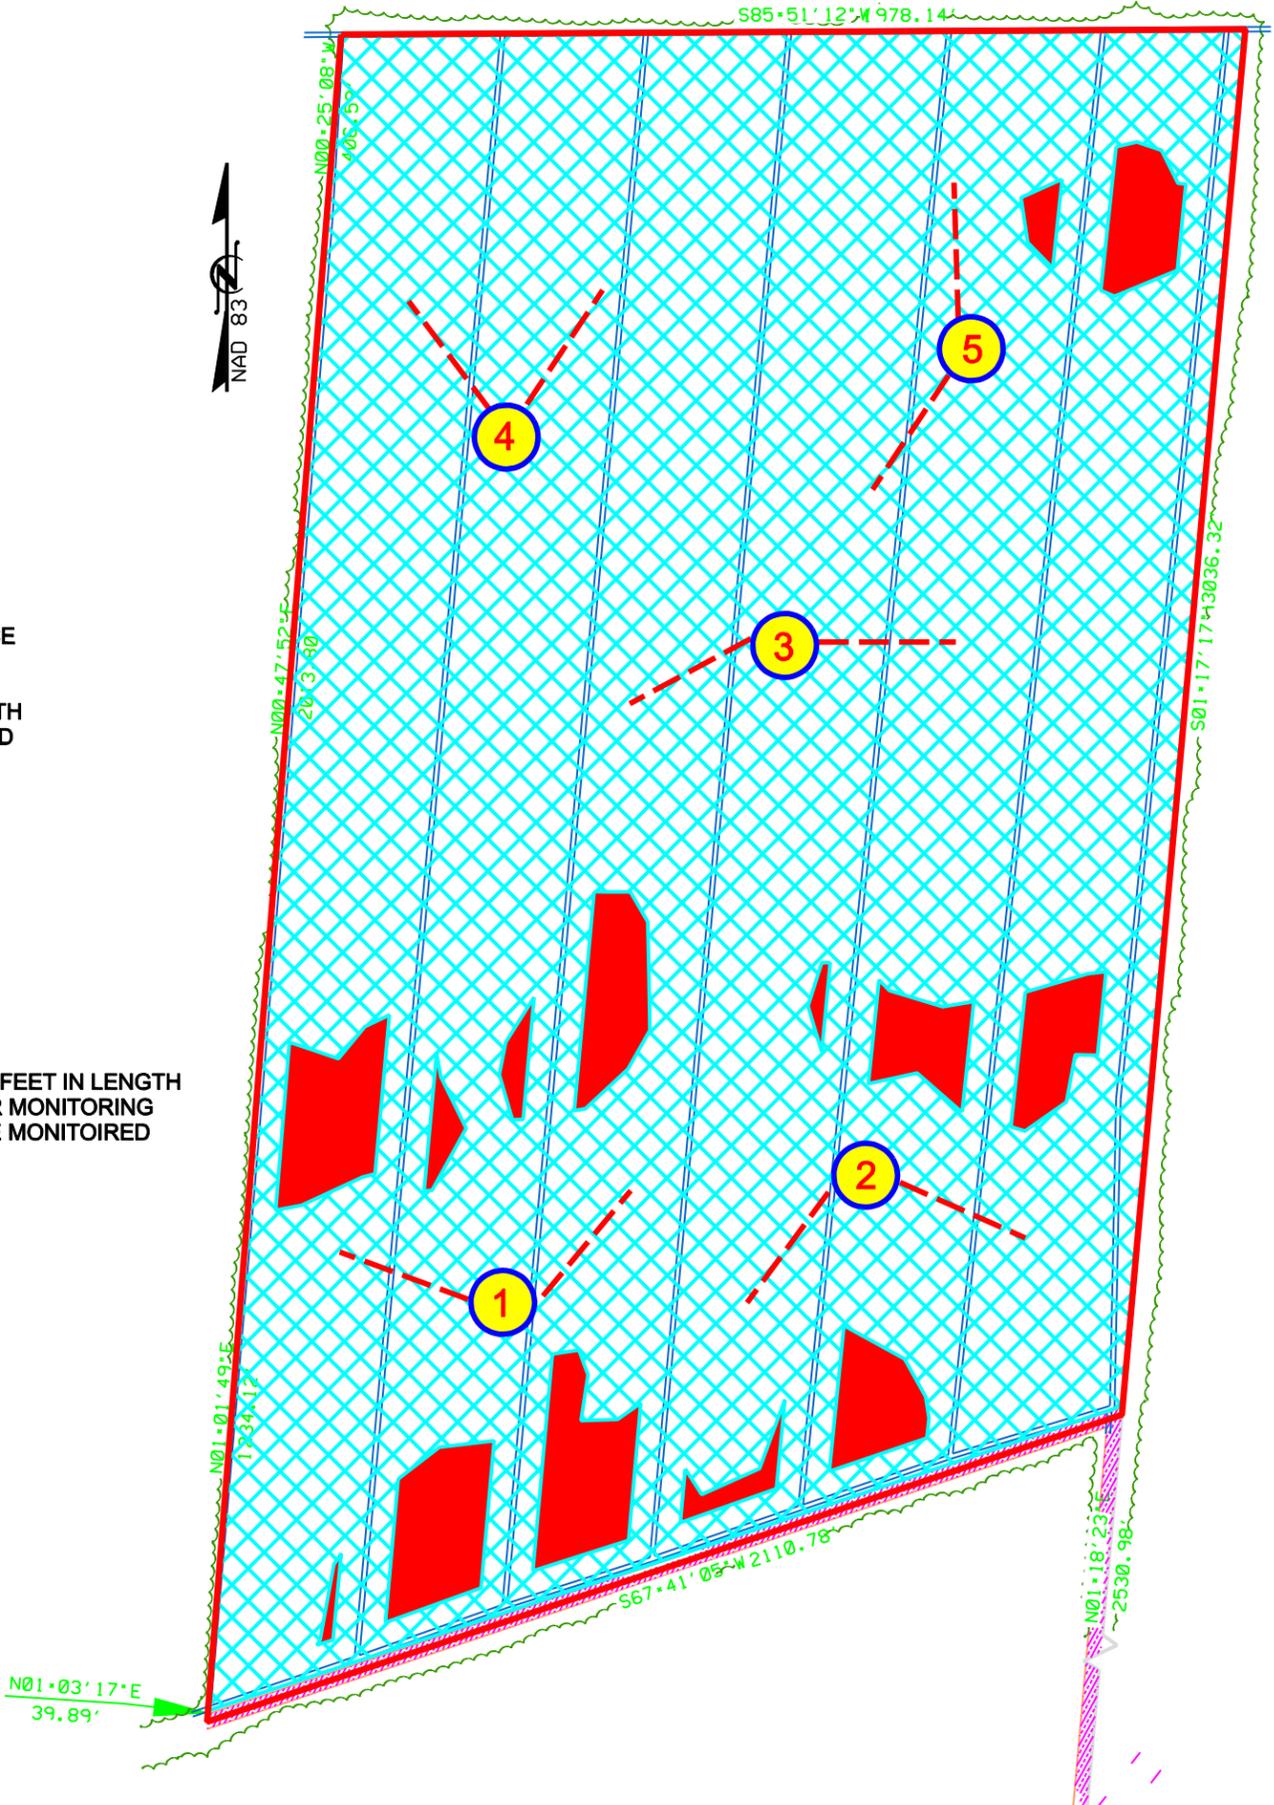
**MONITORING
PLAN**

INFINITY CONTINUOUS MONITORING GAUGES INSTALLED IN ACCORDANCE WITH SPECIFICATIONS OUTLINED IN U.S. ARMY CORPS OF ENGINEERS, INSTALLING MONITORING WELLS/PIEZOMETERS IN WETLANDS (WRP TECHNICAL NOTE HY-IA-3.1, AUGUST 1993). SCREENS ARE SET TO A DEPTH OF APPROXIMATELY 18 INCHES. GAUGES ARE PROGRAMMED TO RECORD AT 24-HOUR INTERVALS. DAILY RAINFALL IS CORRELATED FROM DATA OBTAINED AT A NATIONAL WEATHER SERVICE STATION LOCATED IN TARBORO (STATION 318500 - COOP).

VEGETATION MONITORING PLOTS ARE COMPRISED OF TRANSECTS, 600 FEET IN LENGTH AND 8 FEET IN WIDTH CENTERED ON EACH OF THE FIVE GROUNDWATER MONITORING GAUGES. IN EACH MONITORING PLOT, VEGETATION PARAMATERS TO BE MONITOIED INCLUDE SPECIES COMPOSITION AND DENSITY.

Five monitoring gauges were installed in wetland restoration areas to provide representative coverage of the Site (Figure 7). Two gauges were also placed in a reference wetland area in similar landscape positions for comparison with on-site conditions (Figure 1). Hydrological sampling will be performed in restoration and reference areas during the growing season (March 16 through November 14) at daily intervals necessary to satisfy the hydrology success criteria within each physiographic landscape area.

Quantitative vegetation sampling will be conducted in early fall of the first year. Five sample transects were installed within planted areas of the Site to equally represent the various hydrologic regimes (Figure 7). Each transect is 600 feet in length, 7.25 feet in width (0.1 acre), and consists of two 300-foot long segments. The two segments are anchored to a groundwater monitoring gauge and are defined identified by the corresponding gauge number. Each segment extends from the gauge on a randomly selected compass bearing. In each sample, vegetation parameters to be monitored include species composition and species density. Visual observations of the percent cover of shrub and herbaceous species will also be recorded.
