# Stream Mitigation Plan – FINAL

## Lochill Farm Stream Mitigation Project

Orange County, North Carolina

DMS Project ID No. 97083, DEQ Contract No. 6828, DEQ RFP #16-006477

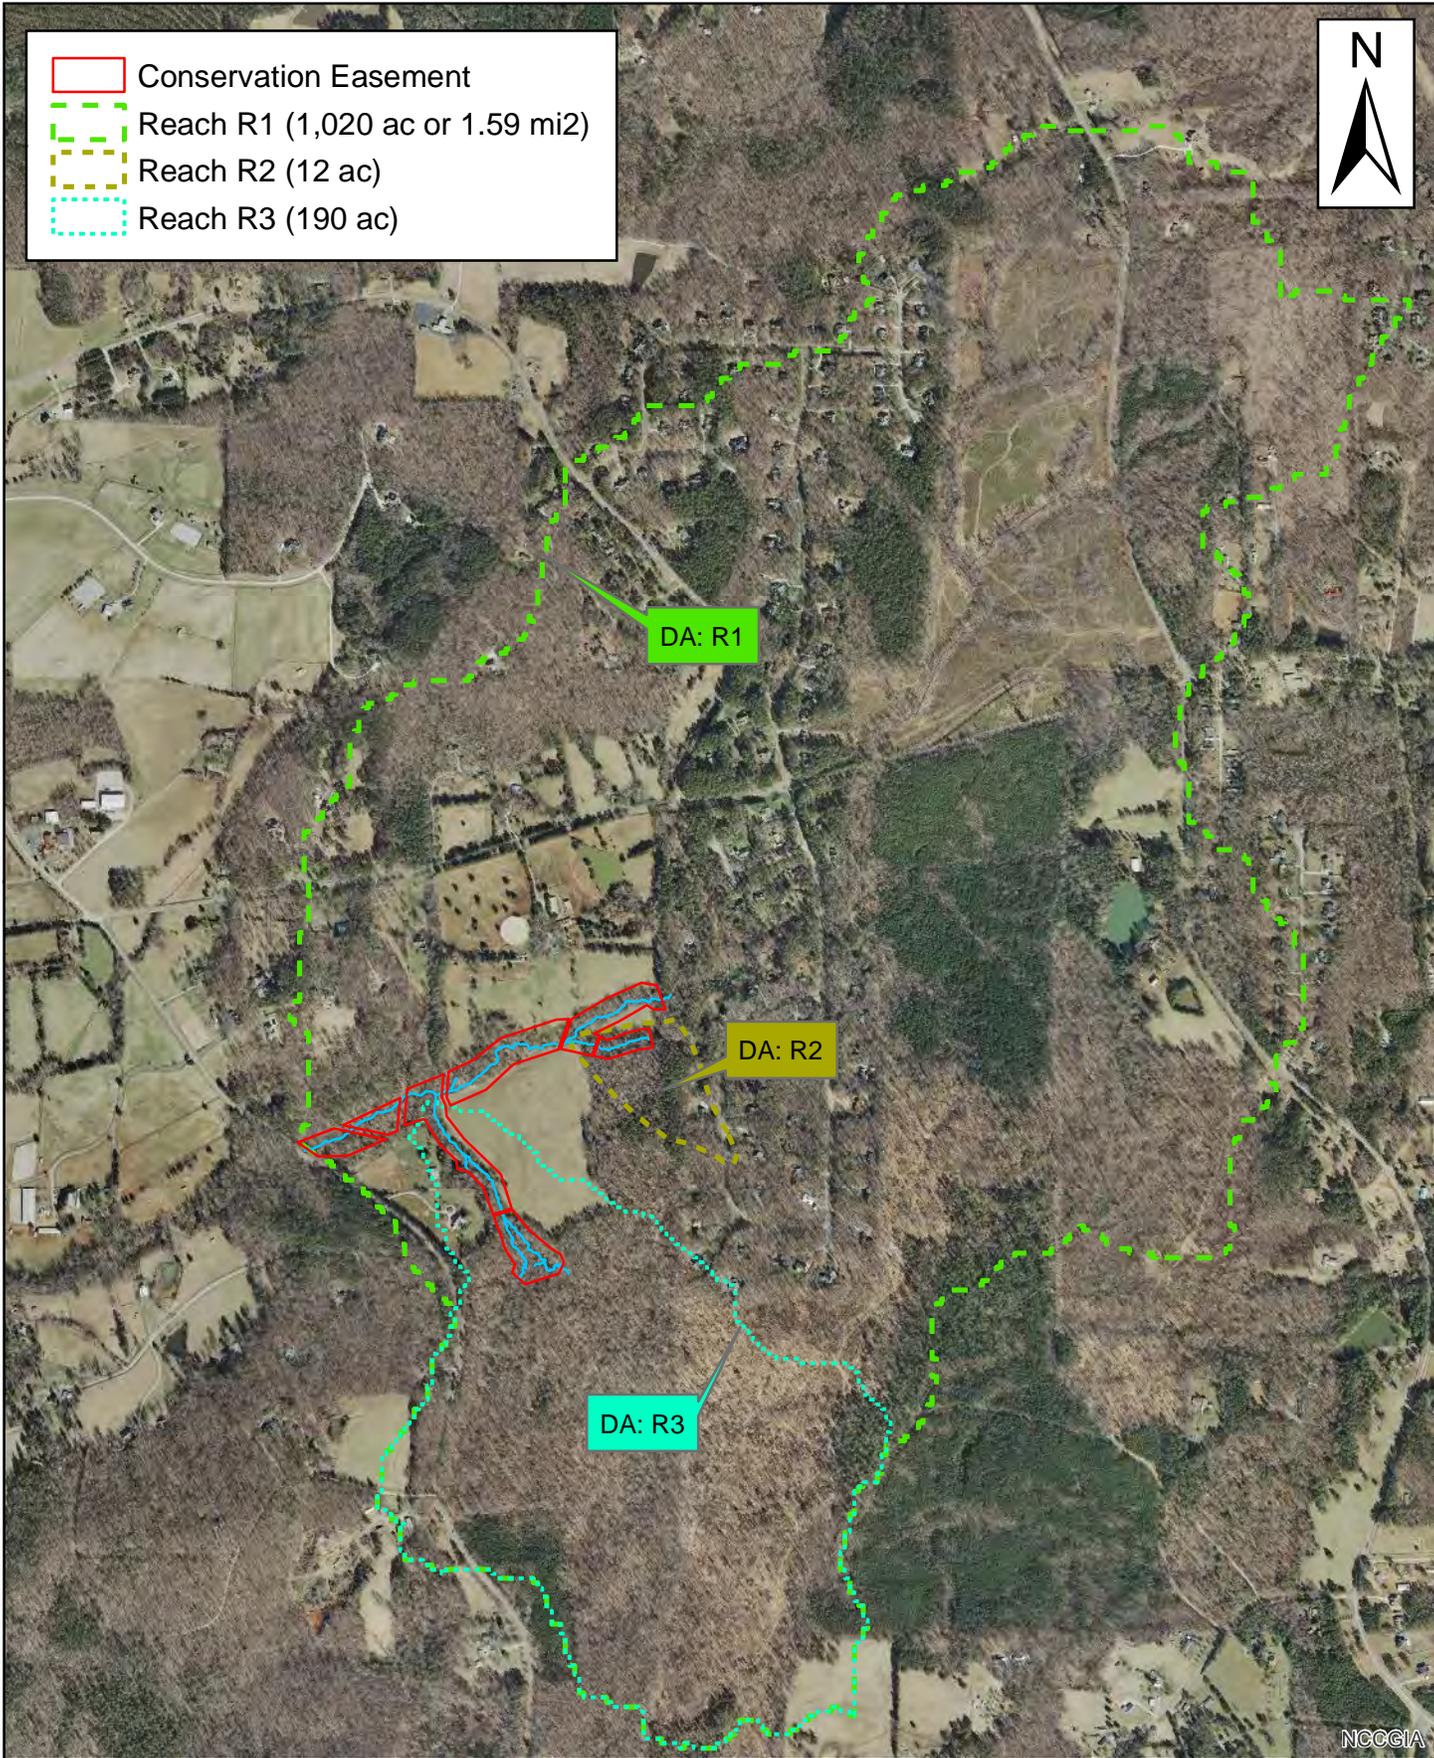
**Figure 5A**  
**Watershed Drainage Areas**  
**Lochill Farm Site**

Field evaluations of intermittent/perennial stream status were made in the summer of 2015. These evaluations were based on NCDWQ (now NCDWR) Methodology for Identification of Intermittent and Perennial Streams and Their Origins (v 4.11) stream assessment protocols. Table 3.2 below presents the assessed stream data for each project reach, while Figure 4 shows their intermittent and perennial status. Copies of the completed classification forms are located in Appendix F. These assessments were confirmed by the USACE in the Preliminary JD received on July 26, 2017, a copy of which can be found in Appendix H. Figures 5A and 5B show the drainage areas for each project reach.

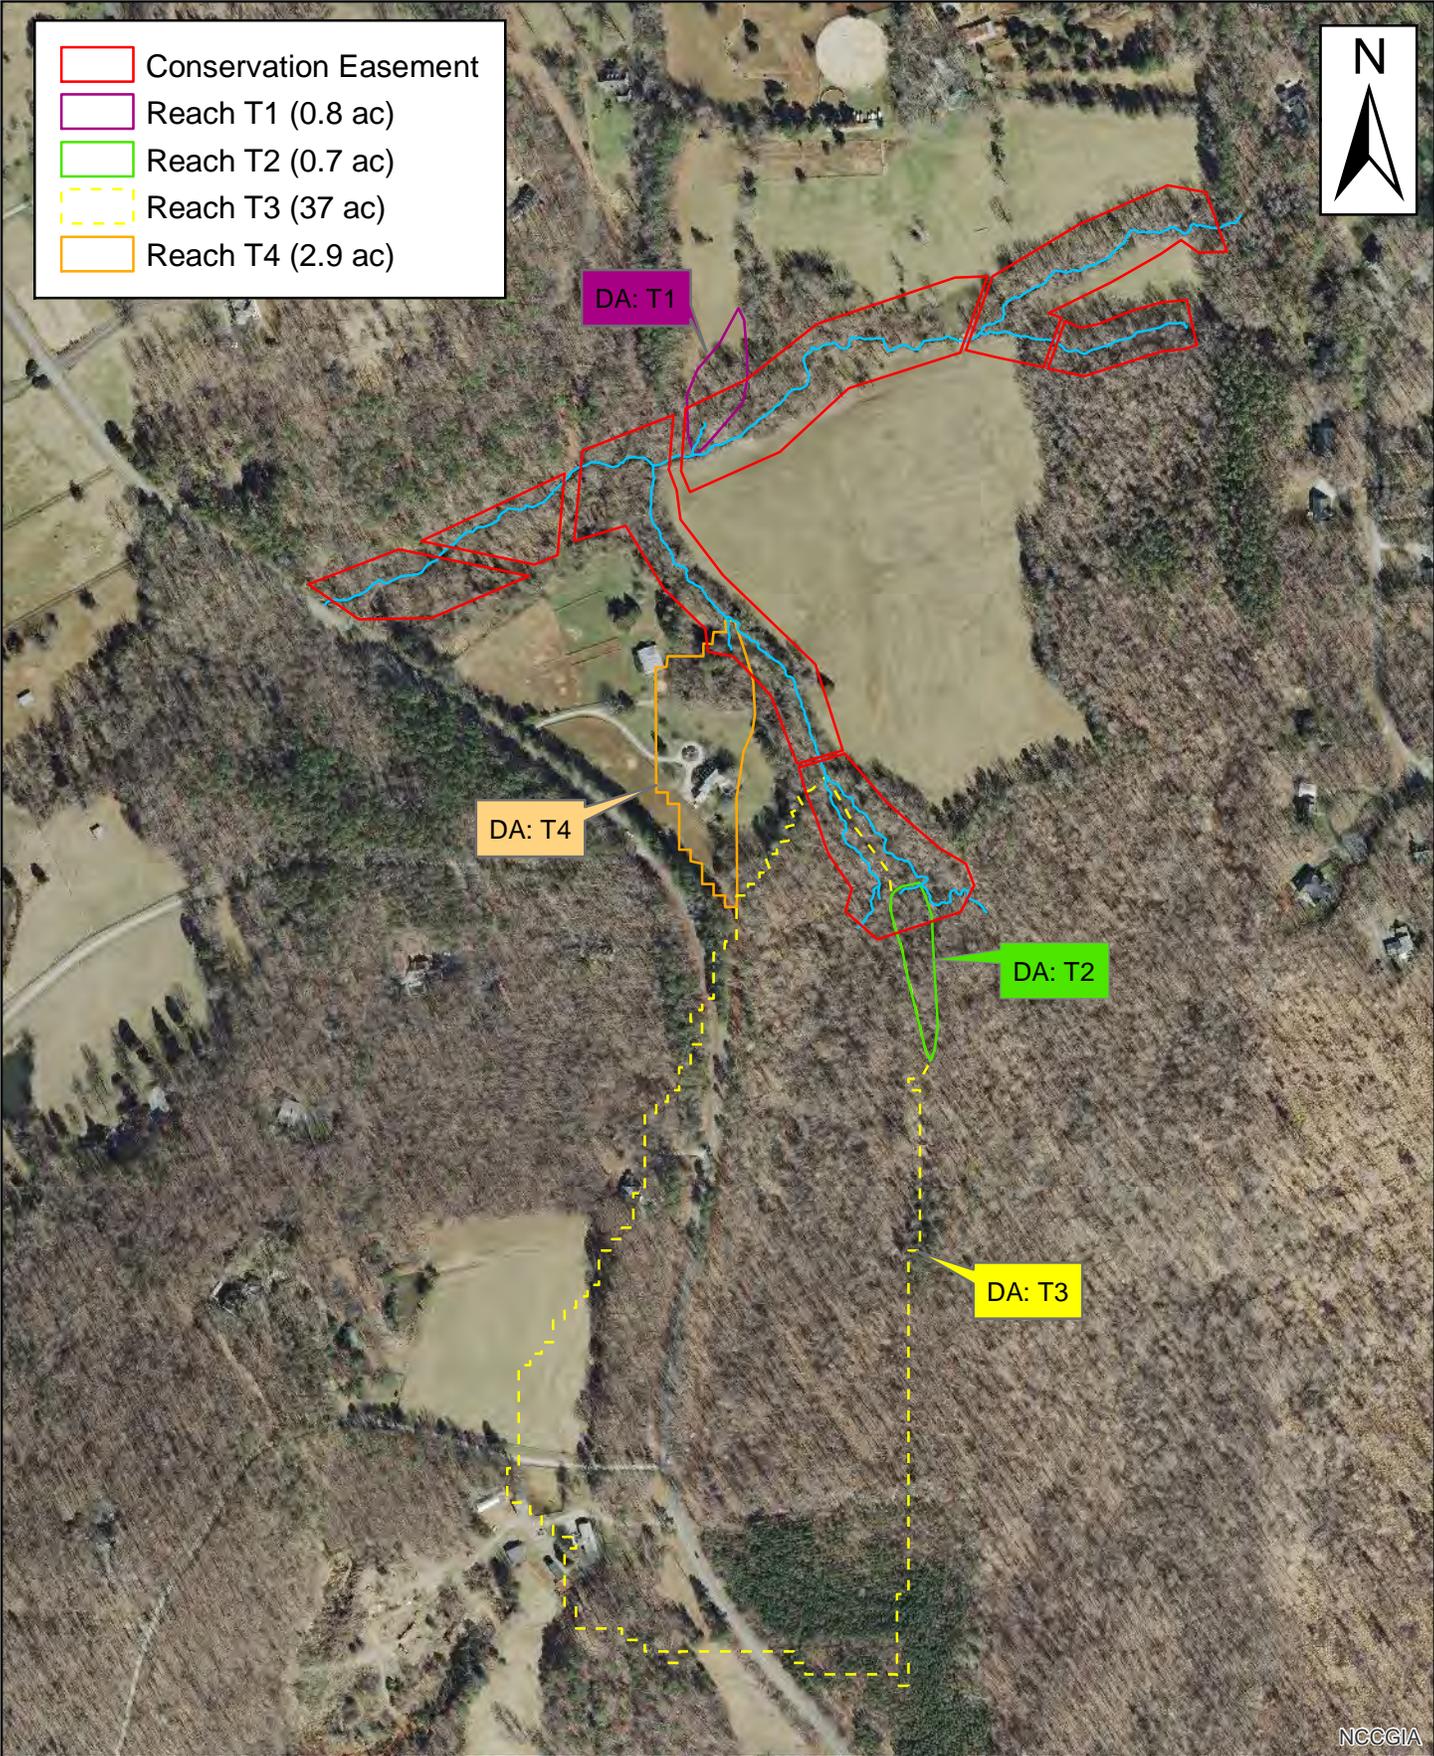
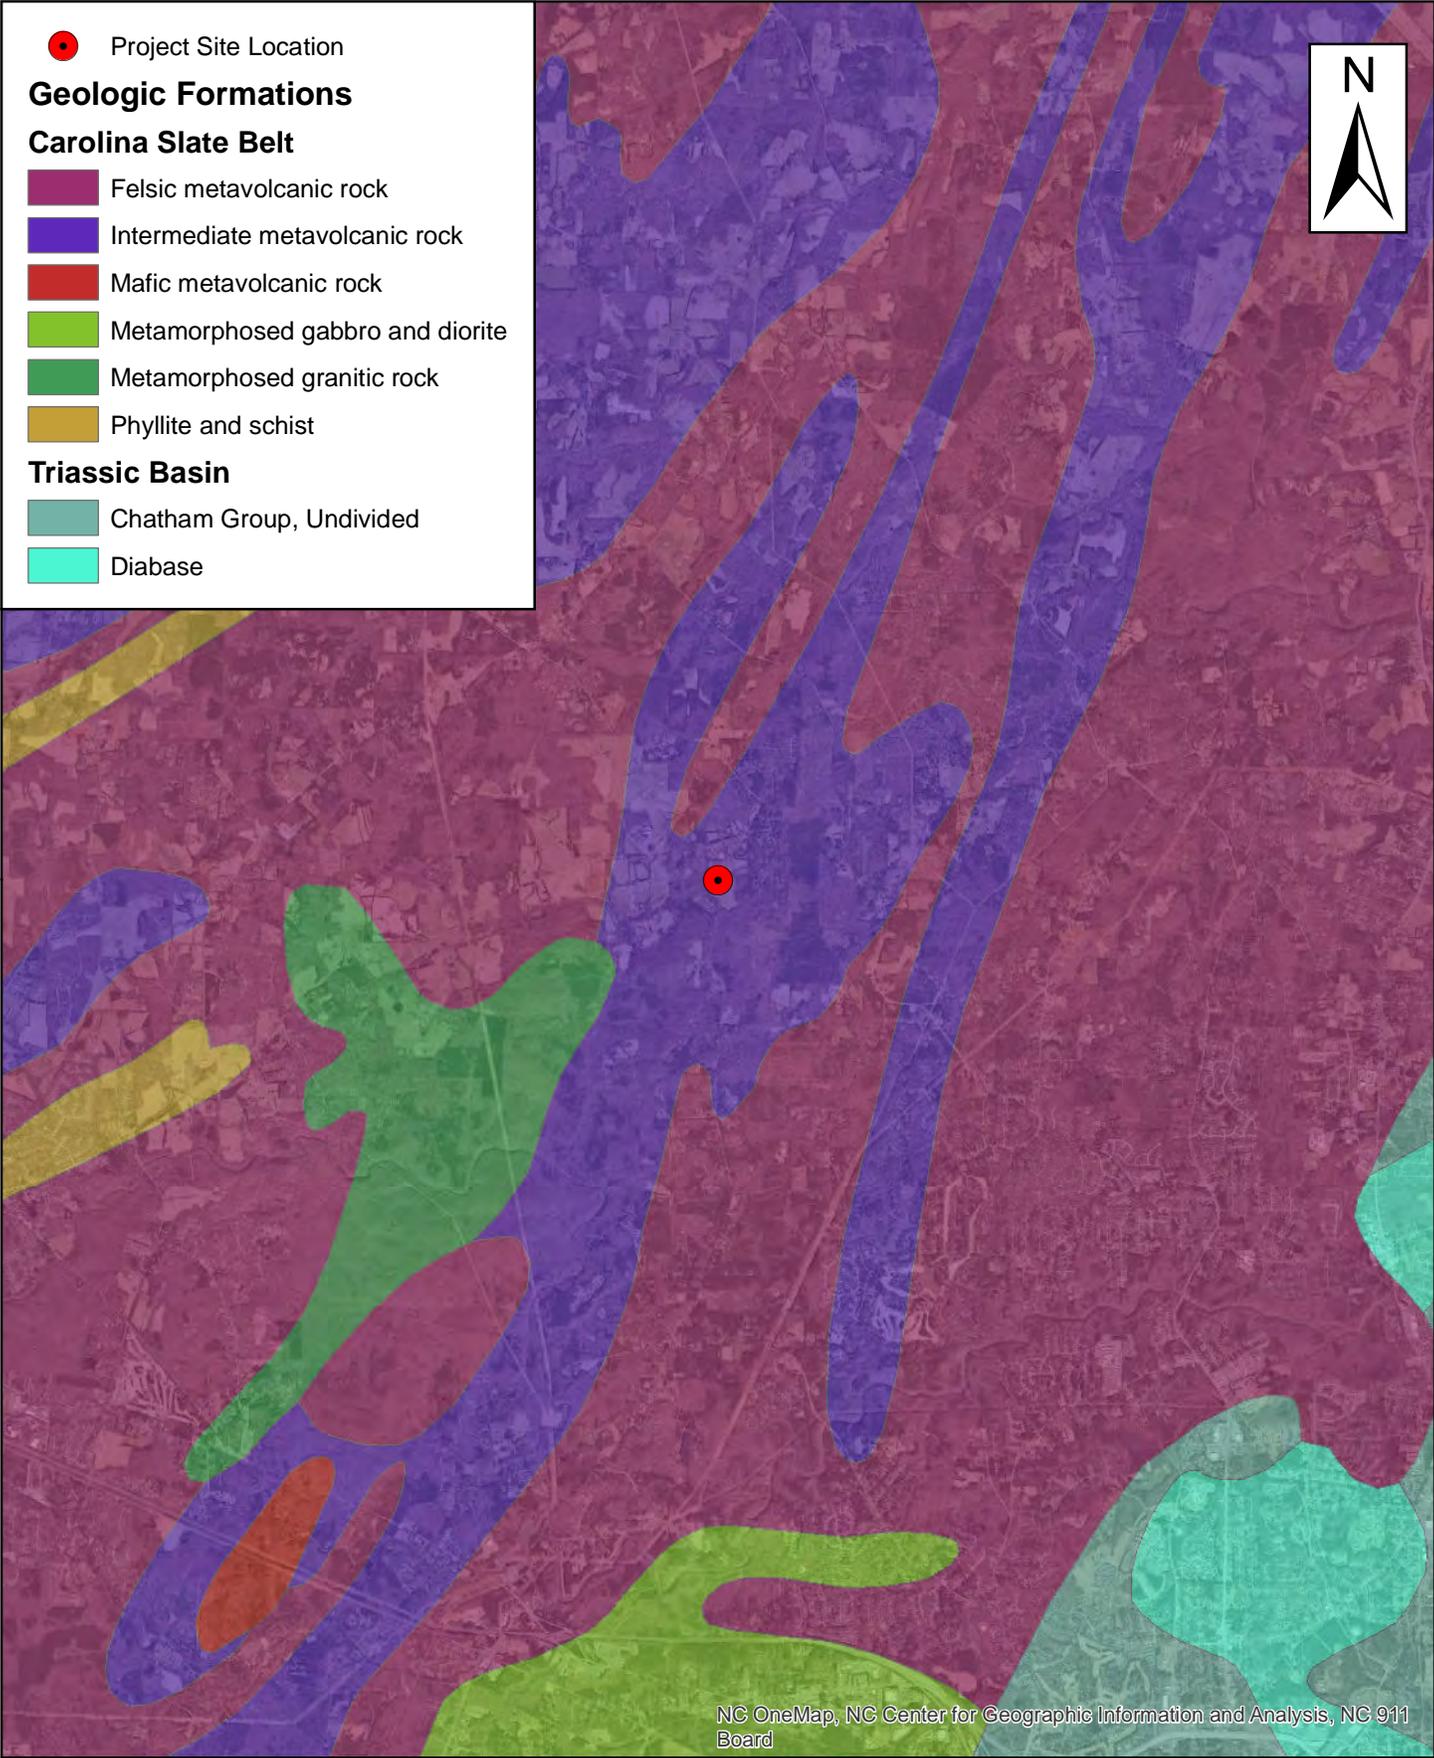
**Figure 6**  
**Geologic Map**  
**Lochill Farm Project**

Geologically, the project location is underlain by the Carolina Slate Belt (Figure 6). The intermediate metavolcanic rocks (metamorphic rock derived from volcanic rock sources) found beneath the site are primarily metamorphosed andesitic tuffs and flows. Basic dikes cut the slate, but most dikes are too narrow to delineate at the project-level map scale. The bedrock is overlain by the regolith, which is composed of saprolite, alluvium, and soil. Saprolite is formed from the in-situ weathering of bedrock and generally retains relict structures from the parent rock. These relict structures also retain the foliation and directional permeability of the parent rock (Daniel and Dahlen, 2002). Baker staff observed at least two instances of exposed bedrock in the channel bed, providing grade control in those locations.

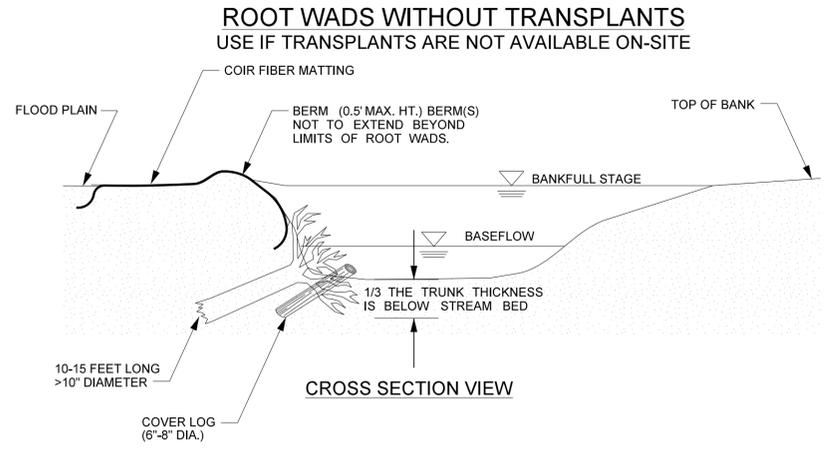
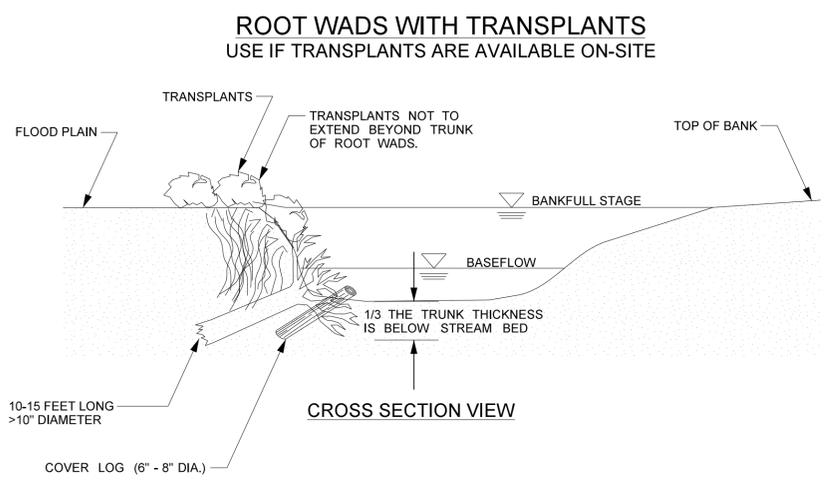
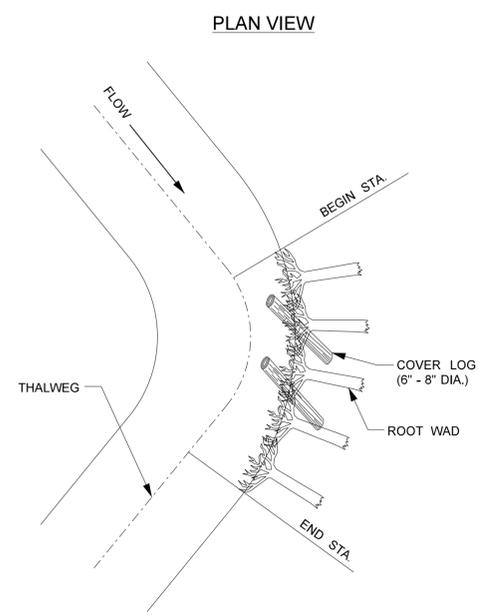
**ROOT WADS**

- NOTES:**
1. INSTALLATION USING THE TRENCHING METHOD REQUIRES THAT A TRENCH BE EXCAVATED FOR THE LOG PORTION OF THE ROOT WAD. ONE-THIRD OF THE ROOT WAD SHOULD REMAIN BELOW NORMAL BASE FLOW CONDITIONS OR CHANNEL BOTTOM.
  2. THE NUMBER OF ROOTWADS ESTIMATED MAY VARY DEPENDING ON THE ROOTMASS SIZE. IN GENERAL, ROOTWADS SHOULD PROTECT THE OUTER MEANDER BEND AS SHOWN. SEE STRUCTURE TABLE FOR APPROXIMATE STATION AND LOCATION.
  3. INSTALL COVER LOGS BETWEEN ROOTWADS TO PROVIDE HABITAT ONLY WHEN AVAILABLE FROM ON-SITE HARVESTING.

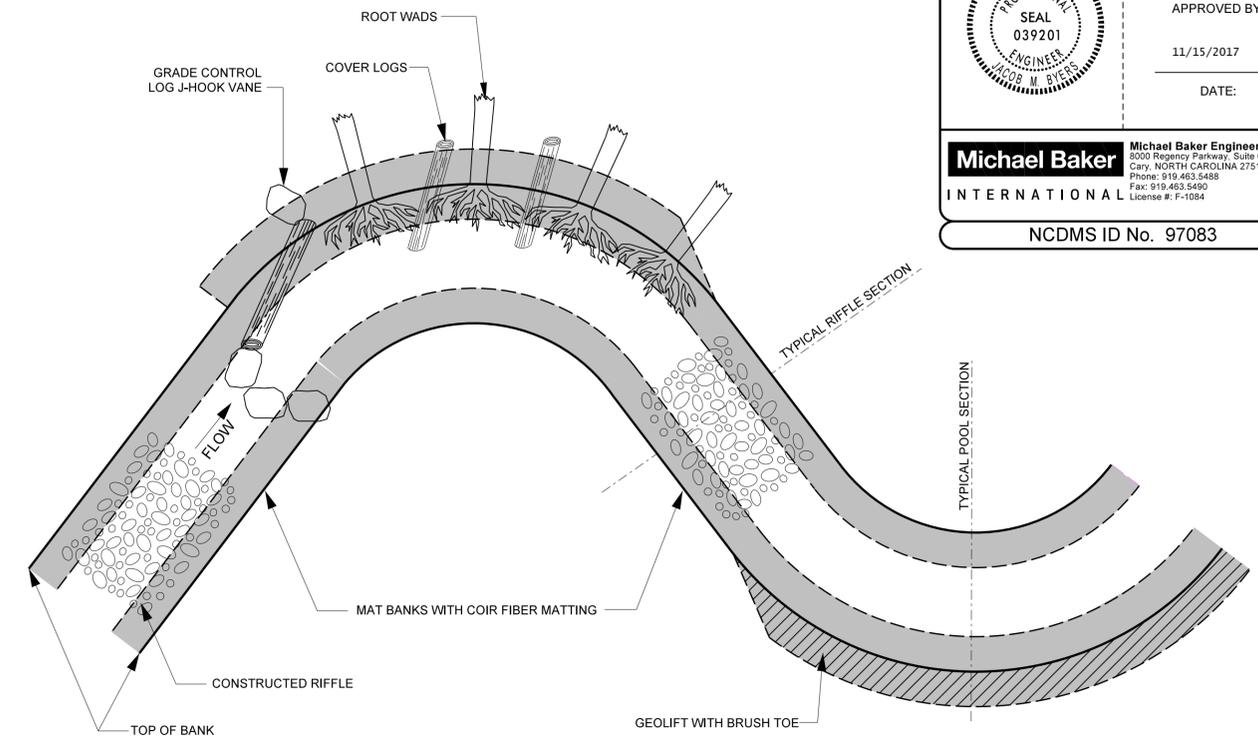
**TYPICAL STRUCTURE PLACEMENT**

- STRUCTURE NOTES:**
1. GENERALLY CONSTRUCTED RIFFLES, ROOT WADS, LOG VANES AND COIR FIBER MATTING WILL BE INSTALLED IN THE LOCATION AND SEQUENCE AS SHOWN.
  2. ANY CHANGES TO NUMBER OR LOCATION OF STRUCTURES DURING CONSTRUCTION MUST BE APPROVED BY THE DESIGN ENGINEER.
  3. COIR FIBER MATTING TO BE INSTALLED ON ALL RESTORED STREAMBANKS, FLOODPLAIN BENCHING, AND TERRACE SLOPES AS DESCRIBED IN THE TECHNICAL SPECIFICATIONS.
  4. ROOTWADS MAY BE REPLACED WITH GEOLIFT.

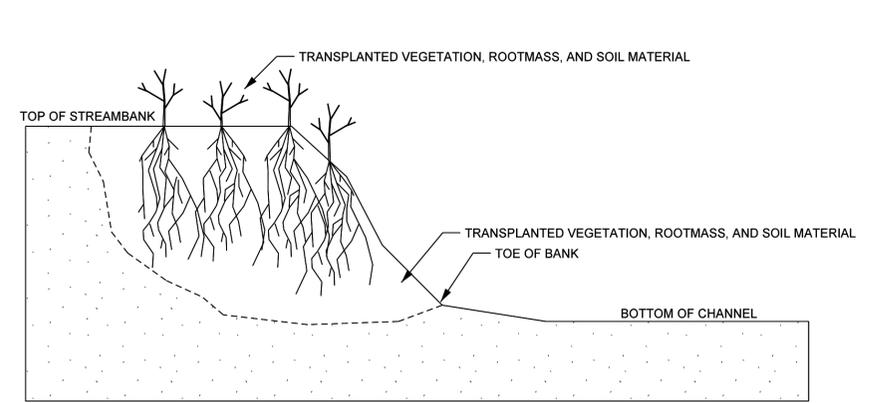
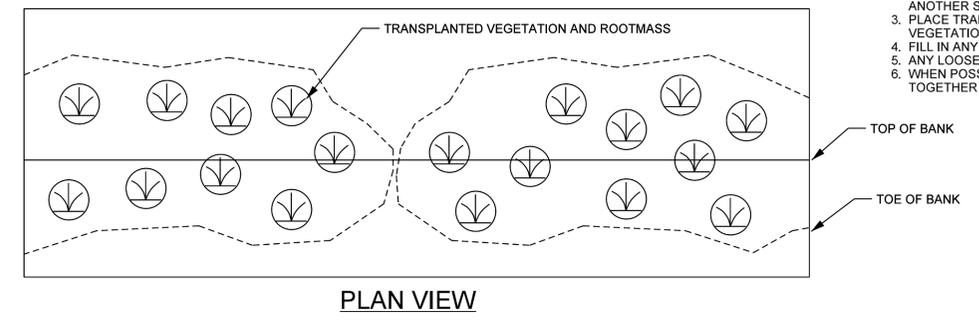
**TRANSPLANTED VEGETATION**

- NOTES:**
1. EXCAVATE A HOLE IN THE BANK TO BE STABILIZED THAT WILL ACCOMMODATE THE SIZE OF TRANSPLANT TO BE PLACED. BEGIN EXCAVATION AT THE TOE OF THE BANK.
  2. EXCAVATE THE ENTIRE ROOT MASS AND AS MUCH ADDITIONAL SOIL MATERIAL AS POSSIBLE. IF ENTIRE ROOT MASS CAN NOT BE EXCAVATED AT ONCE, THE TRANSPLANT IS TOO LARGE AND ANOTHER SHOULD BE SELECTED.
  3. PLACE TRANSPLANT IN THE BANK TO BE STABILIZED SO THAT VEGETATION IS ORIENTATED VERTICALLY.
  4. FILL IN ANY HOLES AROUND THE TRANSPLANT AND COMPACT.
  5. ANY LOOSE SOIL LEFT IN THE STREAM SHOULD BE REMOVED.
  6. WHEN POSSIBLE, PLACE MULTIPLE TRANSPLANTS CLOSE TOGETHER SUCH THAT THEY TOUCH.

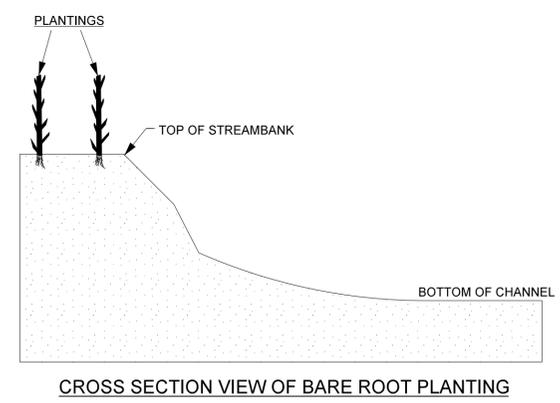
**PLANTING SPECIFICATIONS**

- NOTES:**
1. PLANT BARE ROOT SHRUBS AND TREES TO THE WIDTH OF THE BUFFER/PLANTING ZONE AS SHOWN ON THE PLANS.
  2. ALLOW FOR 6-10 FEET BETWEEN PLANTINGS, DEPENDING ON SIZE.
  3. LOOSEN COMPACTED SOIL.
  4. PLANT IN HOLES MADE BY A MATTOCK, DIBBLE, PLANTING BAR, OR OTHER APPROVED MEANS.
  5. PLANT IN HOLES DEEP AND WIDE ENOUGH TO ALLOW THE ROOTS TO SPREAD OUT AND DOWN WITHOUT J-ROOTING.
  6. KEEP ROOTS MOIST WHILE DISTRIBUTING OR WAITING TO PLANT BY MEANS OF WET CANVAS, BURLAP, OR STRAW.
  7. HEEL IN PLANTS IN MOIST SOIL OR SAWDUST IF NOT PROMPTLY PLANTED UPON ARRIVAL TO PROJECT SITE.

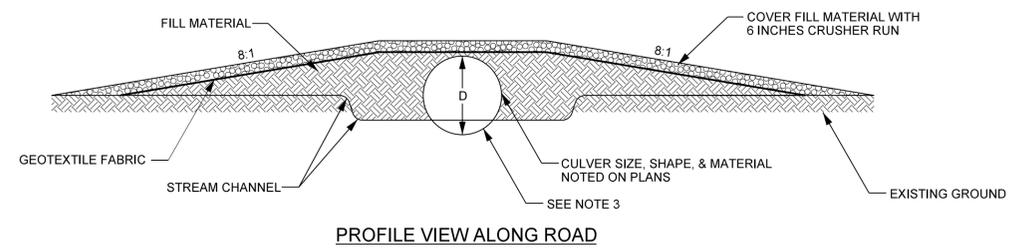
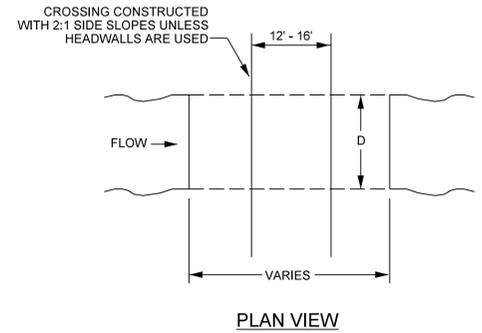
**PERMANENT STREAM CROSSING**

- NOTES:**
1. INSTALL FLOODPLAIN CULVERTS AS SHOWN ON THE PLANS.
  2. UPSTREAM AND DOWNSTREAM ROAD SLOPES SHALL BE PROTECTED WITH CLASS B STONE UNDERLAIN BY FILTER FABRIC OR STACKED BOULDER HEADWALLS AS SHOWN ON THE PLANS.
  3. CULVERTS WILL BE BURIED AT LEAST 6" BELOW THE BED OF THE STREAM.
  4. CULVERTS SHALL HAVE A MINIMUM OF 1' OF COVER.

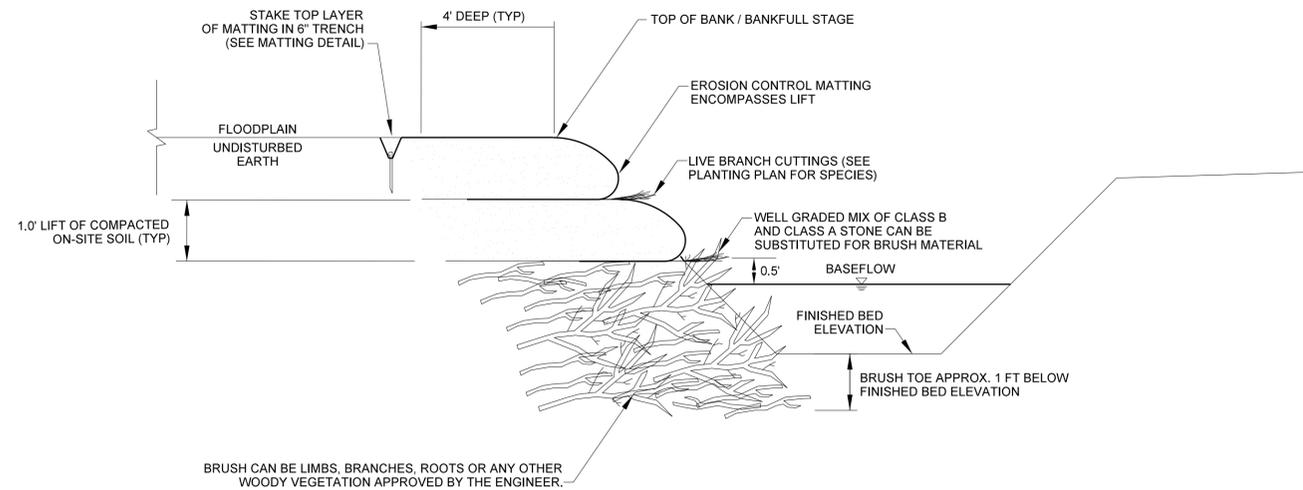
### GEOLIFT WITH BRUSH TOE

- NOTES:**
1. LIVE BRANCH CUTTINGS SHALL BE THE SAME SPECIES AS THE LIVE STAKES AND SHALL BE INSTALLED DURING VEGETATION DORMANCY.
  2. LIVE BRANCH CUTTINGS SHALL BE INSTALLED AT A DENSITY OF 20-30 CUTTINGS PER LINEAR FOOT AND A MAXIMUM DIAMETER OF 2.5 INCHES.
  3. NUMBER OF SOIL LIFTS MAY VARY, IN GENERAL LIFTS SHALL EXTEND TO THE TOP OF BANK OR BANKFULL STAGE.
  4. WHEN GEOLIFTS ARE BUILT ABOVE ROOTWAD CLUSTER, USE LARGE STONE BACKFILL BEHIND ROOT MASS TO BUILT FOUNDATION.

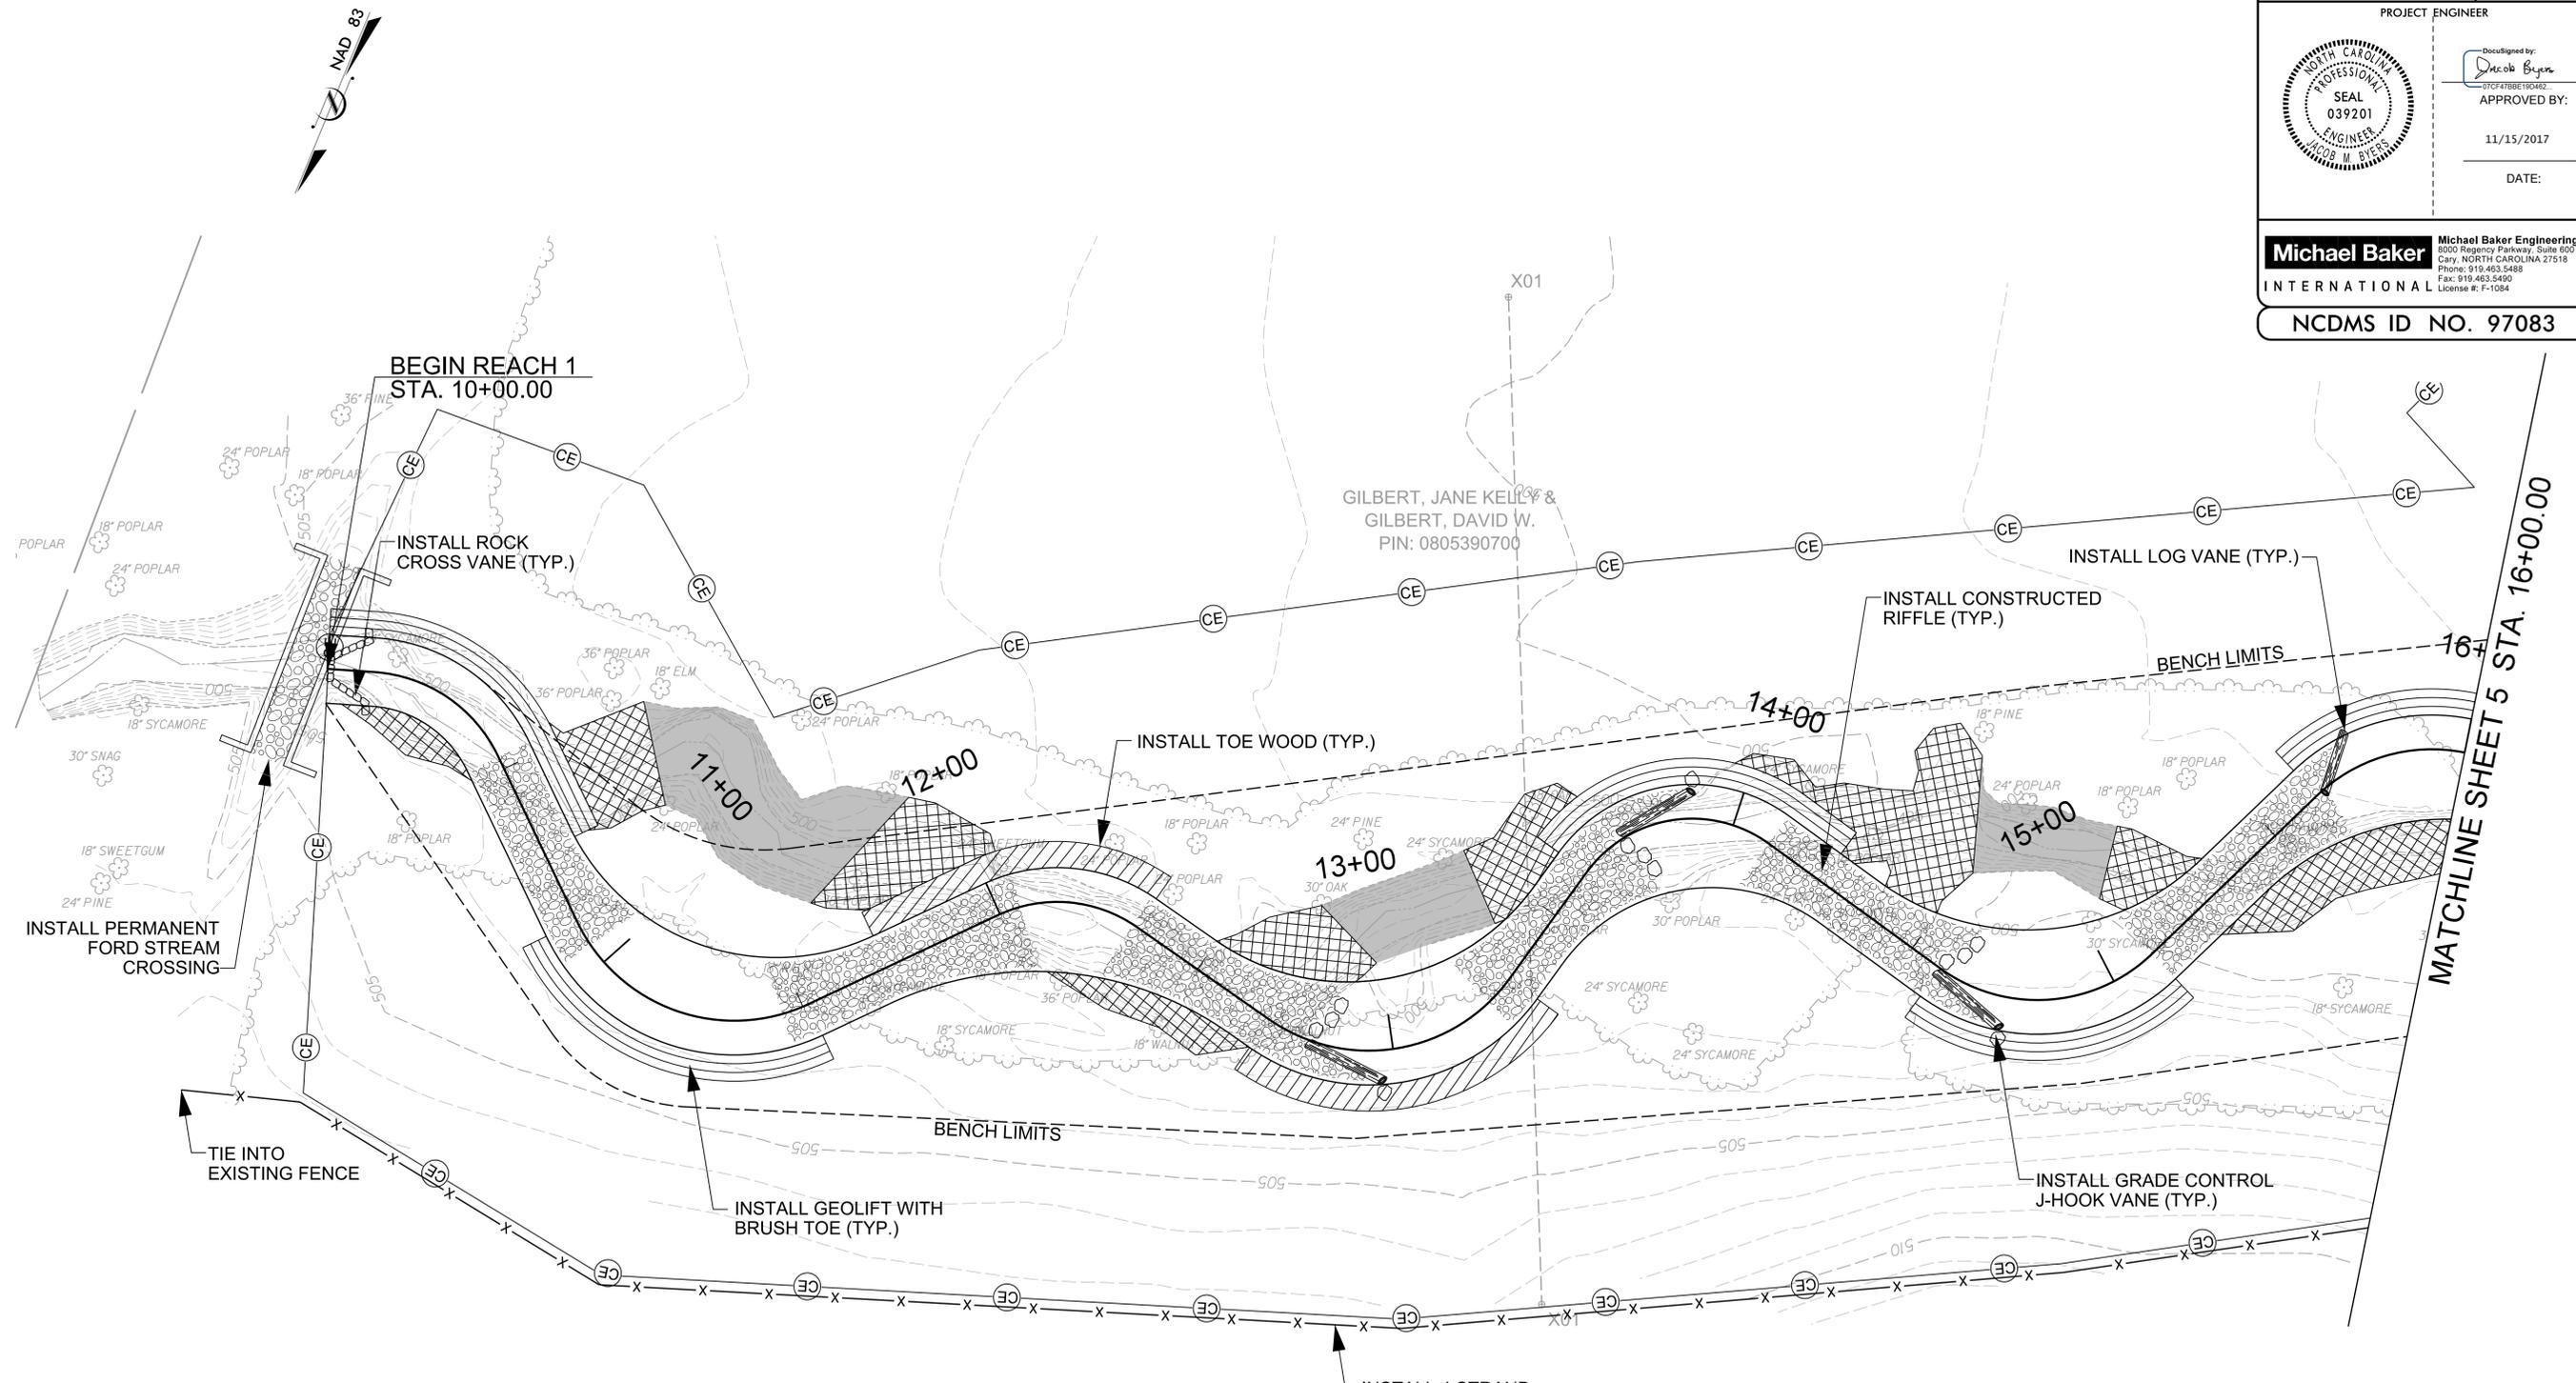
- NOTES:
1. ANY HARDWOOD TREES REMOVED MUST BE INCORPORATED WITHIN THE STRUCTURES BEING INSTALLED.
  2. EXCAVATE STREAMBED MATERIAL BEFORE FILLING IN THE OLD CHANNEL AND USE STREAMBED MATERIAL WITHIN THE NEWLY CONSTRUCTED CHANNEL.

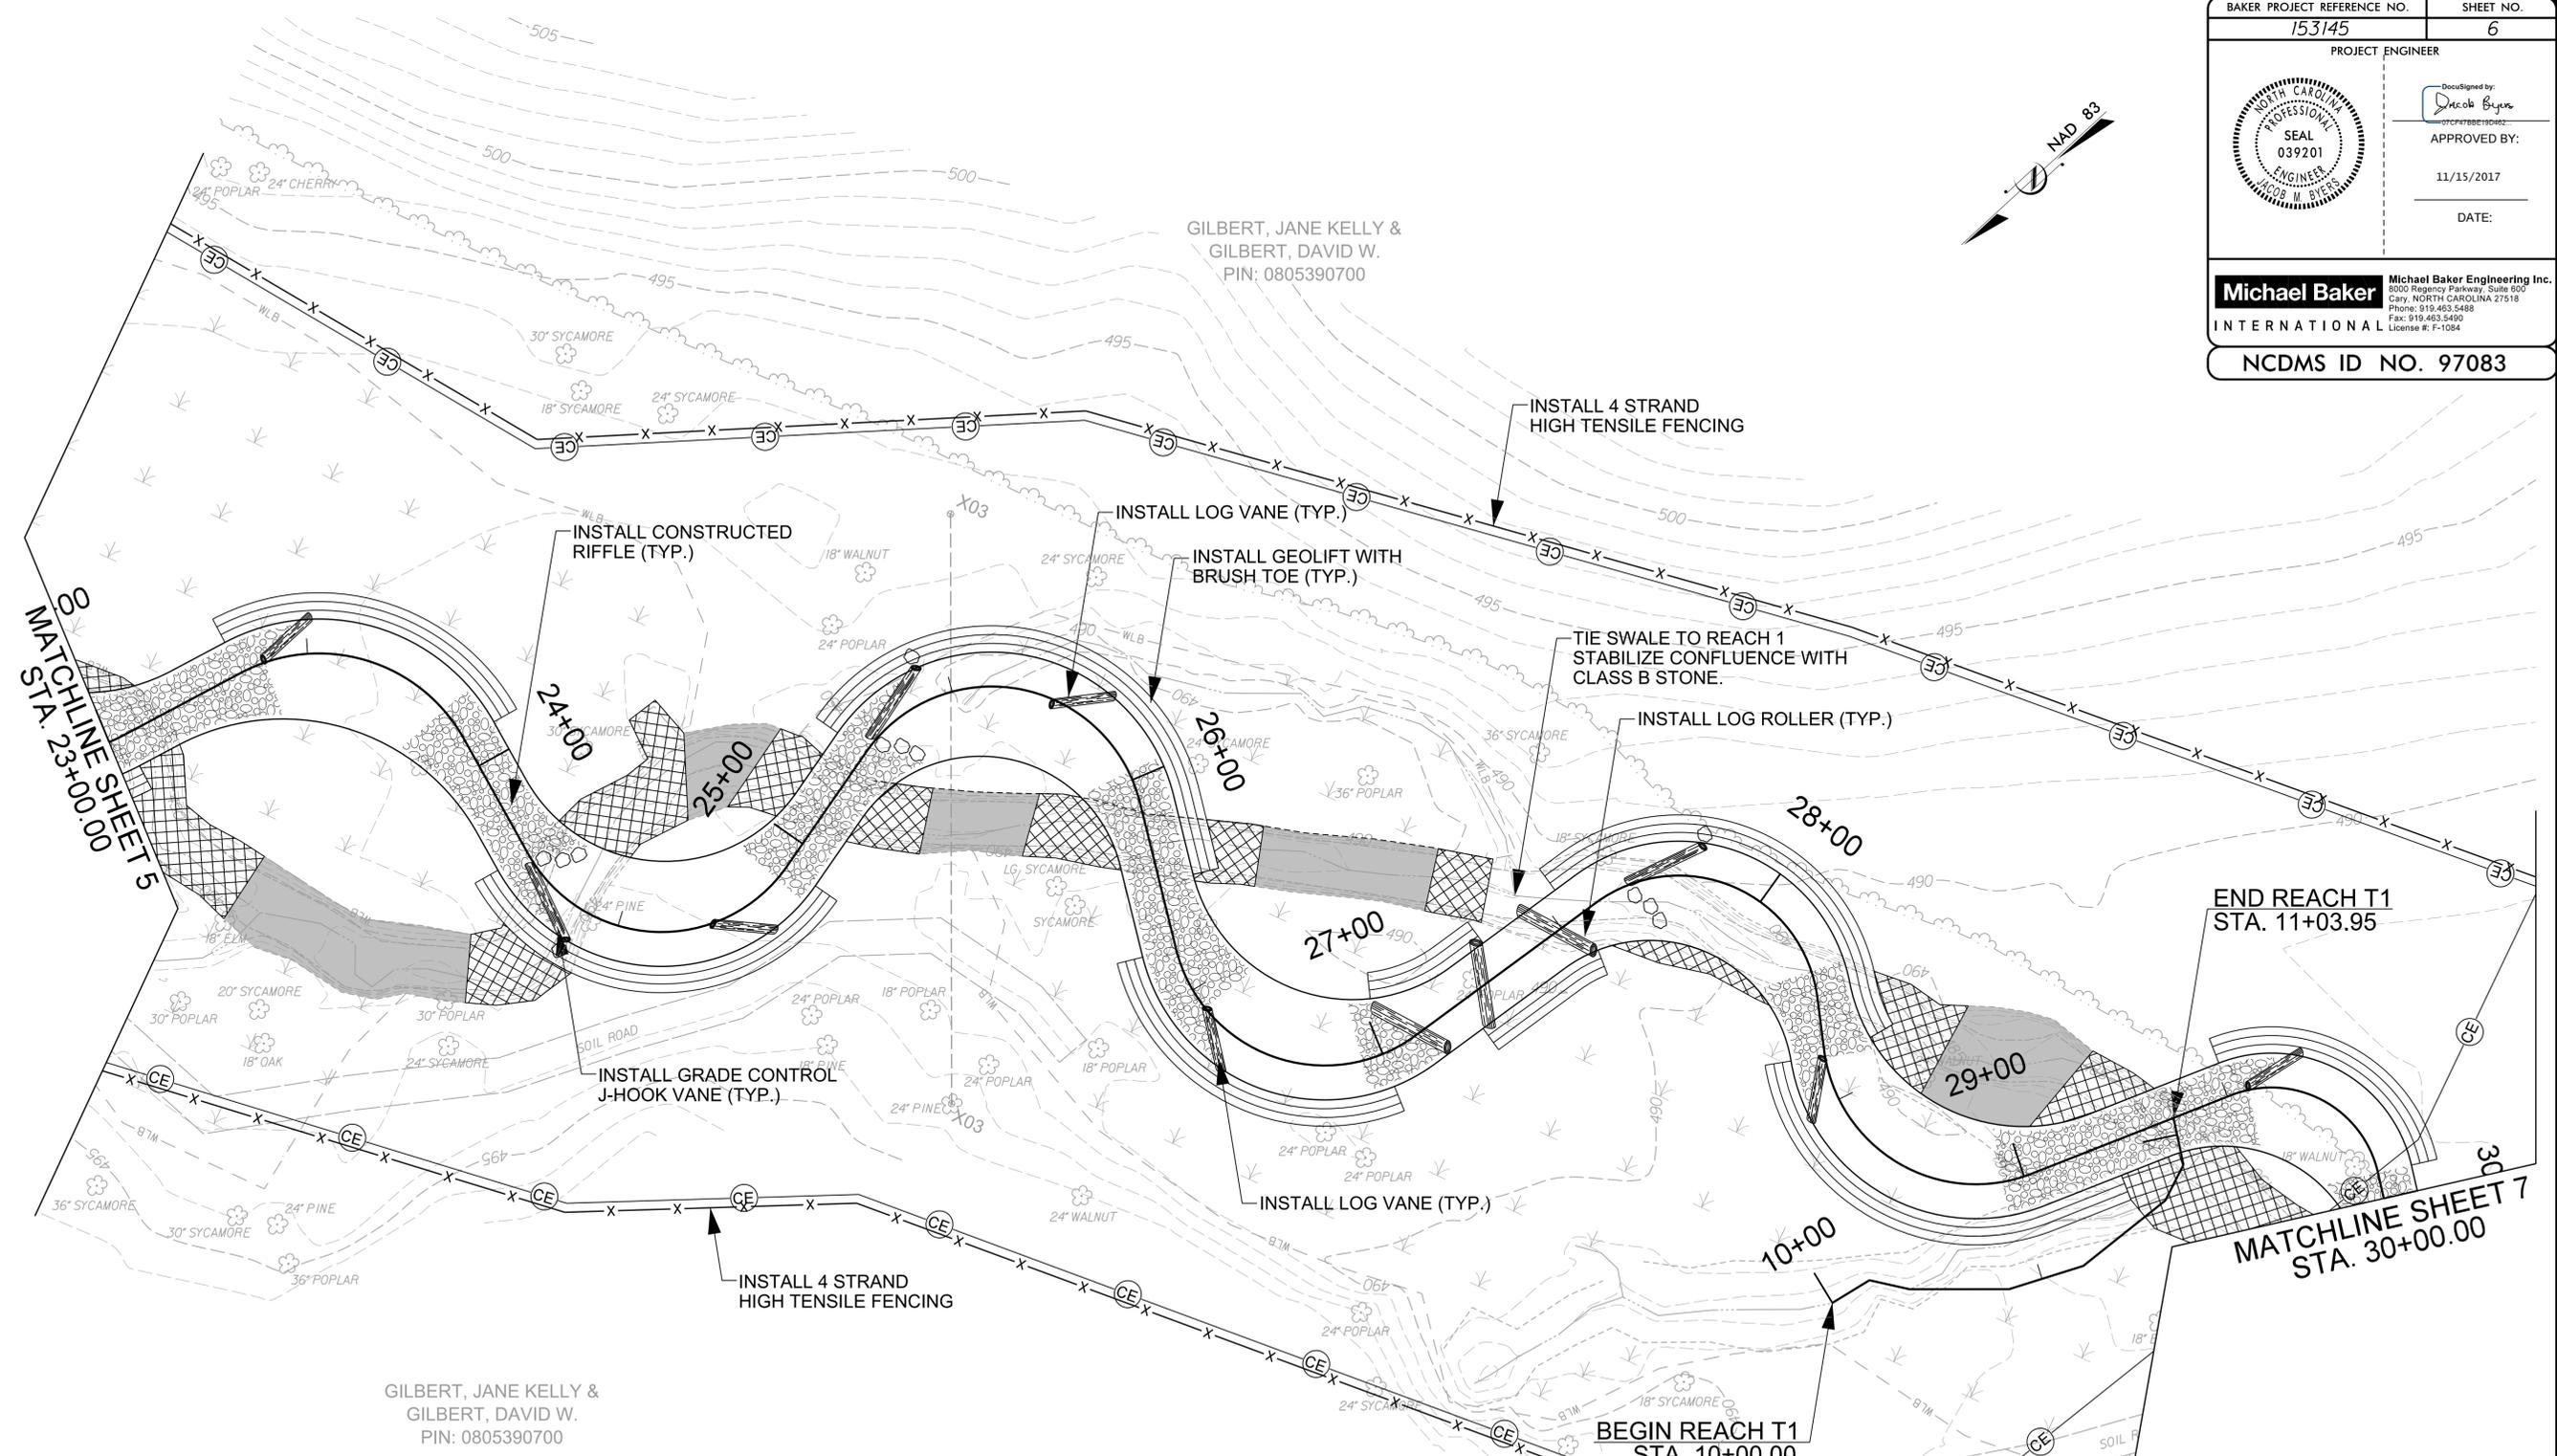
- NOTES:**
1. ANY HARDWOOD TREES REMOVED MUST BE INCORPORATED WITHIN THE STRUCTURES BEING INSTALLED.
  2. EXCAVATE STREAMBED MATERIAL BEFORE FILLING IN THE OLD CHANNEL AND USE STREAMBED MATERIAL WITHIN THE NEWLY CONSTRUCTED CHANNEL.

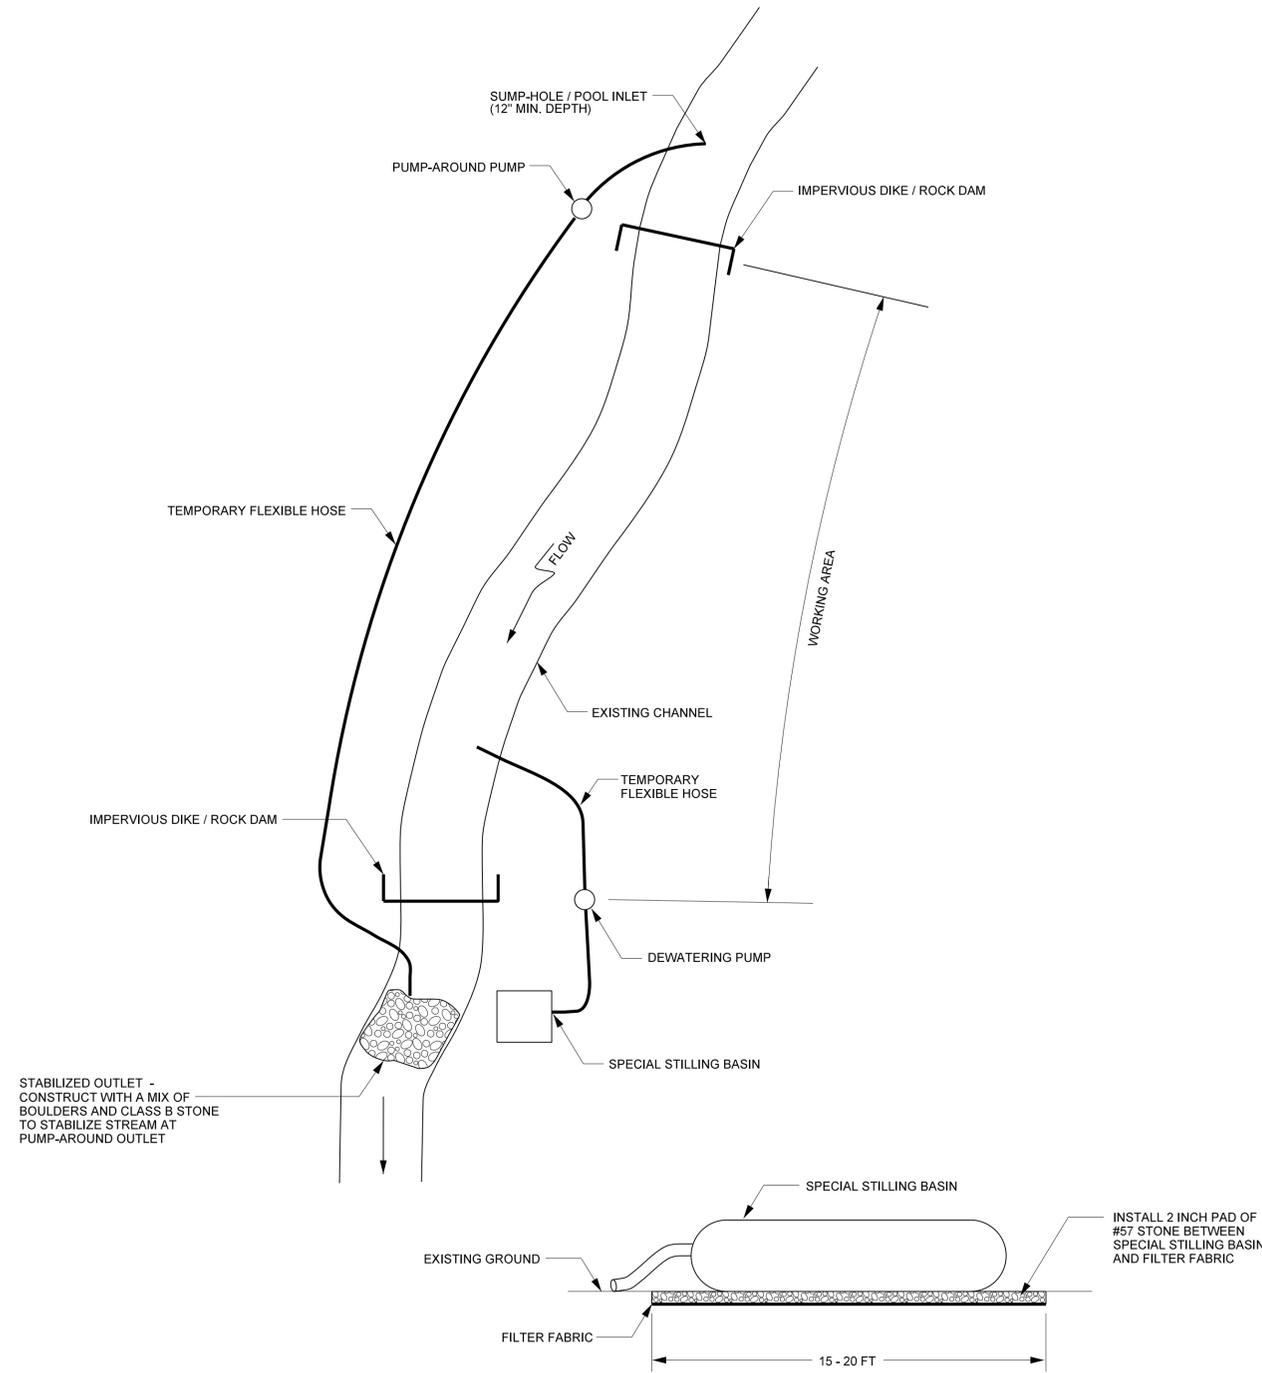
**TYPICAL PUMP-AROUND OPERATION**

**SEQUENCE OF CONSTRUCTION FOR TYPICAL PUMP-AROUND**
