McKee Creek, Cabarrus County

North Carolina Department of Environment and Natural Resources
Ecosystem Enhancement Program

Restoration Plan

August 15, 2008

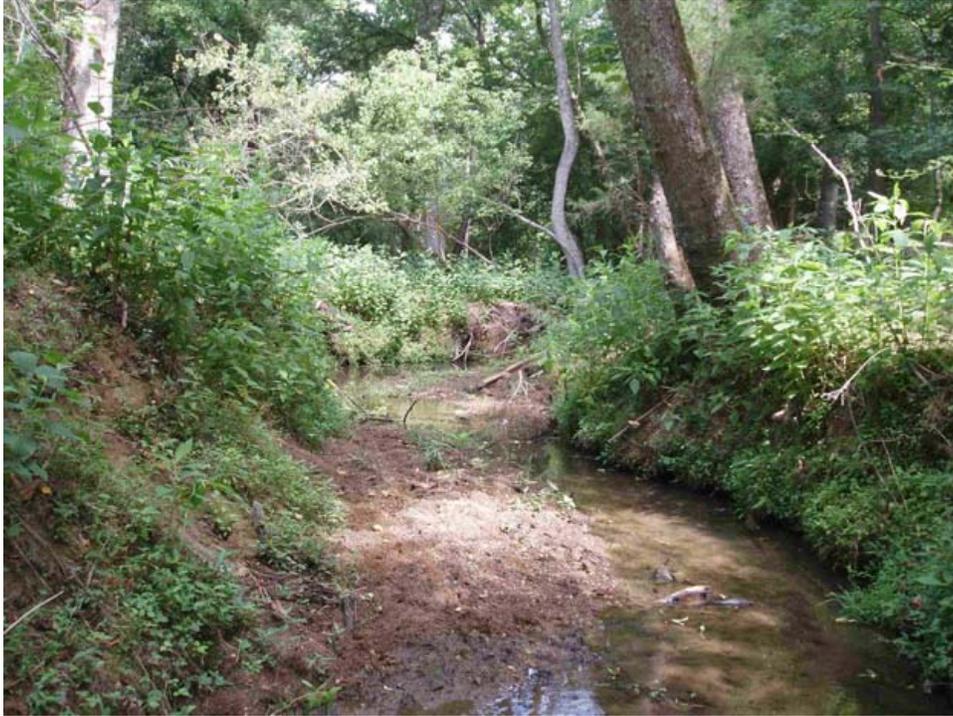
Photograph 1: View of feature A (Clear Creek) just upstream of its confluence with feature B (see Figure 4a and 4b).

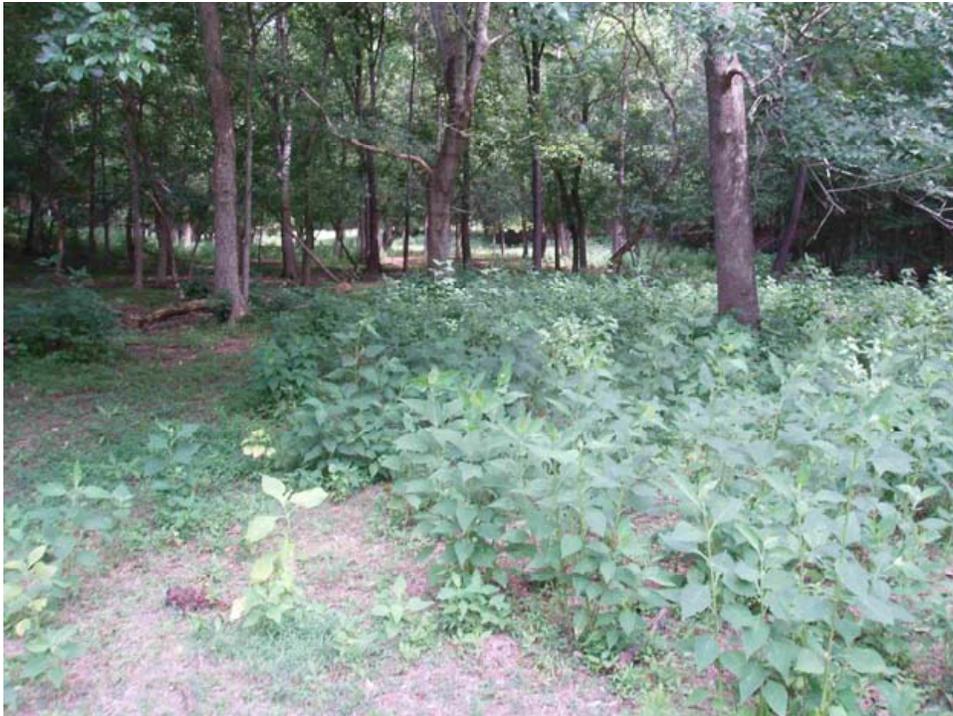
Photograph 2: View of the floodplain of feature A (Clear Creek) (see Figure 4a and 4b).

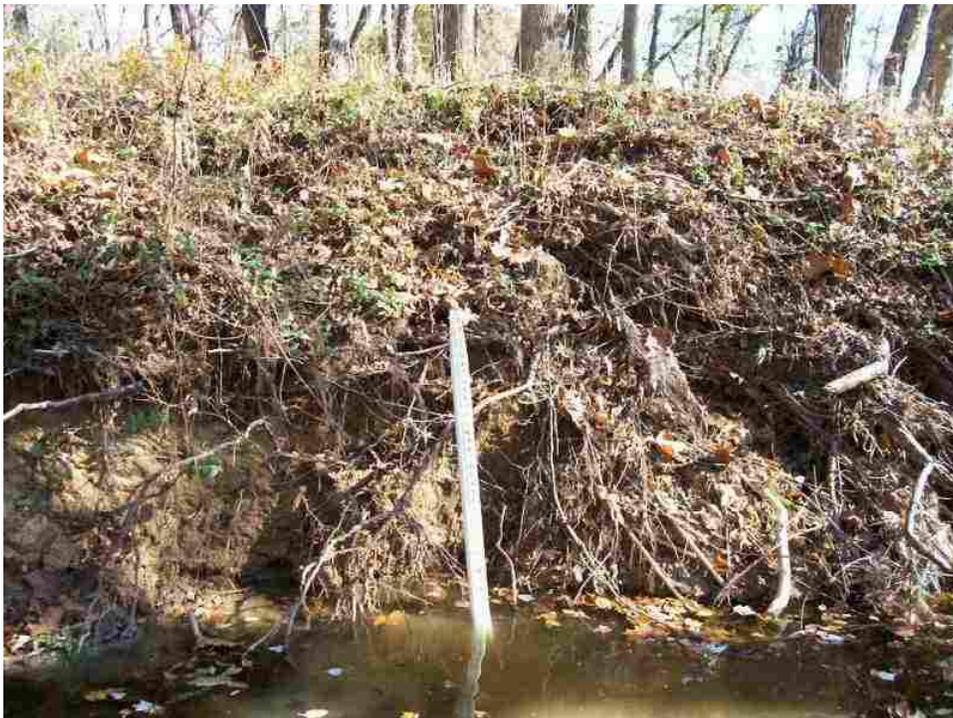
Photograph 30: McKee Creek Bent to be Removed Vicinity of Cross-Section 4
