Wetland Mitigation Site Plan

River Bend
Caswell County, North Carolina

State Project No. 8.1380501
TIP Project No. R-2241

North Carolina Department of Transportation

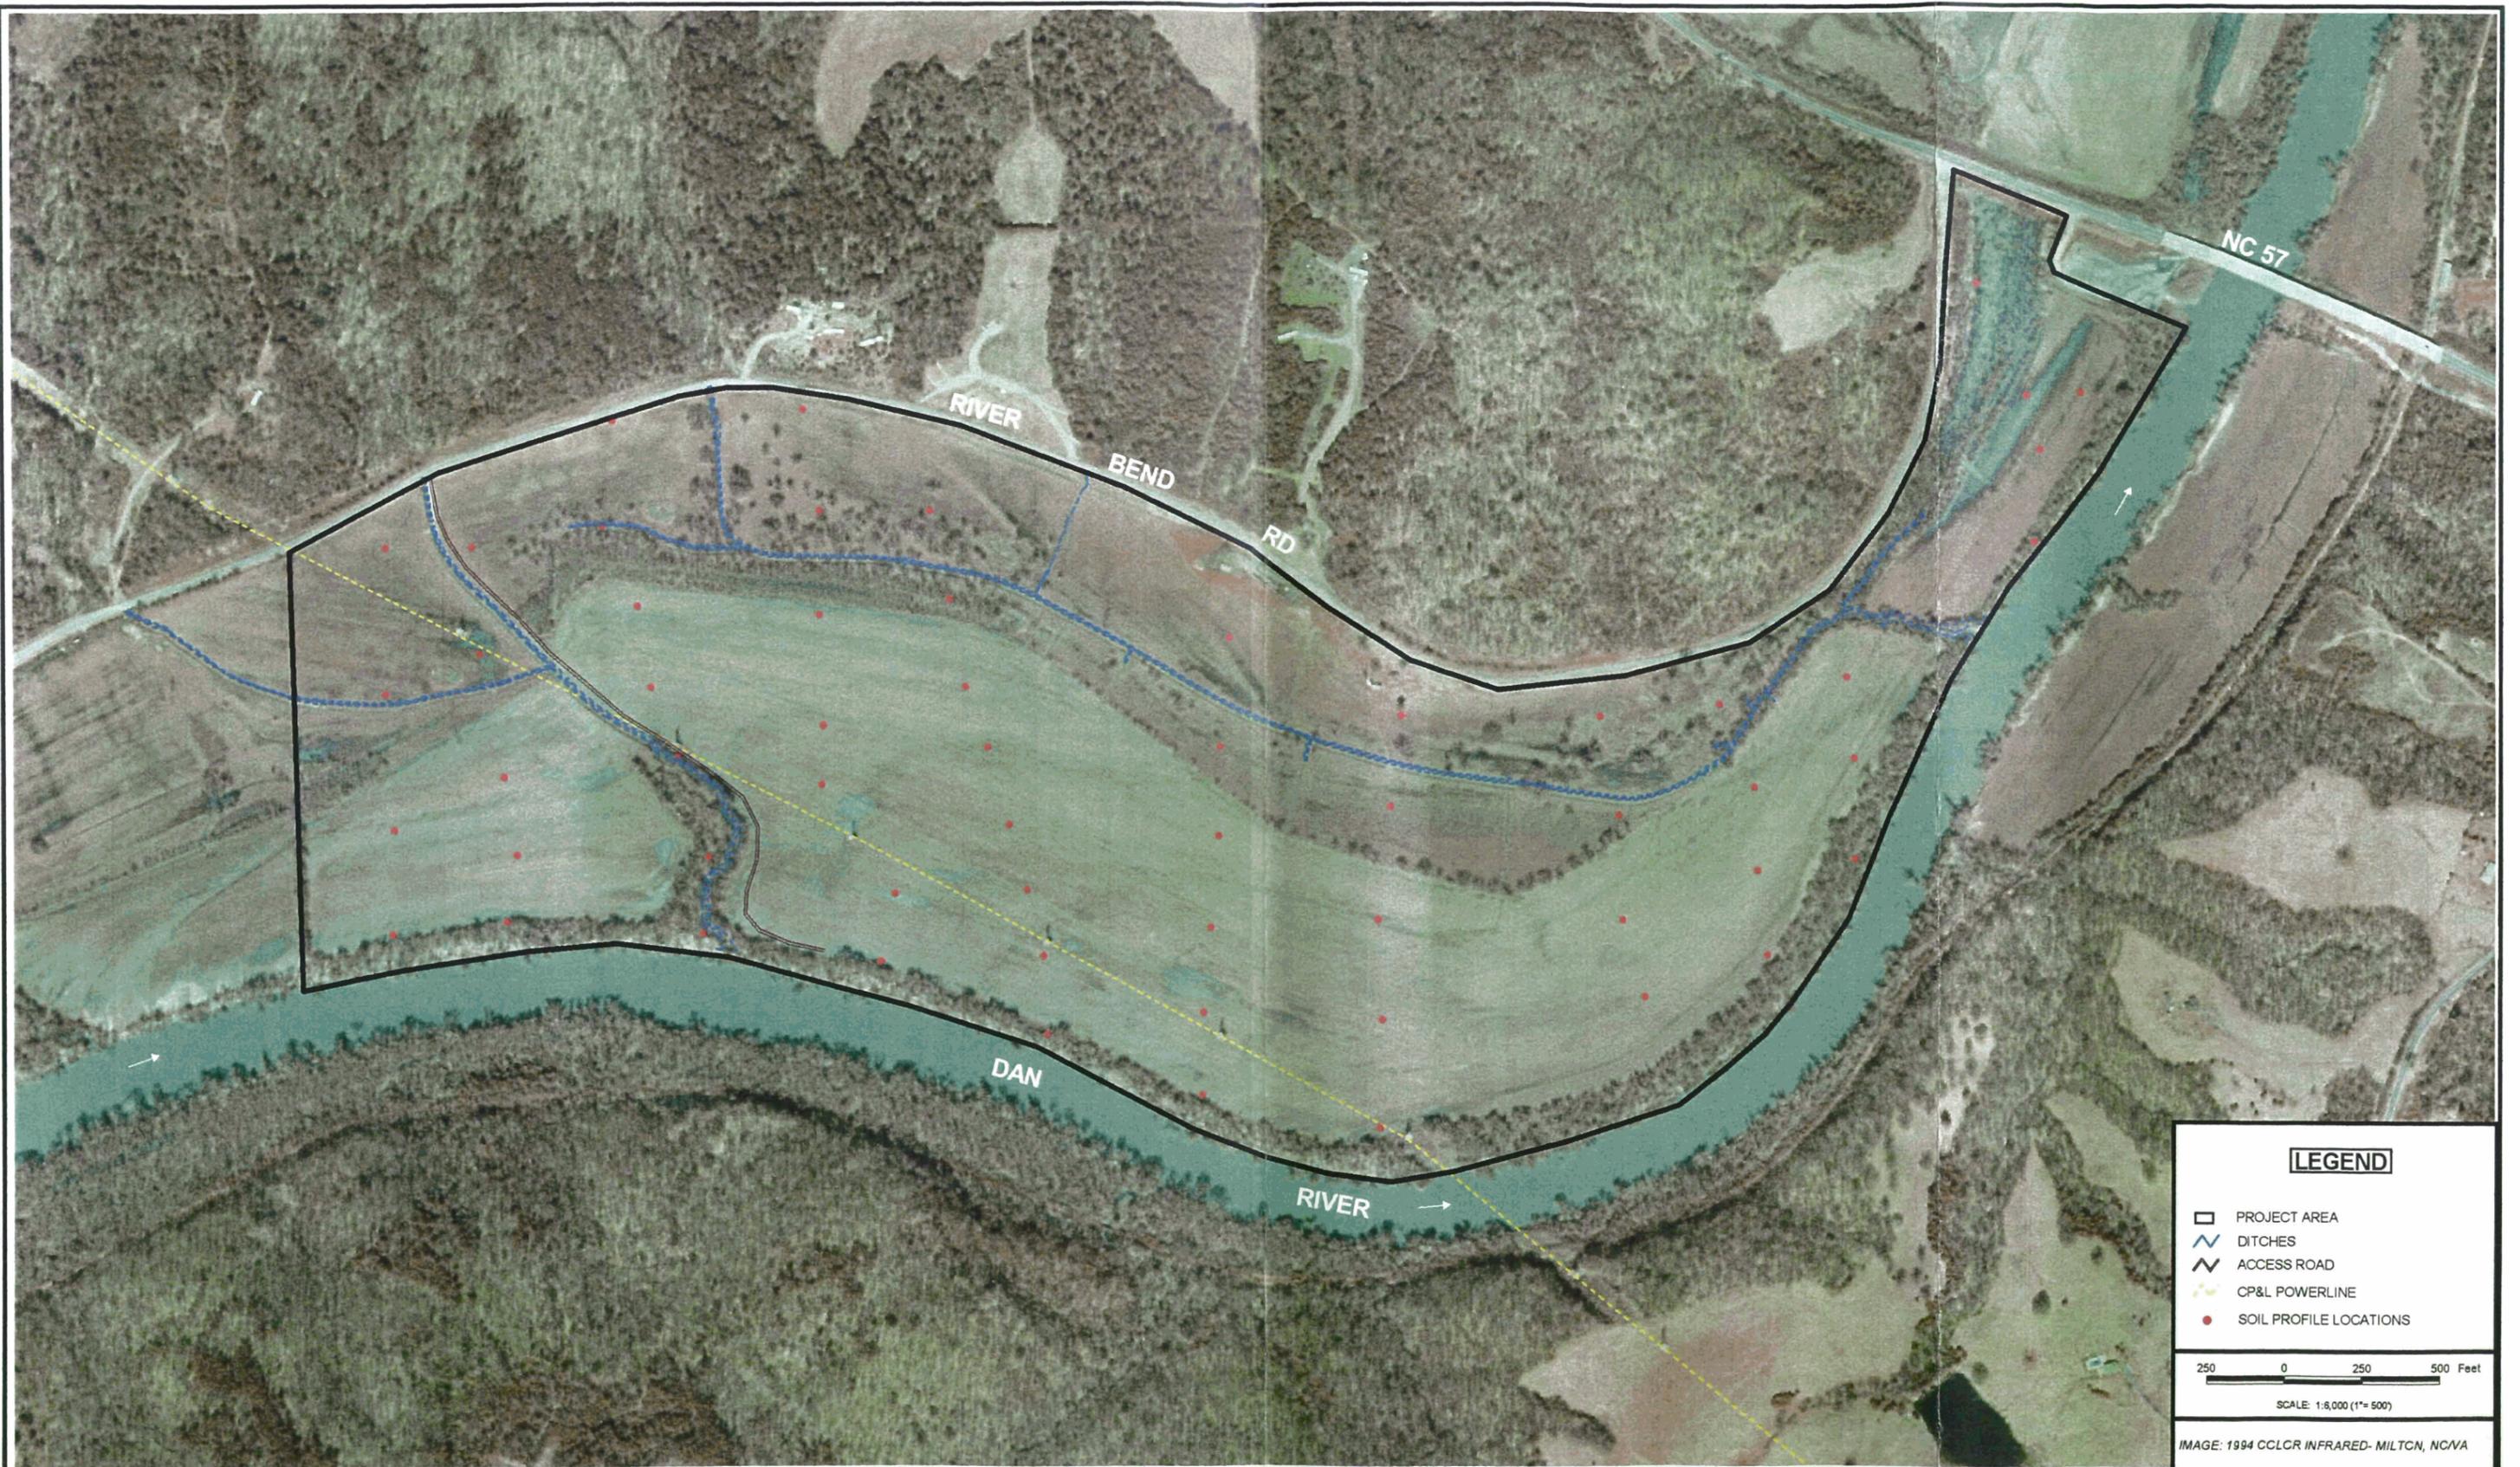
Figure No.
2

SOIL PROFILE DELINEATION
RIVER BEND WETLAND MITIGATION BANK
 CASWELL COUNTY, NORTH CAROLINA

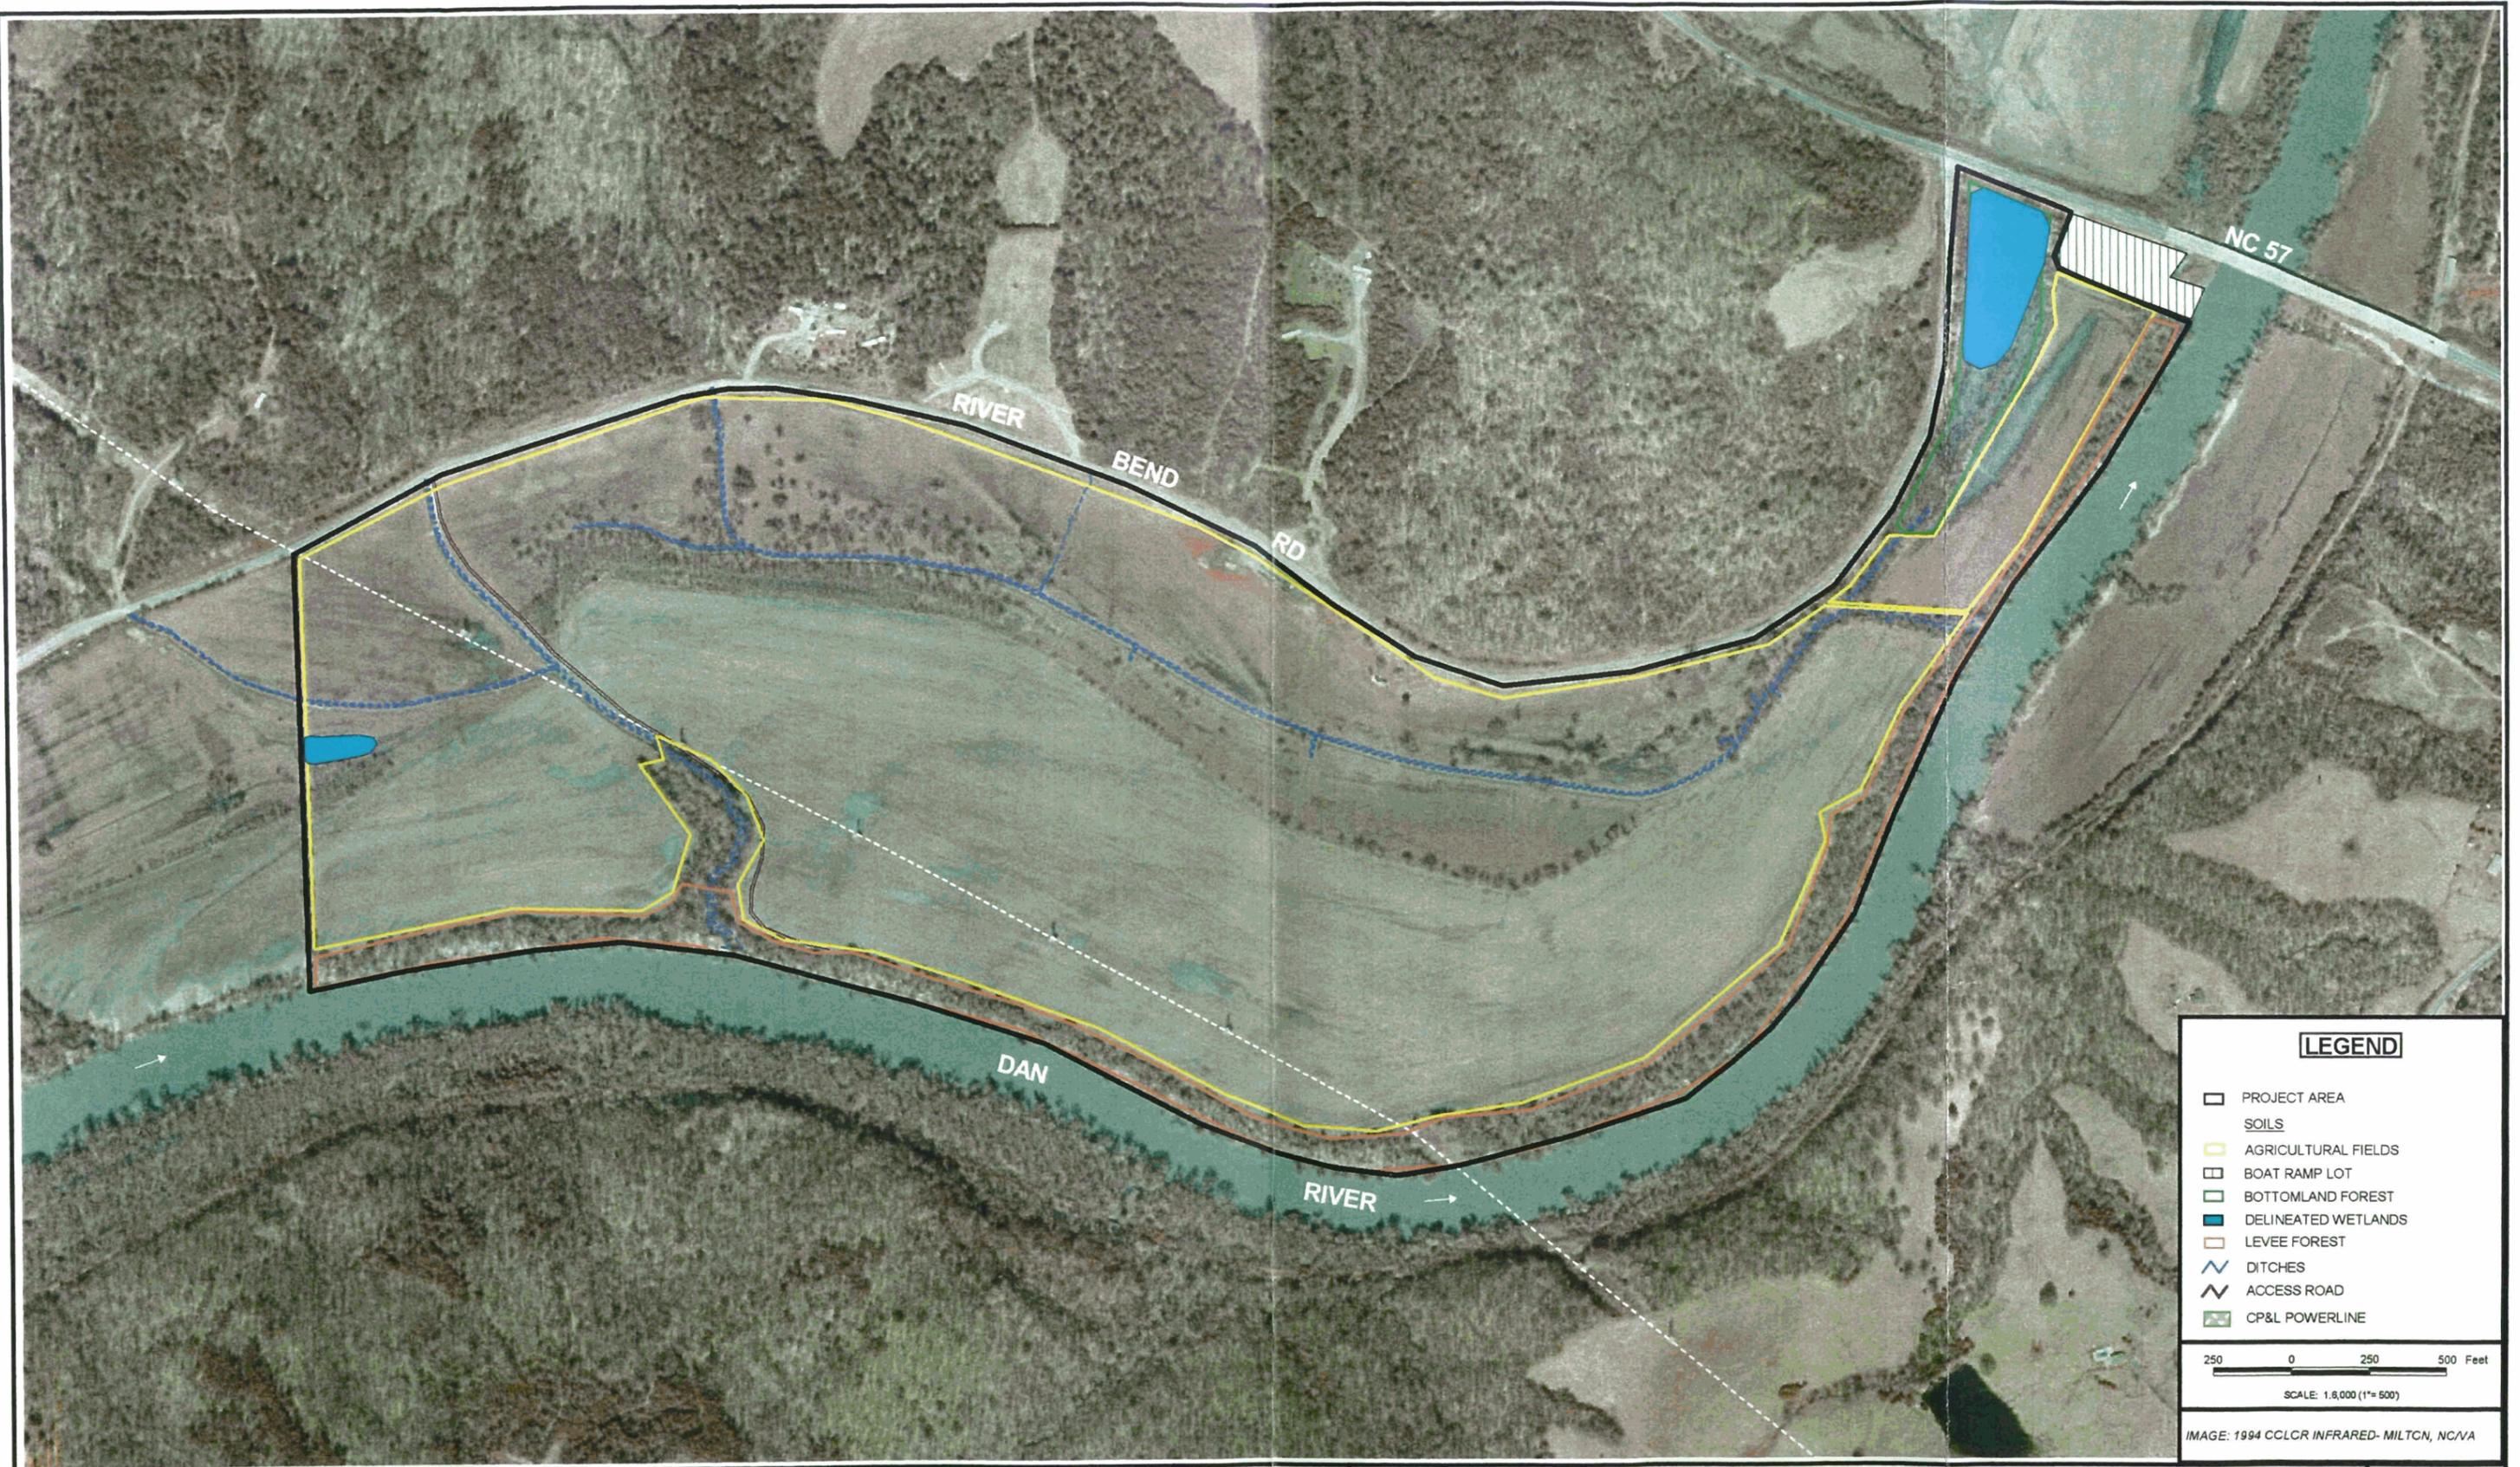
Figure No.
3

EXISTING CONDITIONS
RIVER BEND WETLAND MITIGATION BANK
 CASWELL COUNTY, NORTH CAROLINA

The River Bend site covers 193 acres of previously farmed agricultural land and pastureland along the Dan River. Based on field surveys, existing conditions at the site include 174 acres of open agricultural fields, 14 acres of levee forest, 0.5 acre of floodplain pools, and 4.5 acres of bottomland hardwoods. A wetland delineation was conducted across the site and a field verification was completed with the USACE. A large portion of the site was determined to be non-jurisdictional; however, two jurisdictional wetland areas were found at the site. The largest wetland area is an approximately 2.5-acre bottomland hardwood forest wetland in the northeastern corner of the site, adjacent to the intersection of River Bend Road and NC 57 and the NCWRC boat ramp. The second is a floodplain pool wetland located near the central portion of the site along the western property boundary and covers about 0.5 acre.

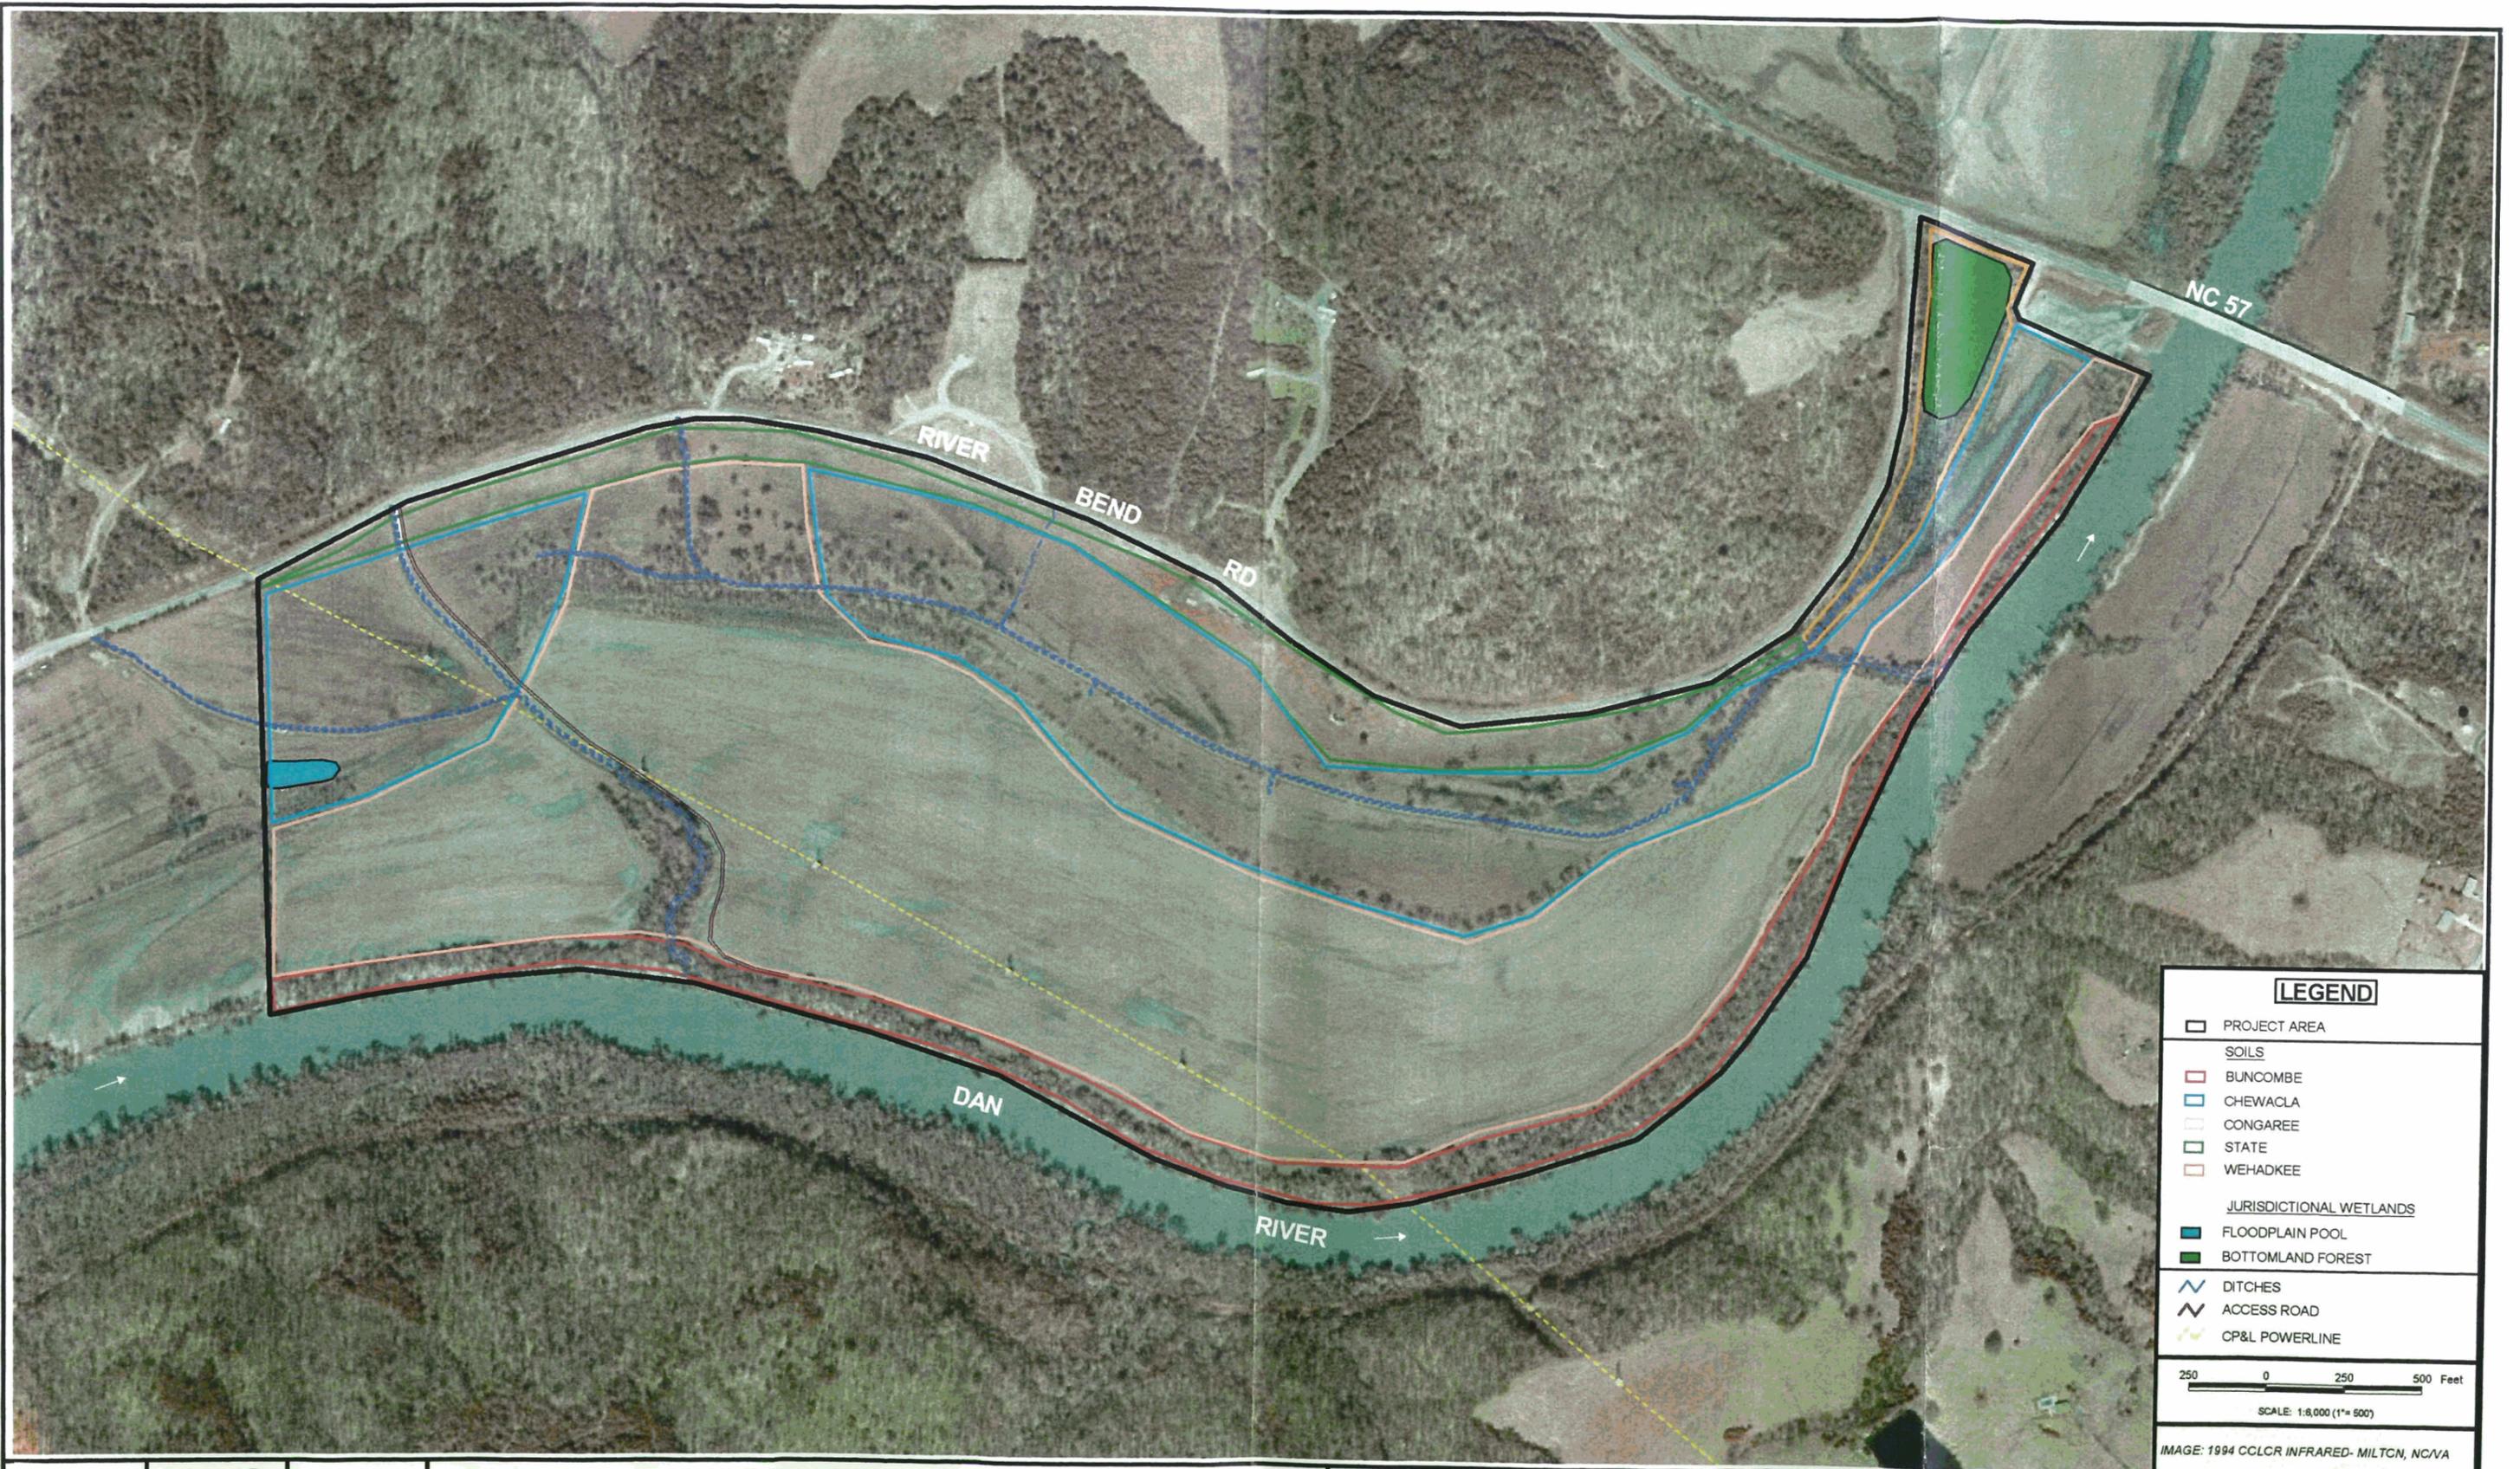
Figure No.
5

DELINEATED SOIL SERIES
RIVER BEND WETLAND MITIGATION BANK
 CASWELL COUNTY, NORTH CAROLINA

The dominant soils in this proposed restoration area were identified as either a Chewacla loam or a Congaree loam. These soils are both listed on the state hydric soils list as hydric B type soils. Figure 5 shows the soil units mapped at the River Bend site. The Chewacla soil unit is a somewhat poorly drained soil taxonomically identified as a Fluvaquent soil, meaning it is classified as a fluvent soil with aquic conditions. Fluvents are soils that have formed in recent loamy or clayey alluvial deposits. They are usually stratified, and have an organic carbon content that decreases irregularly with depth. Aquic conditions exist when continuous or periodic saturation and reduction occurs. The presence of an aquic condition is indicated by redoximorphic features within the soil profile, such as iron or manganese concretions or oxidized root channels. The Congaree soil unit is a well- to moderately well-drained soil that is taxonomically identified as a Udifluent, which is a udic soil with fluvent conditions. Udic conditions exist when soil moisture dries out for neither 90 cumulative days during the year nor 60 consecutive days during the drier summer months (SSSA 2001). Fluvent conditions are related to the alluvial deposition of loamy or clayey sediments.

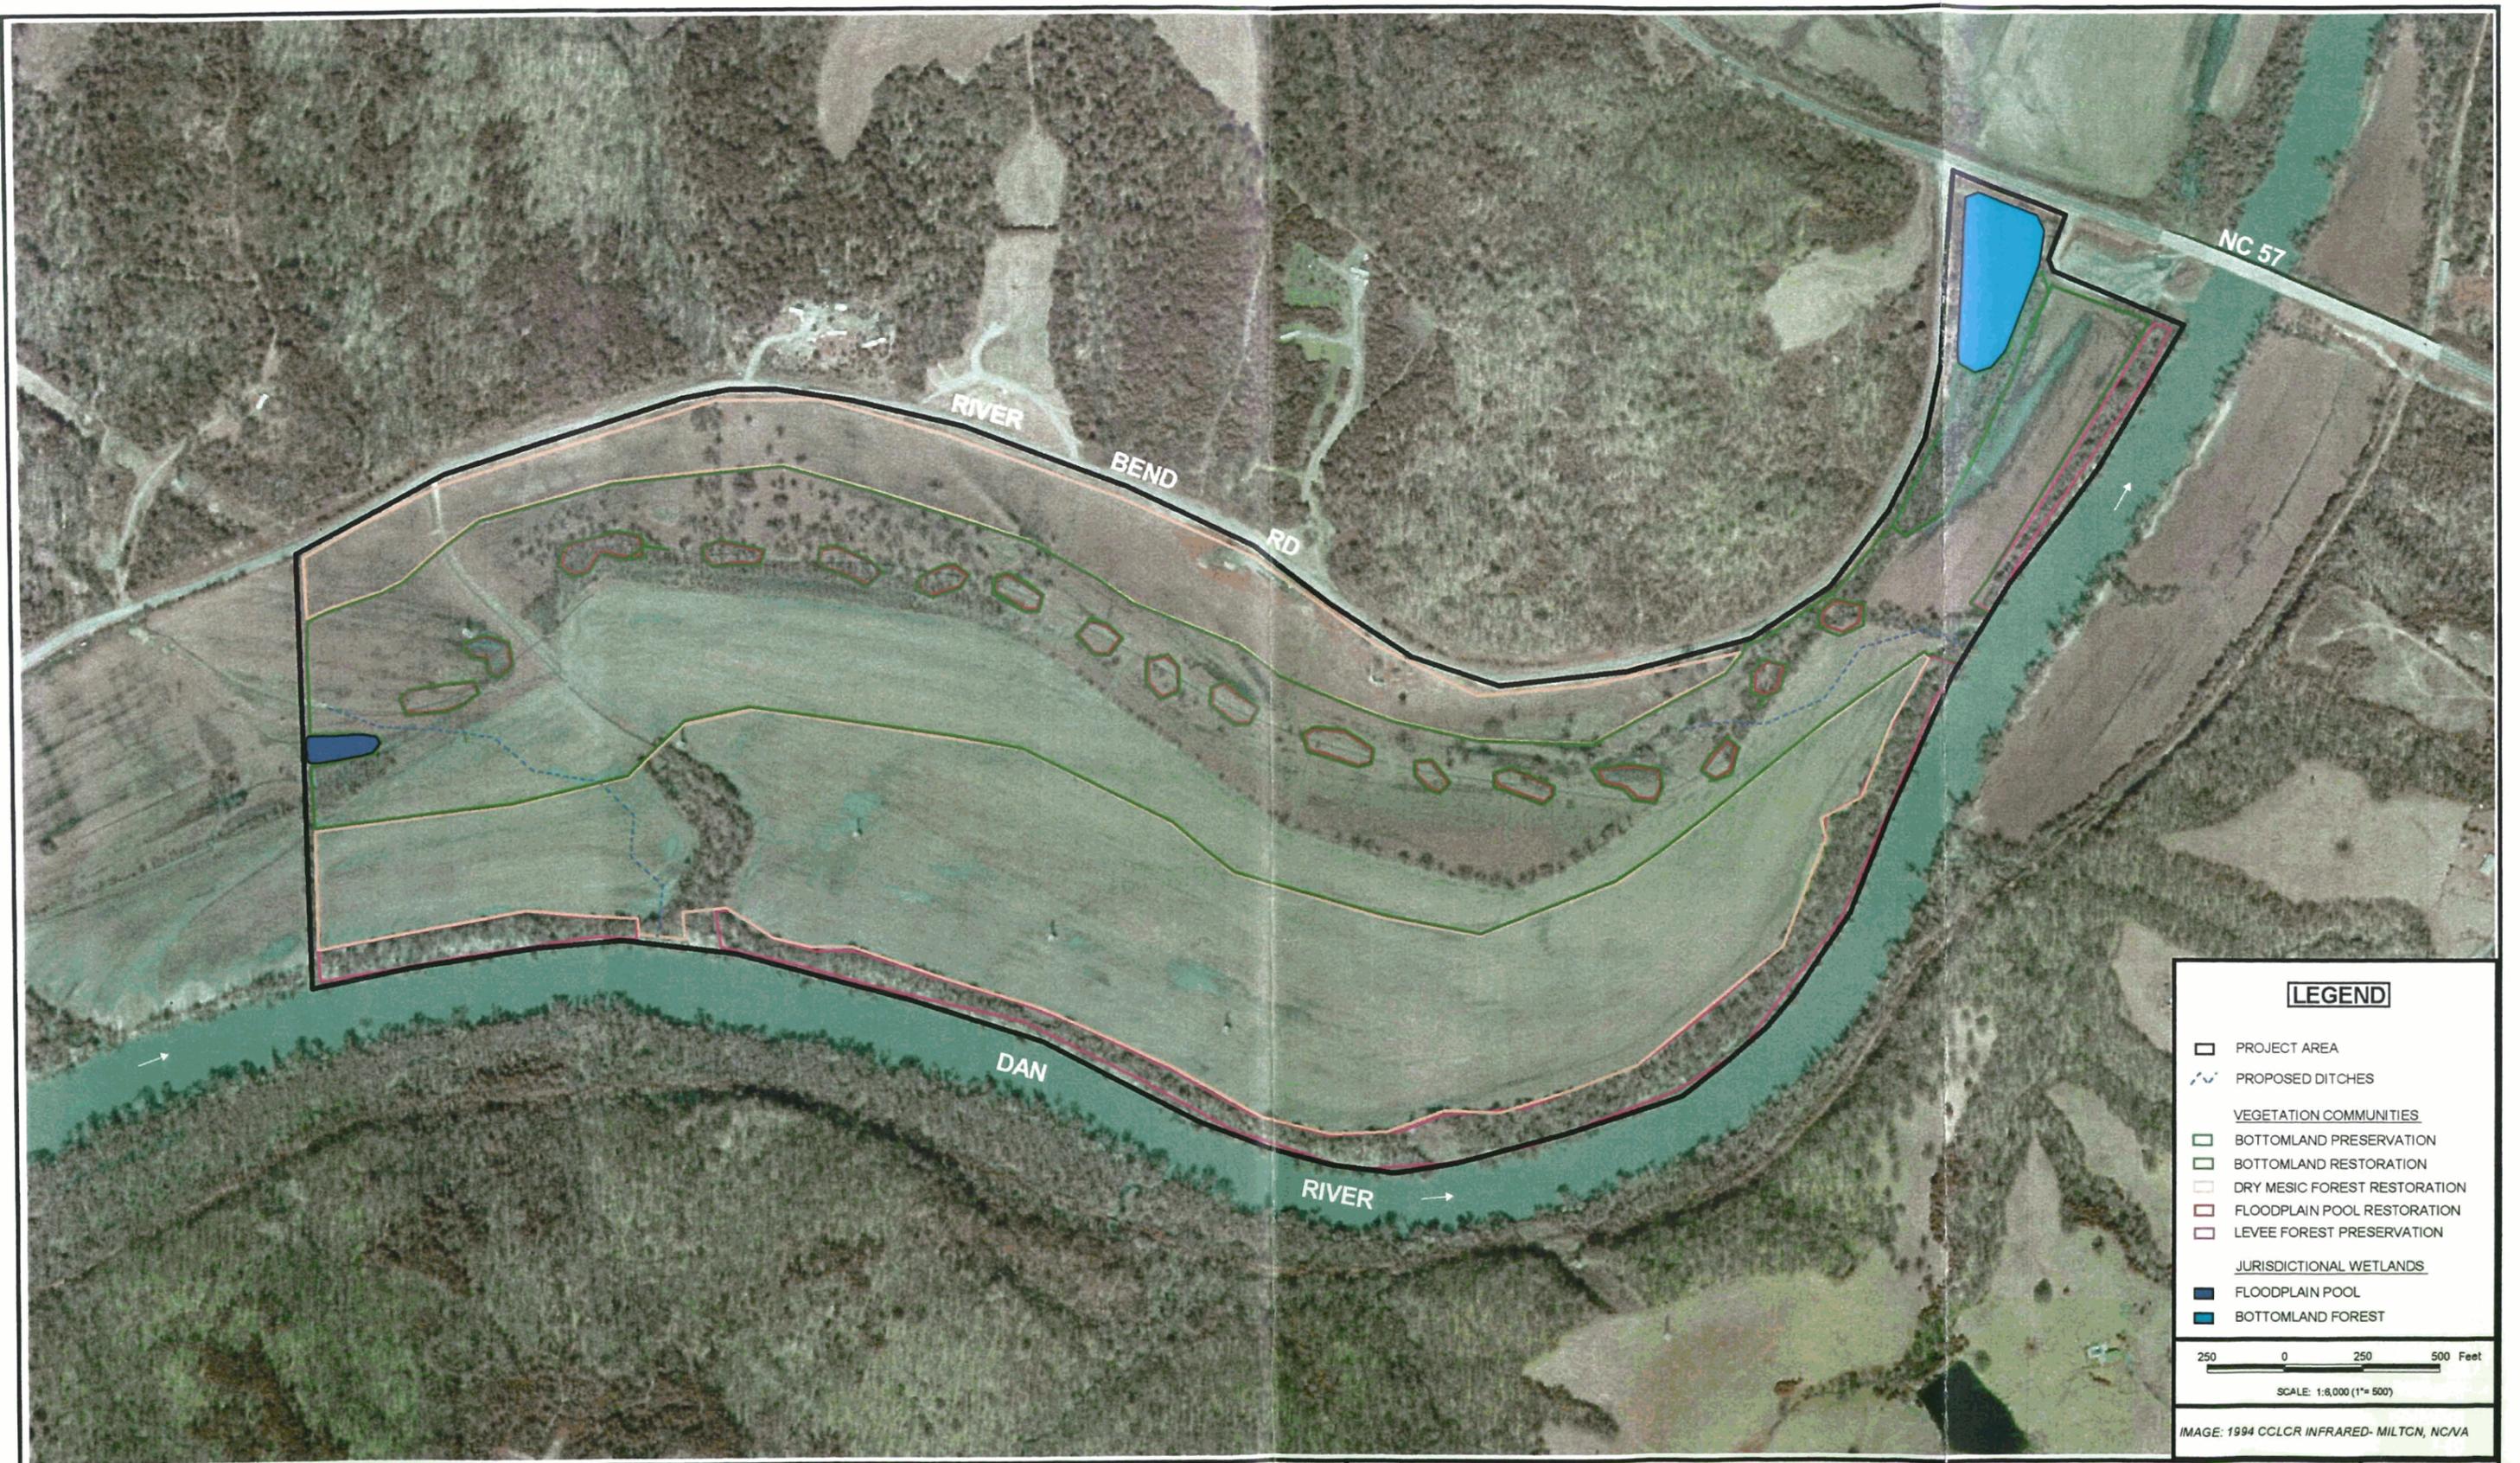
- PROJECT AREA
- PROPOSED DITCHES
- VEGETATION COMMUNITIES**
- BOTTOMLAND PRESERVATION
- BOTTOMLAND RESTORATION
- DRY MESIC FOREST RESTORATION
- FLOODPLAIN POOL RESTORATION
- LEVEE FOREST PRESERVATION
- JURISDICTIONAL WETLANDS**
- FLOODPLAIN POOL
- BOTTOMLAND FOREST

These wetlands tend to be small and as such are not generally mapped or otherwise distinguished in soil surveys. They may occur on the hydric inclusions found in floodplain soils (Shafale and Weakley 1990). The small jurisdictional wetland pool delineated along the western edge of the site, which covers about 0.5 acres, is located at the boundary between the Chewacla and Congaree loam soils. Figure 5 shows the location of these soil units, and Figure 6 shows the proposed location of the floodplain pool wetlands.

those found at the River Bend site. When undisturbed, canopy vegetation is dominated by a mixture of oak and hickory species, such as white oak (*Q. alba*), southern red oak (*Q. falcata*), black oak (*Q. velutina*), scarlet oak (*Q. coccinea*), northern red oak (*Q. rubra*), black gum, mockernut hickory (*Carya tomentosa*), shagbark hickory (*C. ovata*), and pignut hickory (*C. glabra*). The understory includes red maple, dogwood (*C. florida*), sourwood (*Oxydendrum arboreum*), and American holly (*Ilex opaca*). Figure 5 shows the soil units mapped at the site, and Figure 6 shows the location of the dry-mesic oak/hickory forest community.

Vegetation to be planted in the Piedmont/Mountain bottomland forest areas will be based on those available from local nursery stock at the time of planting. Species may include overcup oak (*Q. lyrata*) (OBL), swamp chestnut oak (FACW-), cherry-bark oak (*Q. pagodaefolia*) (FAC+), black walnut (*Juglans nigra*) (FACU), possum-haw (FACW+), highbush blueberry (*Vaccinium corymbosum*) (FACW), and silky dogwood (FACW+). Seeding-in from existing native woody vine, shrub, and tree species from adjacent areas is also expected to occur. Table 3 includes a list of recommended plant species for use in this bottomland forest restoration area. Figure 6 shows the area where this community will be installed.

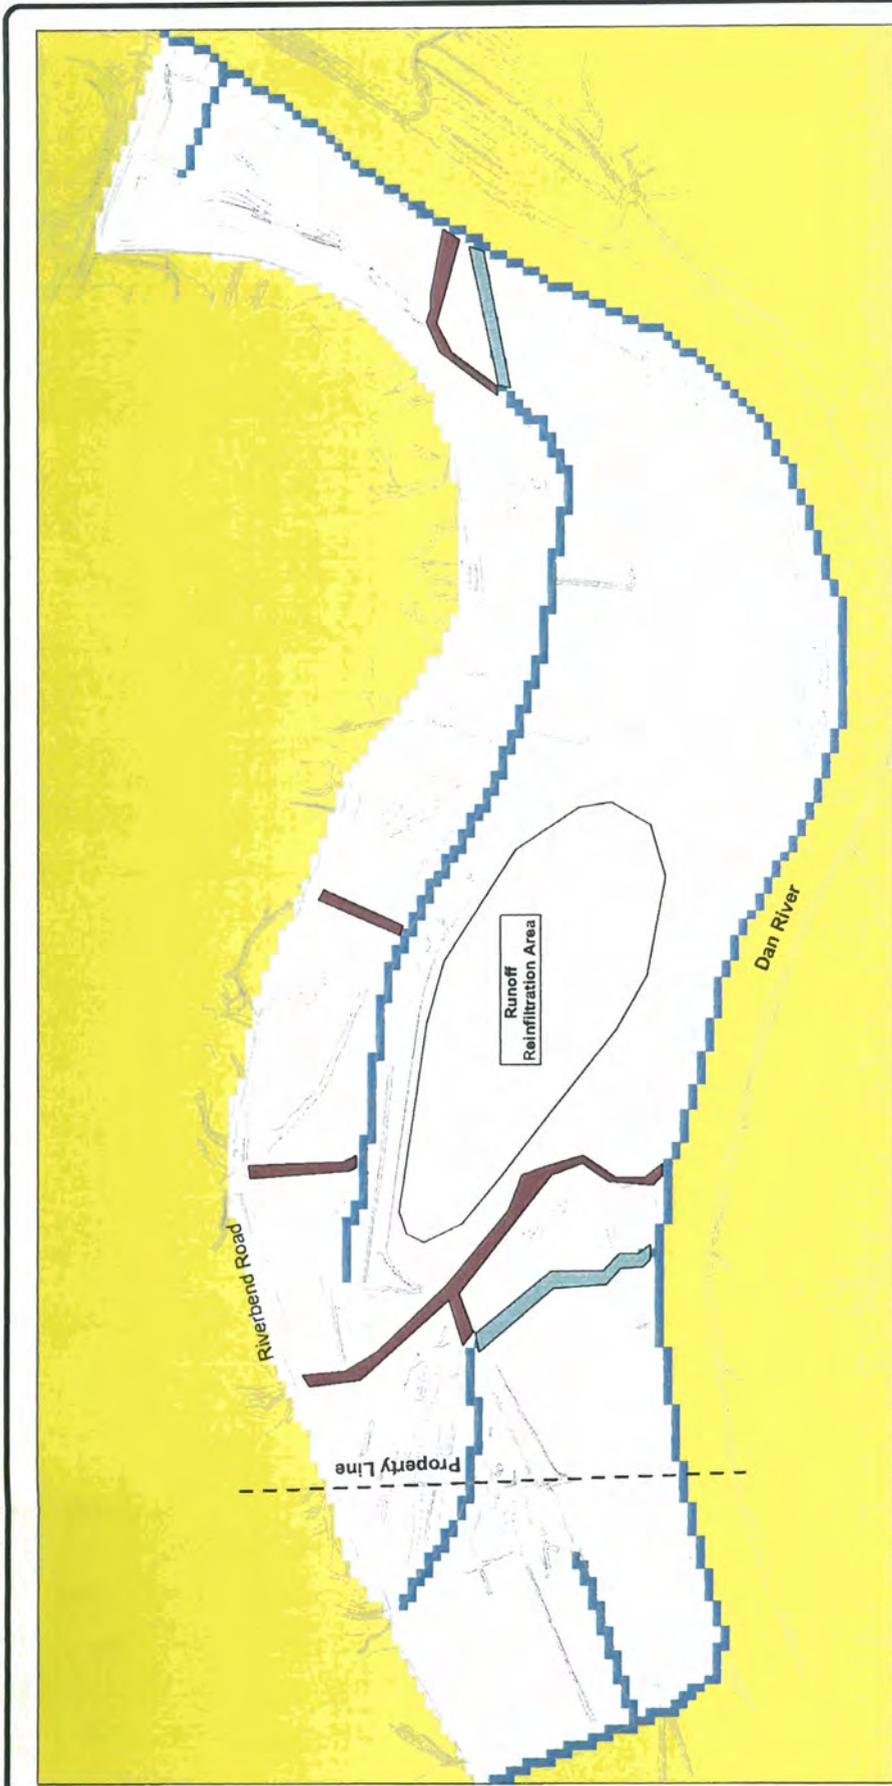
FIGURE
1

Site Layout and Proposed
Drainage Alterations

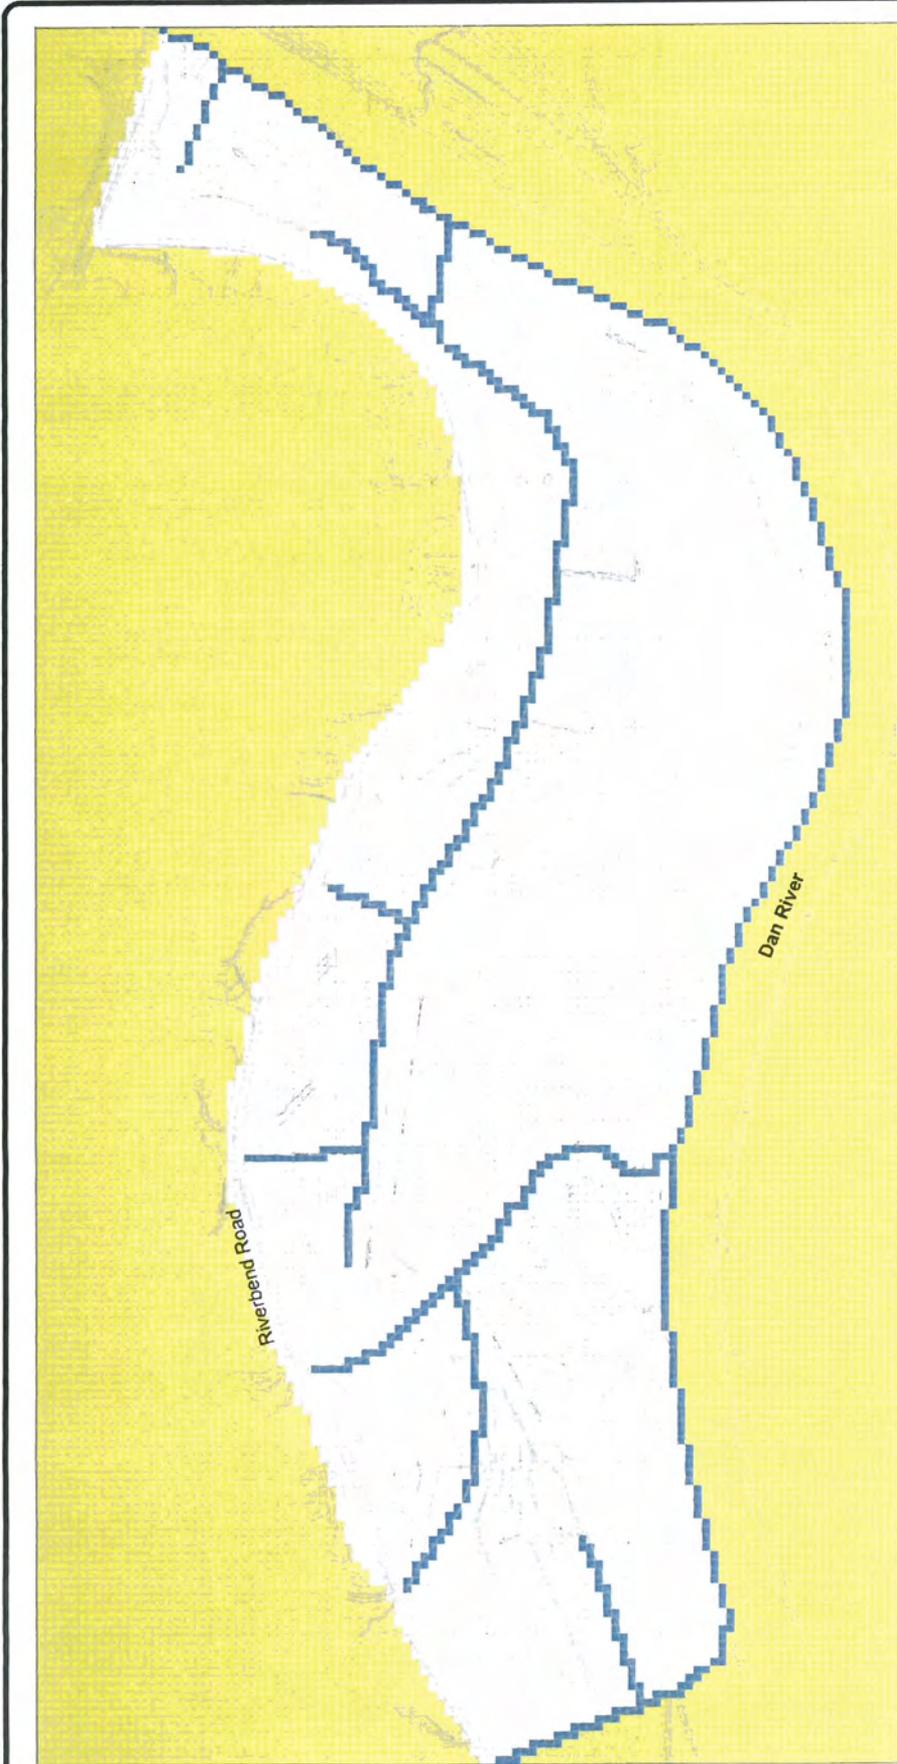
Model Boundary Conditions

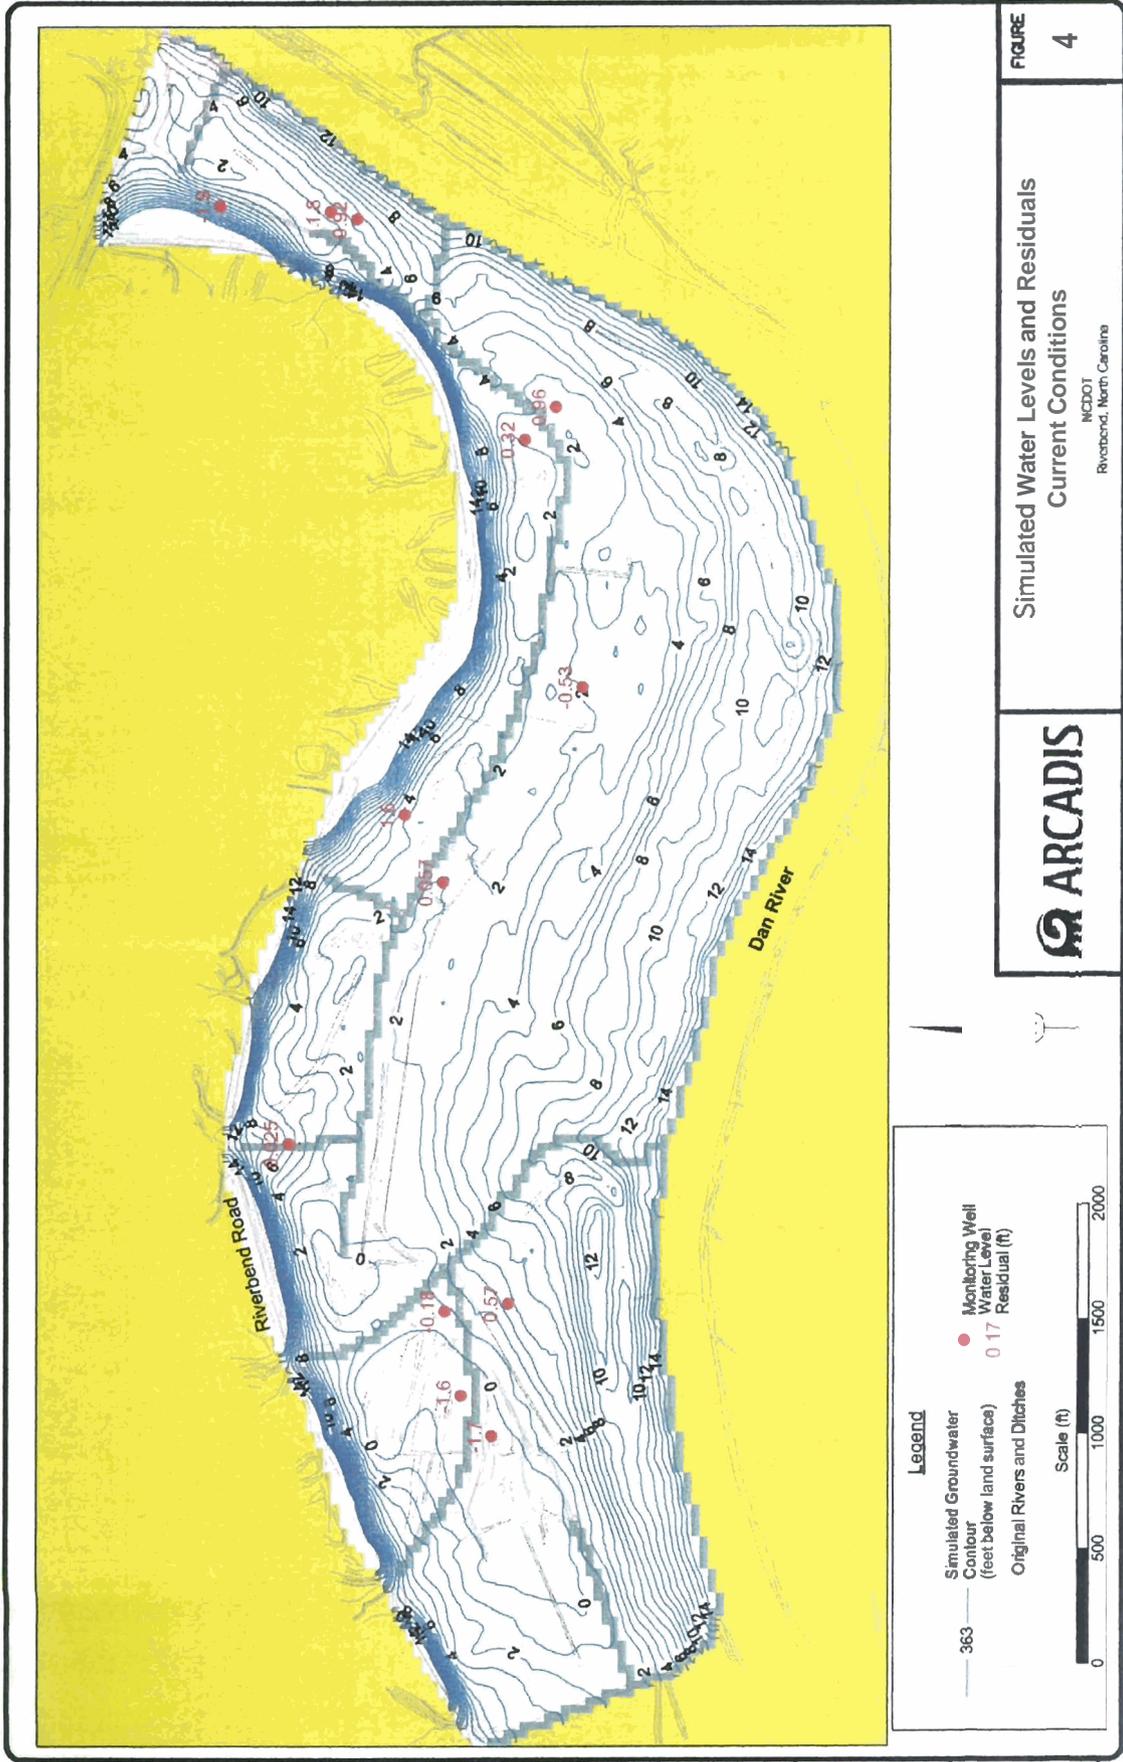
FIGURE 4

**Simulated Water Levels and Residuals
Current Conditions**

Overall, the model accurately reflects the observed flow conditions at the site. Appendix B, Figure 4 shows the simulated water levels and residuals for the calibrated model under existing conditions. Shallow groundwater flows from north to south beneath the site and discharges to the main east/west drainage ditch on the site and eventually into the Dan River. The deflections in the groundwater contours reflect shallow groundwater discharge to the drainage ditches.

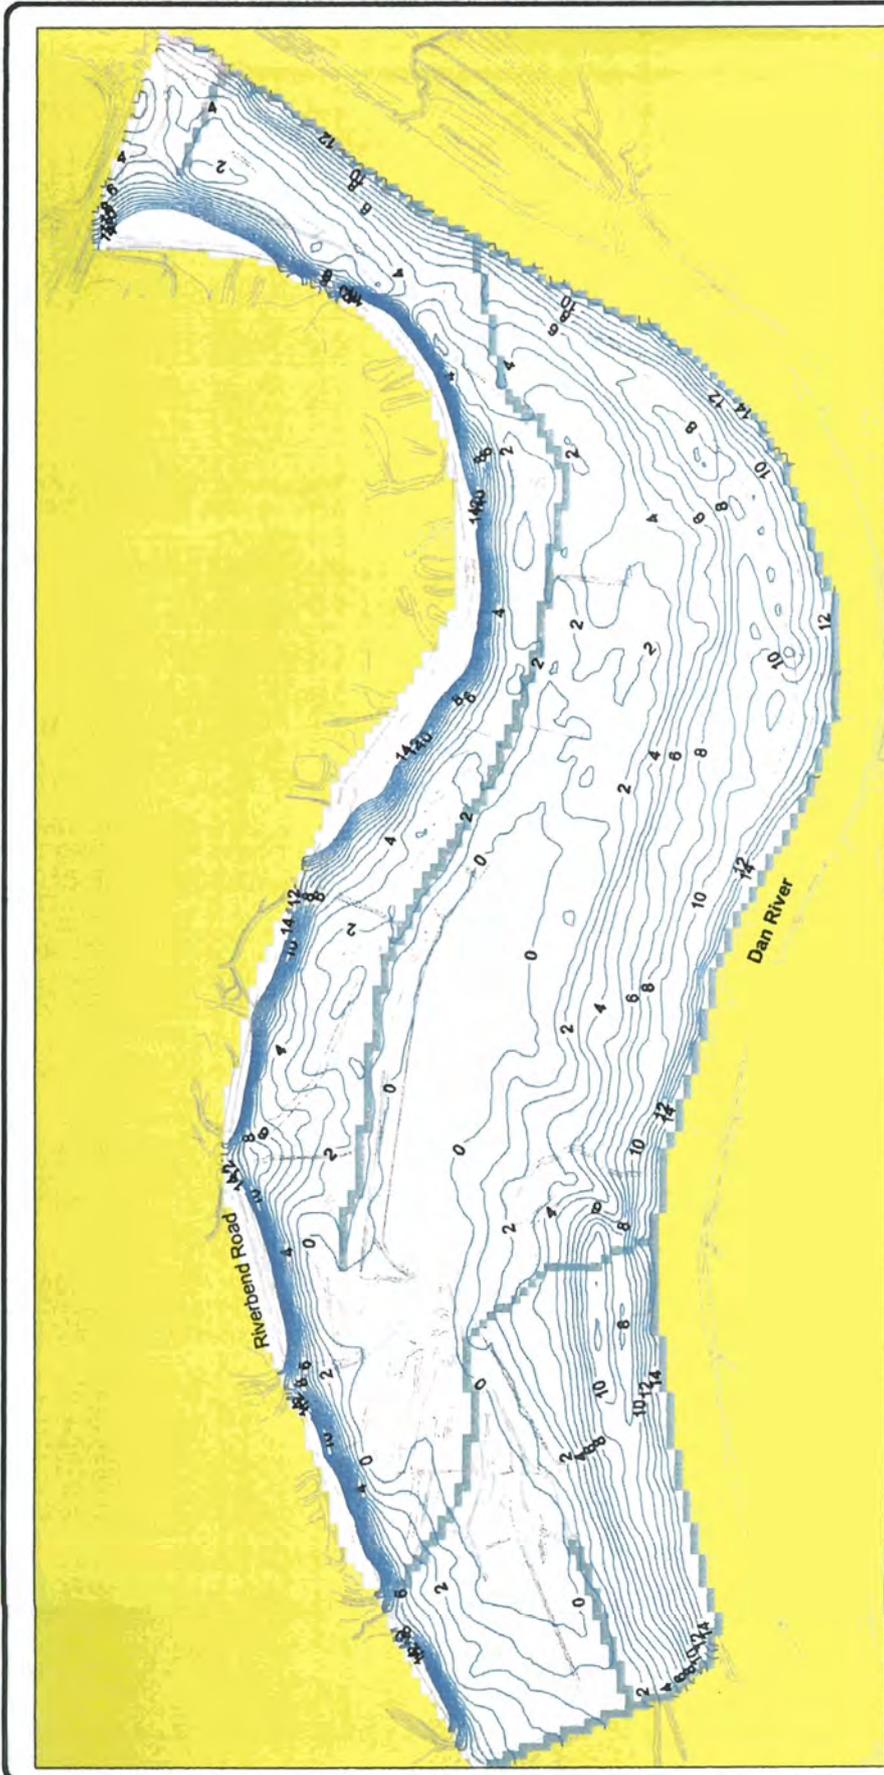
Simulated Water Levels With Proposed
Drainage Alteration
