**UT Pembroke Creek Wetland  
and Stream Restoration Site  
Repair Baseline Report  
Project # 283  
Chowan County**

**Submitted: March 2012**

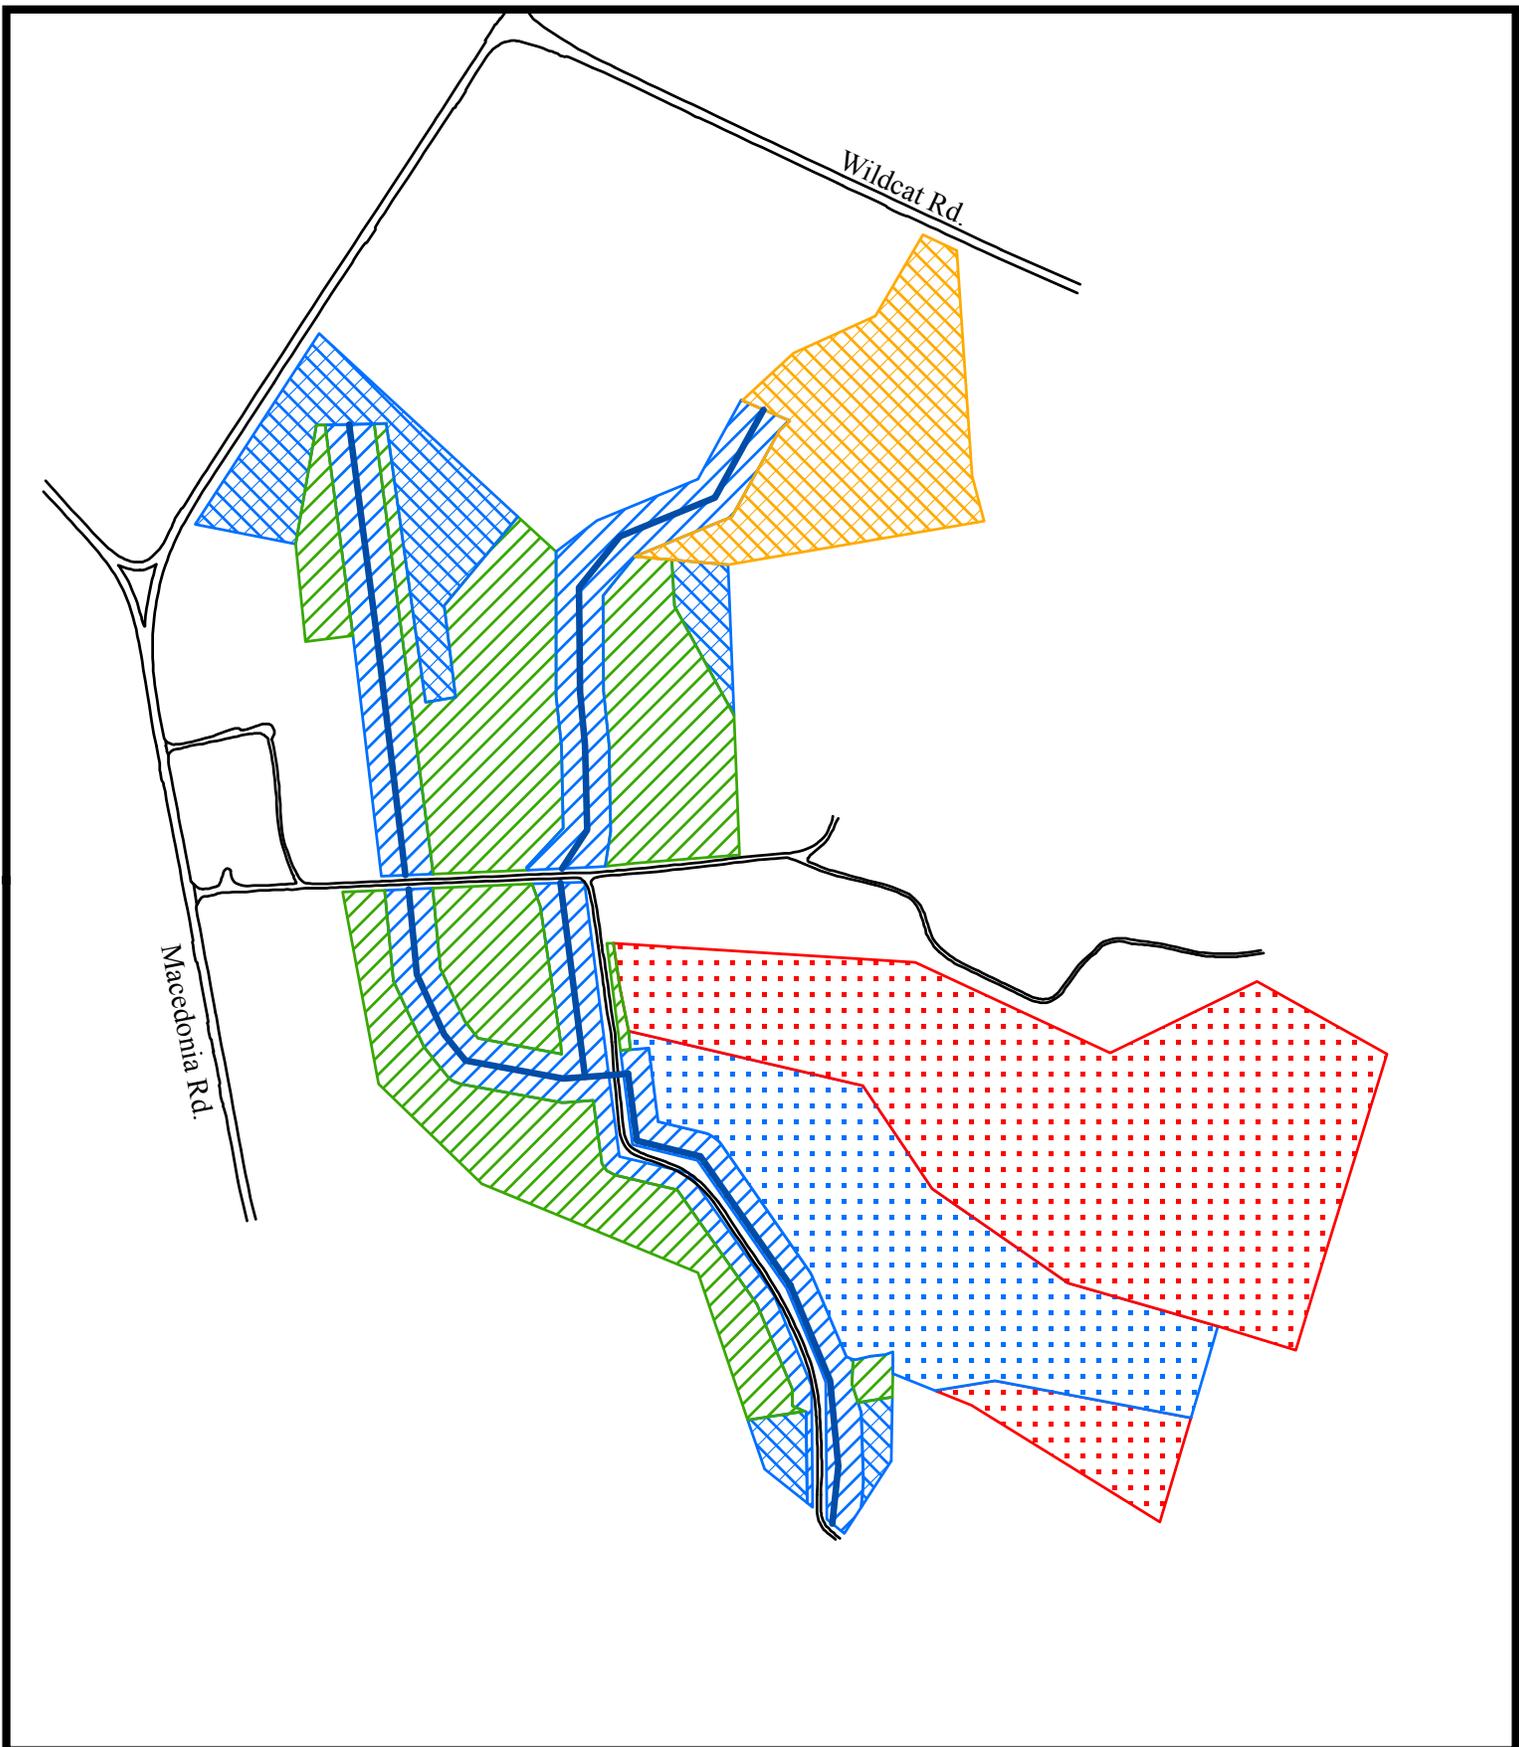
**Figure 1. Post-Repair Site Asset Map**  
**UT Pembroke Creek, Chowan County, EEP Project # 283**

| Wetland Valley Centerline (4,355 lf) | Non-Riparian Wooded Wetland Preservation (16.97 ac) |
| Headwater Wetland Valley (9.94 ac) | Riparian Wetland Restoration (14.41 ac) |
| Non-Riparian Wetland Enhancement (5.26 ac) | Riparian Wooded Wetland Preservation (8.35 ac) |
| Non-Riparian Wetland Restoration (4.46 ac) | |

The repairs have altered the path of the headwater wetland valley. By installing the new road crossing, the headwater wetland valley crosses Road B and flows south along the eastern side of the road to the site’s downstream outlet. This change converts some area from wetland preservation to headwater wetland valley (stream) restoration. This modified flowpath coincides with the natural valley through the site. Since the road is not in the conservation easement, the 100’ corridor for the new location of the wetland valley extends to the western side of Road B. This change decreases the wetland preservation and stream restoration credit, but increases the wetland restoration credit at the site. See Tables 1 and 2 for the revised credit calculation.

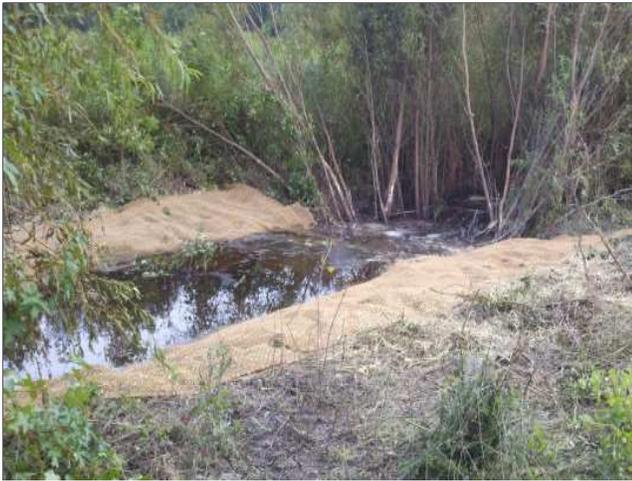
09/12/2011 – View of repair to Grade Transition Structure.

The grade transition structure at the downstream end of the site contributed to the ponding and long hydroperiod at the site. The top of the structure was originally set at 15.0'. To reduce the amount of standing water in the preservation wetland, the top two logs at the top of the structure were removed and the stone base of the step was graded down by approximately one foot. The second log structure was rebuilt to repair piping and lowered to approximately 13.9' in elevation. These measures still maintain a small ponded area at the southern part of the preservation wetland; however, this structure no longer influences the flow and hydroperiod on the western side of Road B.

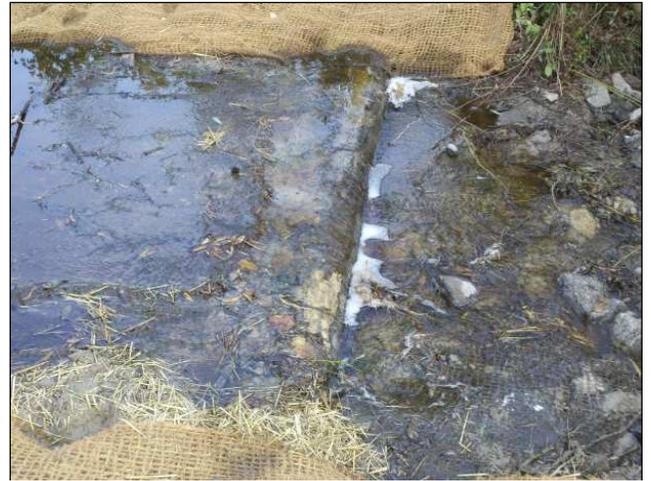
09/12/2011 – View of repair to Grade Transition Structure.

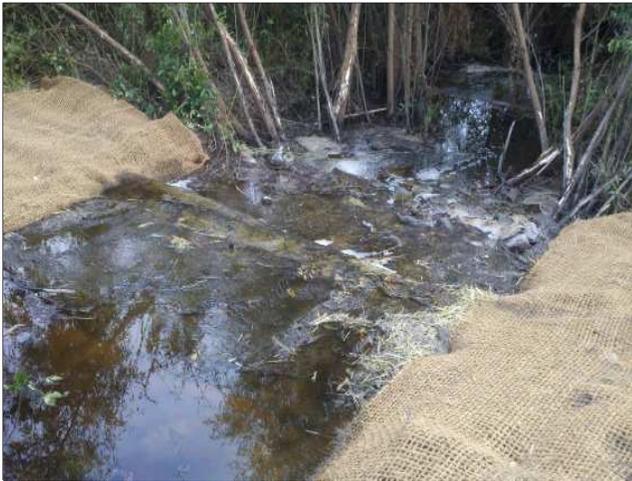
09/12/2011 – View of repair to Grade Transition Structure.

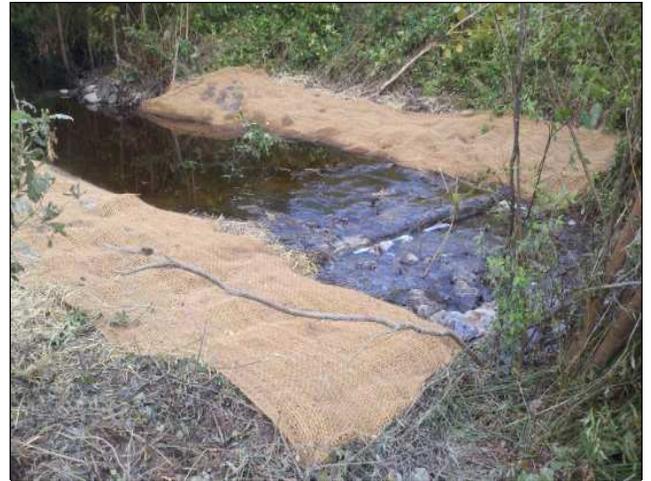
09/12/2011 – View of repair to Grade Transition Structure.

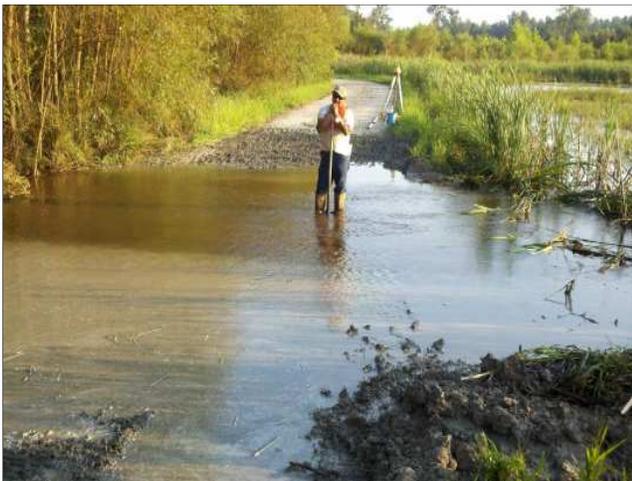
09/13/2011 – View of newly constructed road crossing immediately after installation, with previously ponded water draining across the road.

To reduce the quantity of standing water in the depressional area adjacent to Road B an additional road crossing was installed. As designed, this crossing does not eliminate the standing water, because this depression is naturally the lowest part of the site and parts of it are still lower than the new crossing, but it has reduced the area of standing water. The lowest elevation of the road adjacent to the depression prior to the repair was 15.5'. The elevation of the new road crossing is approximately 14.6'.

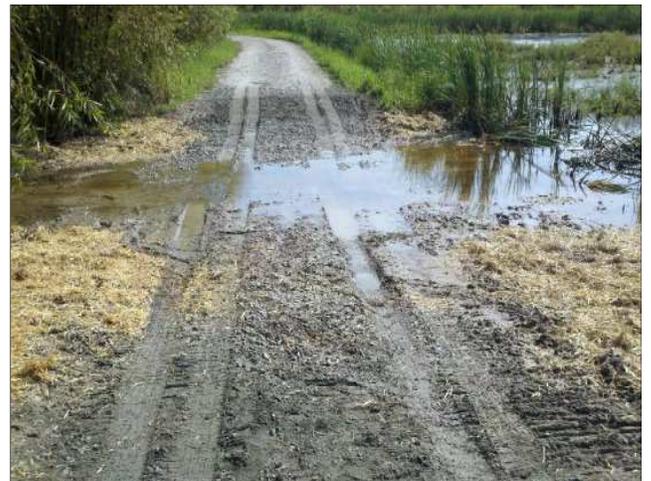
09/14/2011 – View of newly constructed road crossing after water has drawn down.

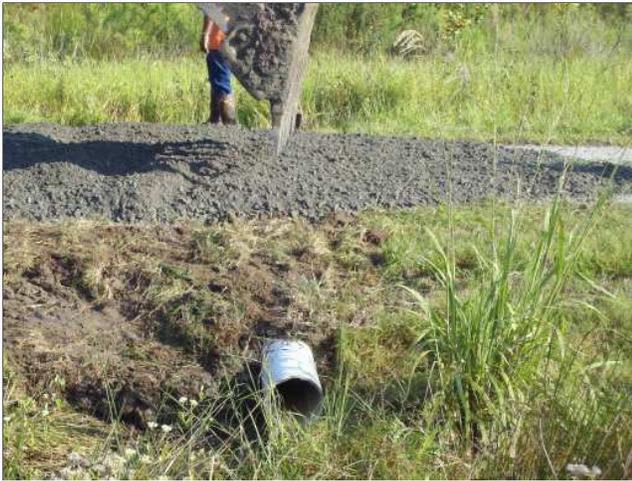
09/14/2011 – View of one of the piped road crossings immediately after installation.

Three drainage pipes were installed under Road A. The pipes are 8" schedule 40 PVC. These pipes increase the volume of water that can flow from the northern to the southern half of the site without flowing over the top of the road. The exact location of the pipes and the elevation of the pipe inverts were determined in the field during construction. The invert elevations are shown in the repair record drawings. These elevations were chosen to hydrologically connect the wetlands on either side of the road. The most easterly pipe was installed with a different type of inlet, because it needed to be buried deep enough below the road grade. A picture of this inlet can be found in Appendix A.

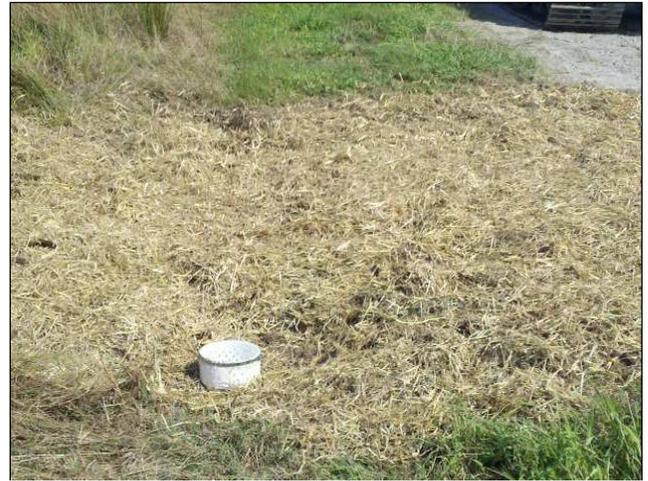
09/14/2011 – View of drain inlet modification to the most eastern piped crossing.

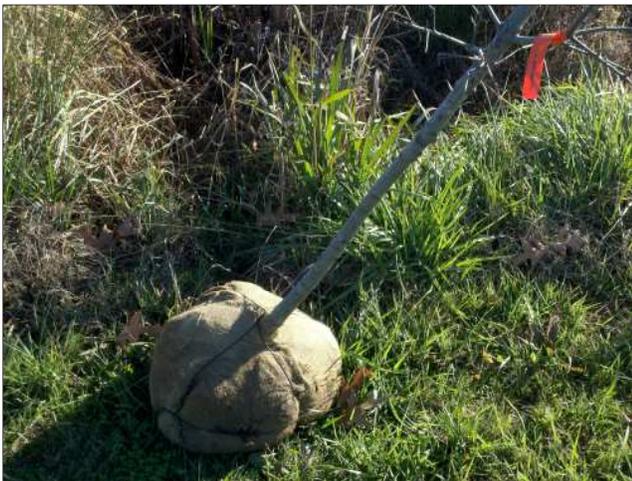
12/08/2011 – View of 1” caliper ball and burlap tree prior to planting.

The site was also planted with additional native trees. These plantings included: 1” caliper trees along some of the site boundaries and in the large areas of standing water; bare root trees in areas of low density and low diversity; and ½” caliper fabricated root ball trees in other parts of the site with low survivability due to excessively long hydroperiods. The plant list and quantities are included in Table 4.

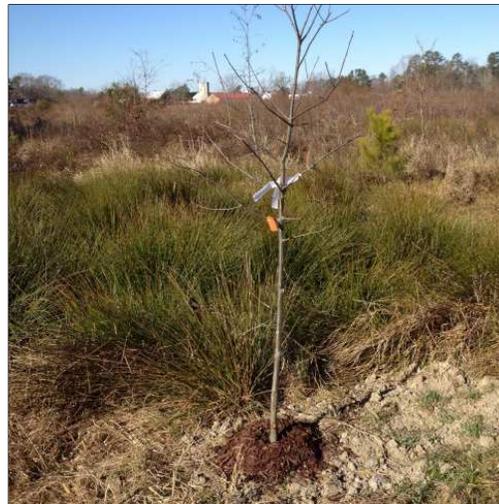
01/03/2012 – View of planted 1” caliper ball and burlap tree.

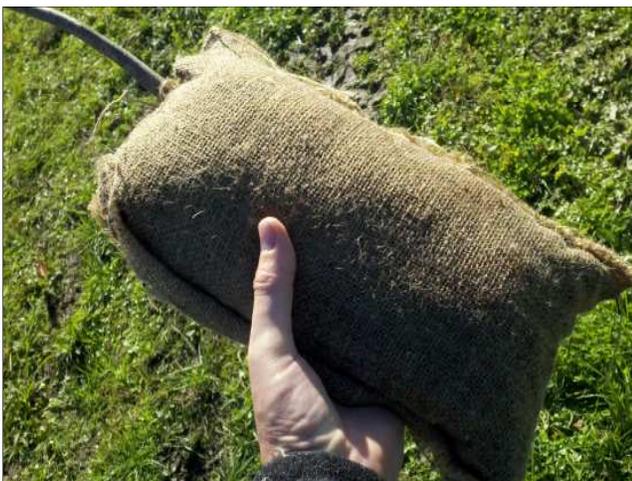
12/08/2011 – View of 1/2” caliper fabricated root ball tree prior to planting.

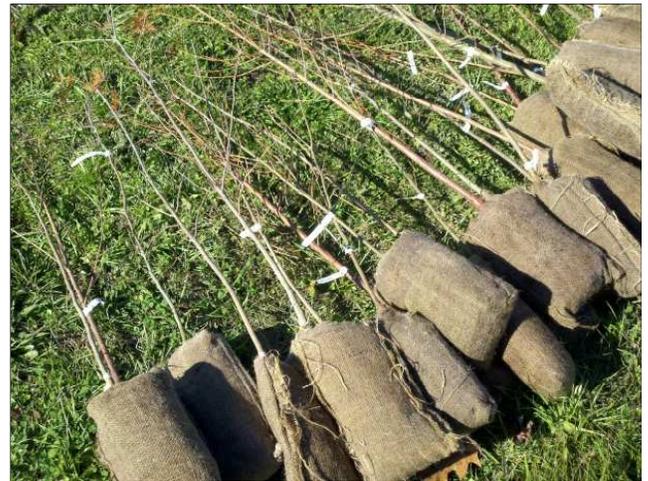
12/08/2011 – View of 1/2” caliper fabricated root ball trees prior to planting.

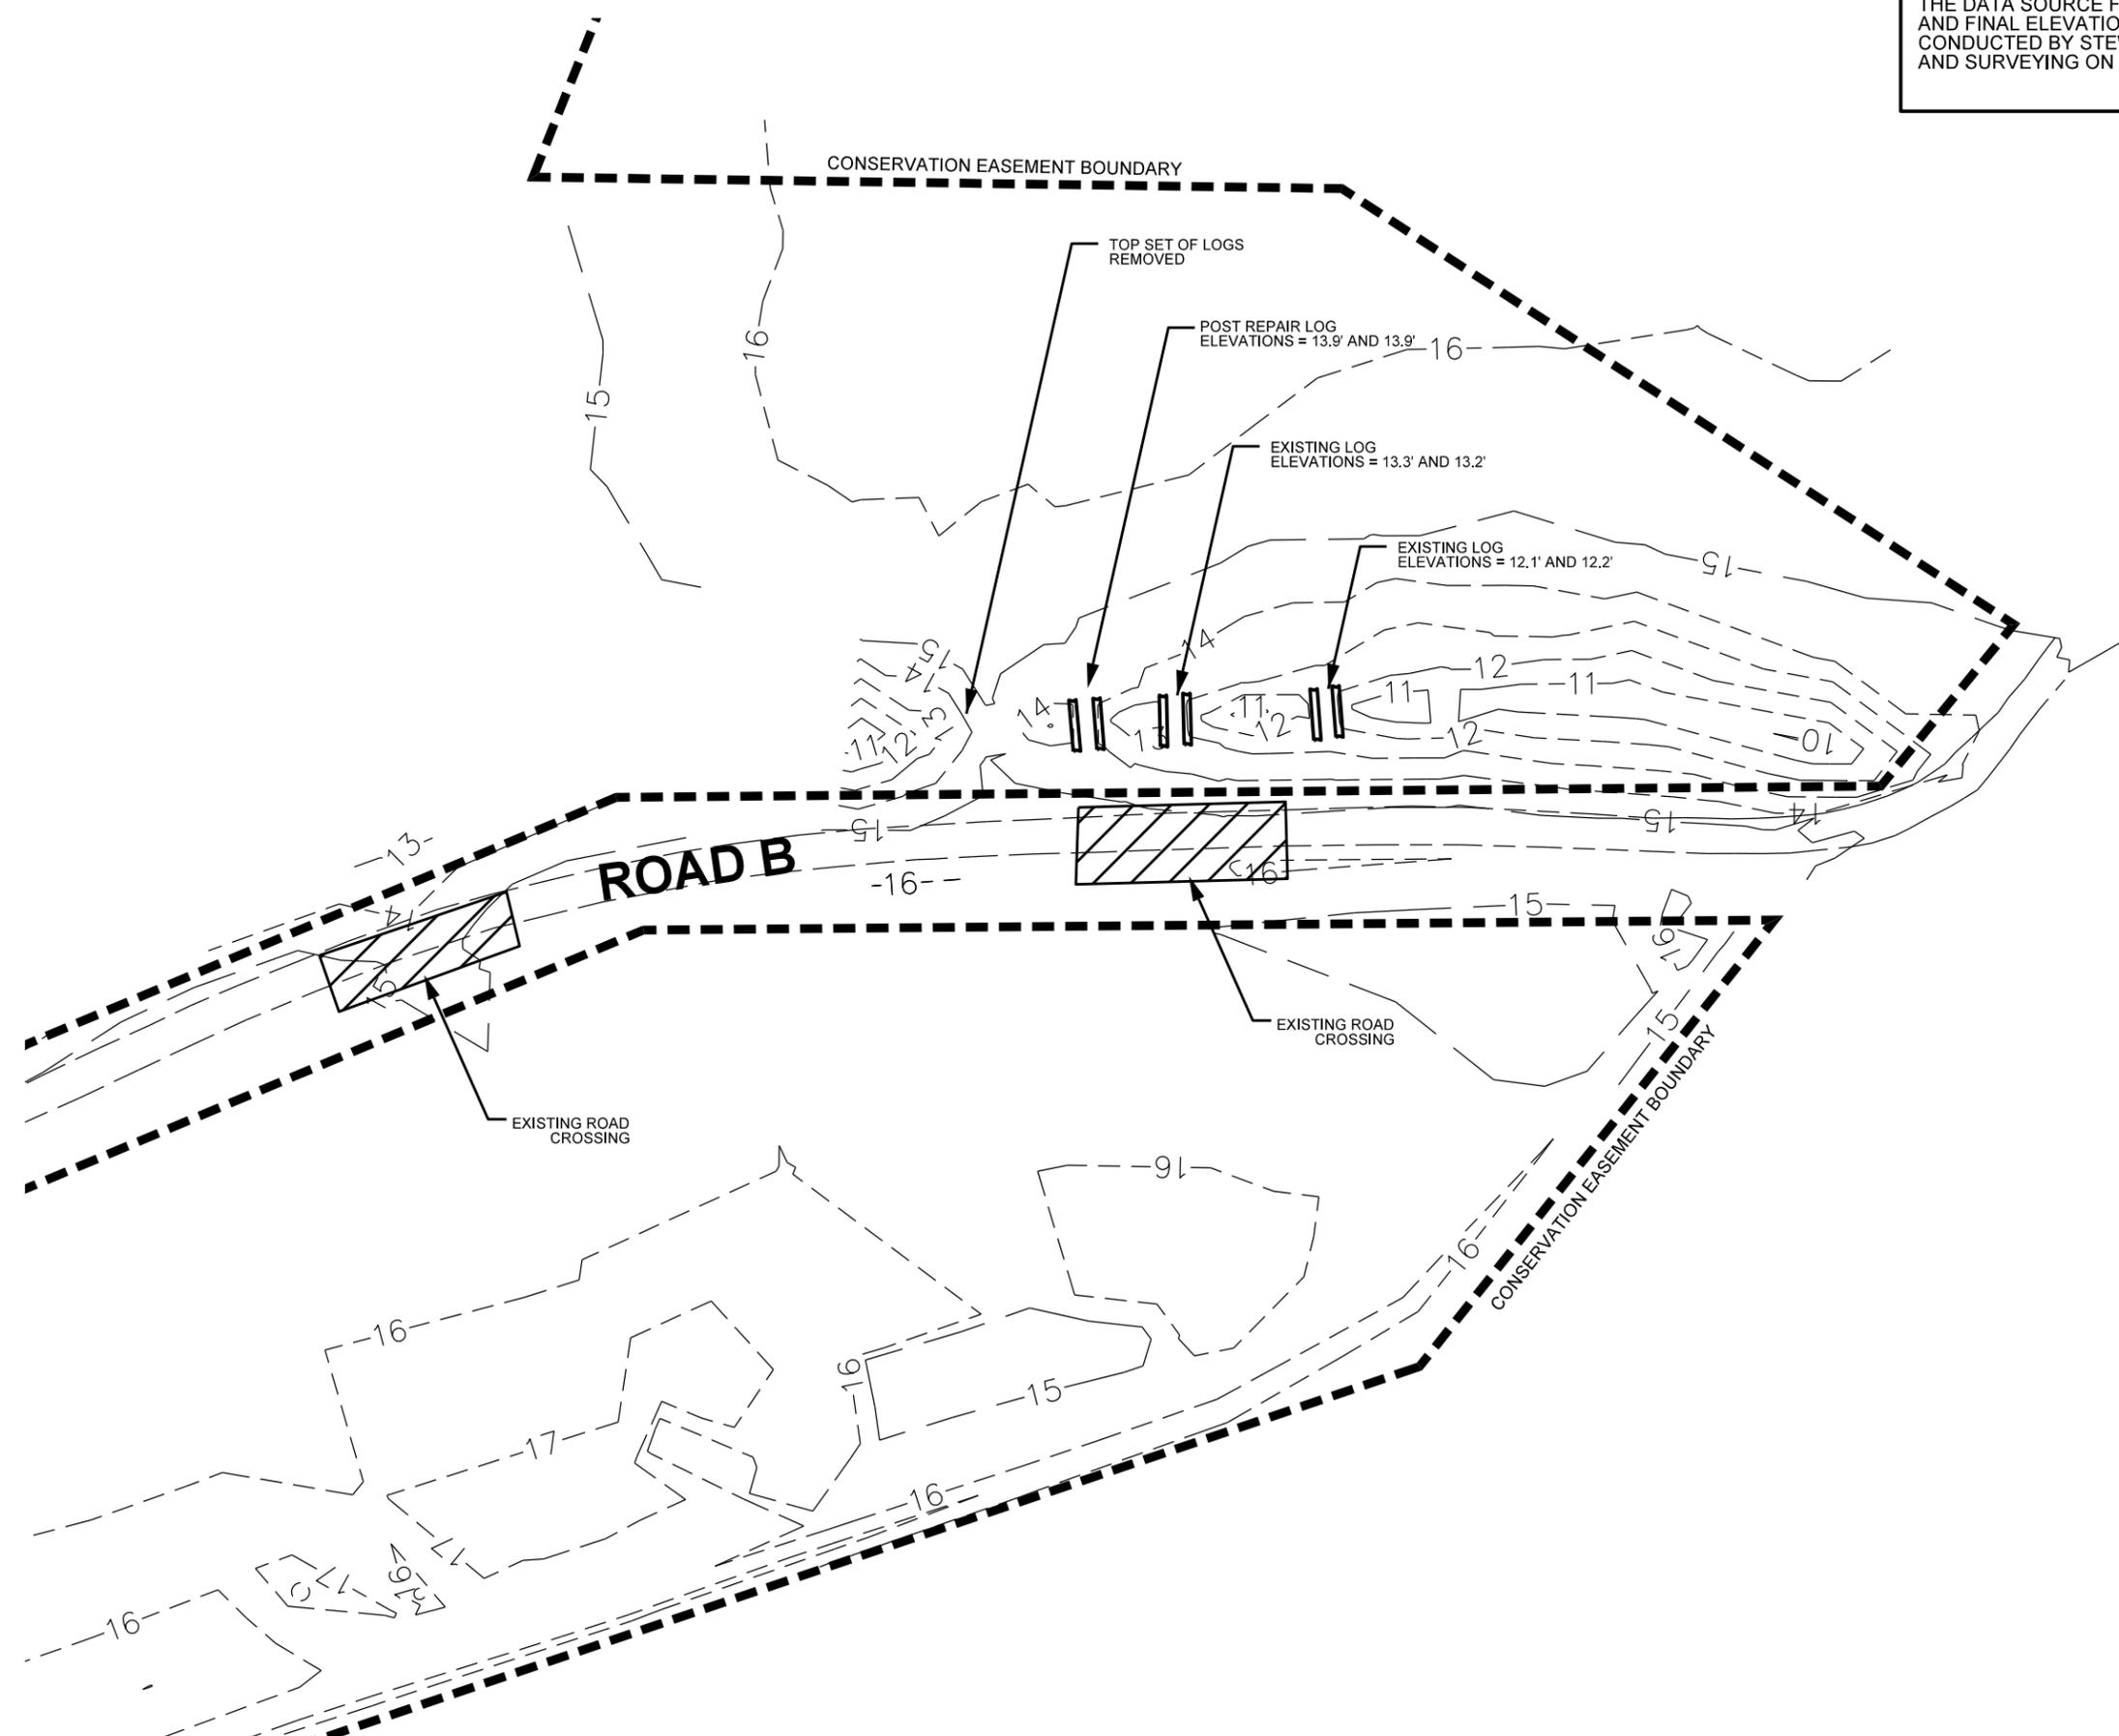
DATE: FEBRUARY 2012  
 SCALE: 1" = 40'  
 REPAIR RECORD DRAWING  
 SHEET 2 OF 4

THE DATA SOURCE FOR THE REPAIR LOCATIONS AND FINAL ELEVATIONS IS THE AS-BUILT SURVEY CONDUCTED BY STEWART - PROCTOR ENGINEERING AND SURVEYING ON OCTOBER 10, 2011.

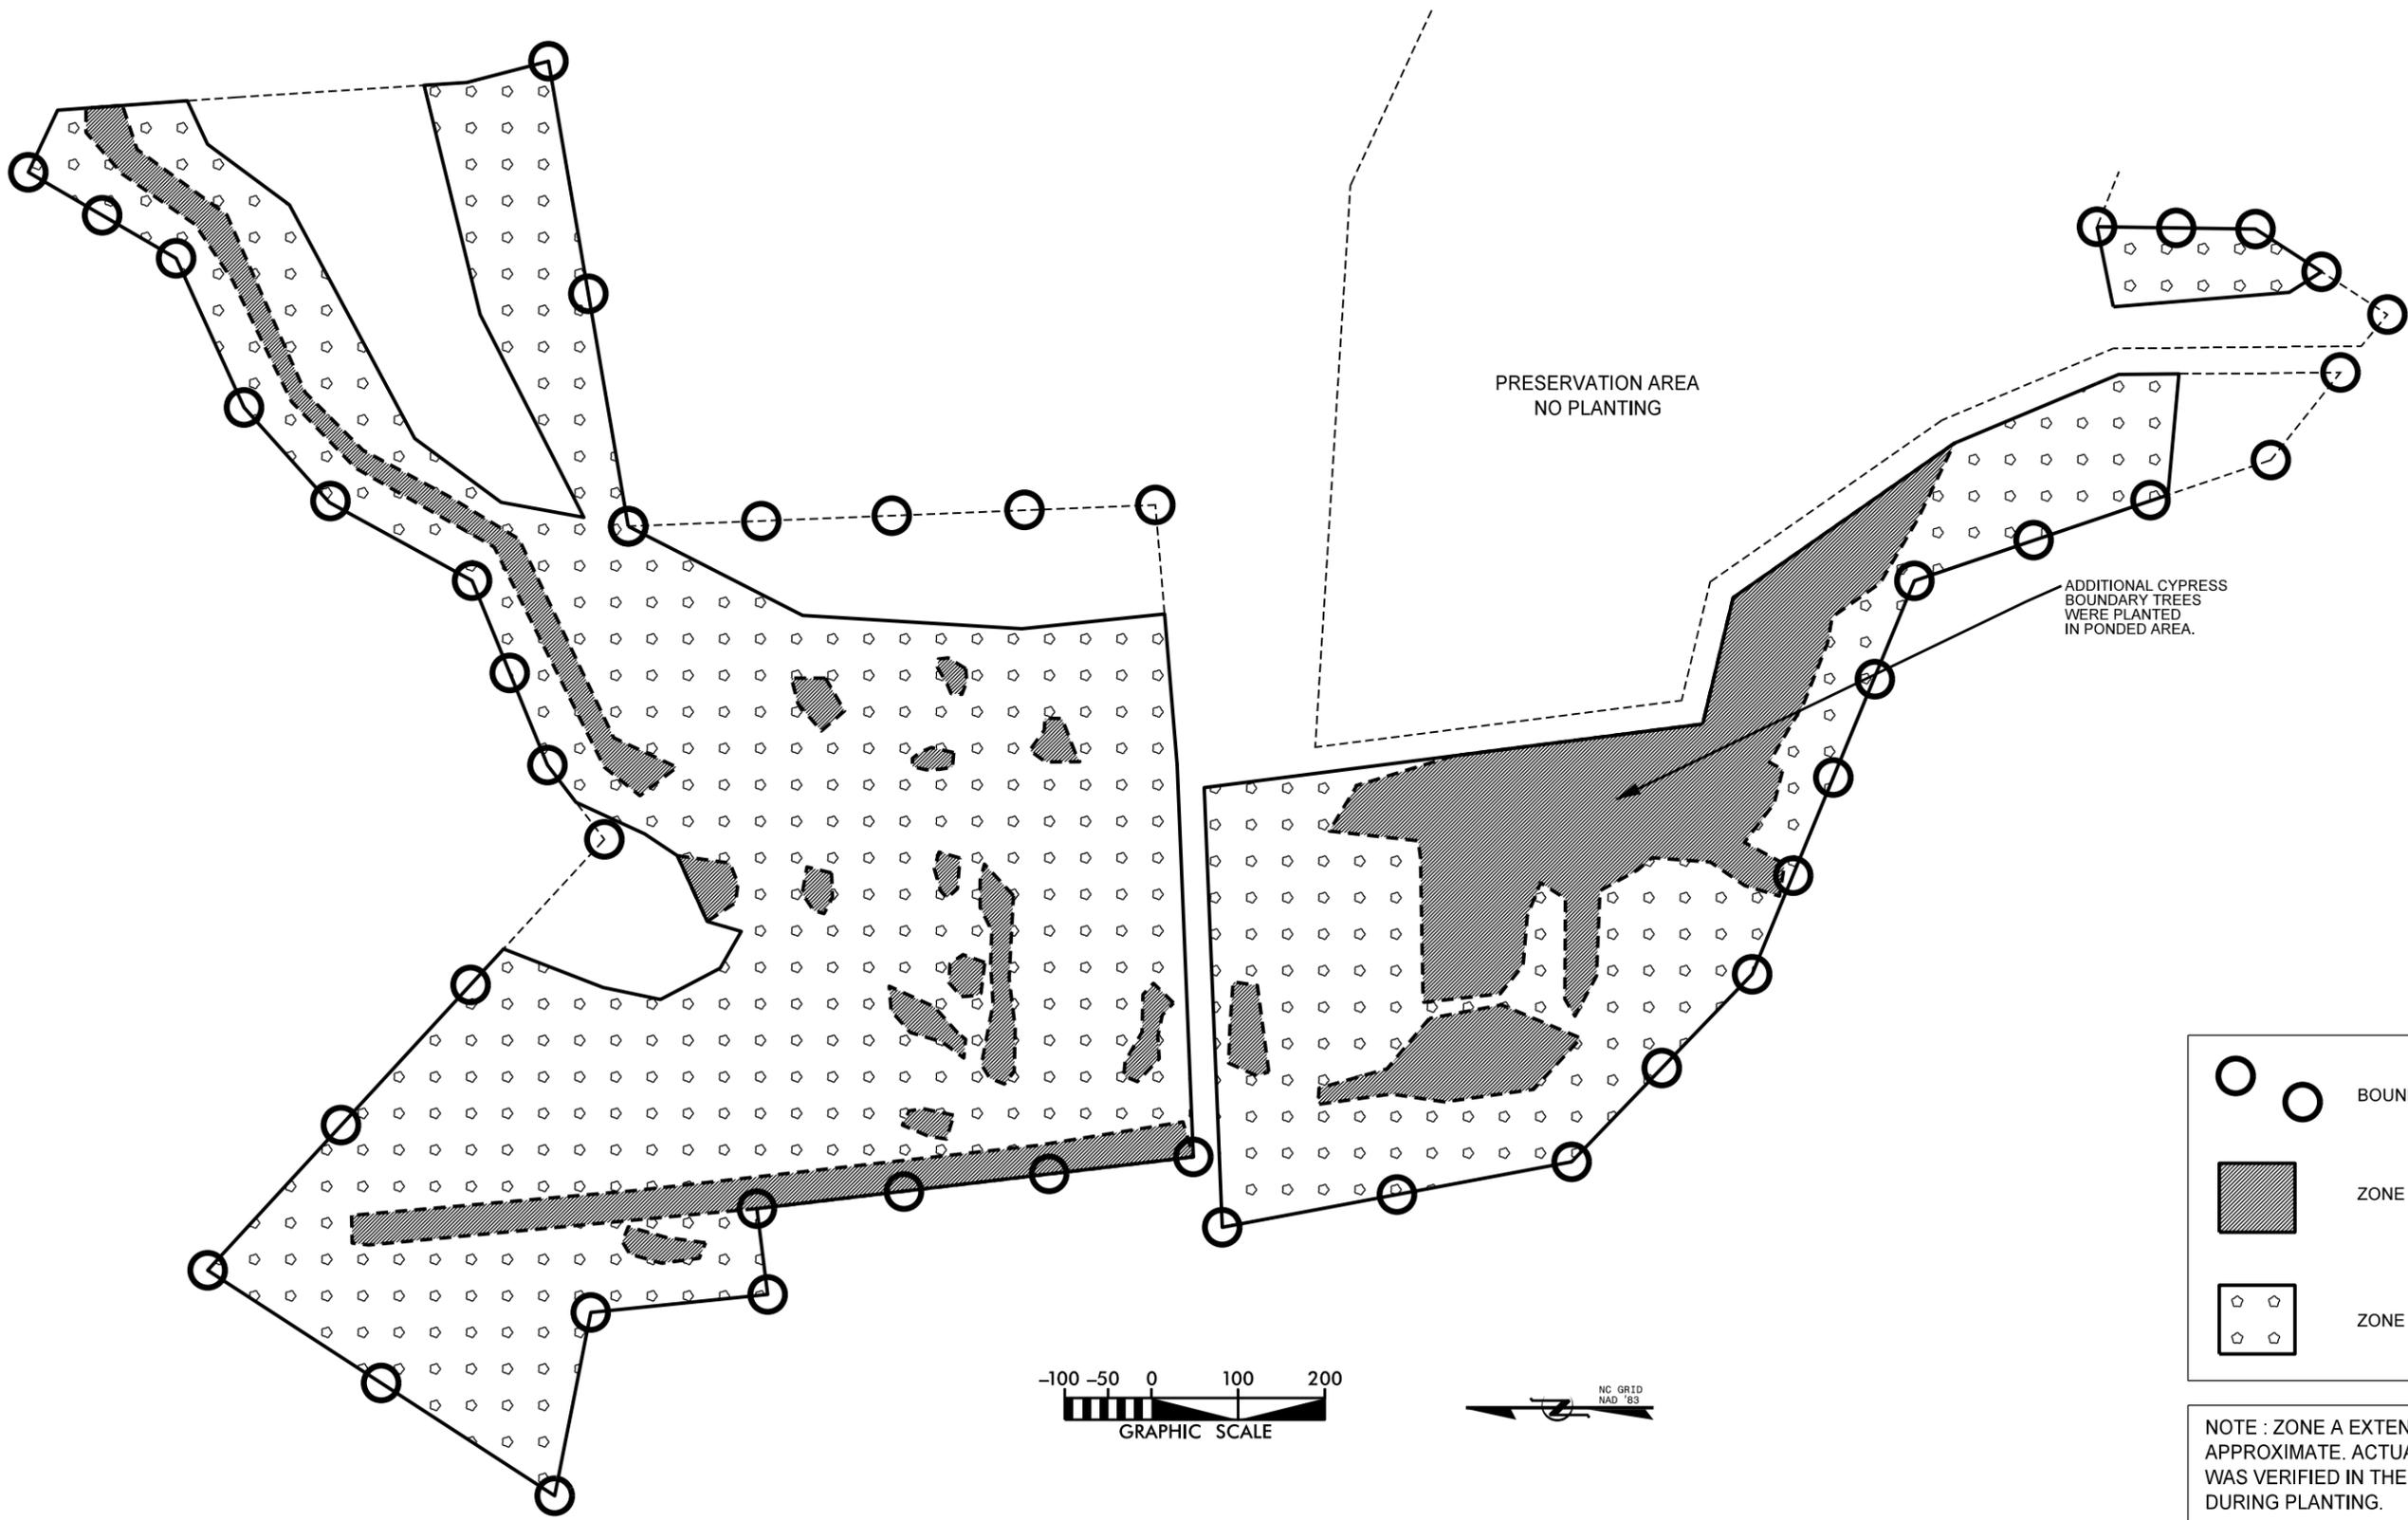
DATE: FEBRUARY 2012  
SCALE: 1" = 200'  
PLANTING PLAN  
RECORD  
DRAWING  
SHEET 3 OF 4

NOTE : ZONE A EXTENT IS APPROXIMATE. ACTUAL EXTENT WAS VERIFIED IN THE FIELD DURING PLANTING.
