STREAM MITIGATION PLAN

BEAR CREEK (PHILLIPS PROPERTY)  
CHATHAM COUNTY, NORTH CAROLINA

January 2003

HDR ENGINEERING, INC. OF THE CAROLINAS

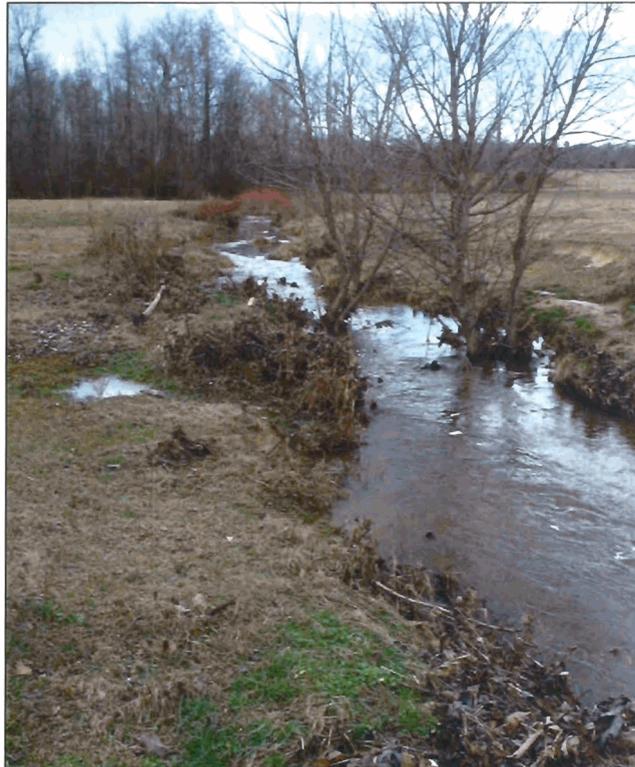
**Photograph 1:** View looking upstream along the upper 500 feet of Bear Creek on the Phillips property reach. The low cross section area of Bear Creek in this pasture setting is in marked contrast to the cross section area seen in the reach immediately downstream that has trees along its border.

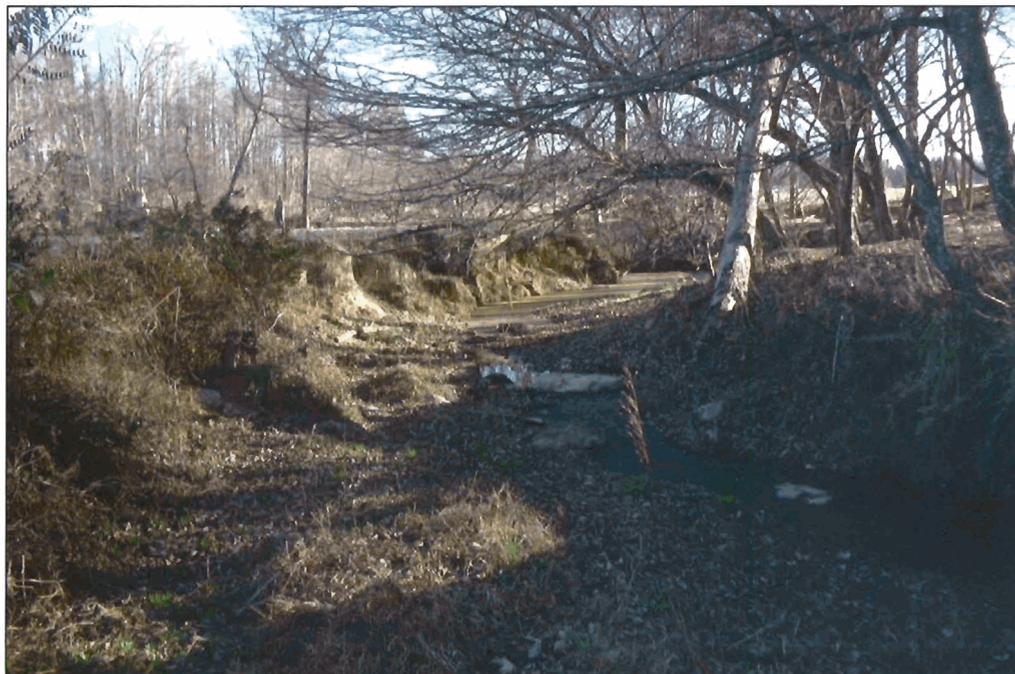
**Photograph 2:** Bear Creek looking down stream on the Phillips property tract. Unstable east bank where pasture without shrub or trees along bank create conditions for rapid bank migration.

Second, along Bear Creek, for approximately 300 to 400 feet below the confluence with the UT, Bear Creek has an east bank with several areas lacking woody riparian bank protection and indications of rapid bank failure. These include rotational bank slumping and bank collapse associated with animal activity. These areas have enlarged channel dimensions, and a need for the re-establishment of bank and riparian areas with more deeply rooted vegetation to promote the stable evolution of the stream.

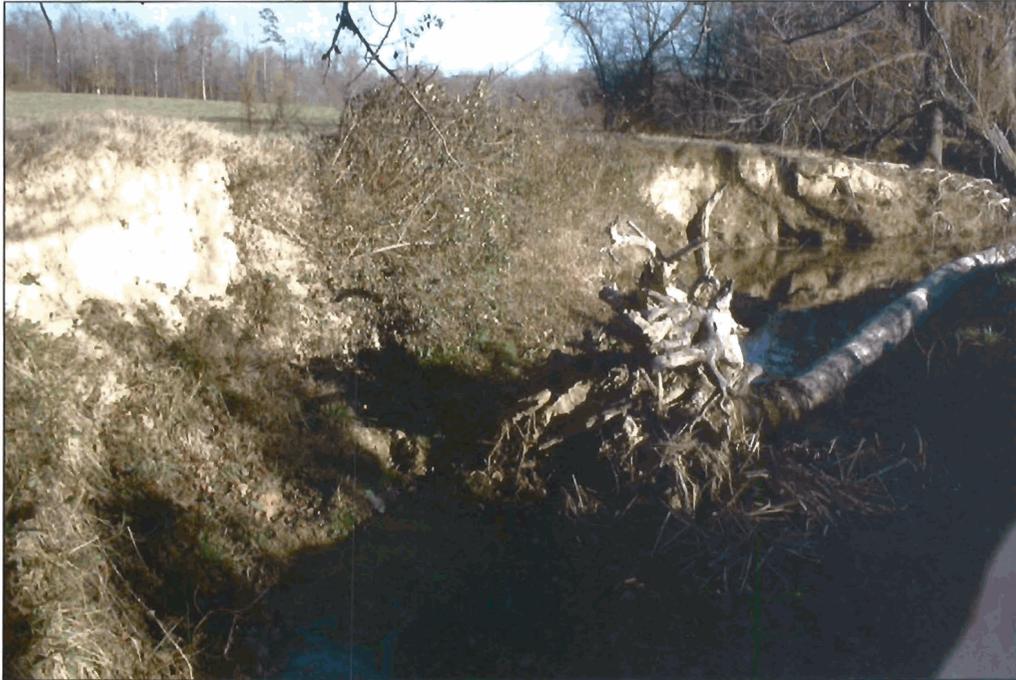
**Photograph 3:** Unstable east bank where pasture without shrub or trees along bank create conditions for rapid bank collapse and migration.

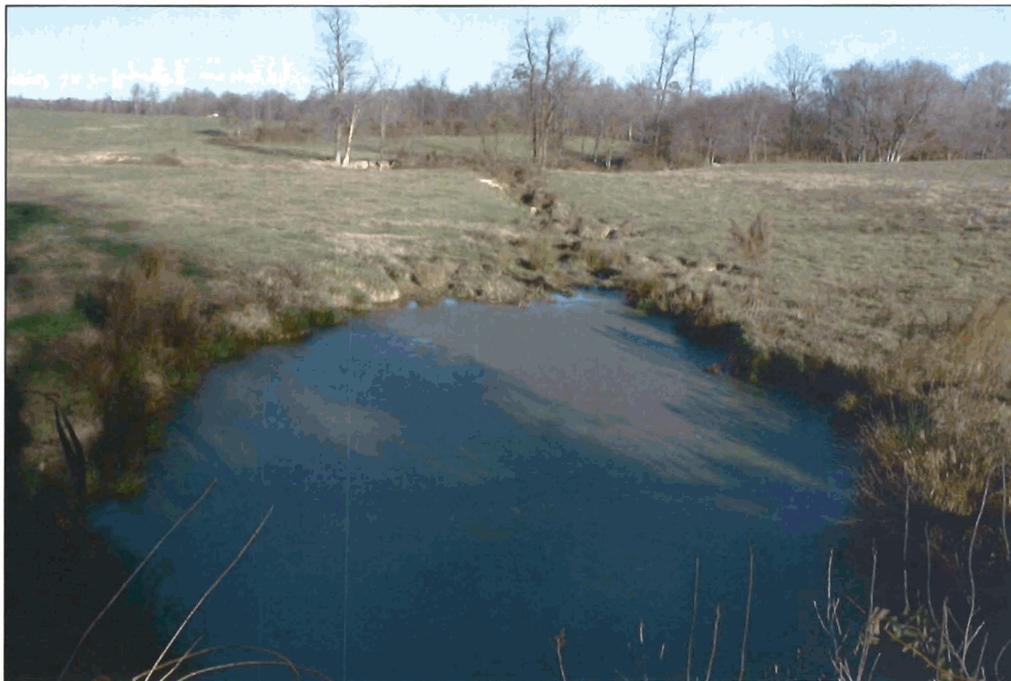
**Photograph 4:** View looking down stream along un-named tributary to Bear Creek that drains western portion of the Phillips property. Reach has a straight, channelized, planform, with undersized cross section. Confluence of un-named tributary with Bear Creek is at trees in background.

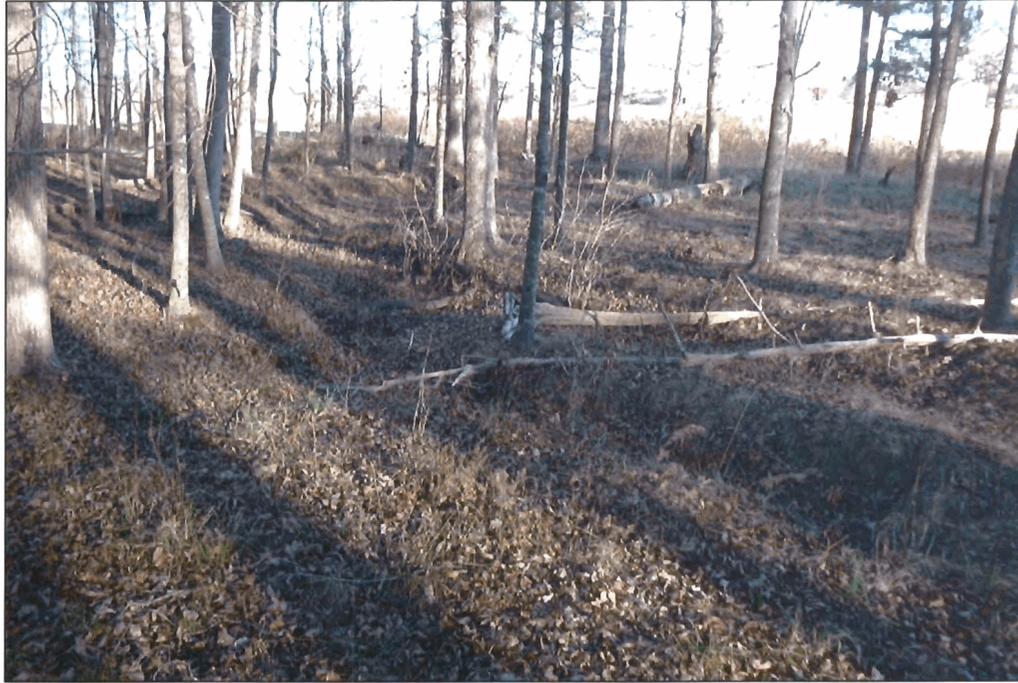
**Photograph 5:** Small dry storm run-off channels in woods along NW portions of Phillips property tract, which drain into Bear Creek during storms. Previously these channels have been suggested as evidence for past channelization of the un-named tributary, but no evidence of channelization of the stream was observed.

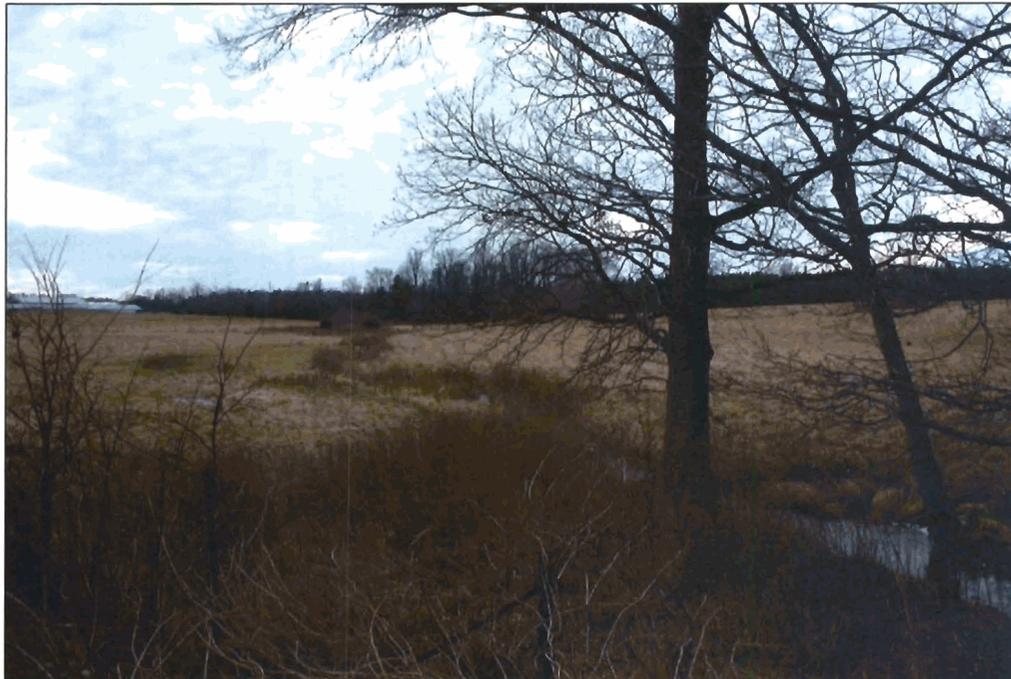
**Photograph 6:** View looking west up the un-named tributary that joins Bear Creek along the Phillips property reach from the Siler City – Glendon Road. The tributary has a low cross section area, common in pasture settings.
