**SUBJECT:** Second year monitoring for supplemental vegetation maintenance work at the Big Warrior Creek mitigation site in Wilkes County, North Carolina, NCEEP Project Number 00412, Task Order # 11-Yad01-2d.

# 1 Project Background and Attributes

### 3 Project Maintenance Condition

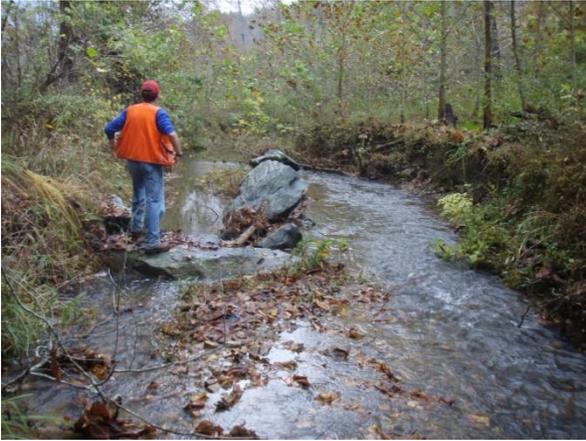
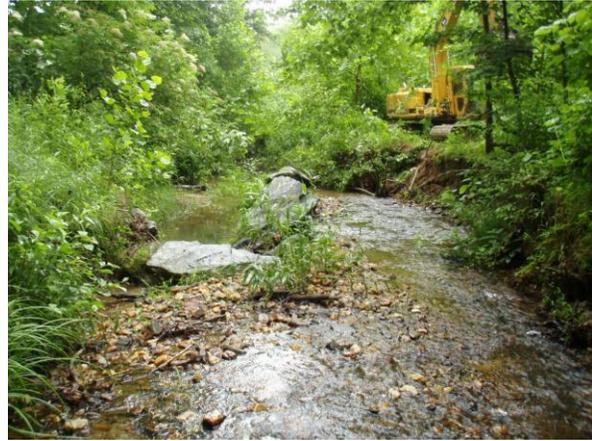
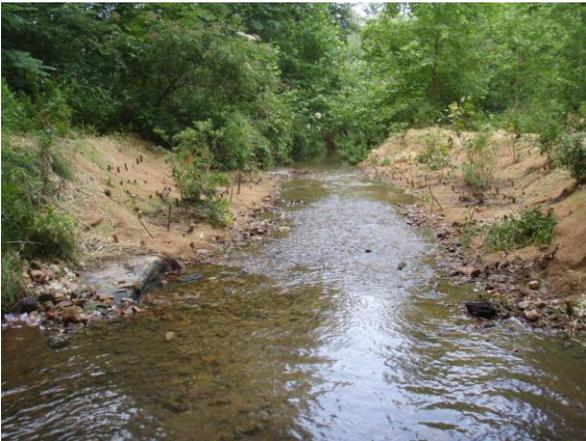
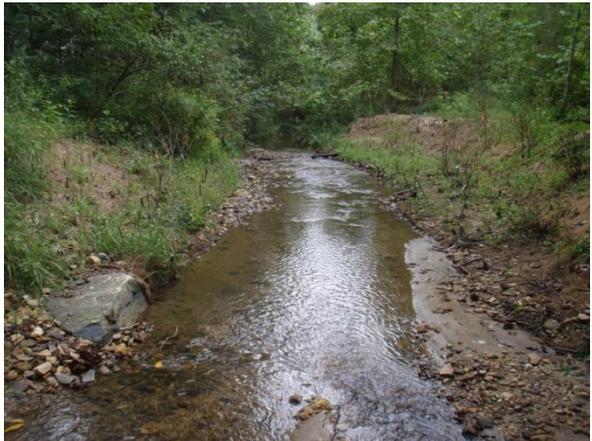
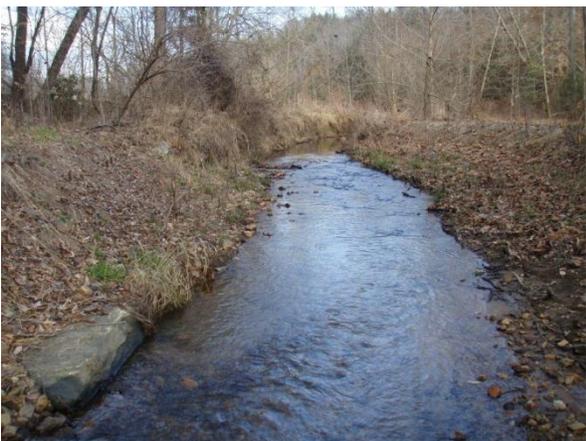
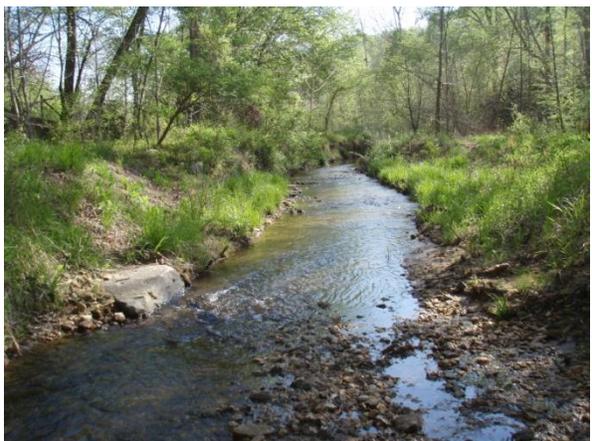
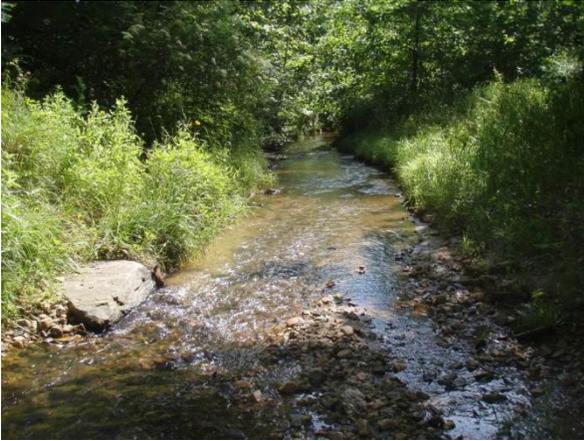
Figure 2. Photographic documentation looking downstream from Station 0+00 on Mountain Creek.

Large storm events between March and December 2009 caused several bank erosion areas along Mountain Creek (Figure 1). The first rock vane failed at station 0+00 and caused the stream to divert around the structure entirely, resulting in 65 ft of bank erosion on the right stream bank. The loss of log bank armoring structures resulted in bank erosion on the left stream bank at station 7+90. The left stream bank moved 10-15 ft to the left over approximately 70 lf of stream. The fence along the conservation easement had to be moved back because of the bank erosion.

Stream channel maintenance work on the two eroding areas was completed between 20 June 2011 and 28 June 2011 (NCWRC 2011). Throughout the quarterly monitoring, the stream banks in the repaired area appeared stable and all structures were functioning properly (Figures 2–5). Planted woody vegetation also appeared healthy. However, one fence post at station 8+20 has begun to lean.

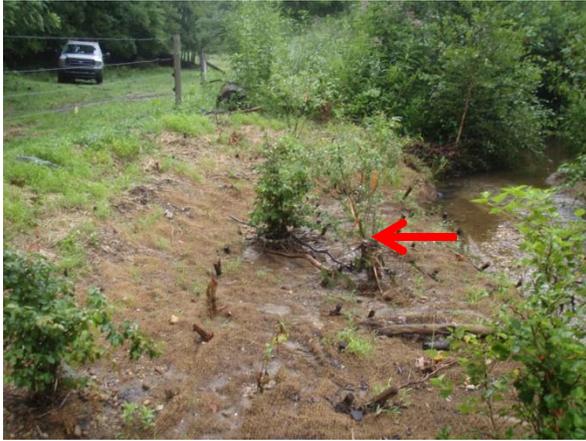
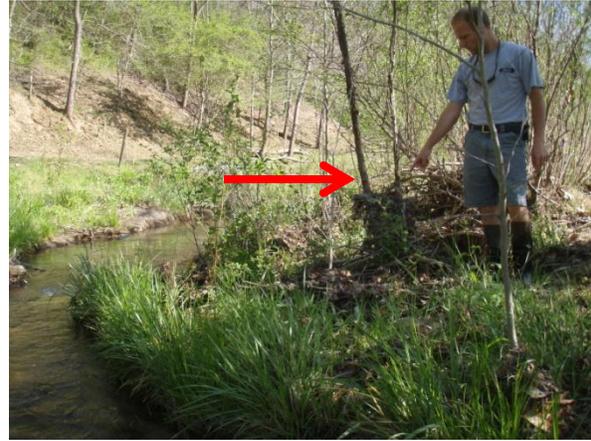
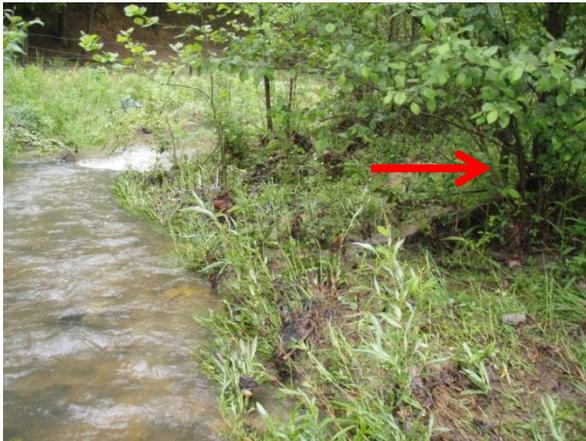
Figure 6. Wrack line indicating bankfull storm events on Big warrior Creek. The top of the wrack line is identified by the red arrow.

During this monitoring year, three bankfull events were identified by on site evidence (Figure 6) and one was recorded at the USGS stream gage (Figure 7). In addition to the 14 May 2012 bankfull event with a discharge of 2,700 cfs, three half bankfull to near bankfull events also occurred; 1,580 cfs on 29 Nov 2011, 1,680 cfs on 7 Dec 2011, and 1,790 cfs on 22 Dec 2011. This exceeds the North Carolina Division of Water Quality's permit requirement of monitoring the site for at least two bankfull events.

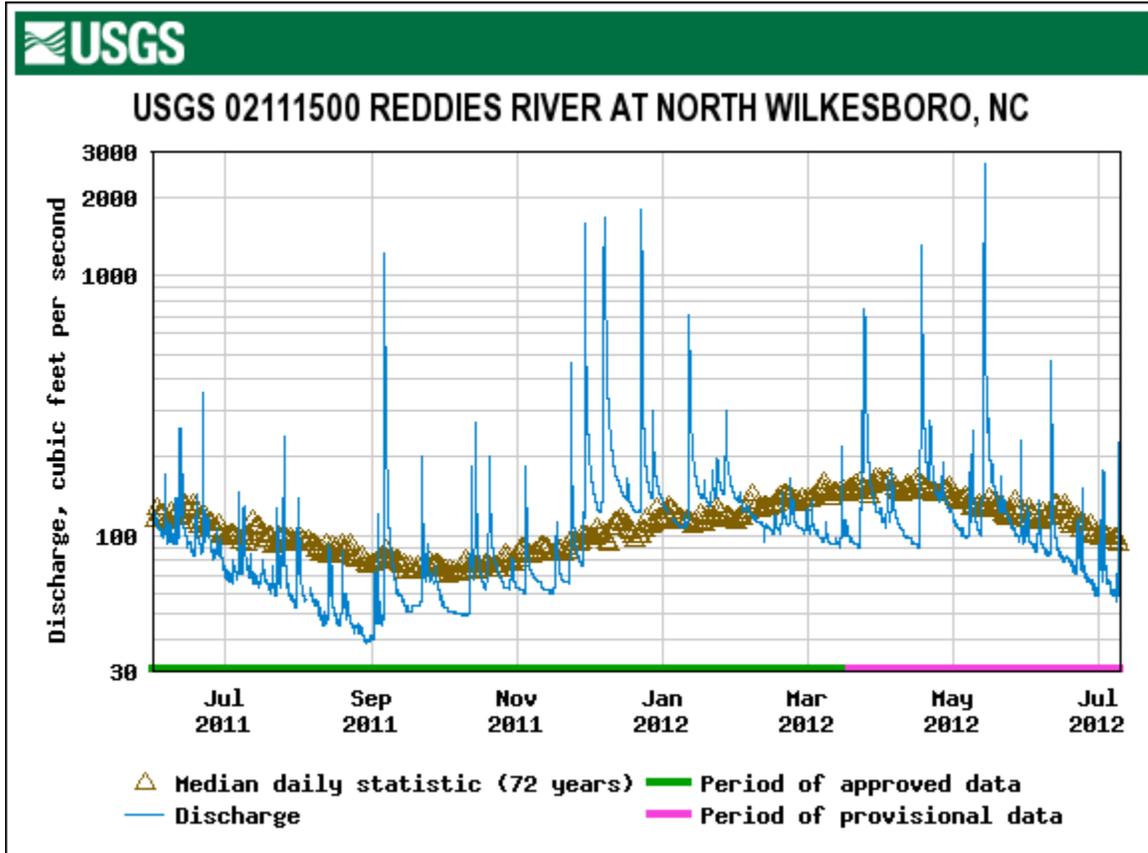
Figure 7. USGS Rain Gage (USGS 02111180) on Elk Creek in Elkville, NC.

Previous monitoring at the site extrapolated bankfull events based on US Geological Survey (USGS) stream gage discharge data for the Reddies River (USGS 02111500) at North Wilkesboro, NC (URS 2010). A bankfull event represents a discharge of approximately 2,250 cubic feet per second (cfs) at the gage. On-site evidence such as the height of wrack lines was also used to determine bankfull events.

Bankfull event is equivalent to a discharge of approximately 2,250 cubic feet per second.

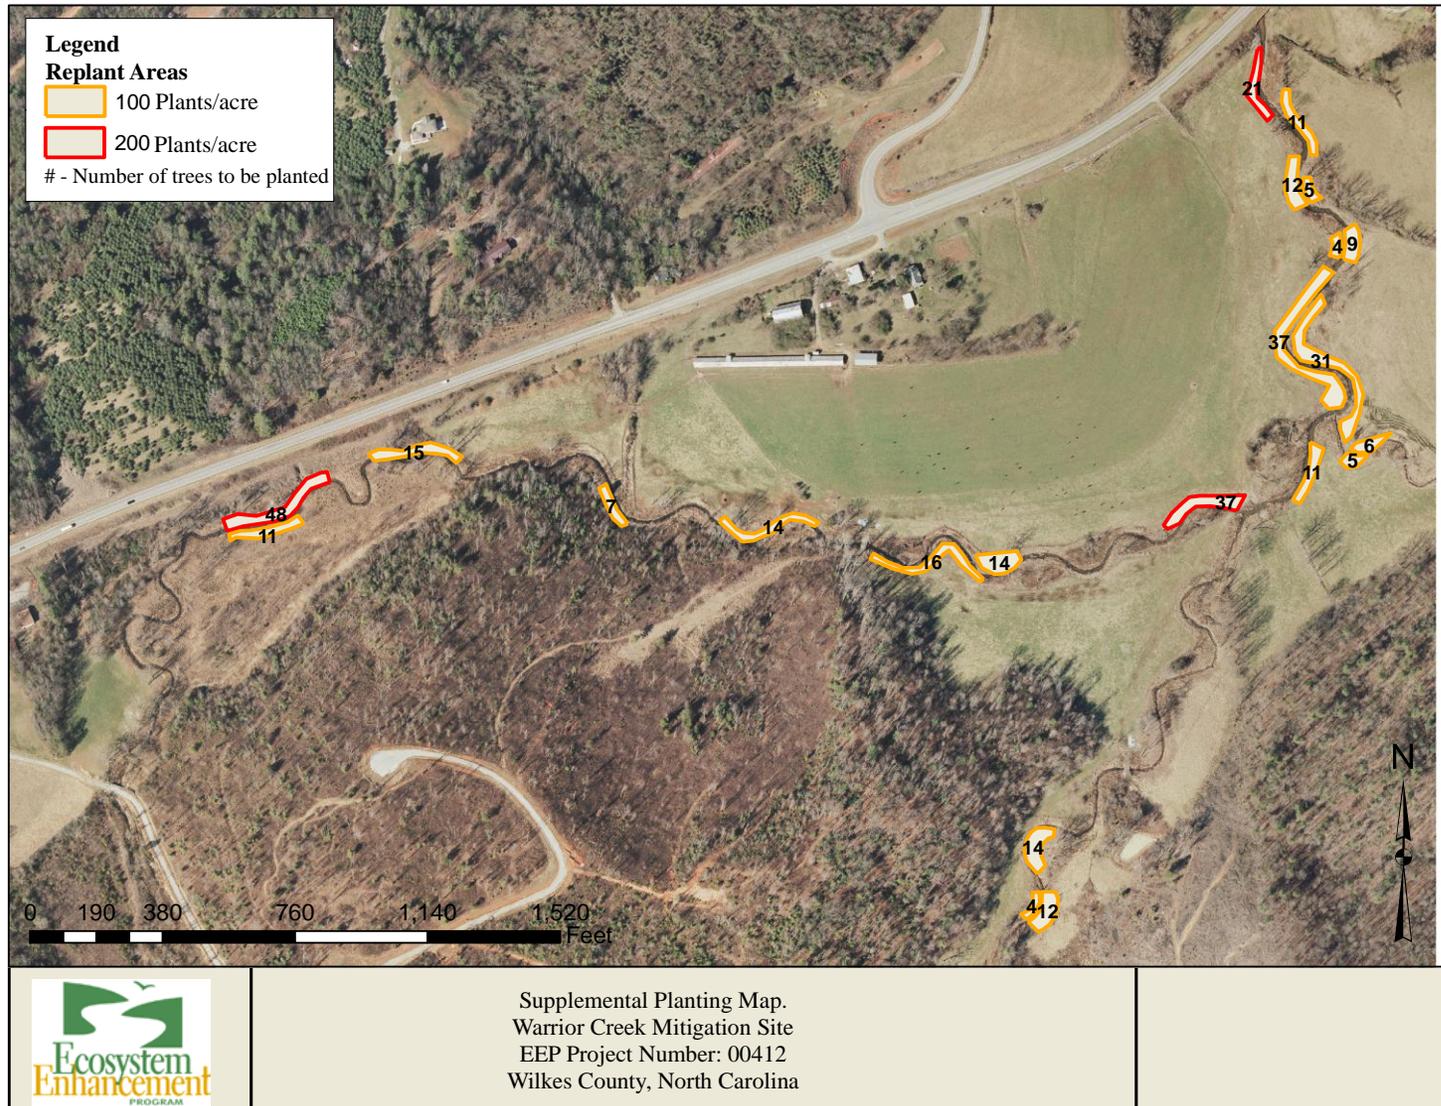
Figure 8. Big Warrior Creek supplemental planting map.

In February 2011 a total of 345 containerized trees and shrubs were planted at designated areas (Figure 8) to augment low woody stem density at the site. These areas were planted at densities of either 100 stems/acre or 200 stems/acre, in order to exceed the success criteria of 260 stems/acre (USACE 2003).

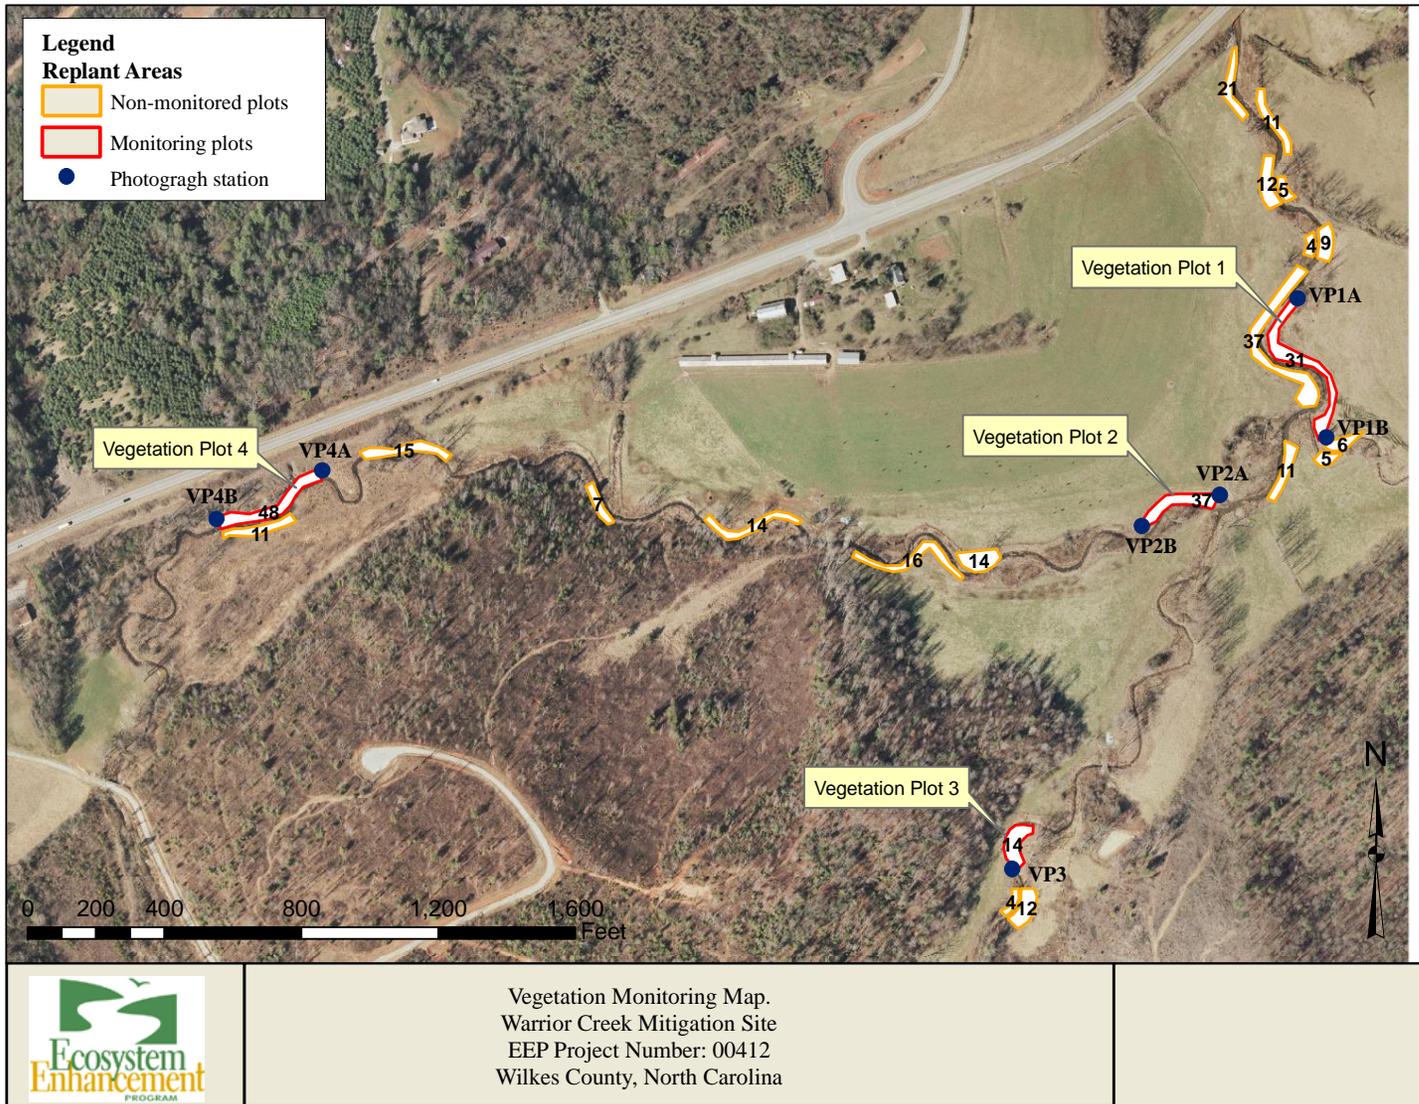
Figure 9. Big Warrior Creek vegetation monitoring map.

The supplemental vegetation was monitored for two growing seasons and site visits were conducted on 1 Aug 2011 and 14 May 2012. This monitoring consisted of stem counts of planted vegetation to determine survivorship at four monitoring plots (Figure 9 and Table 4) and photographic documentation (Figure 10-13). More planted trees were found during the 2012 monitoring because the herbaceous vegetation had not grown very tall. At least 87% of all supplemental trees and shrubs planted survived two growing seasons in vegetation plot 1, 94% in vegetation plot 2, 100% in vegetation plot 3, and 83% in vegetation plot 4. Ninebark *Physocarpus opulifolius* was one of the more difficult species to find because it was planted near the water's edge where the herbaceous vegetation was denser and an area that partially flooded during monitoring. Additionally, survivorship of Northern Red Oak *Quercus rubra* in vegetation plot 4 decreased from 2011 monitoring; however, the overall survivorship of the vegetation plot did not change. Plants that were found appeared to be healthy and growing well. Overall, the supplemental planting appeared to be successful.
