EEP Project Closeout Summary

Project Name/Number: ABC Site
EEP ID: 6
County: Beaufort
Project Type: Wetland Restoration, Enhancement & Preservation
Current Status: 5 Years of Monitoring complete

**ABC MITIGATION SITE
WETLAND RESTORATION SITE
BEUAFORT COUNTY, NORTH CAROLINA**

**Findings Report
April, 2007**

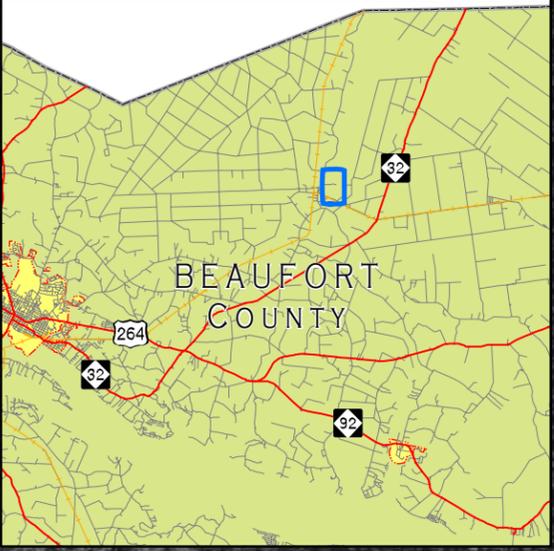
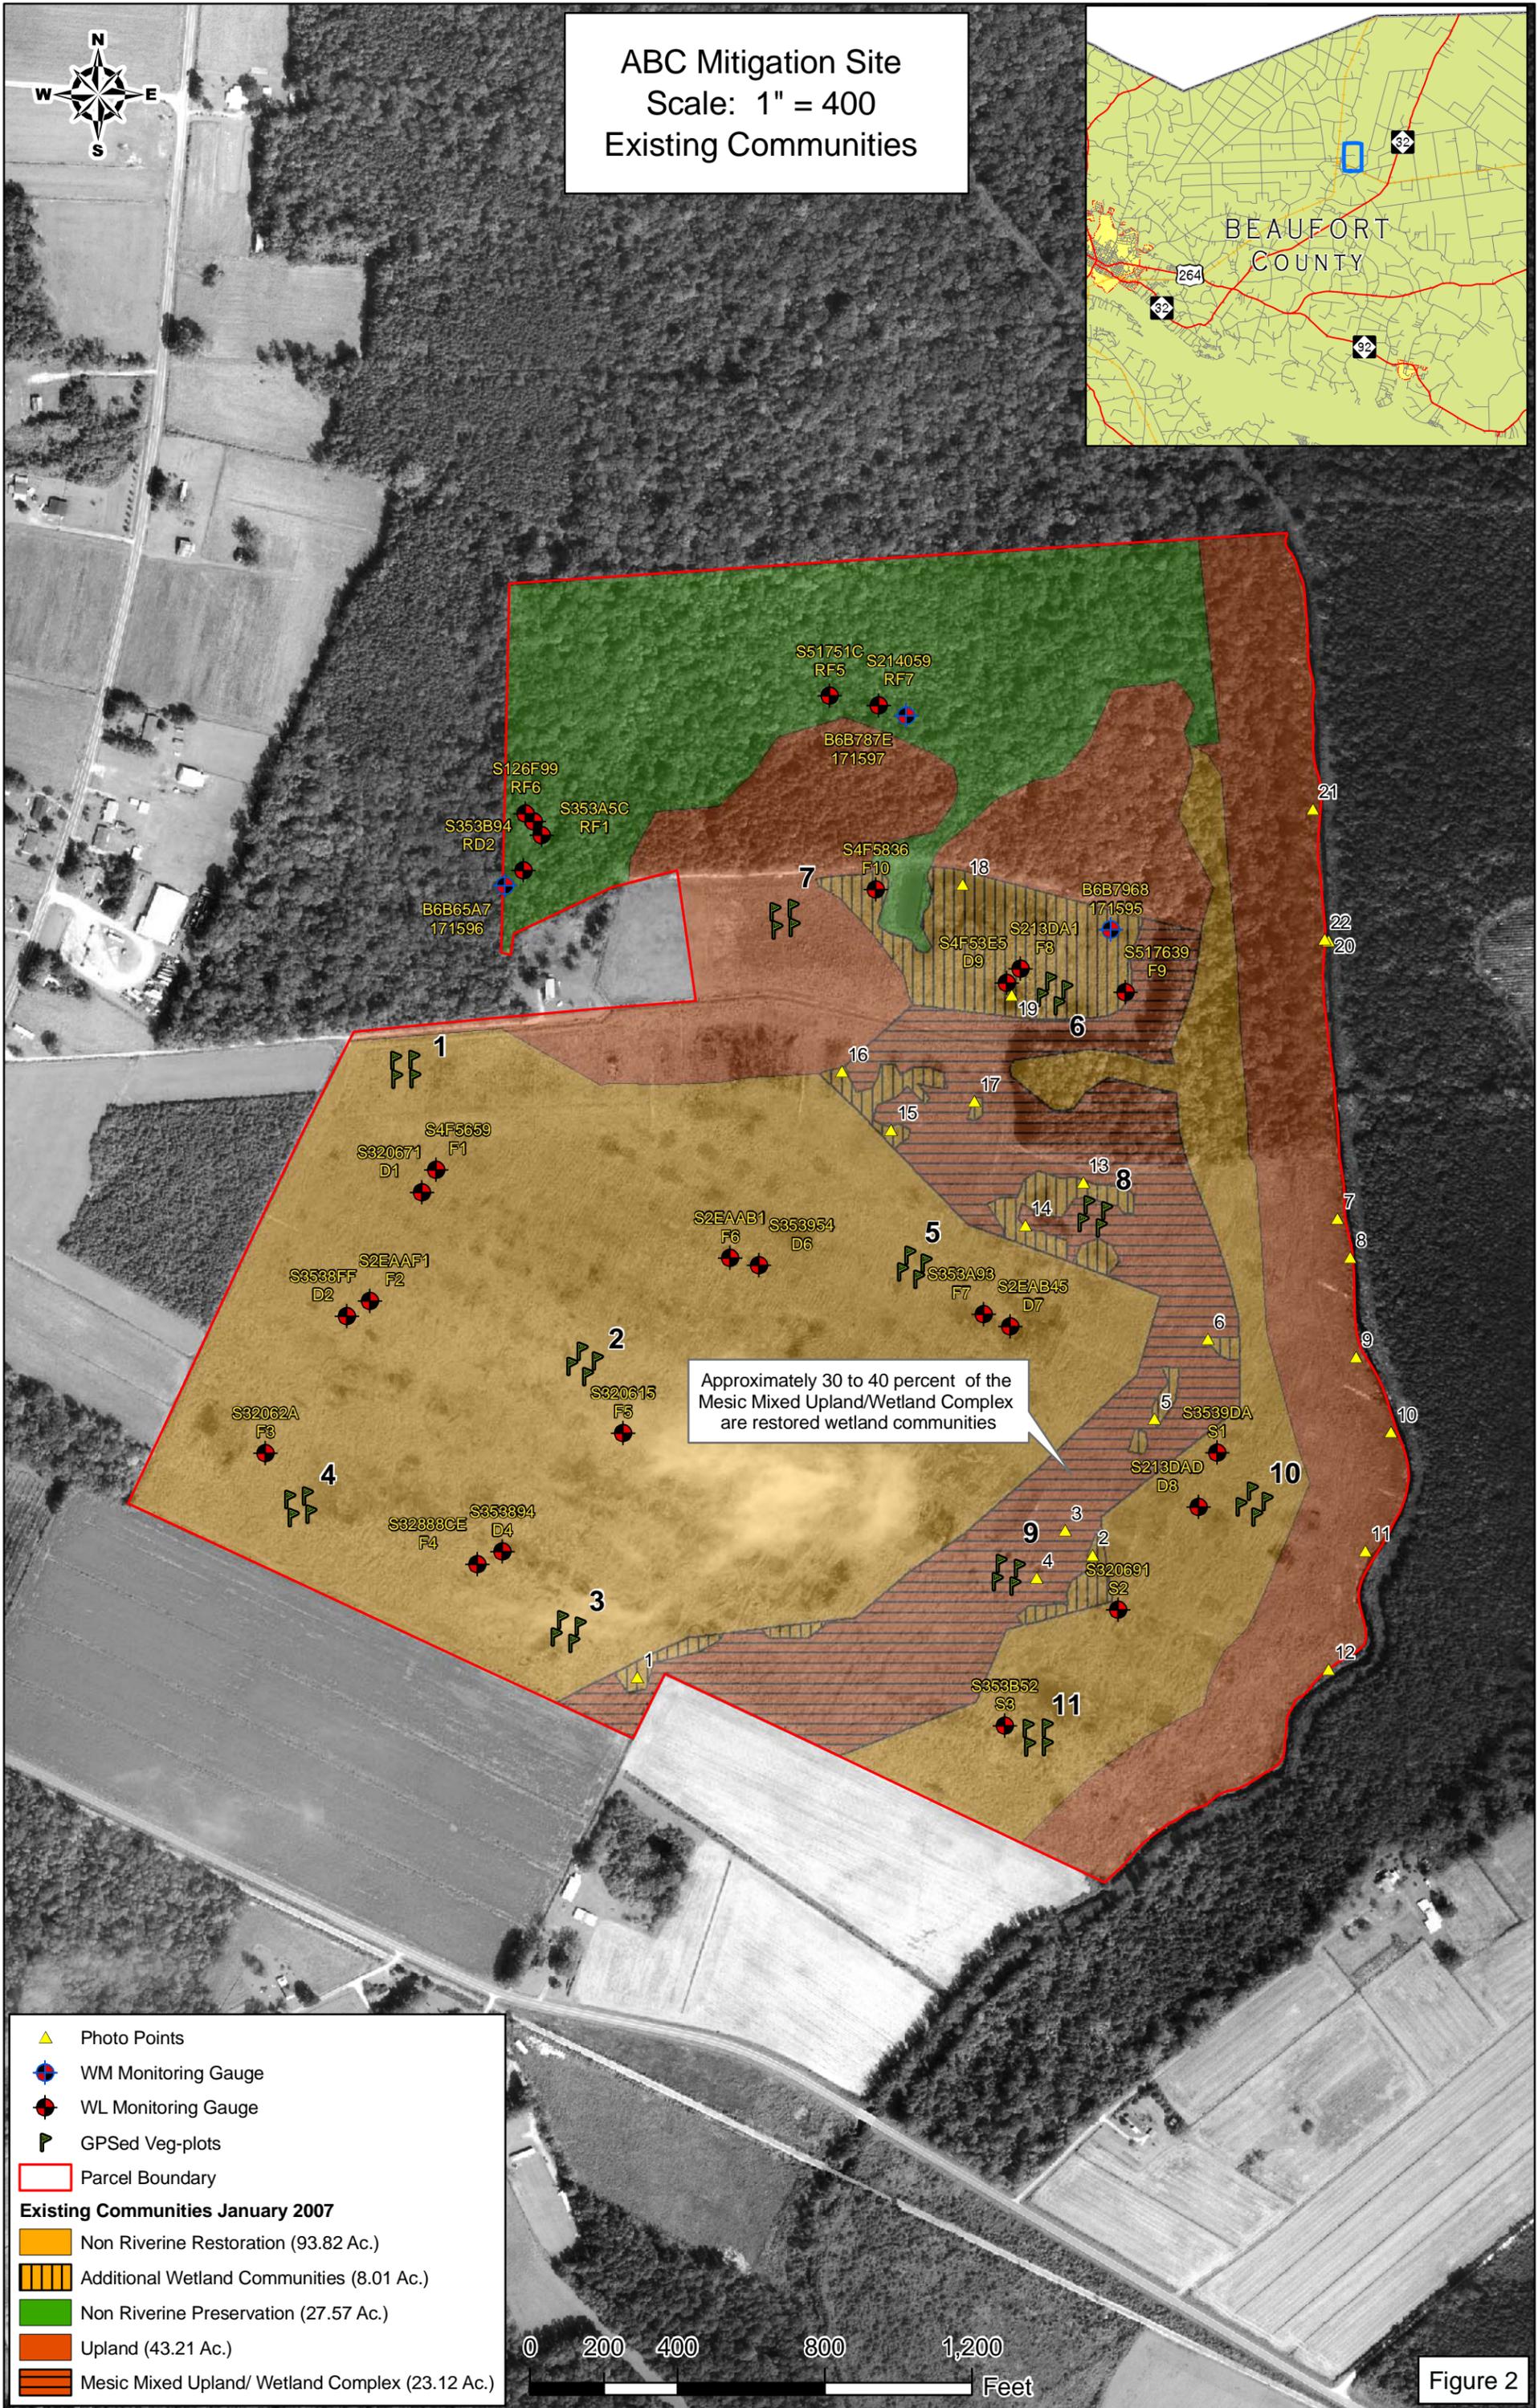
ABC Mitigation Site
Scale: 1" = 400
Existing Communities

Approximately 30 to 40 percent of the Mesic Mixed Upland/Wetland Complex are restored wetland communities

- Photo Points
- WM Monitoring Gauge
- WL Monitoring Gauge
- GPSed Veg-plots
- Parcel Boundary
- Existing Communities January 2007**
- Non Riverine Restoration (93.82 Ac.)
- Additional Wetland Communities (8.01 Ac.)
- Non Riverine Preservation (27.57 Ac.)
- Upland (43.21 Ac.)
- Mesic Mixed Upland/ Wetland Complex (23.12 Ac.)

During the review of digitized data, it was noted that gauges located within designated upland areas achieved jurisdictional hydrology. Subsequently, a review of all designated upland areas was performed to assess the amount of actual wetland communities within upland areas. Figure 2 shows these results of the current wetland communities within the upland areas. These areas are labeled as additional wetland communities in the legend. The mitigation plan did not anticipate these areas achieving jurisdictional hydrology or maintaining hydrophytic vegetation. During the field review, it was clear that wetland areas exist in the designated upland areas and should be considered as wetland restoration. Other portions of the designated upland areas were marginal and had characteristics of both wetland and upland communities. This area is labeled as mesic mixed wetland/upland complex in Figure 2. It is possible that a large portion of the designated upland areas are restored wetlands but additional hydrologic monitoring data is needed to make the determination.

Wetland areas that have been identified within the designated upland area were not accounted for in the mitigation plan. The designed mitigation units are shown in Figure 3 and the wetland areas found within the upland areas are shown in Figure 2. Updated parcel boundary data has been incorporated and new designed mitigation areas (acres) have been calculated and shown in the legend of each figure.

Existing vegetative communities have changed and are mapped in Figure 2. The difference in vegetative community is due to a different hydrologic regime, with longer soil saturation periods, that was not anticipated during site and planting plan design.

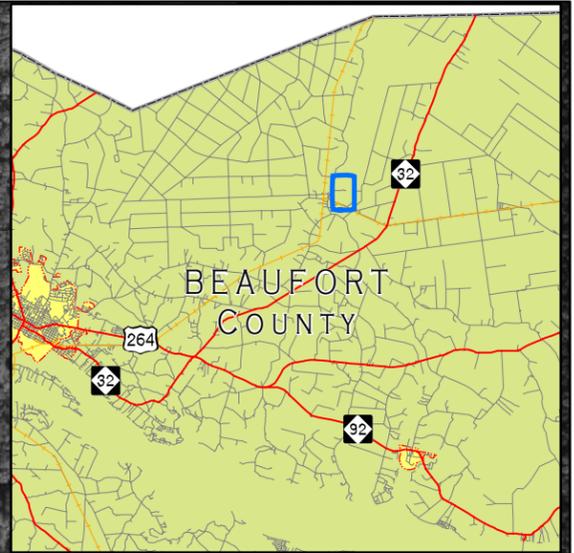
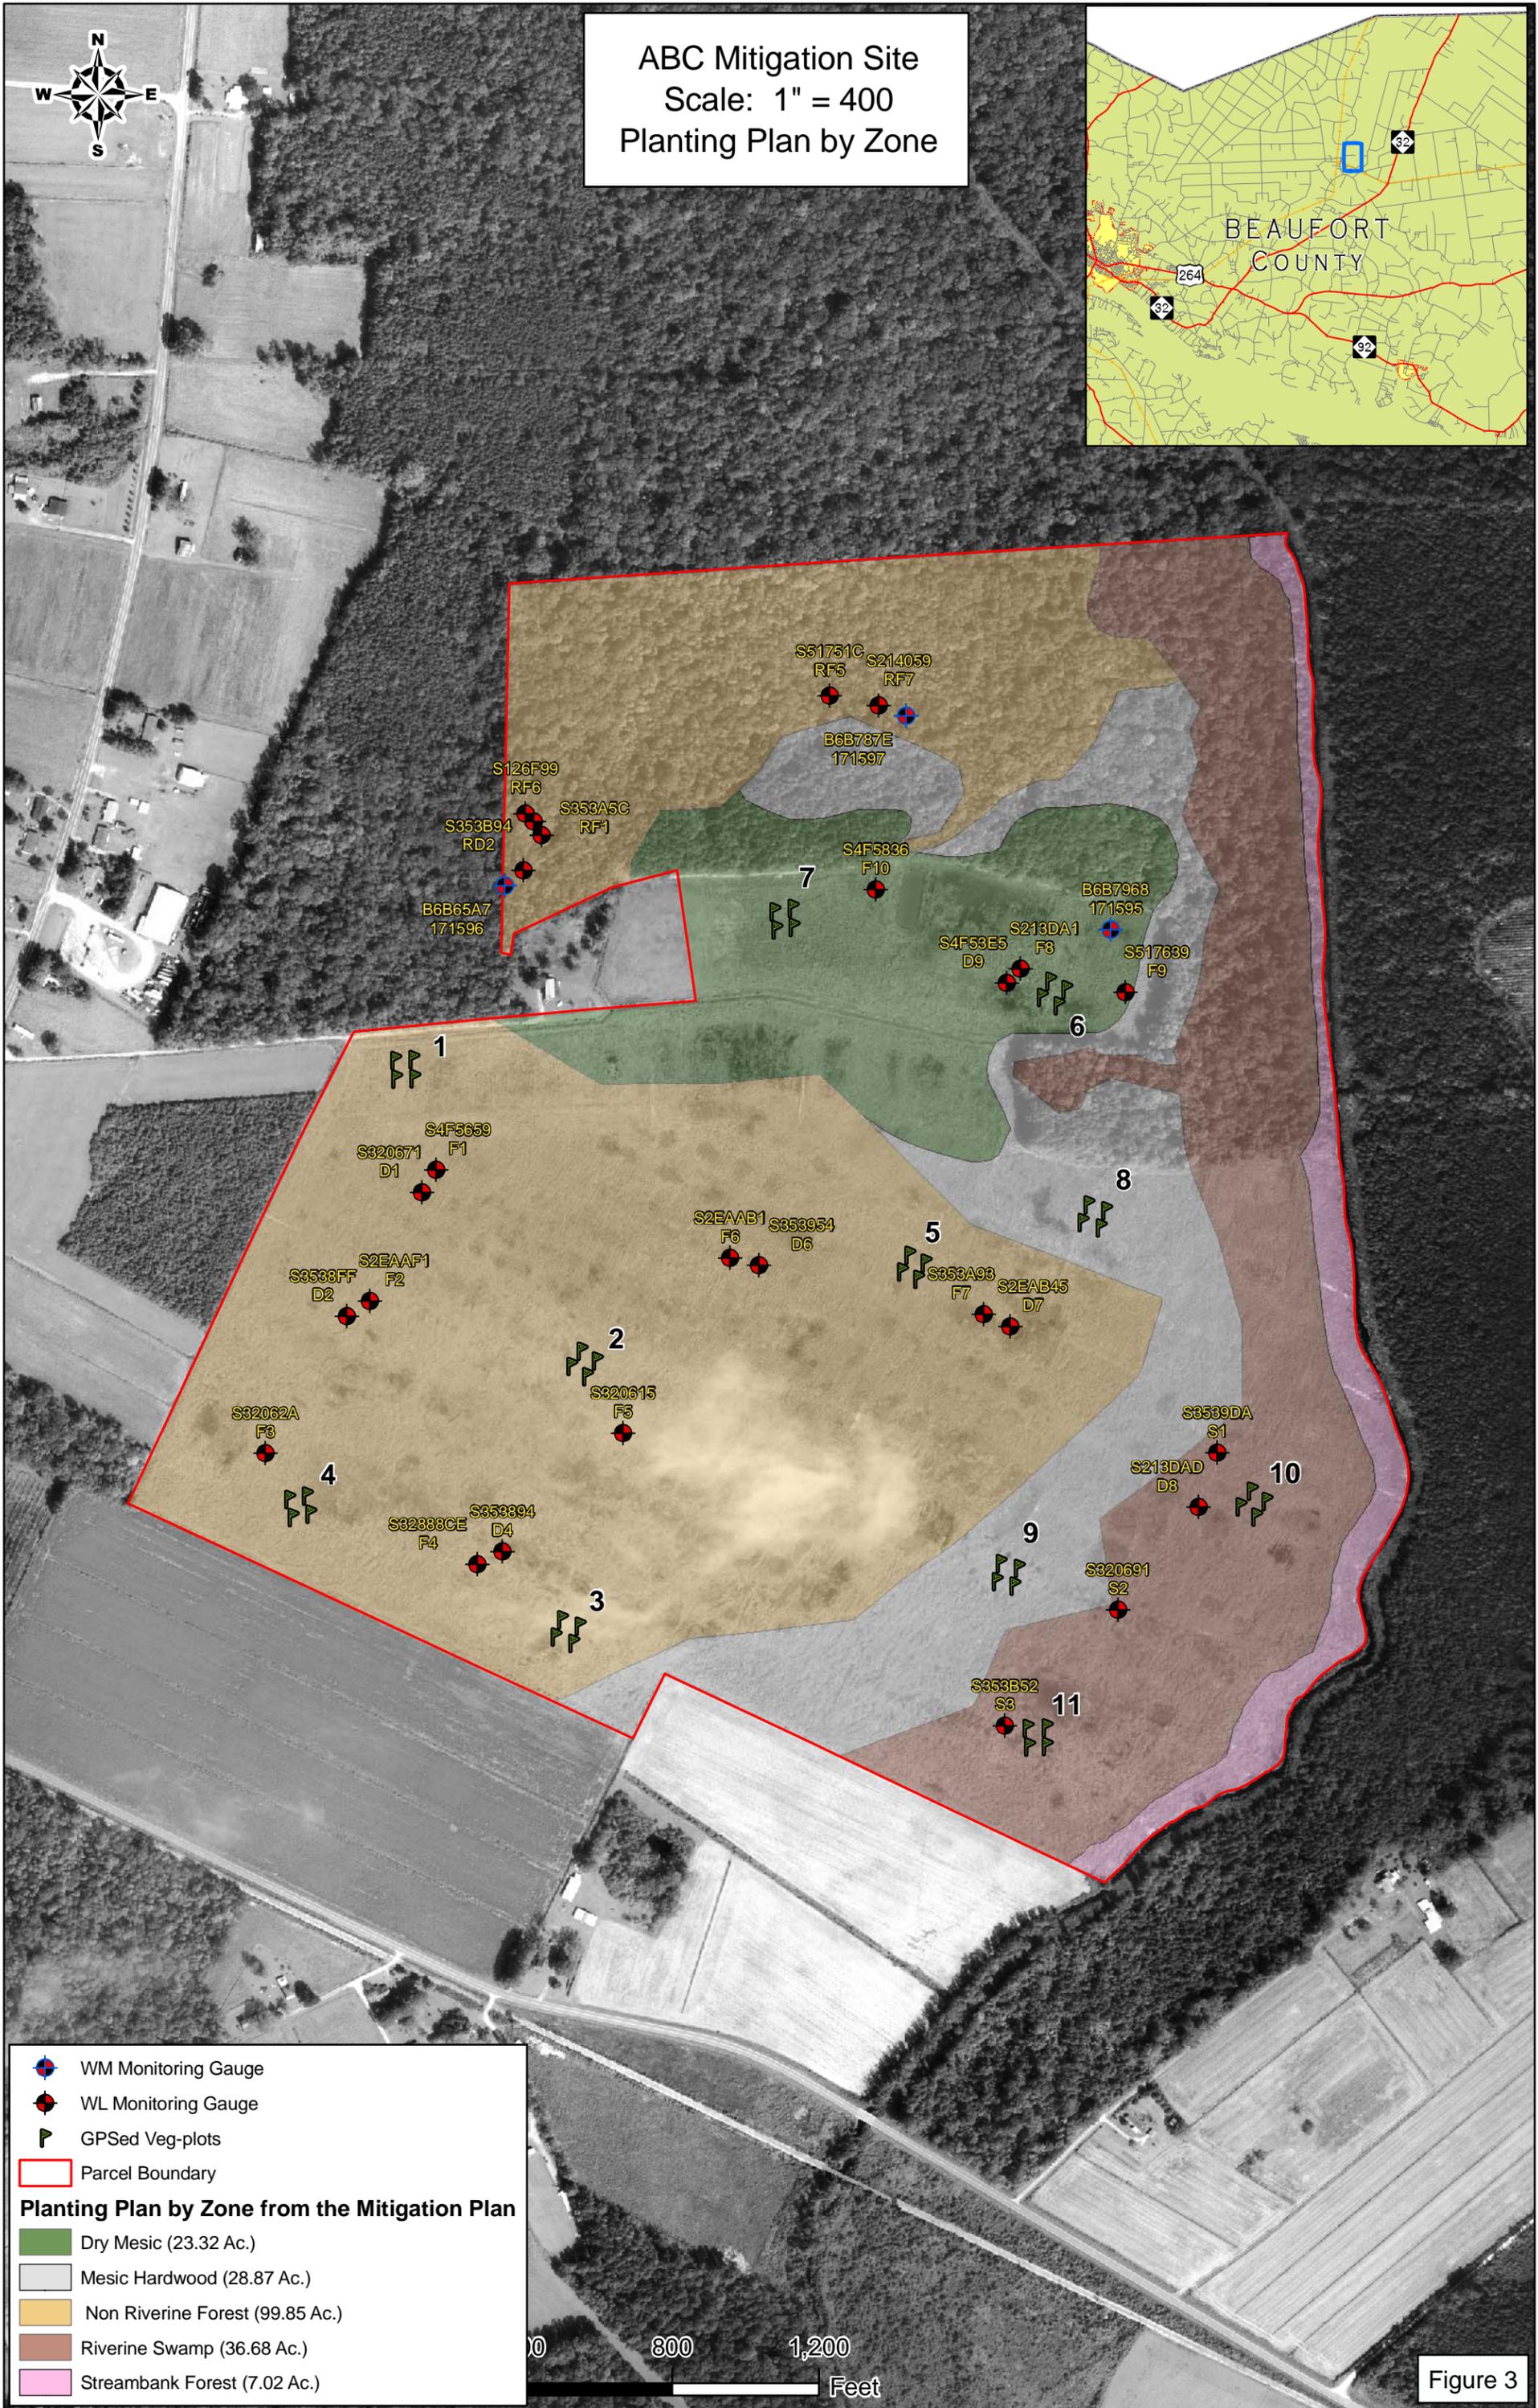
Figure 3

ABC Mitigation Site
 Scale: 1" = 400
 Planting Plan by Zone

Planting Plan by Zone from the Mitigation Plan

- Dry Mesic (23.32 Ac.)
- Mesic Hardwood (28.87 Ac.)
- Non Riverine Forest (99.85 Ac.)
- Riverine Swamp (36.68 Ac.)
- Streambank Forest (7.02 Ac.)

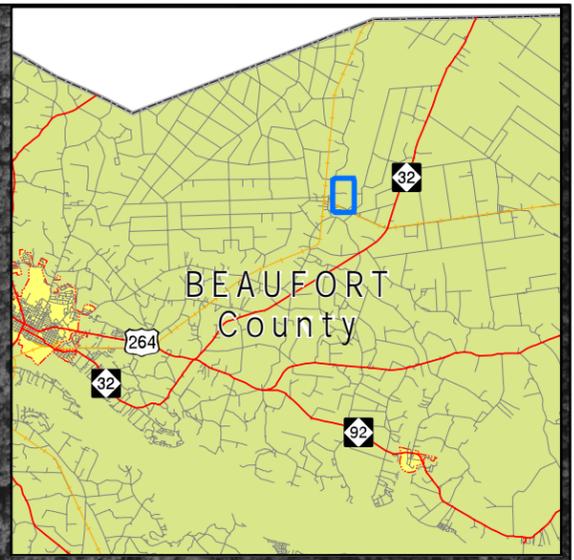
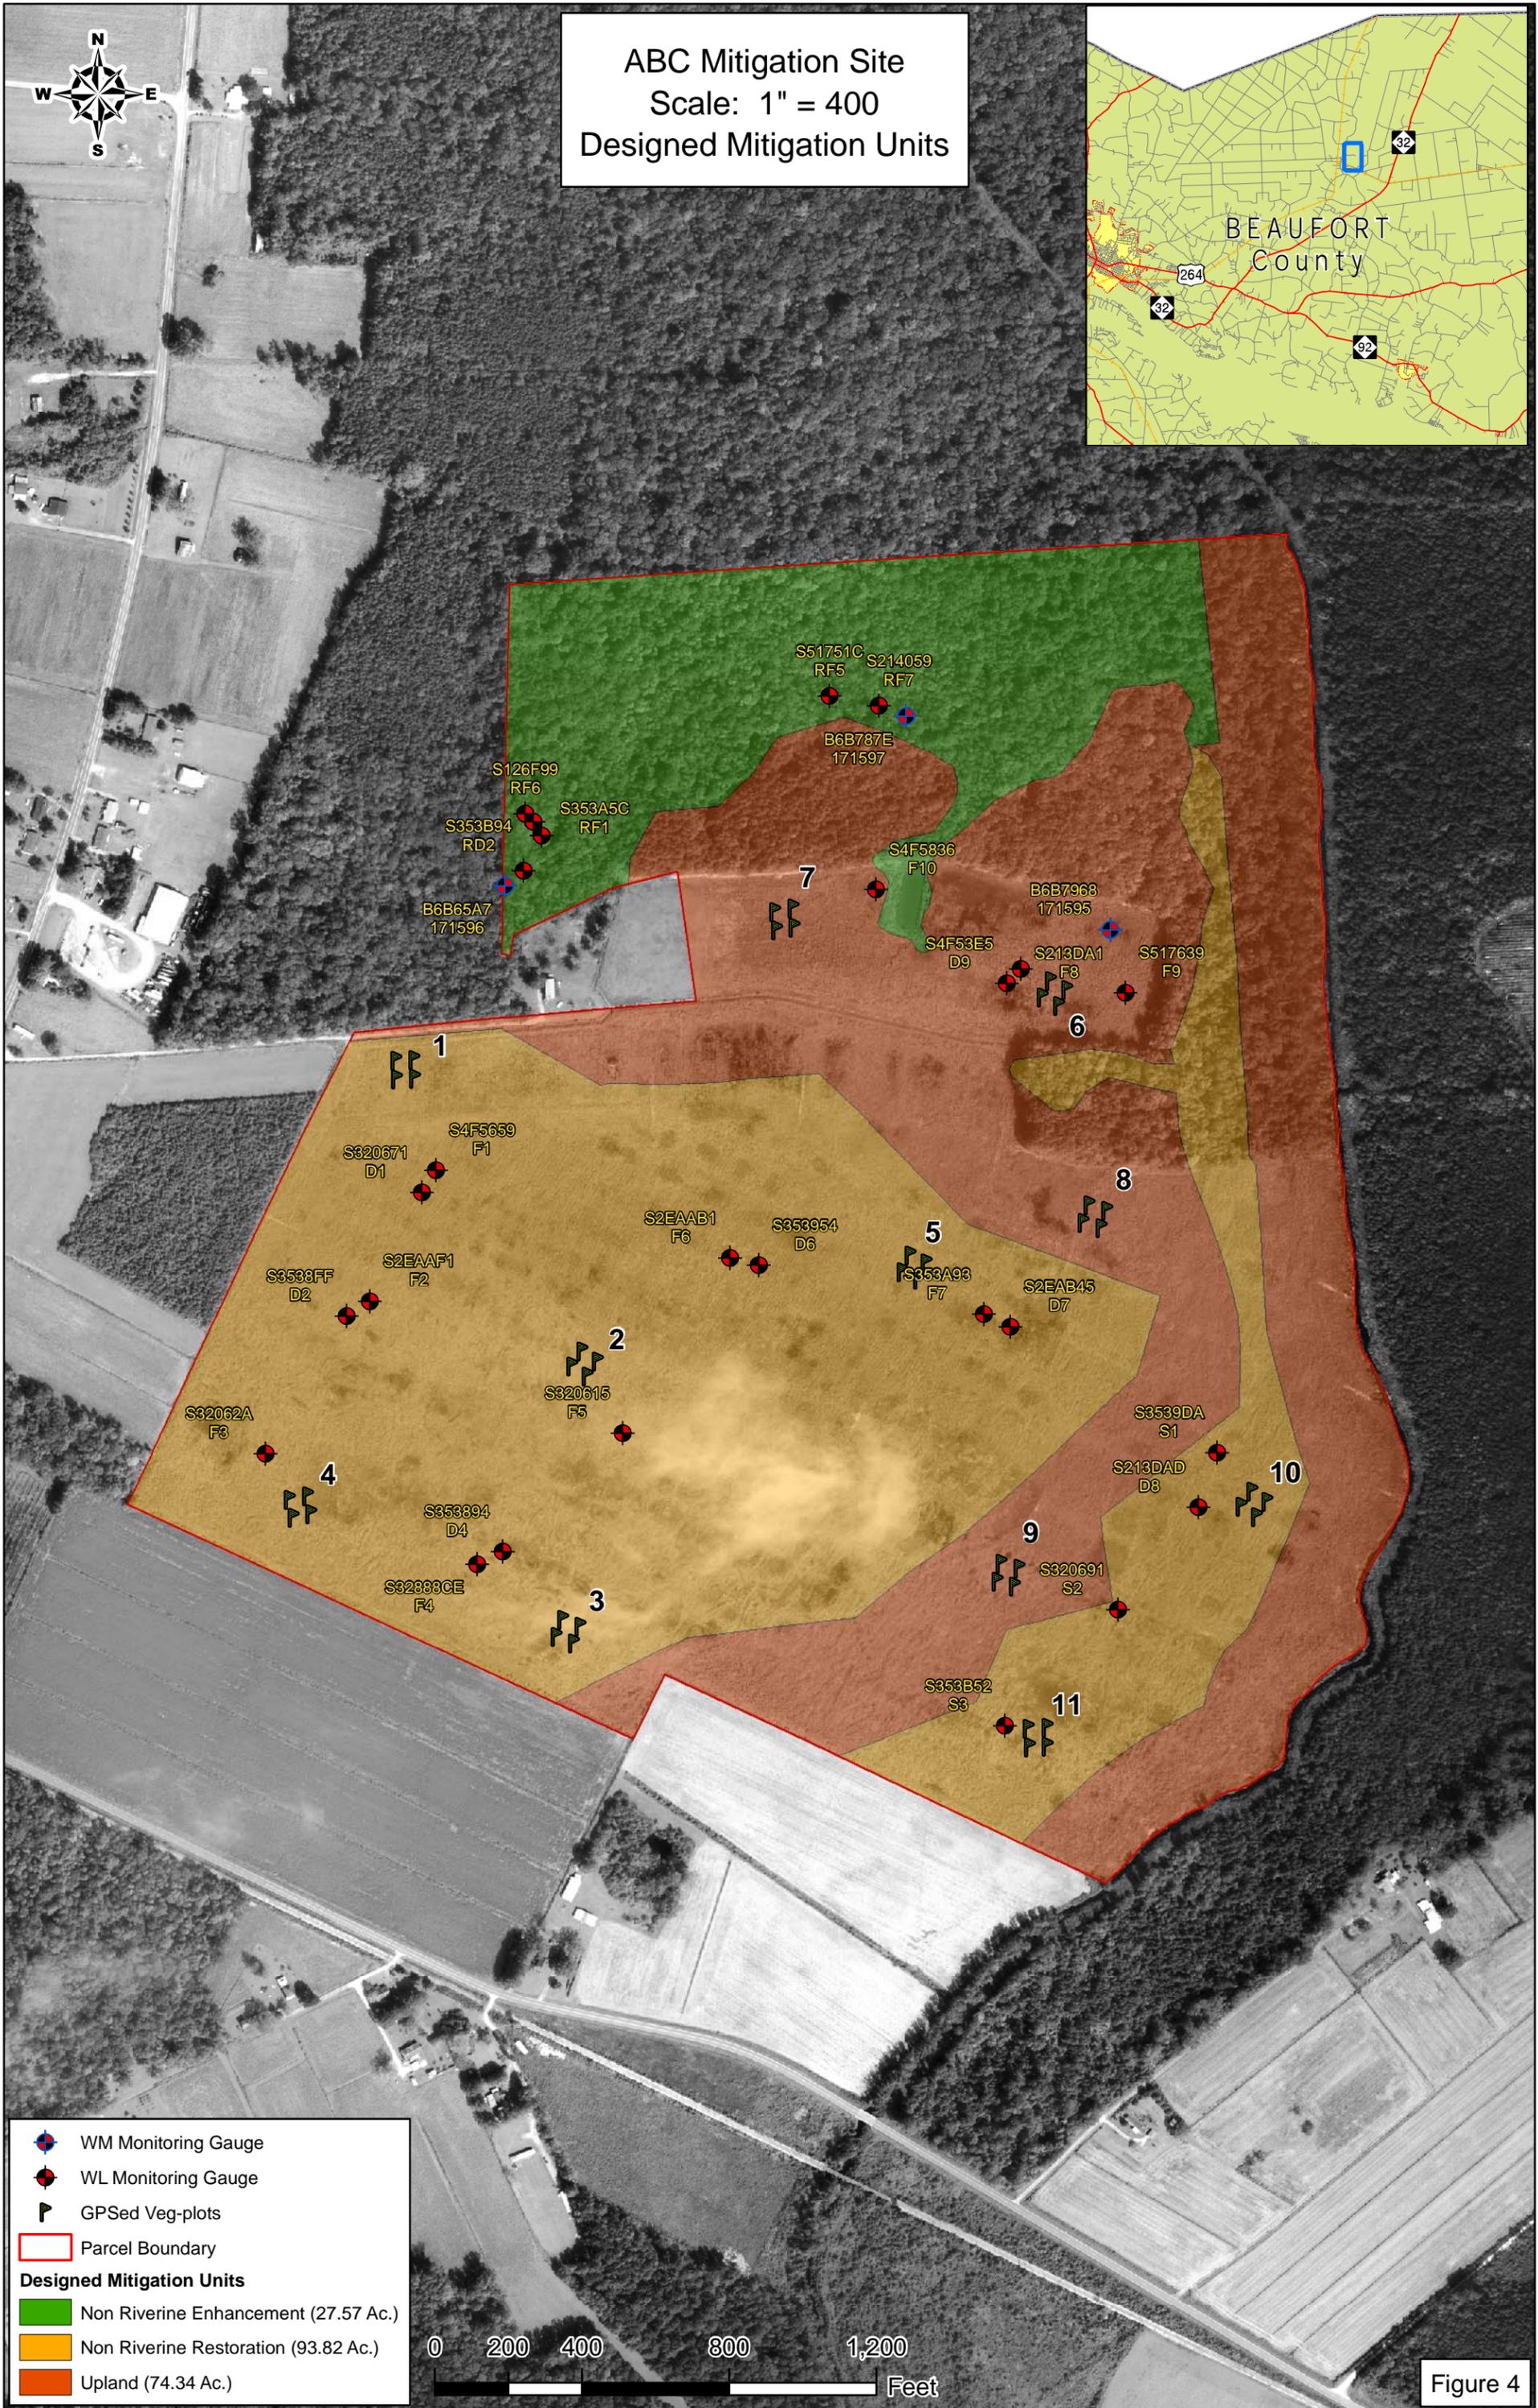
Figure 4

ABC Mitigation Site
Scale: 1" = 400
Designed Mitigation Units

- WM Monitoring Gauge
- WL Monitoring Gauge
- GPSed Veg-plots
- Parcel Boundary
- Designed Mitigation Units**
- Non Riverine Enhancement (27.57 Ac.)
- Non Riverine Restoration (93.82 Ac.)
- Upland (74.34 Ac.)

A large portion of the ABC Wetland Mitigation Site was deemed as jurisdictional wetlands (ABC 1999) by the US Army Corps of Engineers (COE). This area is located along the northern boundary and labeled in the legend as non riverine wetland preservation in Figure 3. The non riverine wetland preservation is accounted for as existing jurisdictional wetlands in the mitigation plan but not accounted for in the mitigation units generated from the ABC Wetland Mitigation Site. A field review of the Wetland A was conducted and deemed accurate. Therefore, all pre-existing jurisdictional wetlands should be considered preservation and accounted for the closeout of the ABC Wetland Mitigation Site.

The designed vegetative communities were digitized and compared to post construction monitoring utilizing GIS technology (Figure 3). The comparison yielded an area of discrepancy within the designated upland areas. Vegetation monitoring plots located within designed wetland restoration areas were successful while plots located with the designed upland areas struggled to meet minimal success criterion.
