**LITTLE PINE – BRUSH CREEK  
AS-BUILT REPORT (MY0)**

**HDR ENGINEERING**

**JUNE 2002**

**Little Pine Creek/Brush Creek  
Monitoring Methodology Report  
Alleghany County, North Carolina  
HDR Project No. 09177-010-018**

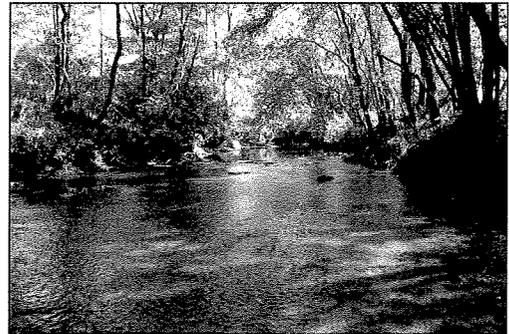
**Lower 700' of Brush Creek**

The lower 700 feet of Brush Creek, which is included in the conservation easement, does not include cross-section or permanent photograph station establishment. No grading work or planting was performed in this stable reach. Two boulder clusters were placed in the stream in this section to augment existing riffle sections.

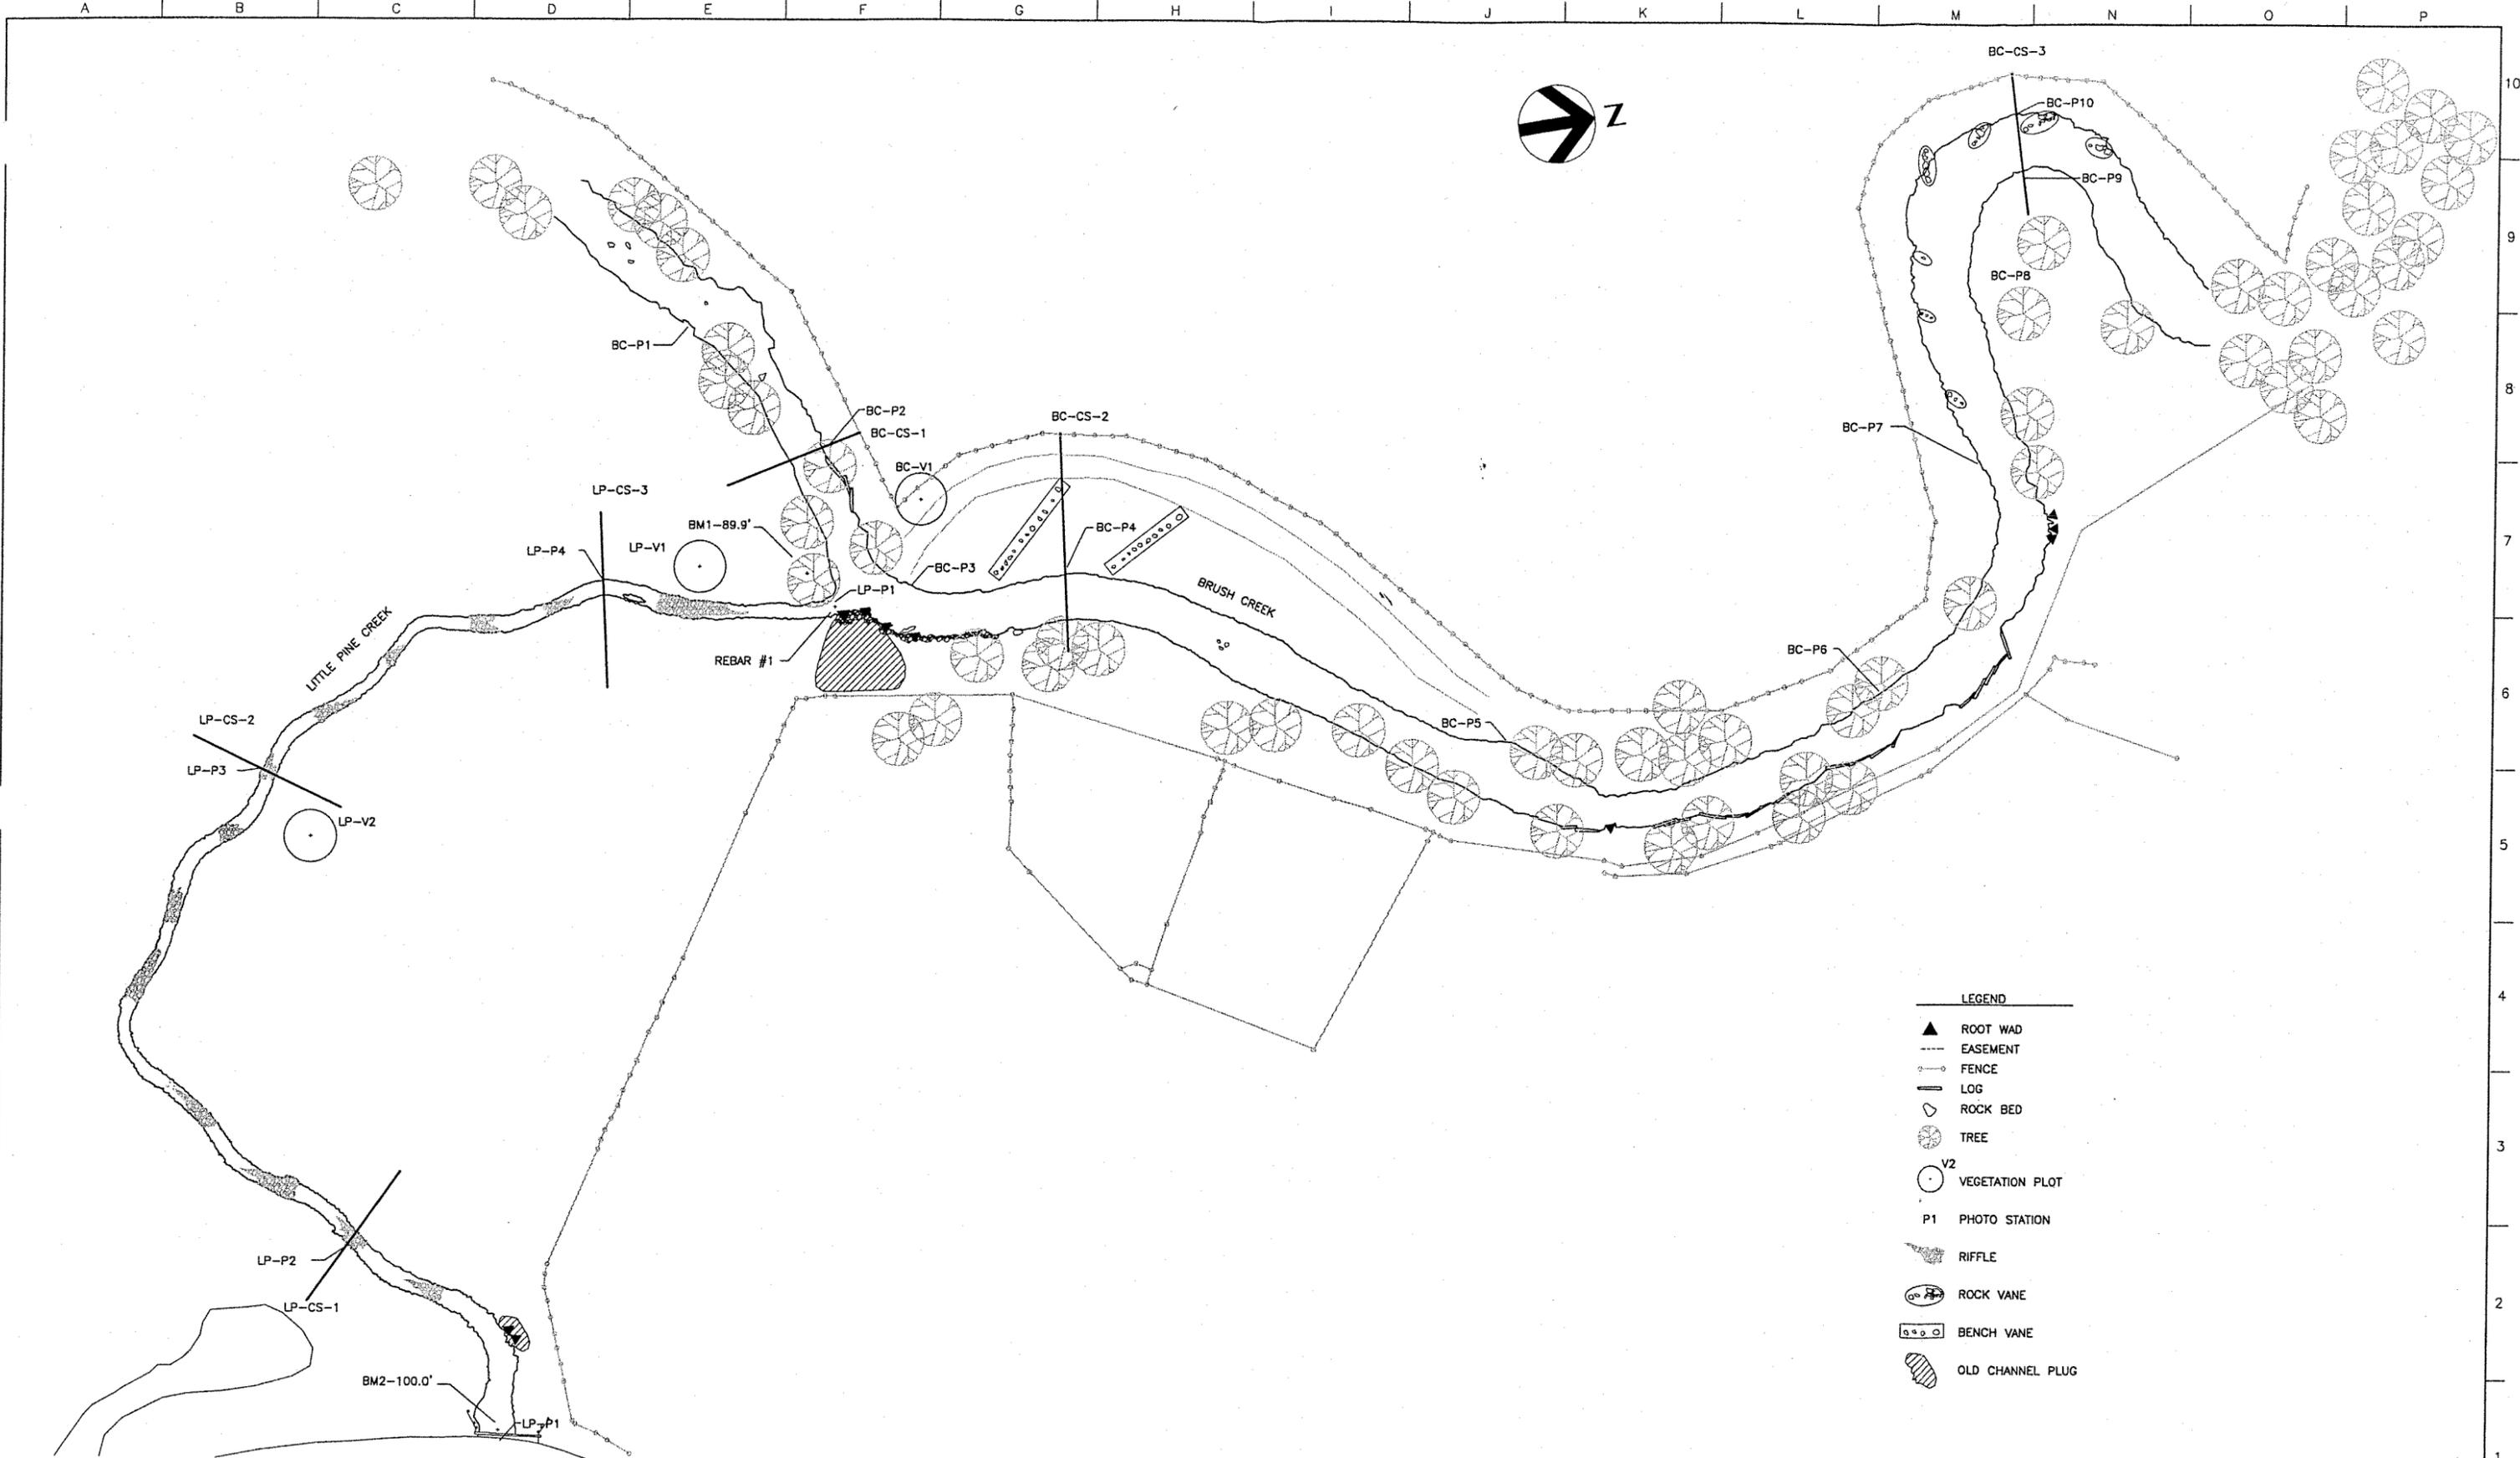
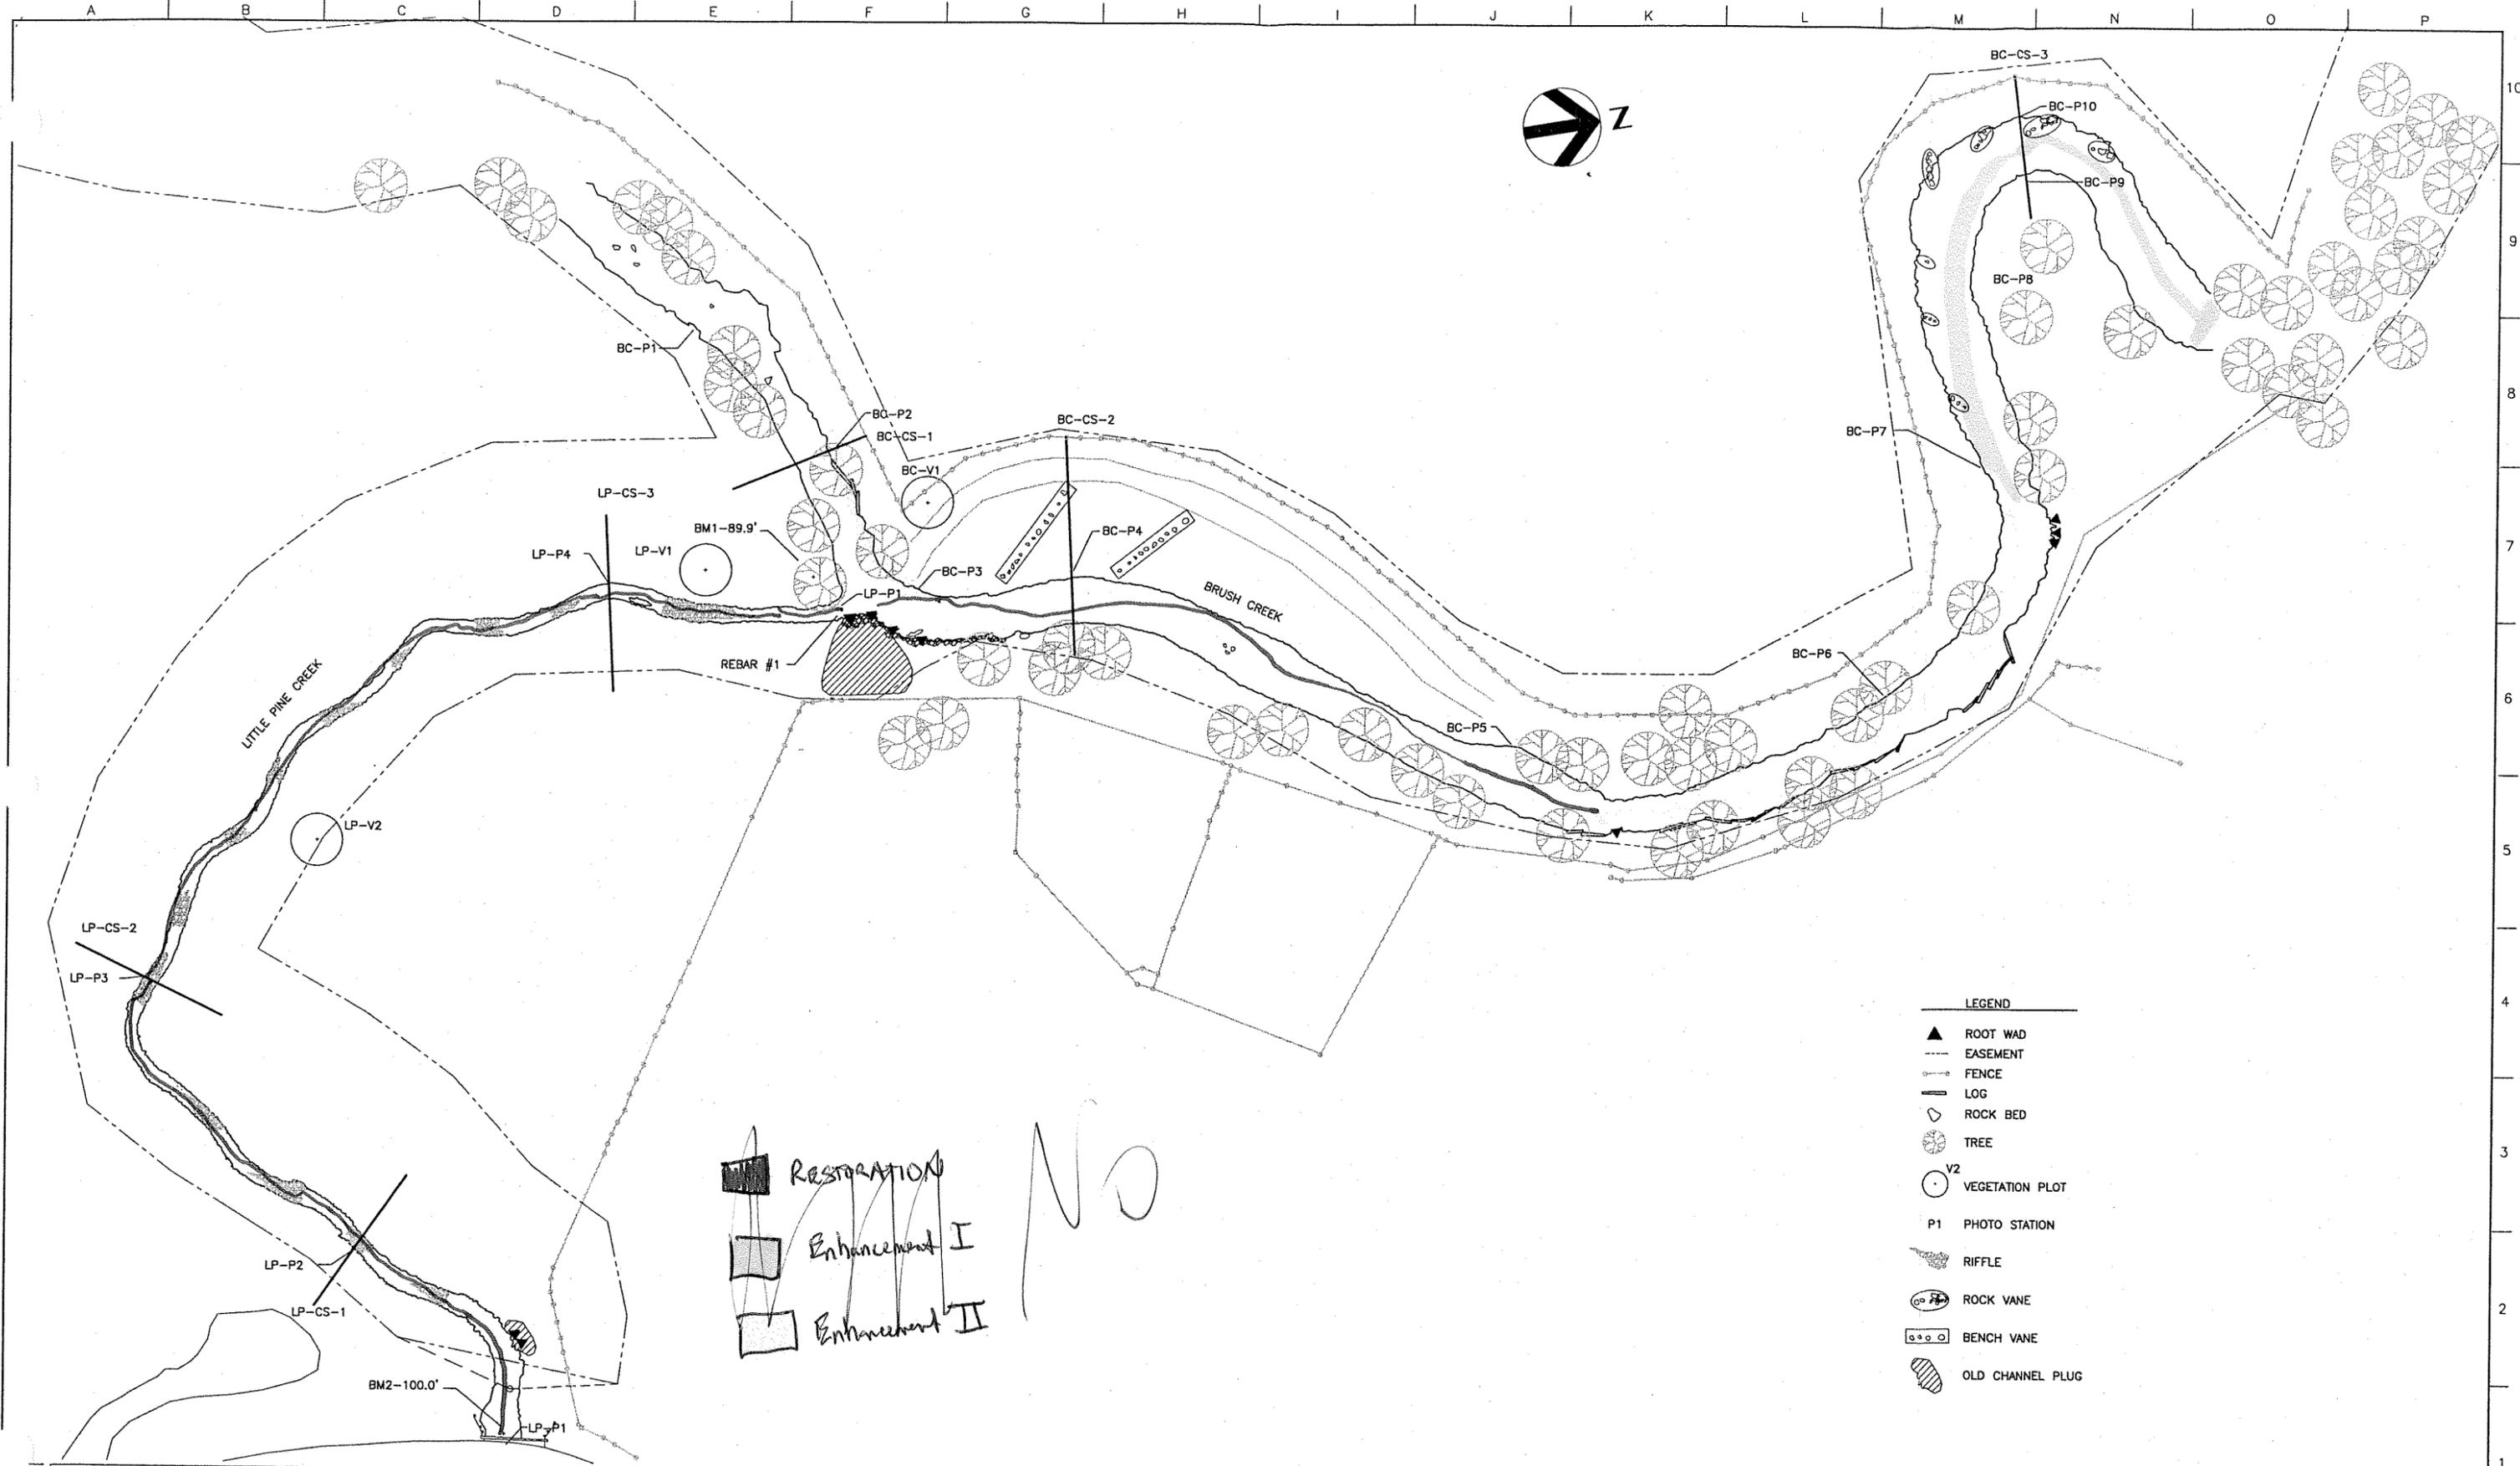
**MONITORING LOCATIONS  
 LITTLE PINE CREEK AND  
 BRUSH CREEK**

Permanent cross-sections were established, at one per 20 bankfull-width lengths, along the stream corridors of the restoration site. Little Pine Creek and Brush Creek each have three established cross-sections, as shown in Figure 2.

All cross-section locations are shown on Figure 2.

Photograph points were established at all cross-section locations and at distinguishing points, including all instream structures, along Little Pine Creek and Brush Creek. Each photograph point was established and either marked with a wooden stake or referenced by cross-section or stream feature (e.g., rock vane). All photograph points are labeled on Figure 2.

Vegetation survival inside the riparian buffer will be documented through evaluation at three pre-established plot areas, as shown on Figure 2, and through photograph documentation of the length of the corridor in which buffers were planted. Documentation will occur at the pre-established plot areas. Vegetation survival of target dominant species will be confirmed. The Brush Creek plot is to be located atop the bankfull bench into the riparian buffer.

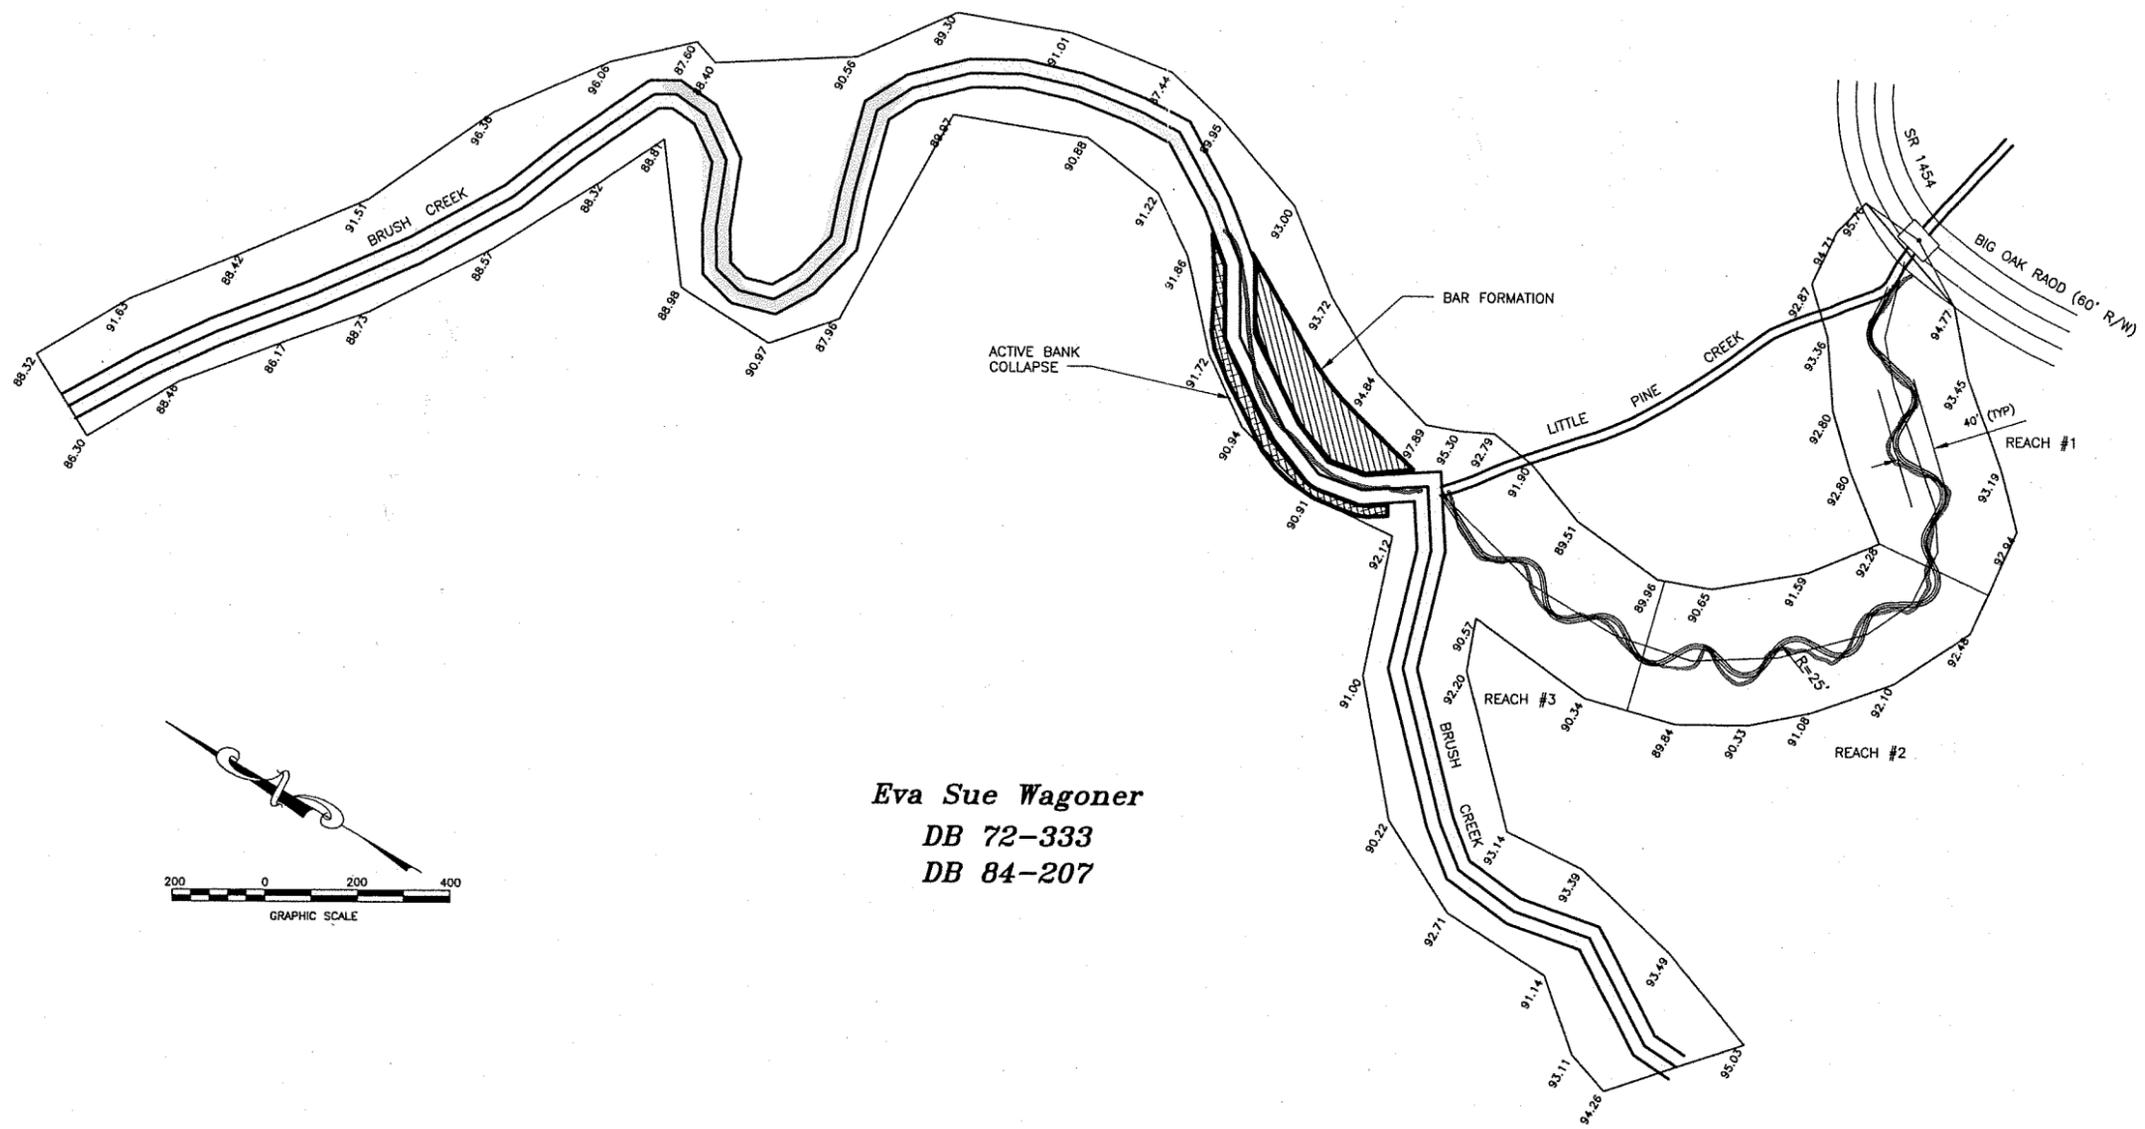
**OVERALL EASEMENTS  
LITTLE PINE CREEK AND  
BRUSH CREEK**

In response to landowner desires to restore Little Pine Creek and Brush Creek to a condition of natural stability, restoration of these streams occurred from April to July 2001, as shown in Figures 2 and 3. Riparian planting was completed in January 2002. Approximately 600 linear feet of altered Little Pine Creek channel were replaced with a new, 950-linear foot meandering channel reconnected to the flood plain and designed to maintain stable dimension, pattern, and profile while effectively transporting anticipated streamflow and sediment load. A vegetated riparian corridor was established along Little Pine Creek in order to improve water quality and increase aquatic and terrestrial habitat resources. In addition, 340 linear feet of Brush Creek were stabilized to eliminate existing severe bank collapse problems. Another 2,300 feet of degraded Brush Creek riparian corridor were enhanced in an effort to stabilize unstable banks, increase instream aquatic habitat, and improve the riparian buffer.

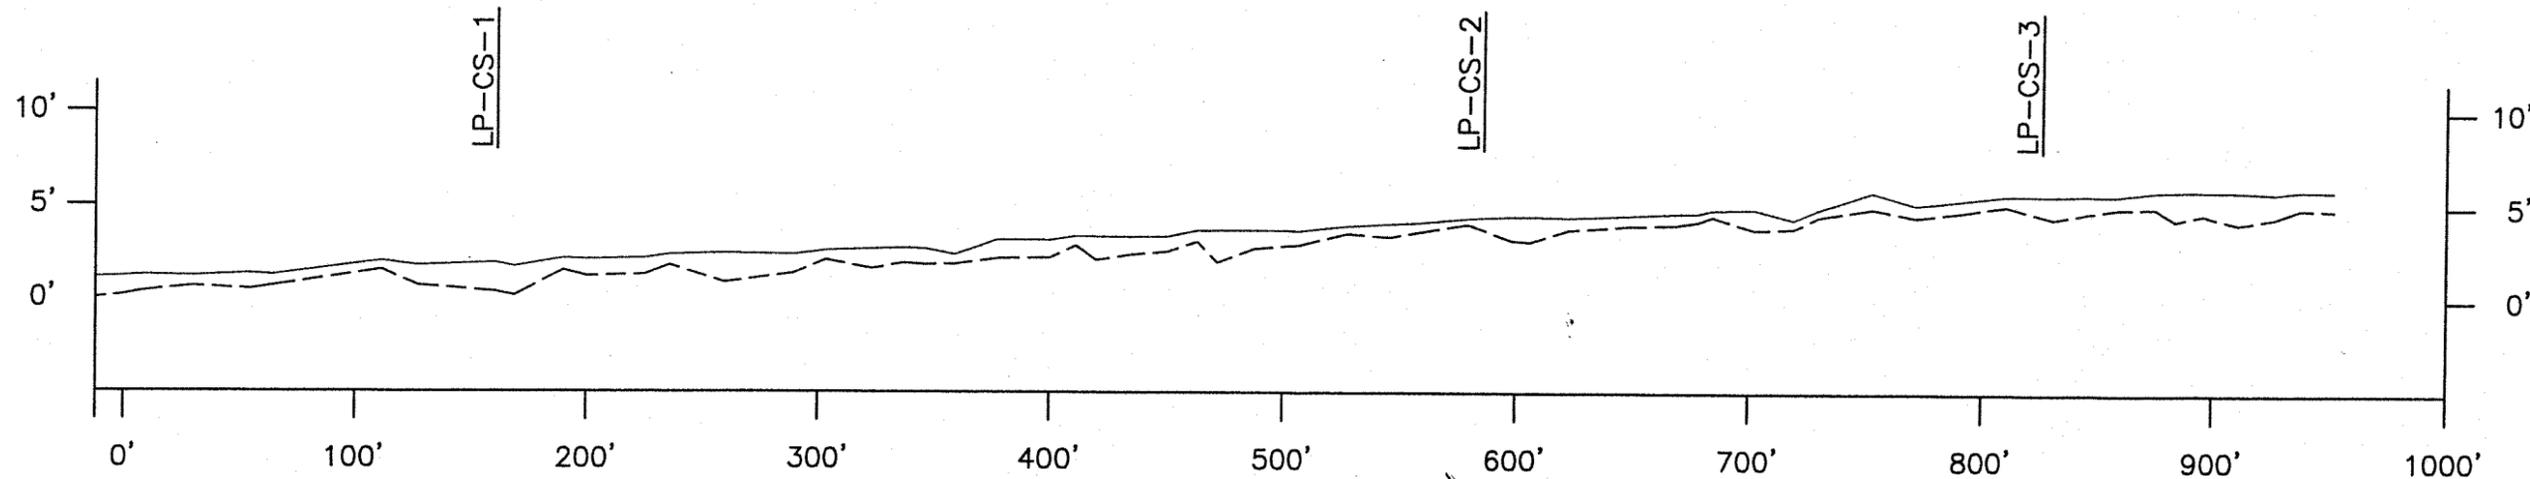
## **LONGITUDINAL PROFILE**

Slope and Maximum Water Depth - Little Pine Creek Alleghany County, North Carolina		
Feature	Slope	Max. H2O depth (ft)
Riffle 1	0.0030	0.86
Riffle 2	0.0176	0.65
Riffle 3	0.0194	0.48
Riffle 4	0.0459	0.45
Riffle 5	0.0207	0.50
Riffle 6	0.0288	0.75
Riffle 7	0.0425	0.80
Riffle 8	0.0587	0.92
Riffle 9	0.0032	0.84
Riffle 10	0.0518	1.00
Riffle 11	0.0472	0.88
Riffle 12	0.0634	1.54
Riffle 13	0.0184	0.58
Riffle 14	0.0123	0.90
<b>Average Riffle</b>	<b>0.0309</b>	
Pool 1	-0.0008	1.72
Pool 2	-0.0025	1.22
Pool 3	-0.0045	0.86
Pool 4	0.0002	1.10
Pool 5	-0.0067	1.34
Pool 6	-0.0036	1.72
Pool 7	-0.0082	1.25
Pool 8	0.0085	1.00
Pool 9	-0.0058	1.05
Pool 10	-0.0080	1.56
Pool 11	-0.0065	0.90
Pool 12	-0.0238	1.54
Pool 13	0.0006	0.85
<b>Average Pool</b>	<b>-0.0047</b>	
Run 1	-0.0057	1.00
Run 2	0.0063	0.65
Run 3	0.0029	0.70
<b>Average Run</b>	<b>0.0012</b>	
<b>Average Slope</b>	<b>0.0125</b>

Calculations based on these measurements include average slope and slopes of the pools and riffles. The longitudinal profile for Little Pine Creek is in Appendix A, while the longitudinal profile for Brush Creek is in Appendix B.

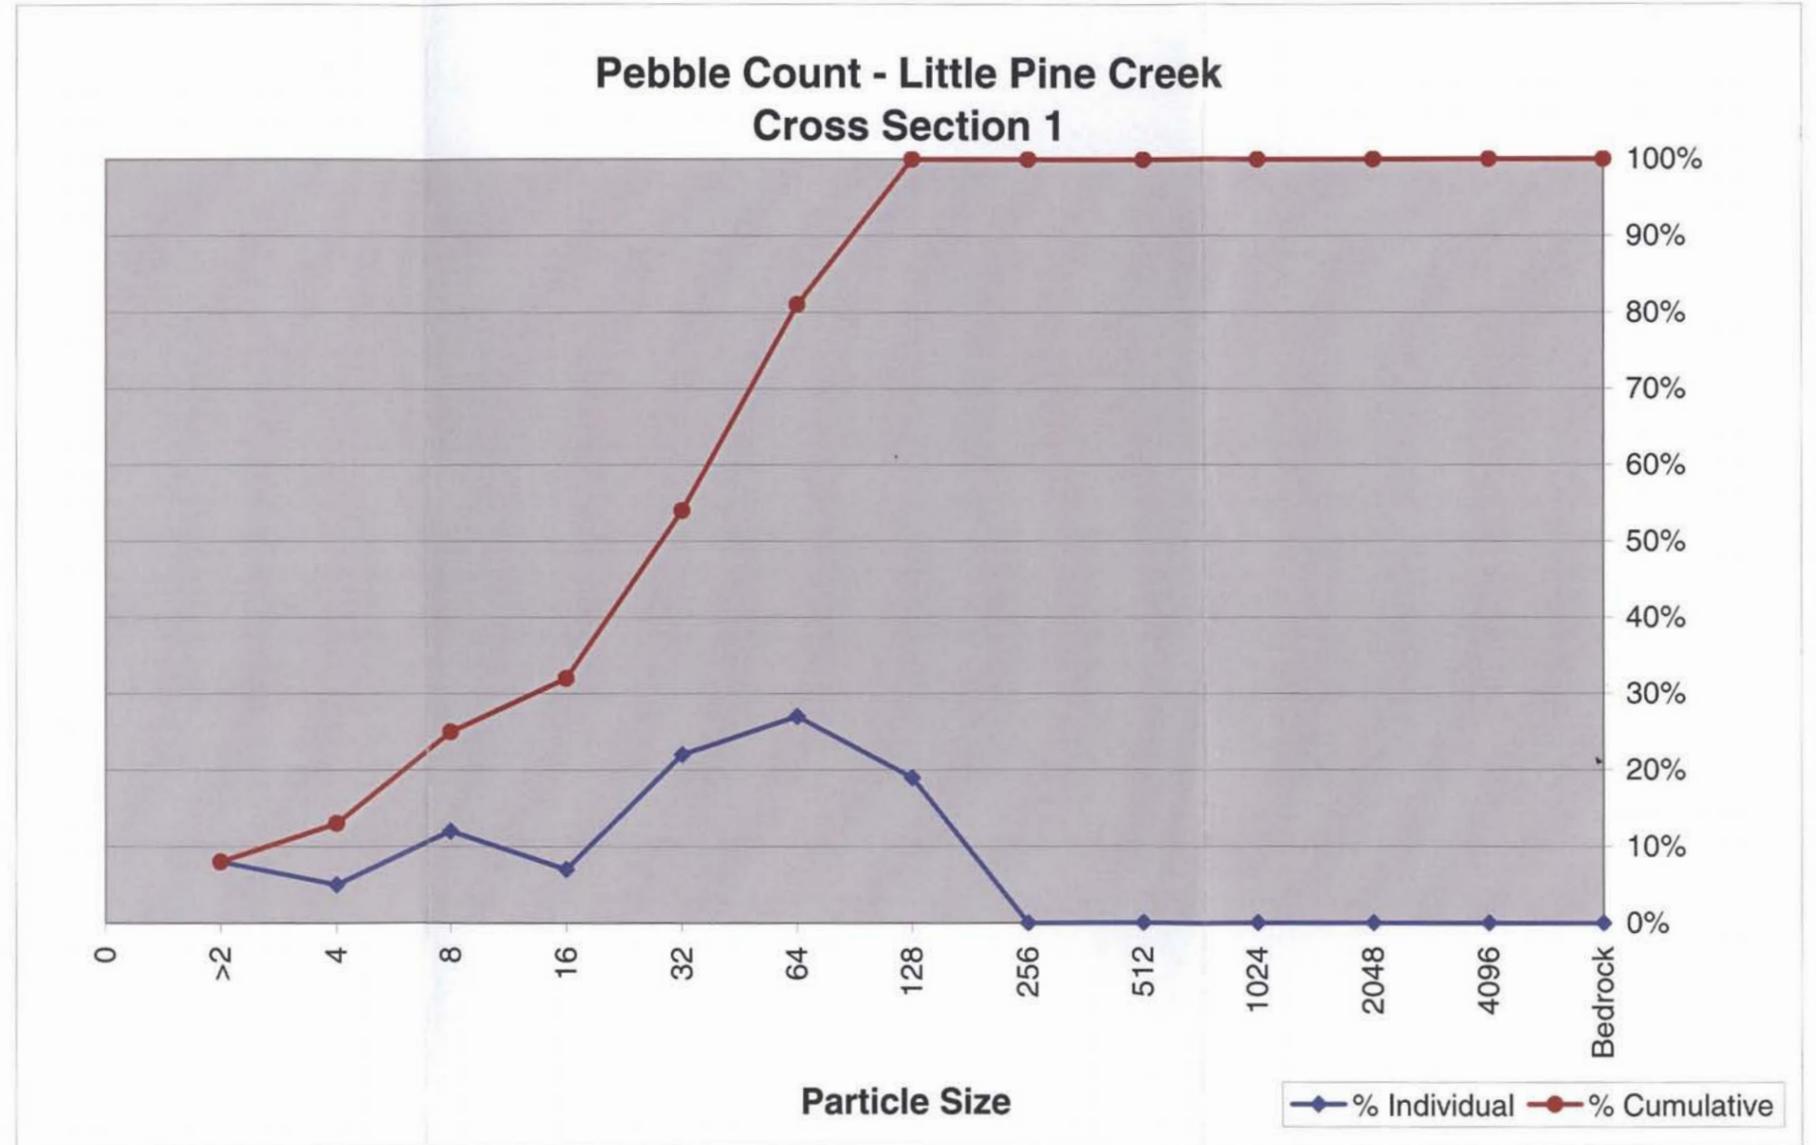
Little Pine Creek Cross Section 1			
Bed Surface Material Particle Size Class (mm)	Number	% Individual	% Cumulative
<2	8	8.0%	8%
2-4	5	5.0%	13%
4-8	12	12.0%	25%
8-16	7	7.0%	32%
16-32	22	22.0%	54%
32-64	27	27.0%	81%
64-128	19	19.0%	100%
128-256		0.0%	100%
256-512		0.0%	100%
512-1024		0.0%	100%
1024-2048		0.0%	100%
2048-4096		0.0%	100%
Bedrock		0.0%	100%
<b>Total</b>	<b>100</b>	<b>100%</b>	<b>100%</b>

d50 = 29.1 mm, d85 = 77.5 mm

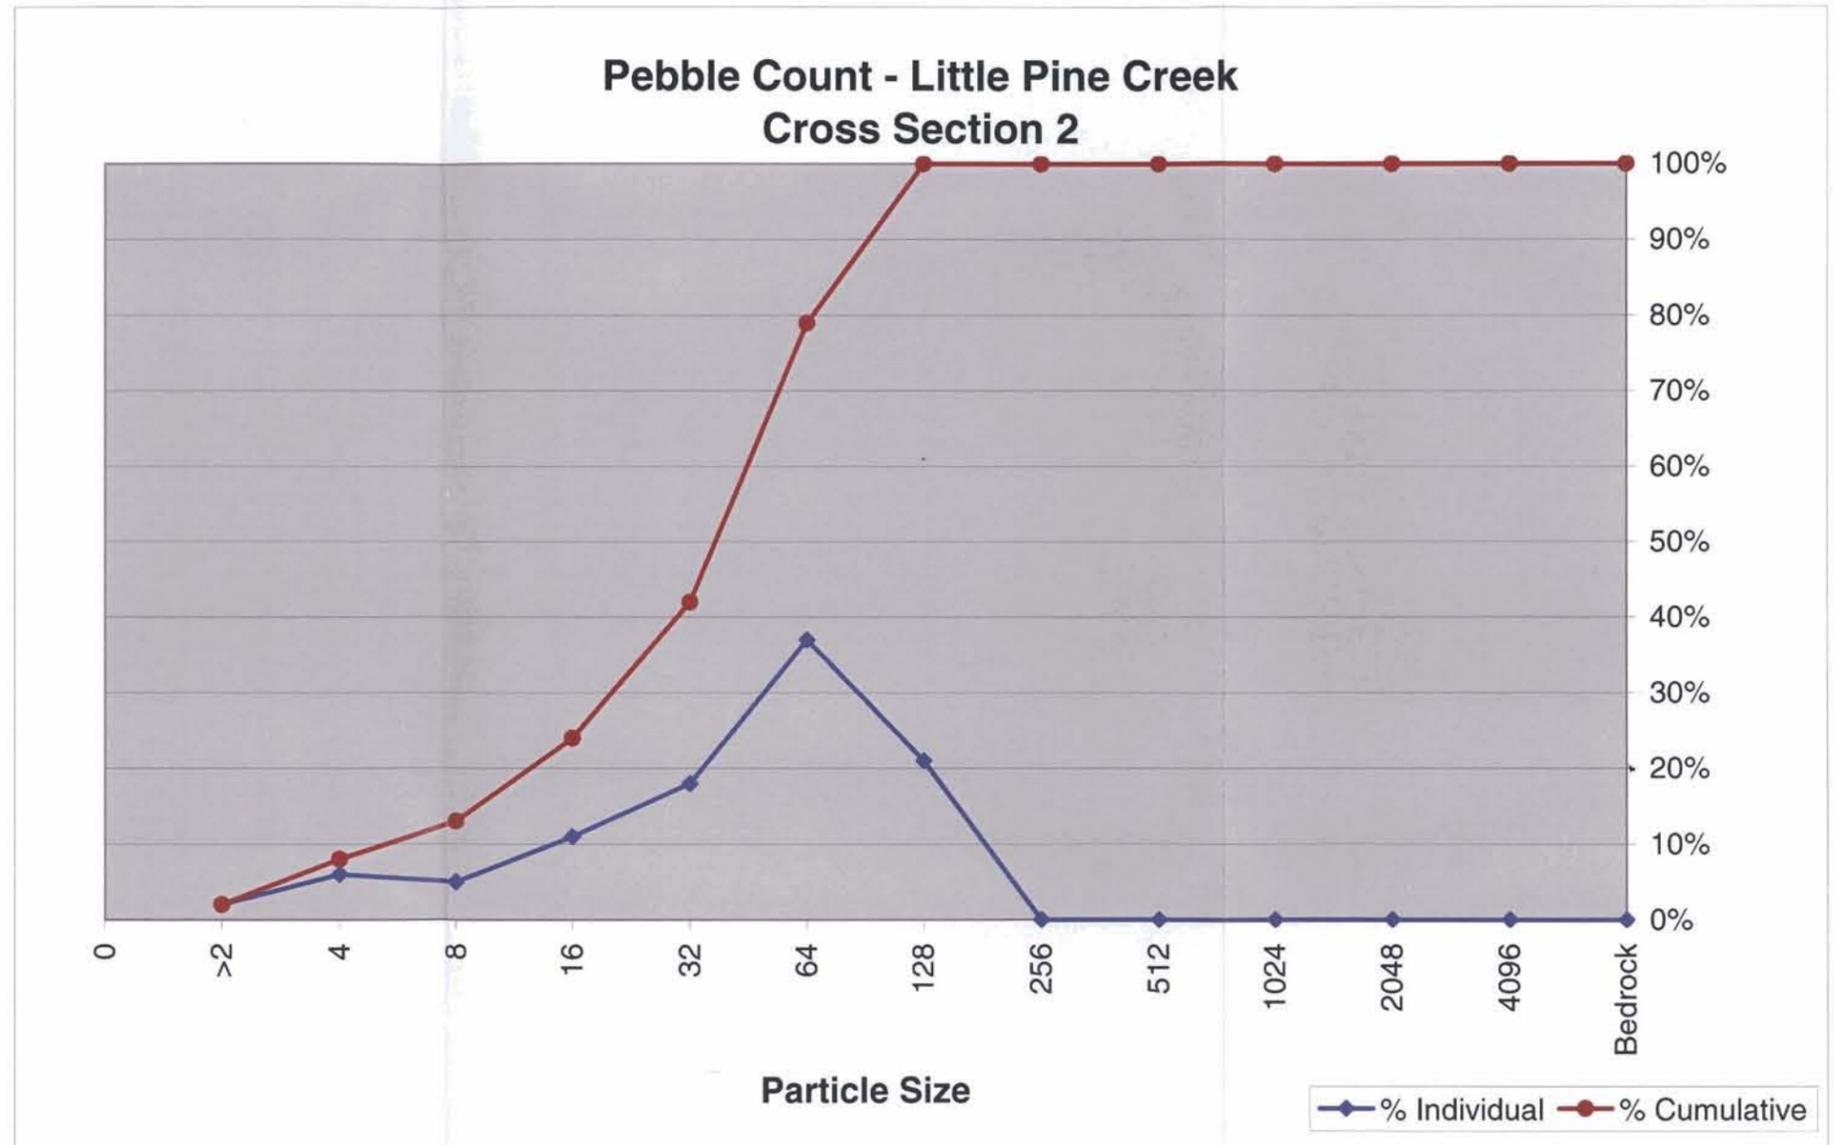
Little Pine Creek Cross Section 2			
Bed Surface Material Particle Size Class (mm)	Number	% Individual	% Cumulative
<2	2	2.0%	2%
2-4	6	6.0%	8%
4-8	5	5.0%	13%
8-16	11	11.0%	24%
16-32	18	18.0%	42%
32-64	37	37.0%	79%
64-128	21	21.0%	100%
128-256		0.0%	100%
256-512		0.0%	100%
512-1024		0.0%	100%
1024-2048		0.0%	100%
2048-4096		0.0%	100%
Bedrock		0.0%	100%
<b>Total</b>	<b>100</b>	<b>100%</b>	<b>100%</b>

d50 = 38.9 mm, d85 = 82.3 mm

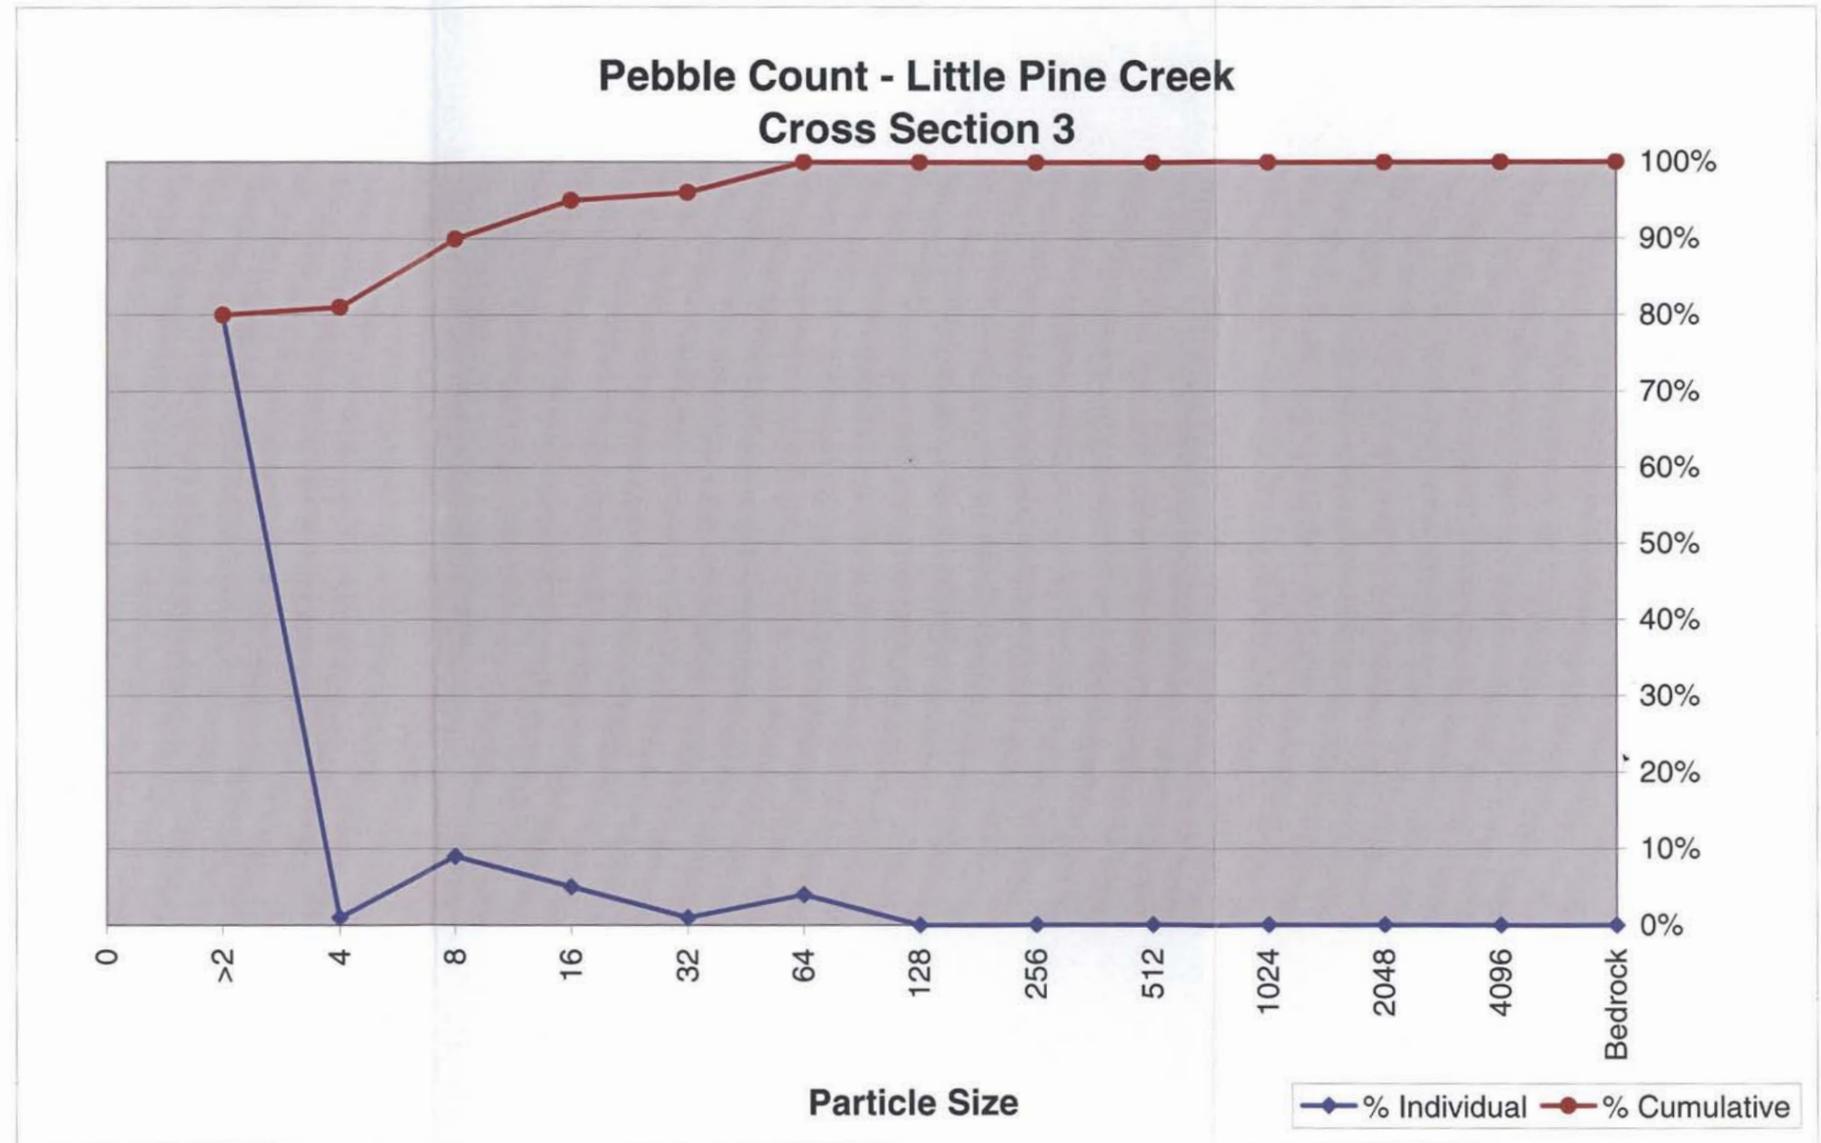
Little Pine Creek Cross Section 3			
Bed Surface Material Particle Size Class (mm)	Number	% Individual	% Cumulative
<2	80	80.0%	80%
2-4	1	1.0%	81%
4-8	9	9.0%	90%
8-16	5	5.0%	95%
16-32	1	1.0%	96%
32-64	4	4.0%	100%
64-128		0.0%	100%
128-256		0.0%	100%
256-512		0.0%	100%
512-1024		0.0%	100%
1024-2048		0.0%	100%
2048-4096		0.0%	100%
Bedrock		0.0%	100%
<b>Total</b>	<b>100</b>	<b>100%</b>	<b>100%</b>

d50 < 2 mm, d85 = 5.8 mm

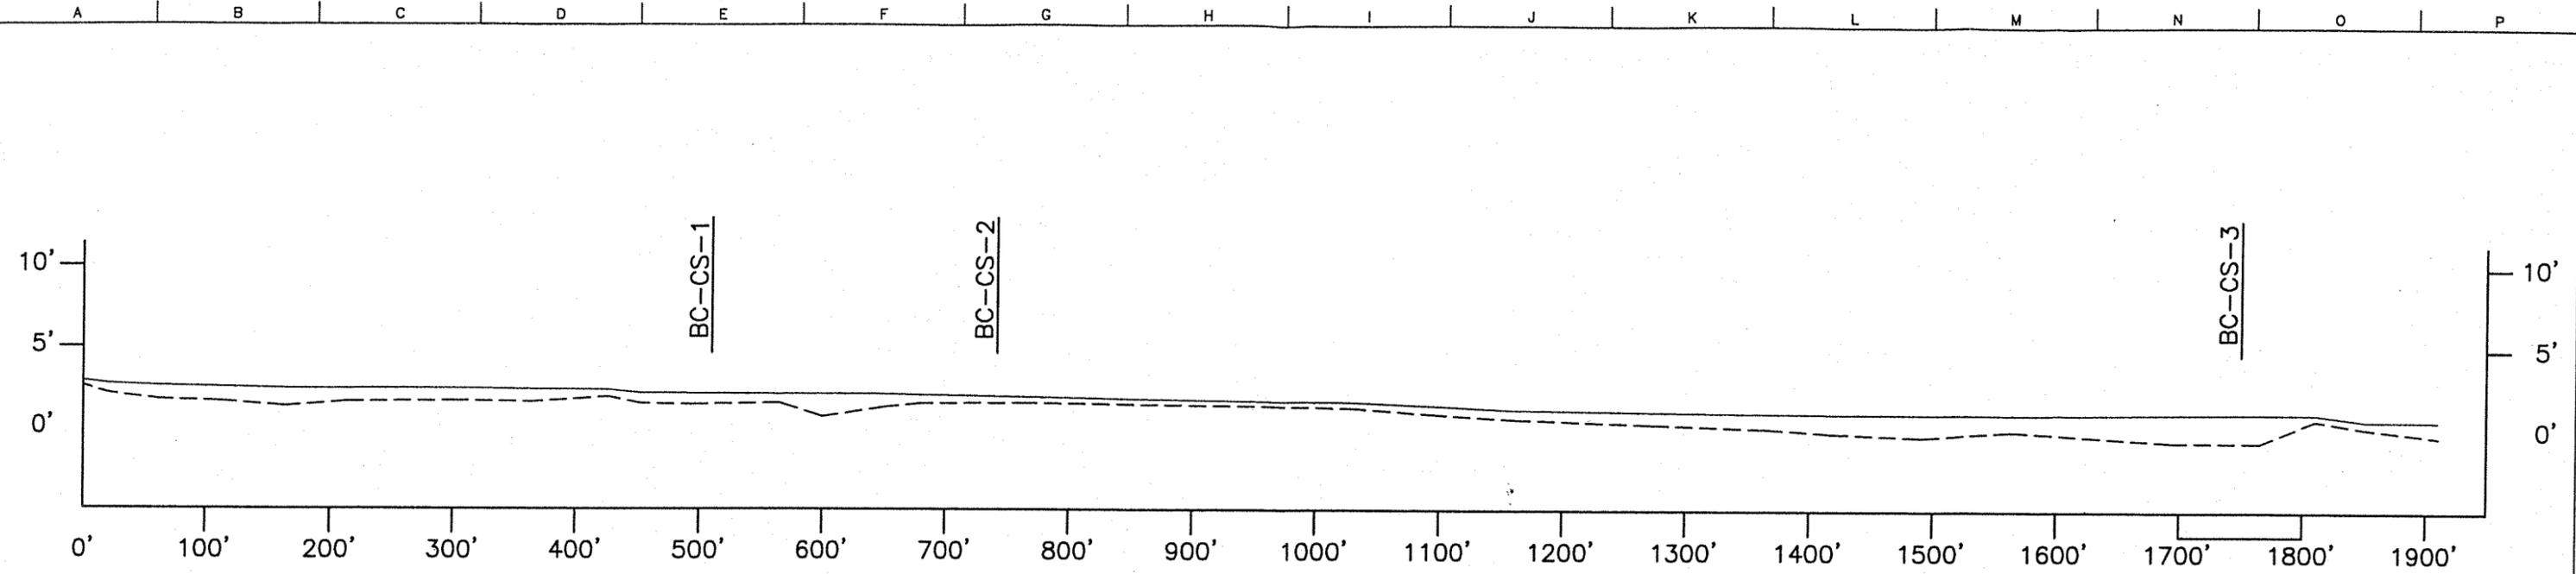
## **LONGITUDINAL PROFILE**

Slope and Maximum Water Depth - Brush Creek Alleghany County, North Carolina		
Feature	Slope	Max. H2O depth (ft)
Riffle 1	0.0380	0.96
Riffle 2	0.0256	1.05
Riffle 3	0.0024	0.85
Riffle 4	0.0203	0.75
<b>Average Riffle</b>	<b>0.0216</b>	
Pool 1	0.0007	1.80
Pool 2	-0.0001	2.30
Pool 3	-0.0022	2.90
Pool 4	0.0143	1.60
<b>Average Pool</b>	<b>0.0032</b>	
Run 1	0.0042	1.50
<b>Average Slope</b>	<b>0.0115</b>

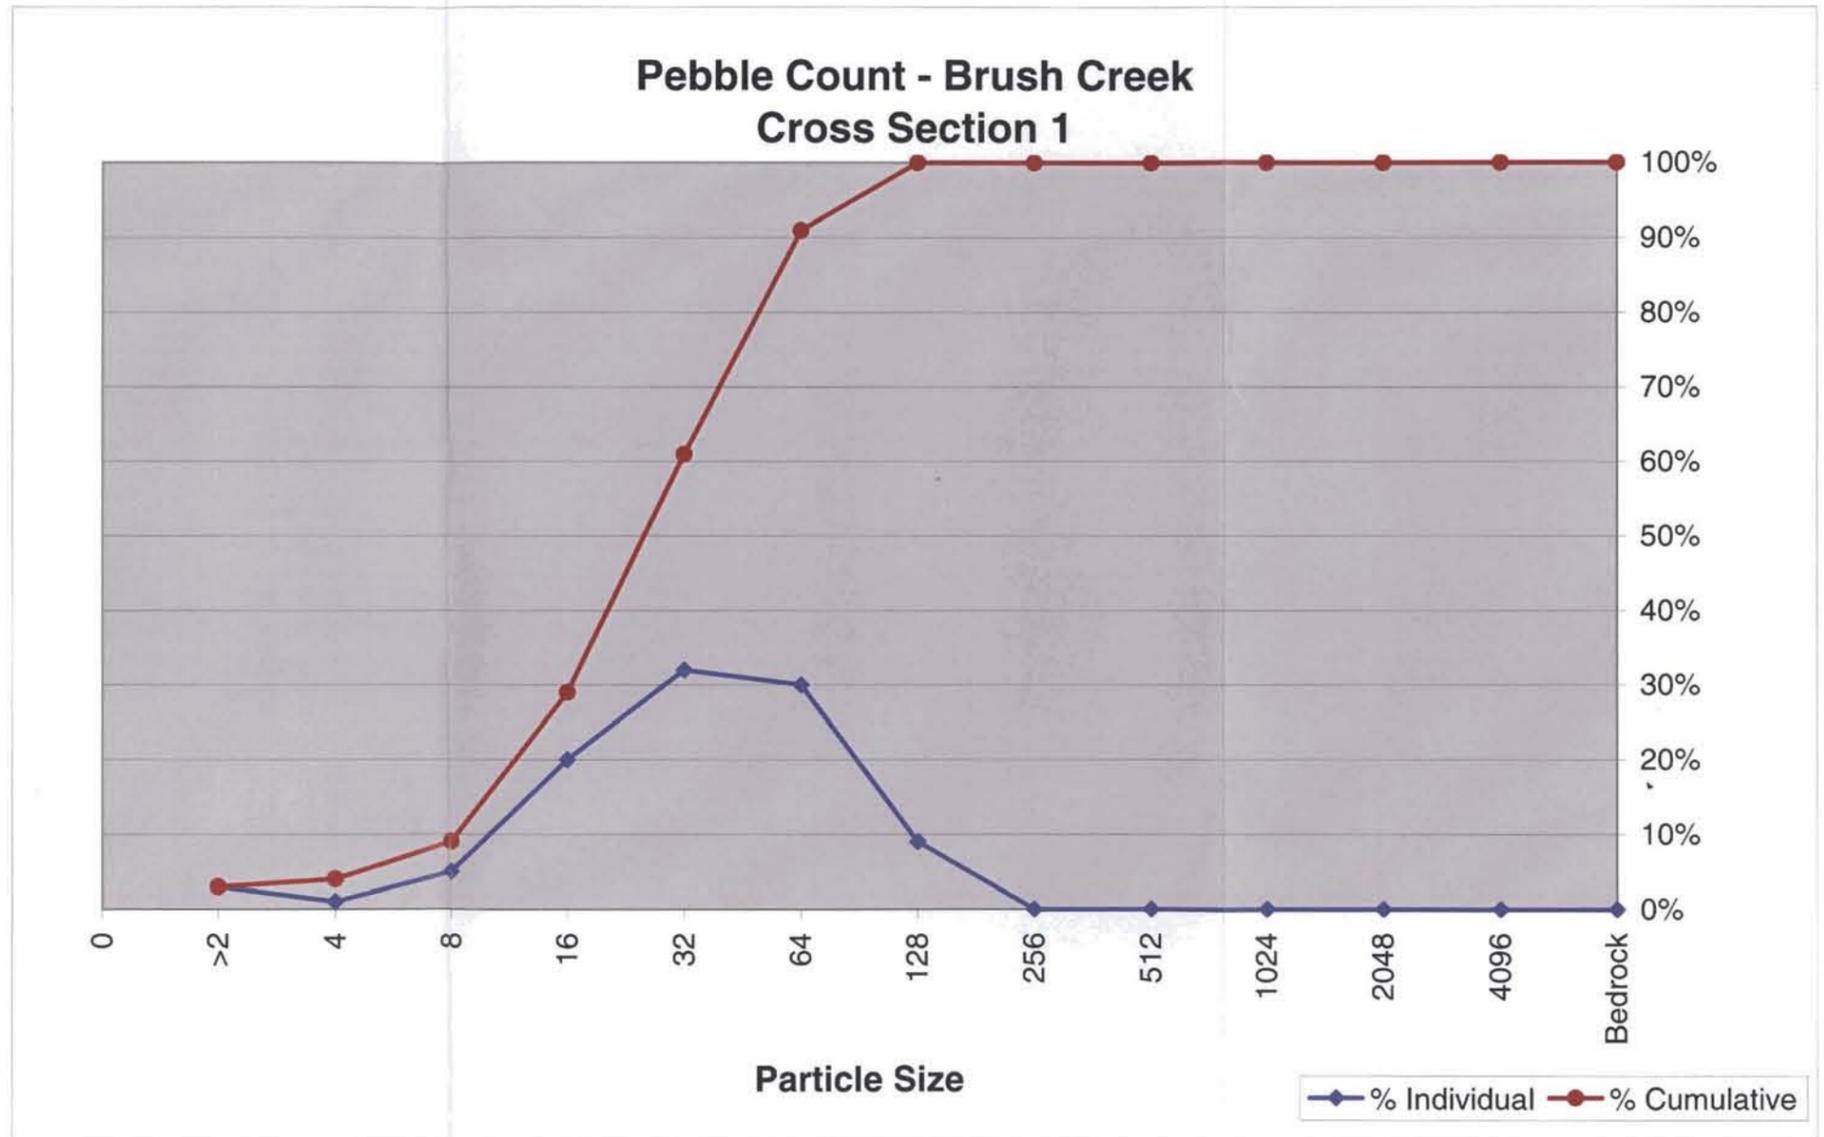
Brush Creek			
Cross Section 1			
Bed Surface Material Particle Size Class (mm)	Number	% Individual	% Cumulative
<2	3	3.0%	3%
2-4	1	1.0%	4%
4-8	5	5.0%	9%
8-16	20	20.0%	29%
16-32	32	32.0%	61%
32-64	30	30.0%	91%
64-128	9	9.0%	100%
128-256		0.0%	100%
256-512		0.0%	100%
512-1024		0.0%	100%
1024-2048		0.0%	100%
2048-4096		0.0%	100%
Bedrock		0.0%	100%
<b>Total</b>	<b>100</b>	<b>100%</b>	<b>100%</b>

d50 = 26.5 mm, d85 = 57.6 mm
