**LITTLE PINE – BRUSH CREEK  
AS-BUILT REPORT (MY0)**

**HDR ENGINEERING**

**JUNE 2002**

**Little Pine Creek/Brush Creek  
Monitoring Methodology Report  
Alleghany County, North Carolina  
HDR Project No. 09177-010-018**

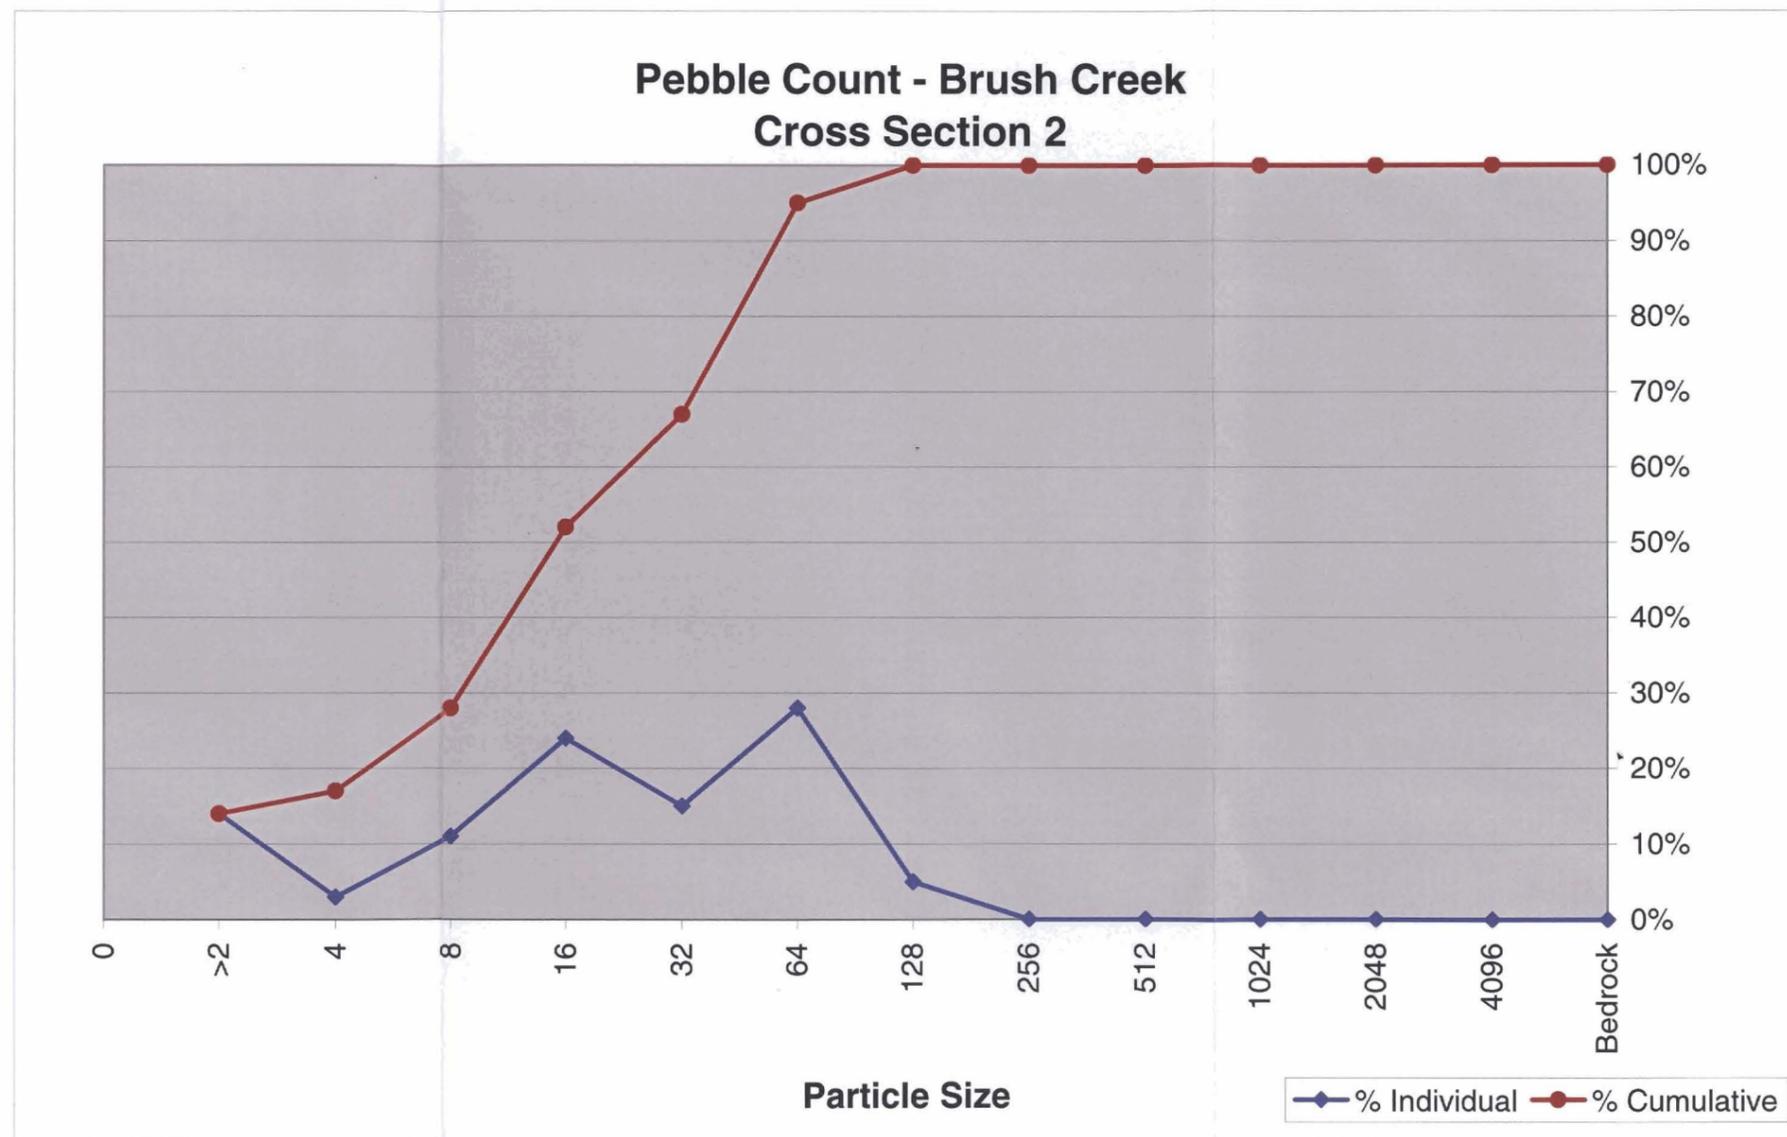
Brush Creek			
Cross Section 2			
Bed Surface Material Particle Size Class (mm)	Number	% Individual	% Cumulative
<2	14	14.0%	14%
2-4	3	3.0%	17%
4-8	11	11.0%	28%
8-16	24	24.0%	52%
16-32	15	15.0%	67%
32-64	28	28.0%	95%
64-128	5	5.0%	100%
128-256		0.0%	100%
256-512		0.0%	100%
512-1024		0.0%	100%
1024-2048		0.0%	100%
2048-4096		0.0%	100%
Bedrock		0.0%	100%
<b>Total</b>	<b>100</b>	<b>100%</b>	<b>100%</b>
d50 = 15.3 mm, d85 = 52.6 mm

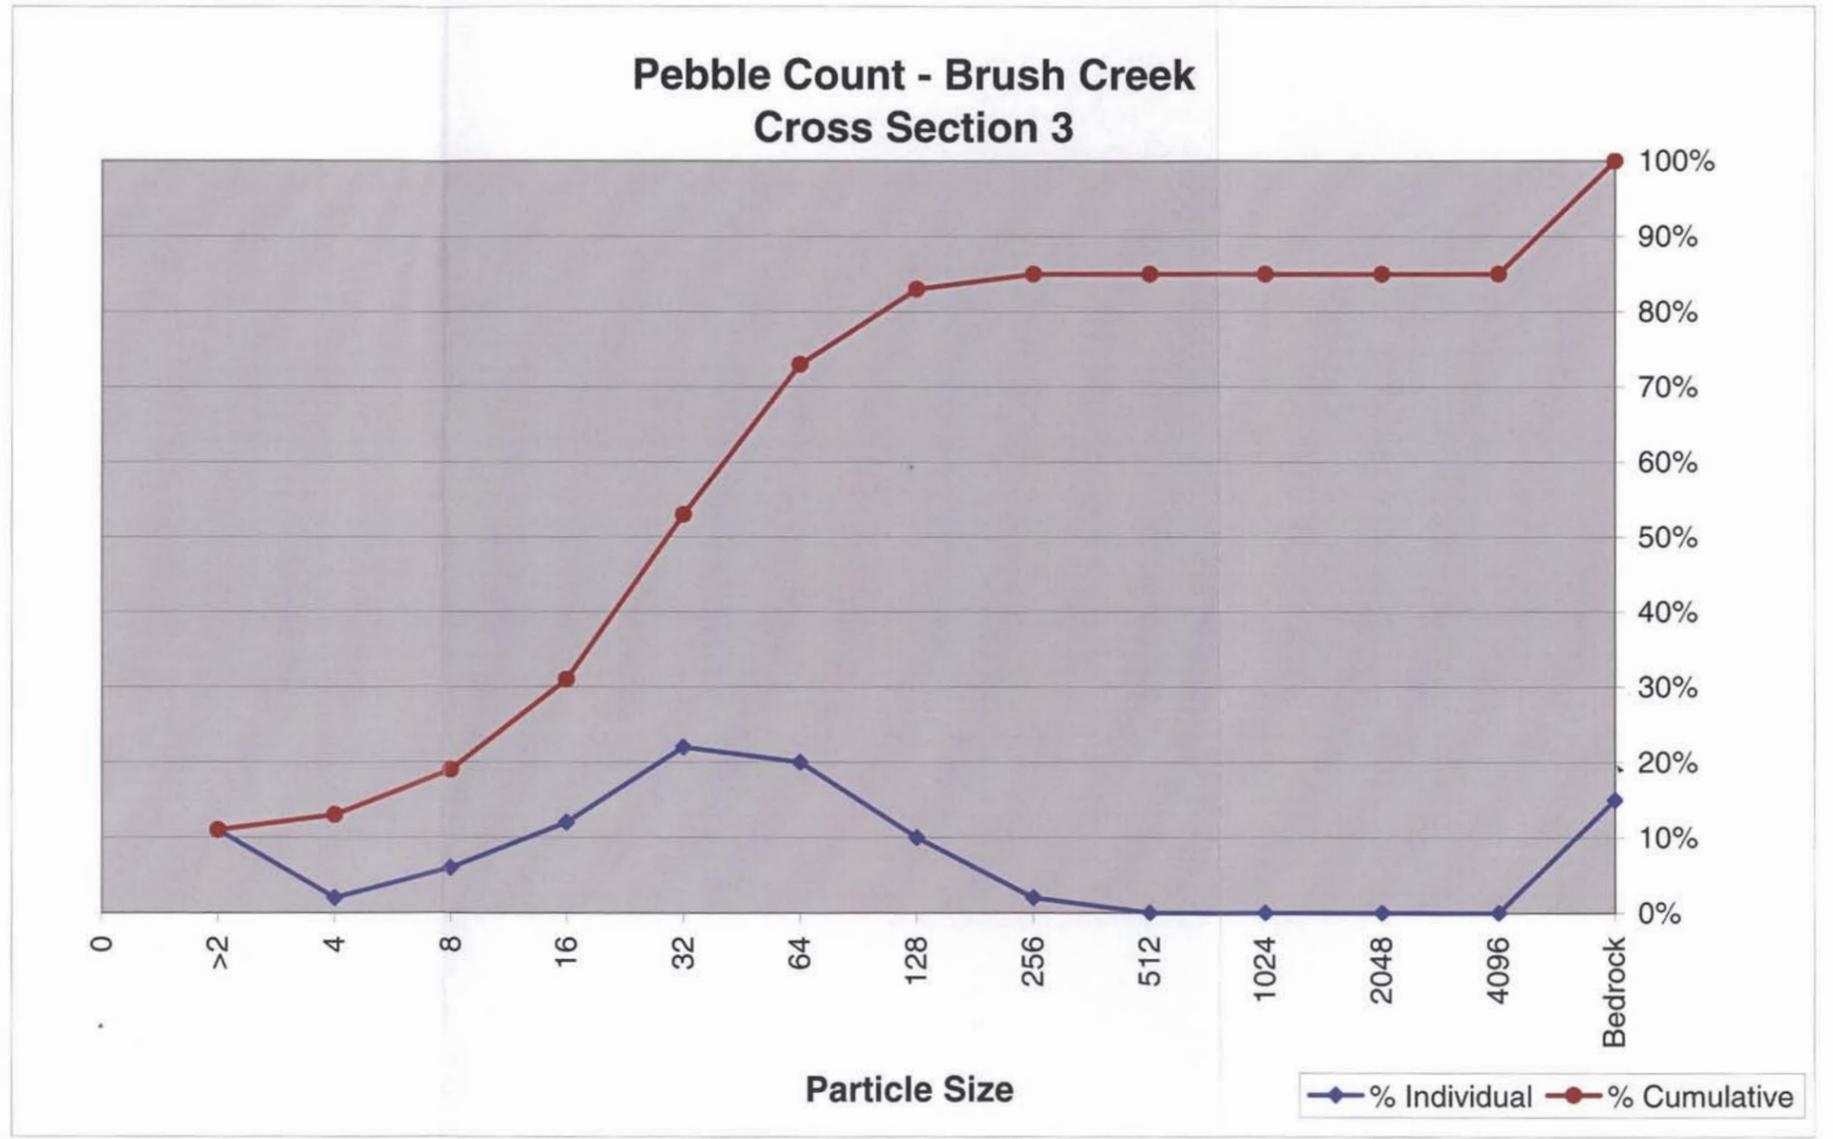
Brush Creek			
Cross Section 3			
Bed Surface Material Particle Size Class (mm)	Number	% Individual	% Cumulative
<2	11	11.0%	11%
2-4	2	2.0%	13%
4-8	6	6.0%	19%
8-16	12	12.0%	31%
16-32	22	22.0%	53%
32-64	20	20.0%	73%
64-128	10	10.0%	83%
128-256	2	2.0%	85%
256-512		0.0%	85%
512-1024		0.0%	85%
1024-2048		0.0%	85%
2048-4096		0.0%	85%
Bedrock	15	15.0%	100%
<b>Total</b>	<b>100</b>	<b>100%</b>	<b>100%</b>

d50 = 29.8 mm, d85 = 192 mm
