Project Closeout Summary—Caviness Site (2009)

<u>Project ID & Status</u>																			
<u>Project Name/Number:</u>	Caviness (Tibbs Run & West Branch)																		
<u>EEP ID :</u>	73																		
<u>County:</u>	Randolph																		
<u>Project Type:</u>	Stream Restoration & Enhancement (DOT Transfer)																		
<u>Current Status:</u>	5 Years of Monitoring complete																		
<u>Project Setting & Classifications</u>	<u>Project Timeline</u>																		
Basin: Deep River of Cape Fear Physiographic Region: Piedmont Drainage: Tibbs Run (3.3 SM) West Branch (1.1 SM) Watershed: Rural Pasture, Imp cover <1% Ecoregion: Carolina Slate Belt USGS Hydro Unit: 03030003 NCDWQ Subbasin: 03-06-09 Thermal Regime: Warm

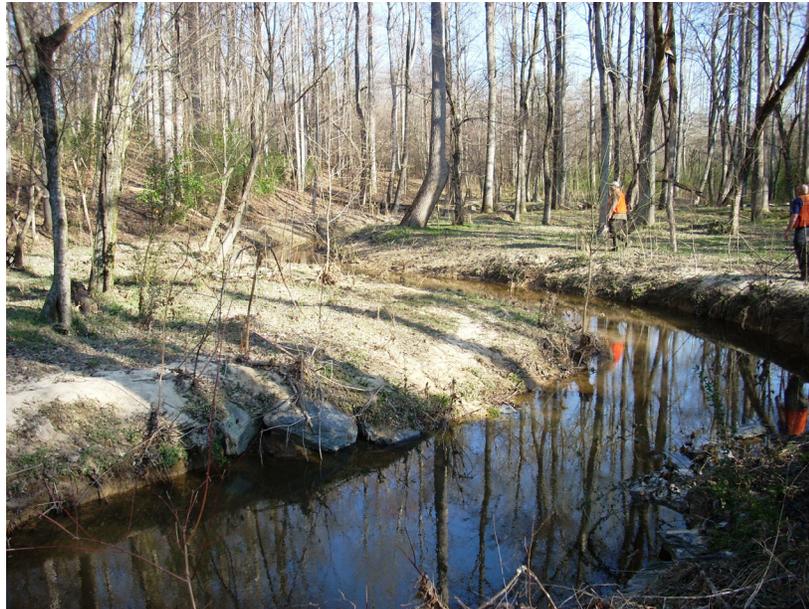
The data record from the monitoring reports of a neighboring site (The Deaton Site) indicate that the surrogate gauge used likely produced 2 events in 2003, 2 in 2005 and 2 between 2006 and 2007 for a total of six possible overbank events. The monitoring firm in 2008 indicated evidence of 2 bankfull events on site in 2008. EEP personnel observed what appear to be fresh alluvium on the upper part of the mainstem early in 2009 and evidence of wrack above the floodplain elevation in the last month. See photos below.

Alluvium—March 2009

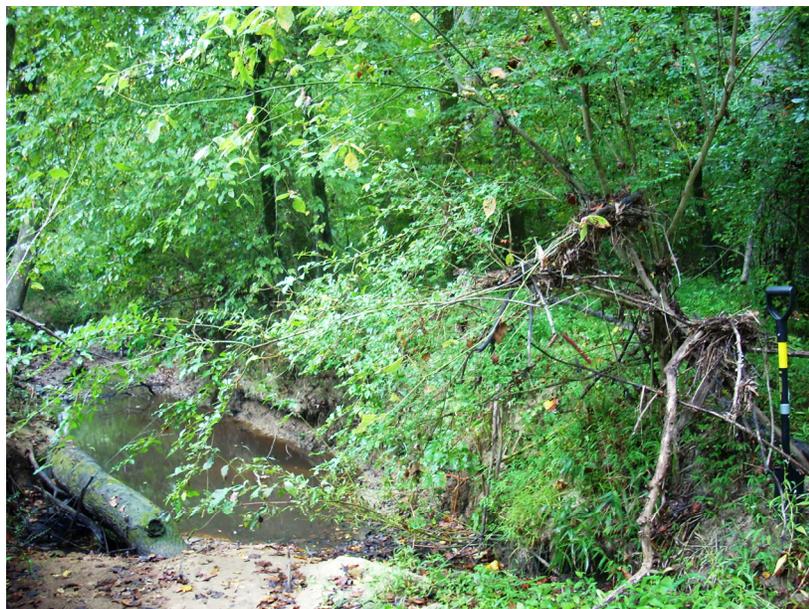
Wrack—September 2009
