WETLAND
MITIGATION PLAN

DUTCHMAN'S CREEK SITE
WAKE COUNTY, NORTH CAROLINA

The North Carolina Department of Transportation
Raleigh, North Carolina

July 1999

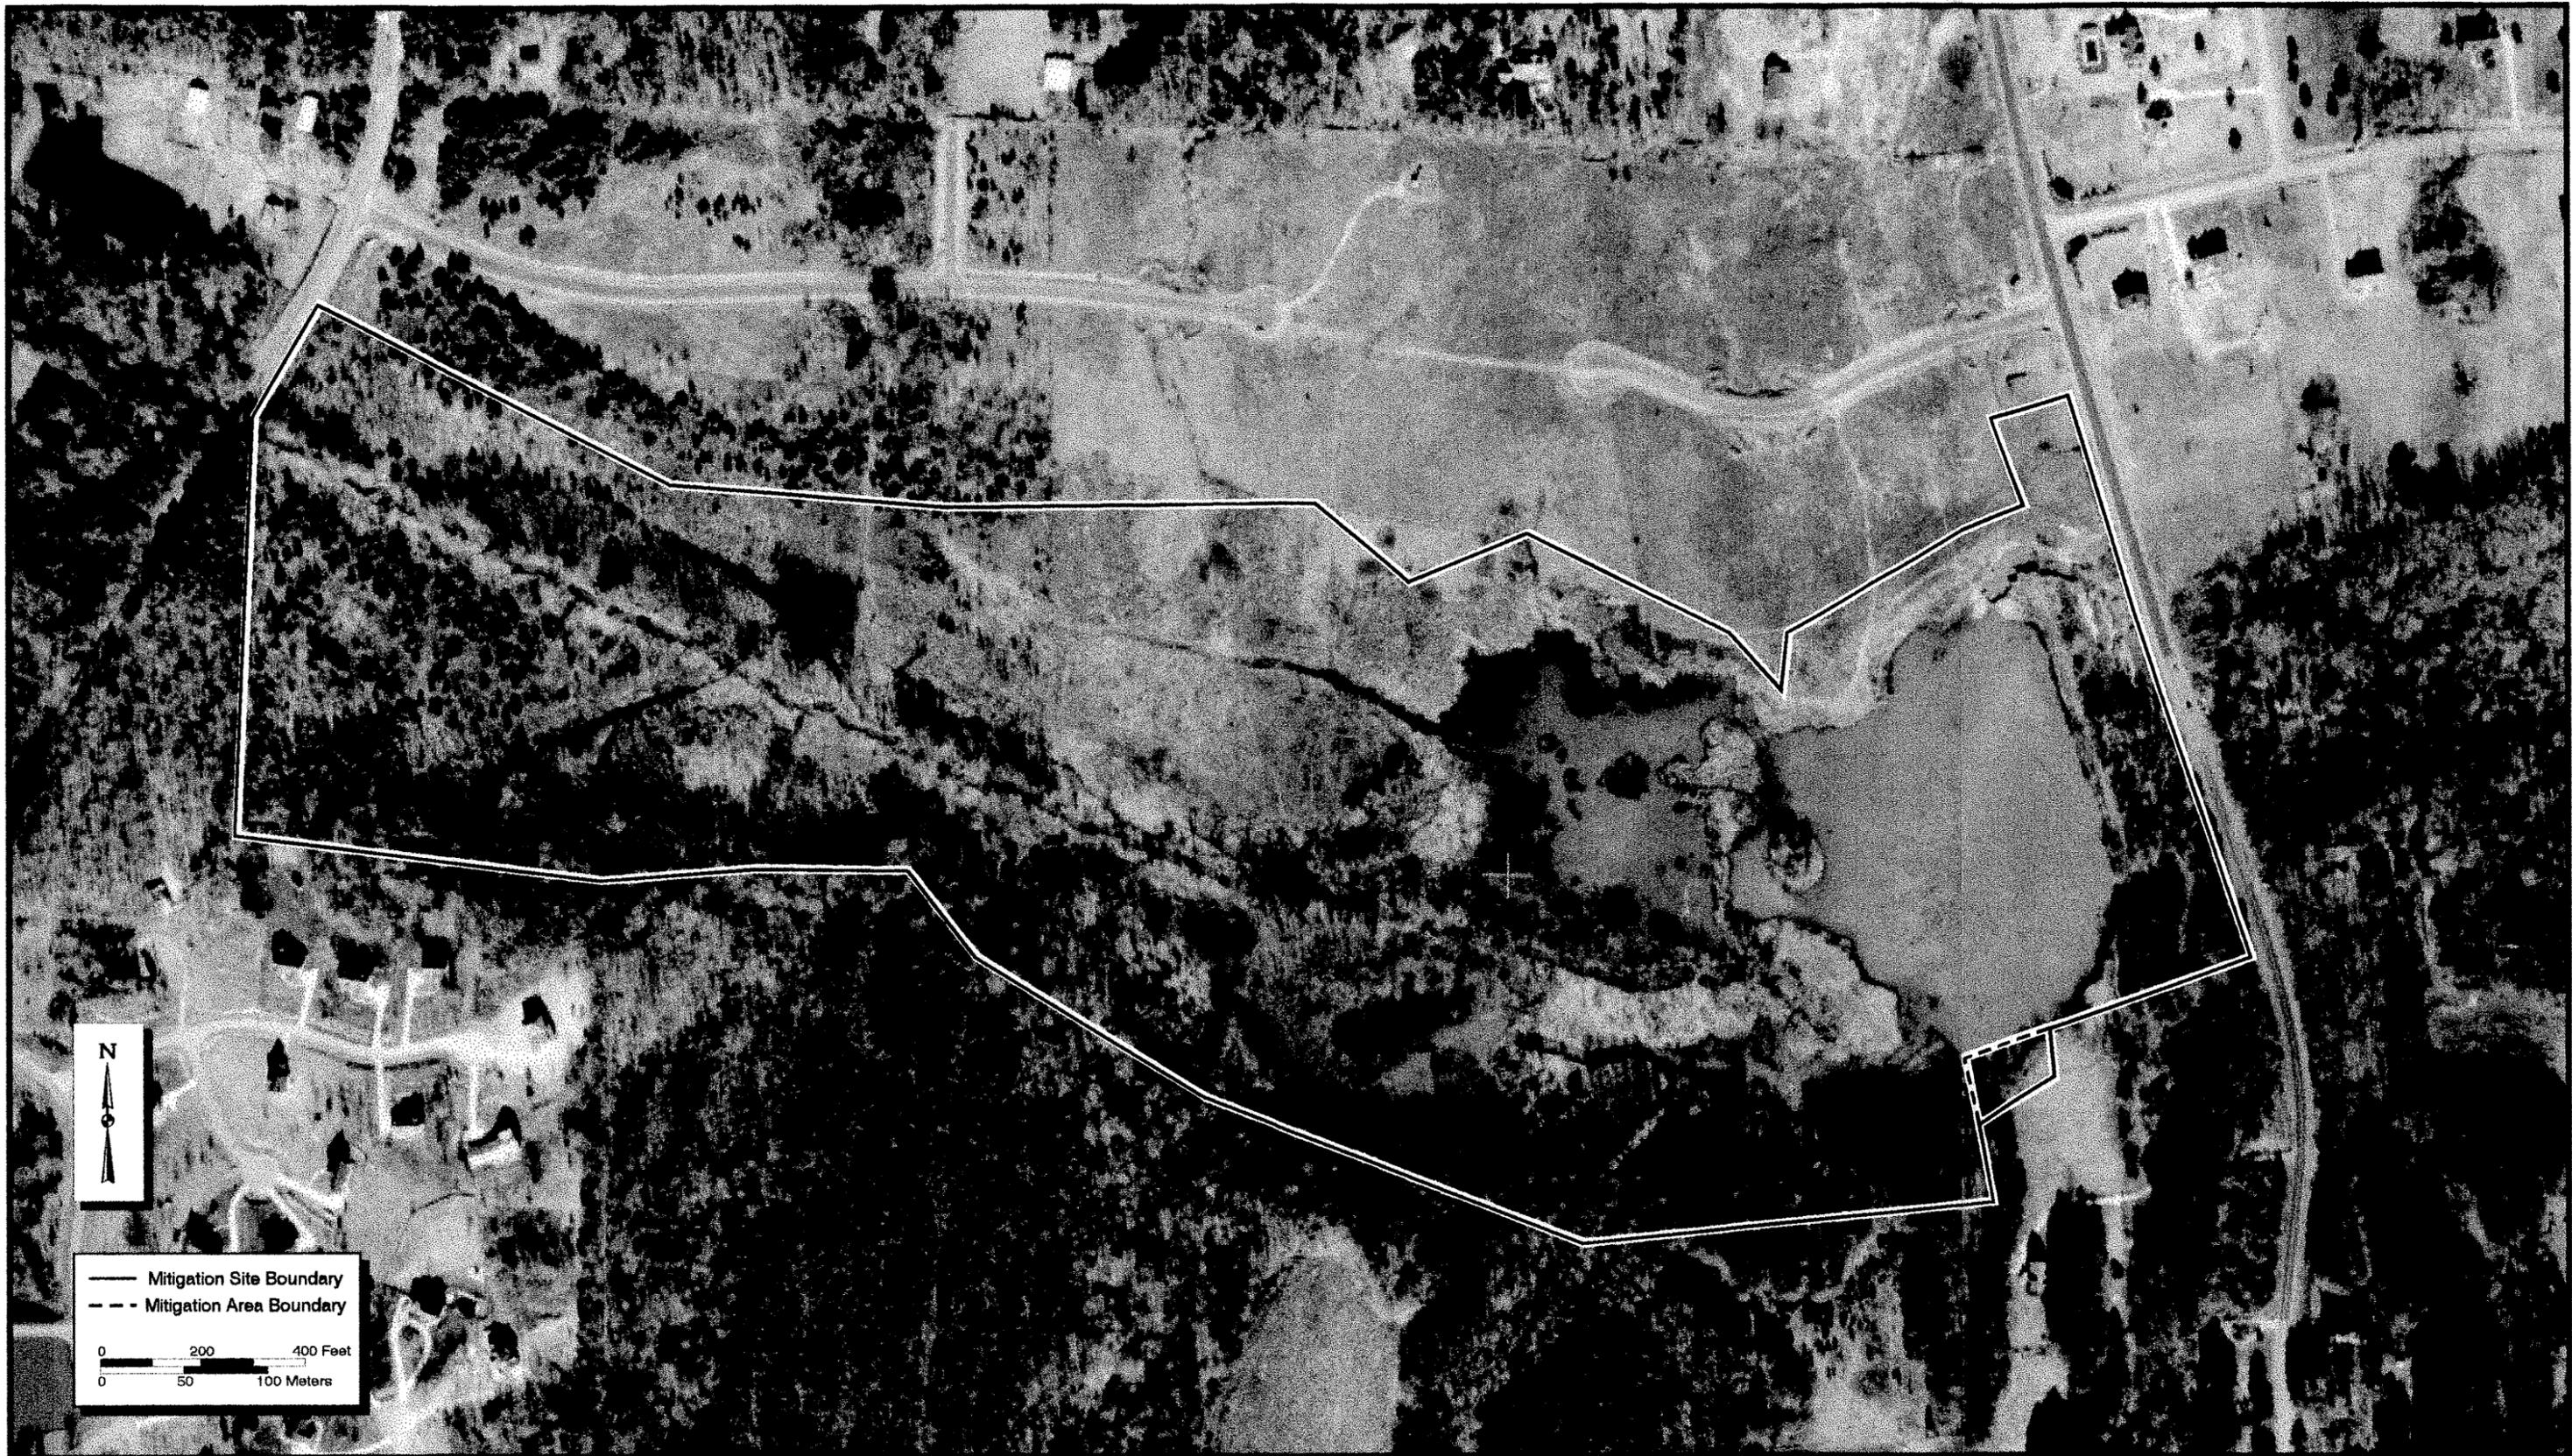
Figure:	2
Project:	ER98006.04
Date:	July 1999

— Mitigation Site Boundary
 - - - Mitigation Area Boundary

Aerial Photograph
 Dutchman's Creek Mitigation Site
 Wake County, North Carolina

The Dutchman's Creek mitigation site encompasses approximately 87 ac containing riverine-influenced wetlands, feeder tributaries, and upland slopes surrounding the Dutchman's Creek stream system (Stream Index: 27-43-4.5 [DEM 1993]). The site is located between SR 1386 (Graham Newton Road) and SR 1377 (Blaney Franks Road) immediately above the confluence with Lake Wheeler, a regional water supply lake (Figure 1). Figure 2 depicts the mitigation site on current (1997) aerial photography.
