ANNUAL REPORT FOR 2004

Grimesland Sand Pit Phase I Site
Pitt County
Project No. 8.T221801
TIP No. R-2510 WM

Office of Natural Environment & Roadside Environmental Unit
North Carolina Department of Transportation
December 2004

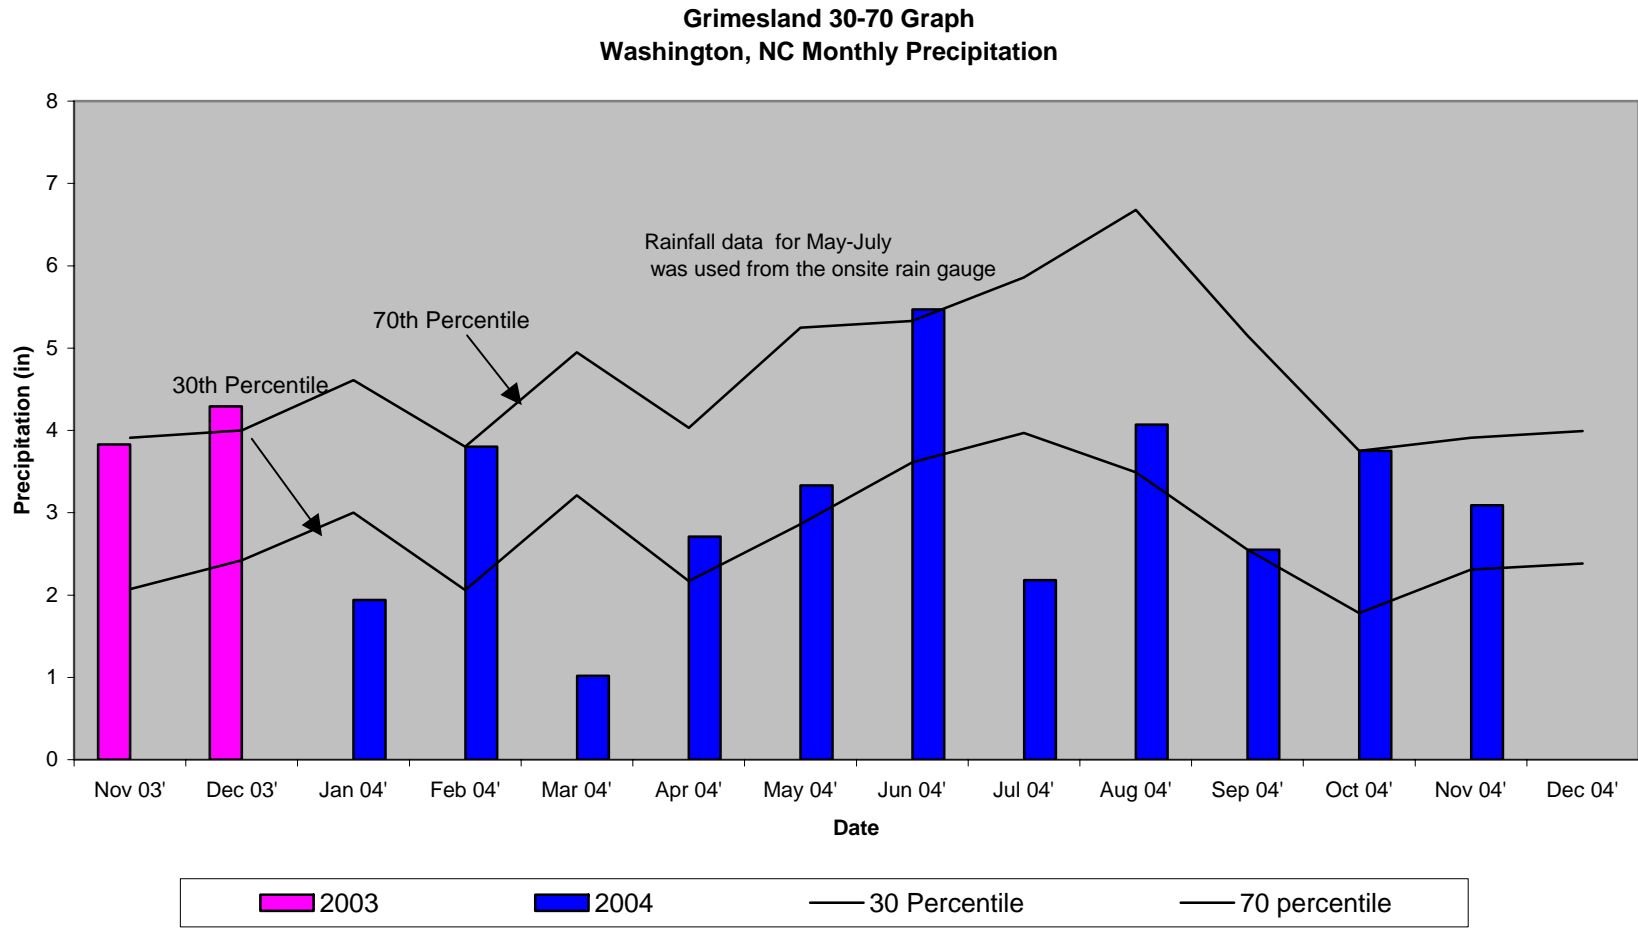
Figure 4. Grimesland Phase I 30-70 Percentile Graph, Washington, NC

Figure 4 is a graph of monthly rainfall for the period of November 2003 through November 2004 compared to historical precipitation data (collected between 1973 and 2004) for Washington, North Carolina. The NC State Climate Office provided the rainfall data. The comparison of 2004 rainfall versus historical values gives an indication of how 2004 compares to historical climate conditions.

For the 2004 monitoring year, December (03') and June experienced above average rainfall. The months of January, March, and June recorded below average rainfall for the site. November (03'), February, April, May, August, September, October, and November experienced average rainfall. Overall, 2004 experienced an average rainfall year.
