# Hanging Rock EEP Project Closeout Summary

Project ID and Status	
Name	Hanging Rock
EEP ID #	165
County	Avery
Type	Stream
Status	5 years of monitoring complete

# Hanging Rock Restoration Project Avery County, NC

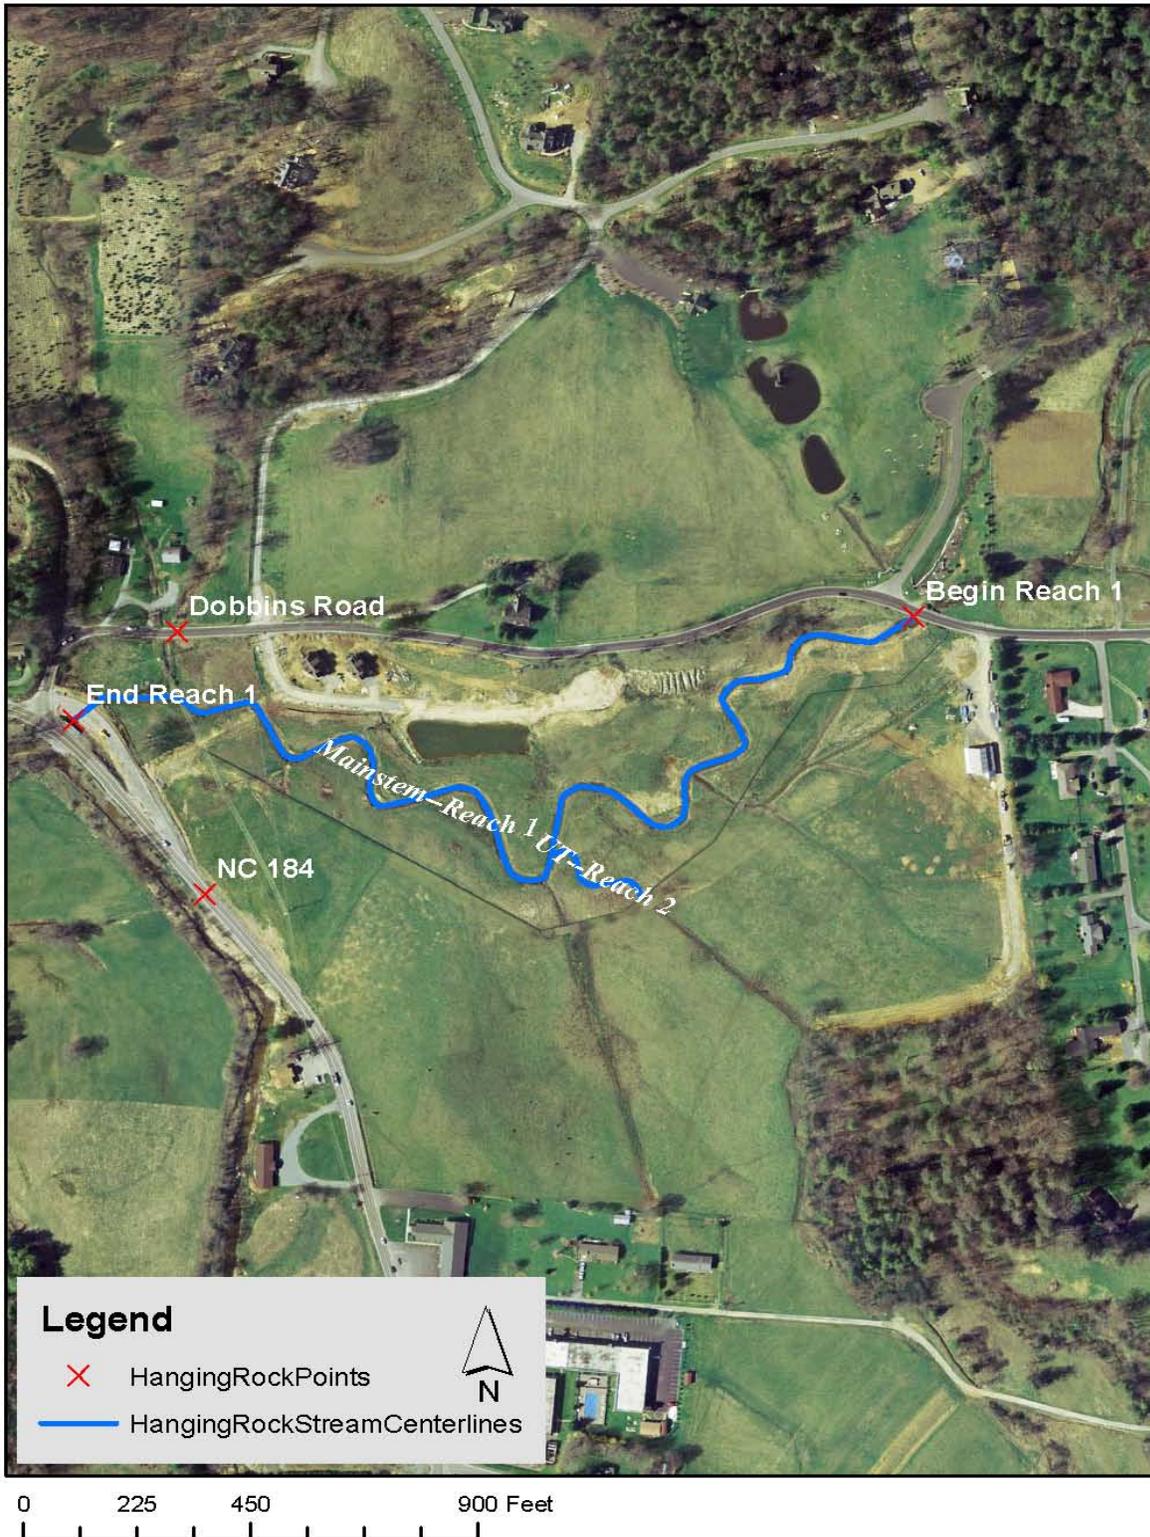
Hanging Rock reach map on 2005 aerial photography.

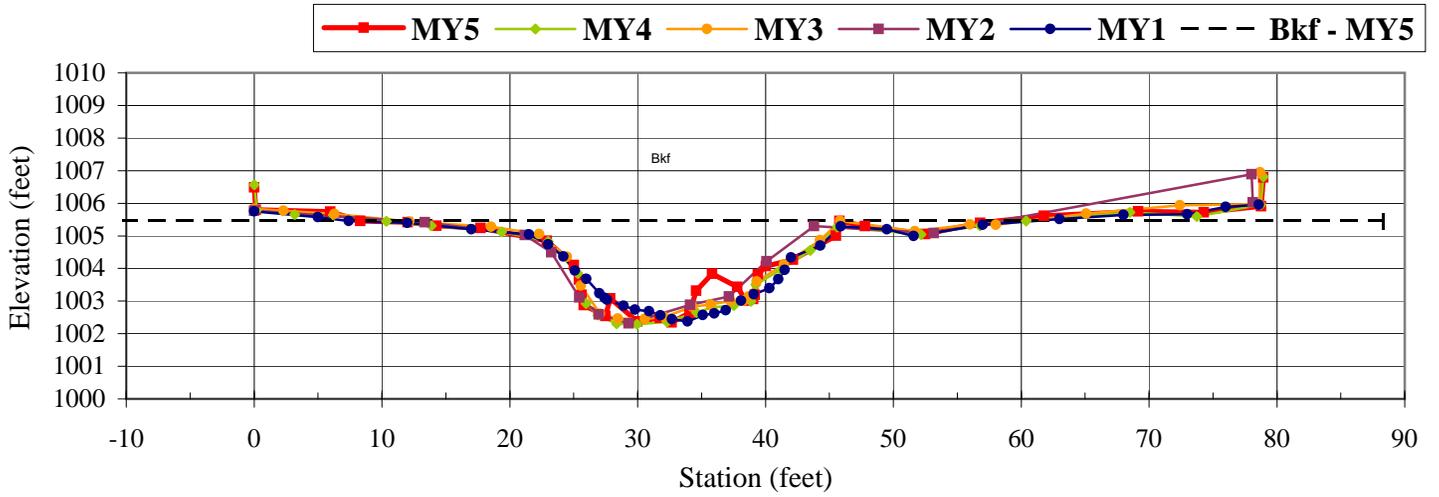
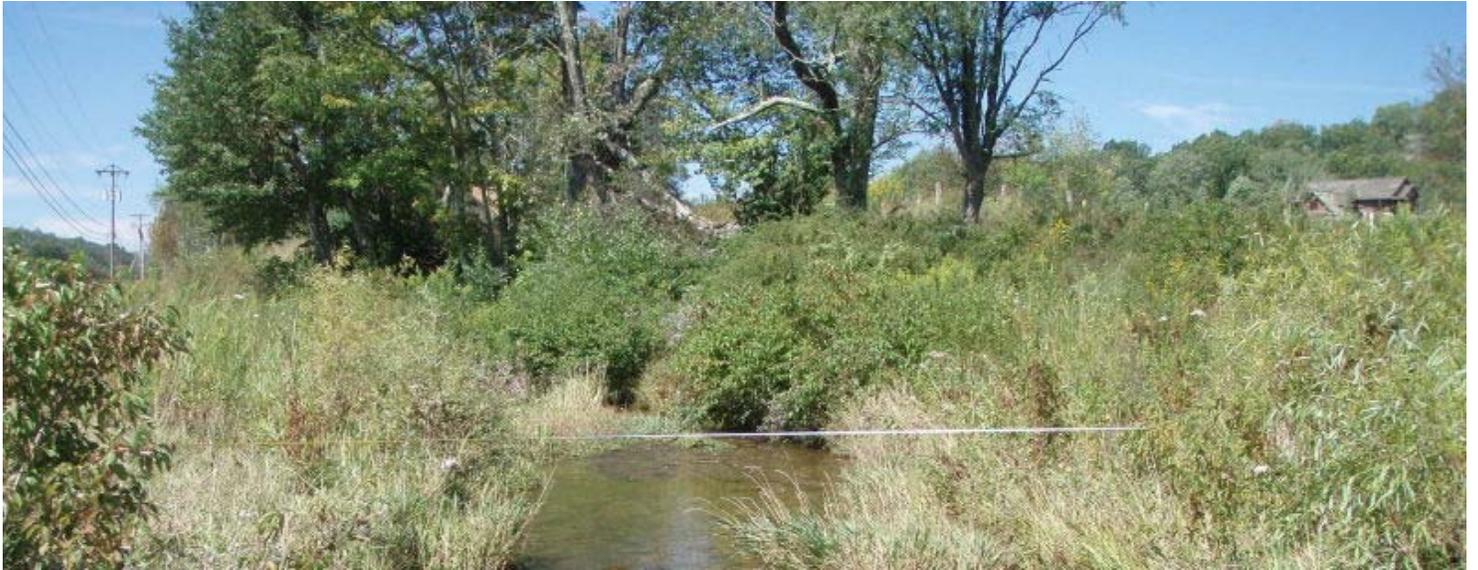
### Hanging Rock Creek Cross Section #1 - Riffle

Hanging Rock repeat riffle X-section surveys. Plots are at a similar scale with modest vertical exaggeration for comparison. Time series demonstrates channel stability. Please note that MY1 is the As-built datum as was common with NCDOT.

According to data collected over a five-year monitoring period, the Hanging Rock project has demonstrated morphologic stability and is functioning as intended. Repeat channel X-sections (N = 7) and longitudinal profile surveys document channel stability with some modest X-section narrowing. The "Bank" feature category of the 2008 Visual Stability Assessment rated at 93% and 100% for the mainstem and UT, respectively. The Vanes/J-Hooks feature category rated lower (79%) for the mainstem, but grade control has been maintained along the project reaches. The average planted stem density determined from 2008 surveys was 222 stems per acre, below the established criteria of 260 stems per acre at the end of monitoring year 5. Vegetation plots #4 and #8 fell below the criteria and both were impacted by unauthorized mowing in 2007. EEP took action to stop the mowing activities, and only minor impacts were noted in 2008 and 2009. Additionally, when naturally recruited stems were counted in 2008, total average stem density was determined to be 455 stems per acre.

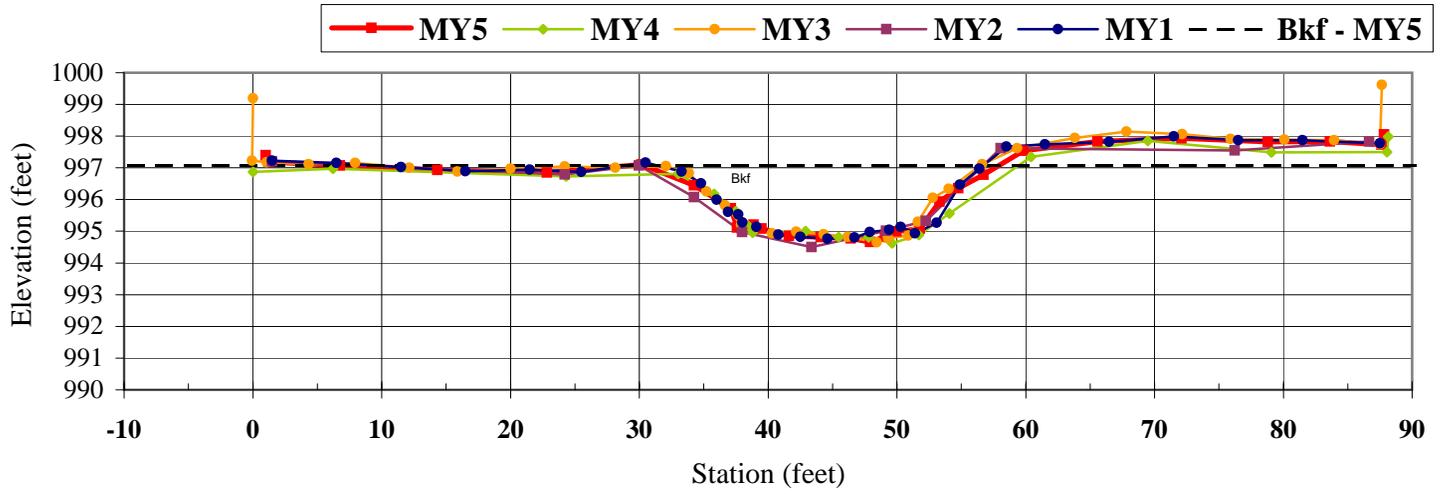
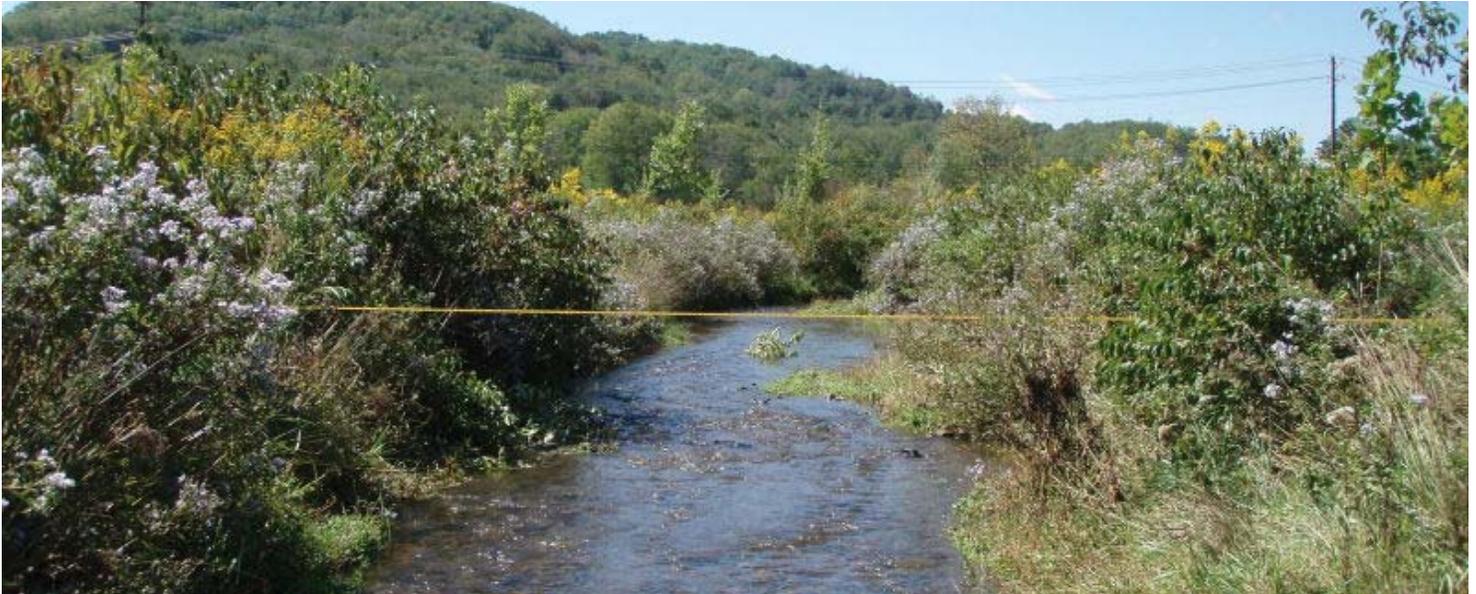
### Hanging Rock Creek Cross Section #7 - Riffle

Hanging Rock and UT repeat riffle X-section surveys. Plots are at a similar scale with modest vertical exaggeration for comparison. Time series demonstrates channel stability. Please note that MY1 is the As-built datum as was common with NCDOT.

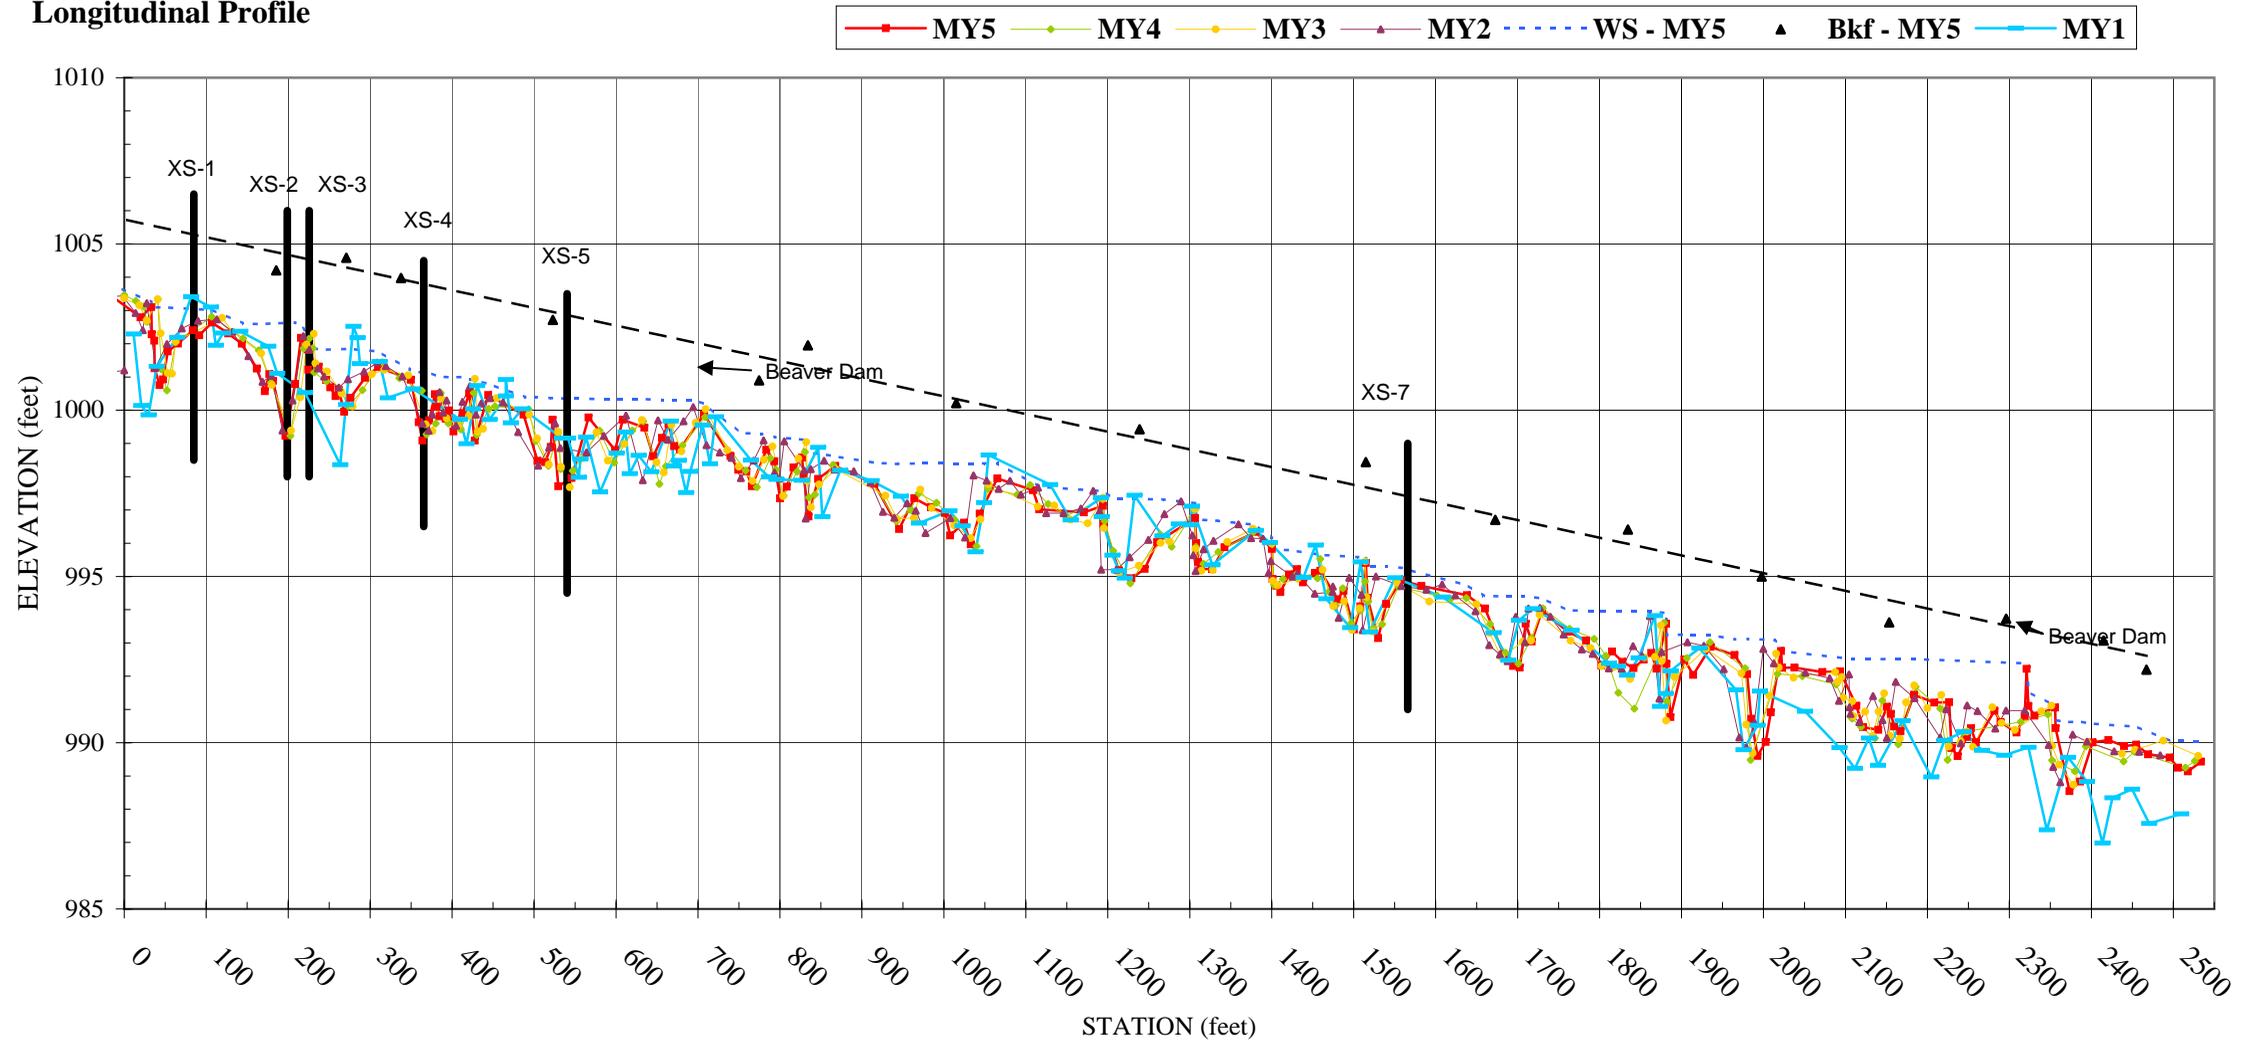
# Hanging Rock Creek Longitudinal Profile

Hanging Rock repeat longitudinal profile surveys. Time series indicates maintenance of project grade and stability of riffle and pool channel units. MY1 is the As-built datum. Please note that beaver dams mapped in 2008 were subsequently removed.

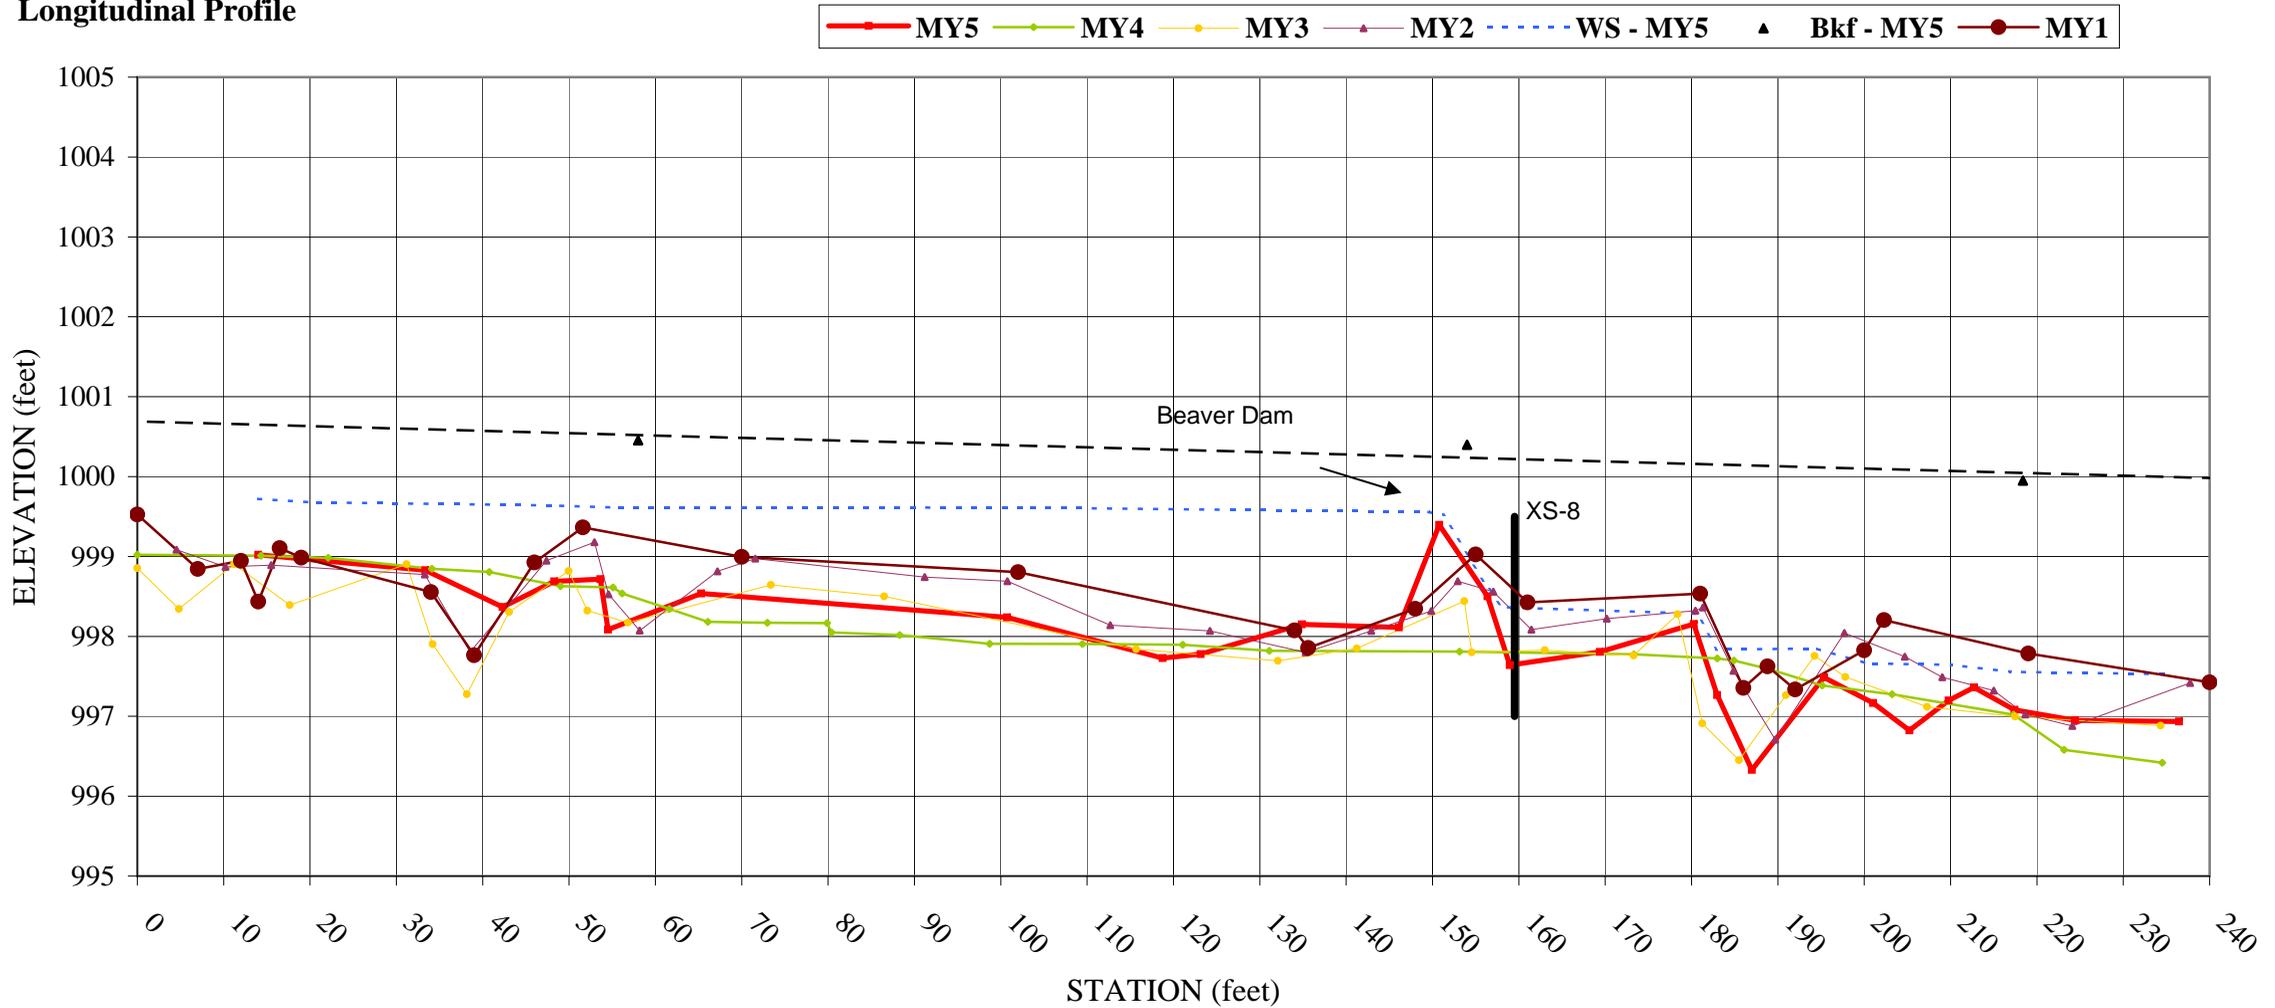
**Unnamed Tributary  
Longitudinal Profile**

UT to Hanging Rock repeat longitudinal profile surveys. Datum issues may have contributed to the appearance of thalweg downcutting over the time series. MY1 is the As-built datum. Beaver dams mapped in 2008 were subsequently removed.

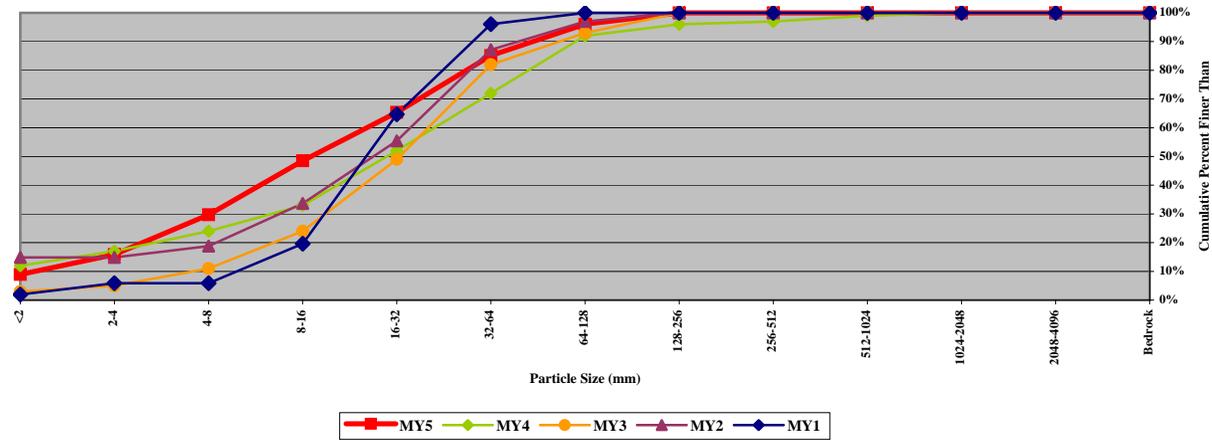
Hanging Rock Creek  
Pebble Count - Percent Cumulative  
Cross Section #1 - Riffle

Median grain size for riffle and run X-section pebble counts (N = 4) for monitoring year 5 ranged from medium to coarse gravel. Pebble count data from same X-sections shown earlier in the report.

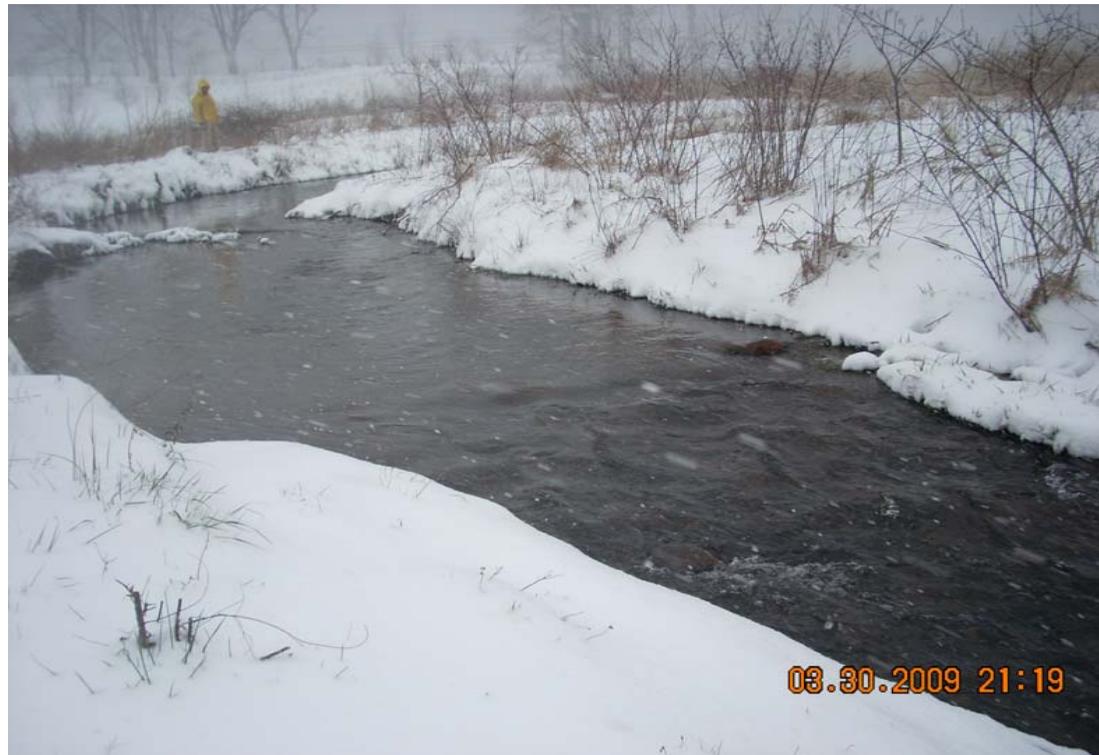
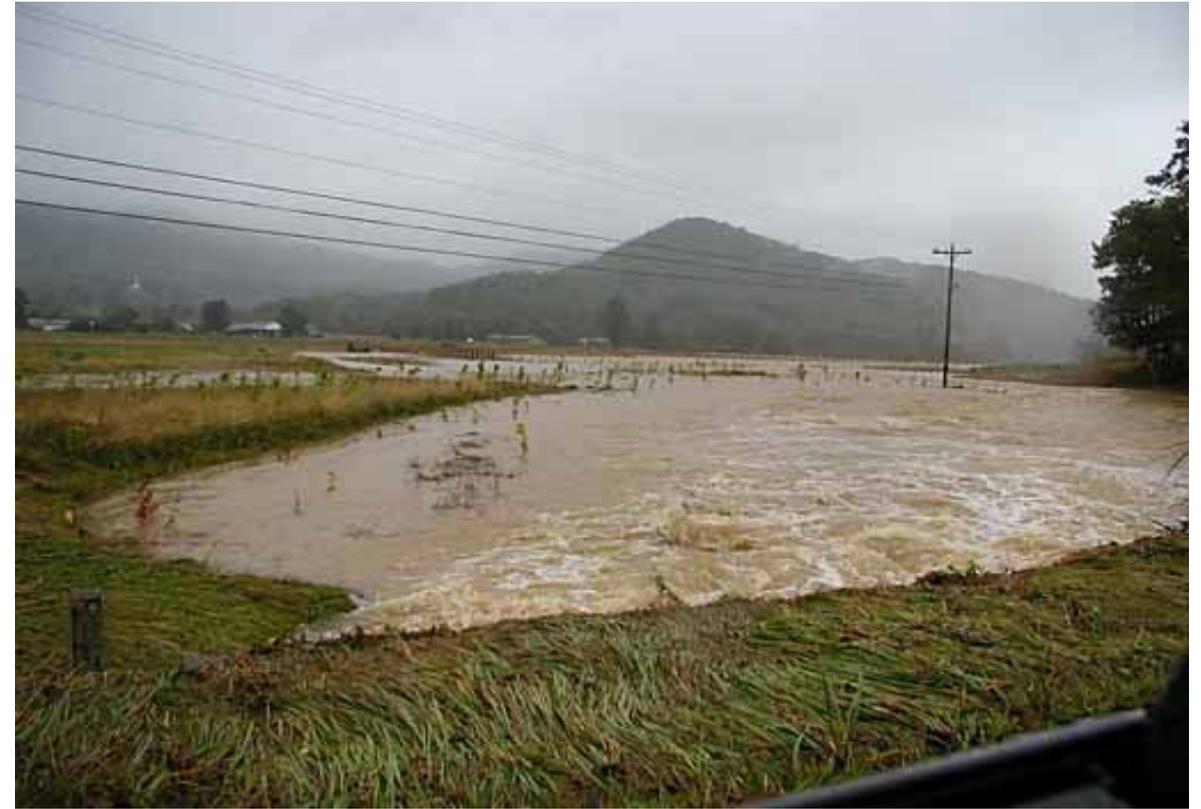
Based on a proxy USGS real time gauge station and on-site observations, the Hanging Rock project has conveyed bankfull events in 2004, 2005, 2006, and 2008.

Photograph of Hanging Rock Ck during Hurricane Francis in September 2004.
