**UT Pembroke Creek Wetland
and Stream Restoration Site
Conceptual Repair Plan
Project # 283
Chowan County**

Submitted: October 2010

**UT PEMBROKE
REPAIRS AND REPLANTING
EEP PROJECT #283
CHOWAN COUNTY, NORTH CAROLINA**

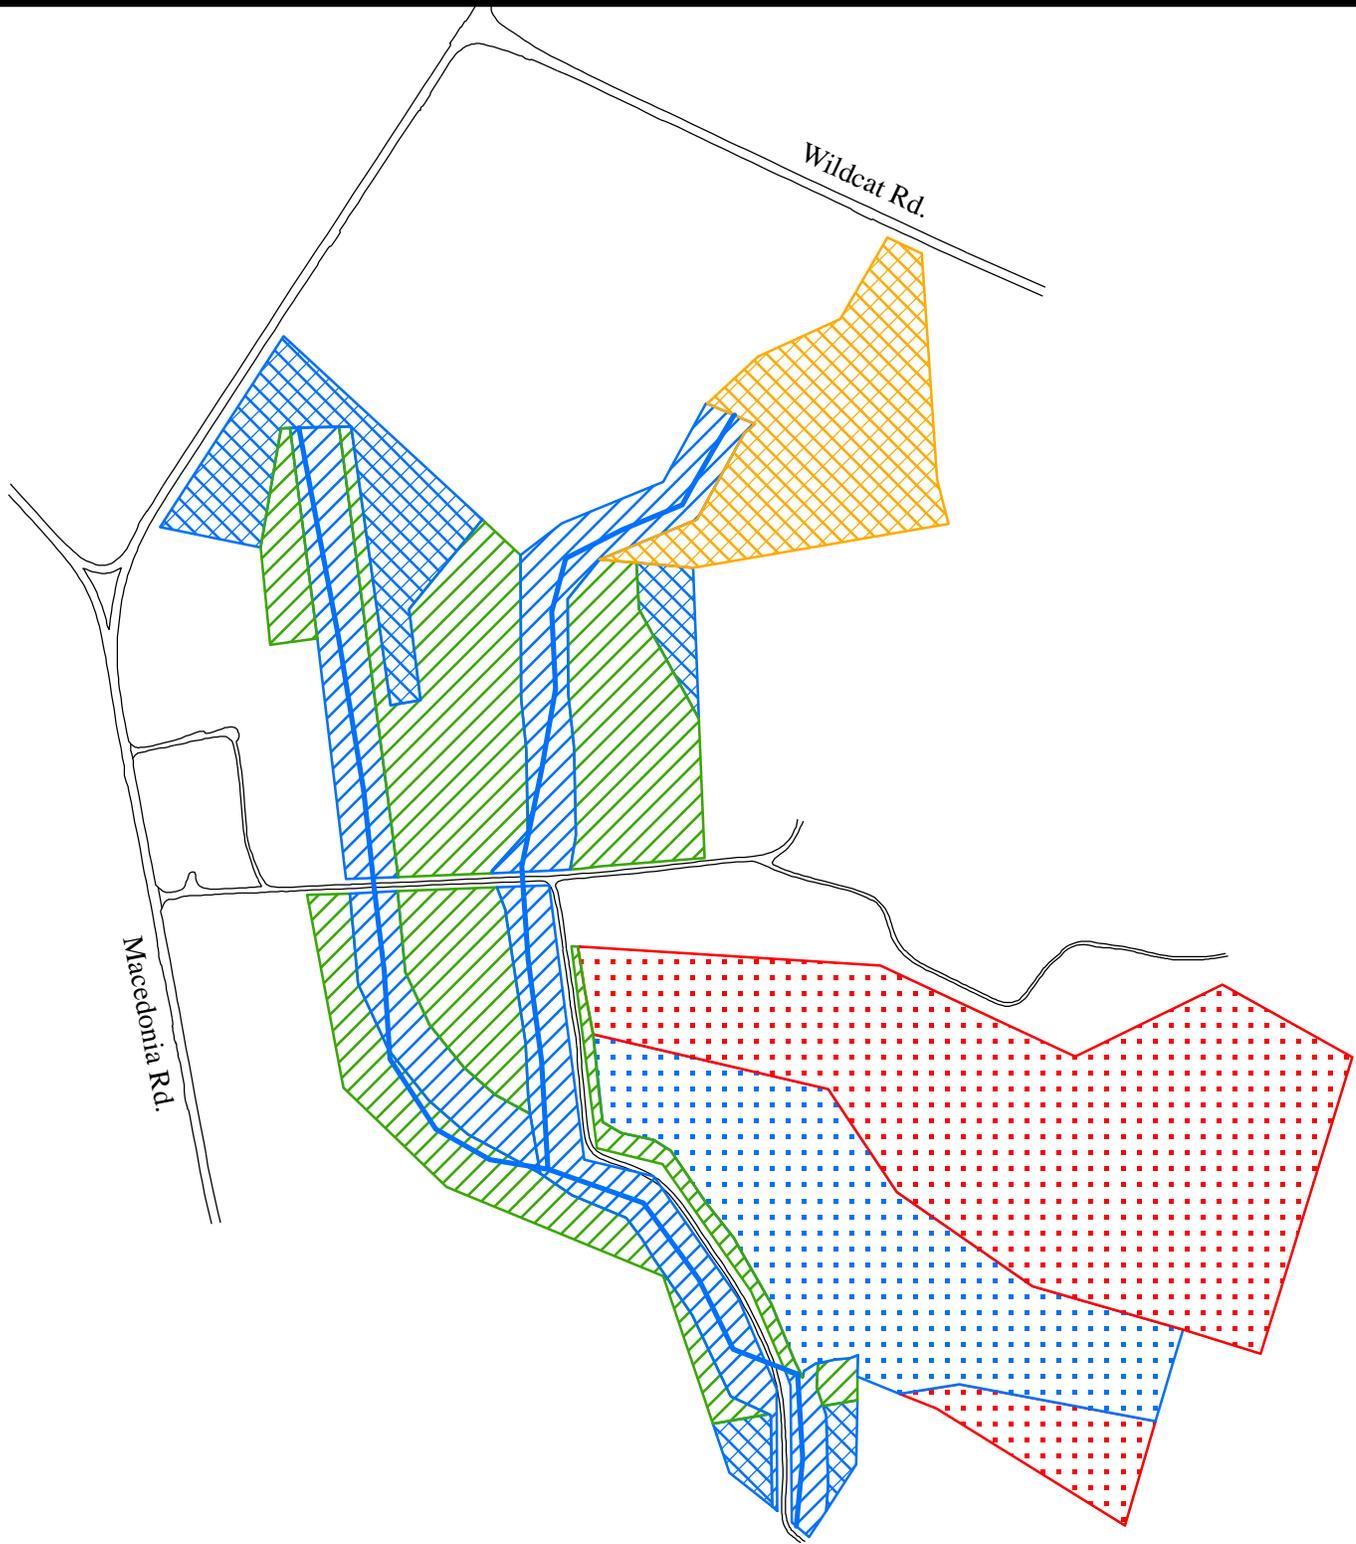
Figure 1. Pre-Repair Site Asset Map
UT Pembroke Creek, Chowan County, EEP Project # 283

The repairs will alter the path of the headwater wetland valley (see Figures 1 and 2). By installing the new road crossing, the headwater wetland valley will cross Road B and flow south along the eastern side of the road to the site's downstream outlet. This change will convert some area from wetland preservation to headwater wetland valley (stream) restoration. This modified flowpath coincides with the natural valley through the site. The flat valley is also the reason that Road B was built in this location. Since the road is not in the conservation easement, the 100' corridor for the new location of the wetland valley will extend to the western side of Road B. This change will decrease the preservation credit, but increase the restoration credit at the site. In addition to altering the location of the centerline at the new road crossing, this asset projection also corrects a conflict in the centerline location that was carried over from the as-built documentation. This conflict is illustrated in Figure 1, where the centerline is not in the center of the wetland valley. The centerline has been repositioned and stationed in Figure 2. See Tables 1 and 2 for the revised credit calculation.

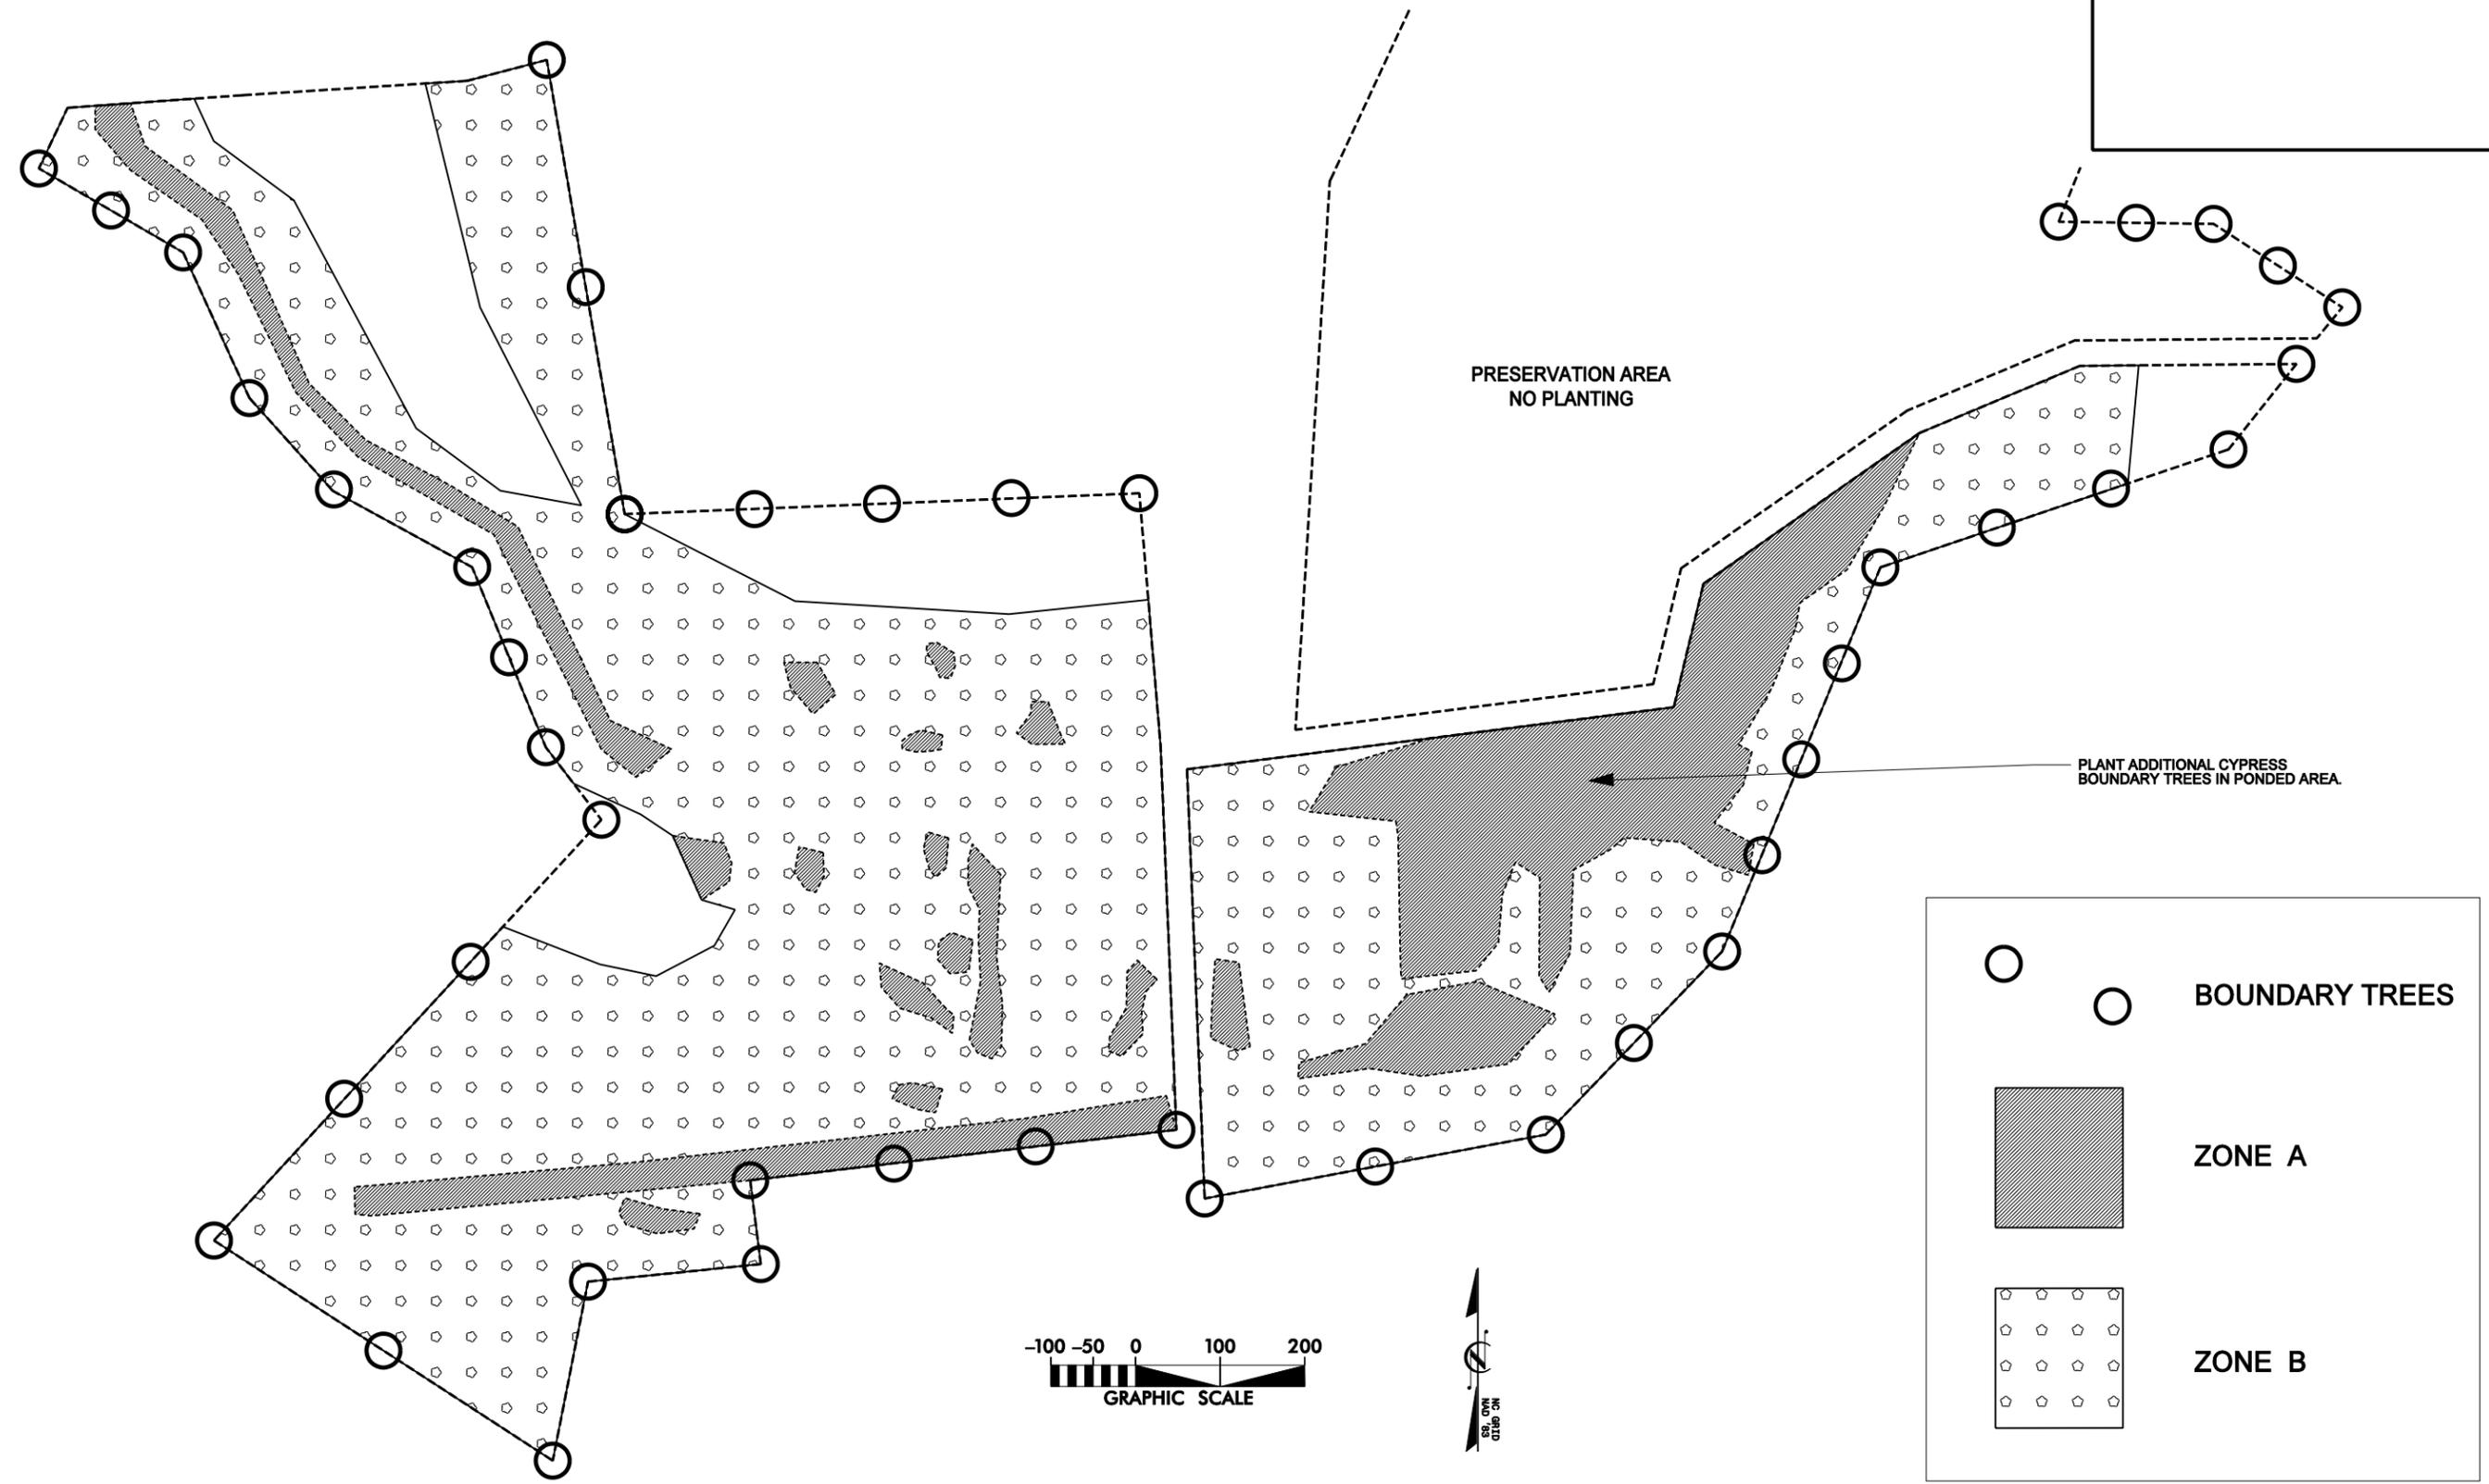
SHEET 3 OF 4

**PLANTING
PLAN**

The site will also be planted with additional trees (see Plan Sheets 3 and 4). The planting will include a variety of containerized and tubling materials. The areas of standing water will be replanted with approximately 3,500 trees that are tolerant of these conditions, such as bald cypress (*Taxodium distichum*) and water tupelo (*Nyssa aquatica*). Other parts of the wetland restoration will be planted with approximately 4,850 tublings to increase the woody species diversity and fill in any areas that experienced increased mortality. Fifty-five 1" caliper trees will be planted along portions of the conservation easement that are bordered by row crops, and some will be put in the large ponded area.
