# Snow Creek

Stokes County, NC

Ecosystem Enhancement Program Project # 344

Draft Closeout Summary Report, 21 May 2010

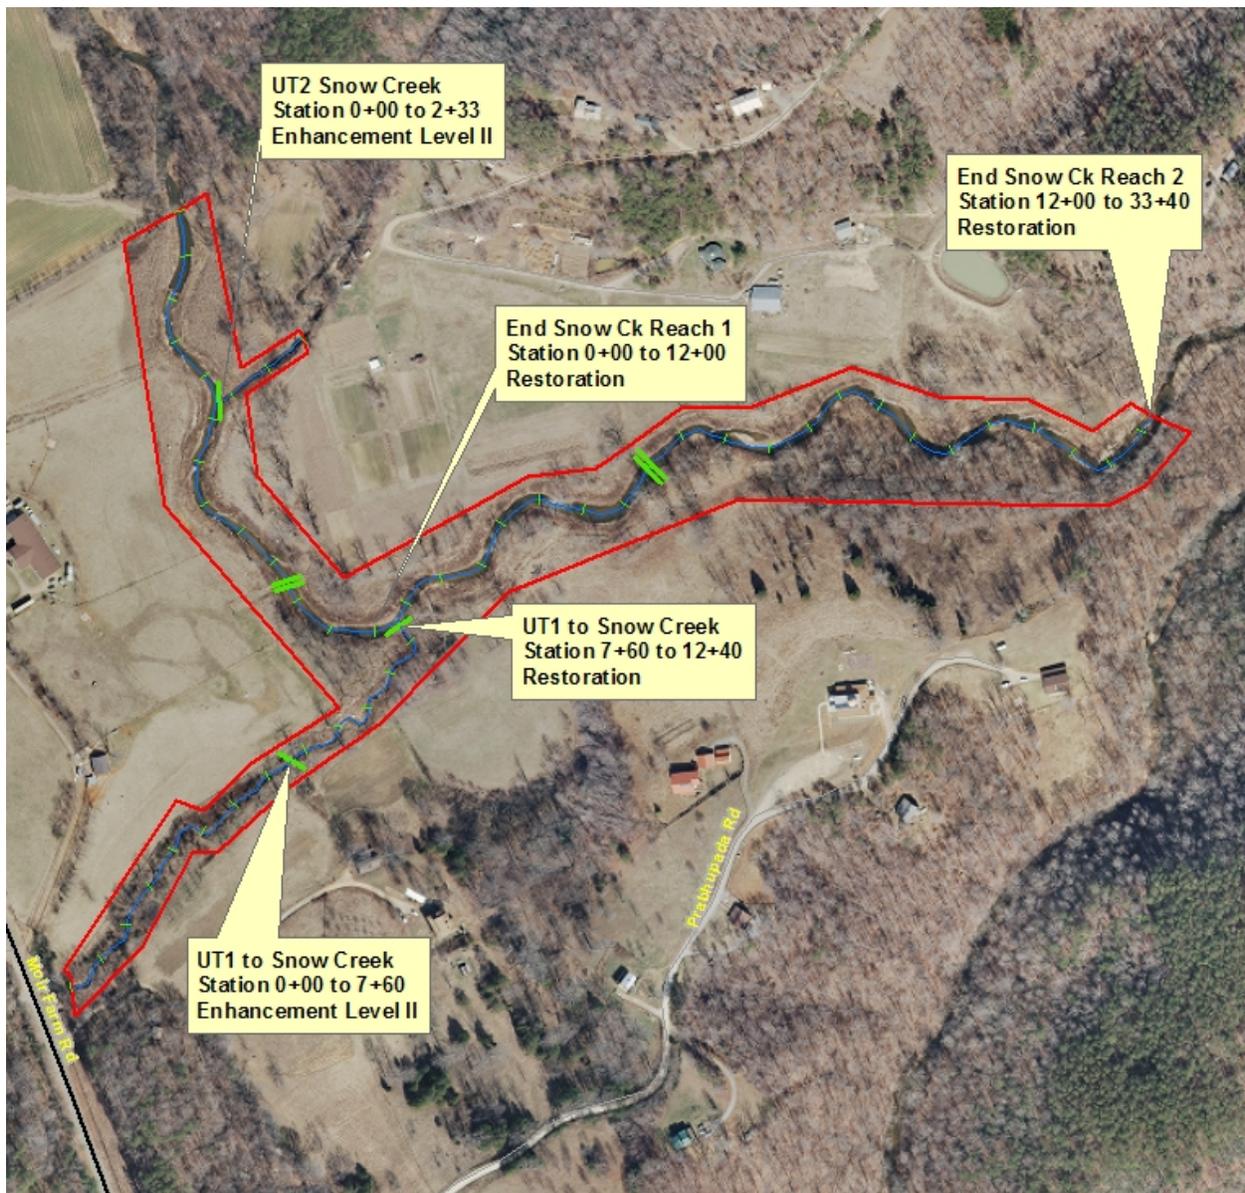
Figure 2: Snow Creek mitigation assets. Reach breaks heavy green lines, fords double green lines, thin green tick marks channel centerline stationing at 100 ft intervals interpreted from 2008 air photos.

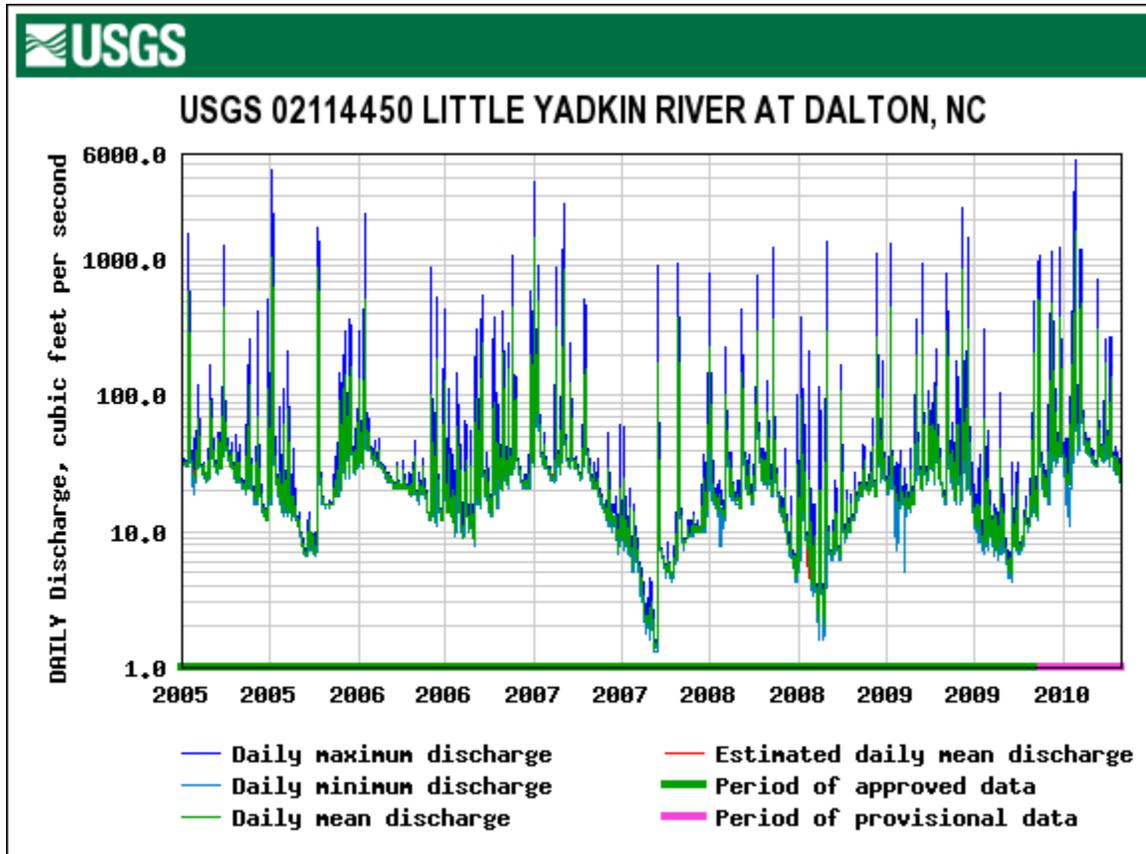
Figure 3: Snow Creek reference discharge data January 1st 2005 through May 1st 2010. Based on the drainage area, bankfull events are inferred at discharges above approximately 1,300 cfs. The gauge record documents 6 events above 2,000 cfs with large storms in July 2005, January 2007, and January 2010. Also note very low flows in fall 2007 and 2008. Station is located approximately 20 miles from the project site with a drainage area of 42.8 miles<sup>2</sup>.

The Snow Creek project has demonstrated geomorphic stability despite at least 6 overbank flow events (Figure 3) and an apparent high sediment load. The 2009 visual assessment indicated 23 of 25 vane structures lacked scour or piping, all constructed pools (N = 19) were sufficiently deep, and no bank length was actively eroding (URS Corporation, 2010). Approximately 500 feet of bed aggradation and a reduction of riffles from 16 (As-built) to 10 was also documented and related to sediment loading.

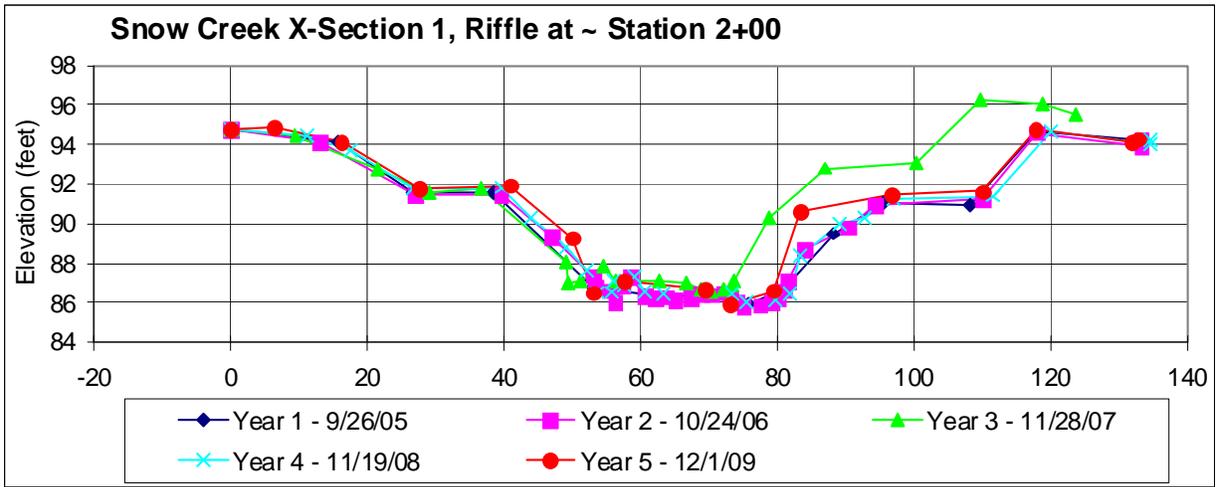
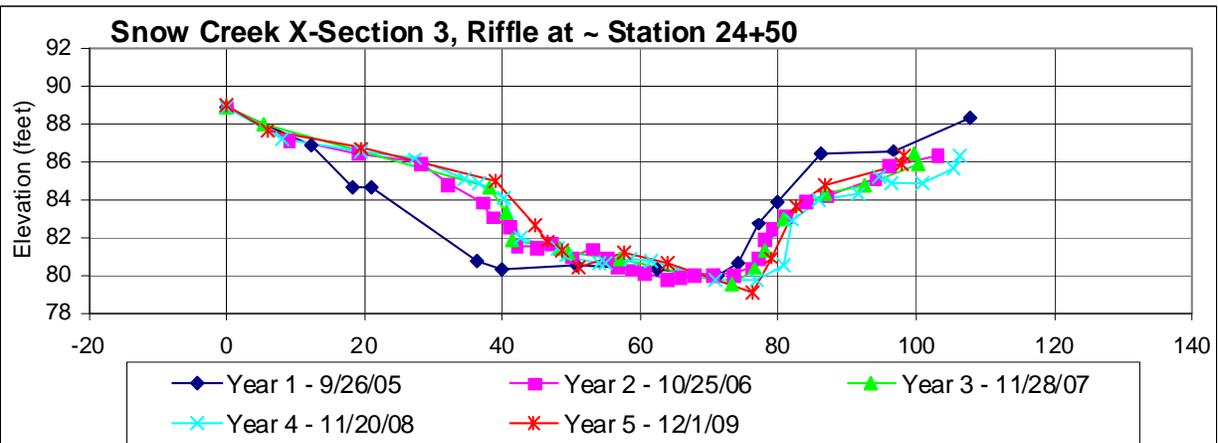
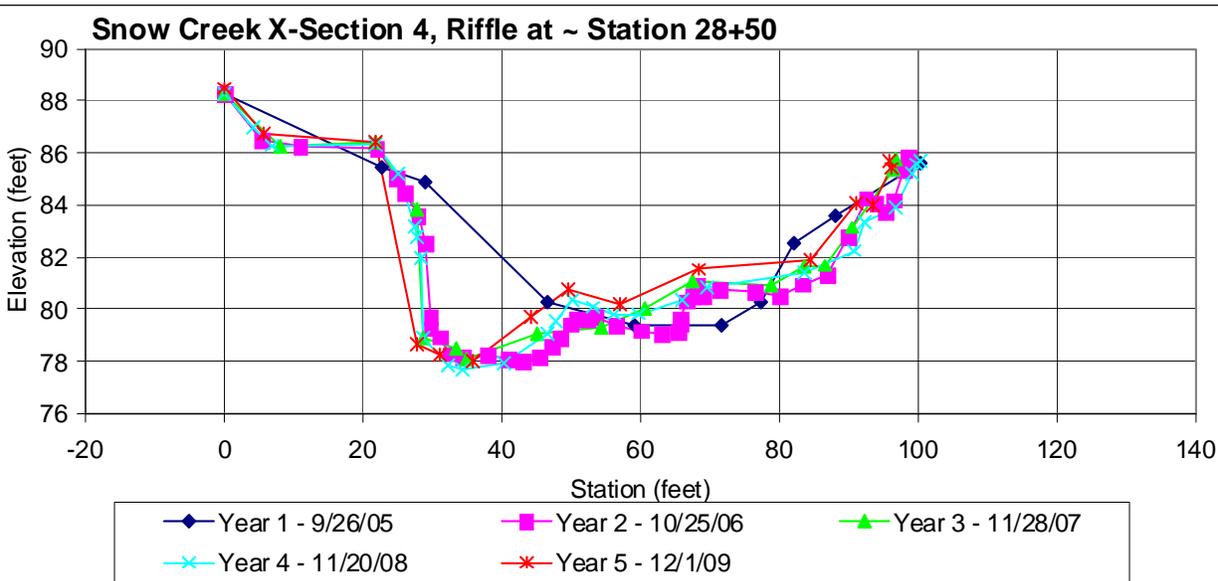
Figure 4: Snow Creek repeat riffle X-section surveys. Time series document a maintenance of riffle thalweg elevations and some channel filling in the form of bank building (narrowing). Note lack of bottom-left-bank survey point in X-Section 4 year-1 data. Year-1 data is the As-built datum.

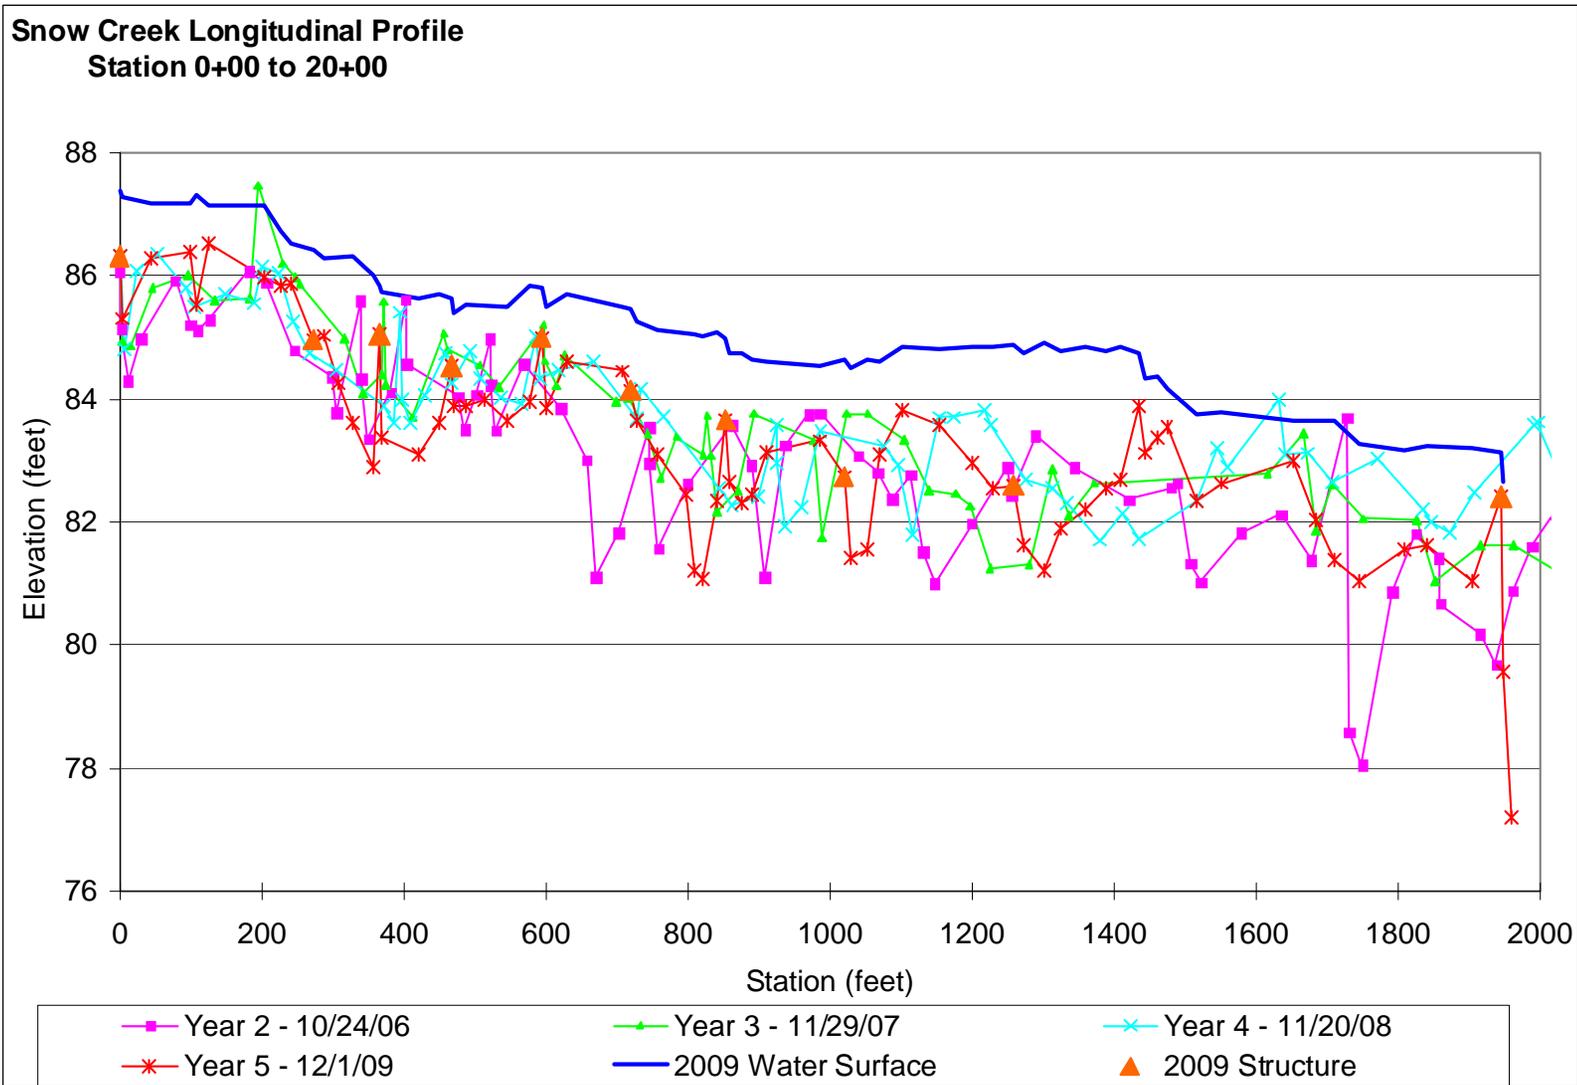
Figure 5: Snow Creek repeat longitudinal profile surveys. Time series indicates riffle-pool morphology and bed elevations have generally been maintained. Year 1/As-built data (designer) could not be rectified with subsequent surveys (monitoring firm) for the purposes of comparable overlays.

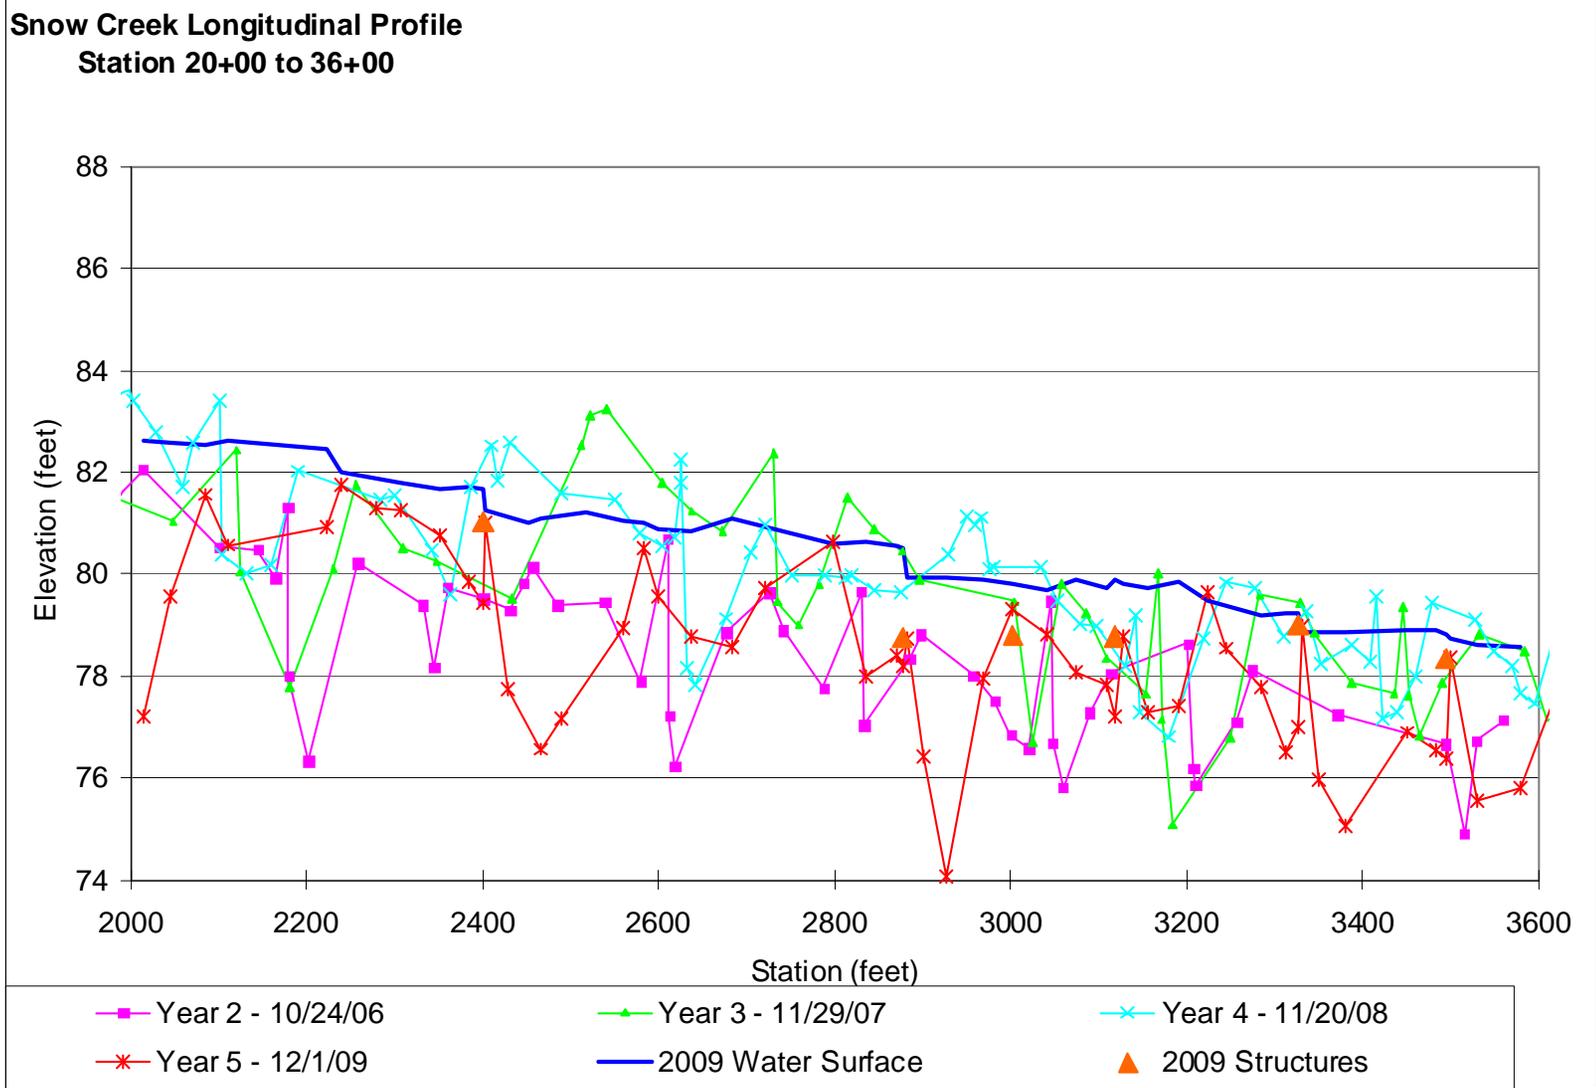
Figure 6: Snow Creek repeat longitudinal profile surveys. Time series indicates riffle-pool morphology and bed elevations have generally been maintained. Year 1/As-built data (designer) could not be rectified with subsequent surveys (monitoring firm) for the purposes of comparable overlays.

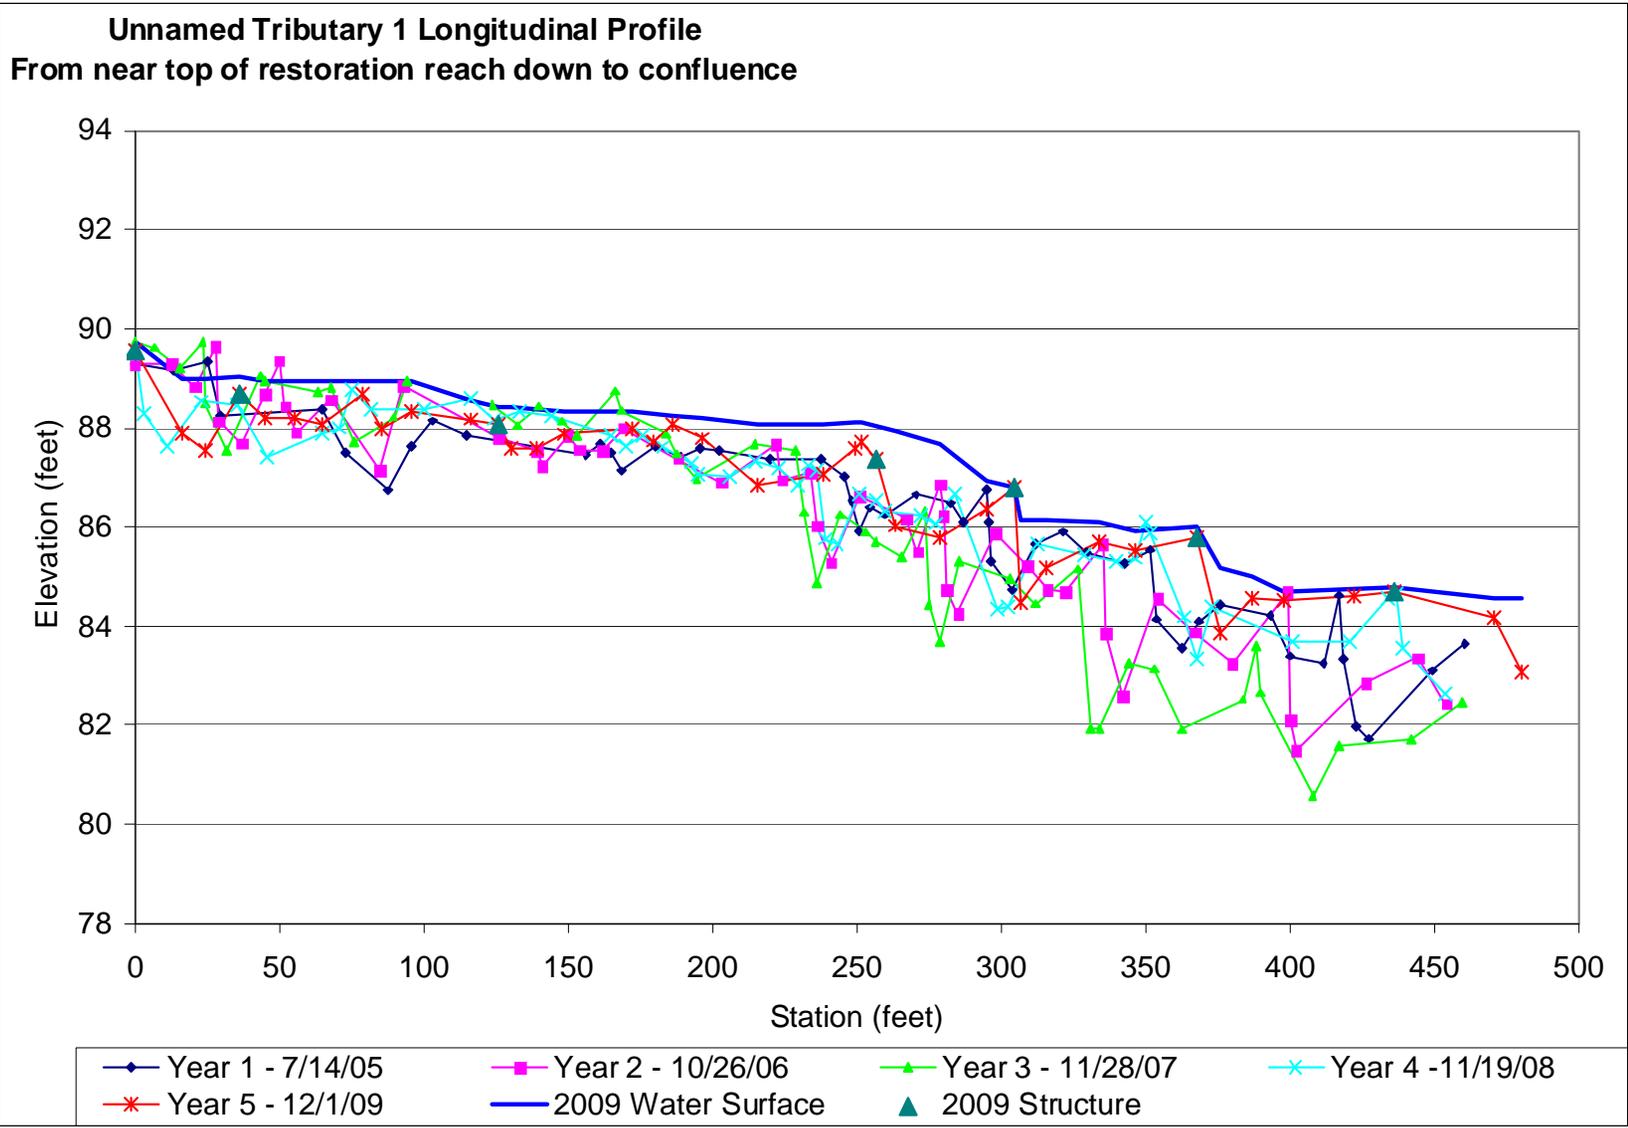
Figure 7: Unnamed Tributary 1 repeat longitudinal profile surveys. Time series indicates riffle-pool morphology and bed elevations have generally been maintained.

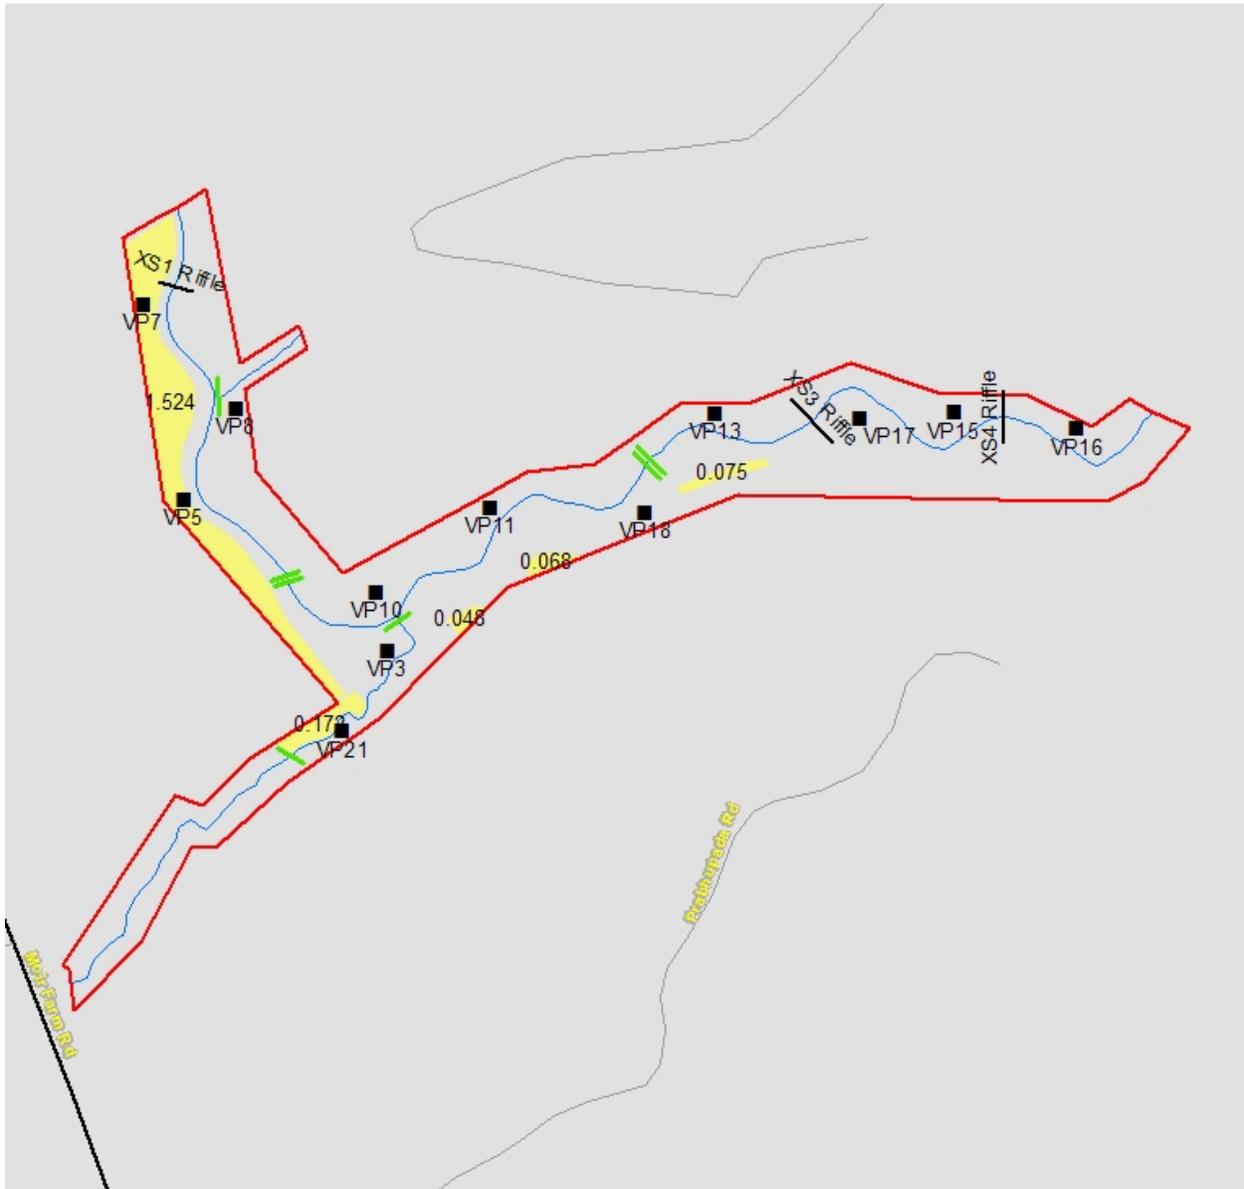
Figure 8: Snow Creek vegetation monitoring plot approximate locations (black squares) and buffer areas lacking appreciable woody stems (yellow polygons with acreages). The three areas identified in Snow Creek Reach 2 area less than 1/10<sup>th</sup> acre in size.

Vegetative success at the project is generally good. 2009 CVS protocol survey data indicated 10 of 11 fixed plots (Figure 8) exceeded the success criteria of 260 stems per acre for planted stems, with one plot (#10) not surveyed due to damage. 2009 mean planted and total (including volunteers) densities were 1,207 and 1,649 stems per acre, respectively. Although the majority of tallied planted stems were silky dogwood and black willow, 2009 survey data documented 12 different woody species. Visual assessment by EEP staff in April 2010 revealed two buffer areas that will require supplemental planting in the winter of 2010-11 (Figure 8). The two planting areas comprise ~ 1.7 acres of the total easement area (less As-built bankfull channel area) of ~ 11.9 acres, or ~ 14%. Additionally, easement fencing damaged by a large flood in February 2010 will be repaired.

The Snow Creek restoration and enhancement project has demonstrated geomorphic stability over the 5 years since construction was completed. 10 of 12 fixed vegetation monitoring plots also indicated success based on 2009 planted stem counts that exceeded 260 per acre. However, visual inspection of the entire riparian buffer in April 2010 revealed 2 areas totaling approximately 1.7 acres that will require supplemental planting. Additionally, a large flood in January 2010 damaged portions of the easement fencing adjacent to the leftbank along Snow Creek Reach 1 and Unnamed Tributary 2. EEP proposes the project for regulatory closure pending documentation of planting and fence repair completed by winter 2010-11, with subsequent documentation of visual inspection through 2011.
