# UT BEAR CREEK MITIGATION PLAN CHATHAM COUNTY, NORTH CAROLINA

T.I.P. No U-2524WM  
O.N.E. # WM 019-001

NCDOT Consulting Project No. 02-ES-01

The North Carolina Department of Transportation  
Raleigh, North Carolina

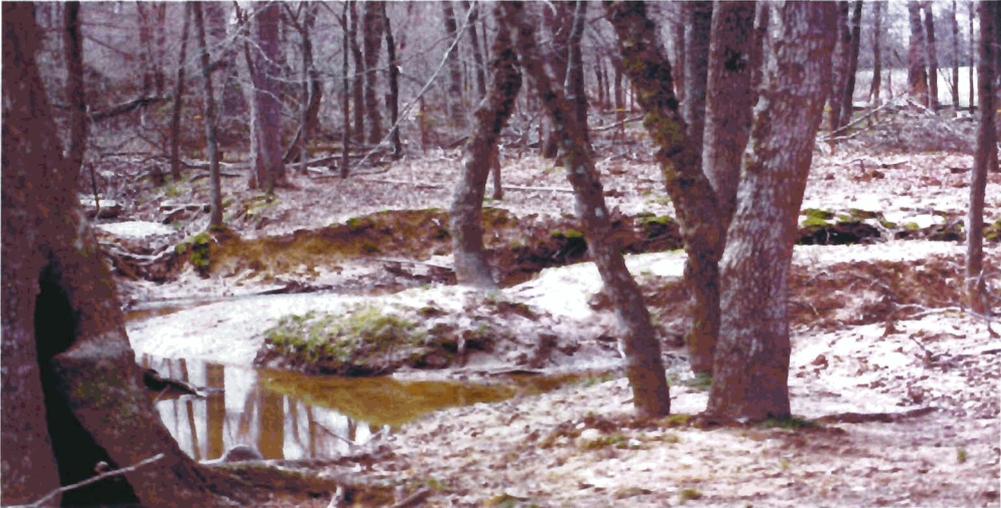
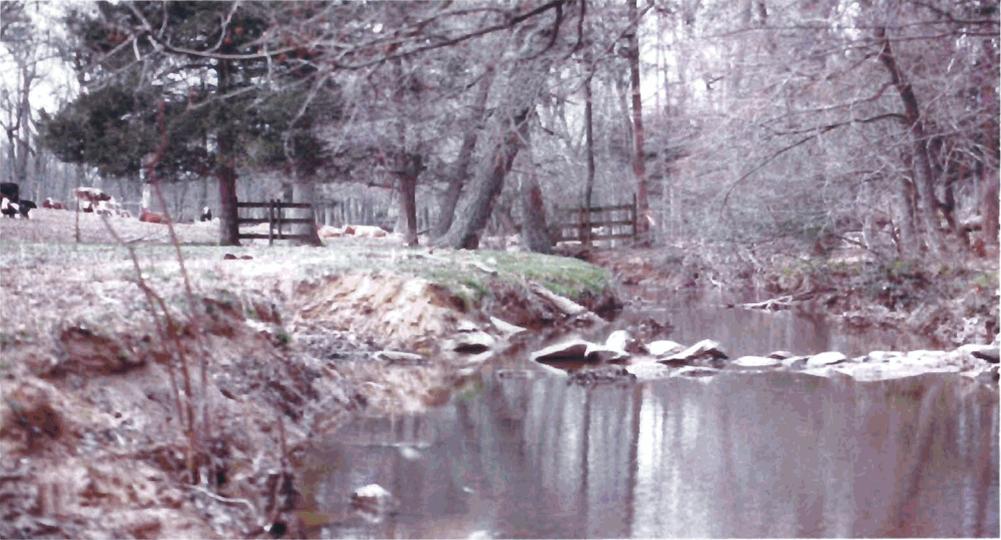
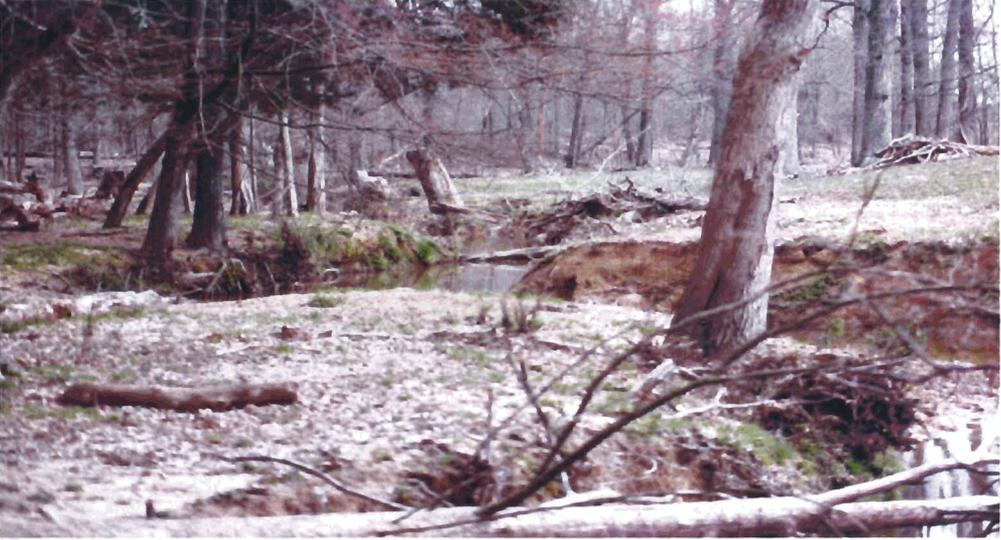
Figure E-1

UT Bear Creek Bank Failures

UT Bear Creek traverses the project study area west to east and has a drainage area of approximately 1,075 acres (1.68 square miles). The channel reach present within the project study area is approximately 2,100 linear feet in length and exhibited no flow, with scattered areas of standing water during the initial field effort. It should be noted that the field work was conducted during a severe drought, and that interviews with the landowners indicate UT Bear Creek has historically exhibited perennial flow. Substrate within the channel reach consisted of silt and clay, with areas of gravel, boulders and bedrock outcrops. Nine bedrock outcrops were noted within UT Bear Creek (Figure A-1 in Appendix A and Photographs 2, 4 and 6 in Appendix E).

A geomorphic characterization of this reach channel indicates the majority of this channel represents a "G" type stream. "G" type streams are generally entrenched systems with gentle to moderately steep channel gradients and are typically deeply incised channels. These stream types have relatively low bedload transport rates and are very sensitive to disturbance and tend to make significant adverse channel adjustments to changes in flow and sediment supply from the watershed. A typical riffle cross-section is located in Appendix A (Figure A-2). One reach surveyed initially appears to be an "E" type stream, with a low w/d ratio and entrenchment ratio. However, it appears that this channel is in transition to a "G" type channel with signs of bank failure noted.

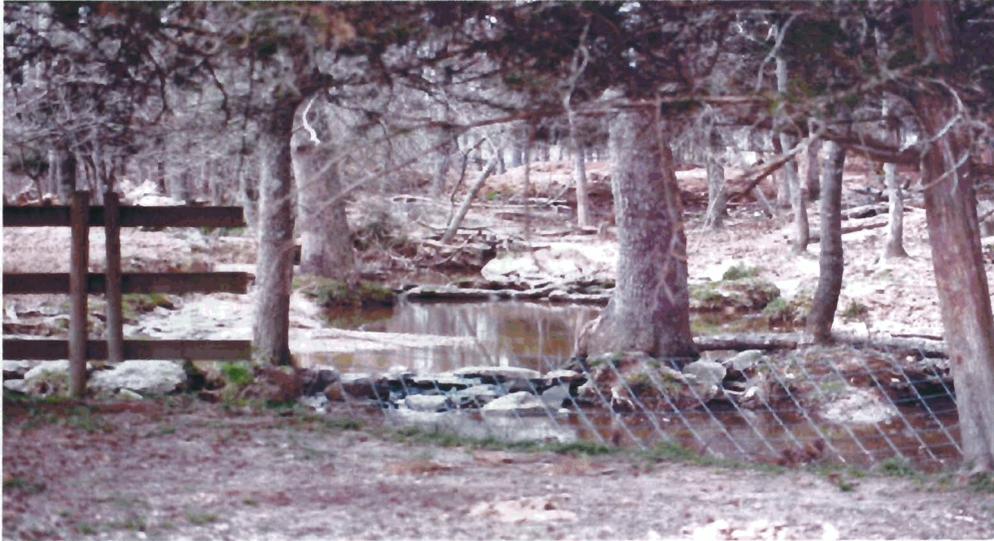
Figure E-2

Proposed Machinery Crossing Location

UT Bear Creek

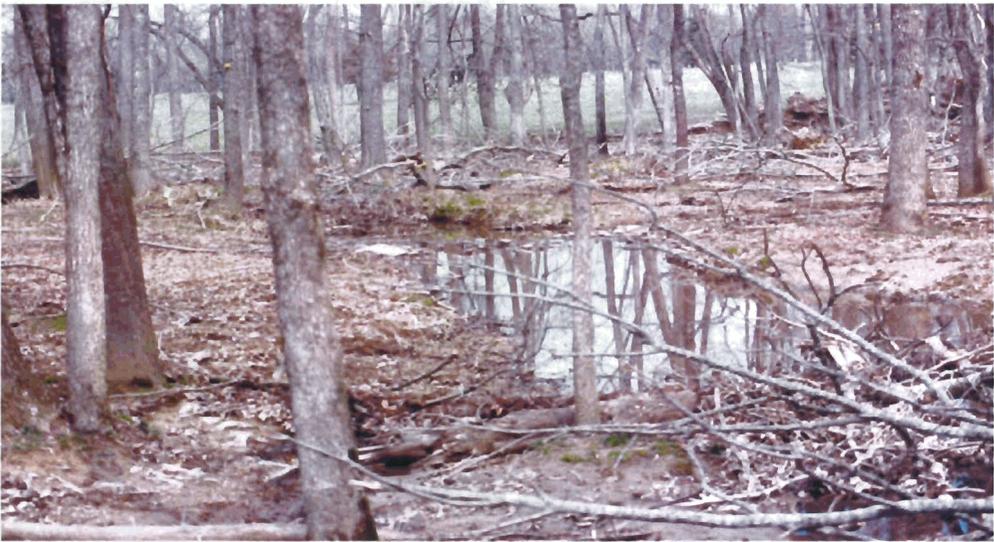
5

UT2

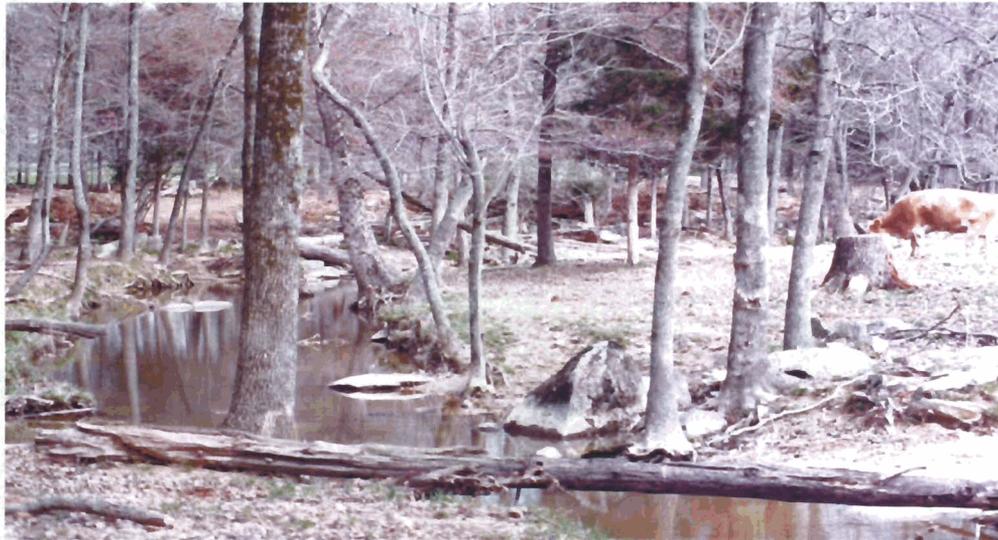
Figure E-3

Rock Outcrop and Cattle Incursions

UT2 begins near the northern boundary of the project study area. The upper reach of this channel has been channelized while the lower reach has been completely destroyed by cattle incursions. A survey of this drainage feature indicates pattern and profile are absent. Dimension is absent within the lower reach due to continual cattle incursions; no discernable stream channel is present (Photographs 7 and 8 in Appendix E). Surveys of the upper channelized reach indicate the channel has a bankfull width of approximately 5.1 to 5.5 feet and a bankfull depth of approximately 13 inches, with a cross-sectional area of approximately 5.7 to 5.9 square feet and extremely low sinuosity. The channel is entrenched, with a low bank height of 3 to 4 feet. Surveys of the longitudinal profile that riffle-pool sequences are not well defined.

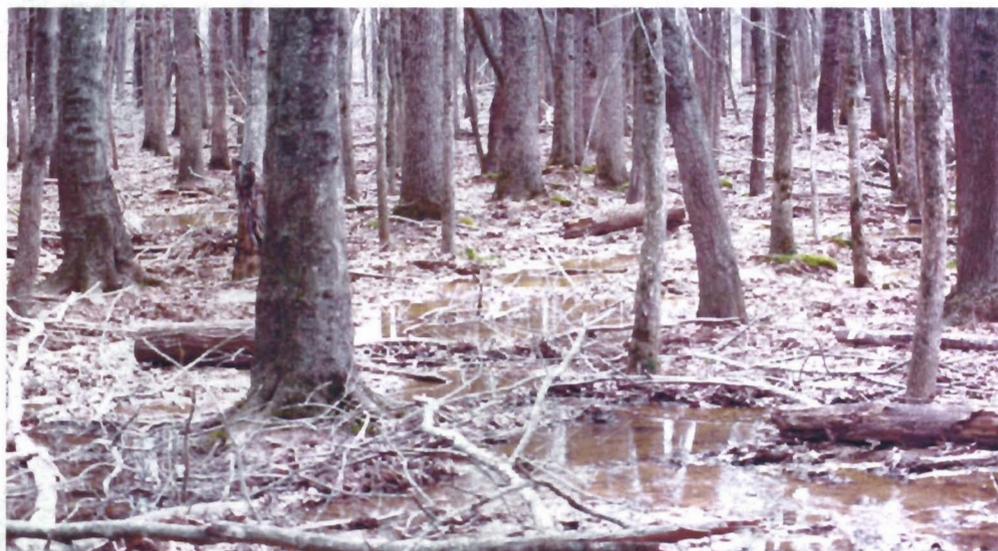
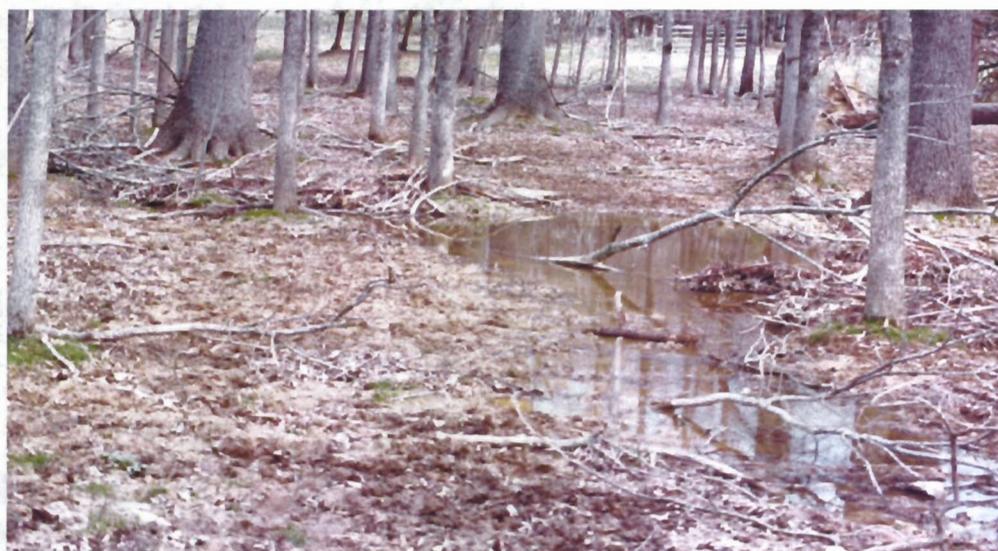
Figure E-4

UT2 Restoration Area
