**Preliminary Findings Report:**

**Troublesome Creek Watershed  
and  
Little Troublesome Creek Watershed**

**NORTH CAROLINA  
WETLANDS RESTORATION PROGRAM**

**TETRA TECH, INC.**

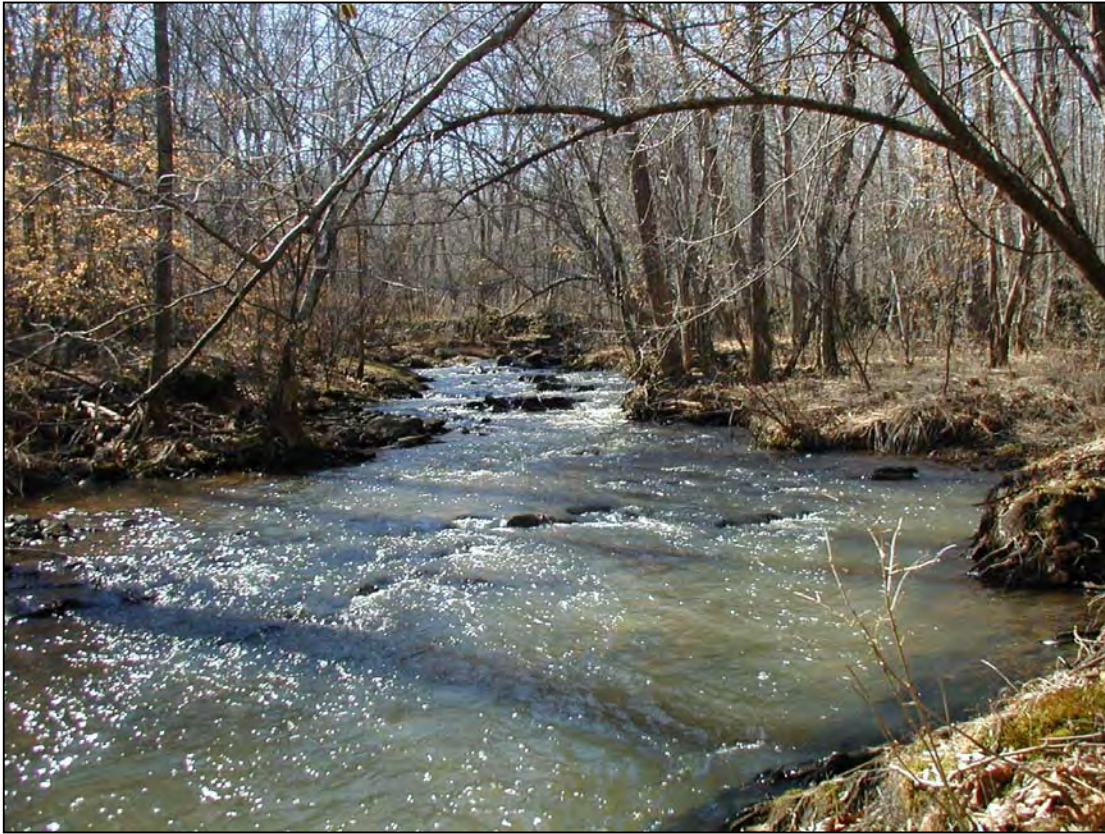
**Figure 5. Troublesome Creek at SR 2422**

The North Carolina Department of Environment and Natural Resources (NCDENR) Division of Water Quality has sampled one benthic community sampling site and one fish community sampling site within the Troublesome Creek watershed (refer to Figure 1). The benthic monitoring station is located at SR2422 just upstream of Lake Reidsville, and the site description in the Basinwide Assessment Document indicates that the site has a rocky substrate, reflecting a localized instance of Carolina Slate Belt geology. A recent photograph of the site (Figure 5) depicts intact stream banks and well-vegetated buffers. Benthic ratings at this station were “Good-Fair” in April 1993 and June 1998. Narratives from the 1998 sampling event indicate low EPT taxa richness was observed in 1998, but that several intolerant taxa were abundant (NCDENR, 1999).

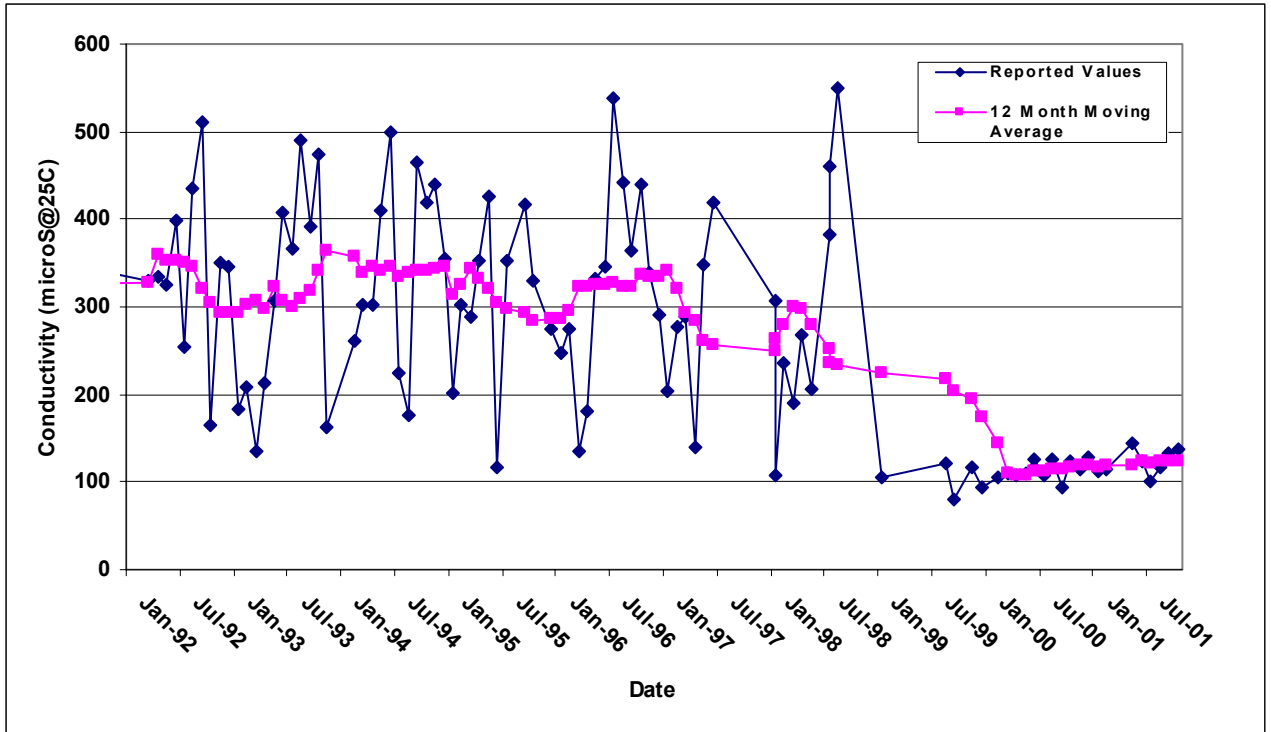
NCDWQ has maintained a water quality monitoring station near the bottom of the Little Troublesome Creek watershed, at SR 2600, as part of its ambient monitoring system from 1968 to the present. Historical ambient data show elevated conductivity, ammonia, total nitrogen, and total phosphorus levels at SR 2600 during the time that the Reidsville WWTP discharged into Little Troublesome Creek. However, levels have declined after the relocation of the discharge (Tyndall, 2002). Figure 13 and Figure 14 are time series graphs with 12-month moving averages for conductivity and total phosphorus, respectively, from 1992 to 2001 at SR 2600. Note the sharp decline in reported values, and particularly in moving averages, for both parameters that occurs in the fall of 1998, when the discharge was removed.

Figure 13. Conductivity in Little Troublesome Creek at SR 2600

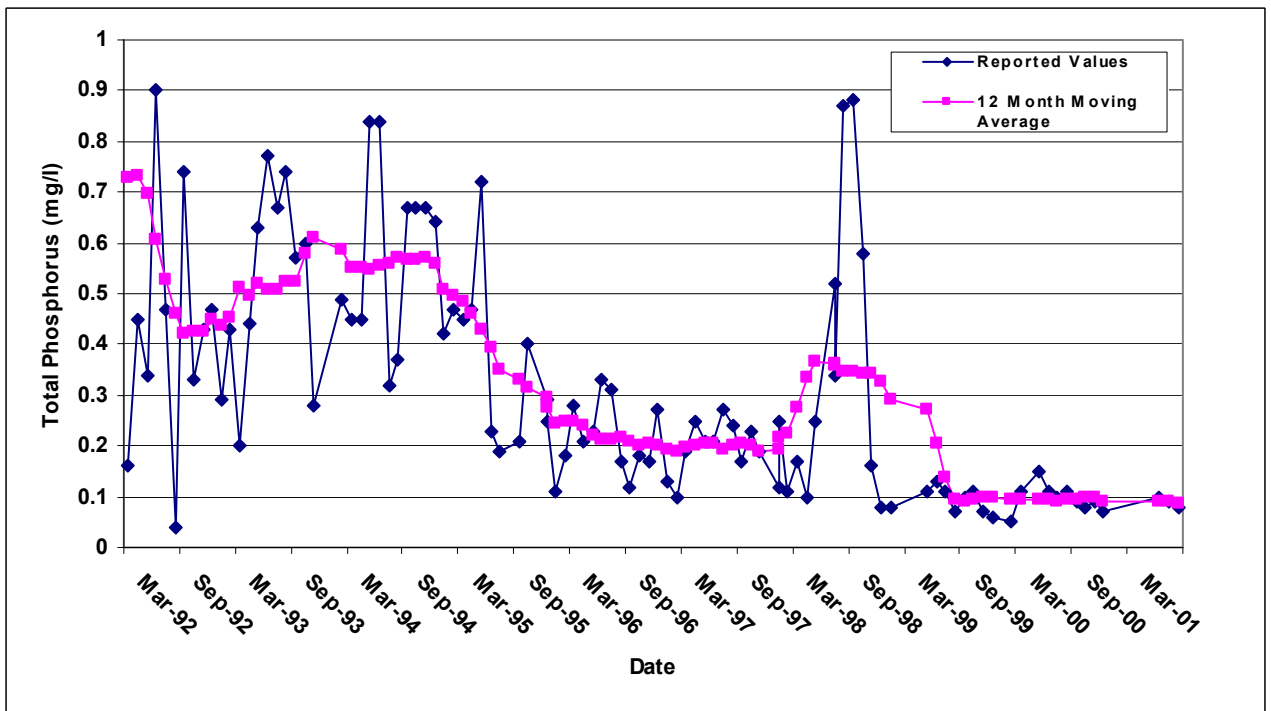
Figure 14. Total Phosphorus in Little Troublesome Creek at SR 2600

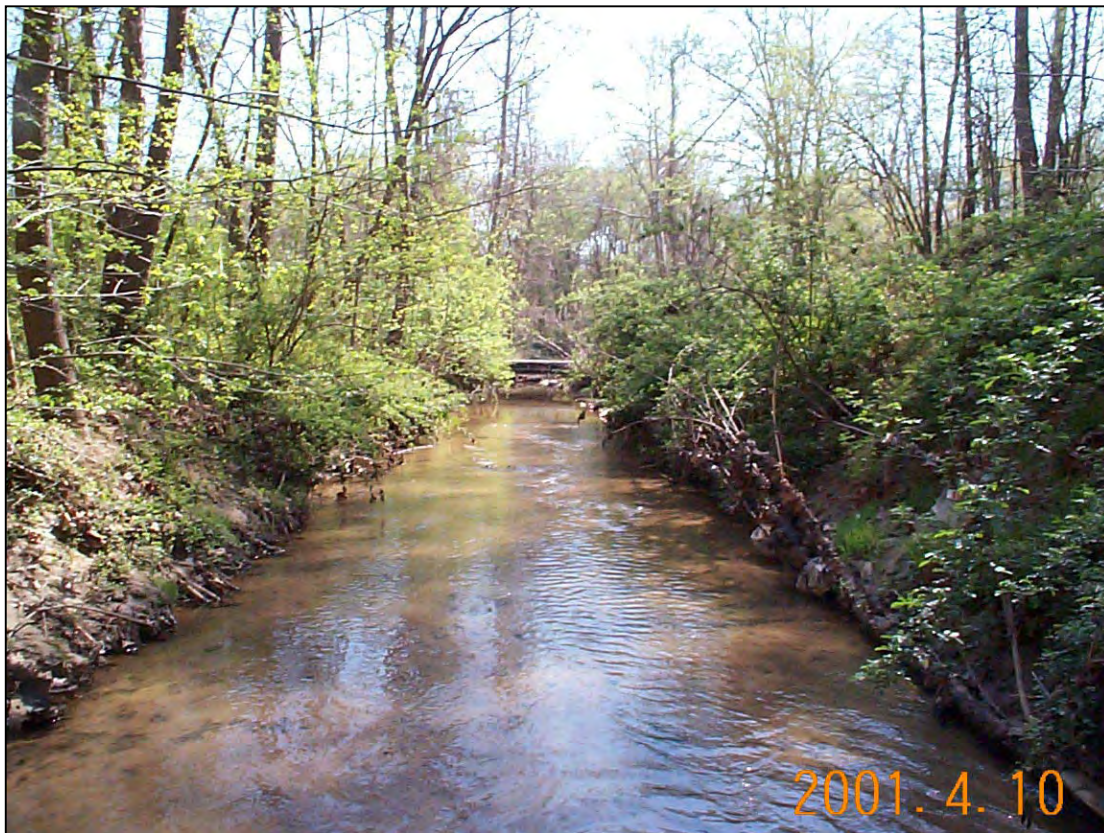
LWP Project Team members and WARP staff have both conducted field reconnaissance surveys of extensive portions of Little Troublesome Creek. Observations from those surveys have shown that significant portions of Little Troublesome Creek have been straightened. Figure 15 shows a section of the Creek in the vicinity of Industrial Drive where straightening has occurred, and the image is unfortunately typical of substantial portions of Little Troublesome Creek. No accounts have been located to date that would indicate when or why this hydro-modification of the stream took place, but the age and extent of floodplain vegetation indicate that it occurred at least 40-50 years ago.

**Figure 15. Straightened Section of Little Troublesome Creek**

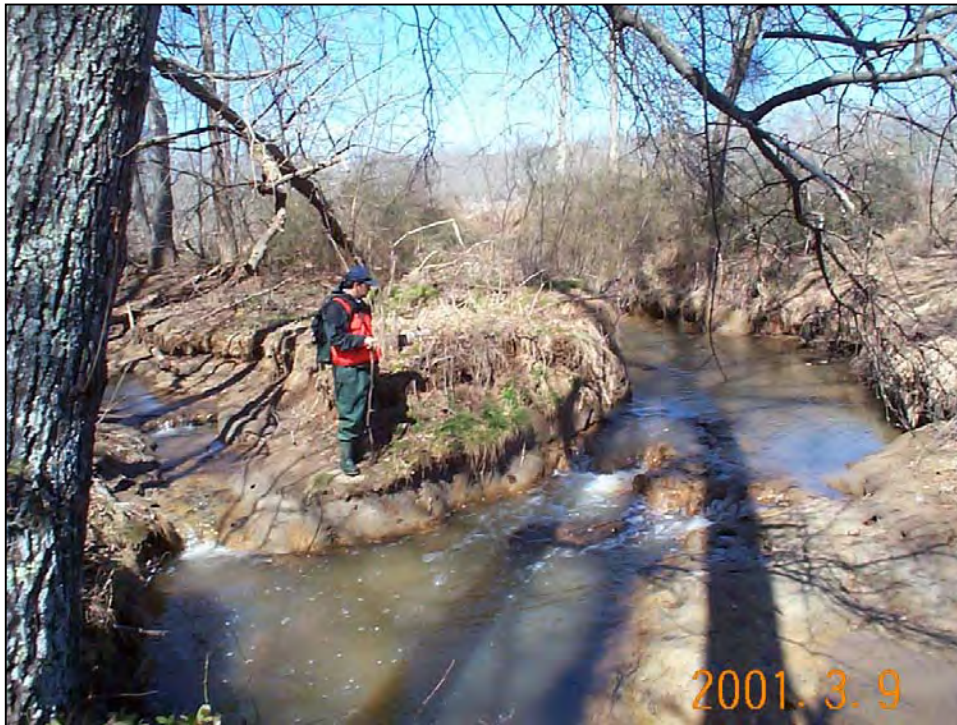
**Figure 16. Head Cut on Little Troublesome Creek near Cook Florist Road**

Taken collectively, reconnaissance efforts have shown Little Troublesome Creek to be a highly unstable system that is actively eroding and unstable throughout the majority of its length. Extensive morphological stream restoration will be required to bring the creek into a state of equilibrium with its sediment load and to re-establish stability.

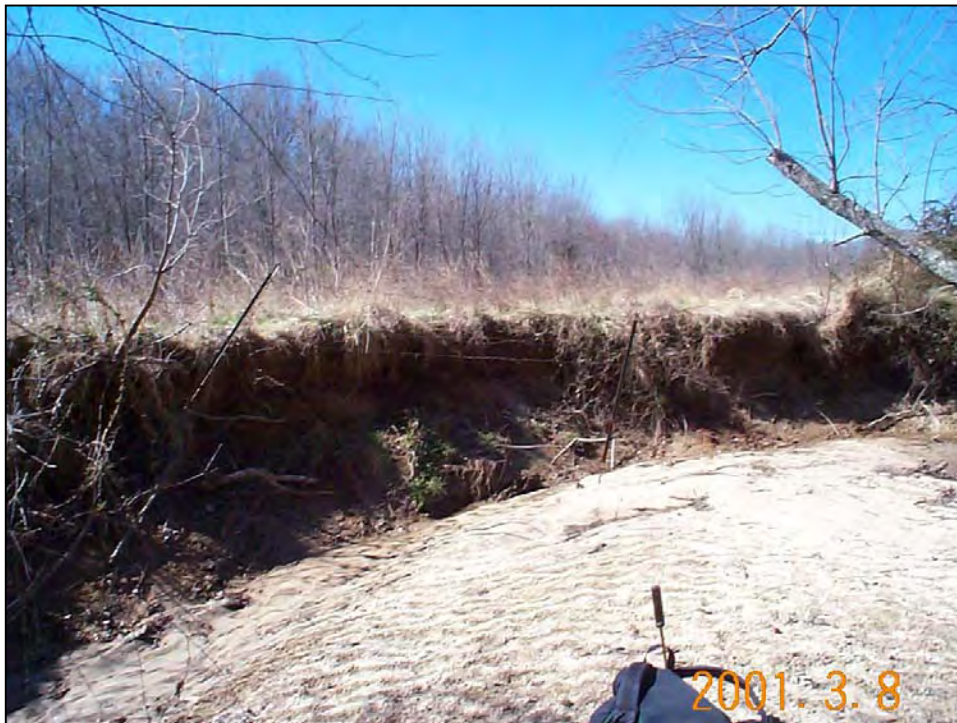
**Figure 17. Severe Bank Erosion on Little Troublesome Creek near Mizpah Church Road**

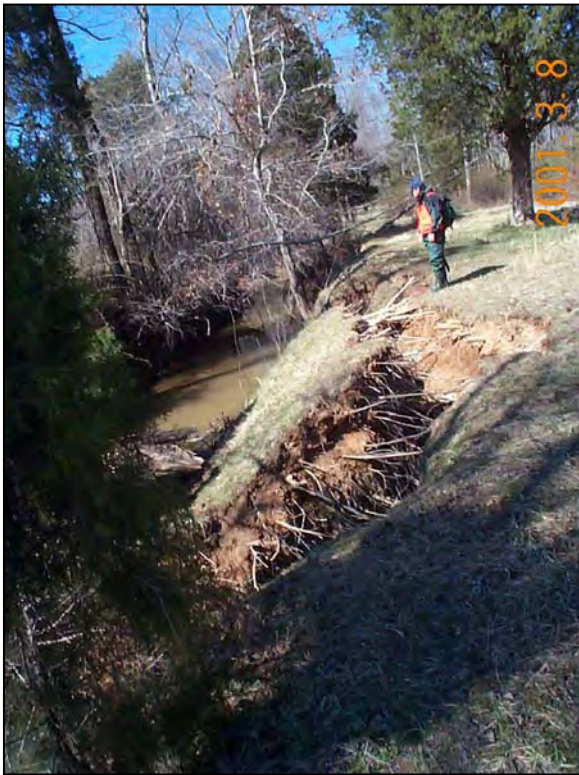
**Figure 18. Bank Failure on Little Troublesome Creek near Mizpah Church Road**

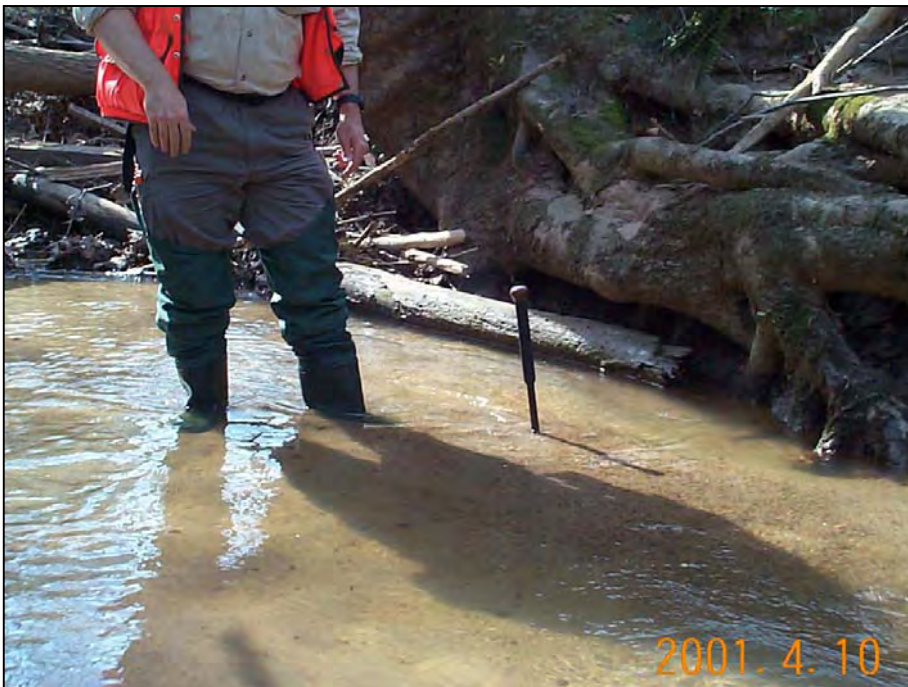
The four-foot rod was inserted two to three feet or more into the streambed sediments with relative ease. This illustration is representative of substantial portions of the creek.

**Figure 19. Sampling Rod Inserted in Little Troublesome Creek Stream Bed**

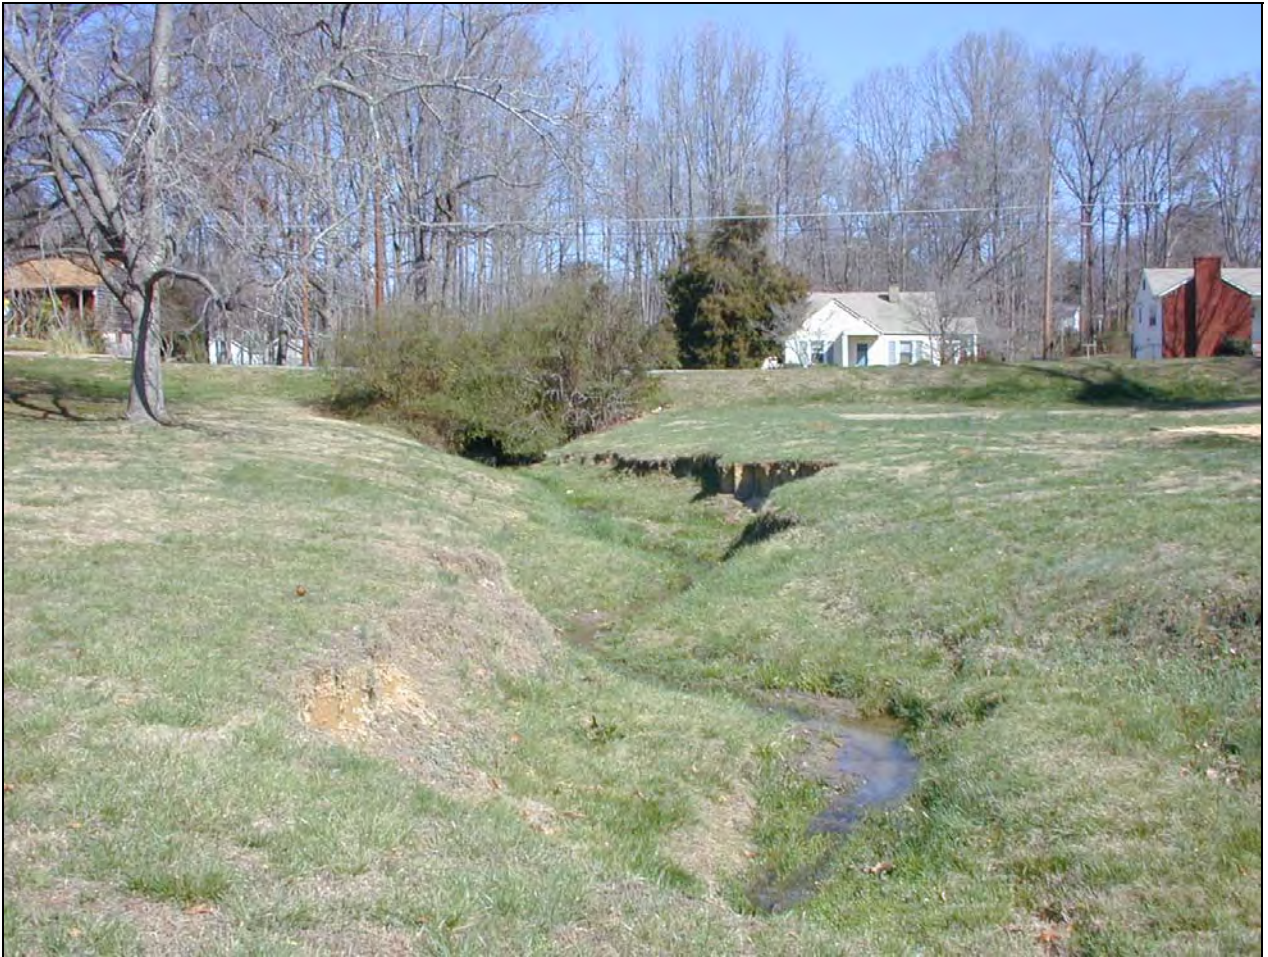
**Figure 26. Upper Section of Unnamed Tributary (UT) to Little Troublesome Creek in Courtland Park**

The potential restoration site consists of two individual stream channels that flow through a Reidsville City Park, Courtland Park, eventually joining at the southern park boundary adjacent to Green Street. The location of the park in relation to the Little Troublesome Creek Watershed and the City of Reidsville is shown in Figure 24 and Figure 25, respectively. The main creek flows from the north to the south through the middle of Courtland Park and is flanked by picnic shelters, parking lots, and playground equipment (Figure 26 through Figure 28). After flowing under Courtland Avenue via two crushed corrugated metal pipes, the creek becomes constrained between Green Street (Figure 29) and a sanitary sewer line. As the reconnaissance photos indicate, the main stem is incised and bank erosion is prominent throughout this section of the park, although the channel does possess some meandering pattern and active floodplain areas. The bank erosion will continue until channel equilibrium is reached and a new lower floodplain is created. The culvert pipes located at the origin and terminus of the channel reach are acting as grade control, limiting further incision and degradation. This reach would be an excellent Priority 2 candidate, which would entail designing an “E” or “C” type channel within an excavated active flood plain bench. There are no apparent constraints (i.e., utilities, etc.) immediately adjacent to the channel that would impede the restoration design.

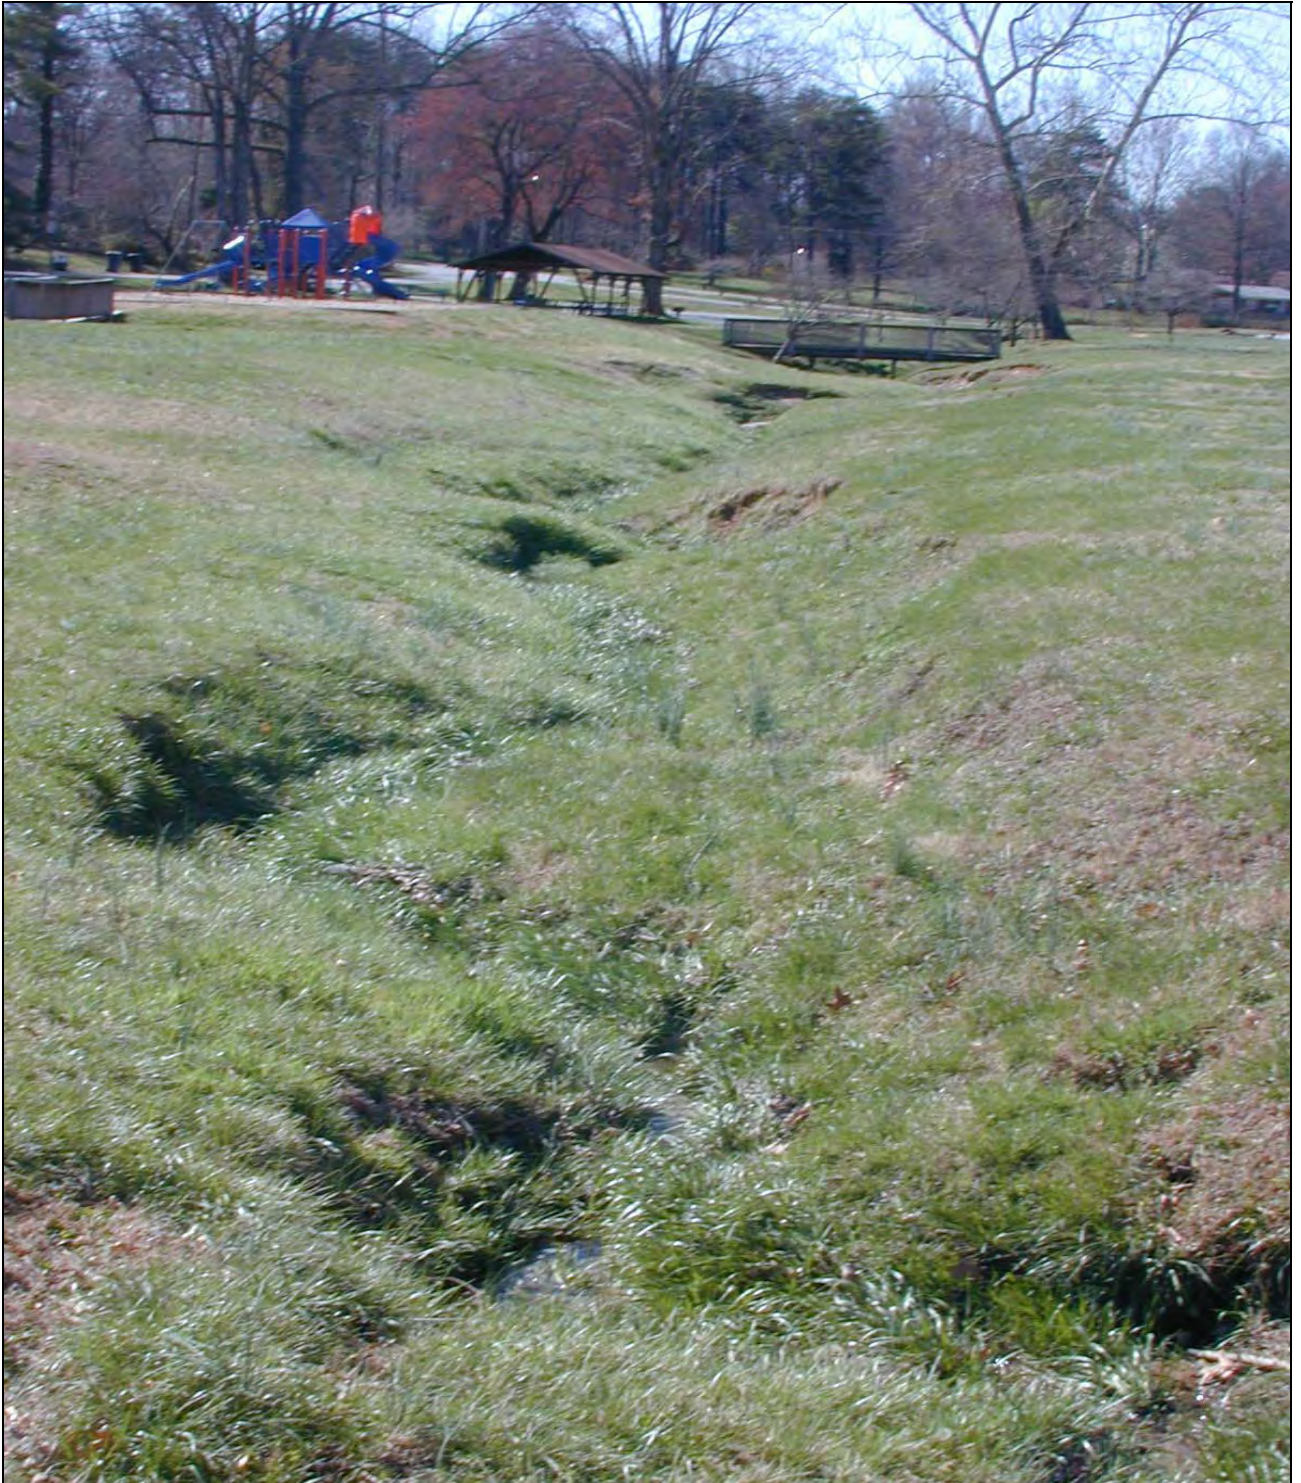
Figure 27. Middle Section of UT to Little Troublesome Creek in Courtland Park

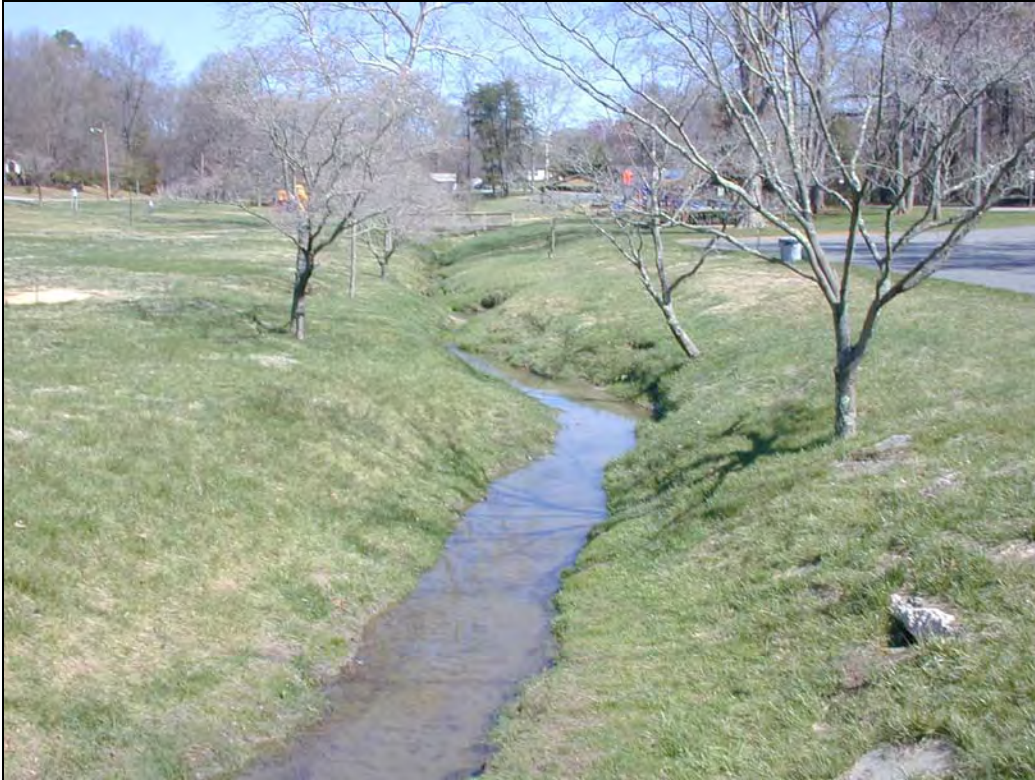
**Figure 28. Lower Section of UT to Little Troublesome Creek in Courtland Park**

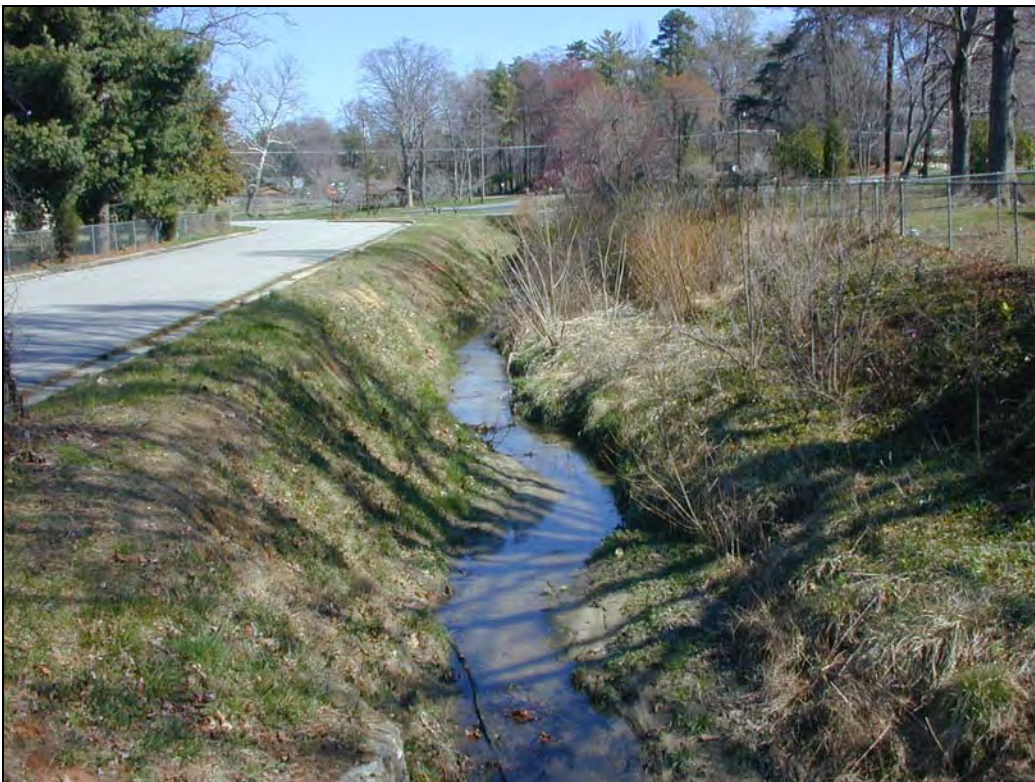
**Figure 29. UT to Little Troublesome Creek below Courtland Avenue**

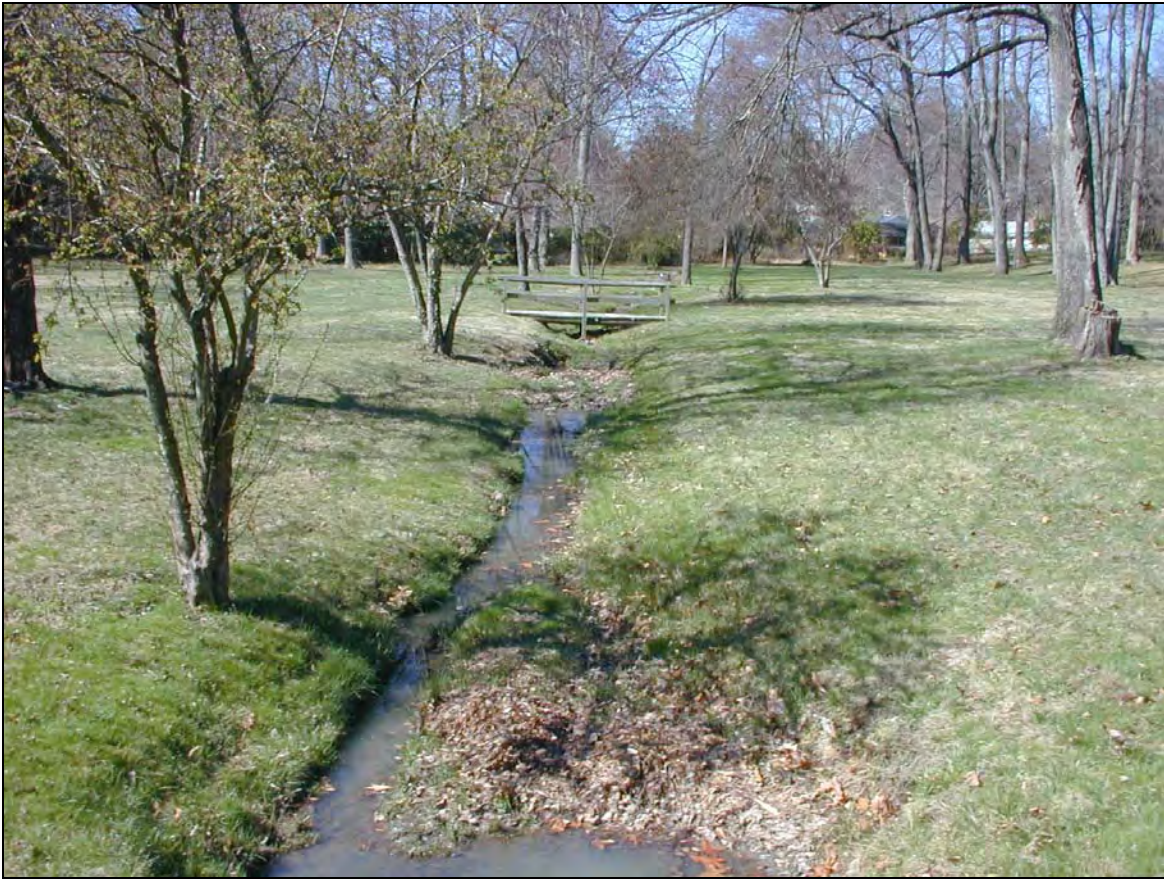
**Figure 30. First Order Tributary at Crescent Drive**

The second restoration opportunity consists of a first-order stream that, as mentioned before, intersects the main channel at the park’s southern property boundary. This small stream appears to have been channelized and diverted when the neighborhood was developed. It possesses several head cuts, but it is not yet incised within the park property. The reach of interest originates at Crescent Drive and flows southwest (Figure 30), then turns to the west, eventually joining the main creek described in the previous paragraph. This reach could be restored as a Priority I restoration and offers the additional possibility of creating wetlands immediately adjacent to the restored channel by excavating down to existing hydric soil indicators. The wetland restoration potential would require more intensive field studies (hydric soil delineation, groundwater investigation, etc.) prior to formalizing the acreage yield and practicality. Other limitations to this option may include the economic feasibility, considering the scale of the site, and the potential for social resistance to the proposal. Social resistance may stem from the cultural bias toward viewing an uninterrupted panorama of the park or the desire for the “manicured” appearance of regularly mowed stream banks.

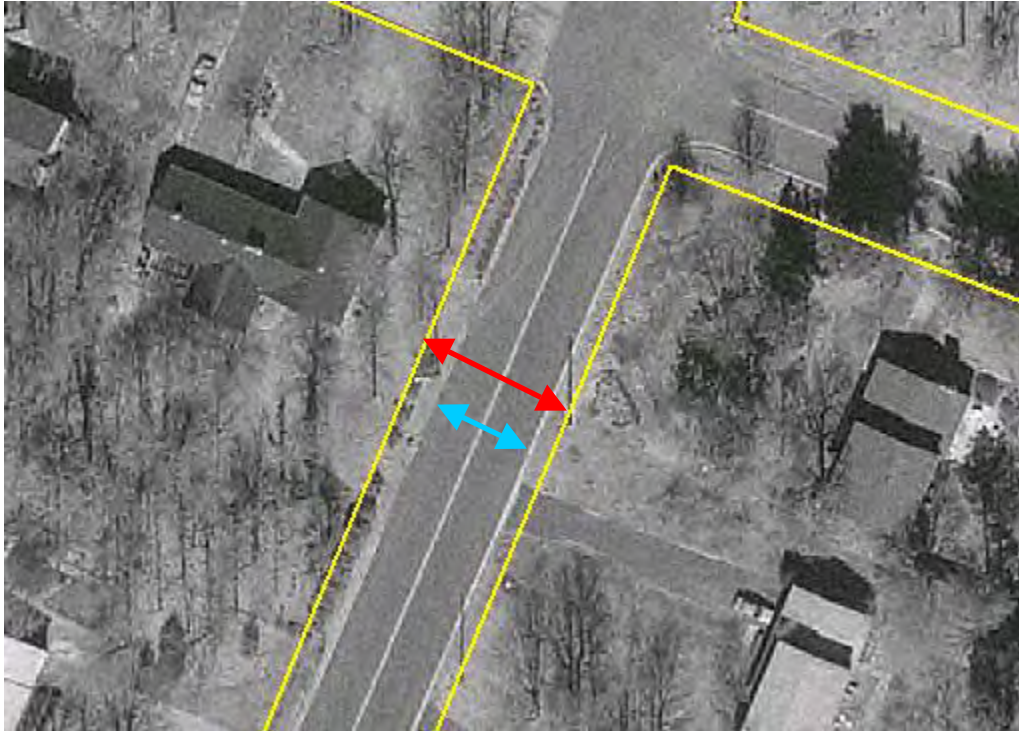
The subwatershed coverage was intersected with the right-of-way coverage to find the right-of-way area within each subwatershed. The product of those areas and the road to right-of-way ratio provided an estimate of the area of roadway imperviousness within each subwatershed.

**Figure B-1. Example of Right-of-Way Imperviousness Measurement**

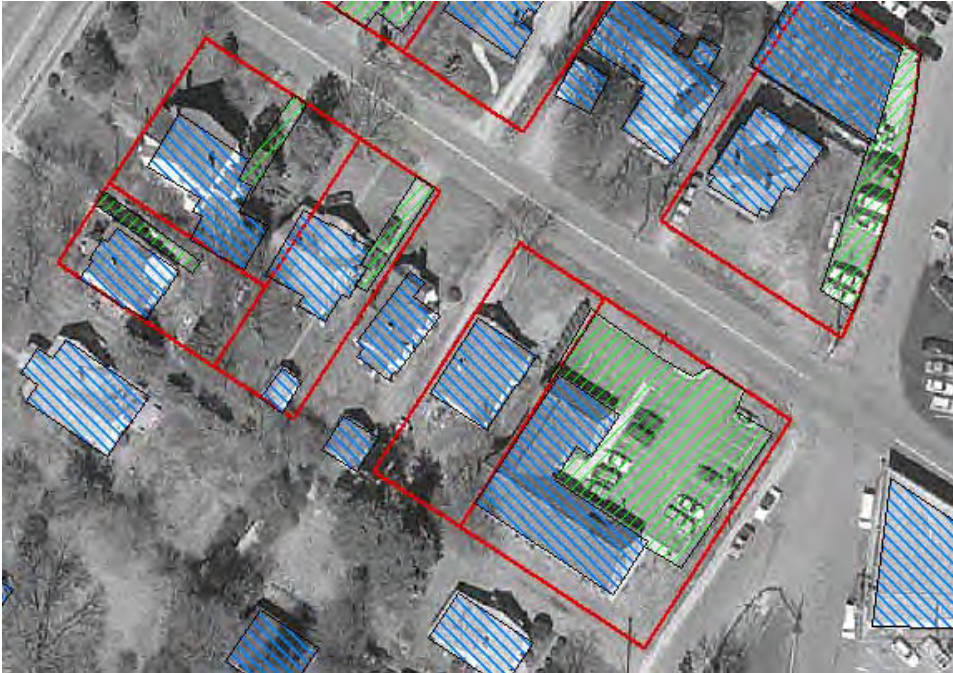
The underlying assumption is that extra imperviousness is related to the zoning class. Therefore, extra imperviousness was always determined for individual parcels, not for specific areas. This was done in ArcView by digitizing with a mouse the impervious areas within specified parcels. An example of this is shown in Table B-2; the red boundaries define parcels which were sampled for extra imperviousness, the blue hatched zones are building planimetric areas, and the green hatched zones were digitized by drawing around the areas that looked like pavement, patios, swimming pools, out-buildings not defined in the planimetric data, etc. For the purposes of this analysis, the Project Team assumed that unpaved areas, such as dirt or gravel driveways, were somewhat permeable to rainfall and therefore not included in estimates of extra imperviousness. This analysis will be used to assess risk and prioritize areas for restoration, so the assumption that unpaved roads are pervious does not adversely affect the results. However, some adjustment should be made to the results if the impervious estimates are used in modeling applications.

**Figure B-2. Example of Sampled Parcels, Building Planimetrics, and Digitized Extra Impervious Areas**
