# MUDDY CREEK WATERSHED RESTORATION INITIATIVE

## Feasibility Report and Restoration Plan for The Muddy Creek Watershed

Burke and McDowell Counties, North Carolina  
Catawba River Basin

December, 2003

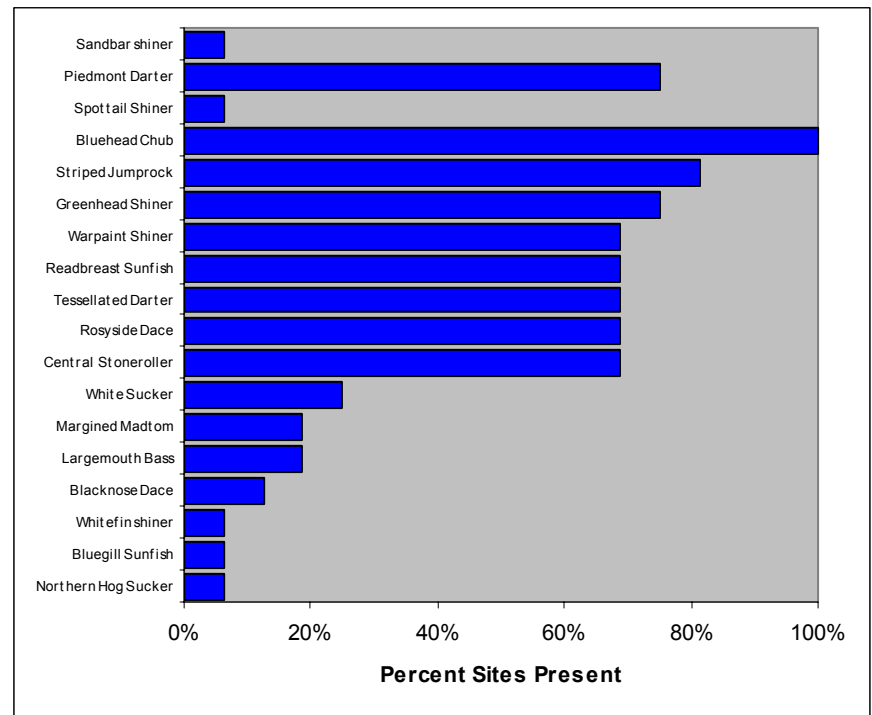
Figure 5: Fish Survey Results in Muddy Creek Watershed

The NCWRC concludes from their qualitative fish studies that the effects of sediment have a cumulative impact on the fish community as one moves downstream and the entire watershed is impacted. A total of 18 species of fish were collected in October 2000. Of these, only two are intolerant of pollution, the spot tailed shiner and piedmont darter, while the remaining 16 species have an intermediate tolerance rating. The piedmont darter was observed in 12 of the 16 sampling sites whereas the spot tailed shiner was reported at only one site. This information is consistent with NCDWQ ratings of “fair” at their two fish community sampling stations (NCDWQ, 1999, p. 83).

NCDWQ’s North Muddy Creek benthic site registers a “good” rating while their South Muddy Creek benthic site registers a “Good-Fair” rating. Duke’s benthic monitoring in North Muddy Creek up and downstream of the Partners’ first restoration sites indicates “fair” water quality.

Both DWQ and Duke’s sampling locations are also very near DWQ’s fish sampling sites. When benthic and fish community data conflict, the fish community results normally take precedence as a superior indicator of long-term water quality.

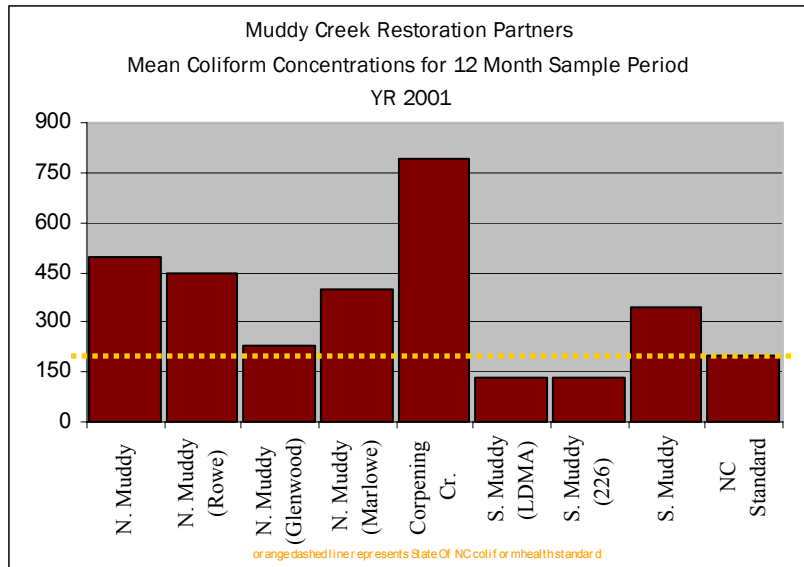
Figure 6: Mean coliform counts in Muddy Creek watershed

Of potential concern is the fecal coliform count whose mean concentration at six of eight sampling sites in the watershed exceed concentrations allowed under State of NC health standards. Figure 6 shows the mean number of colonies for each site. Coliform readings on some streams reflected counts well over 10 times the state standard. Sources of this contamination are not known. Early assumptions for the Corpening Creek drainage are that faulty septic and sewer system failures may be responsible for high coliform counts.

Both coliform and TSS results reflect conditions at time of sample. Most were taken during low-flow periods. Stormflow sediment calculations for the Muddy Creek watershed are still being analyzed and are currently unavailable.

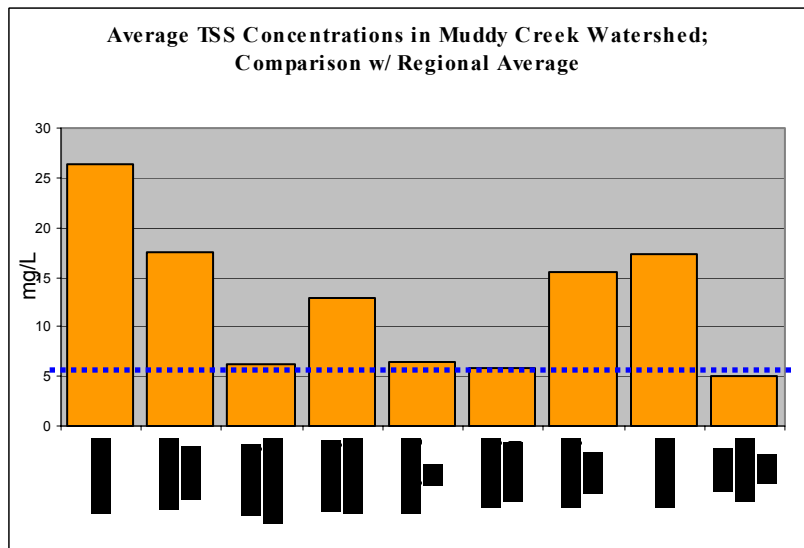
Figure 7: Mean TSS concentrations in the Muddy Creek watershed

Total suspended solid (TSS) measurements are also higher in the watershed compared to the UNC-A VWIN program’s regional average (Figure 7). This NC state certified lab has established over 200 sites in 13 counties in western NC and have a quantity of data to use as a good regional comparison. These grab samples suggest chronically high TSS levels in the watershed.

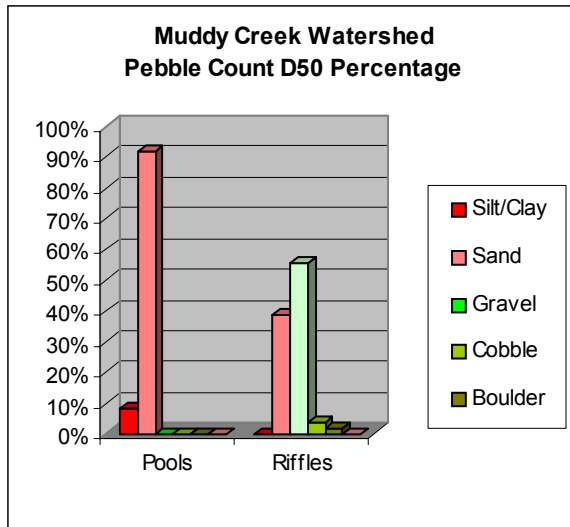
Figure 8: Riffle and Pool D50 Distribution

Modified Wolman pebble counts were taken at 55 locations throughout the watershed to determine dominant stream substrate (See Map C: Bank Pin and Pebble Count Locations). Most of these measurements were of associated riffles and pools, though some counts were taken only at riffles. At most sites, counts were taken both on the major stream course and an associated tributary, but upstream from the zone of influence of each. The diameter of the median pebble count size is referred to as the D50 of the pebble count sample. Pebble counts are ordered by size from smallest particle to largest as silt/clay, sand, gravel, cobble, boulder, and bedrock.

Thirty eight percent of riffles and 100% of pools surveyed in the Muddy Creek watershed are comprised primarily of sand and fine particles, typically poor invertebrate and fish habitat in a southern Appalachian/Piedmont aquatic system. Substrate material was gravel and cobble in 60% of the riffle areas with sand comprising the remaining 40% of riffle material.

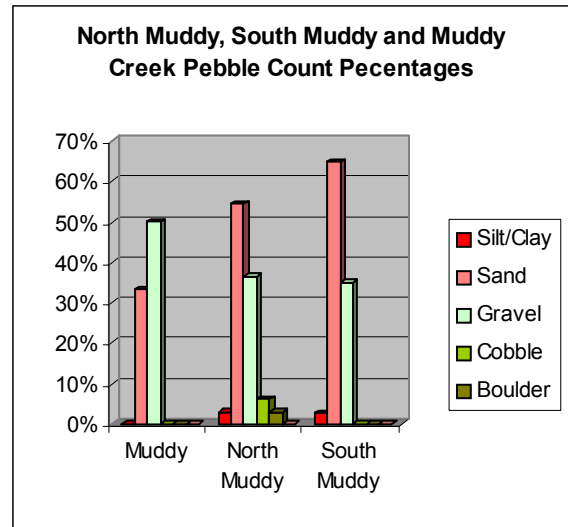
Figure 9: Watershed Substrate Composition

When dividing the watershed into sub-drainages, it becomes clear that South Muddy Creek and its associated tributaries are dominated by sand and silt. The substrate on North Muddy Creek and its associated drainages exhibits a more balanced composition of fine particles, gravel, cobble, and bedrock though fine particles are still the predominant substrate composition.

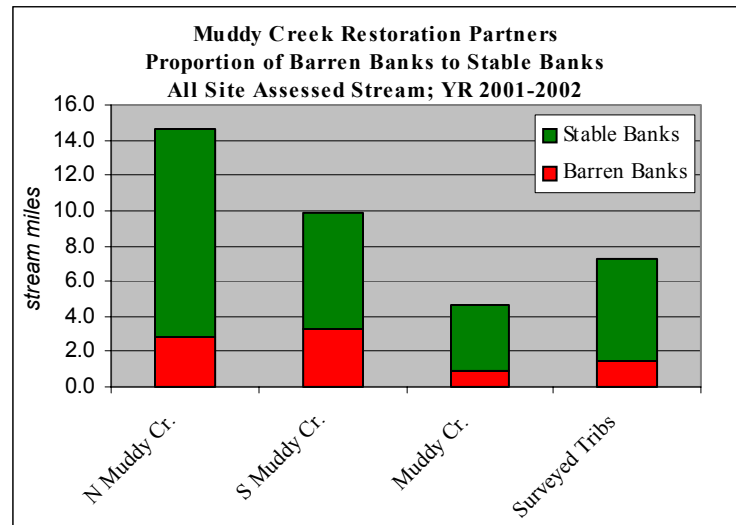
Figure 11: Ratio of Barren to Stable Banks in Muddy Creek

South Muddy Creek has a greater ratio of barren banks to vegetated banks (Figure 11). Much

of this occurs along stretches of the creek that have been dredged and straightened in the past, including former historical wetlands along South Muddy Creek and adjacent to the South Muddy/Hoppers Creek confluence. Most of the central portion of North Muddy Creek shows no sign of barren banks. This is likely because this stretch flows for roughly nine miles through an area dominated by bedrock and deep forestlands. There are barren banks along North Muddy Creek nearer its headwaters where the land is flatter and agricultural and residential land uses intensify in the riparian zone.

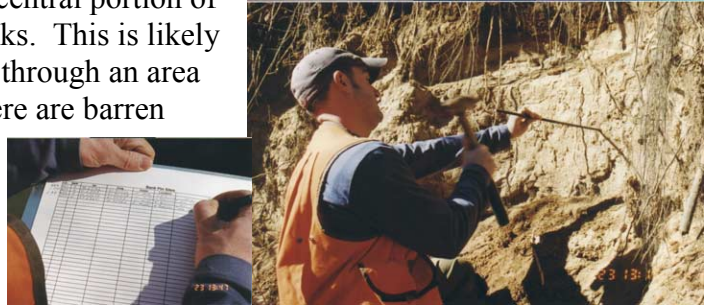
Figure 12

Identifying barren bank sites is an important first step toward prioritizing restoration, but this information alone provides an incomplete picture of the threat these barren bank sites present to watershed health. Some barren banks may be eroding, collapsing, and delivering sediment to the Muddy Creek system while other sites may not. The Muddy Creek Restoration Partners strategically installed bank erosion pins at 38 barren bank sites to gauge the activity level of certain areas (Map C). Some sites contain only one four foot long pin while others contain up to 11 pins. Most contain 6 - 10 pins distributed laterally and vertically across the surveyed barren bank area (Figure 12).

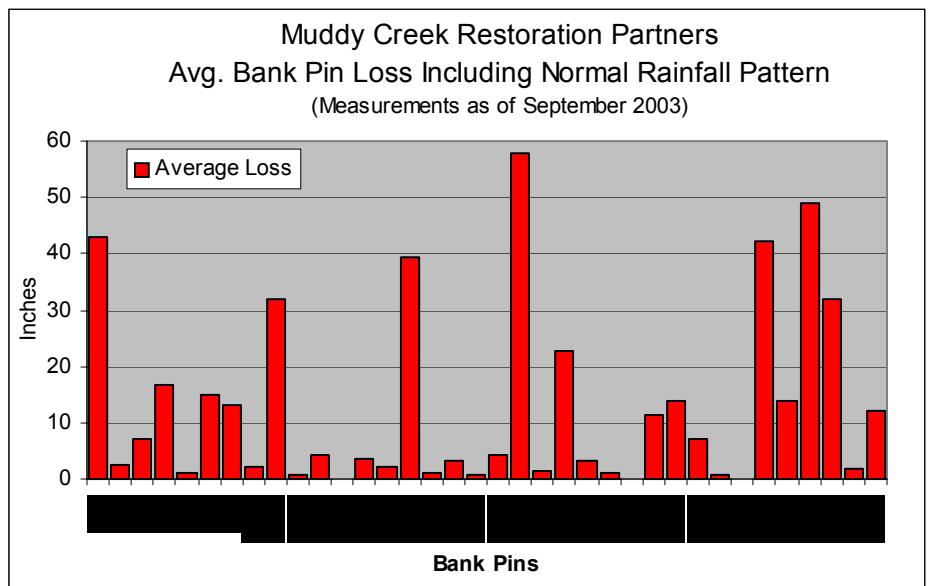
Figure 13: Average Bank Pin Loss in Muddy Creek Watershed After Normal Rains

Results are clear. During periods of below normal rainfall, only a few barren bank sites are significant sources of sediment to the watershed. However, during normal to above normal rainfall, erosion from barren banks increases dramatically

all sites. Since September 2002, the project area has received normal or above-normal rainfall, which has raised the flow level in the watershed substantially. In contrast, during 1998 - 2002, the area was suffering through an extreme drought.

It also appears that a few barren banks in the watershed are not significant contributors of sediment, regardless of rainfall events. The field assessment team speculates from firsthand observation that one reason some sites are less susceptible to bank erosion is the clay composition of their soils. Field observations also revealed that barren banks are susceptible to the forces of freeze/thaw and wind erosion, often overlooked as catalysts of sediment delivery to the watershed. Though likely not as powerful as stormflow to collapsing barren banks, wind and freeze thaw action do contribute over time to the problem.

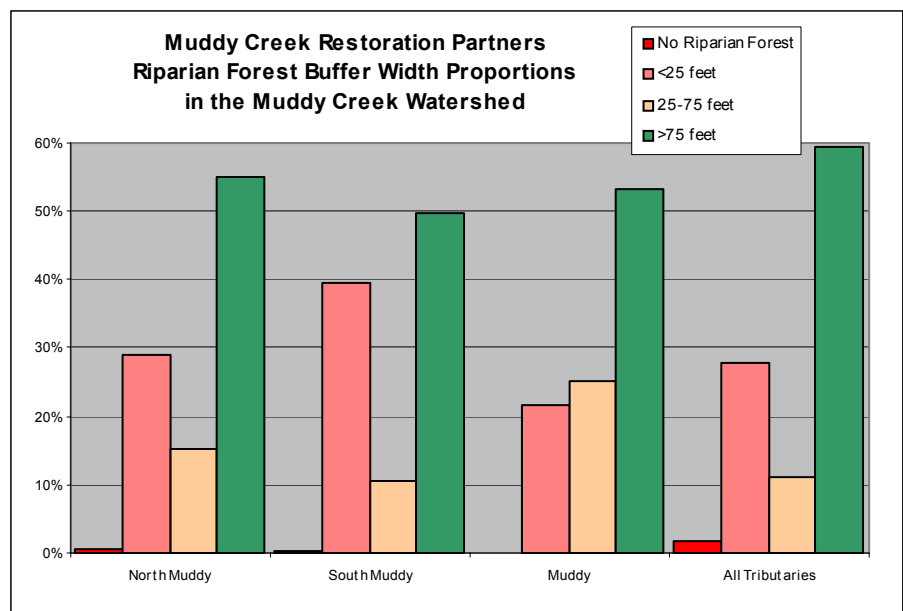
Figure 14: Riparian Forest Buffer Width Proportions in the Muddy Creek Watershed

above are derived from both the in-stream field survey conducted on navigable streams and an analysis of infrared aerial photographs (Map E: Riparian Forest Buffer Widths of Navigable Streams in the Muddy Creek Watershed; Map F: Riparian Forest Buffer Status of 2nd Order and Above Non-Navigable Streams in the Muddy Creek Watershed).

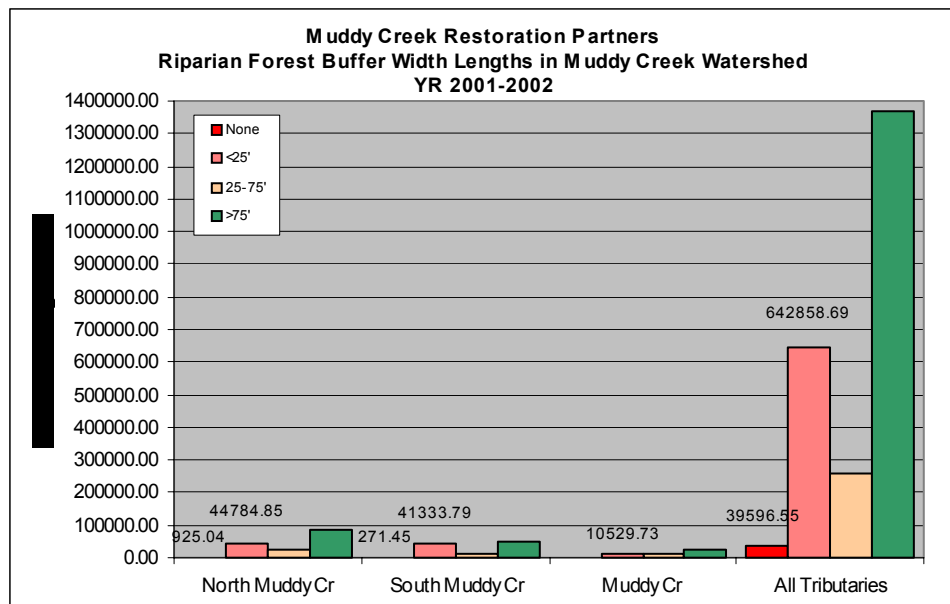
Figure 15: Riparian Forest Buffer Width Lengths in the Muddy Creek Watershed

By far, the greater amount of stream frontage with less than 25 feet of riparian forest buffer occurs on tributaries (Figure 15). Many of these smaller, non-navigable streams dissect residential lots, pastures, fields in row crops, and logged forest lands. In most cases, these streams

Smaller inaccessible tributaries account for 39,000 of the approximately 40,000 linear feet in the watershed having “no” buffer (Table 3; Map F). Most of them are in the North Muddy

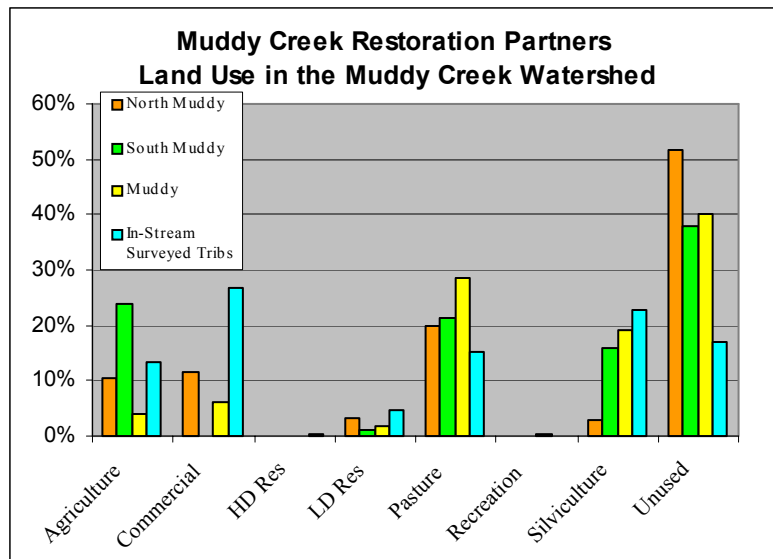
Figure 16: Land Use in the Muddy Creek Watershed

Pasture, agriculture, and commercial land use activities are proportionately more prevalent on tributaries than on the main stems of North and South Muddy Creeks. Some pastures provide direct access to creeks while others were observed to have adequate fencing to preclude cattle access. Cattle access to creeks was found at five sites along the larger accessible streams (Map H: Locations of Fenced and Unfenced Cattle). In addition, a quick random windshield survey of lands identified in pasture through the aerial analysis revealed 10 of 13 sites with unimpeded livestock access to the creek. Though this windshield survey lacks rigorous scientific controls, the Partners are confident in its ability to predict comparable results if randomly employed elsewhere in the watershed. Unchecked animal access to streams can be a major cause of streambank collapse and sedimentation, and coliform bacteria inputs. This land use practice is prevalent in the Muddy Creek watershed.

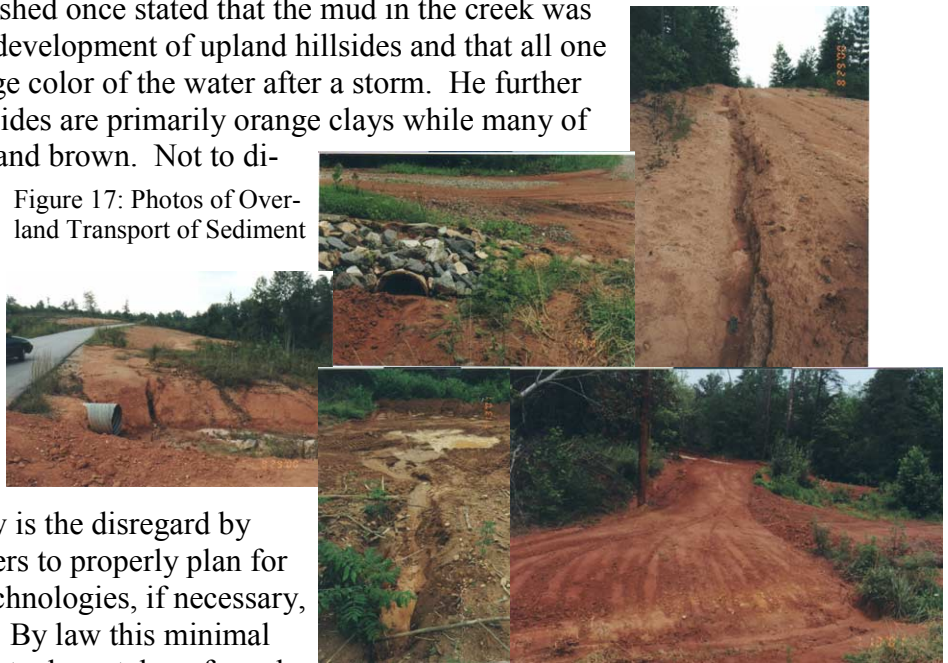
Figure 17: Photos of Overland Transport of Sediment

Recommendation 4) Combat overland transport of sediment with equal fervor as bank erosion.

The State does not have the organizational capacity to monitor and enforce the Sediment and Erosion Control Act of 1974 and McDowell County does not employ anyone to help. The Partners should see to it that someone - even if that be the Coordinator of the Muddy Creek Restoration Partners - monitors the project area for the presence of appropriate sediment and erosion control measures, reports these findings to the State and County leaders, and ensures that existing laws are enforced. If overland transport of sediment is not addressed, sediment loads from these sources will nullify gains from other stream and riparian restoration projects.
