Biological Impairment in the Mud Creek Watershed

**French Broad River Basin
Henderson County**

June 2003

**North Carolina Department of Environment and Natural Resources
Division of Water Quality
Planning Branch**

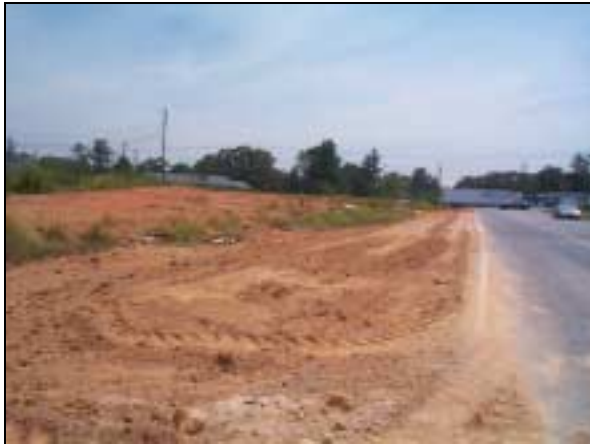
Development associated with home sites and commercial ventures has resulted in increased sedimentation in creeks in the watershed. In the rapidly growing Hendersonville area and I-26 corridor, commercial construction sites often expose a large amount of bare soil (Figure 2.11). Because erosion control measures are often inadequate, many of these sites serve as sediment sources for area creeks. Construction for both house sites and roads in residential developments also serve as sediment sources for streams, especially in higher slope areas where it is more difficult to stabilize disturbed soil. After construction, any slopes that have been cut into hillsides and have not been stabilized with vegetation continue to erode. The IPSI identified 68 miles of road with eroding banks in the Mud Creek watershed. Once in place, gravel and dirt roads in the steep areas of this watershed continue to be a significant source of sediment during storms (Figure 2.12). According to the IPSI, a high proportion (34% or 272 miles) of the roads in the watershed are unpaved.

Figure 2.11 Site prepared for commercial development in the Mud Creek watershed.

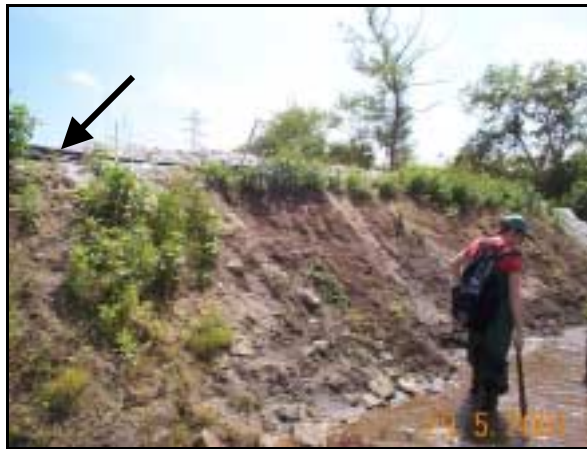
Figure 2.12 Runoff from gravel driveway in the upper Mud Creek watershed.

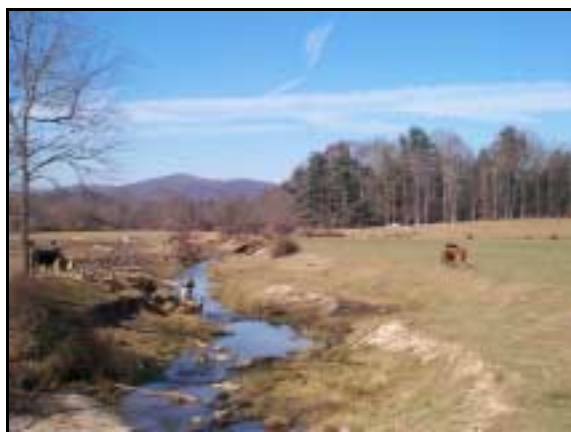
Cattle. Cattle have direct access to a number of streams in the watershed (Figure 2.14). By grazing woody riparian vegetation and creating paths to a stream, cattle destabilize stream banks. They are responsible for severe stream degradation (Figures 2.15, 2.16) along a number of streams in the watershed (e.g., Mud Creek, Bat Fork, and Henderson Creek). Stream bank collapse contributes large amounts of sediment to a stream. Direct input of animal waste into streams and runoff from pasture and feeding areas are sources of nutrients and fecal

Figure 2.15 Cattle pasture in Henderson Creek.

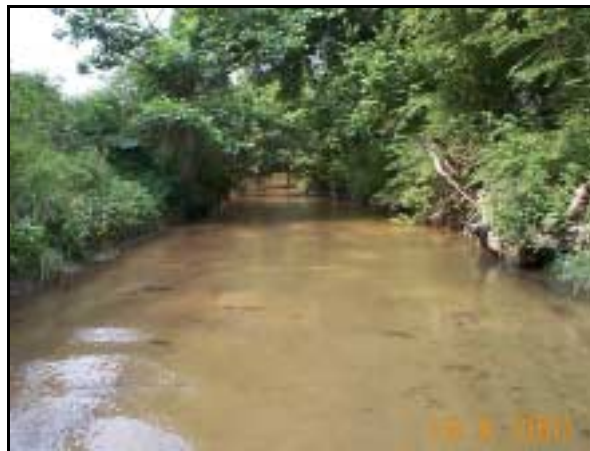
As Mud Creek flows through agricultural and golf course areas, riparian vegetation is generally limited to a thin (0-10 ft) border of a mix of invasive shrubs and herbaceous plants that do not provide much bank stabilization. These unstable banks are prone to sloughing, and recent and older bank blowouts were observed. Recent blowouts were seen in areas where cattle have stream access and at power line crossings (Figure 2.16). In some areas, landowners have attempted to stabilize unstable banks with tires, wood, and other materials. Where the channel is wider due to blowouts, the stream has more room to meander through the incised channel. Bare banks are likely a major source of excess sediment seen in the channels.

Figure 4.2 Channelized reach in upper Mud Creek.

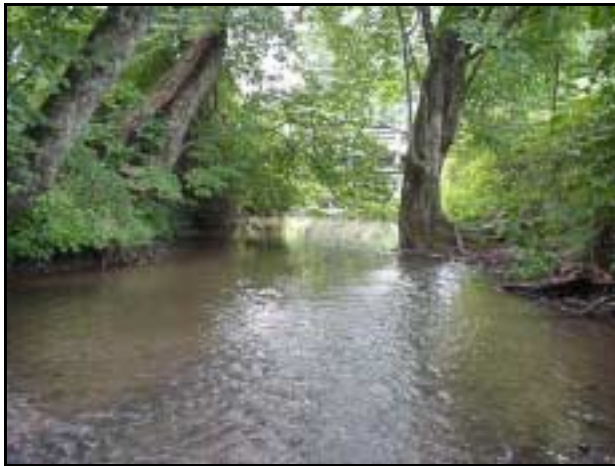
Brief examinations of stream and riparian conditions were performed for Clear Creek and Devils Fork and their tributaries. Sections of the Clear Creek mainstem have been channelized (26% according to IPSI estimates), but it has considerably more sinuosity than much of Mud Creek. Along much of its length, it is bordered by a thin forested riparian area, often just a single line of mature trees. This woody vegetation provides some bank stability and edge habitat (undercut banks), as well as organic microhabitat (Figure 5.3). There are frequent areas of bare and unstable banks along Clear Creek, especially where there is no woody vegetation, cattle have had access to the stream, or bridges have altered the flow pattern of the creek (Figure 5.4). Sand and silt does build up in slower sections of the creek, but Clear Creek's moderate gradient pushes much of these fine sediments through faster riffle and run areas. An active sand dredging business operates near the mouth of the creek.

Figure 5.3 Clear Creek with woody riparian vegetation.

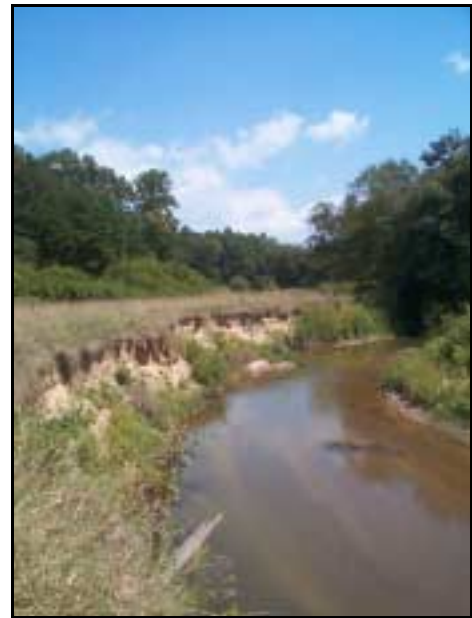
Figure 5.4 Clear Creek in old pasture.

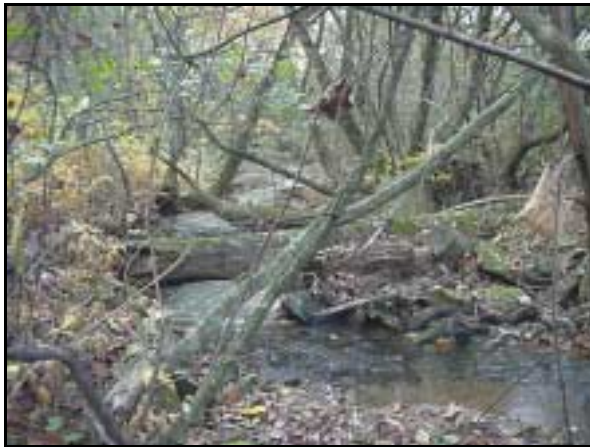
Tributaries of Clear Creek vary in their channel and riparian area characteristics. Generally, tributaries that flow off the northern ridge (e.g., Laurel Fork) have good in-stream habitat, with an adequate mix of inorganic substrate. Where woody riparian vegetation is present, organic microhabitats (woody debris, leafpacks) are abundant (Figure 5.5). Tributaries that flow from the southeast, such as Lewis Creek, are lower gradient and flow through agricultural or residential land. These streams have often been channelized and have little woody riparian vegetation; many of them are incised and unstable. They are unable to transport finer sediments, and sand and silt comprise most of the bed substrate.

Figure 5.5 Laurel Fork.

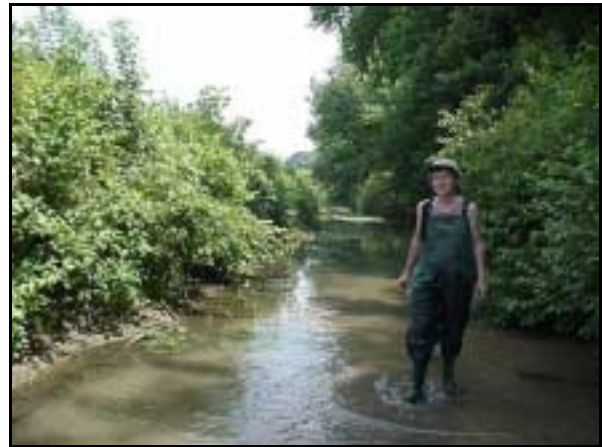
Figure 5.6 Devils Fork at US 64.

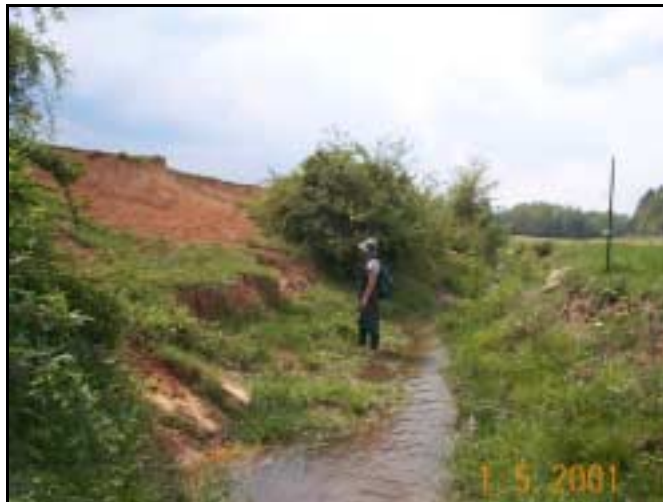
Much of Bat Fork is an unstable system, impacted by multiple factors. The headwater section of Bat Fork is of moderate gradient and begins below a small lake, after which it parallels a road for approximately 1,000 ft; here it has been channelized and is highly incised. It enters a small residential wooded area and then emerges in a cattle pasture near Roper Rd., where cattle have access for 0.5 mi and stream banks are extremely degraded (Figure 6.2).

Figure 6.2 Pasture along Bat Fork near Roper Rd.

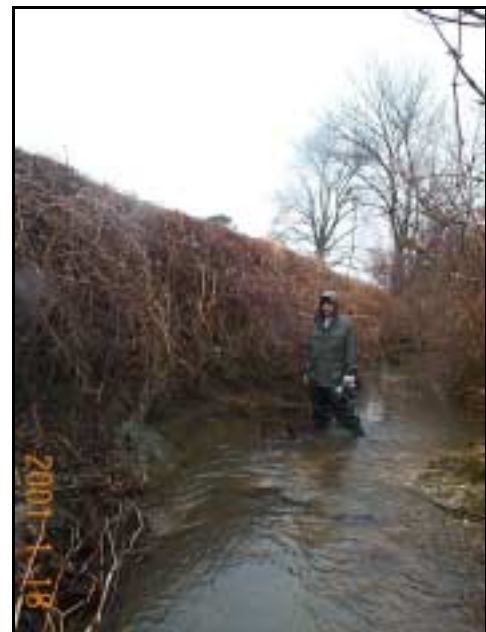
Figure 6.3 Channelized section of Bat Fork.

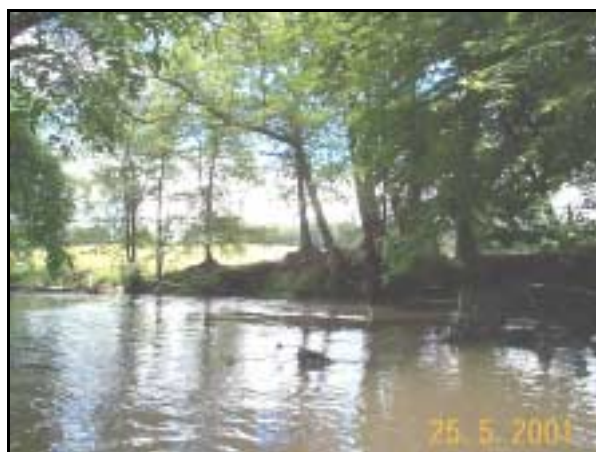
Figure 7.2 Border of trees along lower Mud Cr.

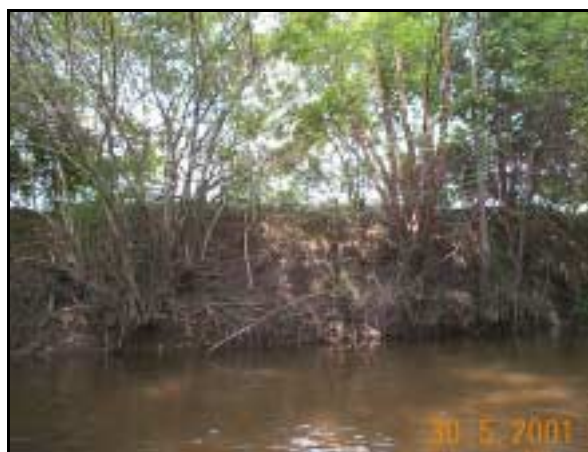
Within the Hendersonville Wetlands Park, most of the flow of Johnson Drainage Ditch joins Mud Creek through a ditch that connects Johnson Drainage Ditch and Mud Creek. Flow from this ditch approximately doubles the flow of Mud Creek. Below this confluence, stream banks of Mud Creek become notably higher and less stable, reflecting the increased stress of stormflows from Johnson Drainage Ditch, which carries runoff from large commercial areas that drain to Bat Fork and Devils Fork (Figure 7.3).

Figure 7.3 Unstable banks on Mud Creek below Johnson Drainage Ditch

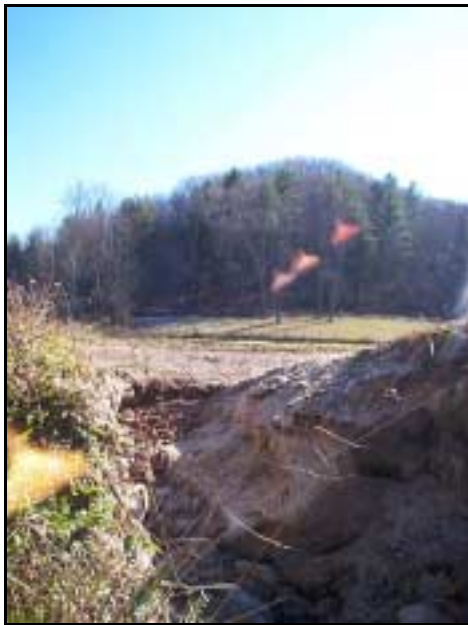
Figure 8.1 Berm break in tomato field.

Impacts from past-use pesticides used on row crops may also be important, especially in the Clear Creek subwatershed. Control of sediments on fields and on eroding stream banks is important to reduce the likelihood of these pesticides reaching streams.

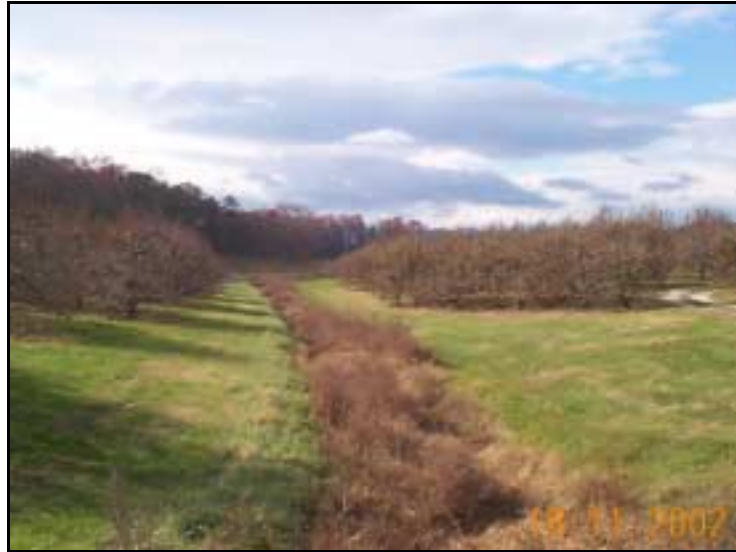
Figure 8.2 Apple orchard near stream.

4. **Effective BMPs to prevent row crop pesticides from entering streams should be used to address four potential delivery mechanisms:**
 - a) Pesticide mixing areas near streams should be replaced with agrichemical mixing facilities that are away from streams and properly manage pesticides.

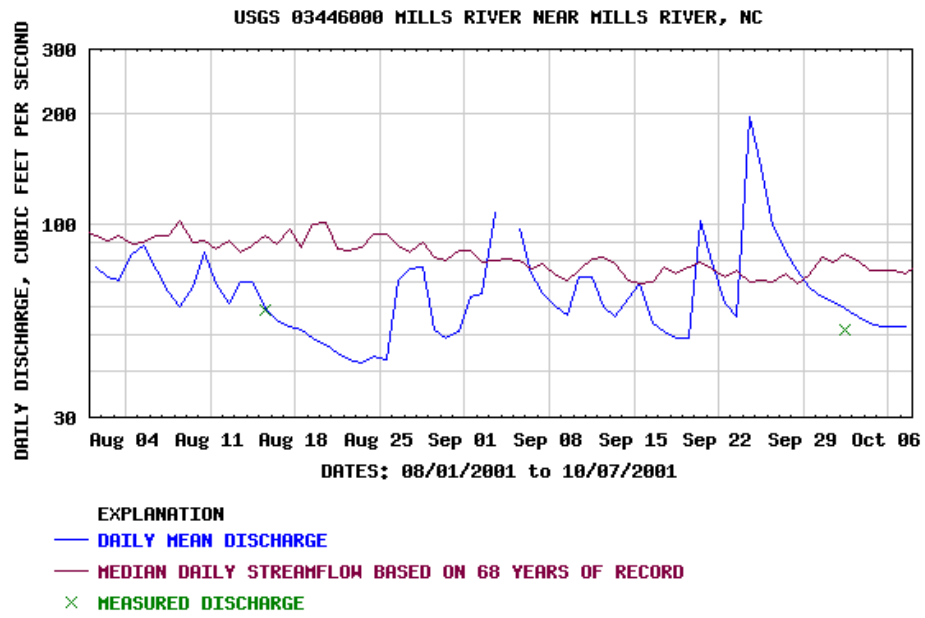
At the time of sampling in October 2001, flows based upon the USGS gage for the Mills River near Mills River, were approximately 71% of the historical median value (Figure 1.). However, rainfall in the week prior to sampling produced flows 285% above the historical median value. Scour and fast moving, high water is a factor to consider in benthic sampling. Results of two reference sites (Laurel Fork and Crab Creek) indicated less diverse biological communities, and the effect of high water on the reference sites and study sites should be considered for the October data.

Figure 1. Daily mean discharge and median daily streamflow August - October 6, 2001.

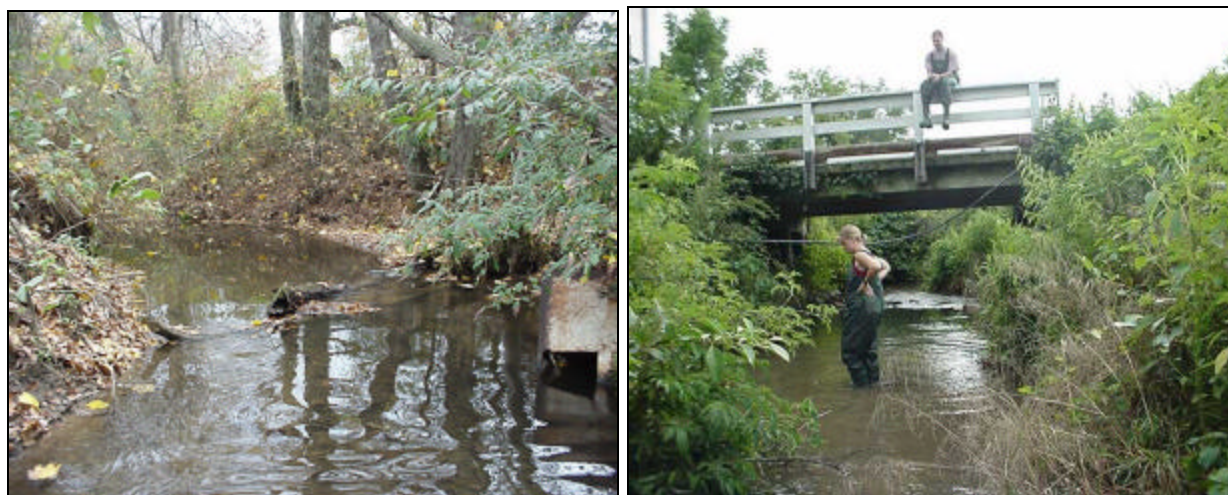
Mud Creek at SR 1125 (left) and Mud Creek at SR 1126 (right)

Mud Creek at SR 1126 This site is located 1 mile below the SR 1125 sampling location. There are tomato fields below SR 1125 that could impact the benthos at SR 1126. The substrate at this station was mostly sand and silt and the stream width increased to 3 meters. There were breaks allowing sedimentation from the minimal riparian zone and severe erosion was noted on the banks. The only riffle in the sampling reach was just upstream of the bridge. The creek appeared to have been channelized in the past and was straight. It also appeared to have been bermed on both sides for agricultural practices. The immediate land use is agricultural. The drainage area is approximately 4.4 mi² (site no.4)

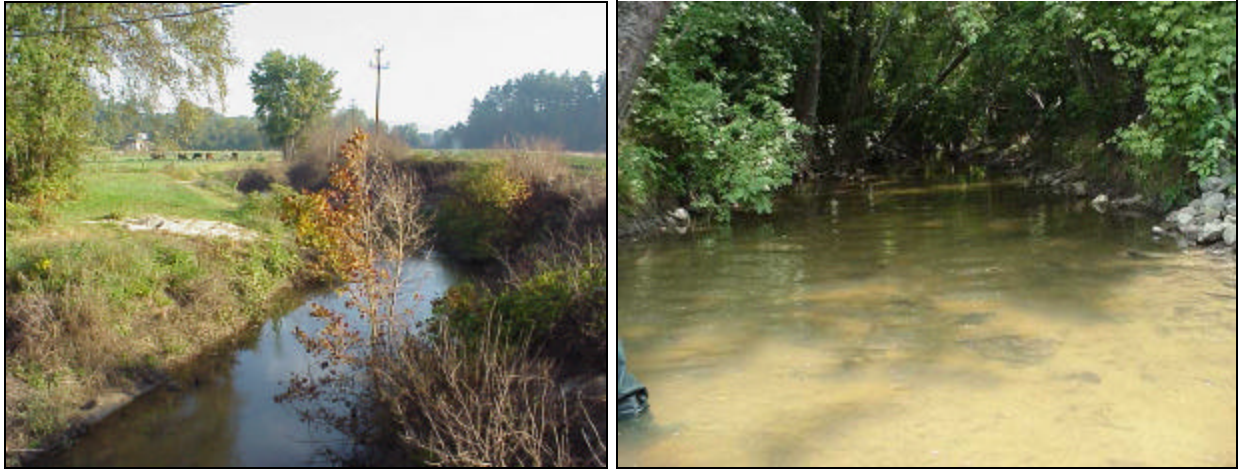
Mud Creek at SR 1164 (left) and SR 1647 (right)

Mud Creek at SR 1647 This station was located in Hendersonville, 7½ miles below the SR 1125 site. The substrate was mostly sand and silt. It was estimated that cinder blocks made up 5% of the substrate. In addition, tires, batteries, car parts, and trash were common in the sampling reach. Riffles and pools were infrequent, the steep eroding banks were very unstable, and the riparian zone was narrow on both sides of the stream. The immediate land surrounding the station is 100% urban. The drainage area is approximately 23.7 mi² (site no. 6).

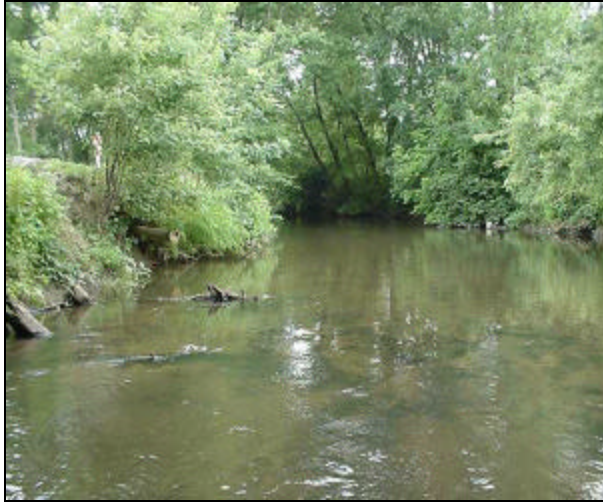
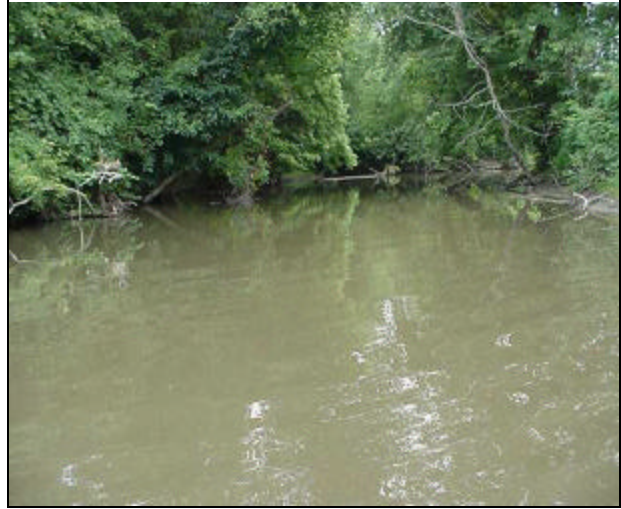
Mud Creek at SR 1508 above the WWTP (left) and SR 1508 below the WWTP

Mud Creek at SR 1508 - below the WWTP The stream was 13 meters wide and the substrate was mostly sand and silt. The only riffle was rip-rap under the bridge. The creek was channelized at this location, but the channelization appears to be older as there are some bends in the stream. There were breaks in the narrow riparian zone allowing sedimentation to enter the stream. The amount of instream habitat (rocks, leafpacks, snags, logs, and undercut banks) favorable for colonization was minimal. Pools appeared to be filling in from sediment and there was minimal shading of the stream. The drainage area is approximately 98 mi² at this location on Mud Creek, due to the addition of the Clear Creek watershed (site no. 8).

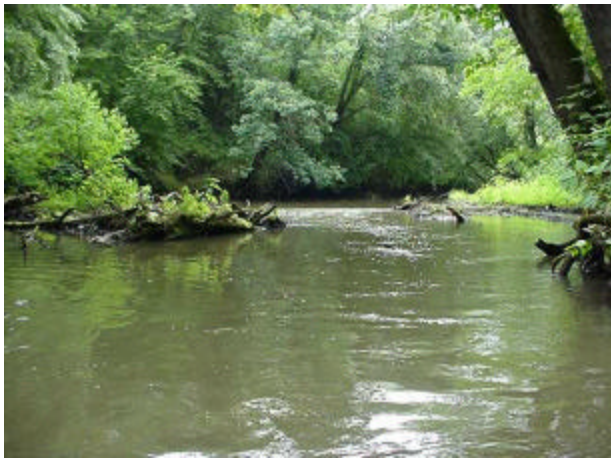
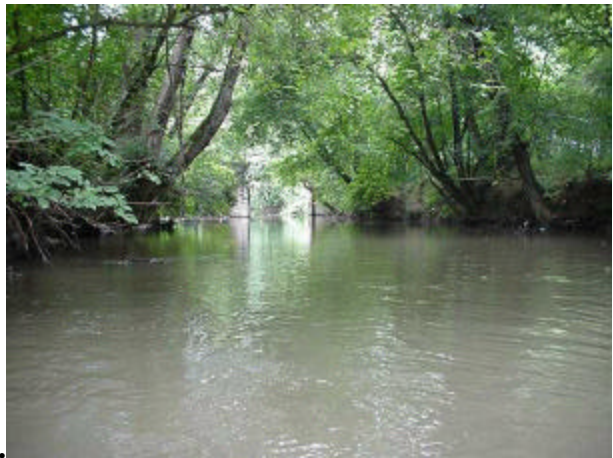
Mud Creek at US 25 (left and right)

Mud Creek at US 25 This is the most downstream of the Mud Creek sites and the width was 20 meters. There were no riffles; kicks were conducted at shallow gravel areas and at shallow areas containing woody debris. Bank erosion was severe and the riparian zone was greater than 18 meters on the left bank, but less than 6 meters on the right bank. Surrounding land use was half forest, and half industrial/commercial. This site is 14 miles downstream from the uppermost site on Mud Creek (SR 1125) and the drainage area at US 25 is approximately 110 mi² (site no. 9).

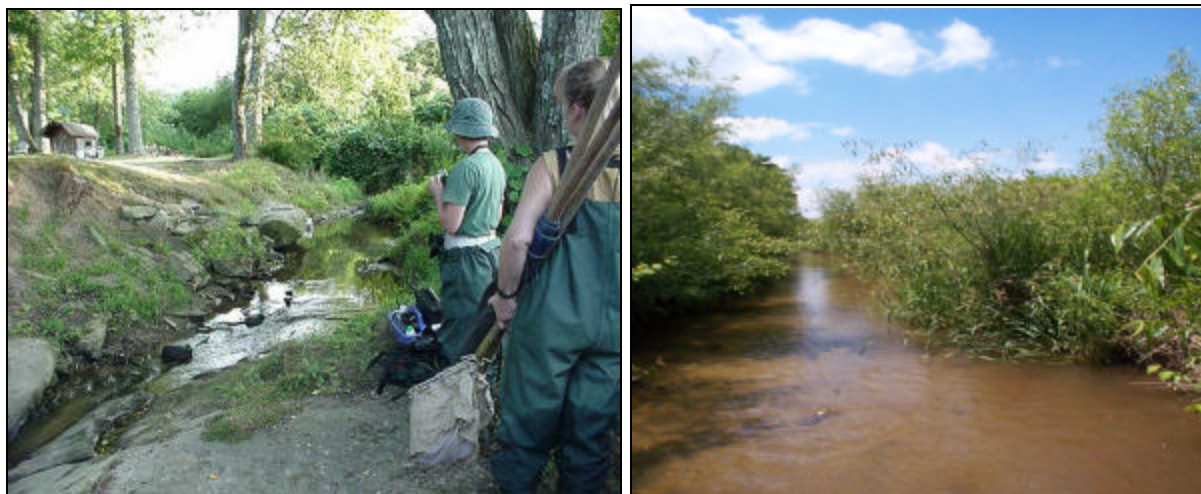
Bat Fork at SR 1809 (left) and Bat Fork below Dunn Creek (right)

Bat Fork below Dunn Creek The substrate was mostly sand and the remaining portion was comprised of gravel and silt. The stream was 2 meters wide and was channelized. Pools and riffles were infrequent and the banks appeared unstable and highly erodable. The riparian zone was narrow on both sides of the stream. The surrounding land was mostly active crops with forest, residential, and commercial comprising the remaining portion. This site is located above the beaver dams on Bat Fork but is below much of the agricultural land that Bat Fork drains. This site is 1.7 miles below the upstream site at SR 1809. The drainage area is approximately 2.2 mi² (site no.14).

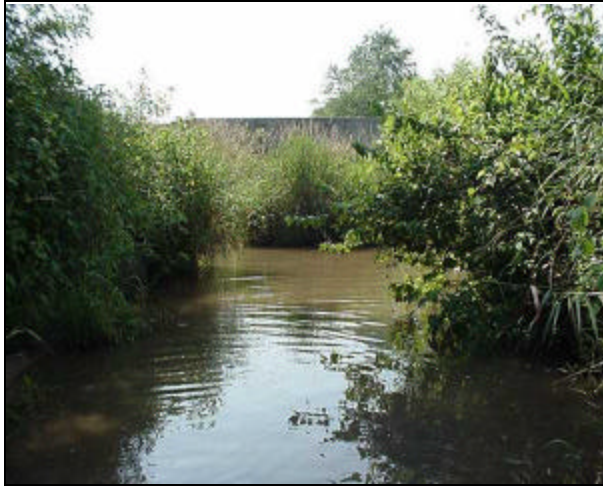
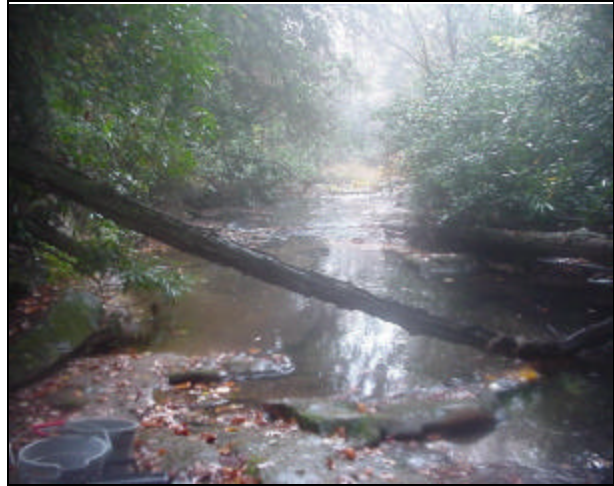
Bat Fork at SR 1779 (left) and King Creek at US 25 (right)

King Creek at US 25 King Creek is a tributary to Bat Fork. This station is located just downstream of the Kenmure Golf Course. There was no forested riparian buffer or canopy in the golf course. As the creek passes under the US 25 bridge, the habitat changed from a flat sand/gravel substrate to a bedrock substrate with gradient and small cascades. The gradient levels out about 150 meters below the bridge and the pool bottoms were filled with sediment. The drainage area is approximately 1.9 mi² (site no. 16).

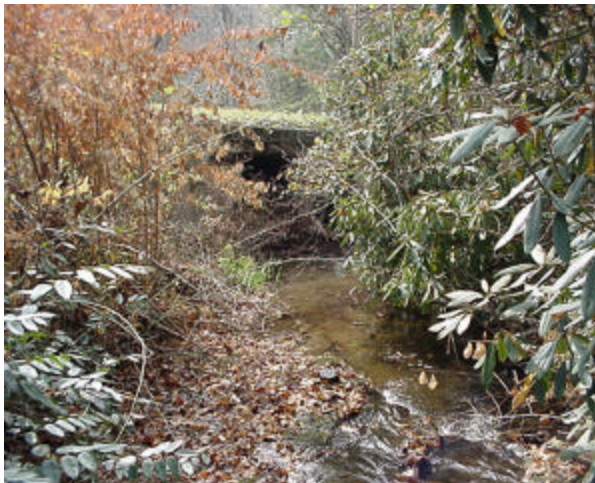
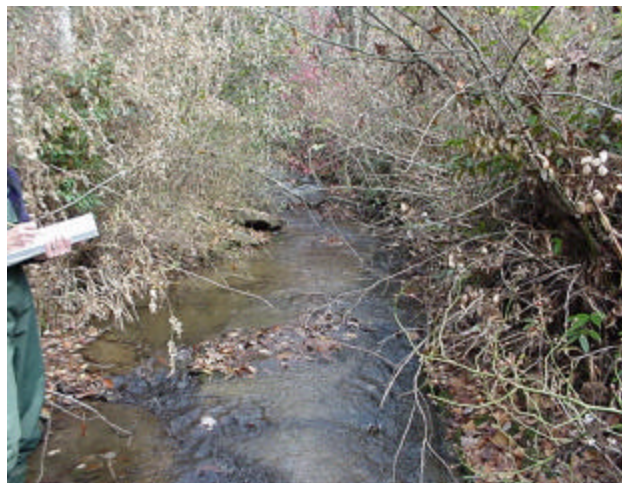
UT to Crab Creek downstream (left) and upstream (right)

UT to Crab Creek at SR 1127 UT to Crab Creek was sampled as a reference site for King Creek. The stream was 2 meters wide, and the substrate was mostly bedrock. The remaining substrate was comprised of boulder, rubble, and gravel with a small amount of sand. The banks were fairly steep with a moderate amount of erosion areas. The riparian zone was minimal on the on the right bank, but somewhat wider on the left bank. The drainage area is approximately 3.7 mi² (site no 2).

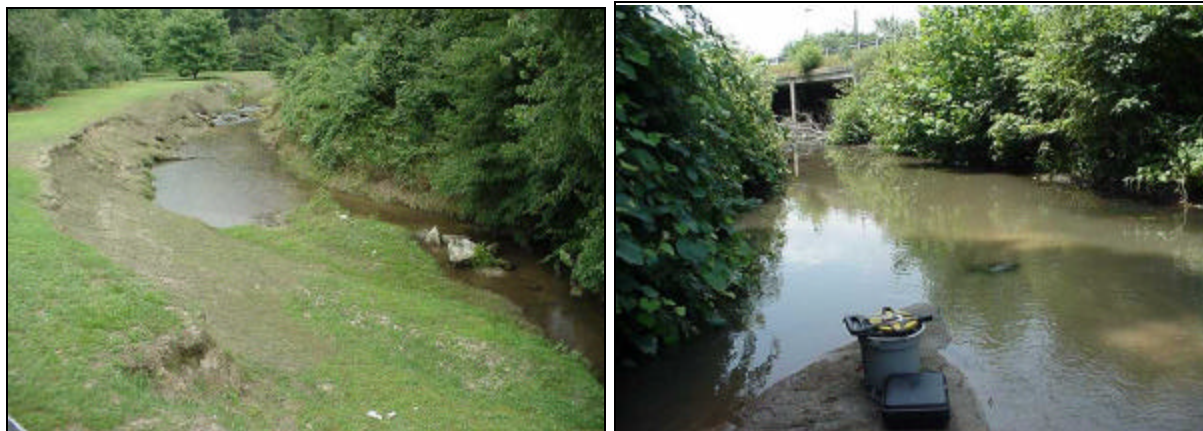
Devils Fork at SR 1006 (right) and Devils Fork at US 64 (left)

Devils Fork at US 64 This site was in a commercial/industrial portion of Hendersonville. The stream was channelized and resembled a straight ditch lacking habitat for any type of colonization. The substrate was all sand and silt. The stream was 4 meters wide and there were no riffles or pools in the sampling reach. The canopy was minimal. The banks were steep and erosion was severe. This site is 3 miles below the upper site and the drainage area is approximately 9 mi² (site no. 18).

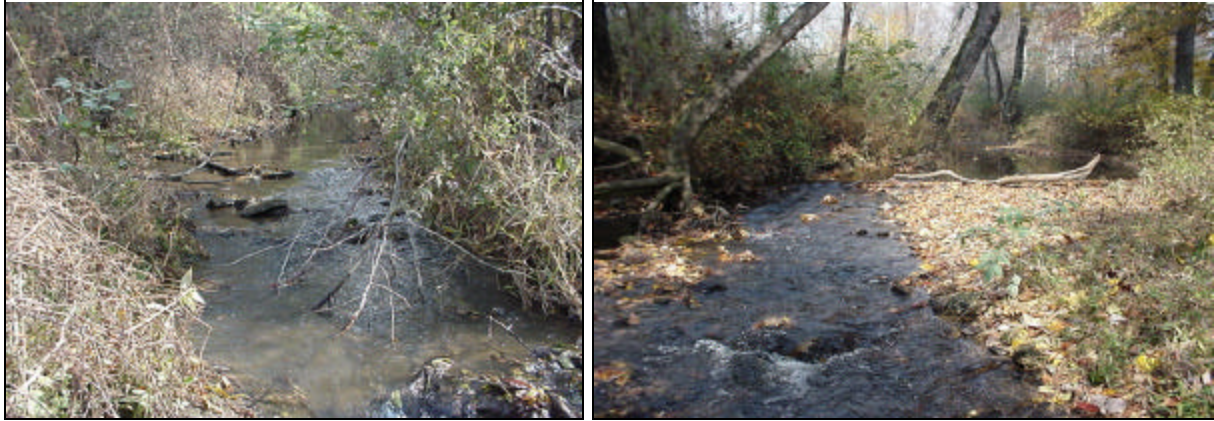
Clear Creek at SR 1591 (left) and Clear Creek at SR 1587 (right)

Clear Creek at SR 1587 At this site, the channel appeared natural with frequent bends and the stream was 5 meters wide. The substrate was a good mix of gravel, cobble, and boulders, and embeddedness was much less than at SR 1591. In addition, the riparian zone was wider than at the upstream site. Pools were frequent and there were a variety of sizes. The banks appeared more stable and were covered with large trees which provided shade for the stream. This sampling site is 2.2 miles downstream SR 1591 and the drainage area is approximately 9.6 mi² (site no 23).

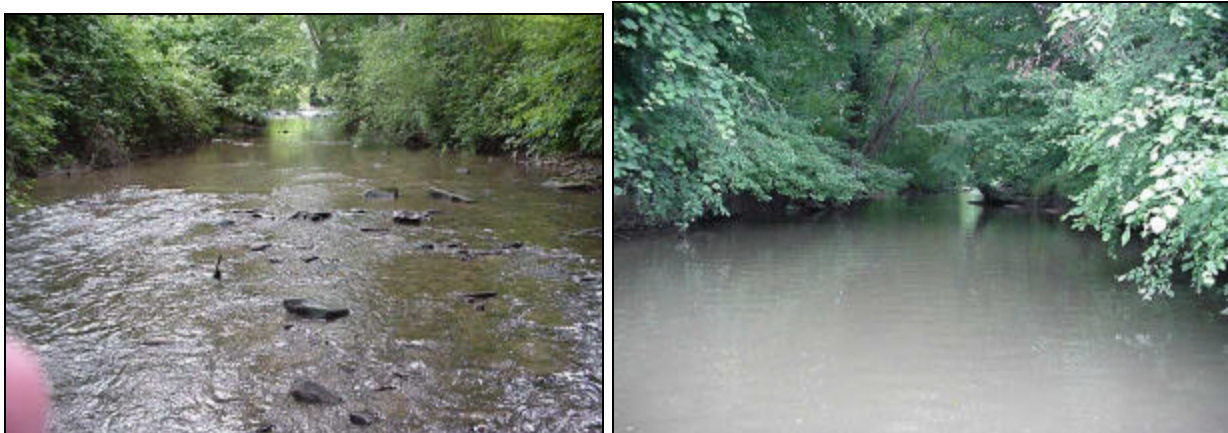
Clear Creek at SR 1586 (left) and Clear Creek at SR 1513 (right)

Clear Creek at SR 1513 This is the most downstream of the Clear Creek sites before it joins Mud Creek. With respect to habitat, this site scored much less than the SR 1586 or 1587 site. The substrate contained a high amount of silt and the infrequent riffles were very embedded. Pools were also infrequent and appeared to be filling in with silt. The stream bank vegetation indicated poor soil binding. It appeared that the creek had been completely channelized and there was a discharge from an apartment complex package plant on the left upstream side of the bridge. This site is 6.2 miles below the SR 1586 site and a total of 11 miles below SR 1591, the uppermost Clear Creek site. The drainage area is approximately 43 mi² (site no. 29).

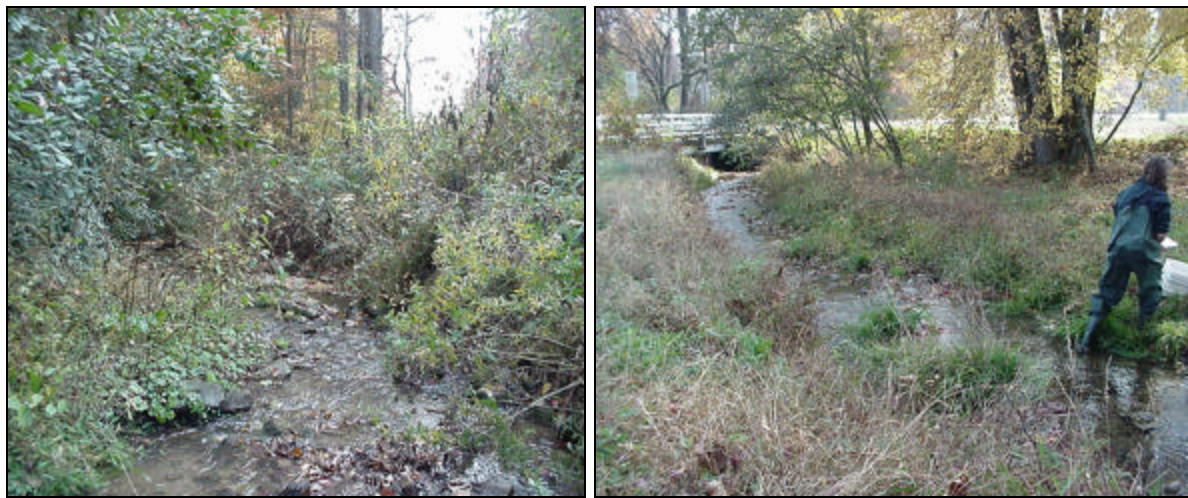
Cox Creek at Hickory Acres Road (left) and Cox Creek at SR 1587 (right)

Cox Creek at SR 1587 This location was situated downstream of the apple orchards. Cox Creek remained 2 meters in width and the substrate was mostly rubble with the remaining substrate comprised of gravel and sand. The riparian zone was minimal on both banks. Riffles remained frequent with low embeddedness. The canopy provided minimal shading of the stream and the banks appeared stable with little potential for erosion. The drainage area is approximately 2.9 mi² (site no. 22).

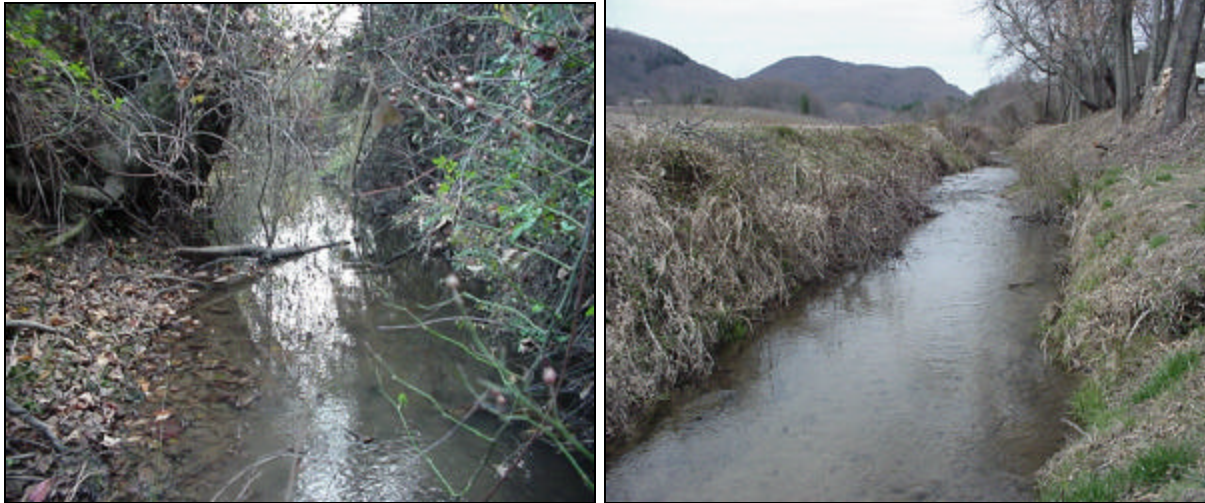
Mill Creek at SR 1586 Mill Creek is a tributary to Clear Creek and is affected by apple orchards. It flows through a cornfield with very little riparian zone. The stream banks were steep and severely eroded. Substrate was mostly sand with the remaining substrate comprised of equal parts rubble gravel, and silt. The stream was 2 meters wide. The drainage area of this site is approximately 1.6 mi² (site no.26).

Kyles Creek at SR 1579 Kyles Creek is a tributary to Clear Creek and there are apple orchards in its catchment. The stream was 2 meters wide and the substrate was a mix of gravel, cobble and boulders, but with a high amount of sand. Pools and riffles were infrequent and bank erosion was severe. The riparian zones were minimal on both sides of the stream and the canopy provided minimal shading. The surrounding land use was evenly divided between forest, fallow fields and residential. The drainage area is approximately 4.5 mi² (site no. 27).

Mill Creek at SR 1586 (left) and Kyles Creek at SR 1579 (right)

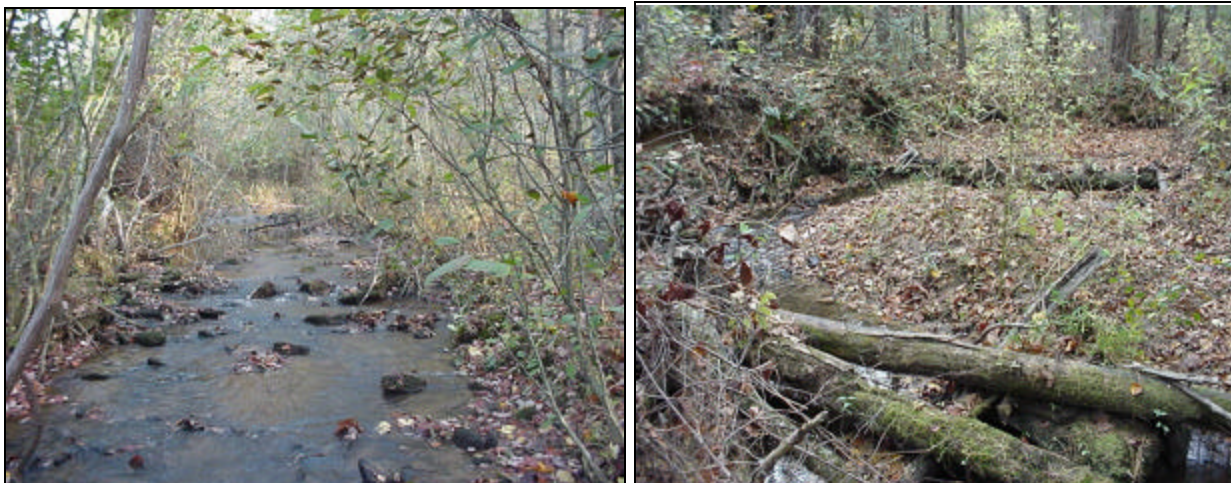
Laurel Fork at SR 1592 Laurel Fork is a tributary to Clear Creek and was sampled as a reference site for Cox Creek, Mill Creek, and Upper Clear Creek at SR 1591. This site is located above the apple orchards. Laurel Fork was 2 meters wide and the substrate was a good mix of gravel, cobble, and boulders. Riffles and pools were frequent and the banks appeared very stable with no evidence of erosion. There were breaks in the minimal riparian zone on the left side of the stream. The surrounding land use was forest, pasture, and a small amount of rural residential. The drainage area is approximately 2.7 mi² (site no. 20).

Harper Creek at SR 1582 Harper Creek is a tributary to Clear Creek and was sampled as a reference site for Cox Creek, Mill Creek, and Upper Clear Creek at SR 1591. Harper Creek was 1 meter wide and the substrate was mostly rubble and gravel. There was a high amount of silt in the stream, which increased the amount of embeddedness and filled in the pool bottoms. The riparian zone was intact on both sides and the surrounding land was mostly forest. The drainage area is approximately 1.3 mi² (site no.28).

Laurel Fork at SR 1592 (left) and Harper Creek at SR 1582 (right)

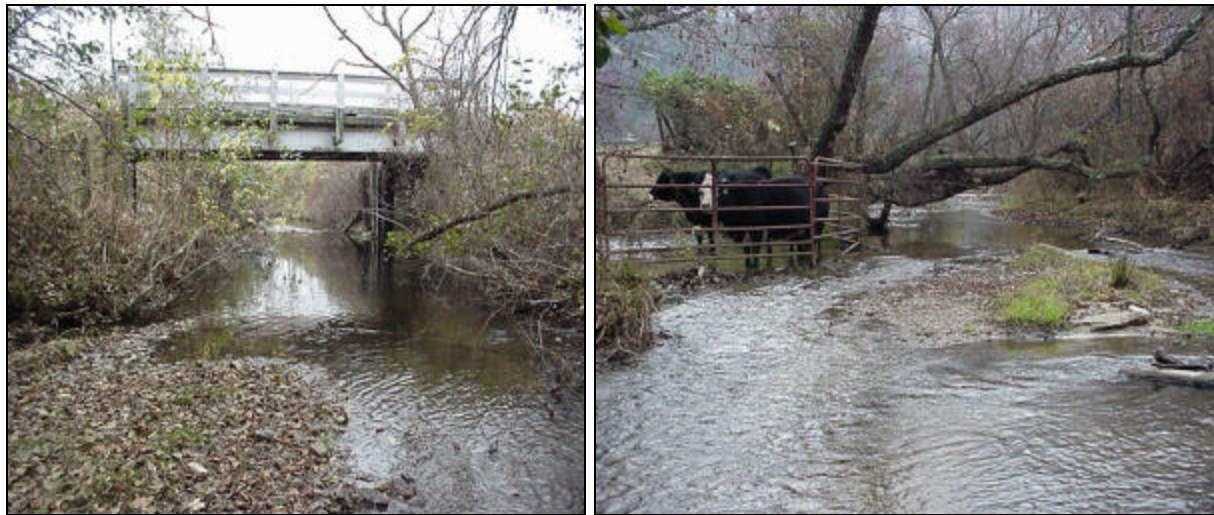
Crab Creek at SR 1532 Crab Creek was sampled as a reference site for the upper-middle portion of Clear Creek. The bottom substrate was 50% sand and silt. The remaining substrate was boulder, rubble, and gravel. The stream width was 5 meters, riffles were infrequent, and pool bottoms were filling in with sediments. Cows had access to the creek upstream of the sampling site. The creek is surrounded by active crops, cow pastures, and fallow fields. The drainage area of Crab Creek is approximately 7 mi² (site no.1).

Crab Creek at SR 1532 downstream (left) and upstream (right)
