**WATERSHED ASSESSMENT REPORT**

**Ararat-Pilot Mountain Local Watershed Plan  
(Surry and Stokes Counties, NC)**

**Prepared by Hal Bryson and Andrea Leslie  
NC DENR – Ecosystem Enhancement Program (EEP)  
February, 2013**

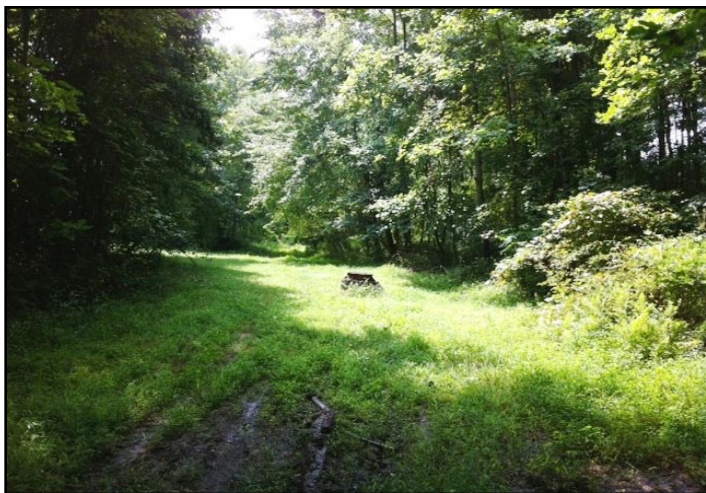
UT to Chinquapin at Old U.S. 52 (CH-1.1): Elevated fecal coliform levels at locations CH-1.1 and CH-A suggest possible sewer line leak(s) along this stream reach (see photo below).

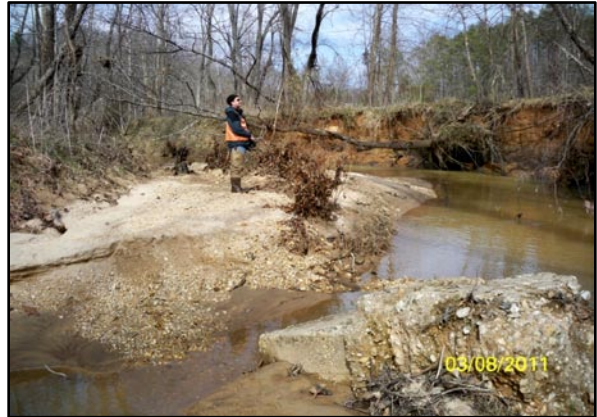
Chinquapin Creek at SR 1830-Matthews Road (CH-1): Extreme channel incision, high unstable stream banks and in-stream sedimentation (see photo at right).

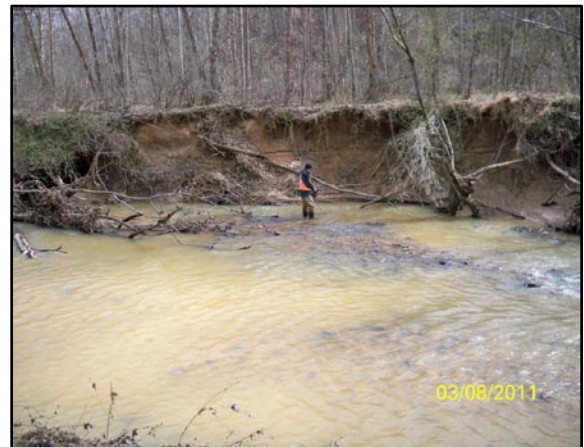
Several segments of extreme bank erosion and in-stream sedimentation were noted at site TC-2 (see photo below) and at discontinuous locations upstream on Toms Creek, plus some areas of nutrient enrichment (algae/periphyton on stream substrate), despite generally excellent buffer conditions.

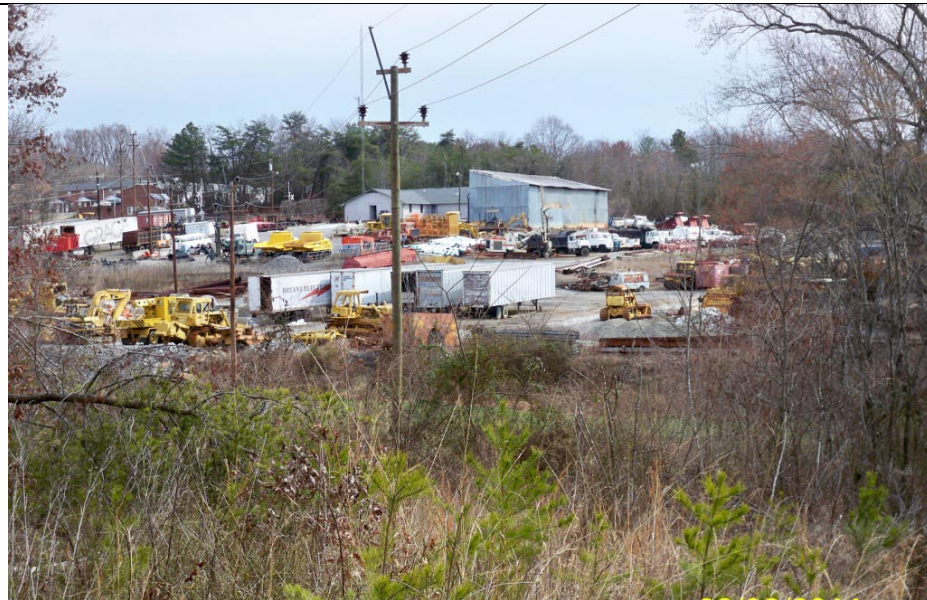
Photo 1. Construction equipment storage yard on Academy Street along a UT to Heatherly Creek near South Davis Street (HC-3.1). A potential stormwater BMP location. Specific conductance at this tributary location was 238 uS/cm.

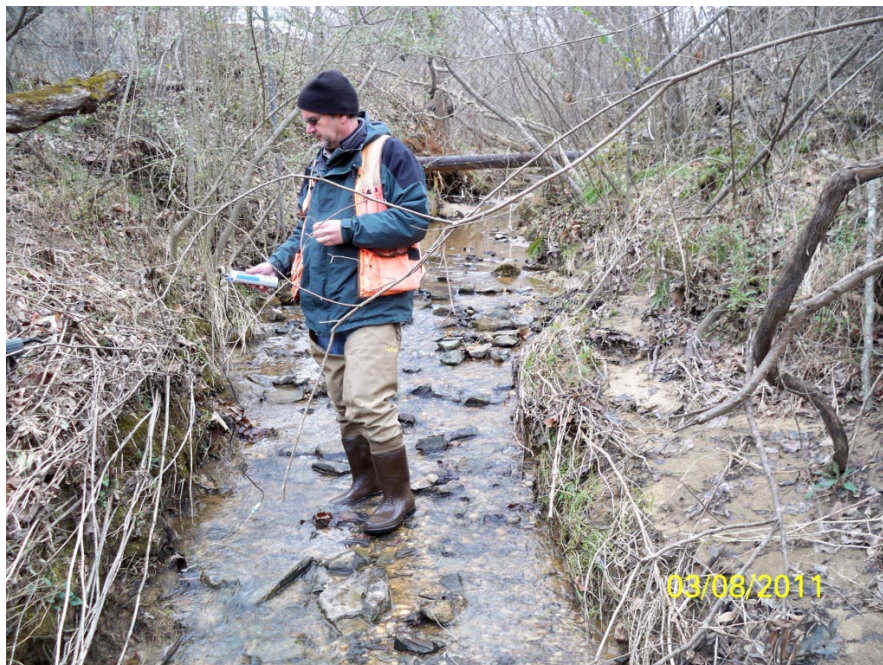
Photo 2. UT to Heatherly Creek at WWTP (HC-2.1). Further assessments needs to be conducted within this tributary due to somewhat elevated fecal coliform bacteria and nutrients relative to other locations in Heatherly Creek.

All nitrogen species (ammonia, total Kjeldahl nitrogen, nitrate-nitrite) and total phosphorus (TP) were higher in the UT near the WWTP (HC-2.1) than in any other sampled location in Heatherly Creek (Table 1 and Photo 2). Periphyton was more evident on submerged rocks and cobbles at this location as well. The next highest nitrate-nitrite concentration was 0.52 mg/L in Heatherly Creek at NC268 (HC-2). Overall, nutrient concentrations were not excessively elevated at any location; although, mostly higher than the nearby reference stream (Indian Creek at SR1001) in Hanging Rock State Park where all nutrient species and TP were below laboratory detection limits. The one exception was in Heatherly Creek at NC268 (HC-2) where total Kjeldahl nitrogen (TKN) was also below detection limits (Table 1).

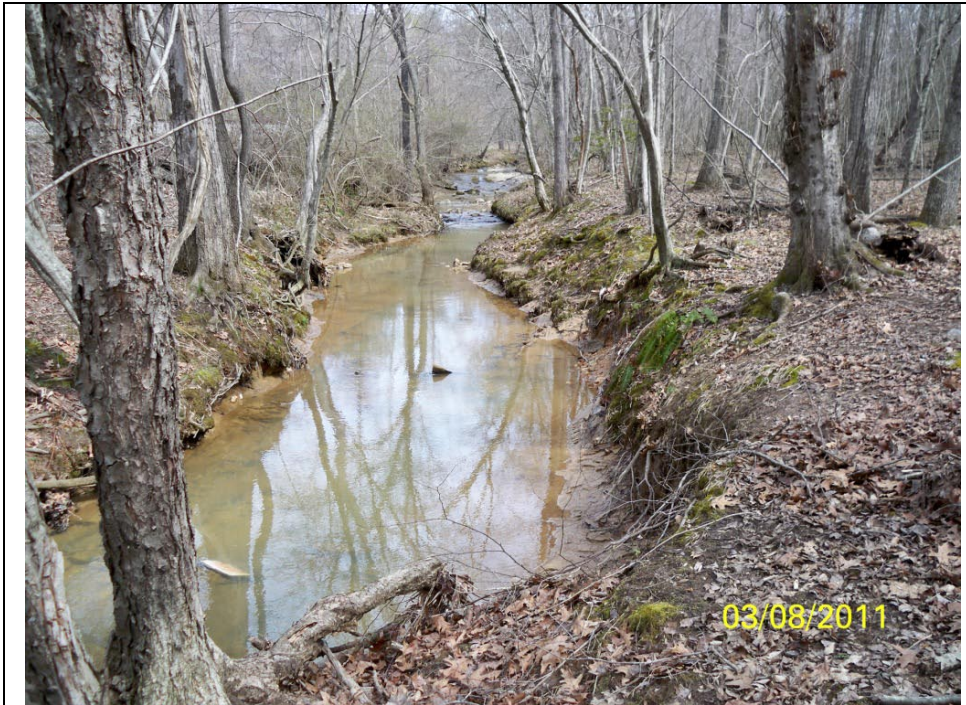
Photo 3. Heatherly Creek at US 52 (HC-1). The stream channel appeared to be over widened at this location. Undercut banks and root mats were exposed.

In general, habitat conditions in Heatherly Creek and its tributaries were observed to possess a good mix of habitat types (e.g., rocks, root mats, sticks) with a variety of pools. Riffle embeddedness was nearly 50%. The channel was over-widened at the US52 location (HC-1) exposing important root mat habitats and undercut banks (Photo 3). Stream bank erosion and bedload sediment was evident throughout (Photo 4) with some extreme erosion noted at the NC268 (HC-2) location. An adequate riparian vegetation zone was present throughout except for some tributary locations in town.

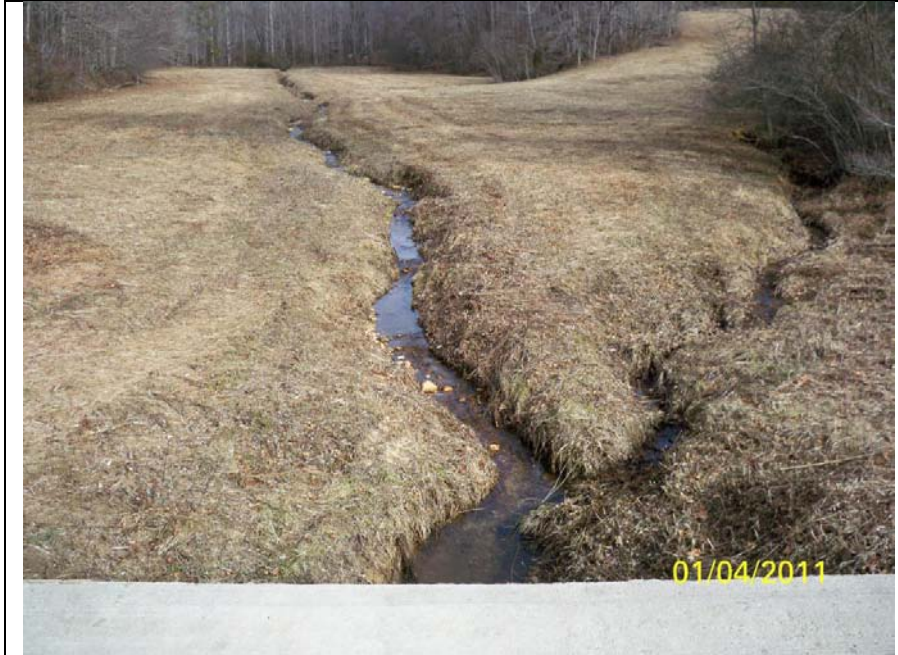
Photo 4. An upstream segment in Heatherly Creek at Academy Street (HC-4) noting the formation of point bars and depositional areas. Habitat conditions were degraded by sediment at this location and others throughout the planning area.

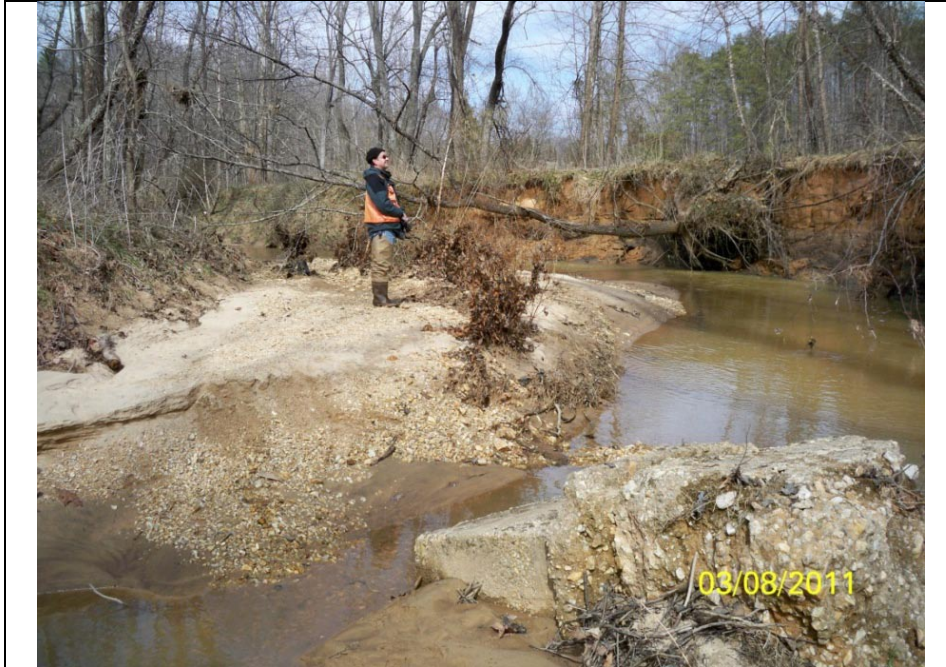
Photo 6. UT to Pilot Creek at Boyd Nelson Road (PC-3.1) indicating a degraded riparian zone. Specific conductance was highest of all locations in Pilot Creek drainage at 125  $\mu\text{S}/\text{cm}$ .

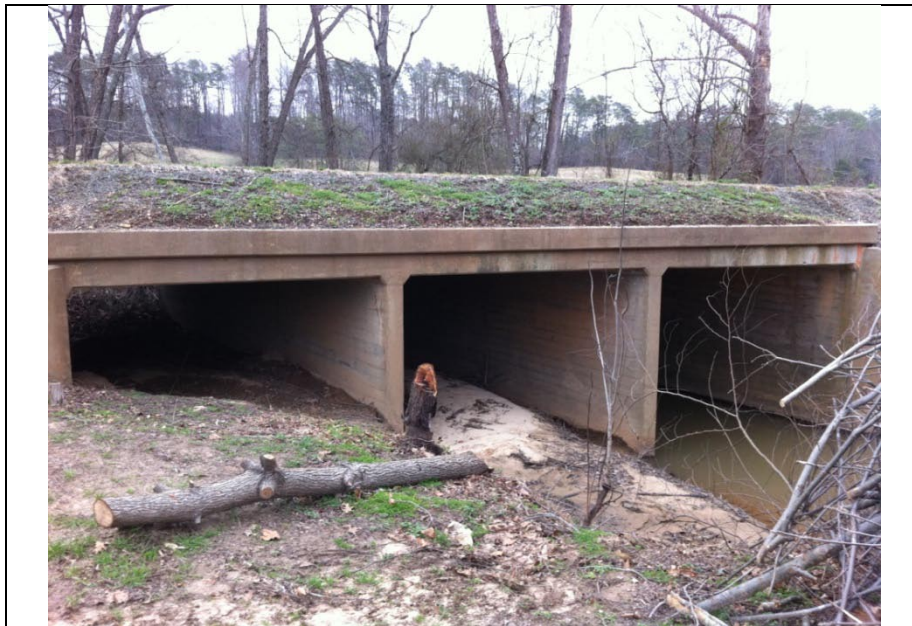
Photo 7. Chinquapin Creek at SR1830 (CH-1). Note the turbid conditions 40 hours following a storm event of approximately two inches over a less than 24-hour period. Also note the stream bank erosion and coarse material located along the inside bend of the meander. Drainage area at this point is 9.4 square miles.

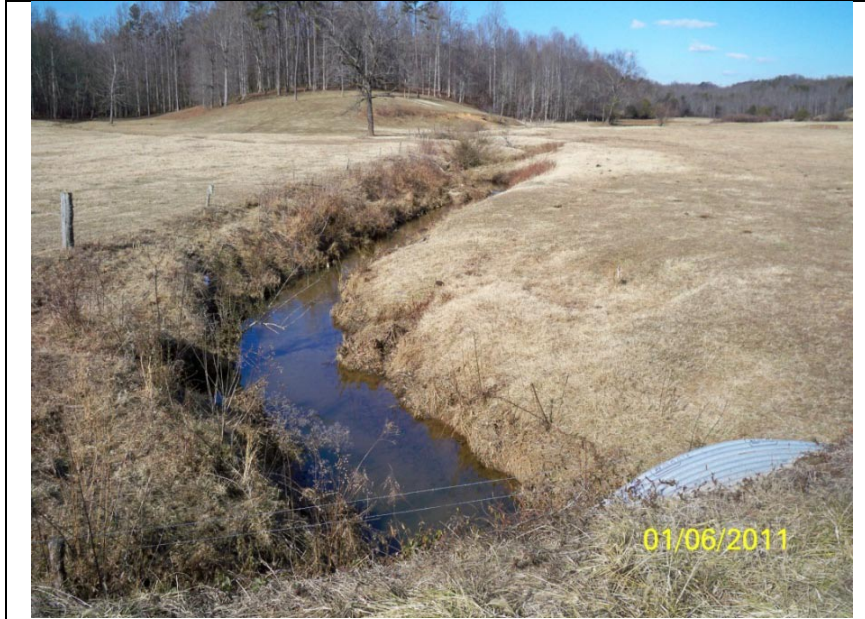
Photo 9. Upstream view of a UT to Toms Creek at SR1811 (TC-4.1) where a cattle operation is located on both sides of the stream. Note riparian impacts.

The most noteworthy nutrient levels were detected in the small catchment where fecal bacteria were elevated at a UT to Toms Creek at Community Building Road (TC-1.1). TKN concentrations were highest here relative to the other locations sampled in Toms Creek at 0.27 mg/L. The highest nitrate-nitrite concentration (0.43 mg/L) was measured in a UT to Toms Creek at SR1811 (TC-4.1). This sampling site is located within sizeable cattle pastures where cattle have access to the stream and riparian vegetation is mostly lacking (See Photo 9). Excessive algae and periphyton were not observed in any location.

favorable with many different sizes present. There were stream segments where riparian zones were wide and forested but many riparian zones were devoid of trees and mostly vegetated with grasses (Photo 9).

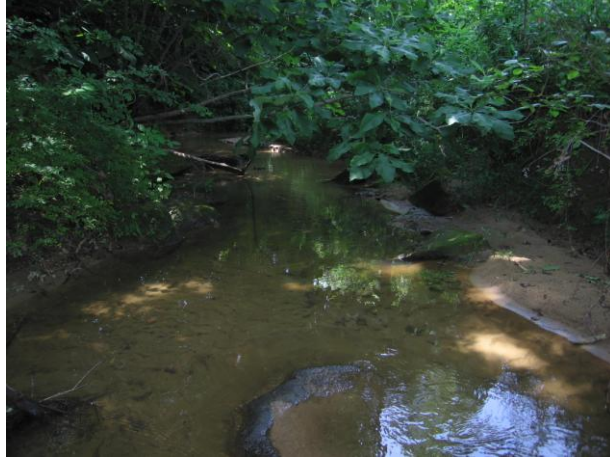
### Toms Creek at SR 1808 (Toms Creek Church Rd) (TC-5)

Photo: mid-reach, looking downstream

**Visible land use:** Forest, residential, fallow fields.  
**Width (m):** 5.0  
**Drainage Area (mi<sup>2</sup>):** 3.3  
**Depth (m):** Average: 0.05  
**Canopy (% cover):** 70, deciduous forest  
**Substrate (%):** Boulder (5), rubble (5), gravel (Tr), sand (85), silt (5), bedrock (Tr).  
**Riparian quality:** Right bank not intact <6 meters. Left bank not intact 12-18 meters with breaks.  
**Instream habitat:** Rocks rare, macrophytes rare, sticks/leafpacks common, snags/logs common, undercut banks/rootmats common.  
**Habitat Score (out of 100):** 46  
**Dissolved Oxygen (mg/L):** 7.4  
**Specific conductance (µS/cm):** 53  
**Temperature (°C):** 23  
**pH:** 7.0  
**Remarks:** Abundant sand. Habitat below SR 1808 supported better fish community; channel width 2 meters, more sinuous,  
**Bioclassification:** Good-Fair

This location on Toms Creek received a Good-Fair rating based on EPT richness. Twenty-five EPT taxa were collected and the community was similar to UT Toms Creek at SR 1811. Many of the same taxa were found at both sites. The EPT BI was lower at this site (3.77 versus 3.98), indicating a slightly less tolerant community. *Rhyacophila fuscula*, an intolerant free-living caddisfly, was Abundant at this site but was not collected at the UT Toms Creek at SR 1811. One individual of *Rhyacophila carolina*, another very intolerant caddisfly, was collected here. Other intolerant caddisflies such as *Neophylax oligius* were Common and *Pychnopsyche* were Abundant. Hydropsychid caddisflies (*Hydropsyche betteni*) were Abundant at this site. The beetle diversity was low at this site; only one type of beetle, *Helichus*, was collected. Similar to UT Toms Creek at SR 1811, both intolerant and tolerant taxa were Abundant. The fact that intolerant taxa were Common and Abundant indicates that the water quality is good enough to support intolerant taxa despite the sandy substrate and low habitat score.

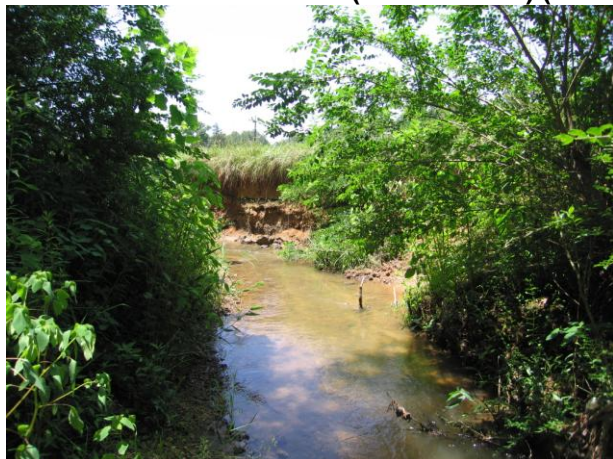
### UT Toms Creek at SR 1811 (Cleo Cain Rd) (TC-4.1)

Photo: mid-reach, looking upstream

**Visible land use:** Forest, active pasture, fallow fields, residential.  
**Width (m):** 4.0  
**Drainage Area (mi<sup>2</sup>):** 3.6  
**Depth (m):** Average: 0.2  
**Canopy (% cover):** 50, deciduous forest  
**Substrate (%):** Boulder (Tr), rubble (5), gravel (20), sand (50), silt (25).  
**Riparian quality:** Both banks not intact (with breaks) and <6 meters.  
**Instream habitat:** Rocks common, macrophytes rare, sticks/leafpacks common, snags/logs common, undercut banks common, rootmats rare.  
**Habitat Score (out of 100):** 44  
**Dissolved Oxygen (mg/L):** 7.4  
**Specific conductance (µS/cm):** 43  
**Temperature (°C):** 29  
**pH:** 6.5  
**Remarks:** Abundant silt  
**Bioclassification:** Good-Fair

This site rated Good-Fair based on the 24 EPT taxa that were collected. The EPT taxa were a mixture of moderately tolerant to intolerant. Abundant mayfly taxa included *Isonychia*, *Baetis pluto*, and *Maccaffertium modestum*. These are all moderately tolerant. The mayfly *Teloganopsis deficiens*, which is intolerant, was Abundant as were the caddisfly taxa, *Ceratopsyche sparna* and *Neophylax oligius*. The most abundant stonefly was *Perlesta*, a moderately tolerant perlid. Intolerant stoneflies were also collected including *Acroneuria abnormis*, *Tallaperla*, *Leuctra*, and *Pteronarcys*. These were all Common or Rare in number. The taxa assemblage was very similar to the headwaters Toms Creek site (Toms Creek at SR 1808). Field notes included that there was a high number of hydropsychid caddisflies which can be an indicator of nutrient enriched conditions. The abundance of the midge, *Tribelos*, which is considered tolerant of enriched conditions further points to enrichment in this tributary. Although there were indicators of nutrient enrichment and a high amount of sand and silt, the water quality was good enough to support some intolerant taxa.

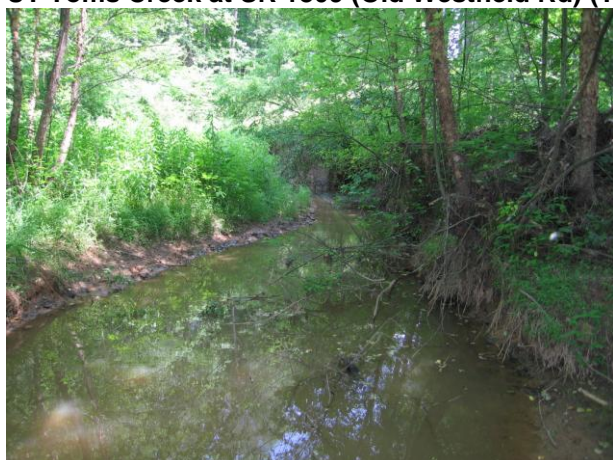
### UT Toms Creek at SR 1809 (Old Westfield Rd) (TC-3.1)

Photo: mid-reach, looking upstream

**Visible land use:** Forest, fallow field, residential.  
**Width (m):** 2.0  
**Drainage Area (mi<sup>2</sup>):** 1.5  
**Depth (m):** Average: 0.3  
**Canopy (% cover):** 50, deciduous forest.  
**Substrate %:** Boulder (Tr), rubble (10), gravel (20), sand (50), silt (20).  
**Riparian quality:** Right bank >18 meters with some breaks. Left bank < 6 meters and not intact.  
**Instream habitat:** Rocks common, macrophytes rare, sticks/leafpacks common, snags/logs rare, undercut banks common, rootmats rare.  
**Habitat Score (out of 100):** 52  
**Dissolved Oxygen (mg/L):** 6.8  
**Specific conductance (µS/cm):** 36  
**Temperature (°C):** 24  
**pH:** not documented  
**Remarks:** Small partially breached earthen dam just above site. Eroding clay from the impoundment appears to greatly impact site. Turbid.  
**Bioclassification:** Good

This site received a Good bioclassification based on small stream criteria. Sixteen EPT taxa were collected. The EPT BI was 4.42 and the NCBI was 4.64. The same stonefly and mayfly taxa that were collected at the UT Toms Creek at SR 1811 and the Headwater Toms Creek site at SR 1808 were collected here. The stoneflies included *Perlesta*, *Acroneuria abnormis*, *Tallaperla*, and *Leuctra*. An intolerant stonefly, *Isoperla holochlora*, was collected at this site (Rare in abundance) but not in any of the other Toms Creek drainage sites. Five stonefly taxa were collected, a fairly high number for such a small drainage. The mayflies at the three sites included *Isonychia*, *Teloganopsis deficiens*, and *Eurylophella verisimilis*. However, only three caddisfly taxa were collected here, which is a very low number for caddisfly diversity. All of the caddisflies that were collected were hydropsychids, which are filter feeders, possibly indicating nutrient enriched conditions.

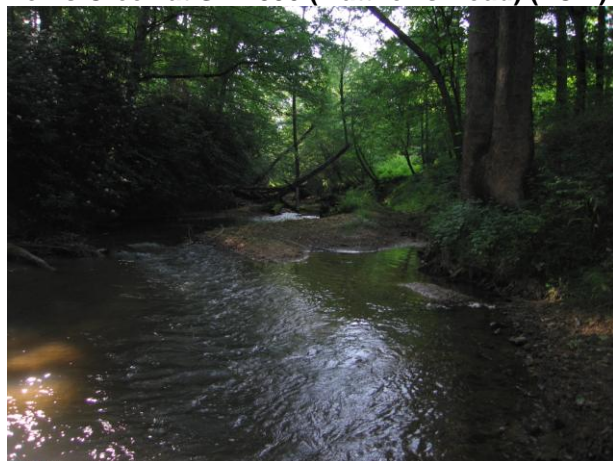
### Toms Creek at SR 1830 (Matthews Road) (TC-2)

Photo: mid-reach, looking downstream

**Visible land use:** Forest, residential, fallow fields.  
**Width (m):** 5.0  
**Drainage Area (mi<sup>2</sup>):** 18.3  
**Depth (m):** Average: 0.2  
**Canopy (%cover):** 80, deciduous forest  
**Substrate %:** Boulder (Tr), rubble (5), gravel (10), sand (75), silt (10).  
**Riparian quality:** Riparian zone > 18 meters on both sides and intact.  
**Instream habitat:** Rocks common, macrophytes rare, sticks/leafpacks common, snags/logs common, undercut banks/rootmats common.  
**Habitat Score (out of 100):** 58  
**Dissolved Oxygen (mg/L):** 7.1  
**Specific conductance (µS/cm):** 49  
**Temperature (°C):** 24  
**pH:** 7.0  
**Remarks:** Abundant sand.  
**Bioclassification:** Fair

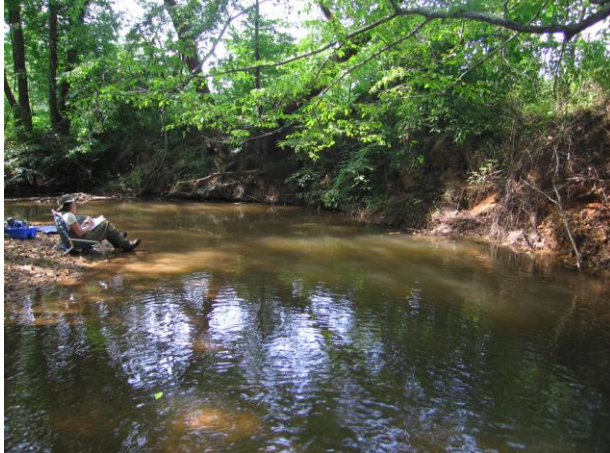
### Chinquapin Creek at SR 1809 (Old Westfield Rd) (CH-2)

**Photo: mid-reach, looking upstream**

**Visible land use:** Forest, residential, fallow fields, commercial.  
**Width (m):** 4.0  
**Drainage Area (mi<sup>2</sup>):** 4.4  
**Depth (m):** Average: 0.2  
**Canopy (% cover):** 70, deciduous forest.  
**Substrate %:** Boulder (10), rubble (15), gravel (30), sand (40), silt (5), bedrock (Tr).  
**Riparian quality:** Right bank >18 meters with breaks. Left bank < 6 meters with breaks. Both banks not intact.  
**Instream habitat:** Rocks abundant, macrophytes rare, sticks/leafpacks common, snags/logs common, undercut banks/rootmats common.  
**Habitat Score (out of 100):** 62  
**Dissolved Oxygen (mg/L):** 6.5  
**Specific conductance (µS/cm):** 74  
**Temperature (°C):** 23  
**pH:** 7.2  
**Remarks:** channel filled in with sediment, bar development, exposed bedrock.  
**Bioclassification:** Good-Fair

Twenty-five EPT taxa were collected at this location, yielding a Good-Fair bioclassification. The intolerant mayflies, *Epeorus vitreus*, and *Teloganopsis deficiens* were Abundant. *Epeorus* was not collected at any sites in the Toms Creek watershed. The intolerant stoneflies, *Acroneuria abnormis* and *Eccoptura xanthenes* were Abundant. In addition, the intolerant caddisflies, *Neophylax oligius* and *Chimarra* were Abundant. The benthic community was comprised of intolerant and moderately tolerant taxa.

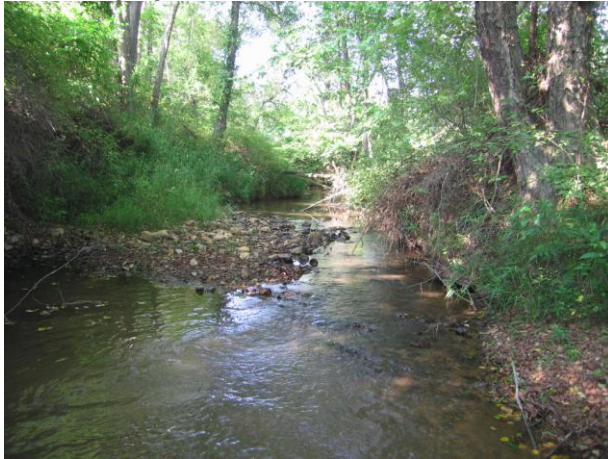
### UT Chinquapin Creek at SR 1809 (Old Westfield Rd) (CH 1.2)

Photo: mid-reach, looking downstream

**Visible land use:** Forest, residential, fallow fields, commercial.  
**Width (m):** 3.0  
**Drainage Area (mi<sup>2</sup>):** 4.9  
**Depth (m):** Average: 0.1  
**Canopy (% cover):** 70, deciduous forest.  
**Substrate %:** Boulder (5), rubble (20), gravel (25), sand (40), silt (10).  
**Riparian quality:** Both riparian zones < 6 meters not intact.  
**Instream habitat:** Rocks abundant, macrophytes rare, sticks/leafpacks common, snags/logs common, undercut banks/rootmats common.  
**Habitat Score (out of 100):** 59  
**Dissolved Oxygen (mg/L):** 6.6  
**Specific conductance (µS/cm):** 53  
**Temperature (°C):** 23  
**pH:** 7.0  
**Remarks:** channel filled in with sediment, bar development, steep, straight banks.  
**Bioclassification:** Good-Fair

Twenty-four EPT taxa were collected and a Good-Fair rating was assigned to this UT to Chinquapin Creek. The EPT BI (3.62) and the NCBI (4.15) were slightly lower at this site than at the Chinquapin Creek site, indicating a slightly less tolerant benthic community. Many of the same taxa were present, but there were some differences such as *Isonychia*, a moderately tolerant mayfly that feeds by filtering food particles, was Abundant in the UT Chinquapin site and was not collected in the Chinquapin site. The intolerant mayfly, *Epeorus vitreus*, was Abundant at both locations as were the intolerant caddisflies, *Neophylax oligious* and *Chimarra*. The stonefly taxa that were collected in Chinquapin Creek and UT Chinquapin Creek were similar.

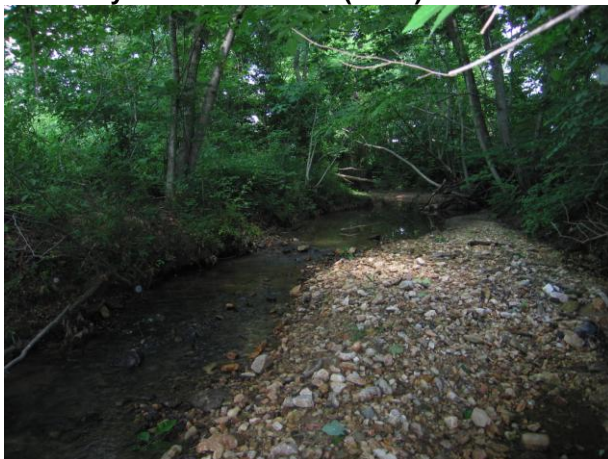
### Heatherly Creek at NC 268 (HC-2)

Photo: mid-reach, looking upstream

**Visible land use:** Forest, residential, commercial.  
**Width (m):** 1.5  
**Drainage Area (mi<sup>2</sup>):** 0.8  
**Depth (m):** Average: 0.15  
**Canopy (% cover):** 80, deciduous forest.  
**Substrate %:** Boulder (Tr), rubble (10), gravel (20), sand (65), silt (5).  
**Riparian quality:** Right riparian zone >18 meters and intact. Left riparian not intact and 6-12 meters.  
**Instream habitat:** Rocks common, macrophytes rare, sticks common, leafpacks rare, snags/logs common, undercut banks/rootmats abundant.  
**Habitat Score (out of 100):** 66  
**Dissolved Oxygen (mg/L):** 7.0  
**Specific conductance (µS/cm):** 95  
**Temperature (°C):** 19  
**pH:** 7.0  
**Remarks:** Abundant sand.  
**Bioclassification:** Good

This small Heatherly Creek site (drainage area = 0.8 square miles) received a Good Bioclassification based on small stream criteria for mountain streams. Fifteen EPT taxa were collected and the EPT BI was the second lowest of the 12 sites after the comparison site. It was observed that hydropsychid caddisflies were scarce at this site while midges (*Tvetenia bavarica*, *Thienemannimyia gr.*) and baetid mayflies (*Baetis pluto*) were Abundant. The intolerant caddisfly, *Neophylax oligius*, was Abundant. The sample was a mixture of intolerant and moderately tolerant taxa. Although many of the intolerant taxa were Rare in number, their occurrence at all in such a small stream produced a Good rating.

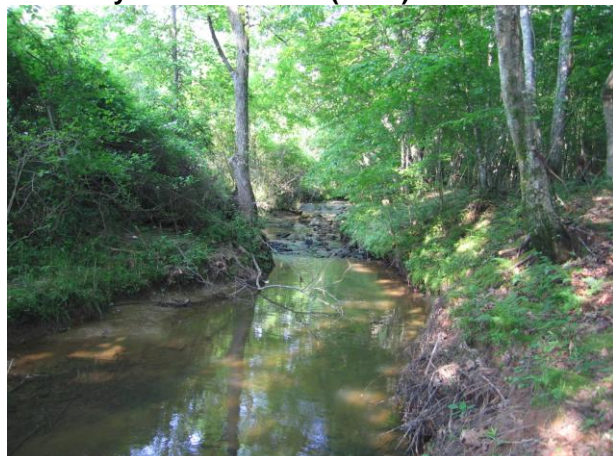
### Heatherly Creek at US 52 (HC-1)

Photo: mid-reach, looking upstream

**Visible land use:** Forest, highway, railroad tracks.

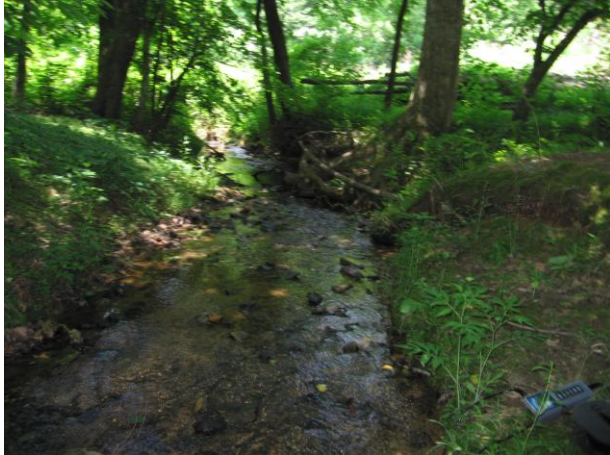
#### **Pilot Creek off SR 2144 (Stone Haven Drive) (PC-5)**

**Photo: mid-reach, looking downstream**

**Visible land use:** Forest and residential.  
**Width (m):** 1.5  
**Drainage Area (mi<sup>2</sup>):** 0.5  
**Depth (m):** Average: 0.1  
**Canopy (% cover):** 75, deciduous forest  
**Substrate (%):** Boulder (Tr), rubble (15), gravel (30), sand (40), silt (10), bedrock (5).  
**Riparian quality:** Right bank >18 meters and intact. Left bank <6 meters and not intact.  
**Instream habitat:** Rocks abundant, macrophytes rare, sticks/leafpacks common, snags/logs common, undercut banks rare, rootmats common.  
**Habitat Score (out of 100):** 60  
**Dissolved Oxygen (mg/L):** 7.4  
**Specific conductance (µS/cm):** 66  
**Temperature (°C):** 22  
**pH:** 6.8  
**Remarks:** above golf course abundant sand, silt .  
**Bioclassification:** Good

This small site rated Good based on small stream criteria. Twenty-five EPT taxa were collected. The EPT BI was 3.42 and the NCBI was 4.05. Six different stonefly taxa were collected including *Eccopectura xanthenes*, *Perlesta*, *Tallaperla*, *Amphinemura*, *Leuctra*, and *Isoperla holochlora*. Eight mayfly taxa were collected including the intolerant taxa *Paraleptophlebia* and *Habrophleboides*. This is the only site where *Habrophleboides* was collected. The intolerant caddisfly, *Dolophilodes*, was Abundant. Other intolerant caddisfly taxa collected included *Diplectrona modesta*, *Glossosoma*, and *Pycnopsyche gentilis*. Twenty-five EPT is a high number of taxa for a 0.5 square mile drainage area.

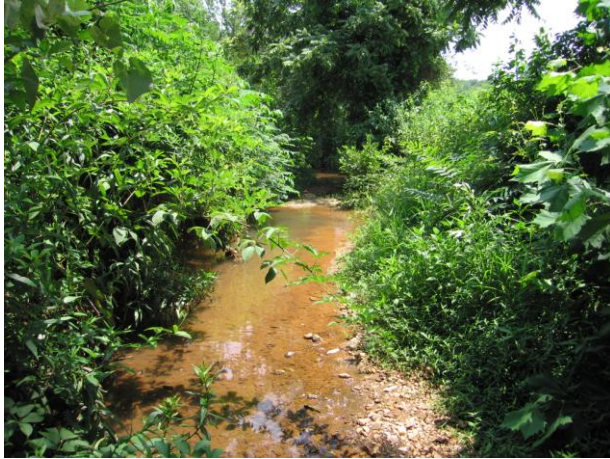
### Pilot Creek at Sand Trap Lane (PC-4)

Photo: mid-reach, looking downstream

**Visible land use:** Forest, agriculture.

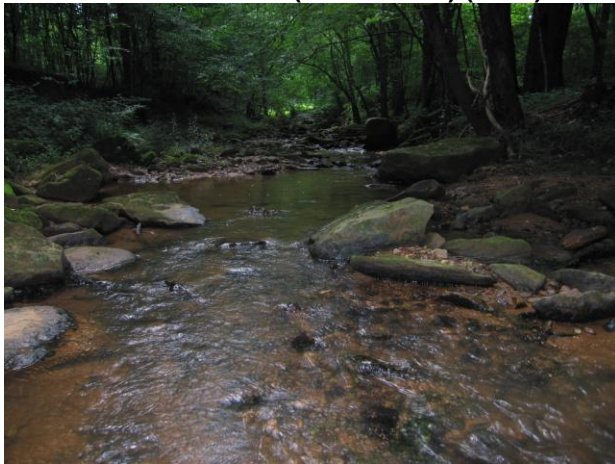
### Pilot Creek at SR 2047 (Shoal Road) (PC-1)

Photo: mid-reach, looking downstream

**Visible land use:** Forest.  
**Width (m):** 3.0  
**Drainage Area (mi<sup>2</sup>):** 6.0  
**Depth (m):** Average: 0.2  
**Canopy (% cover):** 70, deciduous trees, shrubs  
**Substrate (%):** Boulder (20), rubble (20), gravel (25), sand (20), silt (15).  
**Riparian quality:** Left and right banks >18 meters. Right bank intact. Left bank not intact.  
**Instream habitat:** Rocks abundant, macrophytes common, sticks/leafpacks common, snags/logs rare, undercut banks/rootmats rare.  
**Habitat Score (out of 100):** 75  
**Dissolved Oxygen (mg/L):** 7.8  
**Specific conductance (µS/cm):** 60  
**Temperature (°C):** 21  
**pH:** 6.9  
**Remarks:** Abundant silt on rocks and roots.  
**Bioclassification:** Good

This site received a Good bioclassification. Thirty-three EPT taxa were collected, the highest number of EPT taxa collected at the 12 sites. The EPT BI (3.29) was the third lowest, after the reference site (UT Pilot Creek at State Park Road) and the upper Heatherly Creek site at US 268. The NCBI (3.79) was the second lowest after the reference site. Fourteen different caddisfly taxa were collected, which is the highest number of the 12 sites. This was the only site where the caddisfly *Ceratopsyche morosa* was collected. The intolerant mayflies, *Leucrocota* and *Epeorus vitreus* were Abundant. Although silt was abundant, *Neophylax oligius*, an intolerant caddisfly that attaches its retreat to rocks was Abundant.

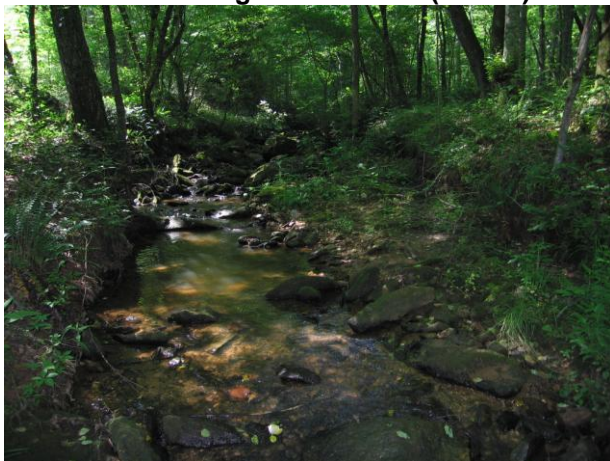
### UT Pilot Creek off gated SP Road (PC-2.1)

Photo: mid-reach, looking upstream

**Visible land use:** Forest  
**Width (m):** 1.5  
**Drainage Area (mi<sup>2</sup>):** 0.8  
**Depth (m):** Average: .15  
**Canopy (% cover):** 80, deciduous forest  
**Substrate (%):** Boulder (15), rubble (20), gravel (25), sand (35), silt (0), bedrock (5).  
**Riparian quality:** Right bank >18 meters and intact. Left bank not intact (gravel road parallel to stream) riparian width 12-18 meters.  
**Instream habitat:** Rocks abundant, macrophytes rare, sticks common, leafpacks abundant, snags/logs rare, undercut banks/rootmats rare.  
**Habitat Score (out of 100):** 78  
**Dissolved Oxygen (mg/L):** 8.4  
**Specific conductance (µS/cm):** 43  
**Temperature (°C):** 18  
**pH:** 6.9  
**Remarks:** abundant sand.  
**Bioclassification:** Excellent
