**Division of Water Quality
Biological Assessment Unit
November 3, 2003**

MEMORANDUM

Subject: TMDL stressor study of Little Alamance Creek, Alamance County,
Cape Fear subbasin 03, June 2003.

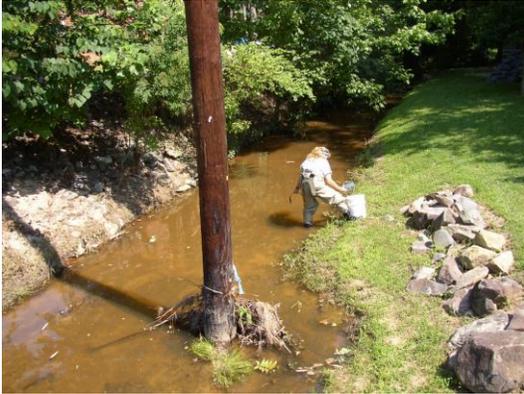
Headwaters of Little Alamance Creek begin around Glen Raven, south of NC 100. Gant Lake is the source of Gant Brook, which drains the eastern half of this general area. Gant Brook was inspected at Woodland Avenue as a possible sampling location. The stream was a channelized ditch about 2 meters wide with no visible flow. There was a telephone pole in the middle of the stream and the whole immediate area was heavily urbanized. Water chemistry measurements showed a conductivity value of 192 $\mu\text{hos/cm}$. The western half of the headwaters region is drained by West Prong Little Alamance Creek. Gant Brook joins this stream just south of Woodland Ave.

Gant Brook at Woodland Avenue.

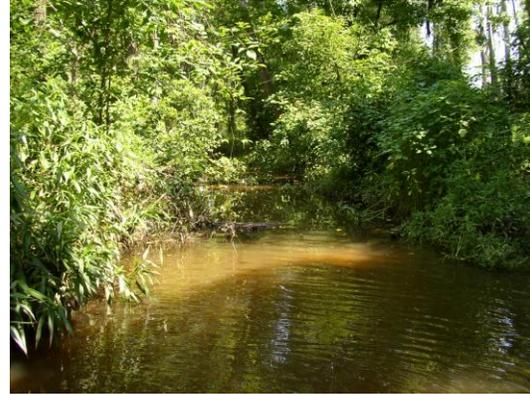
West Prong Little Alamance Creek at Edgewood Avenue was also considered as a possible sampling location. At this location the stream was channelized, possibly from the construction of Rockwood Avenue, which runs parallel to the channel. The water

was turbid and there was no flow. Water chemistry measurements indicated a conductivity of 170 $\mu\text{mhos/cm}$.

W Prong L Alamance Cr. at Edgewood Ave.

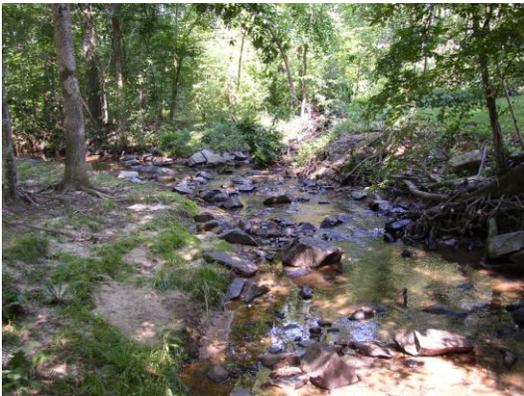
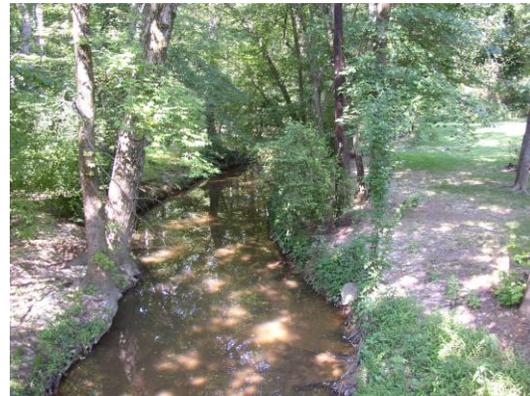
Coble Brook at Engleman Avenue

Coble Brook drains a largely residential area of west Burlington. Together with West Prong of Little Alamance Creek, this stream forms Mays Lake. At this site, the stream was only 3 meters wide with a drainage area of 0.9 square miles. A Qual 4 sample was taken here.

Coble Brook at Engleman Ave., upstream.

Coble Brook at Engleman Ave., downstream.

The substrate here was mostly sand, however, there was one riffle area that contained a significant amount of boulder and rubble. Downstream the stream bottom was all sand and the streambed appeared channelized. The banks were unstable and the riparian zone was a combination of a few larger trees and mowed lawns on both sides. The habitat score at this site was 56. The conductivity value of 90 $\mu\text{mhos/cm}$ was the lowest recorded in this survey.

The macroinvertebrate fauna was sparse with only four EPT taxa; all of which are tolerant. Tolerant midges including *Polypedilum sp.*, *Natarsia*, *Thienemannimyia group*, and *Ablabesmyia mallochi* were common to abundant. This assemblage of highly tolerant organisms produced a Biotic Index value of 6.96. This is in the Fair range for larger streams.

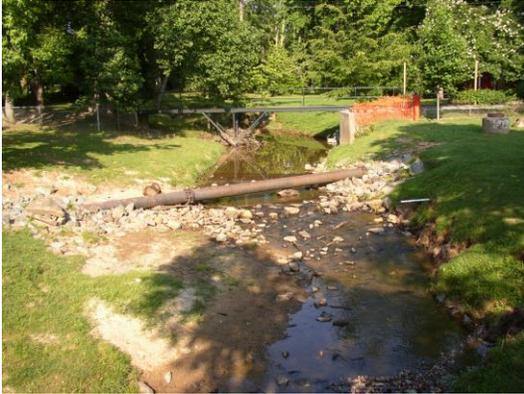
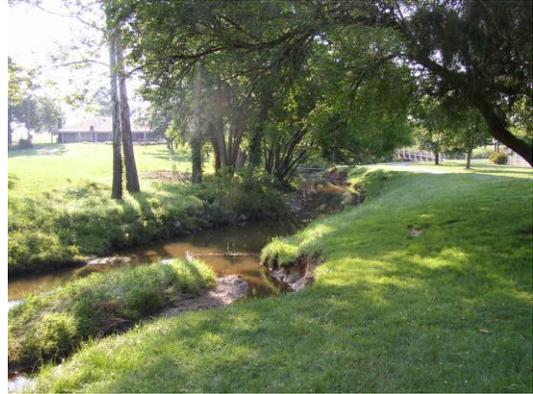
Little Alamance Creek begins at the overflow of Mays Lake and flows through an urban area and then through a Burlington city park from NC 62/70 to Overbrook Road. Within the park, the riparian zone consisted of mowed grass down to the edge of the stream with a few isolated large trees. The banks were eroded and the substrate was mostly sand and gravel.

Little Alamance Cr. at Burlington city park.

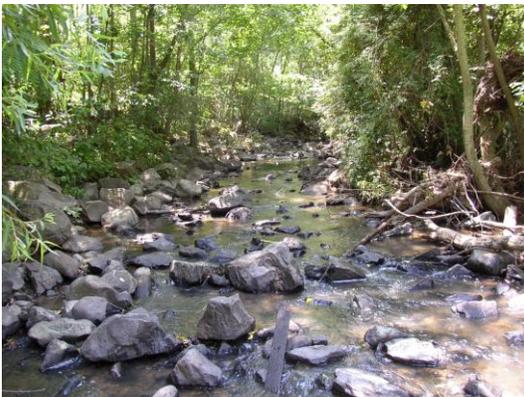
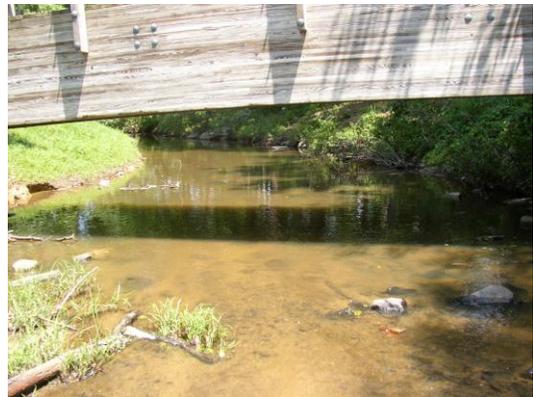
Little Alamance Creek at Overbrook Road

Conditions improved slightly as the stream approached Overbrook Road. The riparian zone had more trees and shrubs and banks were more stable. The substrate had a large area of boulder and rubble that appeared to have been placed there. Further downstream, the substrate was again sand and gravel. The rocks were embedded, and other instream habitat was poor. The habitat score was 64. Conductivity was 185 $\mu\text{mhos/cm}$.

Little Alamance Creek at Overbrook Road, looking upstream.

Little Alamance Creek at Overbrook Road, looking downstream.

The macroinvertebrate fauna was similar to Coble Brook. One additional tolerant EPT taxon (*Caenis sp.*) was present here. Tolerant midges, including *Polypedilum sp.*, *Natarsia*, *Glyptotendipes*, and *Ablabesmyia mallochi*, were the dominant organisms.

Blackflies (*Simulium*) were also abundant. The Biotic Index value (7.25) was slightly higher than the value recorded at Coble Brook, and this site received a rating of Poor.

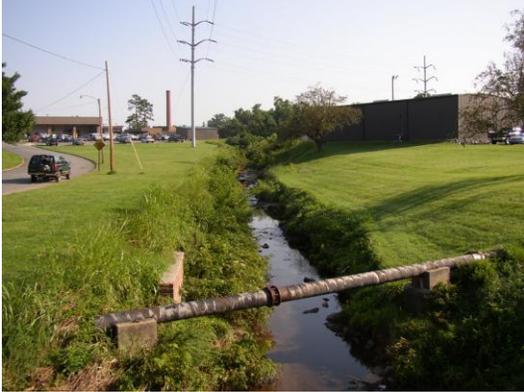
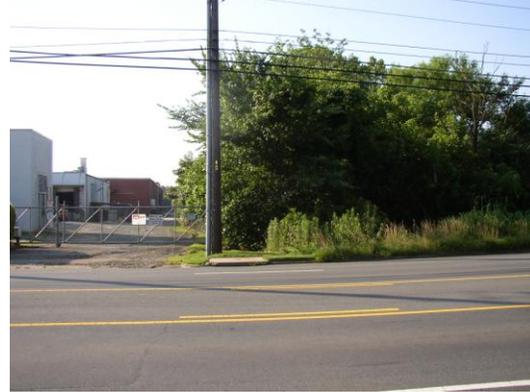
Willowbrook Creek is a tributary of Little Alamance Creek that drains a heavily urbanized area of western Burlington. The city of Burlington Public Works is just upstream of Mebane Street. Here the stream is a channelized ditch with mowed grass lawn on both banks. At the time of sampling, there was no visible flow, and no benthos sample was taken. Water chemistry measurements indicated a conductivity of 285 $\mu\text{mhos/cm}$; the highest value recorded in this study. Willowbrook Creek joins Little Alamance Creek just upstream of Chapel Hill Road (NC 54).

Willowbrook Creek at Mebane Street
Upstream view of Burlington Public Works.

Willowbrook Creek at Mebane Street
Downstream view; stream is hidden by the trees on the right side of the photo.

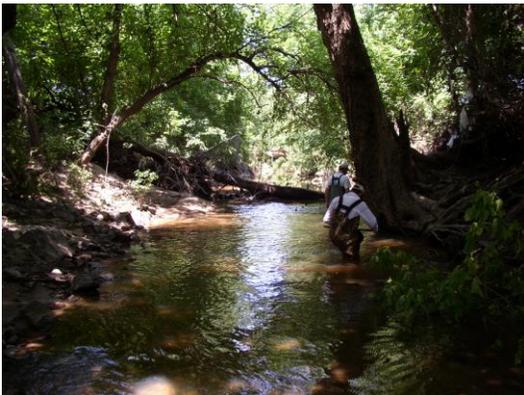
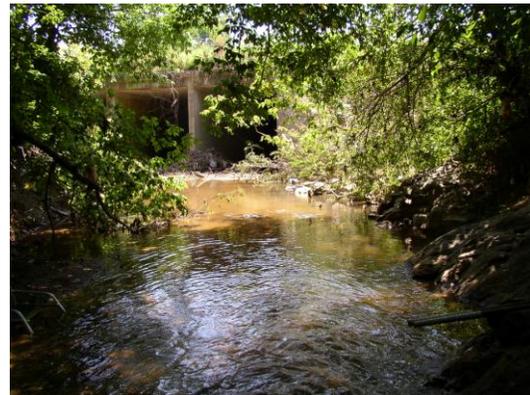
Little Alamance Creek at I- 85

At this location, the stream flows through a heavy industrial area and is about five meters wide. The high, steep banks were badly eroded, and the riparian area was sparsely vegetated with widely spaced large trees and grasses. Infrequent riffles and pools, and a mostly sand substrate contributed to a low habitat score of 57. Margin and rootmat habitats were better than at upstream sites. Conductivity at this site was 214 $\mu\text{mhos/cm}$.

Little Alamance Creek at I- 85, upstream.

Little Alamance Creek at I- 85, downstream.

Only four EPT taxa were collected at this site, with three of the four rare in abundance. *Cheumatopsyche* was the only abundant EPT taxon, resulting in the lowest EPT abundance (13) of all sites. *Polypedilum* was the most dominant midge genus with four species present. Other tolerant midges were also common, including *Ablabesmyia mallochi*, *Thienemannimyia* group, *Glyptotendipes*, and *Natarsia*. The Biotic Index score of 7.6 was the highest noted in this survey. This site received a rating of Poor. The increase in the Biotic Index and decrease in EPT abundance indicates a decline in water Quality relative to the Overbrook Rd site.

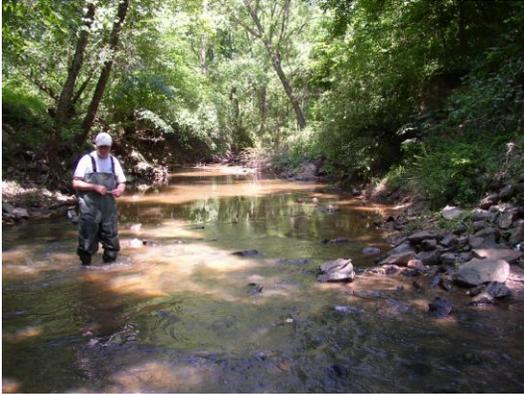
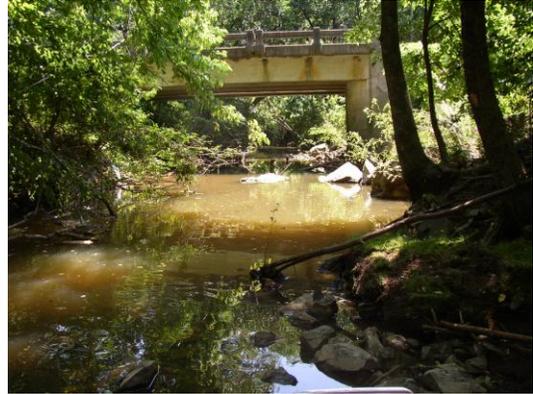
Little Alamance Creek at NC 49

Habitat at this site was much better than at upstream locations. The substrate was a mixture of boulder, rubble, gravel, and sand, with far less embeddedness. Pools and riffles were frequent, and the water was less turbid. Both banks were steep and eroded but with much more vegetation and rootmats. The riparian areas were largely intact with large trees and a diverse understory providing good shading to the stream. Instream habitat was adequate. The habitat score was 75, however, a conductivity value of 208 $\mu\text{mhos/cm}$ indicated water quality problems.

Little Alamance Creek at NC 49, upstream.

Little Alamance Creek at NC 49, downstream.

The macroinvertebrate fauna here was very similar to the I- 85 site. Baetid mayflies were more numerous, increasing EPT abundance to 22. *Caenis* was absent, and *Hydropsyche betteni* was still rare. Tolerant midges were again the dominant group, including *Polypedilum scalaenum*, which outnumbered all other species. The Biotic Index improved slightly to 6.85, but this site was also rated Poor.

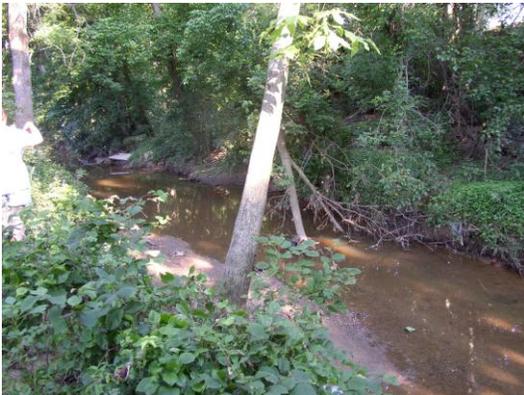
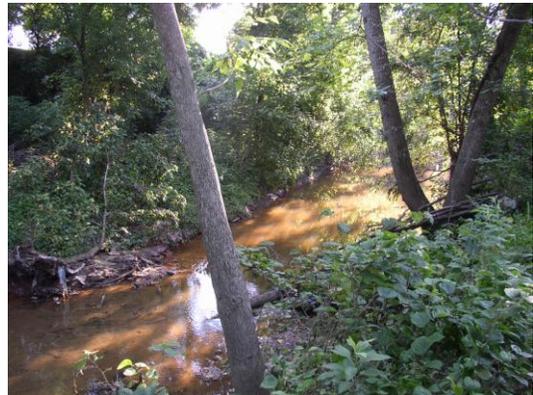
Bowden Branch at SR 2312

Bowden Branch is a tributary to Little Alamance Creek that drains the eastern portion of the catchment near Graham. This stream was considered as a possible benthos site, but was not sampled due to lack of flow. It was typical of other small streams in the area with high, steep banks that were badly eroded, and a sandy substrate with little instream habitat. Water chemistry measurements indicated a conductivity value of 161 μmhos .

Bowden Branch at SR 2312, upstream view.

Bowden Branch at SR 2312, downstream view.

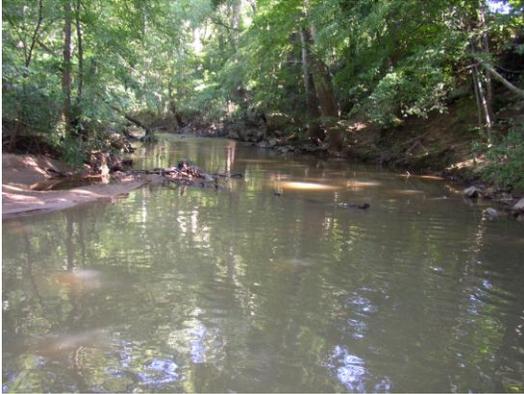
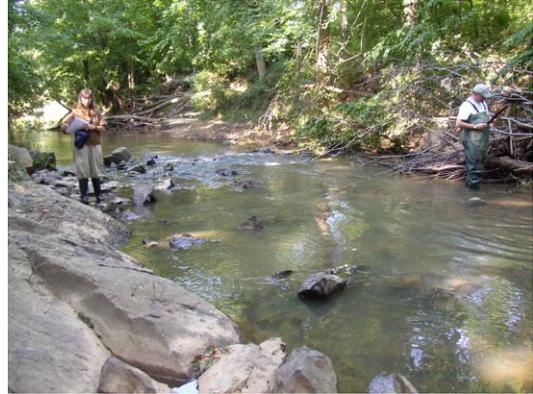
Little Alamance Creek at SR 2309

This site is the last road crossing downstream on Little Alamance Creek, located at the South Graham Municipal Park. The stream was seven meters wide with a mixed substrate containing less sand than upstream sites. There was a well-defined riffle area with only slightly embedded rocks. Both banks were high and steep with erosion exposing large tree roots. The riparian zone was narrow due to the developed park, but otherwise intact with large trees. Favorable instream habitat produced a score of 73. Water chemistry indicated problems with a conductivity measurement of 181 $\mu\text{mhos/cm}$.

Little Alamance Creek at SR 2309, upstream.

Little Alamance Cr. at SR 2309, downstream.

This location has been sampled twice previously. A full scale sample in 1985 produced a rating of Fair, and an EPT sample in 1998 turned up only six taxa, and a Poor rating. Five EPT taxa were found here in 2003, including *Stenonema modestum*. This species had not been collected at any sites upstream. *Stenacron interpunctatum* was abundant in the previous two collections here, but was not present in 2003. As with upstream sites, midges were the most common group of organisms. The Biotic Index improved slightly to 6.69, while EPT abundance (50) and total taxa richness (41) values were the highest of all sites. These improvements raised the rating to Fair.

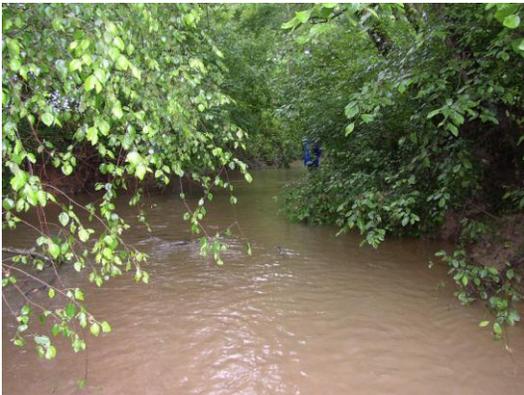
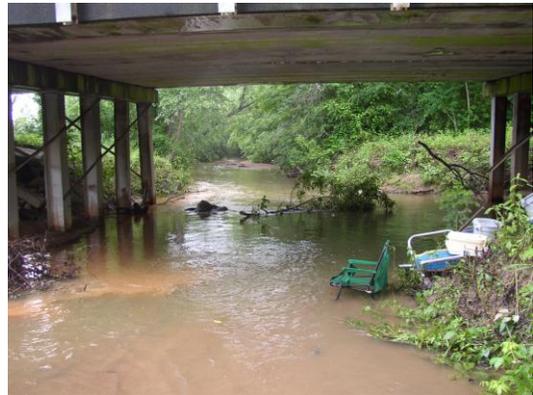
Reedy Fork at SR 2269

This stream was used as a reference site. It is similar in size and geology to Little Alamance Creek, and has the same types of habitat degradation. The banks were badly eroded and the channel was filled with sand. Riparian areas were broken, and poor instream habitat. The habitat score was 43, however, conductivity was measured at 90 $\mu\text{mhos/cm}$.

Reedy Fork at SR 2269, upstream view.

Reedy Creek at SR 2269, downstream view.

An EPT sample here yielded 14 taxa. Most notable among the taxa collected were four species of stoneflies, which are fairly intolerant of pollution. No stoneflies were found in Little Alamance Creek. This demonstrates that even with degraded habitat, Little Alamance Creek should be capable of supporting a more diverse benthic fauna.
