North Carolina Division of Water Quality
Surface Water Protection Section
May 6, 2005

Summary of Physical and Chemical Water Quality Data
Little Mountain, Mountain and Jacobs Creek Local Watershed Plan
Prepared for the
North Carolina Ecosystem Enhancement Program

Yadkin Pee Dee River Basin
Subbasin 03-07-08
Catalog Unit # 03040104
HU #s 010010, 010020

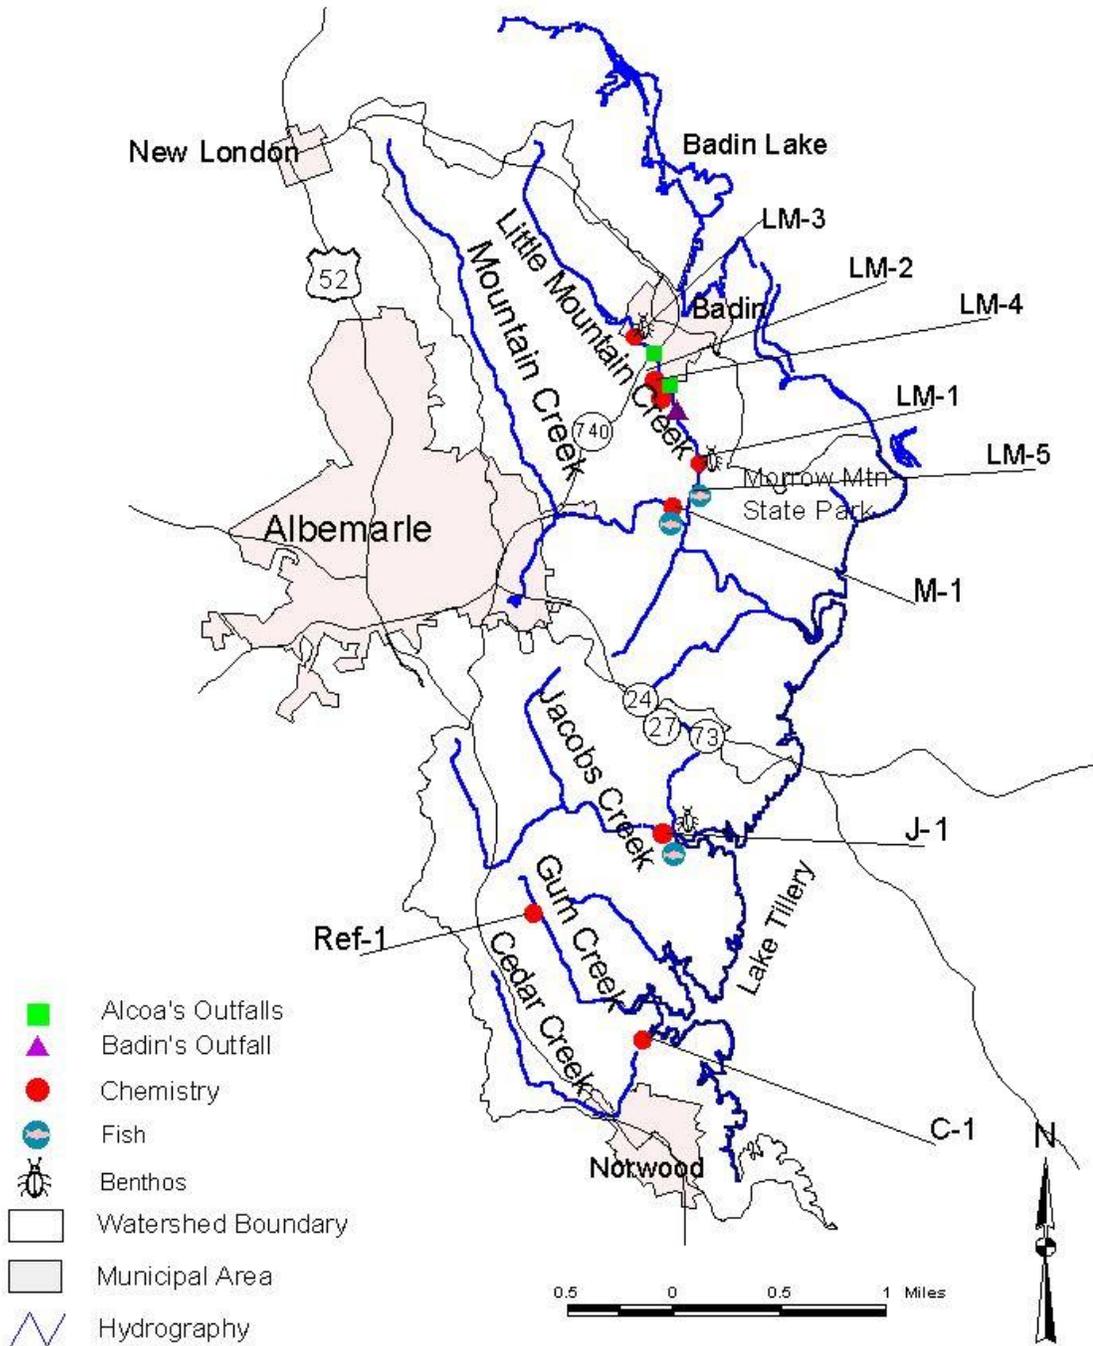
Figure 1. NCDWQ Monitoring sites for Mountain, Little Mountain and Jacobs Creeks Local Watershed Plan.

Chemical/physical water quality monitoring locations were established for five streams within the planning area: one each for Little Mountain, Mountain, Jacobs, Gum and Cedar Creeks. Three additional upstream locations were selected for Little Mountain Creek (two mainstem and one tributary). An upstream portion of Gum Creek was selected to serve as the local reference stream representing a minimally impacted drainage area within the study area (Figure 1, Table 1)

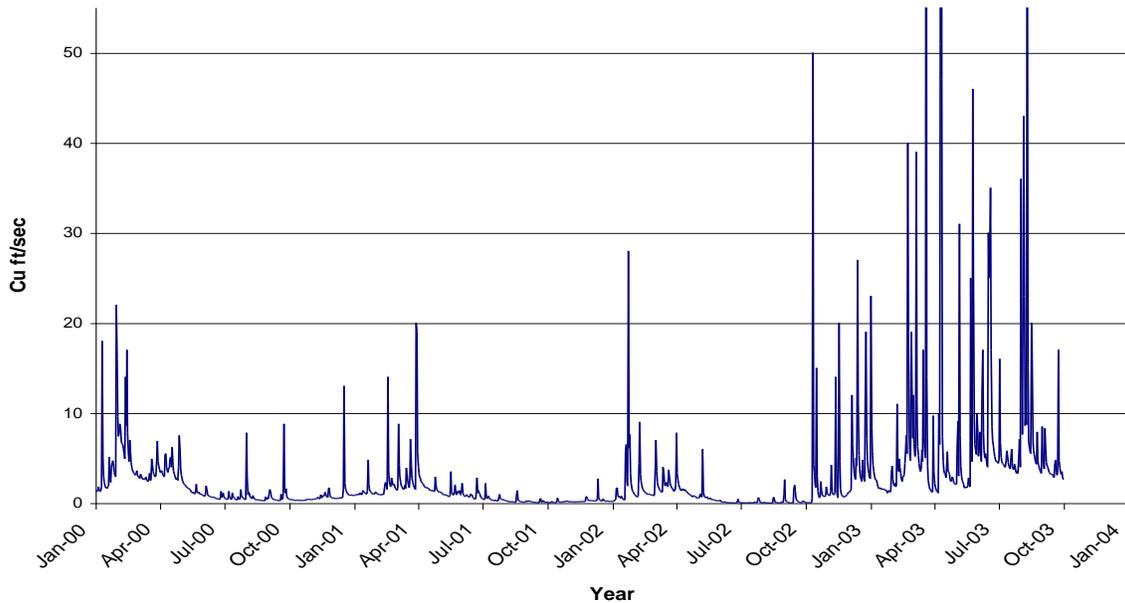
Figure 2. Daily mean streamflow for Dutchmans Creek drainage area (3.4 sq. mi.). USGS gage 02123567.

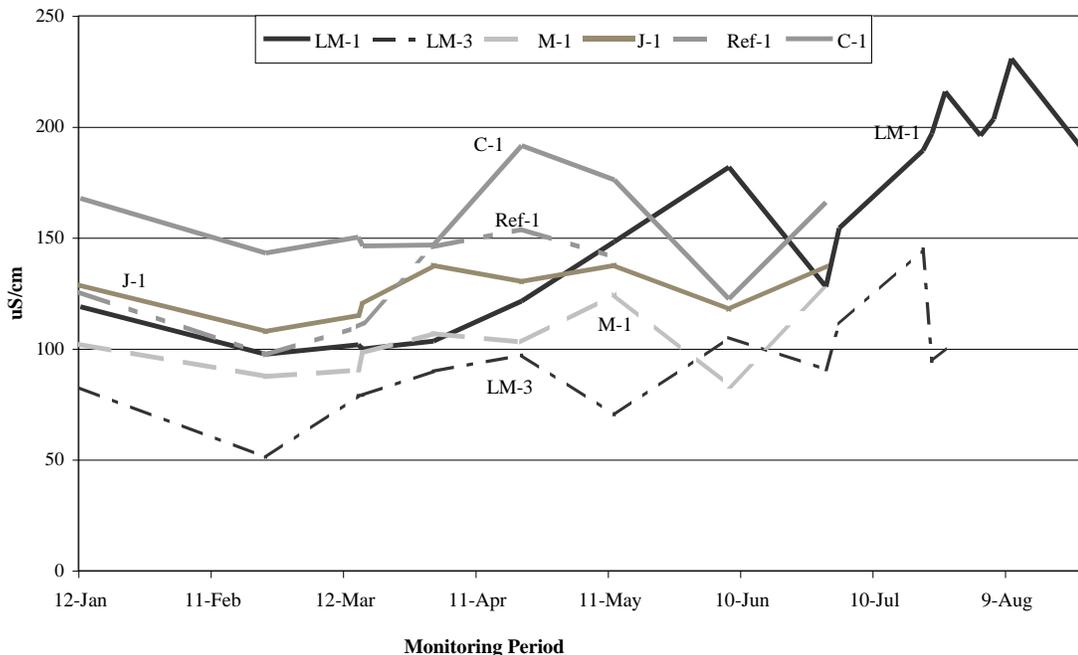
Figure 3. Baseflow specific conductance by subwatershed from January through August 2004.

Baseflow. Observed baseflow field readings for all subwatersheds were within reasonable values. Dissolved oxygen and pH measurements consistently met NCDWQ water quality standards (Table 2). As expected, median specific conductance was highest in Little Mountain Creek (LM-1) downstream of Badin and Alcoa's point discharges (154 $\mu\text{S}/\text{cm}$); however, it was unexpected to observe the relatively high median value (150 $\mu\text{S}/\text{cm}$) recorded for Cedar Creek (C-1) because no upstream point discharges were present (Table 2). The most upstream location on Little Mountain Creek (LM-3) was consistently lower in specific conductance than all other locations including Gum Creek (Ref-1; Figure 3). This was most likely due to influences of an upstream impoundment.

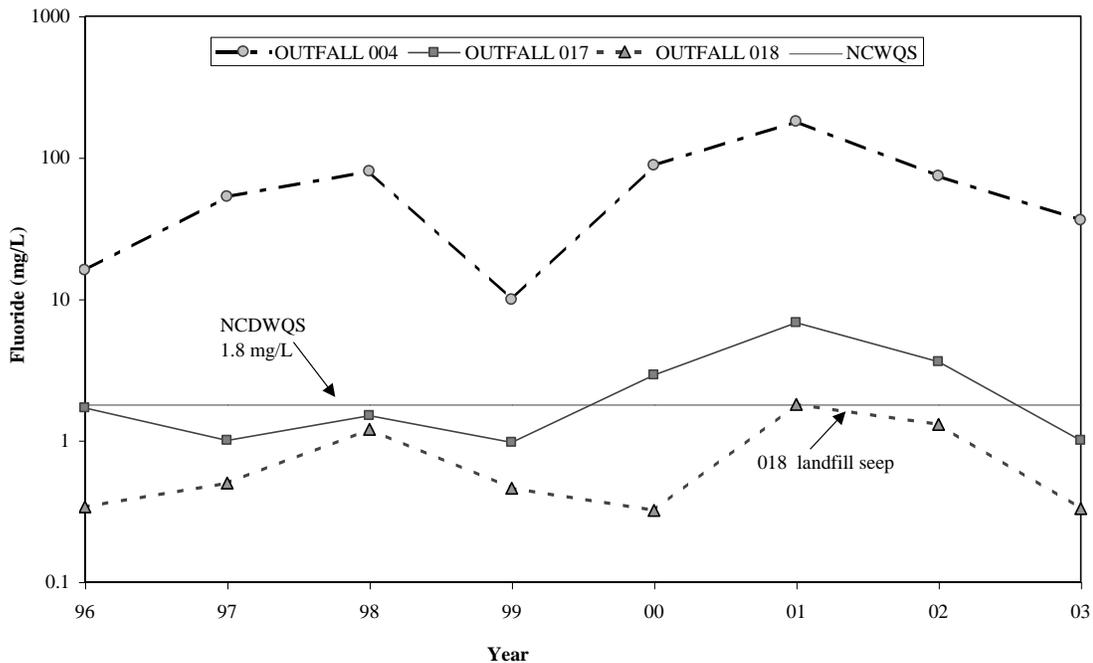
Stormwater fluoride data during the same period (1996 – 2003) are presented in Figure 4. Monitoring associated with the on-site outfall (004) revealed elevated fluoride concentrations well above the water quality standard of 1.8 mg/L every year. These flows were apparently combined with other on-site stormwater as fluoride concentrations were diluted prior to entering Little Mountain Creek. However, according to the data from outfall 017, dilution to below the standard occurred only during the first four years (1996 through 1999) and the last (2003). For a three-year period (2000 – 2002) coinciding with drought conditions during those years, the fluoride standard was exceeded.

Figure 4. Alcoa's stormwater fluoride.

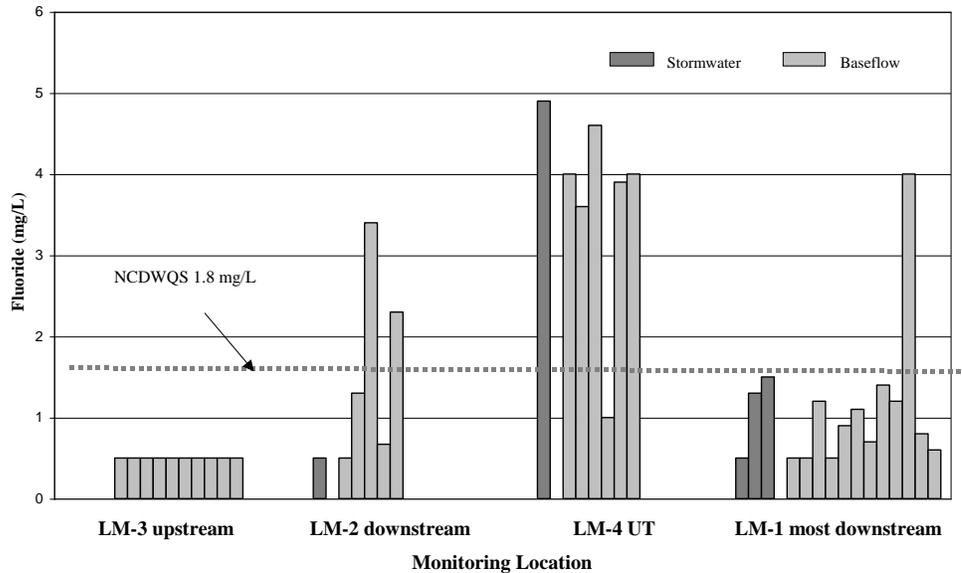
NCDWQ data. Fluoride data collected for this study is presented below in Figure 5. In the UT to Little Mountain Creek (LM-4), fluoride was detected above the standard five times out of six baseflow-monitoring events and in stormwater monitoring. At the most downstream location in Little Mountain Creek (LM-1) fluoride concentrations were, for the most part, diluted to below the standard. Fish and macroinvertebrates were collected at this location.

Figure 5. NCDWQ fluoride at Little Mountain Creek December 2003 - August 2004 (baseflow and stormwater).

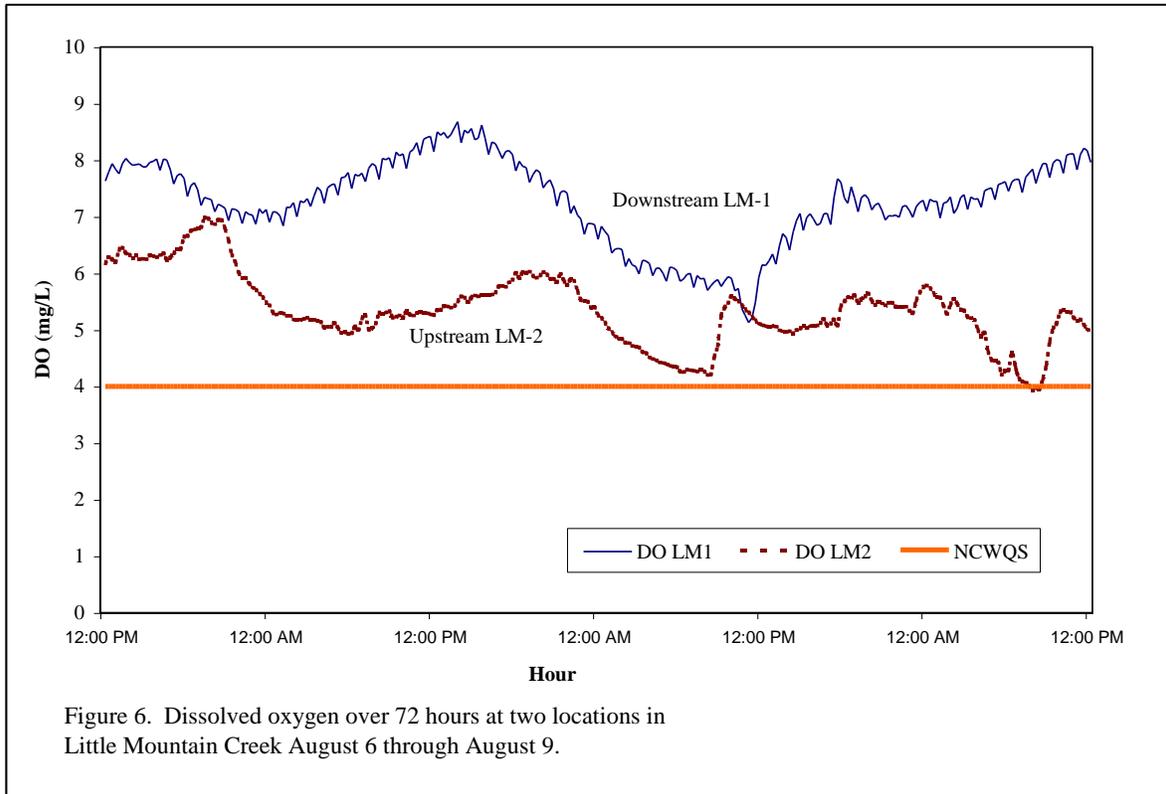
To further evaluate dissolved oxygen at Little Mountain Creek, data sondes were simultaneously deployed for a 72-hour period in August 2004 in Little Mountain Creek upstream and downstream of Badin and Alcoa’s outfalls at LM-1 and LM-2. Probes were programmed to record readings every 15 minutes. Dissolved oxygen followed a typical diurnal pattern with

minimal values occurring overnight. Upstream recordings fell below 4.0 mg/L during the last 24-hour period but recovered during daylight hours. Observations downstream remained above 4.0 mg/L throughout the period (Figure 6).

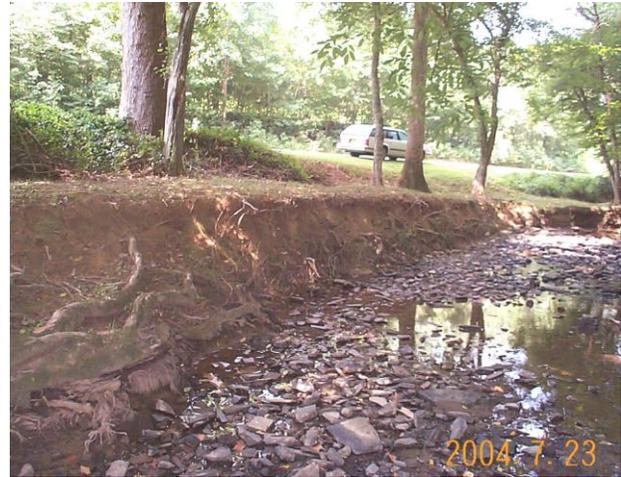
Stream banks ranged from 0.5 to 1.5 feet in height and were mostly 90 degrees vertical. Bankfull height was at or near bank height resulting in a bank height ratio approaching 1.0. One area of bank instability was observed near SR 1723 where the road comes to within 30 feet of the stream (Figure 7). An evaluation of the area using Rosgen's bank erosion hazard index (BEHI) resulted in an index value of moderate; near bank stress was judged to be high (stream velocity vectors pointing at bank). High flows during storm events may eventually erode the outside bank to a point at which SR 1723 could become compromised.

Figure 7. Moderate bank erosion at Little Mountain Creek at SR 1723.

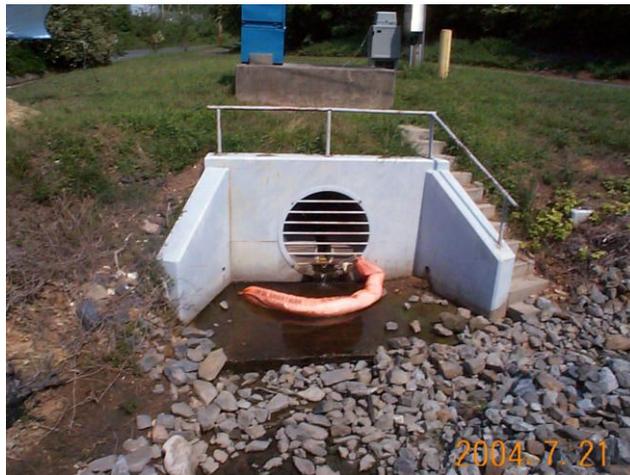
Badin's WWTP outfall was observed 1000 feet downstream from NC 740; nothing unusual associated with the discharge was observed. One of Alcoa's stormwater outfalls discharges to the stream at NC 740 (Figure 8). It was observed discharging during each visit (30 observations) to the subwatershed; nothing unusual with respect to the discharge was observed other than there was flow during dry periods. A county recycling facility is located across NC 740 could provide land for an appropriate structural stormwater best management practice.

Figure 8. Alcoa's stormwater outfall.

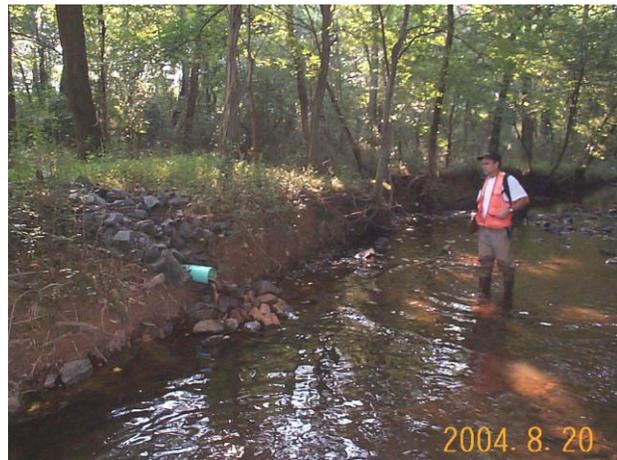
Figure 9. Alcoa's landfill seep discharge.

- Alcoa's fluoride inputs to Little Mountain Creek at (LM-4) often exceeded water quality standards. There were toxicity failures upstream of this location during the past ten years. The most recent failure was in 2002. Alcoa's landfill seep discharged toxicants to Little Mountain Creek 1400 feet upstream of NC 740 but loadings were not significant. Recently, DWQ has given Alcoa permission to connect the landfill seep discharge to Badin's WWTP at flows less than 7500 gallons per day.

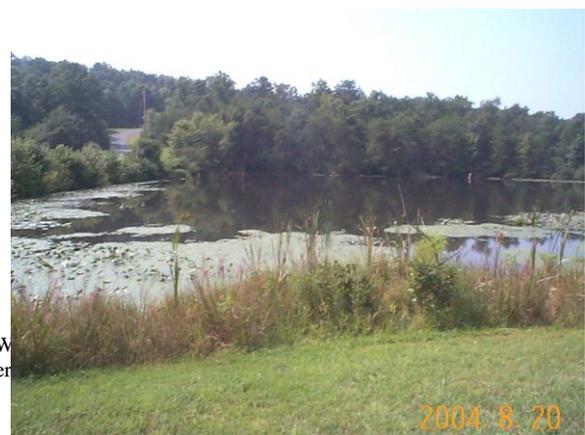
A gravel road ran the length of the earthen dam. The impoundment was not assessed but covered approximately 15 acres in area (Figure 10). The original stream channel was at one end of the dam; an emergency spillway at the other. The spillway was essentially a dug out channel 300 feet north of the original channel and was not discharging at the

time of this assessment. The elevation of the impounded water is maintained by an overflow pipe (12-inch diameter) which removes water from the surface down through the dam about 50-75 feet to a concrete culvert and then to the original channel. Field measurements of water quality were recorded (dissolved oxygen-78.4% and 6.4 mg/L, water temperature-21.9° C, specific conductance-93.8 μ S/cm), and were not unusual for this stream and were similar to baseflow measurements recorded downstream in Little Mountain Creek (LM-3). It appeared also that several large dump truck loads of spoil material (mostly slate bedrock gravel and pebbles) left over from spillway construction were deposited within the original channel which in turn modified stream flow.

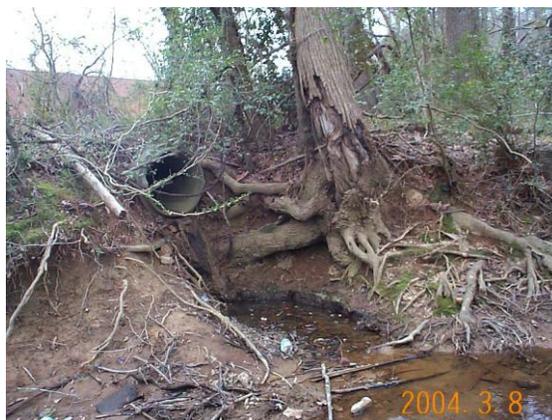
Riparian Zone. The left riparian area was an empty overgrown lot of sparse weeds and *Ligustrum sp.* The right riparian area consisted of an industrial building and sewer right of way < 20 feet from top of bank. A concrete outfall was observed (source unknown) to have previously discharged a thick black substance. The outfall discharge was a source of scour, erosion and a headcut was developing (Figure 11).

Further upstream (100 feet) Cedar Creek makes a 90 degree turn to the north. Stream velocity vectors at this point were high. If allowed to continue, stream bank erosion would most likely result in impacts to adjacent property(s). The stream continued in a mostly straight pattern paralleled by a rail line along the right bank and continued under SR 1922. The channel associated with the segment upstream of SR

1922 appeared to have been relocated to accommodate surrounding land use as well. The original channel was most likely filled. An overhead high voltage utility line impacted this portion of the stream as well.

The Cedar Creek watershed was more unstable than Little Mountain Creek characterized by eroding banks and riparian zone impacts. Two critical areas need to be investigated further to prevent continued water quality degradation, headcutting, bank erosion and possible property damage. These include the outfall described above and the unstable bank where Cedar Creek makes its turn to the north.
