**Assessment Report:
Biological Impairment in the
Morgan Mill and Peter Weaver
Creek Watershed**

**French Broad River Basin
Transylvania County, N.C.**

June 2002

**North Carolina Department of Environment and Natural Resources
Division of Water Quality
Planning Branch**

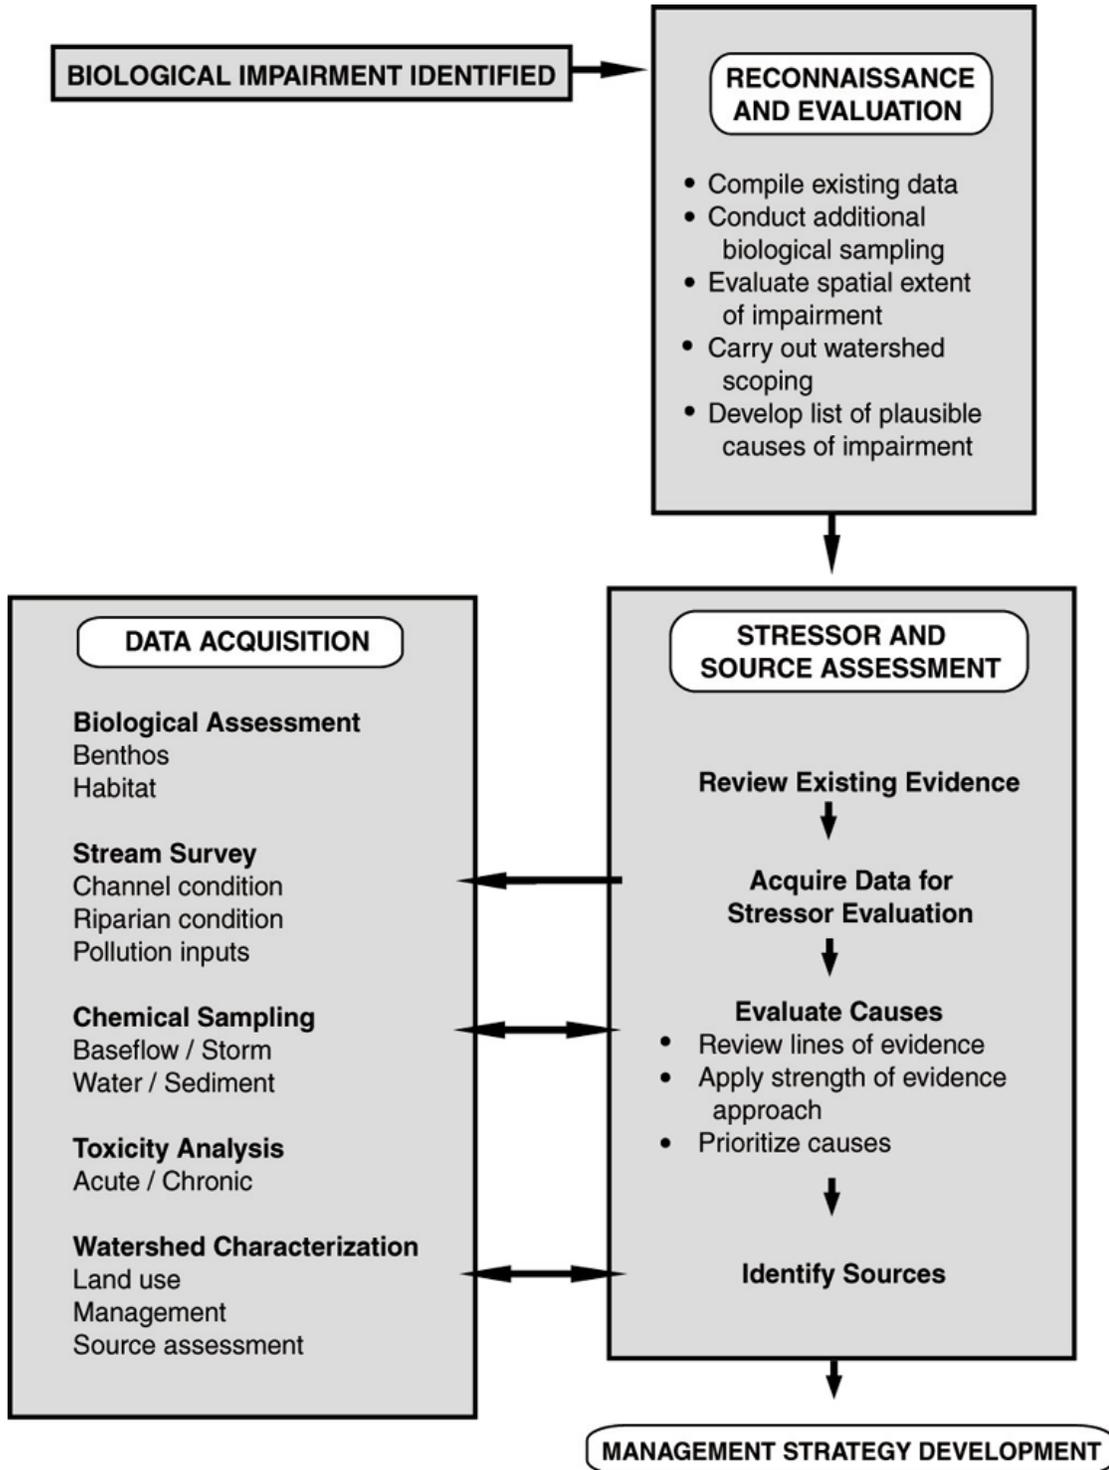
Figure 1.2 Overview of Study Activities

Of the study’s three objectives, identification of the likely cause(s) of impairment is a critical building block, since addressing subsequent objectives depends on this step (Figure 1.2). Determining the primary factors causing biological impairment is a significant undertaking that must address a variety of issues (see background note “Identifying Causes of Impairment” for additional details). While screening level assessments can be used to attempt to identify potential causes of impairment, we have taken a more detailed approach in order to maximize the opportunity to reliably and defensibly identify causes and sources of impairment within the time and resource framework of the project. This provides a firmer scientific foundation for the collection and evaluation of evidence, better enables us to prioritize problems for management, and offers a more robust basis for the commitment of resources. EPA’s recently published guidance for stressor identification envisions that causes of impairment be evaluated in as rigorous a fashion as is practicable (USEPA, 2000).

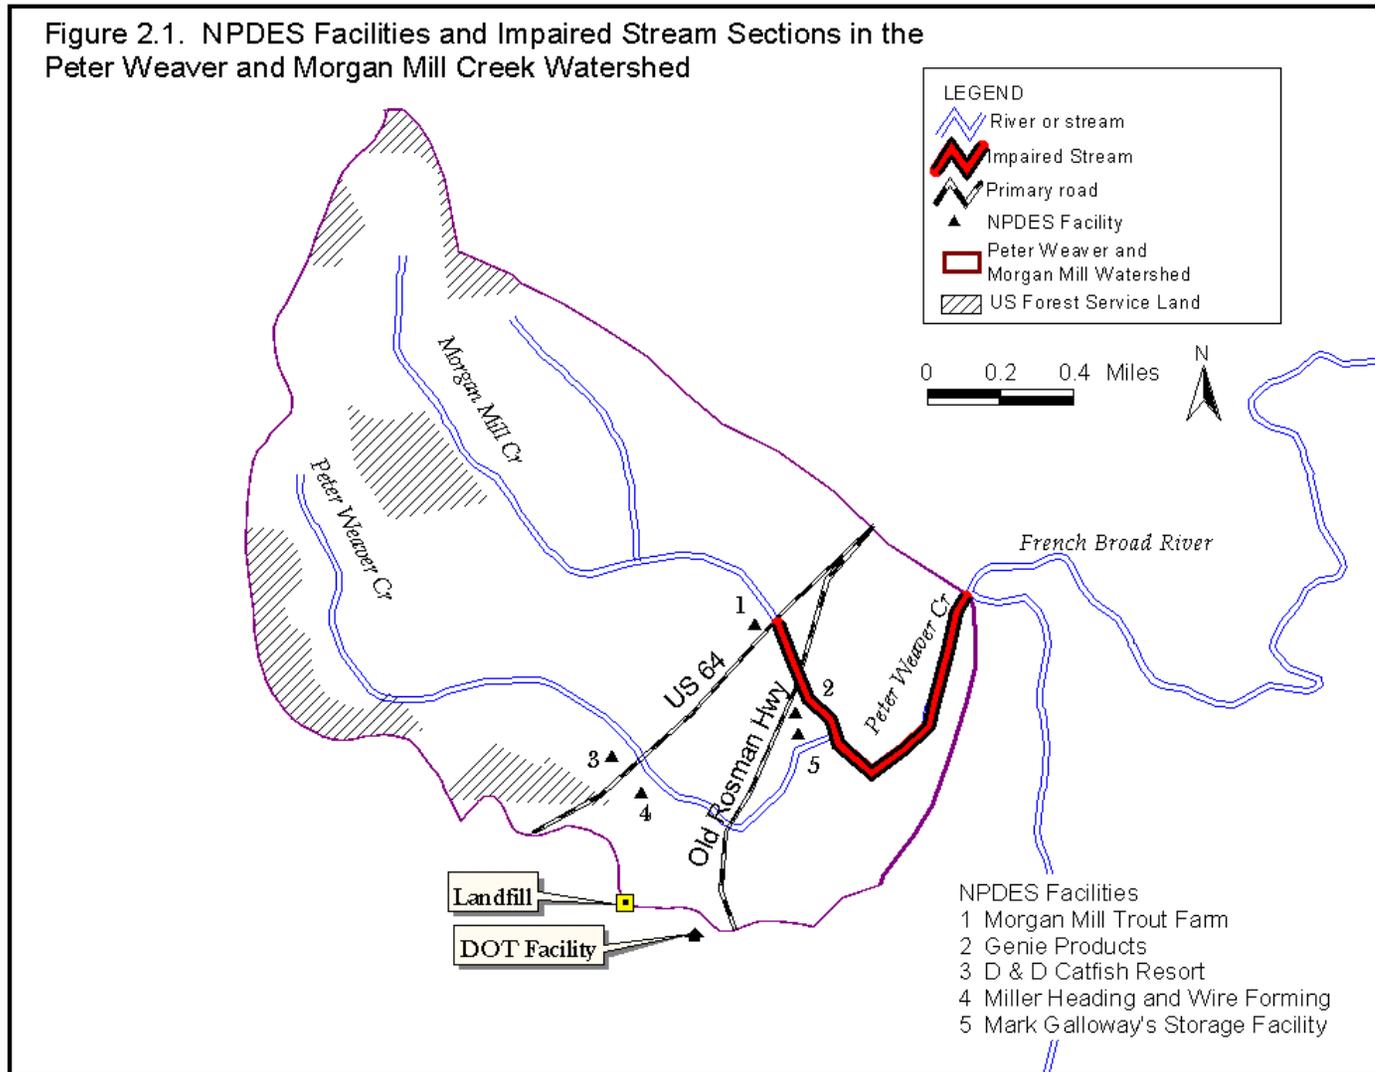
Figure 2.1. NPDES Facilities and Impaired Stream Sections in the Peter Weaver and Morgan Mill Creek Watershed

There are seven facilities with National Pollutant Discharge Elimination System (NPDES) permits in the watershed, but only five facilities--Morgan Mill Trout Farm (NC permit 0081001), Genie Products (G550995), Mark Galloway's Storage Facility (G550879), D & D Catfish Resort (0086223), and Miller Heading and Wire Forming (G550692)--are discharging at this time (Figure 2.1). The first two of these facilities discharge to Morgan Mill Creek, and the last three discharge to Peter Weaver Creek. Genie Products, Mark Galloway's Storage Facility, and Miller Heading and Wire Forming are operating under general permits and are treating and discharging domestic waste. According to the DWQ Asheville Regional Office, these three facilities are operating without notable problems. See Appendix D for permit limits and monitoring requirements for NPDES permitted facilities.

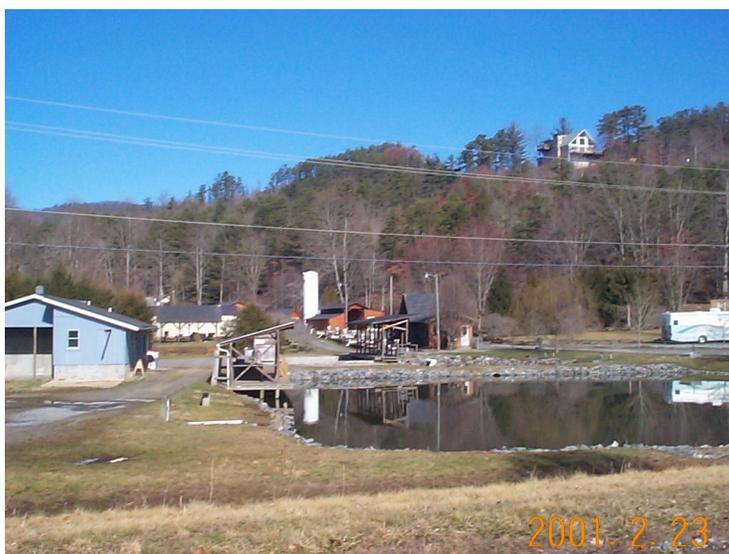
Figure 2.2 Morgan Mill Trout Farm

The Morgan Mill Trout Farm (Figure 2.2) is operating under a general permit for trout farm facilities, which requires annual monitoring of flow, total suspended solids, settleable solids, and dissolved oxygen. This permit prescribes no discharge of fish parts, floating solids or visible foam in other than trace amounts. This farm began trout production in 1984 and produced up to 70,000 lbs/yr until 1999, when it cut production to 15,000 lbs/yr. The farm draws water from Morgan Mill Creek, sending it through trout raceways and three settling ponds, after which it returns the water to the creek. According to an aquaculture extension agent, there have been heavy growths of aquatic plants in the past in the settling ponds; the trout farmer has noted that he has treated these with copper sulfate. The farm currently has a trout fingerling nursery and fish processing facility. Waste from the processing facility is disposed in a septic system.

In July 2001, a Notice of Violation (NOV) was sent to the Morgan Mill Trout Farm for dewatering Morgan Mill Creek. The trout farm facility was removing the entire stream flow to operate the farm and returning the water once it proceeded through the trout raceways and three settling ponds. After the NOV was received, the farm added water to the dewatered creek bed with piped groundwater. Later, the sediment above the dam was cleaned out and a small amount of water allowed to pass through an outflow structure at the base of the dam. Groundwater addition was discontinued.

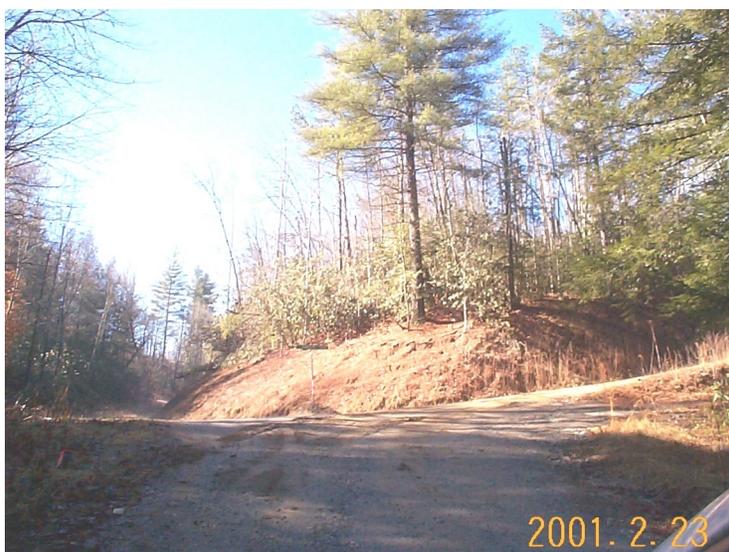
Figure 2.3 Dirt road in upper part of Peter Weaver Creek watershed

Development associated with home sites and commercial ventures (e.g., D & D Catfish Resort) has resulted in increased sedimentation in creeks in the watershed. Severe problems with soil erosion during storms have been observed during road building along steep slopes above US 64. Once in place, gravel and dirt roads in the steep areas of this watershed continue to be a significant source of sediment. Both paved and unpaved roads and driveways are problematic if eroding bare slopes are not stabilized (Figure 2.3). Home sites both during and after construction are a source of sediment, as well; after construction, any bare slopes that have been cut into hill sides and have not been stabilized with vegetation continue to erode. When construction is sited near a creek, the stream banks are often cleared of vegetation, exposing bare banks and promoting future bank instability. Much of this development is taking place in the upper portion of Peter Weaver Creek's watershed, above US 64.

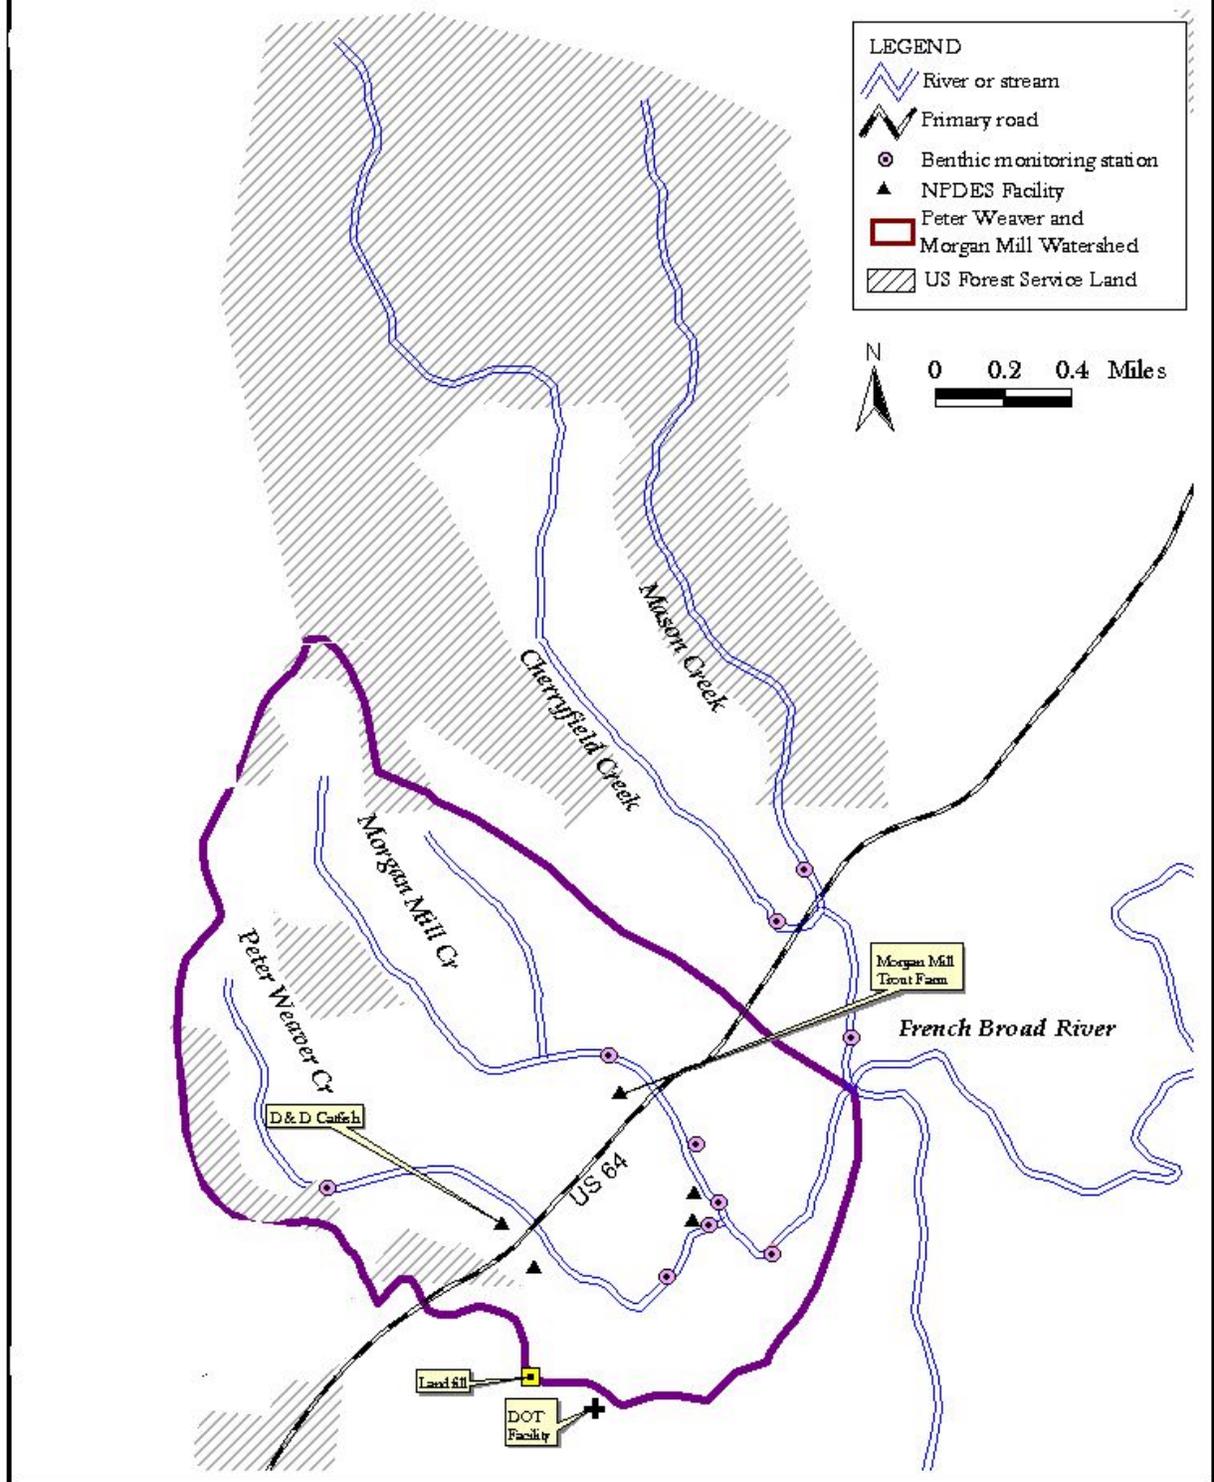
Figure 4.1. Benthic Monitoring Stations in the Peter Weaver and Morgan Mill Creek Watershed

Benthic macroinvertebrate community samples were collected at seven sites in the watershed, with three locations on Morgan Mill Creek and four locations on Peter Weaver Creek (Figure 4.1). In order to compare study streams to relatively unimpacted streams, reference sties were

chosen in the adjacent Cherryfield Creek watershed. These reference streams were of similar gradient and watershed size but drained primarily forested catchments. Due to the large area of pasture and residences in the sampled area, the lowest Cherryfield Creek site was not a typical reference site. It was sampled, however, in order to provide a comparison site for the lowest site on Peter Weaver Creek, which is also in the French Broad River valley. All sampling was performed in May and August 2000 and July 2001.

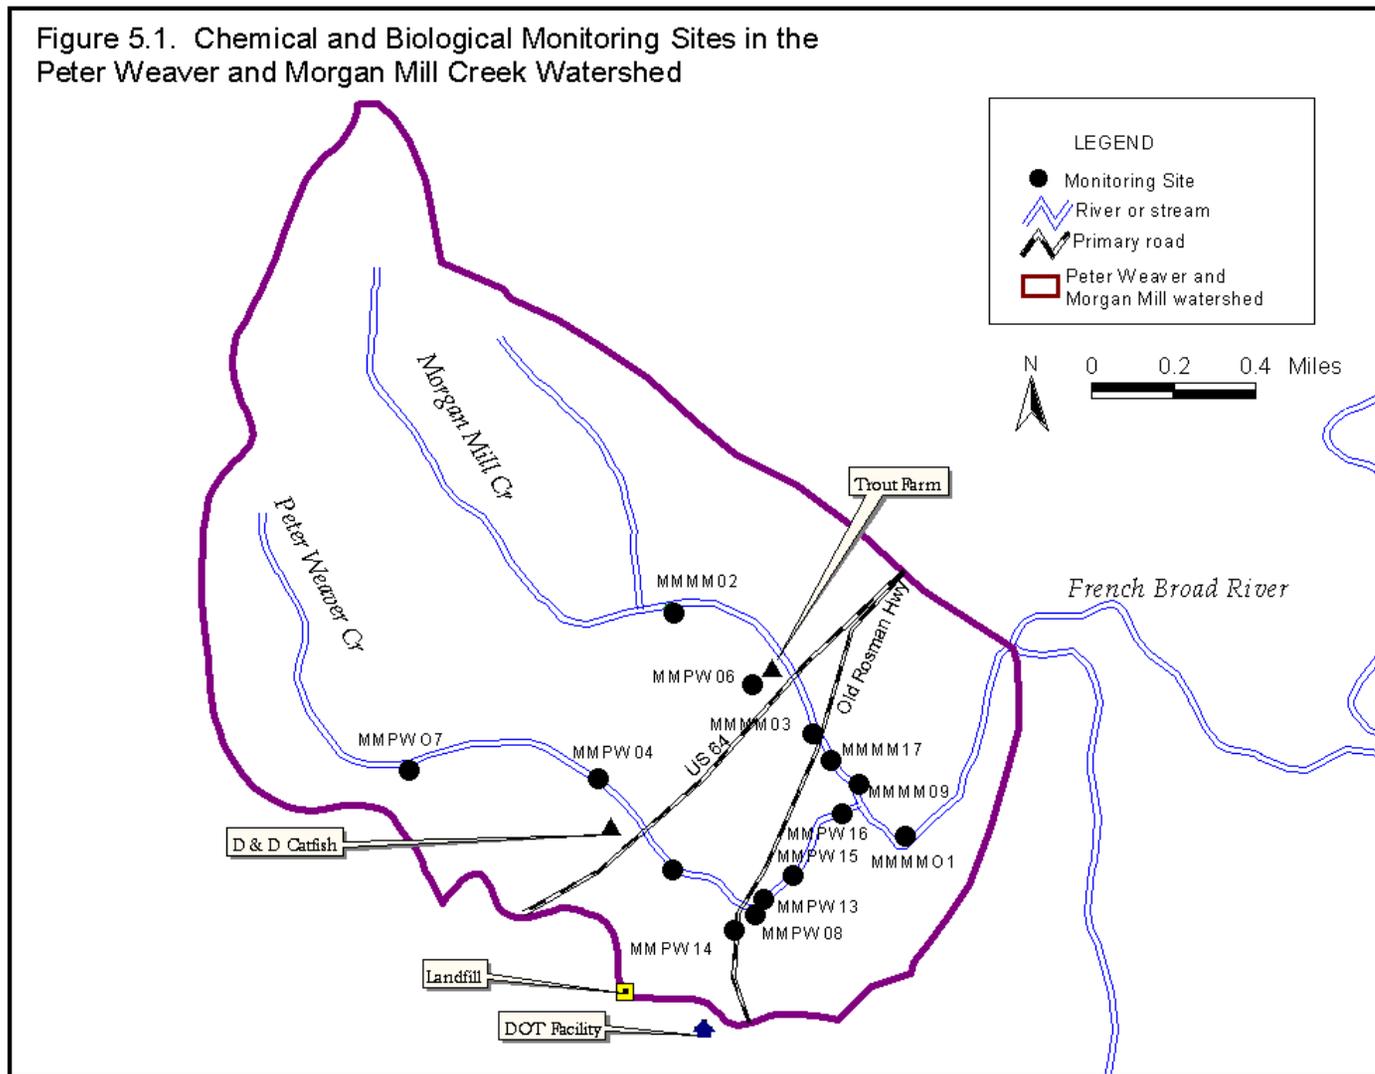
Figure 5.1. Chemical and Biological Monitoring Sites in the Peter Weaver and Morgan Mill Creek Watershed

Stressor identification sampling locations: BOD and nutrient study

- *Morgan Mill Creek off Camp Kahdalea Road* (MMMM02). This site is upstream of the trout farm in a forested stretch of stream. This site was selected to provide upstream background water quality information when paired with the site below the farm.

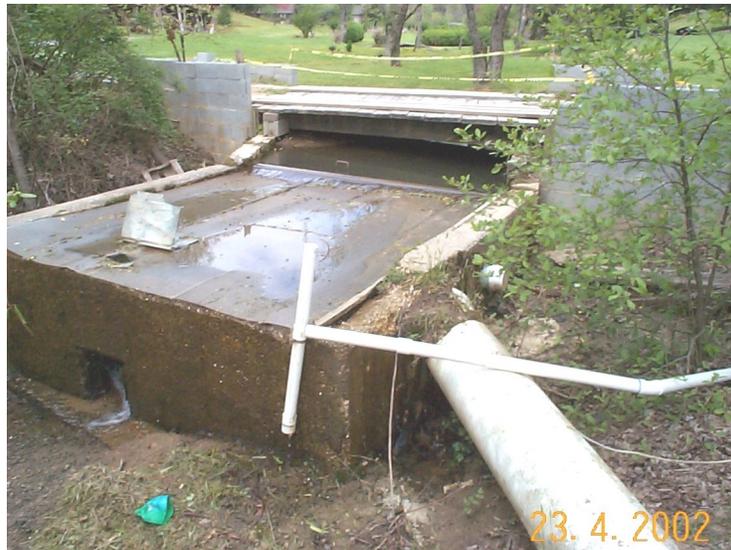
Figure 8.1 Water intake structure at the Morgan Mill Trout Farm

The dam structure at the inlet for the trout farm on Morgan Mill Creek blocks all downstream drift when all water is diverted to the trout farm. Currently, some water is allowed through a bottom outlet at the foot of the dam structure (Figure 8.1). It is necessary to insure permanent water flow below the dam. This small dam should also be retrofitted to allow for the safe passage of aquatic invertebrates to the creek below the dam.

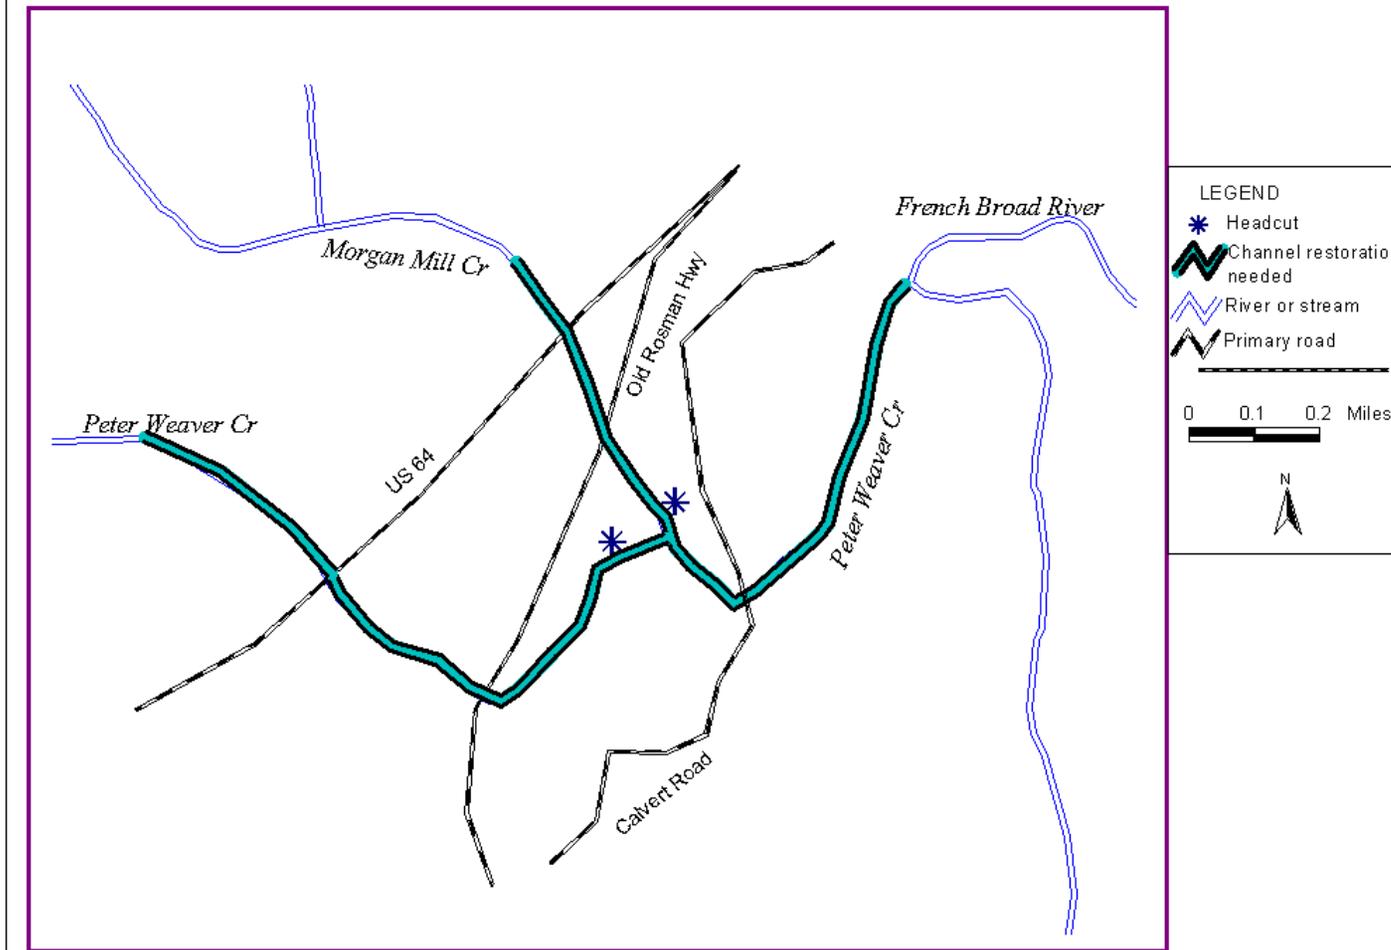
Figure 8.2. Stream Segments Pinpointed for Restoration

Stream bank instability is a watershed-wide problem due to historic and present-day practices, and it is particularly notable in the French Broad River valley part of the watershed (Figure 8.2). Here, Morgan Mill and Peter Weaver Creeks are often incised and unstable, contributing a large amount of sediment to the streams.

If no action is taken to stabilize Peter Weaver and Morgan Mill Creeks, these streams will widen until they have created a stable channel configuration within their current incised channels. This will occur once these streams are wide enough to allow for the natural dynamic processes of meandering and flooding. This process may take decades, and as it occurs, stream banks will contribute in-stream sediment as the channel widens. Habitat degradation will continue to be a major stressor for aquatic communities, landowners will lose property, and this watershed will serve as a continued source of sediment to the French Broad River.

In addition, if the headcuts in both creeks are not stabilized, they will gradually move up these streams, causing further incision and widening. This will not only impact the local area of the headcut, but also that further downstream, which will suffer from increased sediment inputs from these headcut areas.
