**Integrated Analysis Report of Water Quality
for the
Ararat River Watershed**

**Yadkin-Pee Dee River Basin
Catalog Unit # 03040101**

**Prepared By
North Carolina Division of Water Quality
Watershed Assessment Team**

Version 3.0
July 2009

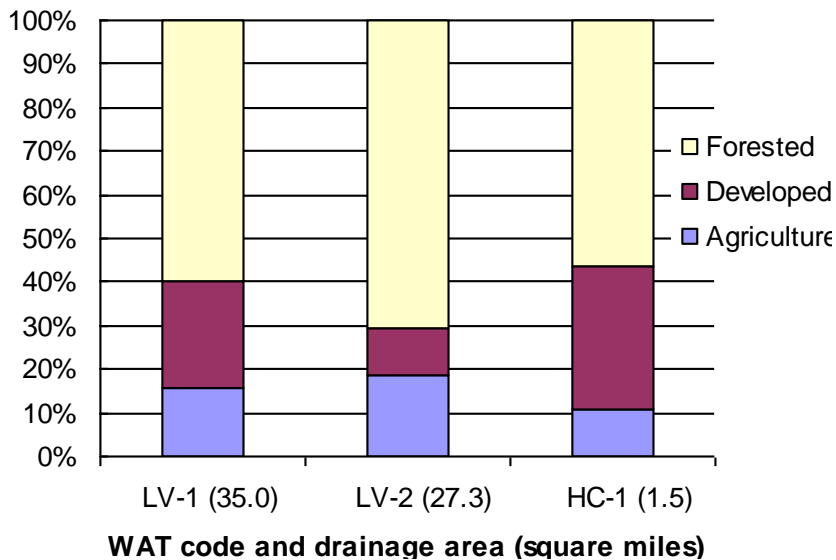
Figure 6. Land uses for subwatersheds prioritized for stormwater BMPs.

Three monitoring locations (numbered 6 through 8 below) were within subwatersheds prioritized for **stormwater BMPs**. A breakdown of major land uses for each subwatershed along with drainage areas (square miles, in parenthesis) are provided in Figure 6.

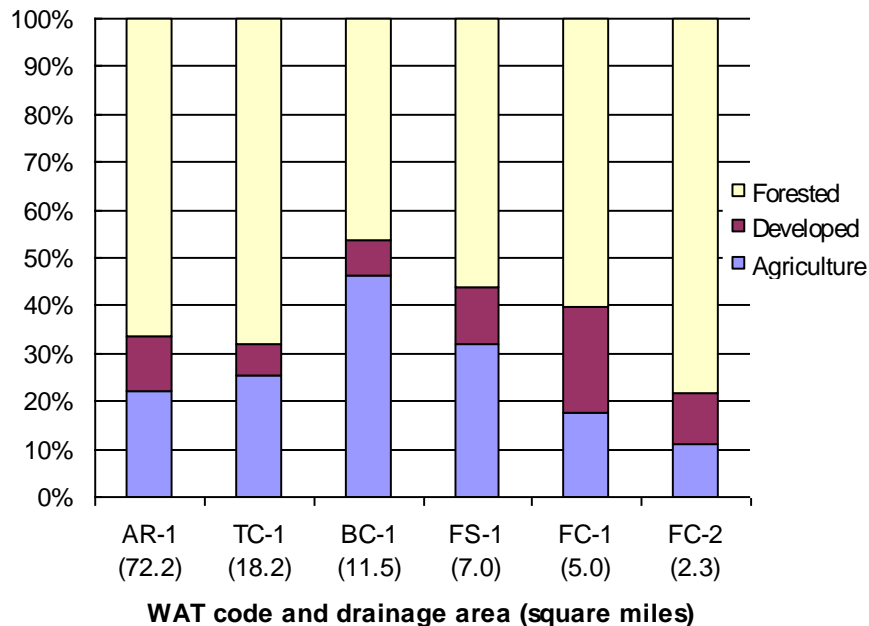
Figure 7. Land uses for other monitored subwatersheds.

Six monitoring locations (numbered 9 through 14 below) were within subwatersheds that were not prioritized for reasons explained above. In essence, we were not limited to monitoring only priority subwatersheds because non priority subwatersheds could also contain good candidates for preservation, restoration or BMPs. A breakdown of major land uses for each subwatershed along with drainage areas (square miles, in parenthesis) are provided in Figure 7.

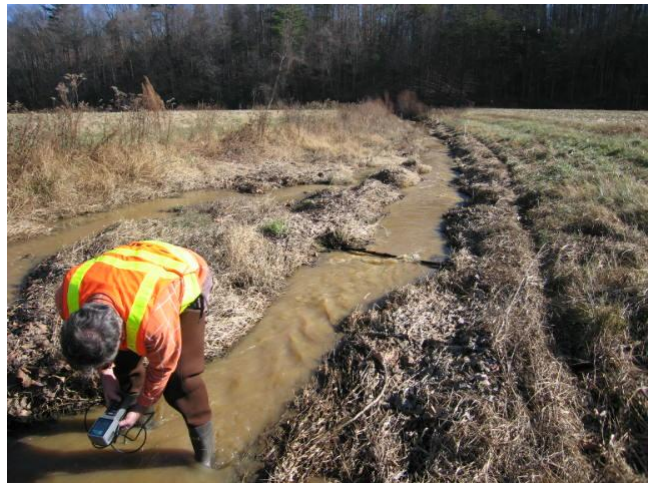
During baseflow monitoring in Moores Fork a front-end loader was working in the stream channel removing what was likely a beaver dam upstream of the sampling location (Photo 1). As a result, sediment was resuspended and stream was turbid. In addition to the usual baseflow parameters (nutrients, fecal coliform and residue) samples were also collected for copper, chromium, lead, iron, magnesium, manganese, potassium and zinc.

Photo 1. Turbid conditions in Moores Fork during December monitoring event due to a front end loader upstream working in the stream channel likely to remove a beaver dam.

Fecal coliform, nutrients and residue were elevated. Copper, iron, manganese and zinc were detected above water quality standards or action levels (see Appendix). It was likely that suspended sediment was the source for the metals since the samples were not filtered prior to preservation. Silt and clay sized particles possess cation exchange capacity (Miller and Donahue, 1990) which chemically bind with positively charged ions (cations) such as the metals listed above. Fecal coliform bacteria from a variety of sources can reside in stream sediments (USEPA, 2001).

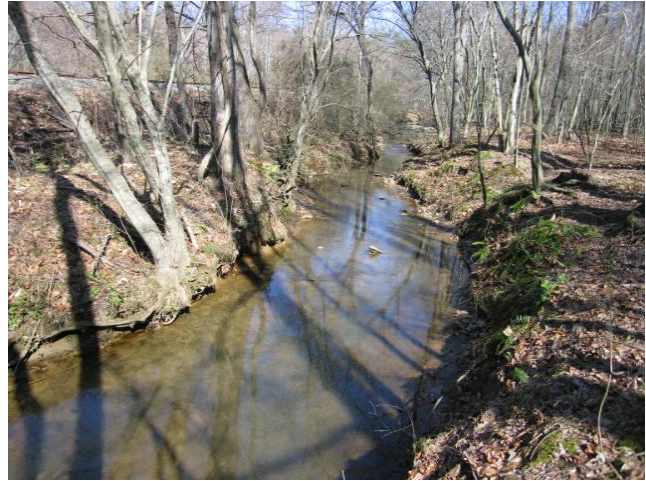
Photo 1. Starting point of stream corridor assessment and location of chemical and biological monitoring in Heatherly Creek. Point A in Figure 15.

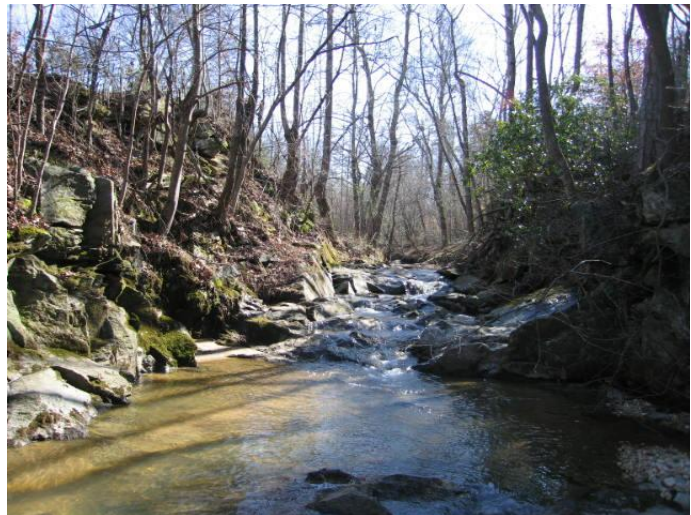
Photo 2. Bedrock substrate area in Heatherly Creek 0.4 miles upstream from starting point.

In summary, Heatherly Creek was observed to be a mostly stable stream with very little current active stream bank erosion. The stream is confined for much of its length by a rail line and bedrock outcroppings; however, this is balanced by access to a wide forested flood plain in the downstream segment. Habitats are only slightly degraded but are likely impacted by scour during significant rain events.

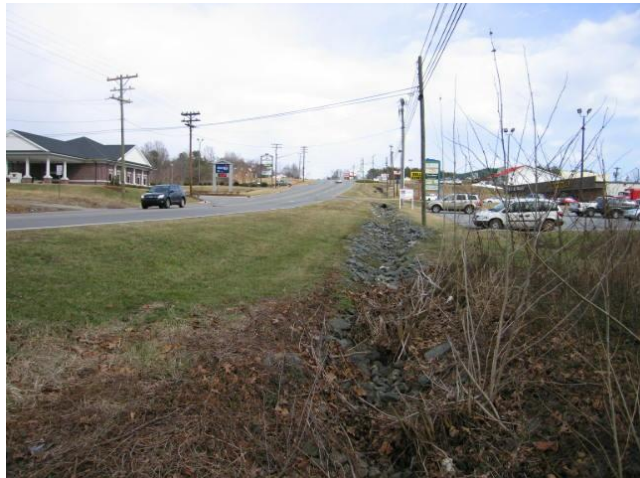
Photo 3. Rock lined stormwater ditch along NC 268 that discharges directly to Heatherly Creek at NC 268.

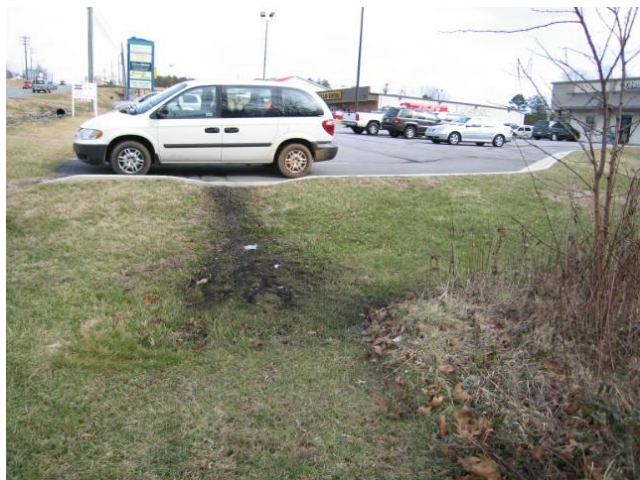
Photo 4. A grass filter strip (providing some unintentional filtration) that may be suitable for retrofitting to provide improved treatment of runoff from the parking lot.

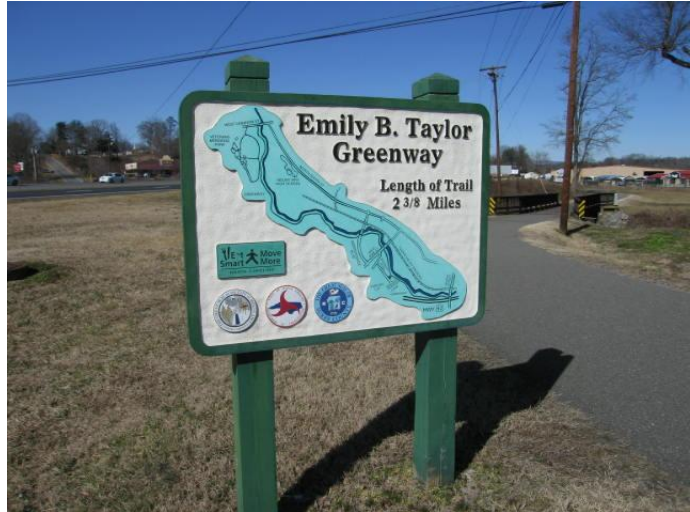
Photo 5. Beginning of greenway trail that paralleled Lovills Creek through Mount Airy.

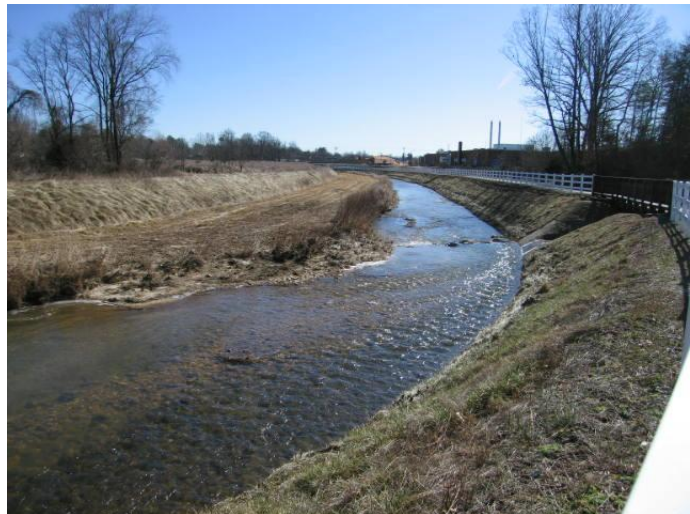
Photo 6. Lovills Creek in an engineered flood control channel.

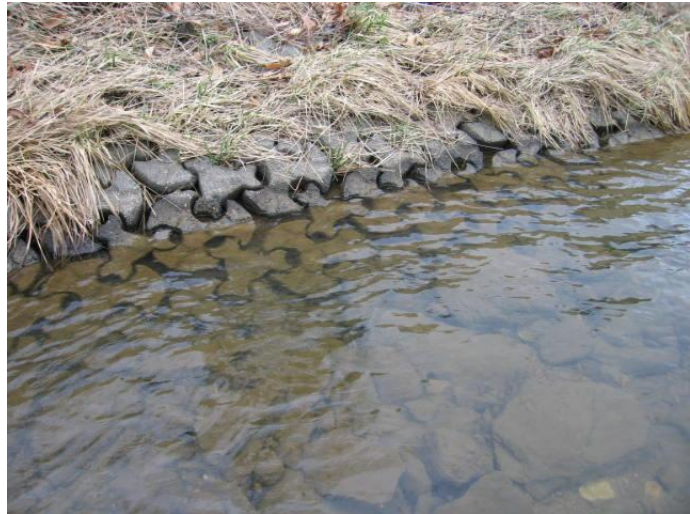
Photo 7. Interlocking concrete pavers lined stream banks to prevent erosion worked very well. None to very little stream bank erosion present along the entire length of channel.

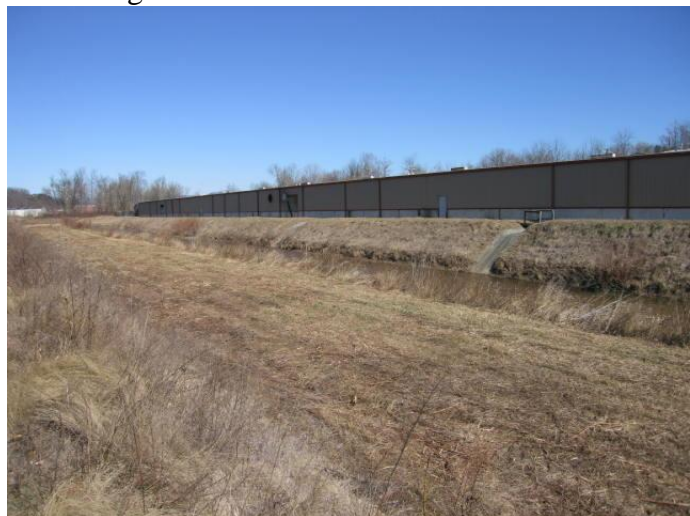
Photo 8. Breaks were common and consisted of embedded concrete lined channels. A total of 87 were counted for the entire length of engineered channel.

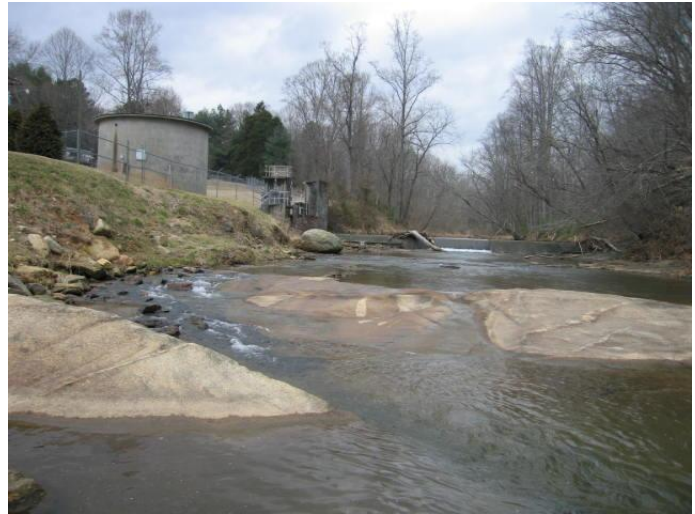
Photo 9. Mount Airy pump station and low flow dam at upstream end of engineered channel in Lovills Creek.

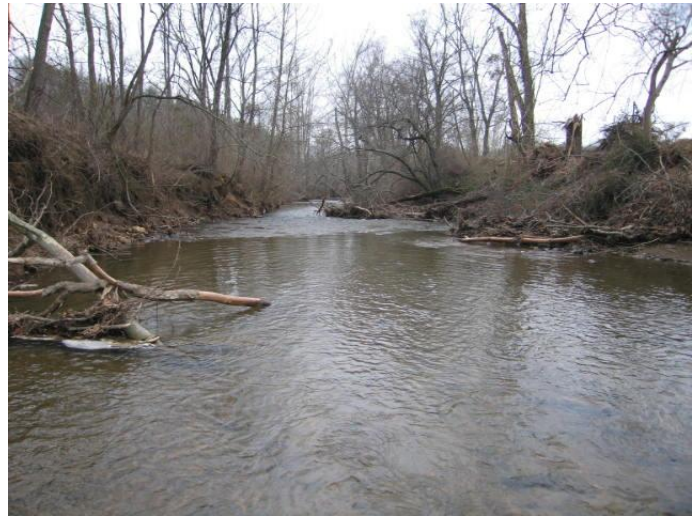
Upstream of the low flow dam the stream channel was natural and included a 2,000-foot segment with a wide riparian zone that was forested on both sides providing organic debris and shade. Bank height varied from two feet to 12 feet from water's surface. Some bank erosion was present (Photos 9 and 10).

Photo 10. A more natural channel in Lovills Creek upstream of pump station and downstream of golf course.

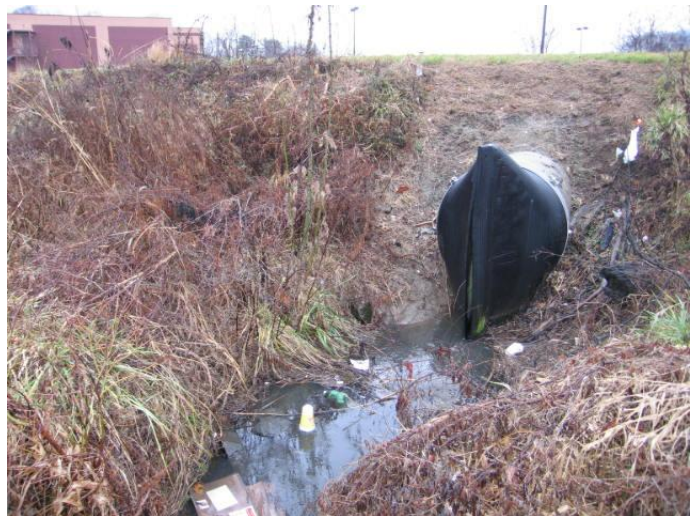
Photo 11. Check valve observed along Lovills Creek allows stormwater to discharge and prevents flood water back flow to upstream parking lot.

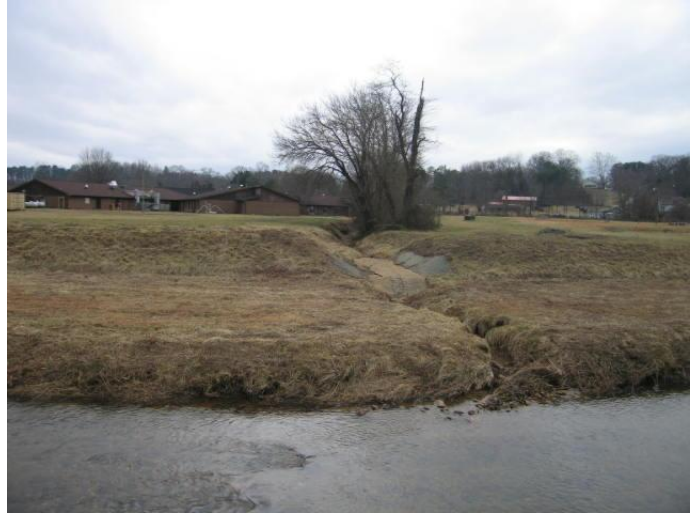
Photo 12. A UT to Lovills Creek where a BMP (restored buffer) may help to improve water quality in Lovills Creek.

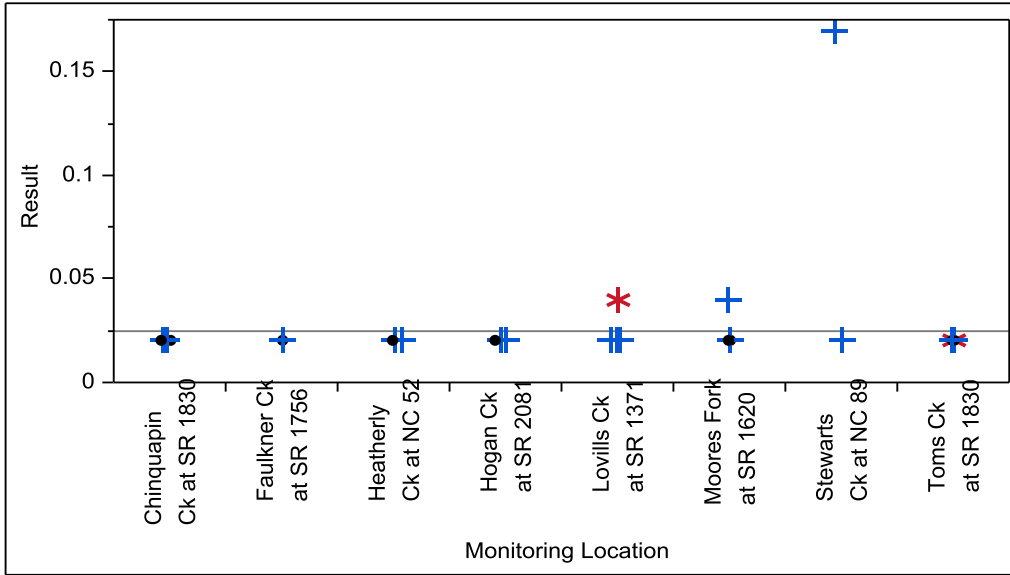
Ammonia Nitrogen as N (mg/L)

Four out of 37 results were greater than the detection level (0.02 mg/L)

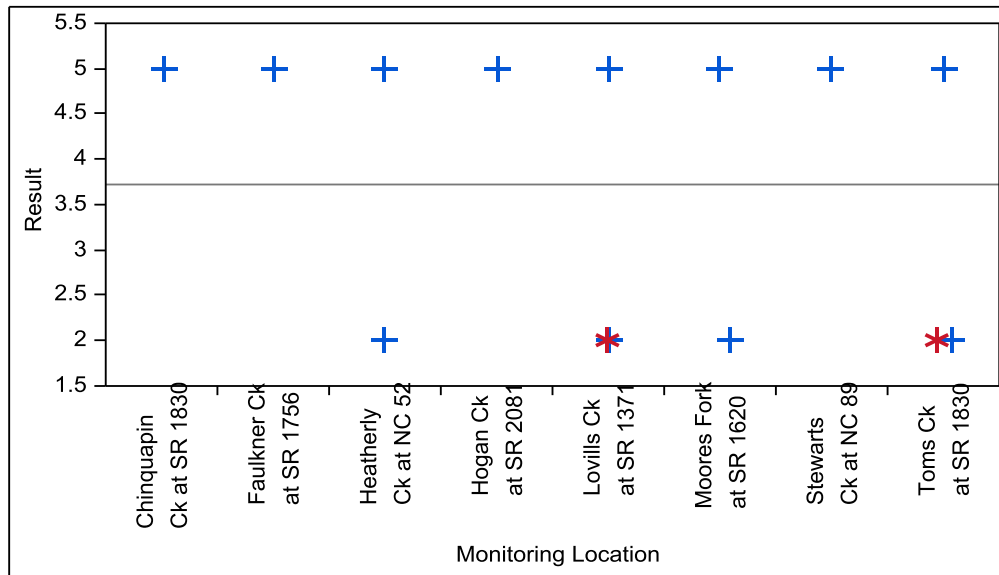
Arsenic (µg/L)

None of the 14 results exceeded the detection levels (5 µg/L or 2 µg/L)

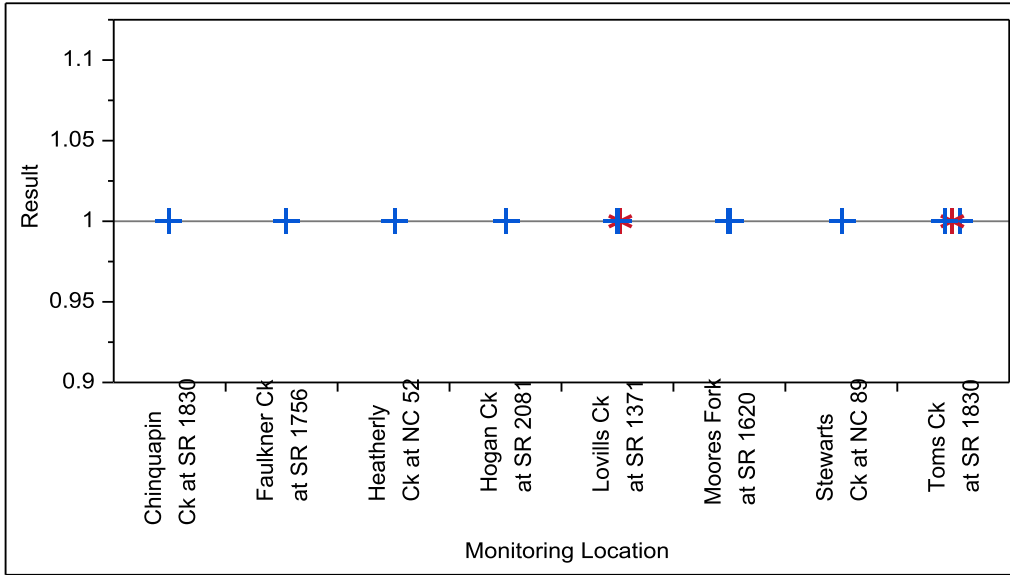
Cadmium (µg/L)

None of the 14 results exceeded the detection level (1 µg/L)

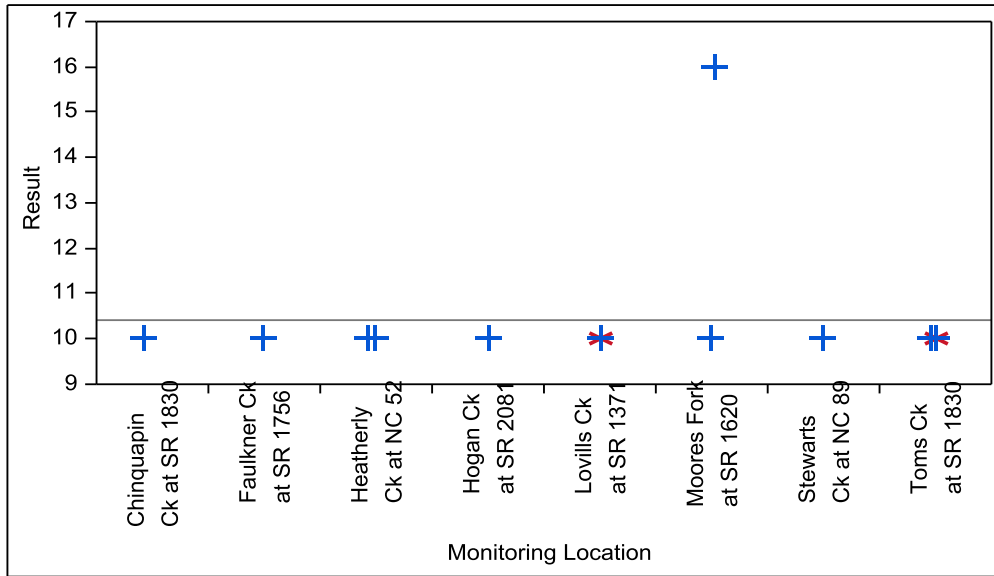
Lead (µg/L)

One of the 14 results exceeded the detection level (10 µg/L).
 The one baseflow result that exceeded the detection level occurred at Moore's Fork on 12/3/2008.
 The water quality standard for lead is 25 µg/L. See 15A NCAC 02B .0211 (3) (I) (viii) for details.
