**Division of Water Quality
Biological Assessment Unit, November 16, 2009**

Subject: Ecosystem Enhancement Program (EEP) Baseline Macroinvertebrate Monitoring in the Goose and Crooked Creek Drainages (Yadkin Subbasin 12), Union County, July 2009.

**Macroinvertebrate Monitoring in Goose and Crooked Creek
(Yadkin HUC 03040105), July 2009**

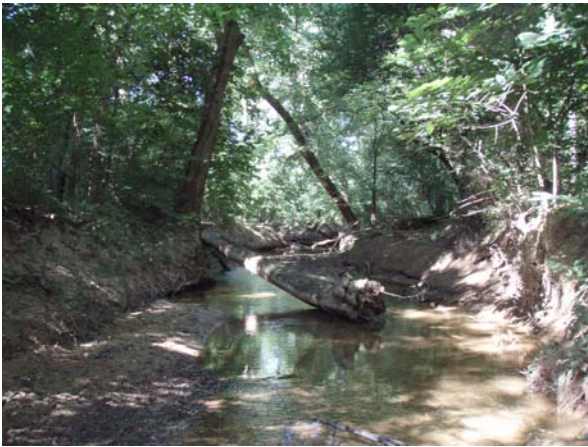
Figure 2. Upstream view of North Fork Crooked Creek at SR 1514, Union County, NC, sampled on July 14, 2009.

Date: July 14, 2009
Drainage area: 15.1 square miles
Qualitative Visible land use (%): 30 forest, 30 residential, 40 fallow fields
Width (m): 5
Depth (m): Avg: 0.2 Max: 0.5
Canopy (% cover): 90, mixed hardwood
Substrate (%): boulder (0), cobble (0), gravel (50), sand (25), silt/fine particulate (25)
Riparian quality: riparian zone intact (>18m)
Instream habitat: Rocks and macrophytes absent. Sticks/leafpacks and snags/logs are common. Undercut banks abundant.
Dissolved Oxygen (mg/L): 5.2
Specific conductance ($\mu\text{mhos/cm}$): 425
Temperature ($^{\circ}\text{C}$): 22.5
pH: 7
Habitat Score: 61

North Fork Crooked Creek at SR 1514 had the lowest EPT taxa richness (4) and abundance (EPTN = 31) and highest NCBI (7.09) (Table 5, Appendix 1) compared to all other sampling locations. Tolerant taxa were dominant at this site including: *Hydropsyche betteni* (abundant) and *Cheumatopsyche spp.* (abundant). *Maccaffertium modestum* was absent from this site and abundant at all other sampling sites within this study suggesting a lack of riffle habitat. Low flows were noted at the site in addition to lack of habitat favorable for macroinvertebrate colonization including the absence of cobble riffle substrates and submerged root mats. Additionally, this stream segment is suffering from severe bank erosion leading to increased scouring and sediment input. The severe erosion and scouring suggest this site receives periodic drastic increases in flow followed by quick lower water levels which can lead to rapid inputs of accumulated nonpoint pollutants from upstream. A sewage smell was noted and conductivity was high at 425 $\mu\text{mhos/cm}$ (Table 6). High amounts of upstream urban land use activities in addition to point source dischargers are likely contributing to the degraded macroinvertebrate community here. This site could be good candidate for implementation of future upstream stormwater BMPs and/or stream restoration activities. However, any issues with upstream dischargers such as Hemby Acres WWTP would need to be resolved.

- North Fork Crooked Creek at SR 1514 is a recommended candidate for future stormwater BMP implementation and/or stream restoration activities. This stream reach suffers from severe erosion, lack of coarse substrate, and narrow/patchy riparian zones. restoration activities such as riparian buffer enhancement, stream bank stabilization, and additions of coarse substrate for water velocity control during storm events may benefit downstream water quality. Additions of coarse substrate and riparian buffer enhancements may also provide enhanced habitat favorable for macroinvertebrate colonization. Any upstream noncompliance issues with point source dischargers would need to be resolved prior to these enhancement activities.

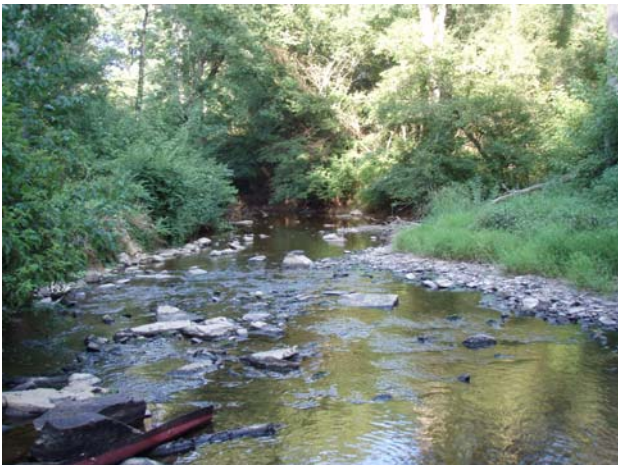
Figure 3. Downstream view of Crooked Creek at SR 1547, Union County, NC, sampled on July 14, 2009.

Date: July 14, 2009
Drainage area: 47.3 square miles
Qualitative Visible land use (%): 80 forest, 10 residential, 10 fallow fields
Width (m): 10
Depth (m): Avg: 0.1 Max: 0.25
Canopy (% cover): 60, hardwood
Substrate (%): boulder (10), cobble (40), gravel (30), sand (10), silt/fine particulate (10)
Riparian quality: Intact wide riparian zone (>18m). Erosion moderate.
Instream habitat: Rocks abundant. Macrophytes common, sticks/leafpacks common, snags/logs rare, and undercut banks and root mats rare.
Dissolved Oxygen (mg/L): 6.5
Specific conductance ($\mu\text{mhos/cm}$): 471, **Temperature ($^{\circ}\text{C}$):** 26.1, **pH:** 7.8, **Habitat Score:** 88

Ten EPT taxa were present at the downstream Crooked Creek site. This site received a Fair (NCBI = 6.65, EPTBI = 5.67) rating suggesting slight decline in water quality compared to the 2006 sample. EPT taxa richness and EPTBI remained similar from 2006 to 2009 (Table 5) however the NCBI value was elevated from 6.27 to 6.65. This is potentially due to the higher abundance of tolerant taxa in 2009 such as the chironomids *Cricotopus bicinctus* and *Dicrotendipes neomodestus* (Appendix 1). Both taxa are tolerant of high nutrients/organic wastes. The presence of so many low dissolved oxygen tolerant taxa such as the midges *Polypedilum illinoense*, *Phaenopsectra obediens*, and *Dicrotendipes neomodestus*; the odonates *Argia spp.* and *Ischnura spp.*; the flatworm *Dugesia tigrina*; and the slow water limpet *Laevapex fuscus* suggests the site suffers from periodic low oxygen levels compounded by the low flows common in slate belt streams. Observations at the site imply that macroinvertebrates are not limited by habitat but more likely general water quality. Conductivity was high at 471 $\mu\text{mhos/cm}$ (Table 6). There are two minor dischargers and one major discharger (>1 MGD) located upstream from this sample site (Table 2) likely contributing to degraded water quality. Any upstream WWTP discharge issues would need to be resolved before additions of stormwater BMPs in order to detect positive effects on stream water quality.

- Benthic samples suggest impaired waters in Crooked Creek at SR 1547 for the first time since 1996. The exact source of this impairment is not known. Possibilities include the presence of upstream dischargers in combination with increased impervious surface in the headwaters leading to stormwater runoff events. Pollutants entering Crooked Creek could be escalated during fluctuating drought conditions common in the Slate Belt.

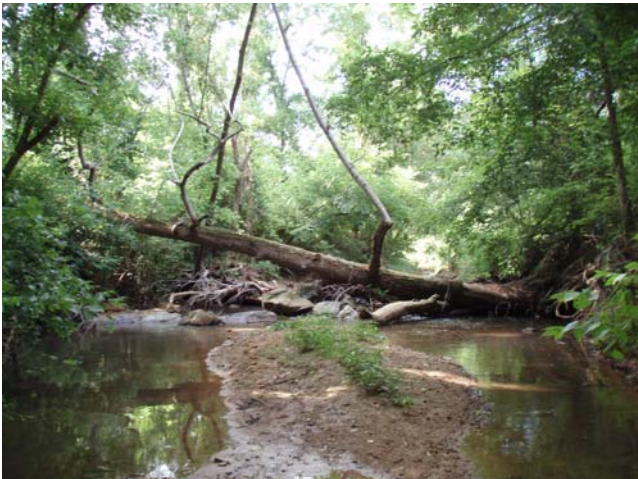
Figure 4. Upstream view of Goose Creek at SR 1524, Union County, NC, sampled on July 13, 2009.

Date: July 13, 2009
Drainage area: 8.4 square miles
Qualitative Visible land use (%): 50 forest, 30 residential, 20 golf course
Width (m): 8
Depth (m): Avg: 0.2 Max: 0.5
Canopy (% cover): 85, mixed hardwood
Substrate (%): boulder (20), cobble (20), gravel (20), sand (20), silt/fine particulate (20)
Riparian quality: Intact riparian zone. Narrow on the right bank (< 6m). Erosion severe.
Instream habitat: Rocks common. Macrophytes rare, sticks/leafpacks common, snags/logs and undercut banks/root mats common.
Dissolved Oxygen (mg/L): 6.7
Specific conductance ($\mu\text{mhos/cm}$): 121
Temperature ($^{\circ}\text{C}$): 23.7
pH: 7.0
Habitat Score: 77

Goose Creek at SR 1524 also received a Fair bioclassification in 2009 compared to Good-Fair in 1998. Despite this rating, water quality in this reach seems the best compared to all other sample sites within the Goose Creek catchment (EPTBI = 6.11, NCBI = 6.40) (Table 5). Thirteen EPT taxa were collected at the site. Most are fairly tolerant taxa with the exception of *Chimarra spp.* and *Mystacides sepulchralus* (both rare at the site). Intolerant taxa abundant in 1998, such as *Serratella deficiens*, were absent in 2009. The intolerant beetle *Psephenus herricki* was common at the site (Appendix 1). This site is located ~100 meters downstream from the Hunley Creek WWTP (Table 2), which is a minor discharger that has had occasional violations of ammonia and chlorine. The absence of long-lived stoneflies and other common intolerant taxa could be due to multiple variables. These could include drought, periodic toxicity, lack of upstream riparian buffers, and/or runoff from the upstream golf course and residential areas leading to the increased erosion and sediment accumulation observed. This site may be a good candidate for future stormwater BMP implementation, stream bank stability, riparian buffer enhancements, and/or other restoration activities.

- Goose Creek at SR 1524 may also be a good candidate for future stormwater BMP implementation and/or riparian buffer widening/stream bank stabilization. Despite the Fair bioclassification, benthic metrics suggests this site has the best water quality compared to all sites in the catchment. This may be due a combination of better habitat and only one nearby upstream discharger.

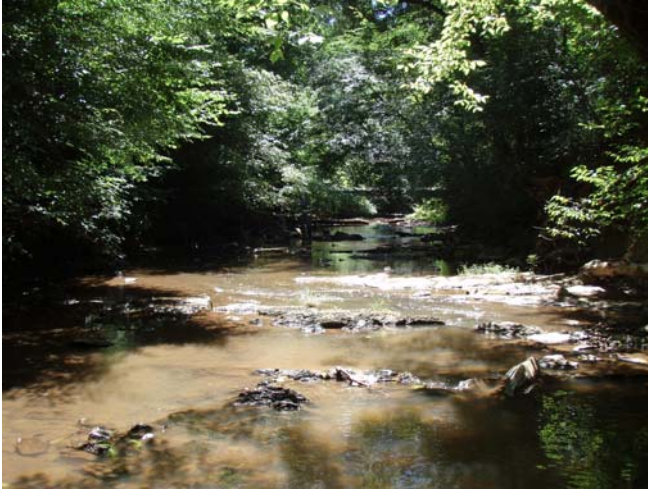
Figure 5. Downstream view of Goose Creek at SR 1525, Union County, NC, sampled on July 14, 2009.

Date: July 14, 2009

Drainage area: 11.0 square miles

Qualitative Visible land use (%): 50 forest, 20 residential, 20 goat pasture, 10 fallow fields

Width (m): 10

Depth (m): Avg: 0.1 Max: 0.5

Canopy (% cover): 80, mixed hardwood

Substrate (%): bedrock (10), boulder (30), cobble (20), gravel (20), sand (10), silt/fine particulate (10)

Riparian quality: Intact riparian zone. Width 12-18m on left bank. Moderate Erosion.

Instream habitat: Rocks abundant. Macrophytes absent, sticks/leafpacks common, snags/logs and undercut banks/root mats common.

Habitat Score: 90

This Goose Creek site has improved slightly from Poor in 1998 to Fair in 2009. EPT taxa richness increased from 4 in 1998 to 6 in 2009. However, this is a 2-fold decrease in EPT taxa richness when compared to the SR 1524 site just upstream (Table 5, Figure 1). The SR 1525 site has the lowest EPTN (35) and highest NCBI (7.01) suggesting the worst water quality among all Goose Creek sites in 2009. Chironomid taxa richness doubled from 13 just upstream at the SR 1524 site to 25 at this site potentially signifying some nutrient enrichment from upstream sources. The Country Woods WWTP is the nearest of three WWTPs located within 1 mile upstream of the site (Figure 1, Table 2). A sewage smell was observed. Macroinvertebrate assemblages suggest impaired water quality despite high quality habitat suggesting either point source or nonpoint source pollution inputs at this site.

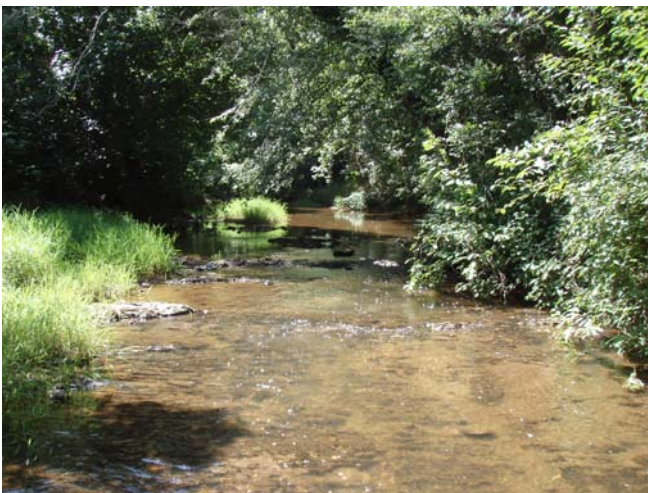
Figure 6. Upstream view of Goose Creek at U.S. 601, Union County, NC, sampled on July 14, 2009.

Date: July 14, 2009

Drainage area: 24.1 square miles

Qualitative Visible land use (%): 40 forest, 35 active crops, 25 fallow fields

Substrate (%): boulder (25), cobble (25), gravel (10), sand (20), silt/fine particulate (20)

Riparian quality: Intact riparian zone. Width 6-12m on right bank. Moderate Erosion.

Instream habitat: Rocks abundant. Macrophytes common, sticks/leafpacks common, snags/logs and undercut banks/root mats common.

Habitat Score: 88

Goose Creek at U.S. 601 rated Fair based on benthic macroinvertebrates in 2009 for the second consecutive time since 2006 (Table 5). This site had a Poor bioclassification from 1996-2001. The Fair rating suggests a water quality improvement following the removal of discharge from the Fairview Elementary WWTP just upstream in 2005. Despite observations of high quality habitat, a pollution tolerant benthic community assemblage continues to reside here suggesting point source dischargers and/or nonpoint source runoff limiting water quality. Four total point source dischargers are located upstream from this site (Figure 1). Conductivity was elevated (232 $\mu\text{mhos/cm}$), however, water quality improved slightly from the SR 1525 site when comparing benthic metrics (Table 5).

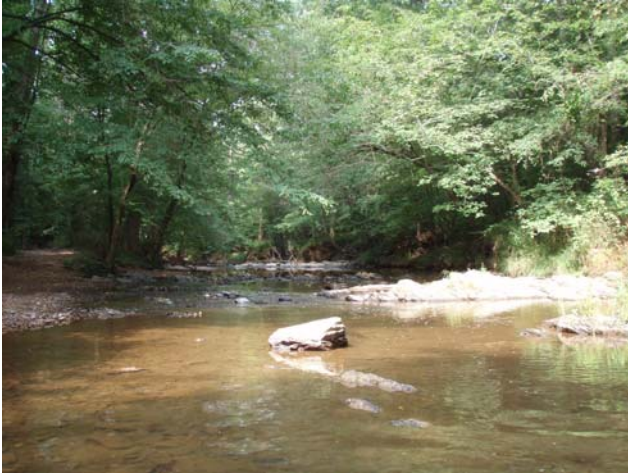
Figure 7. Upstream view of Goose Creek at SR 1547, Union County, NC, sampled on July 15, 2009.

Date: July 15, 2009
Drainage area: 77.0 square miles
Qualitative Visible land use (%):
 100 forests
Width (m): 11
Depth (m): Avg: 0.1 Max: 0.25
Canopy (% cover): 90, mixed
 hardwood
Substrate (%): boulder (20), cobble
 (20), gravel (20), sand (20), silt/fine
 particulate (20), trace of bedrock
Riparian quality: Intact wide (>18m)
 riparian zone. Moderate to severe
 erosion.
Instream habitat: Rocks abundant.
 Macrophytes absent, sticks/leafpacks
 common, snags/logs common and
 undercut banks/root mats rare.
Dissolved Oxygen (mg/L): 6.8
Specific conductance ($\mu\text{mhos/cm}$):
 229
Temperature ($^{\circ}\text{C}$): 21.2
pH: 7.3
Habitat Score: 86

This Goose Creek site is just upstream from its confluence with Rocky River. The benthic community assemblage at this site remained similar to that found during sampling in 1998 (Table 5). EPT abundance (69) in 2009 was much higher than in 1998 (35), however, slightly more pollution tolerant EPT taxa were present in 2009 (EPTBI = 6.47) compared to 1998 (EPTBI = 6.0). Conductivity was elevated (229 $\mu\text{mhos/cm}$). This site is downstream from Ashe Plantation WWTP, a minor permitted discharger to Duck Creek, a tributary of Goose Creek (Figure 1). Five total permitted dischargers are located upstream from this sampling station. Most of these downstream Goose Creek sites have exceptional habitat available for macroinvertebrate colonization suggesting impaired water quality from upstream point source or nonpoint source pollution inputs.

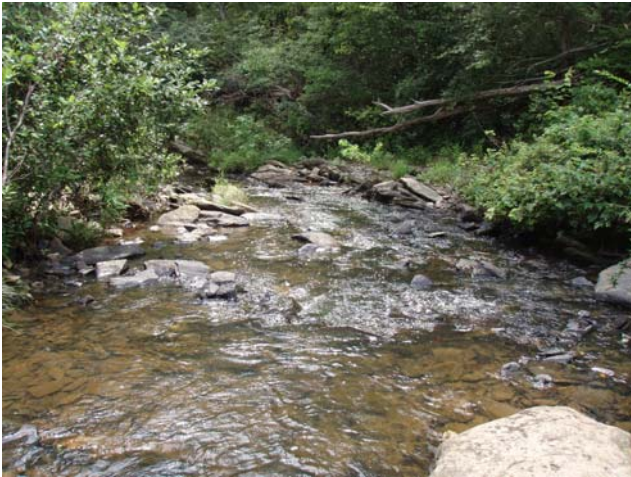
Figure 8. Downstream view of Barnes Creek at SR 1303, Union County, NC, sampled on July 15, 2009.

Date: July 15, 2009
Drainage area: 23.1 square miles
Qualitative Visible land use (%):
100 forest
Width (m): 11
Depth (m): Avg: 0.2 Max: 1.0
Canopy (% cover): 75, hardwood
Substrate (%): bedrock (10), boulder (30),
cobble (30), gravel (15), sand (10), silt/fine particulate
(5)
Riparian quality: Breaks rare. Wide
(>18m) riparian zone. Minimal erosion.
Instream habitat: Rocks abundant.
Macrophytes absent, sticks/leafpacks
common, snags/logs rare and undercut
banks/root mats common.
Dissolved Oxygen (mg/L): 7.7,
Specific conductance (µmhos/cm):
51, **Temperature (°C):** 23.8, **pH:** 7.1,
Habitat Score: 92

Barnes Creek at SR 1303 was selected for benthic sampling as a Slate Belt reference site for comparison to that of the Goose and Crooked Creek catchments. This stream is a tributary to the Uwharrie River in rural Montgomery County. The reach of stream sampled is almost completely surrounded by forest with little to no anthropogenic activity upstream. The site obtained a benthic bioclassification of either Good or Excellent every time it has been sampled since 1985. It has been rated Good on three occasions out of nine including this year. Intolerant taxa were common at this site including several fairly rare taxa for the Piedmont such as *Maccaffertium vicarium* (abundant), *Epeorus vitreus* (common), *Acroneuria abnormis* (abundant) and *Neoperla spp.* (common). Stoneflies such as *Acroneuria abnormis* are commonly found in fairly clean North Carolina Piedmont streams. No stoneflies were collected in Goose or Crooked Creeks further suggesting impaired water quality at those sites. Based on DWQ habitat forms Barnes Creek received a high habitat score (92), somewhat comparable to that of downstream reaches of Goose and Crooked Creeks (Table 6). Total EPT taxa (27) and EPT abundance (125) was at least double that of all Goose and Crooked Creek samples (Table 5). The EPTBI (4.17) and NCBI (4.97) are low suggesting good water quality within the reach. Specific conductance (51 µmhos/cm) was less than half that of any sites sampled in Goose or Crooked Creeks. Chironomid richness was moderate (18) but biomass was low (Appendix 1). Only one chironomid taxa *Cladotanytarsus sp. E* was abundant at the site and the majority of other chironomid taxa were rare. The intolerant beetles *Psephenus herricki* and *Optioservus ovalis* were also abundant in Barnes Creek.

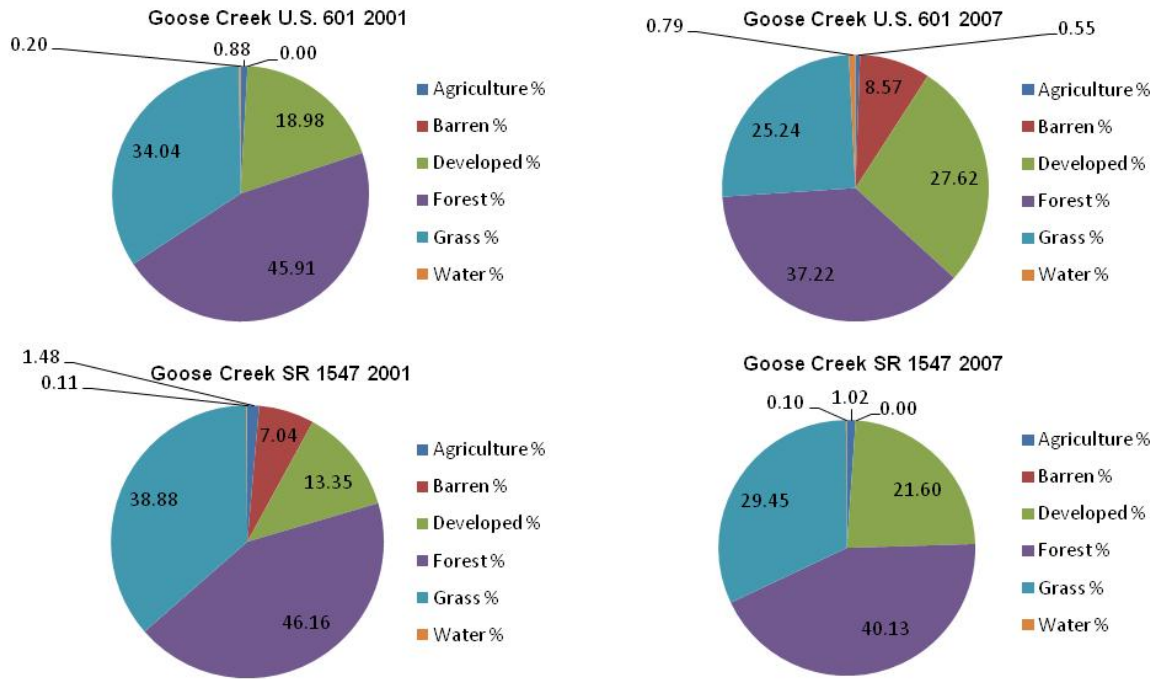
Agricultural and urban land use activities and associated increased impervious surface in smaller headwater streams is known to negatively affect water quality downstream (Alexander et al. 2007, Meyer et al. 2007). Commercial/Industrial and residential land use has significantly increased in the Goose and Crooked Creek watersheds since 1992 (Tetra Tech 2008). Both catchments have similar percentages of developed land. The Crooked Creek catchment has a slightly higher percentage of high density impervious surfaces; particularly commercial land use (7.4%) compared to that of the Goose Creek drainage at 4.1%.

Rapid continued urbanization in the headwaters of Goose and Crooked Creek could lead to the impaired water quality found in both upstream and downstream sample locations. Urban land use percentages are highest in the headwaters of both the Crooked and Goose Creek catchments (Figure 9). Percentage of forests continues to decrease from 2001 to 2007 throughout both catchments. Trends suggest urban areas decrease spatially as you move downstream in both drainages. These observations imply stream and/or wetland restoration efforts focused in the headwaters may benefit downstream water quality. Commercial/Industrial and residential land use in headwaters leads to more impervious surface and ultimately, to a modified hydrologic regime. Stormwater runoff over impervious surfaces with reduced riparian buffers may lead to the rapid movement of water downstream increasing scour, erosion, and sediment input. North Fork Crooked Creek at SR 1514 may be an example of this altered hydrologic flow. Virtually no course substrate was observed at this site potentially due to high flows through the channel during stormwater events. Altered hydrology in addition to fluctuated drought conditions known to occur in the Slate Belt can escalate the effects of nonpoint sources via buildup of pollutants and quick runoff of these sources into the catchment.

Figure 9. Land use comparisons among Goose Creek and Crooked Creek benthic sites in 2001 and 2007.

Figure 9 cont.
