# BASINWIDE ASSESSMENT REPORT: CHOWAN RIVER BASIN

NORTH CAROLINA DEPARTMENT OF  
ENVIRONMENT AND NATURAL RESOURCES  
Division of Water Quality  
Environmental Sciences Section

December 2011

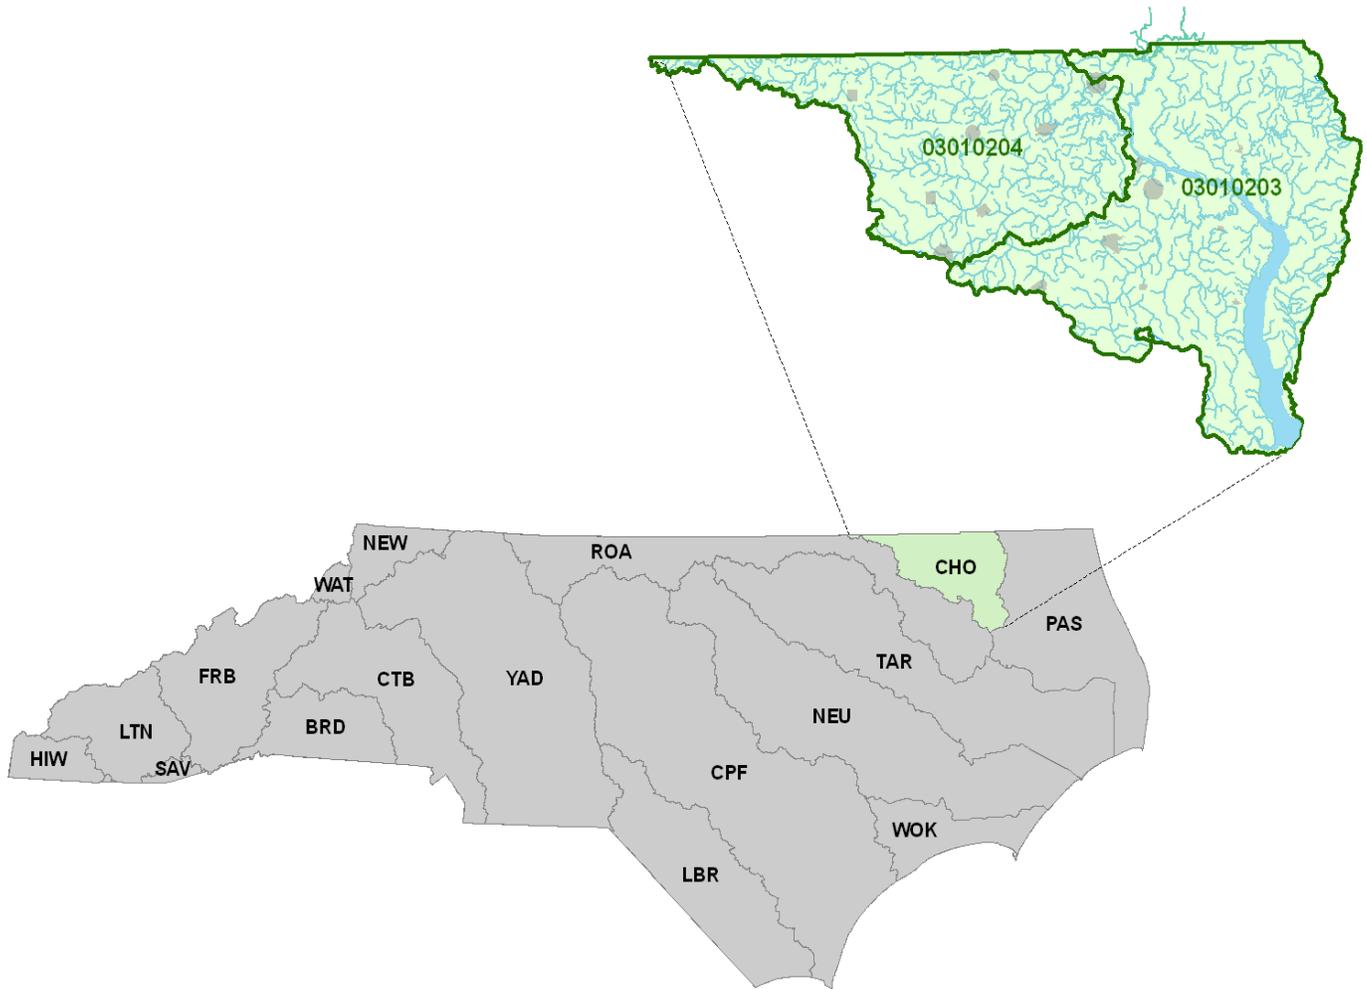
**Figure 1. Geographic relationships and eight-digit hydrologic units of the Chowan River basin.**

Basinwide sampling for macroinvertebrates in 2010 includes samples in subbasin 02 (HUC 03010204) and subbasins 01, and 04 (HUC 03010203). To date, no suitable benthic macroinvertebrate sampling sites have been found in subbasin 03 (HUC 03010203).

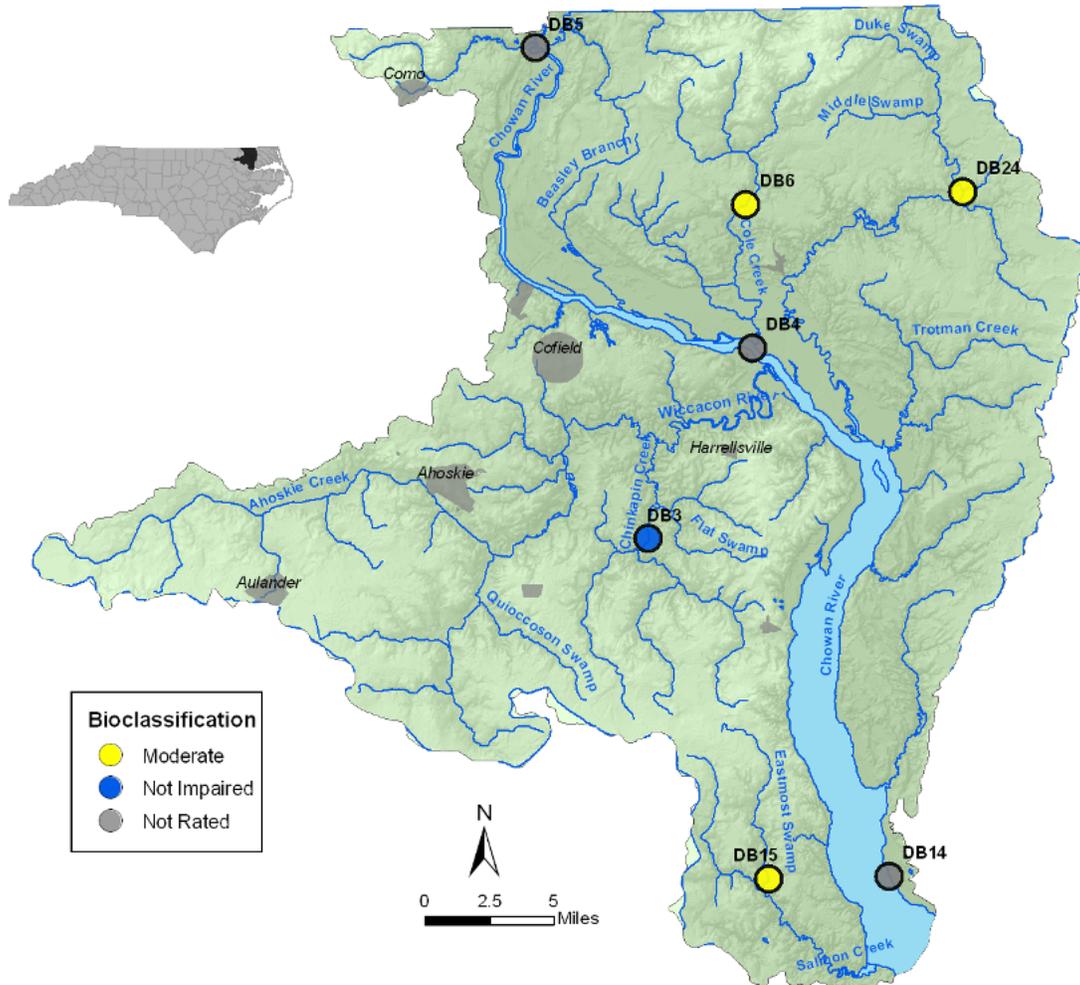
**Figure 2. Sampling sites in HUC 03010203**

To date, no suitable benthic macroinvertebrate sampling sites have been found in subbasin 03 within this HUC and all samples have thus far been restricted to subbasins 01 and 04. Numerous sites sampled during the 2005 basinwide cycle were not assessed in 2010 due to staffing reductions. These sites included the Wiccacon River at SR 1433 (Hertford County), Ahoskie Creek at NC 42 (Hertford County), and Stony Creek at SR 1235 (Bertie County). In 2010, a previously sampled site (Bennetts Creek at SR 1400 in Gates County) was dropped due to its close downstream proximity to Merchants Mill Pond. However, a new basinsite (Duke Swamp at SR 1400 in Gates County) was added in 2010. The Duke Swamp catchment represents a significant increase in bioassessment monitoring in this HUC and should be re-sampled during the next basinwide monitoring cycle if resources permit.

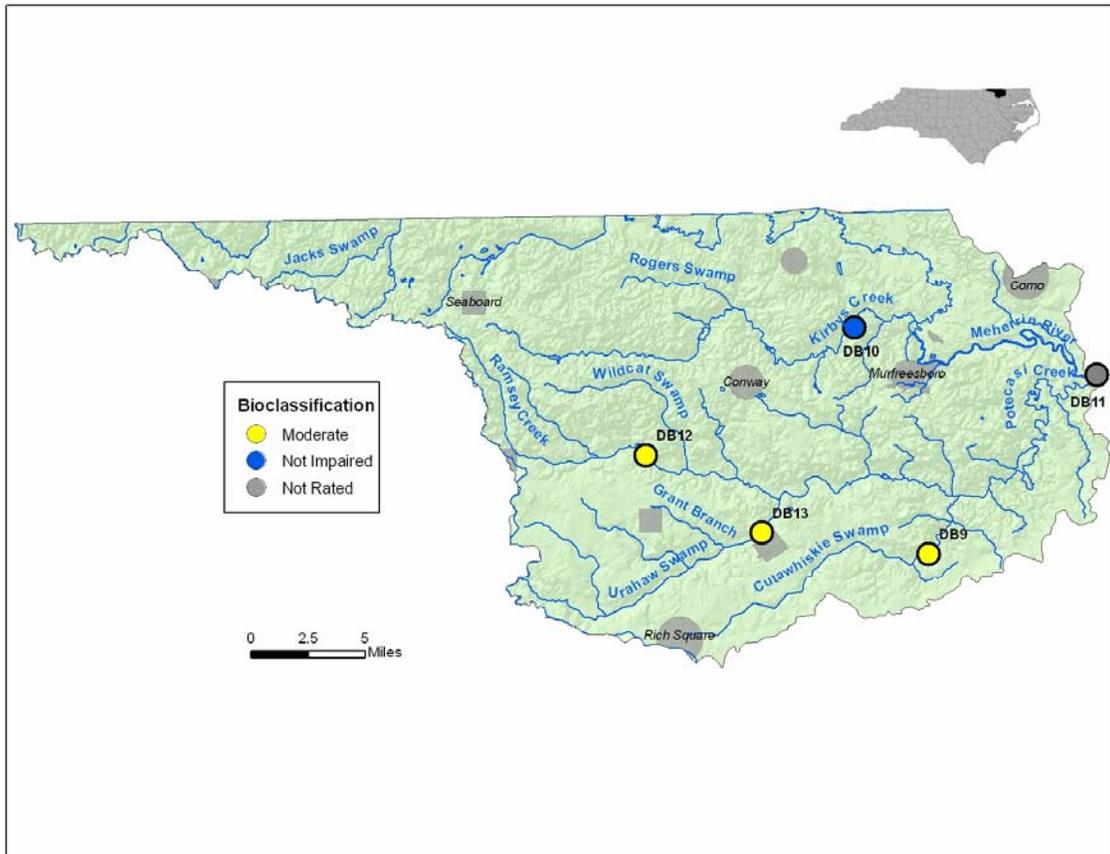
**Figure 3. Sampling sites in HUC 03010204**

Unlike sites in HUC 03010203, all previously sampled benthic macroinvertebrate monitoring locations were resampled here in 2010. Nevertheless, there continues to be an overall paucity of benthic macroinvertebrate sampling sites in this HUC due to a lack of wadeable waterbodies and summer flow.

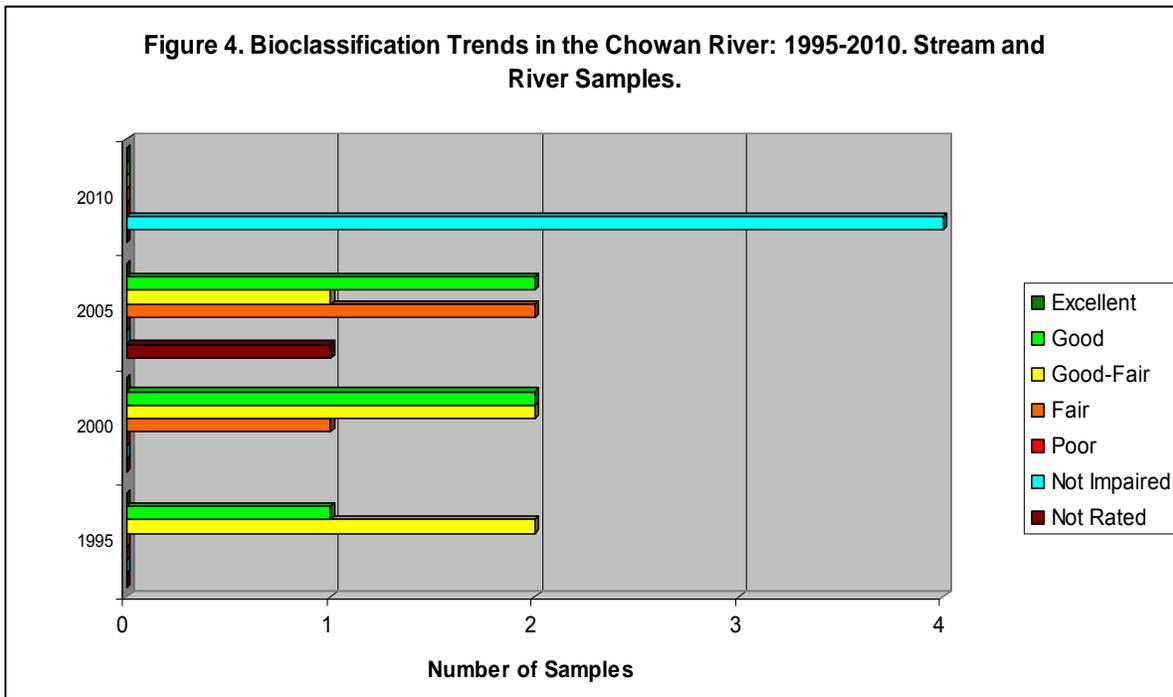
**Figure 4. Bioclassification Trends in the Chowan River: 1995-2010. Stream and River Samples.**

Since 1995, the largest trend noted among the river and stream samples was an increase in the number of Not Impaired designations (Figure 4). The sources of these changes included the Meherrin River at SR 1175 (Hertford County), the Chowan River at US 17 (Chowan County), Chowan River near New Ferry Road (Gates County) and the Chowan River at SR 1319 (Hertford County). All of these stations were previously assigned a bioclassification (i.e., Poor, Fair, Good-Fair, Good, Excellent) in 1995 based on provisional biocriteria which was derived from EPT species richness (EPTS). However, upon a more rigorous review of existing data and biocriteria for Coastal B rivers, it was determined in 2010 that all subsequent Coastal B river samples should not be assigned a bioclassification (i.e., Poor, Fair, Good-Fair, Good, Excellent) and were instead designated as Not Rated or Not Impaired. Not Rated is equivalent to a Fair bioclassification or worse based on the provisional (EPTS) Coastal B river criteria, while a Not Impaired designation is equivalent to a bioclassification of Good-Fair or better. From 1995 to 2010, all of these sites (excluding the Meherrin River) have increased in EPTS (Figure 5) with only the Meherrin River showing a very slight decrease in EPTS over the same time. Excluding the Meherrin River, the steady increase in pollution intolerant EPT taxa at these sites suggests an improvement in physico-chemical conditions in these waterbodies since 1995. Conversely, the slow decline in EPTS at the Meherrin River may suggest a slight deterioration in physico-chemical conditions here since 1995.

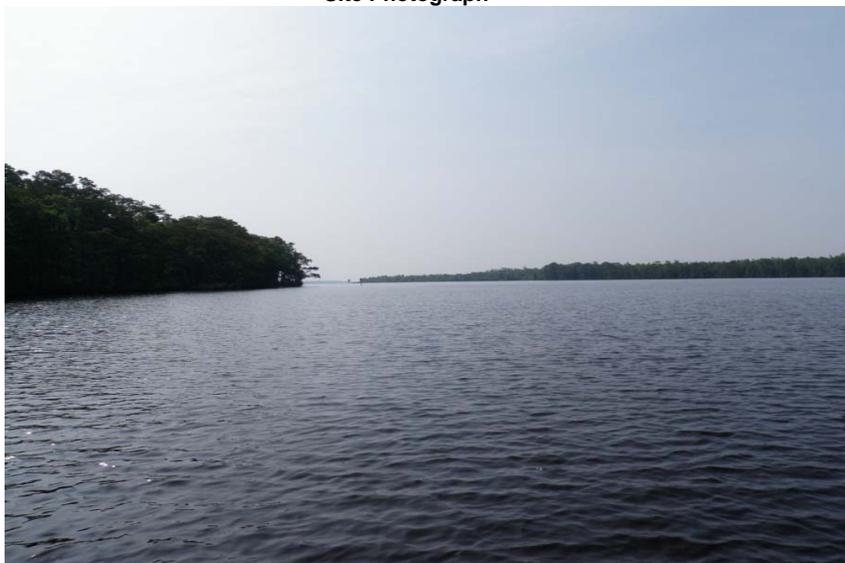
**Site Photograph**

| <b>Substrate</b> | silt, sand, detritus |

Compared to the previous two samples, the 2010 collection produced a slight increase in the richness of intolerant and facultative EPT taxa. Indeed, this (along with a decrease in the EPTBI) was the most notable change in this community from the previous two samples. Specifically, the 2010 sample resulted in two new caddisfly records for this location: *Oecetis Sp A* and *Oecetis Sp D*. The increase in EPT richness observed in 2010 suggests improved physico-chemical conditions in this waterbody from previous years. This conclusion is supported by the improvement noted in the specific conductance data which was 157 µS/cm in 2005 but decreased to 98 µS/cm in 2010. Samples obtained from this site have previously been assigned bioclassifications. However, these bioclassifications were based on provisional biocriteria. Given the provisional status of biocriteria for large, non wadeable coastal plain rivers, the 2010 sample was assigned a Not Impaired rating. However, for purposes of inter-year comparison, the 2010 collection would have received an Excellent bioclassification based on the provisional criteria.

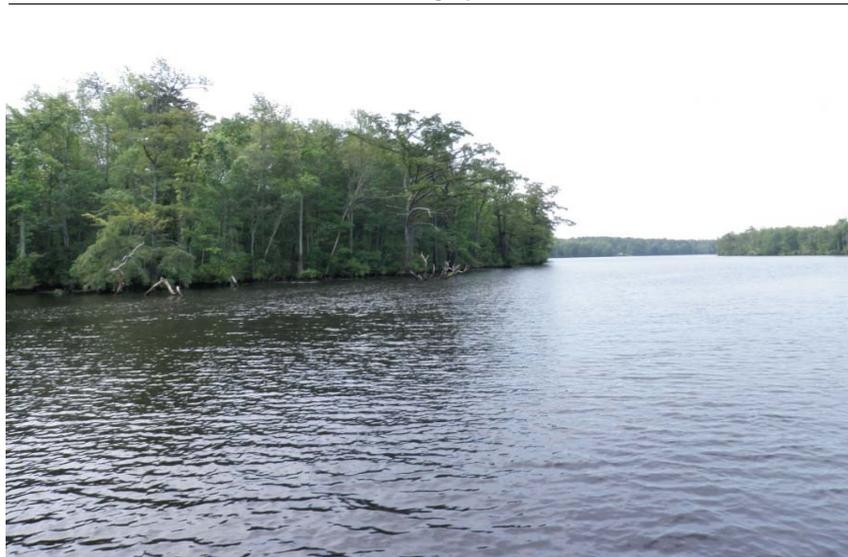
**Site Photograph**

| Substrate | silt, sand, detritus |

Compared to the previous two samples, the 2010 collection produced a significant increase in the richness of intolerant and facultative EPT taxa. Indeed, this was the most notable change in this community from the previous two samples. Specifically, the 2010 sample resulted in several new caddisfly records for this location: *Hydroptila spp*, *Oecetis persimilis*, *Oecetis Sp A*, *Trienodes ignitus*, *T. perna/helo* and *Polycentropus spp*. The increase in EPT richness observed in 2010 suggests improved physico-chemical conditions in this waterbody from previous years. This conclusion is supported by the large improvement noted in the specific conductance data which was 157 µS/cm in 2005 but decreased to 98 µS/cm in 2010. Samples obtained from this site have previously been assigned bioclassifications. However, these bioclassifications were based on provisional biocriteria. Given the provisional status of biocriteria for large, non-wadeable coastal plain rivers, the 2010 sample was assigned a Not Impaired rating. However, for purposes of inter-year comparison, the 2010 collection would have received an Excellent bioclassification based on the provisional criteria.

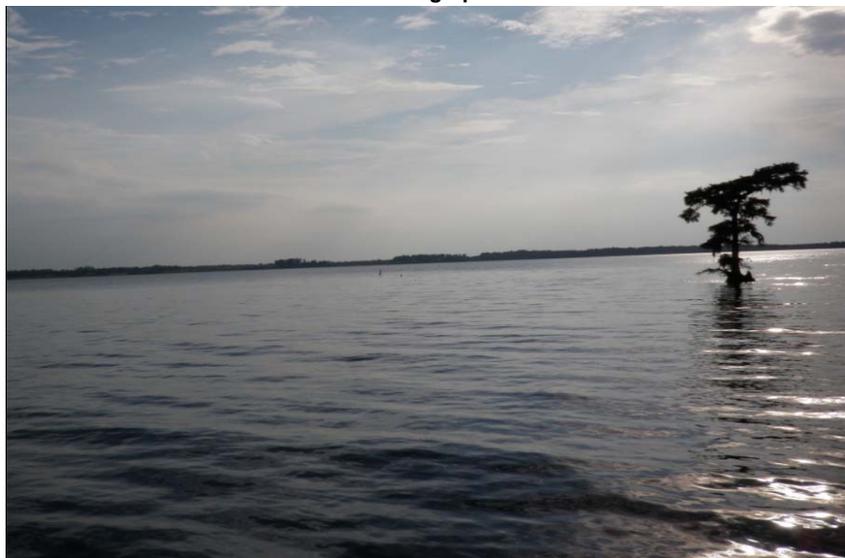
**Site Photograph**

| Substrate | sand, silt, detritus |

The 2010 collection produced the lowest biotic index on record for this location and the EPT richness of 11 repeated the previous high for this metric observed in 1990. Of note, the caddisfly *Oecetis nocturna* was collected here for the first time in 2010. The all-time low BI and high EPT richness suggest that physico-chemical conditions may have improved here slightly since 2005. This is supported by the improved water chemistry parameters as conductivity decreased from 400 µS/cm in 2005 to 126 µS/cm in 2010. This site has previously been assigned bioclassifications. However, these bioclassifications were based on provisional biocriteria. Given the provisional status of biocriteria for large, non-wadeable coastal plain rivers, the 2010 sample was assigned a Not Impaired rating. However, for purposes of inter-year comparison, the 2010 collection would have received a Good bioclassification based on the provisional criteria.

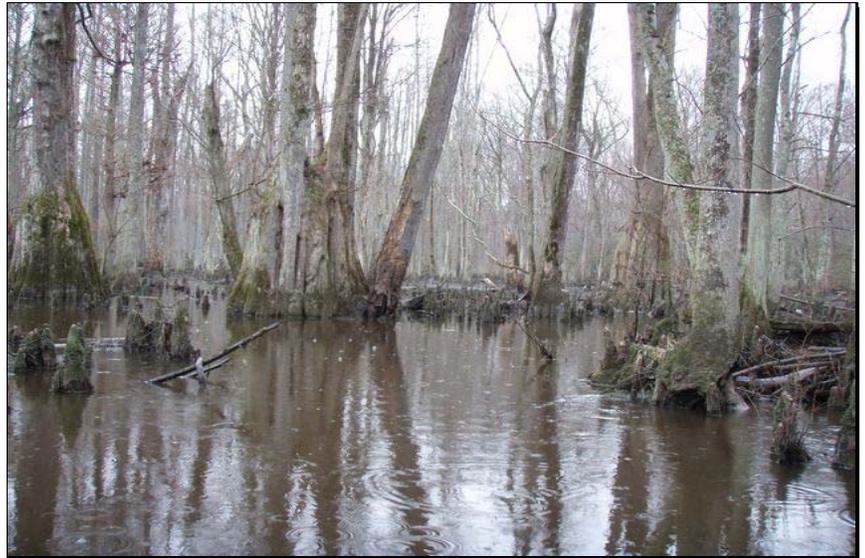
**Site Photograph**

| Substrate | 100% detritus |

Cole Creek, a tributary of Sarem Creek, drains a portion of east-central Gates County. Likely influences on water quality appear to come from agriculture and forestry practices, although there are a few very small municipalities located within the watershed. Cole Creek has maintained its Moderate rating and appears to have stable water quality. There are no severe habitat issues for this waterbody and the riparian appears intact. This site is one of the few swamps in the region where the caddisfly *Platycentropus* can be found and has been collected each time since 2000.

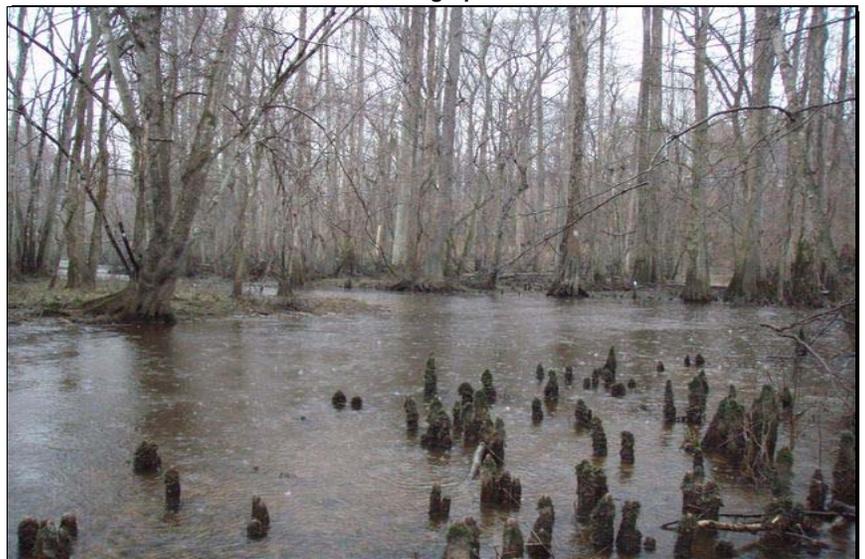
**Site Photograph**

| Substrate | mix of detritus, silt, and sand |

Chinkapin Swamp has a more forested catchment than other swamps in the Chowan basin although agricultural activities still occur in the upper portions of the watershed. Habitat at this site was the best noted for any streams in the Chowan River Basin. The stream channel was braided and unaltered and the riparian was mature forest on either side of the stream. Flows were good and colonizable substrate (coarse woody debris) was prevalent. Despite having a lower EPT richness (with 3 fewer mayfly taxa) than previous samplings the fauna present indicated no water quality issues. Chinkapin Swamp rated Natural for the third straight time.

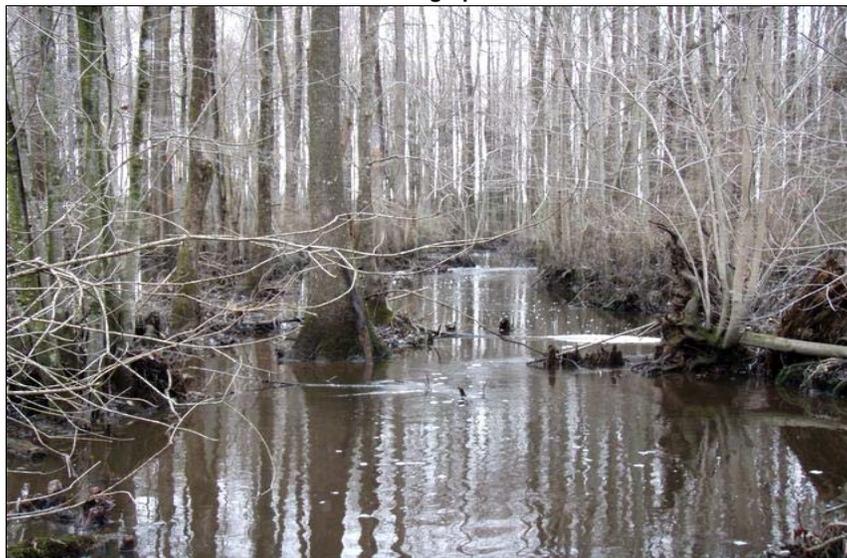
**Site Photograph**

| Substrate | mostly detritus mixed with some silt |

Potecasi Creek's catchment is located in central Northampton County and drains into the Meherrin River close to the Meherrin's confluence with the Chowan. The macroinvertebrate habitat of Potecasi Creek was typical of a slow moving swamp with bottom substrate a limiting factor in EPT colonization. However, physico-chemical parameters were within normal ranges for benthos. Aside from some channelized braids of the swamp, little human influence was noted although a beaver dam upstream was present. EPT taxa richness was higher than historical levels and consisted of typical lentic/slow moving water taxa. Water quality appears stable and Potecasi Creek rated Moderate for the third straight time.
