BARE MITIGATION SITE ON AN UNNAMED TRIBUTARY TO PEAK CREEK, ASHE COUNTY

Year 5 Monitoring Report
Period Covered: June 16, 2005 – March 3, 2007

Prepared for the
North Carolina Ecosystem Enhancement Program

North Carolina Wildlife Resources Commission
Watershed Enhancement Group
Raleigh

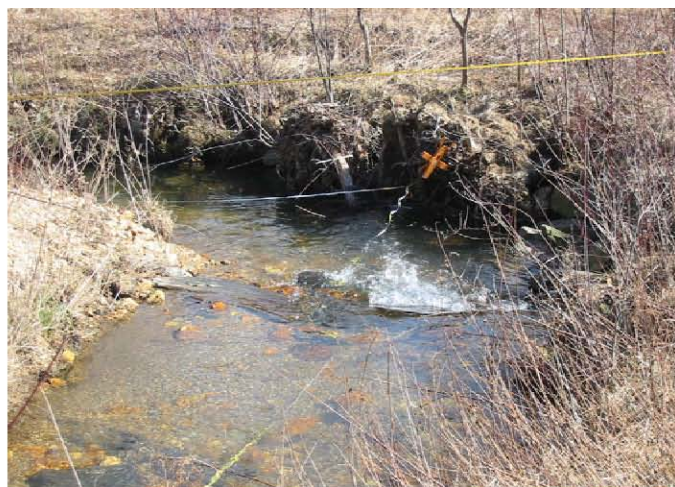
March 2, 2007

CROSS-SECTION 2+90 – pool (Figure 3.2): This cross-section transects a pool maintained by a rock vane and root wads. The pool has deepened below the 2001 as-built survey elevation, which could be credited to two storm events occurring between the 2005 and 2007 surveys producing flows $>4,000 \text{ ft}^3/\text{s}$ per second. The streambanks increased in height since the 2004 repairs (Mickey and Wasseen 2005a). This is attributable to streambed materials being captured

by riparian vegetation during flood events. The banks are stable and there has been no lateral shift in the stream channel.

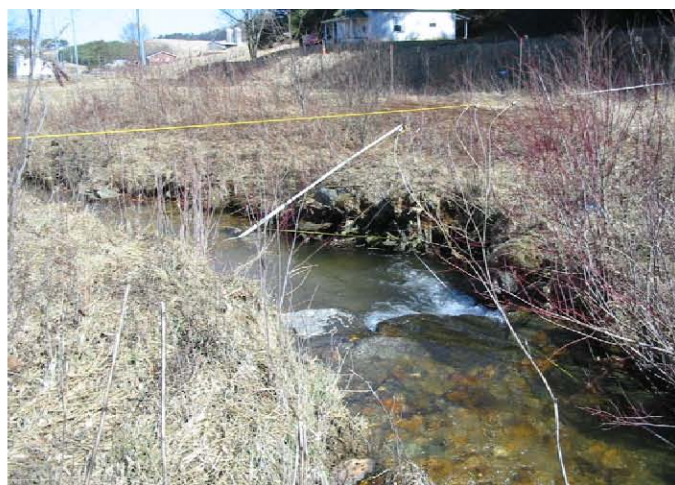
March 2, 2007.

CROSS-SECTION 7+19 – pool (Figure 3.4): This cross-section transects a pool maintained by a cross-vane and root wads. The 2007 monitoring survey indicates no major changes from the 2005 survey. Point bar height has increased as streambed materials were captured by riparian vegetation during flood events. This cross-section has remained stable with no lateral movement observed along the stream banks.

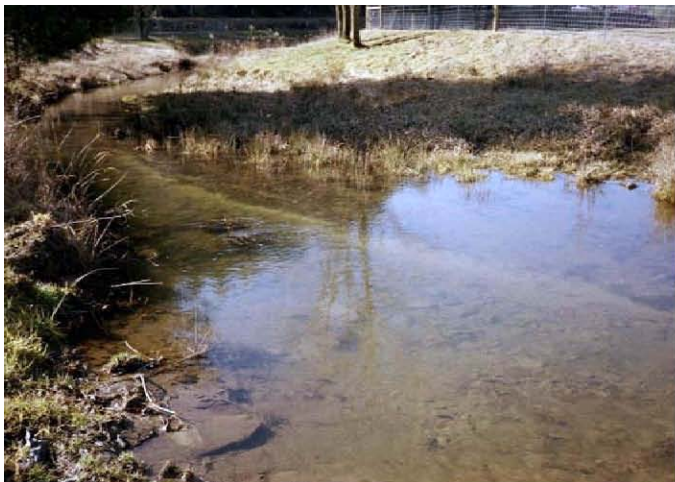
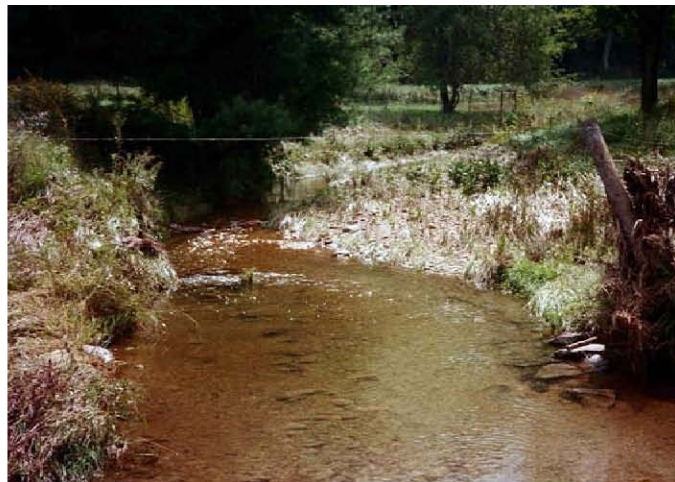
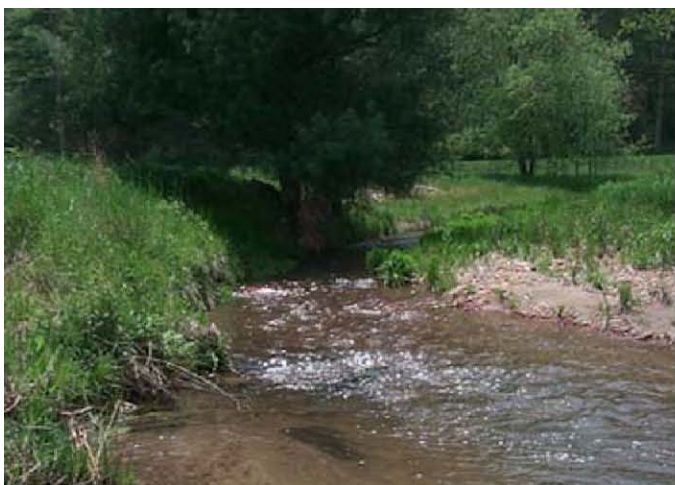
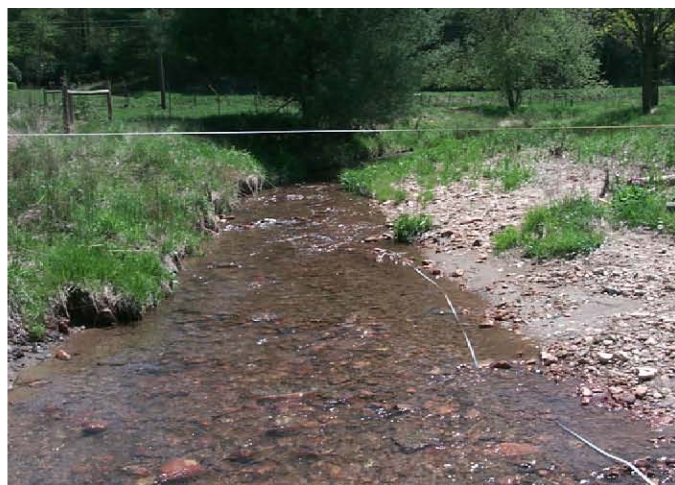
CROSS-SECTION 10+35 – riffle (Figure 3.5): This cross-section transects a stable riffle immediately upstream of the lower livestock crossing located at longitudinal profile station 10+64. No in-stream channel modifications were made at this site in order to monitor the natural recovery of the channel once livestock were excluded from the riparian zone. The wetted stream width as measured from water's edge to water's edge at base flow (elevation approximately 85.2 feet) narrowed from 18.3 feet in 2001, to 8.0 feet in 2005, and then to 7.0 feet in 2007. Vegetation along the left bank continues to trap streambed materials during bankfull and flood events, effectively narrowing the wetted perimeter of the channel. The right bank has remained stable.

Appendix 6: Photographs of the Bare mitigation site, unnamed tributary to Peak Creek, New River drainage, Ashe County. Looking upstream from station 10+35 Note: No work occurred at this cross-section. The wetted stream width at base flow has narrowed approximately 11 feet since 2001.
