EEP Project Closeout Summary

Project Name/Number: Payne Dairy (Jumping Run Creek)
EEP ID 279
County: Alexander
Project Type: Stream Restoration, Enhancement
Wetland Preservation
Current Status: 5 Years of Monitoring complete

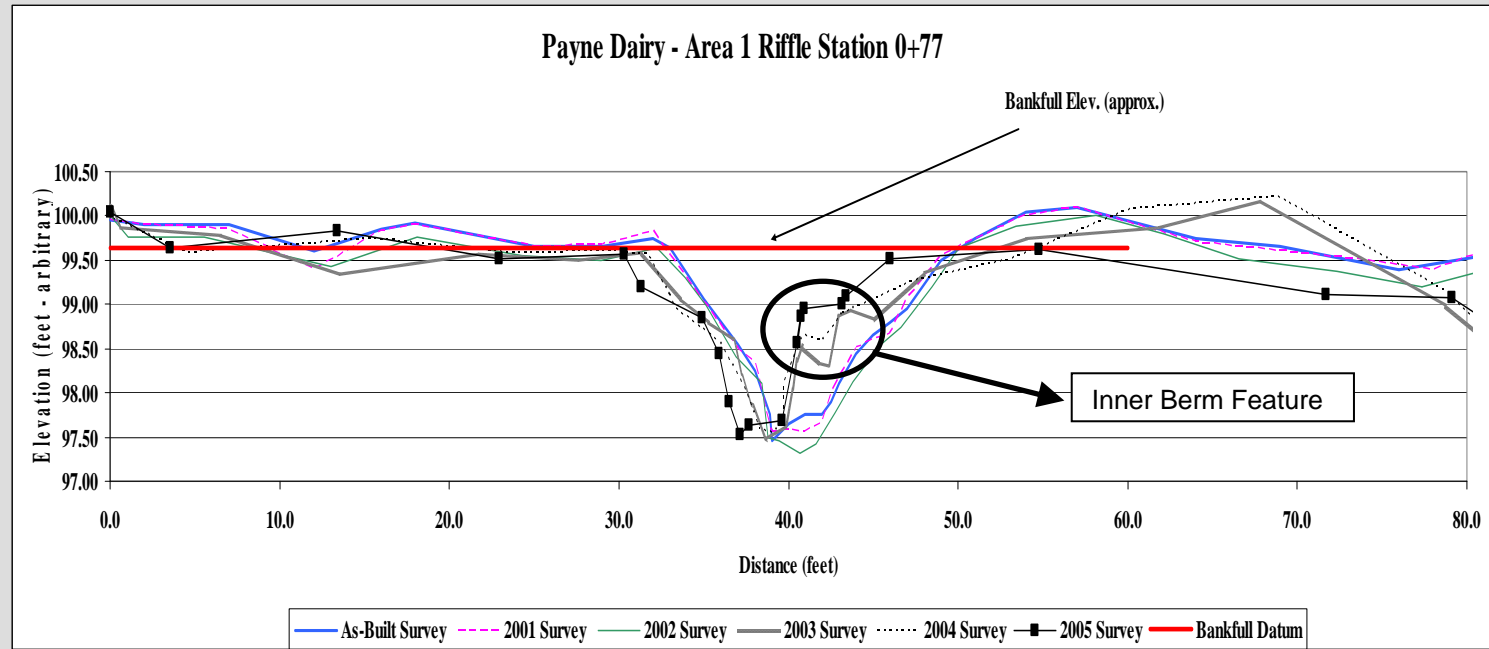
The restored channel's dimension exhibited stability. There appeared to be some lateral migration in one of the paired riffle and pool cross-sections at the very upper end of the project, but this may have been a lateral shift in the survey by the monitoring consultant in years 3-5. In any case, this is not evident in the field and did not represent a systemic reach response. The riffle cross-sectional areas were either maintained or decreased due to a decrease in channel width, primarily below the bankfull elevation (development of an inner berm feature See Area 1 Riffle Cross section below), which was coincident with the development of dense vegetation in year 3. The riffle cross-sections classified as either the C channel that was designed or exhibited tendencies towards development of an E channel as a result of the aforementioned narrowing. In all cases, healthy entrenchment ratios were maintained indicating good floodplain capacity. With the exception of one riffle-pool cross-section pairing, the pool cross-sections exhibited and maintained greater depths than the riffles, indicating the maintenance of distinct bedform features. Collectively, these conditions indicate stability or stable trends of the restored dimension. The plots below describe or typify some of the conditions and trends with regard to channel dimension.

In order for the reach dimension to be considered stable, the change in the cross-sectional area should not be unidirectional and the amplitude in the variation should not increase over the 5-year monitoring period. A stream's cross-section may exhibit an initial adjustment before a stable variation pattern can be observed around some new point of equilibrium. This is often due to the fact that there is some level of uncertainty in any stream design, and the vegetation often takes 2-3 years to exert significant influence on the channel. The above plot includes the percent change relative to the as-built for each of the 4 project riffle cross-sections. The mean is also included. The project's cross-sectional area generally demonstrated a healthy pattern of variability. After an initial moderate increase in the cross-section between years 1 and 2, the cross-section generally decreased with the development of an inner berm depositional feature, effectively narrowing the channel. This condition was particularly evident in the cross-section from area 4. The onset of very dense vegetation was coincident with this decrease in area in Year 3. This adjustment was followed by a lower level of variation in years 4 and 5, indicating the cross-section has likely reached a stable equilibrium. The observed pattern indicates that the intended floodplain access was provided and maintained. Maintenance of a mean entrenchment ratio of approximately 5 over the 4 riffle cross-sections supports this observation.

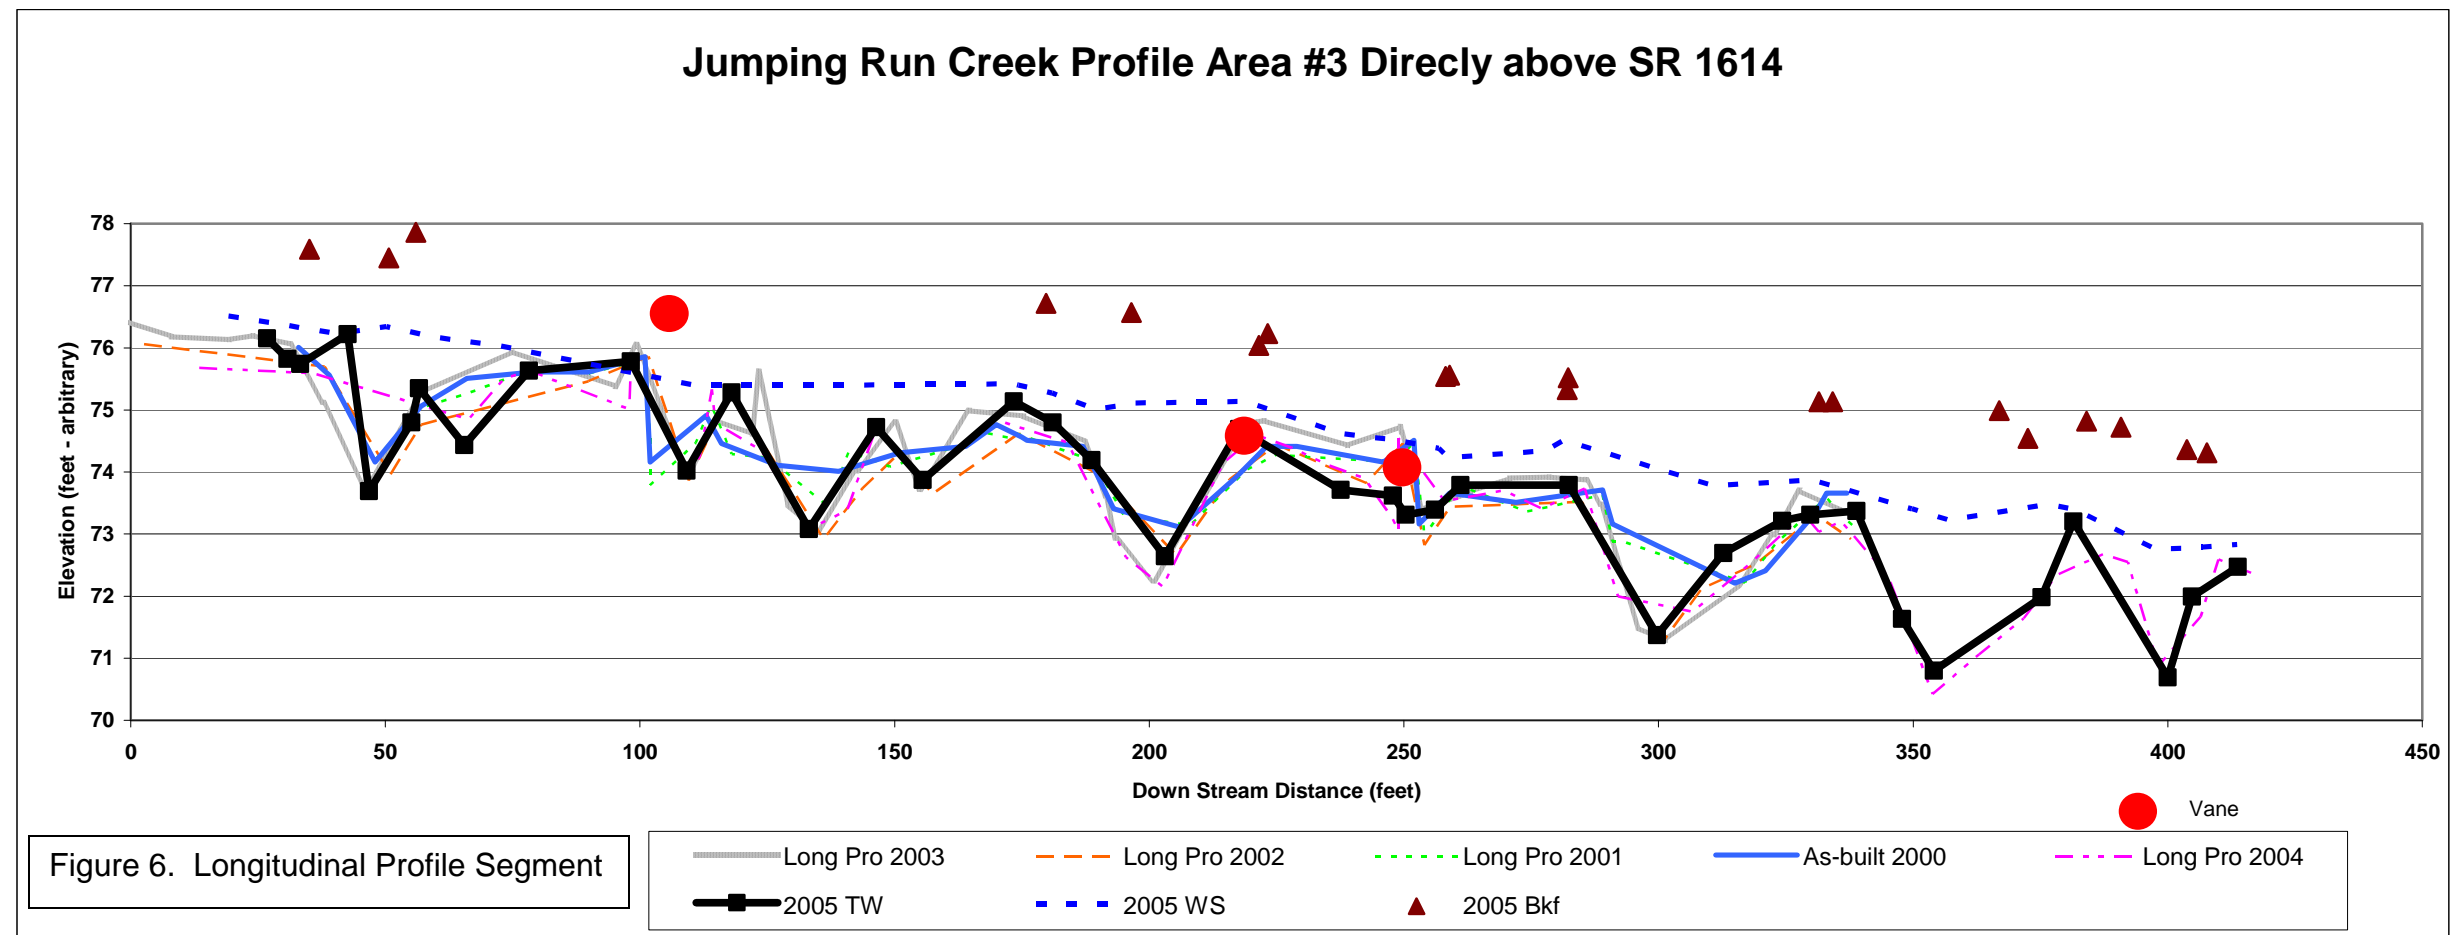
The upper section of the reach above Henry road demonstrated some vertical adjustment during year 2 which has since arrested. There was some aggradation above structure 2 near the top of the project and some downcutting below it resulting from a short headcut for this upper section, but the monitoring reports/data for years 3 through 5 indicated this has stabilized. The measured profiles indicated that the project reaches were vertically stable overall. The figure below provides a sampling of the surveyed profile. Bedform slope and spacing distributions naturally varied from year to year, but distinct riffle-pool bedform distributions were maintained, providing diversity in the project bedform.
