EEP Project Closeout Summary

Project Name/Number: Reedy Branch
EEP ID: 301
County: Alamance
Project Type: Stream Restoration,
Current Status: 5 Years of Monitoring complete

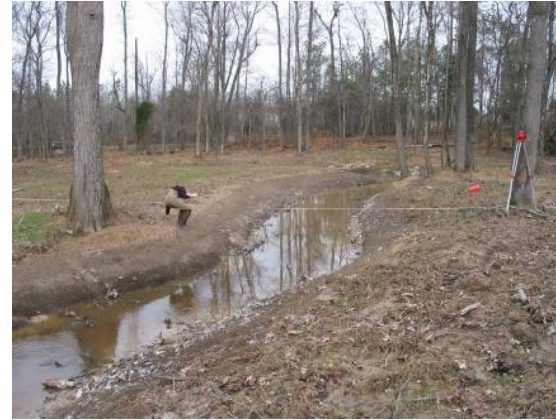
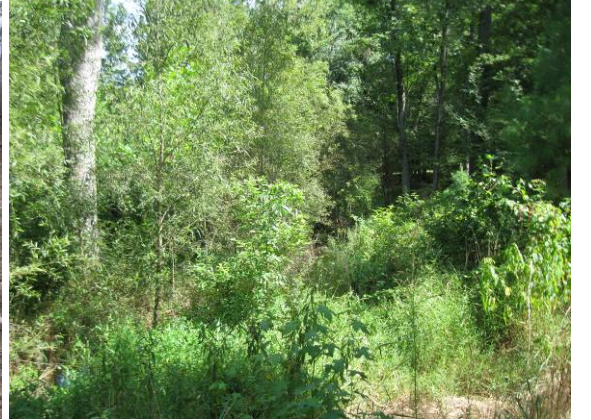
Photo Point #35.

Livestock were excluded from the entire project, except where two cattle crossings were installed as part of the restoration. Both cattle crossings were noted to have severe fencing damage as a result of flooding in the past. Both crossings experienced damaged fencing, dislodged fence posts, and scour of the gravel path. Both of these crossings will be repaired in 2010. As noted in the Project Timeline table on page 1 of this report, warranty repair work was performed on the project in May of 2005 (Monitoring Year 1). There were three problems that were repaired. The first was a small area of run-on erosion down-slope from one of the construction access areas. The second area was a cross vane that was leaking. The last repair area was a section of cattle crossing fence that was pulled down during a storm flow event. The landowner repaired this fencing at his own expense, with help from the local County Extension Office.

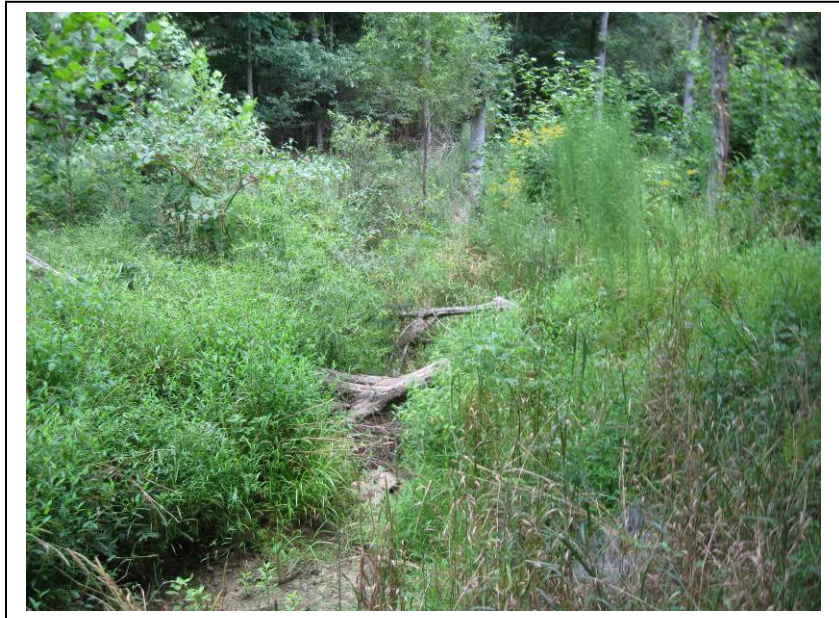
Figure 4. Riffle cross-section (XS-4) typifying minor incision observed at some riffles. Photo is view facing downstream of cross section 4 vicinity on August 4, 2009

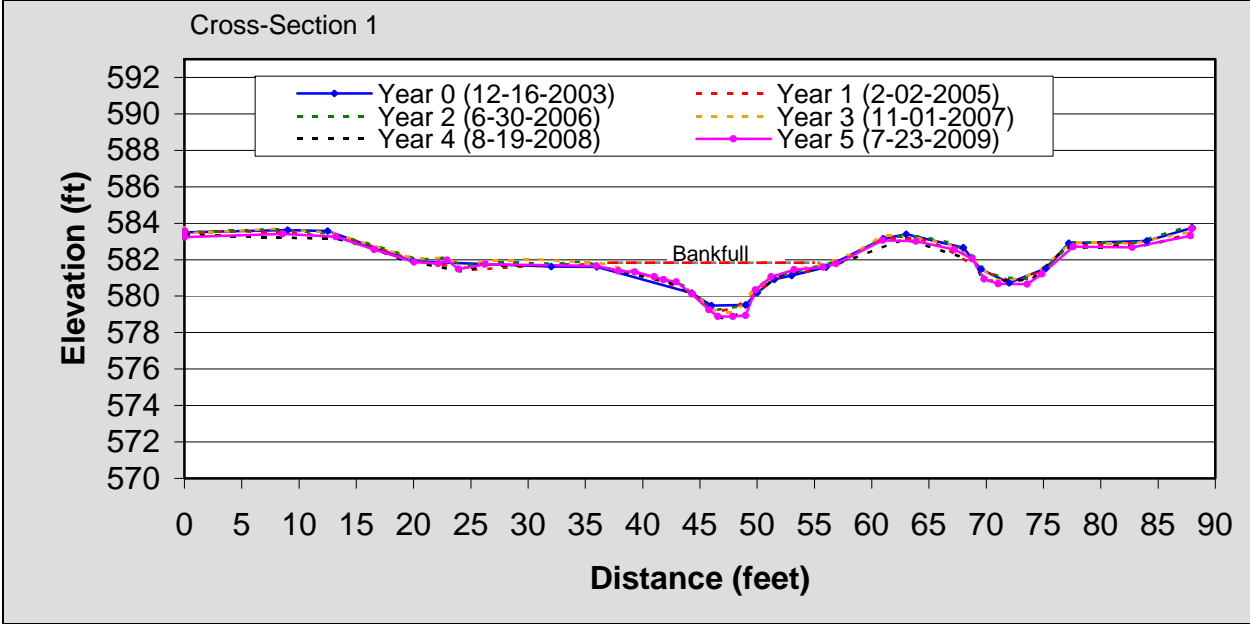
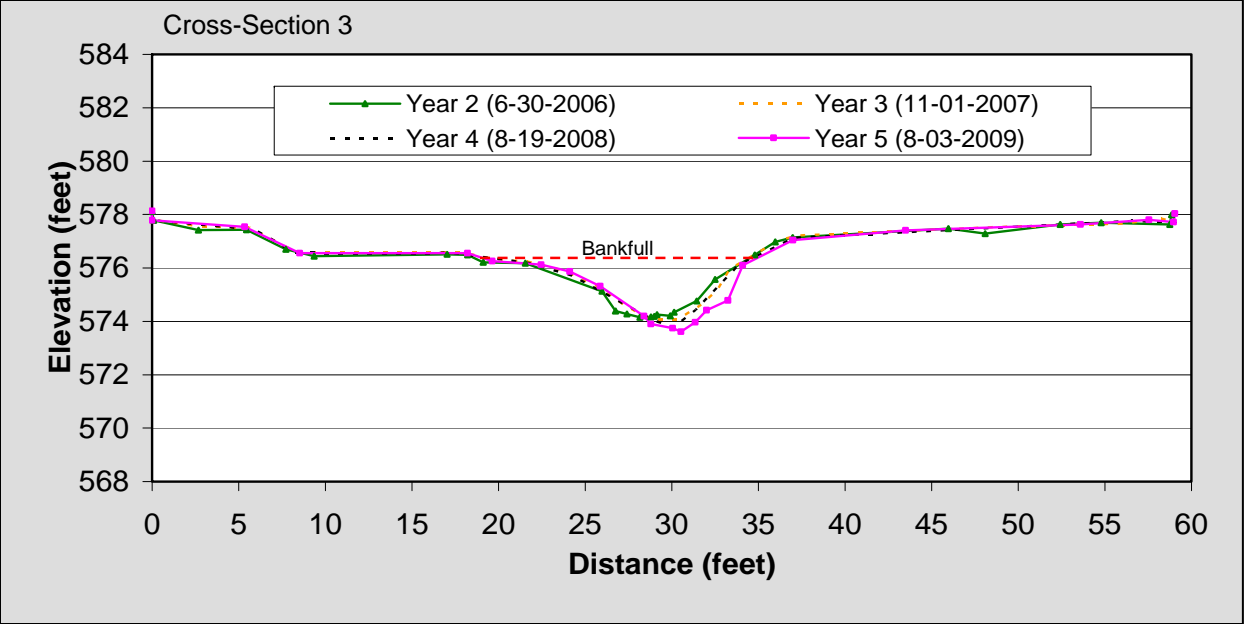
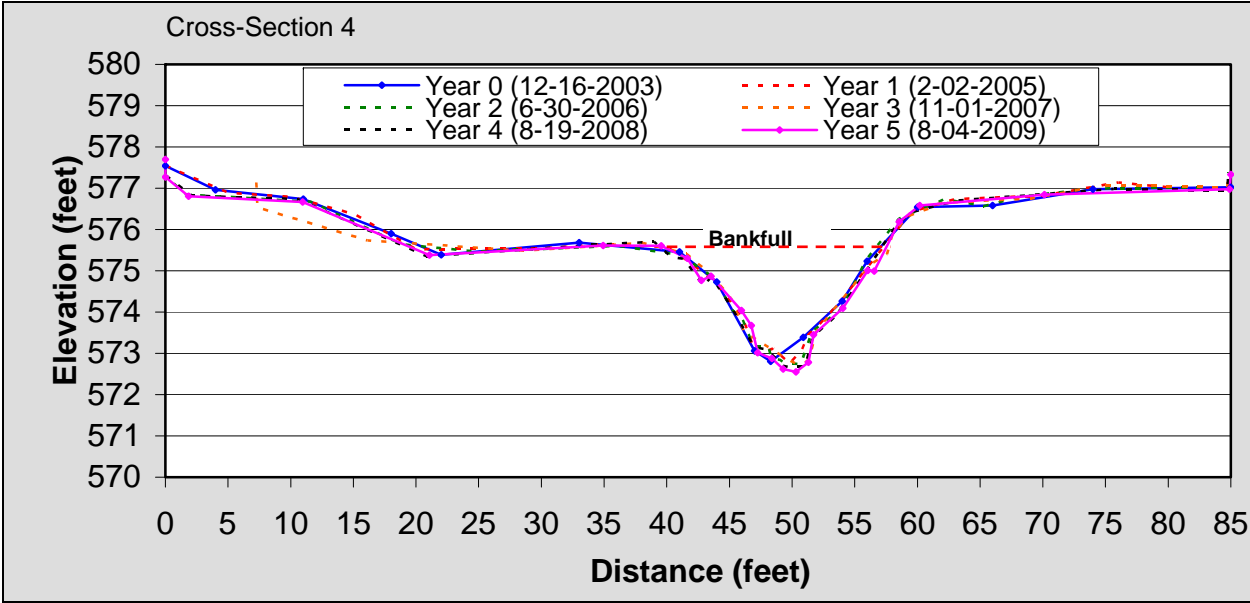
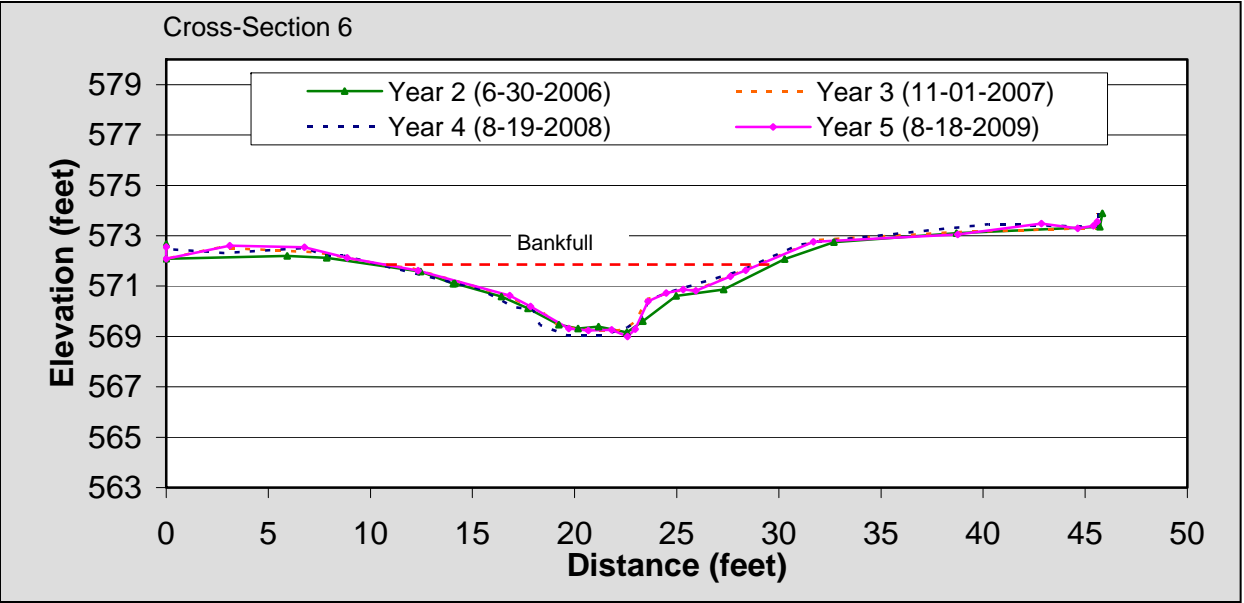
Annual Riffle Cross-Section Overlays

The reach demonstrated some vertical adjustment during Monitoring Years 1 – 3 in the form of aggradation in riffles, followed by stabilization of these areas in the final Monitoring Years. During Monitoring Year 2, 244 lf (8%) of the monitoring reach was noted to be affected by aggradation. During Monitoring Year 3, 293 lf (9%) of the monitoring reach had noted aggradation. However, riffle aggradation areas were probably normal post-construction channel adjustments in the form of the riffles narrowing to a stable dimension. That assessment was based on the trend observed during the final two Monitoring Years of aggradation clearing within the thalweg. By the final Monitoring Year, only one area (17 lf) of aggradation was found within a riffle, affecting 1% of the channel bed. No channel downcutting was documented during the five year monitoring period. The Monitoring Year 5 measured profile indicated that the project reach was vertically stable overall when compared to the project baseline. The figure below provides a sample of the surveyed profile. Bedform slope and spacing distributions naturally varied from year to year, but distinct riffle-pool bedform distributions were maintained, providing diversity in the bedform.
