# BASIN FAILURE

## A Case Study on a Skimmer Basin Failure and Downstream Remediation

Jay Wilson, CPESC  
City of Charlotte

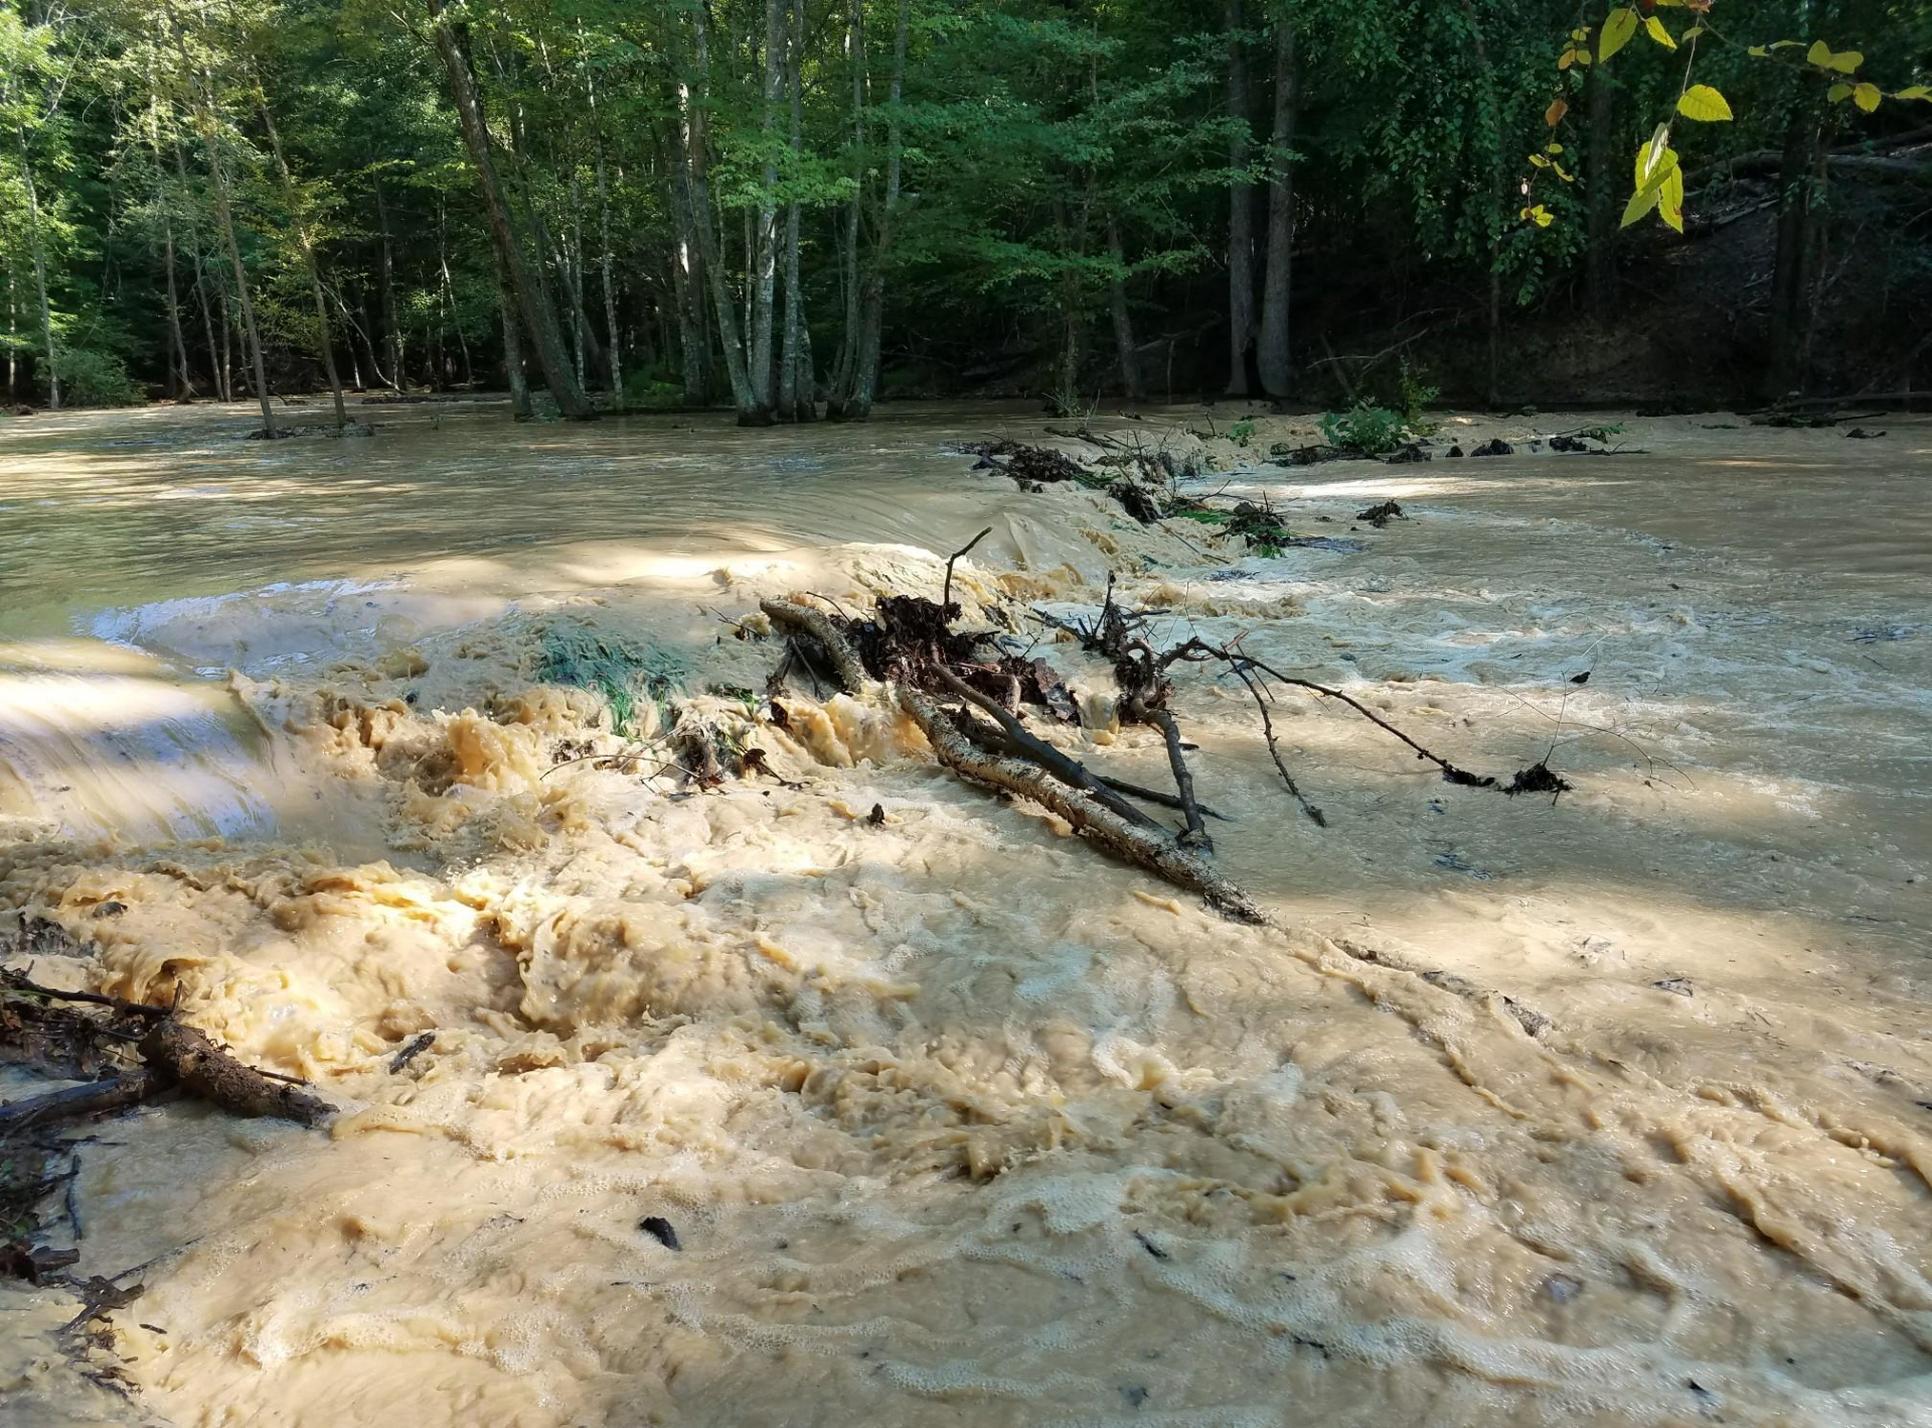
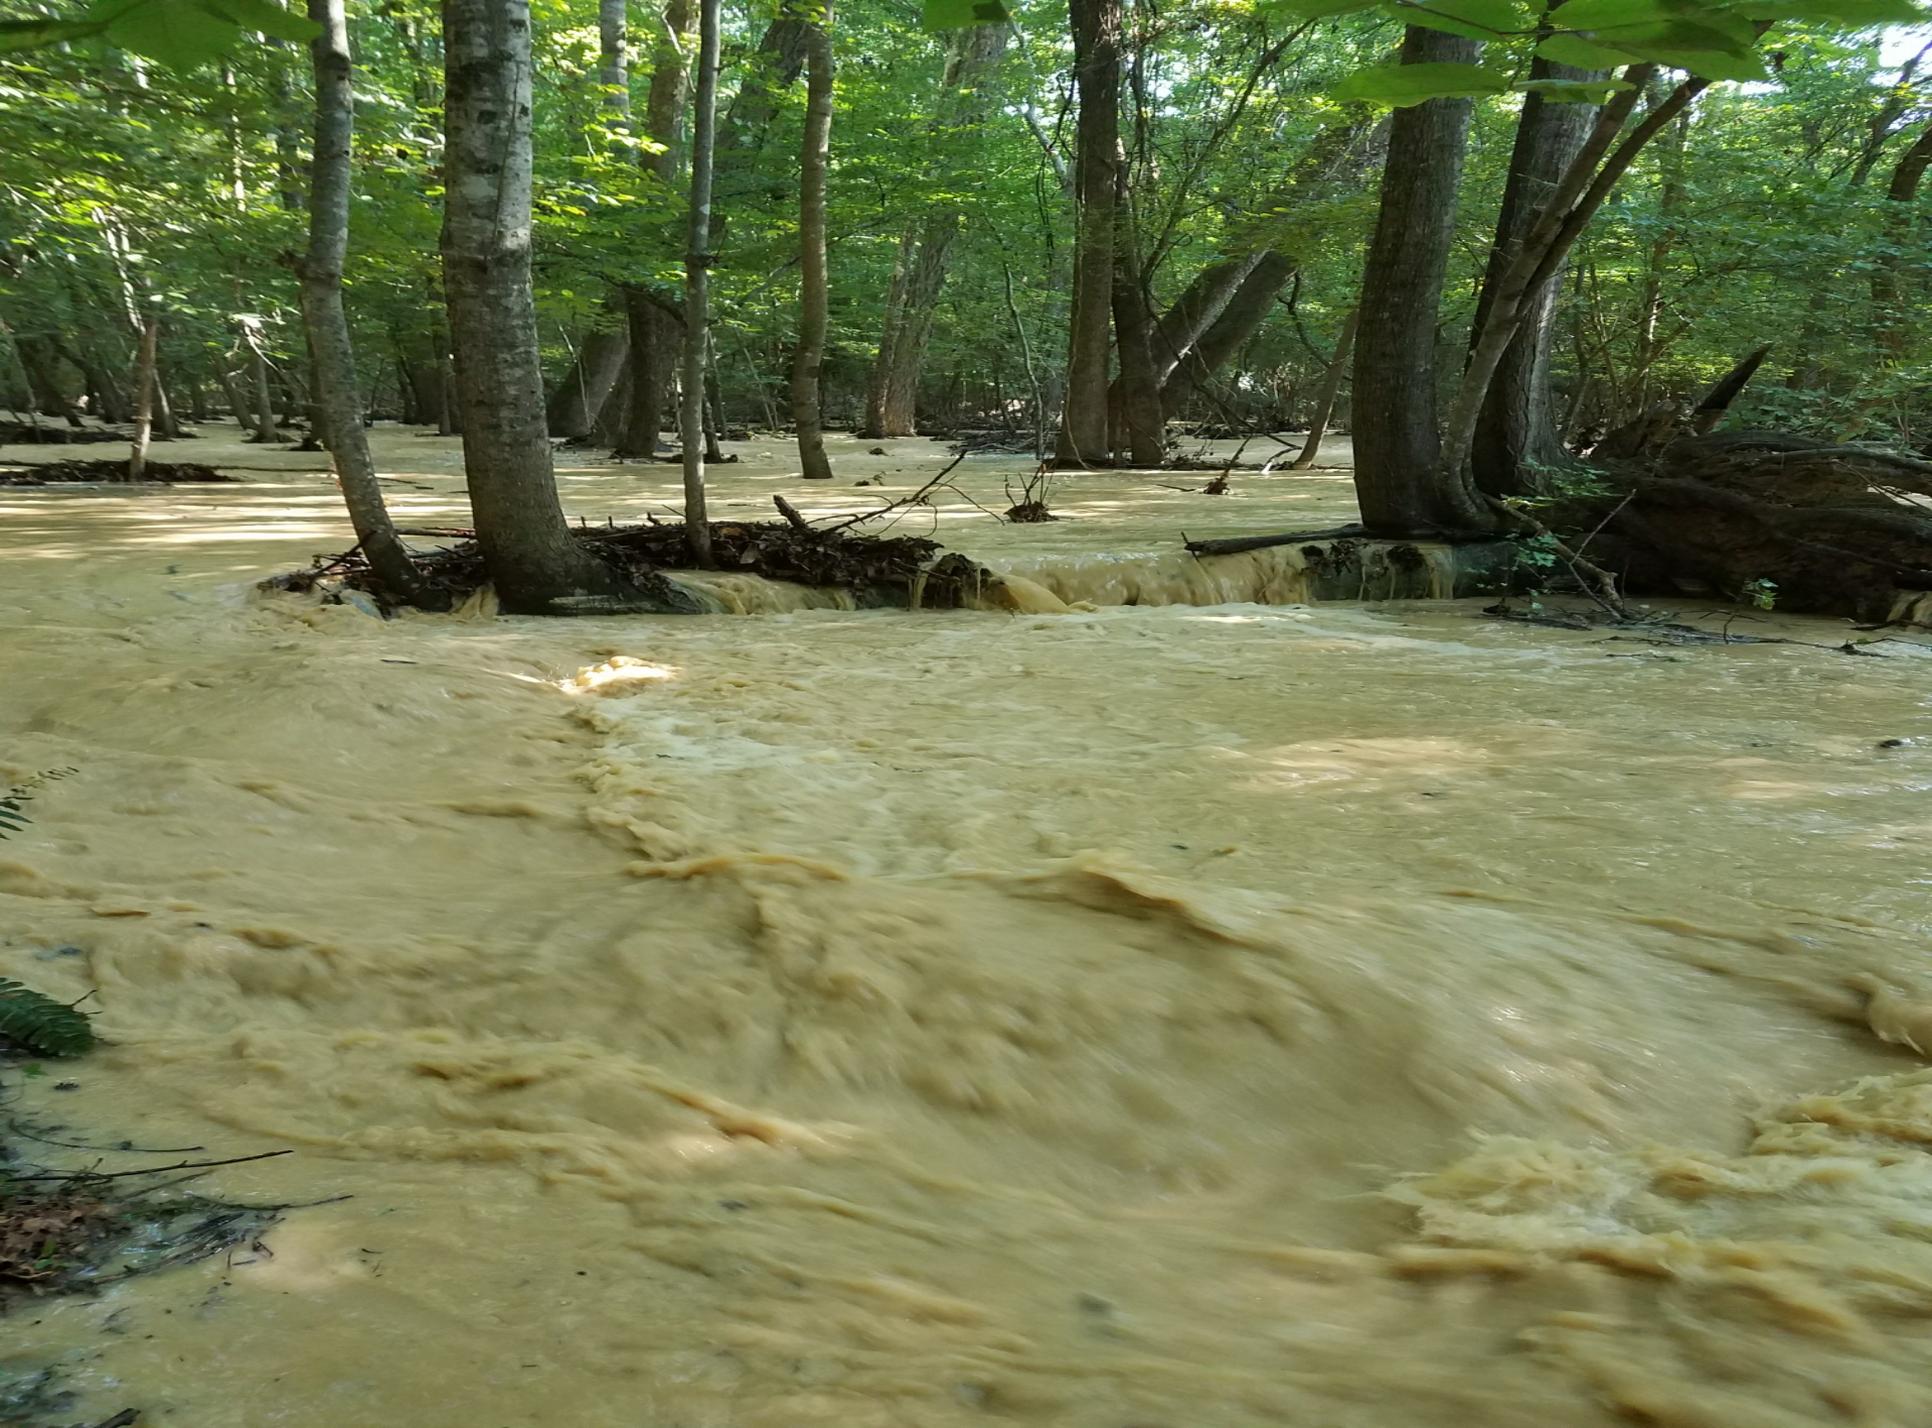
- Received calls from downstream residents in NC and SC
- Developer called to self-report the incident

- Sunny day breach; had not rained in a week
- Trench-type failure over the barrel pipe

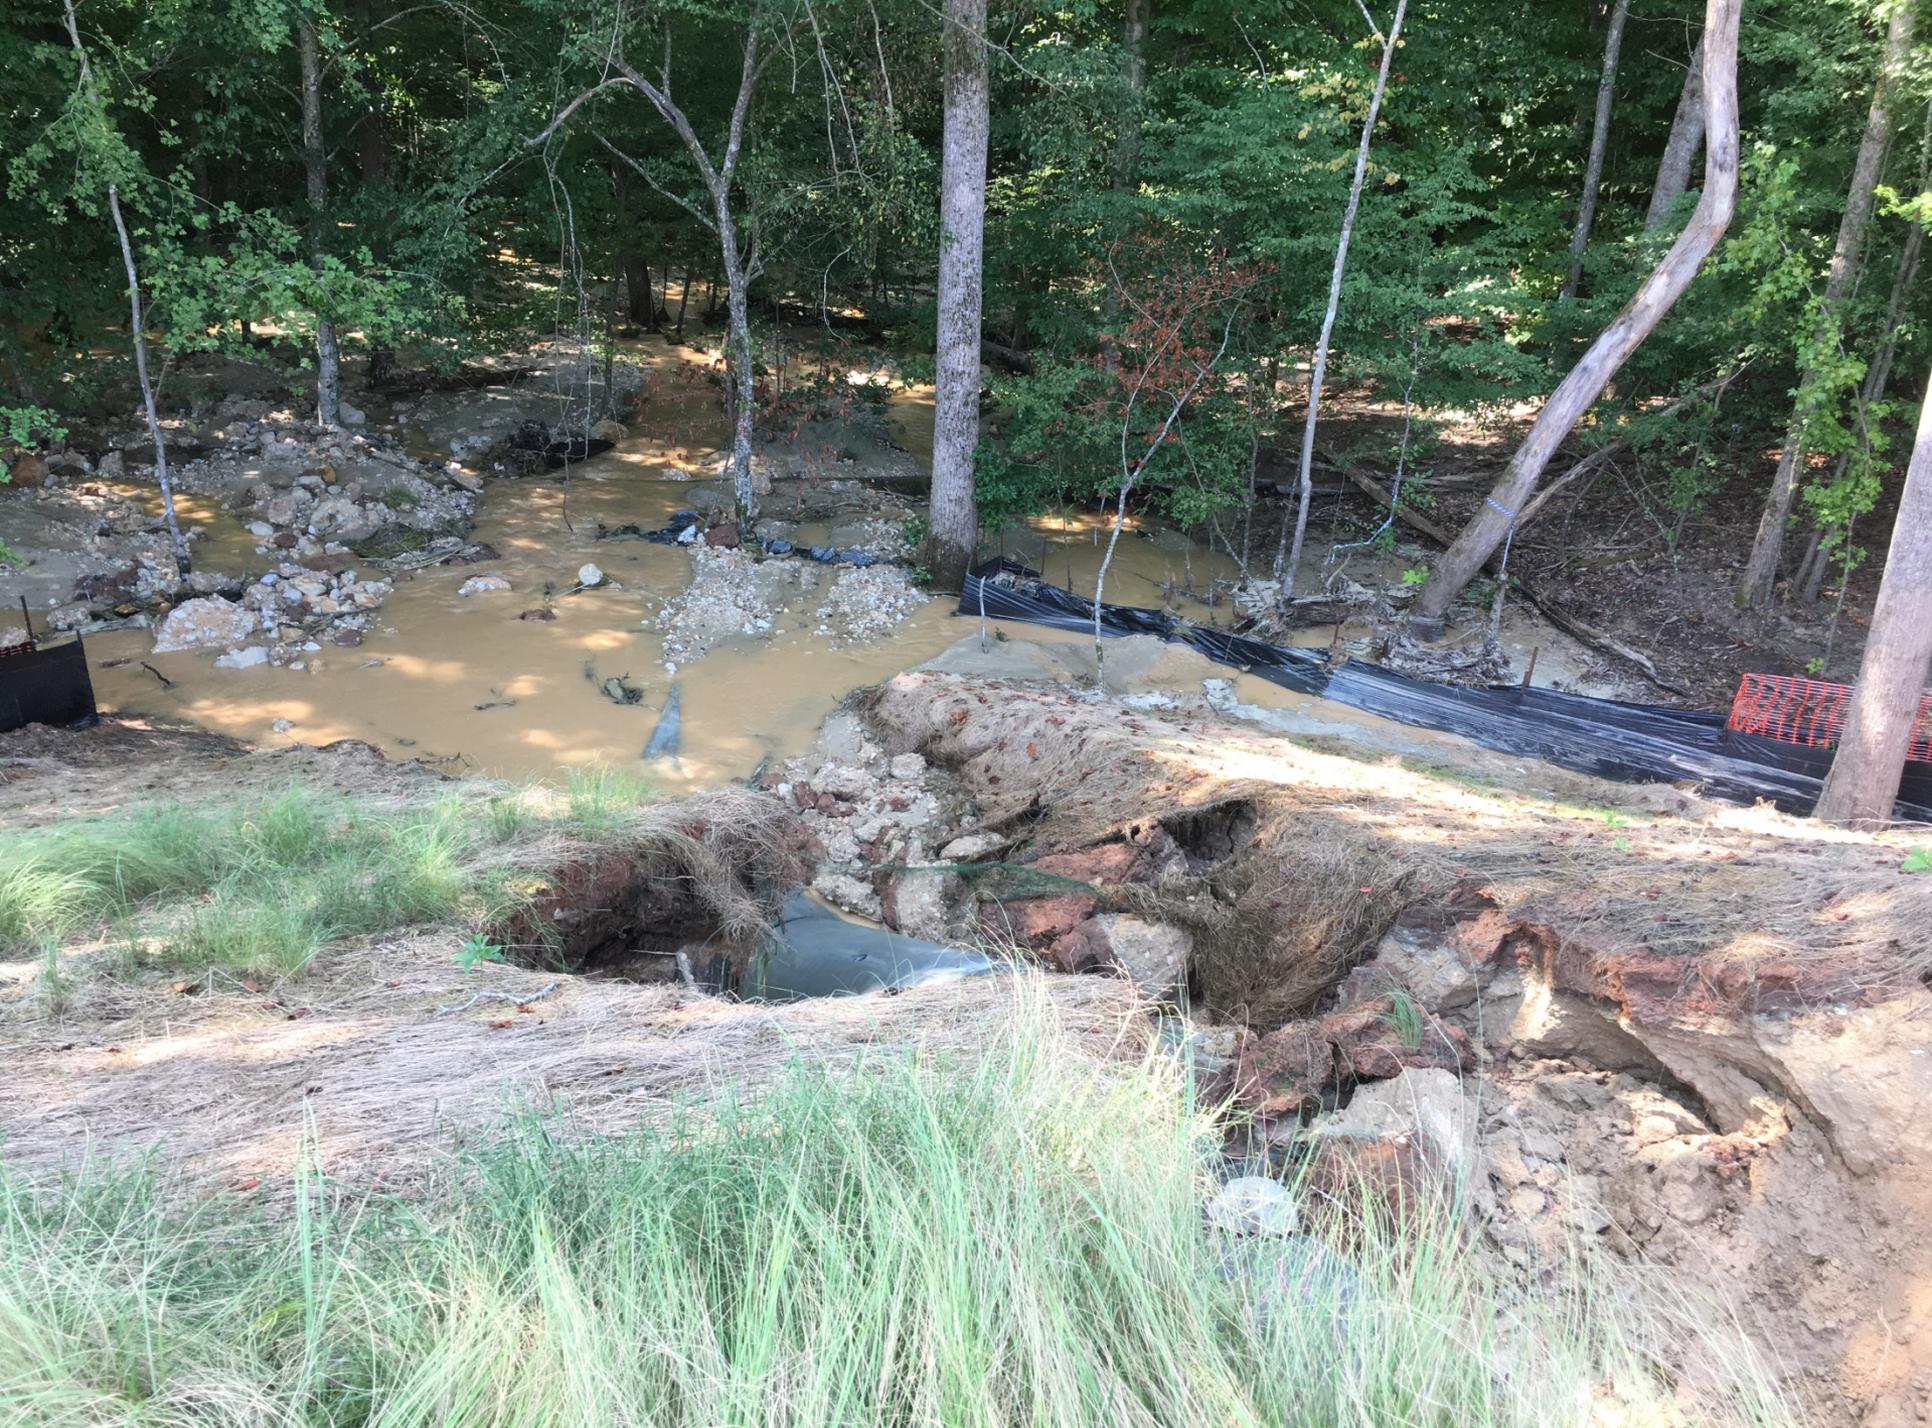
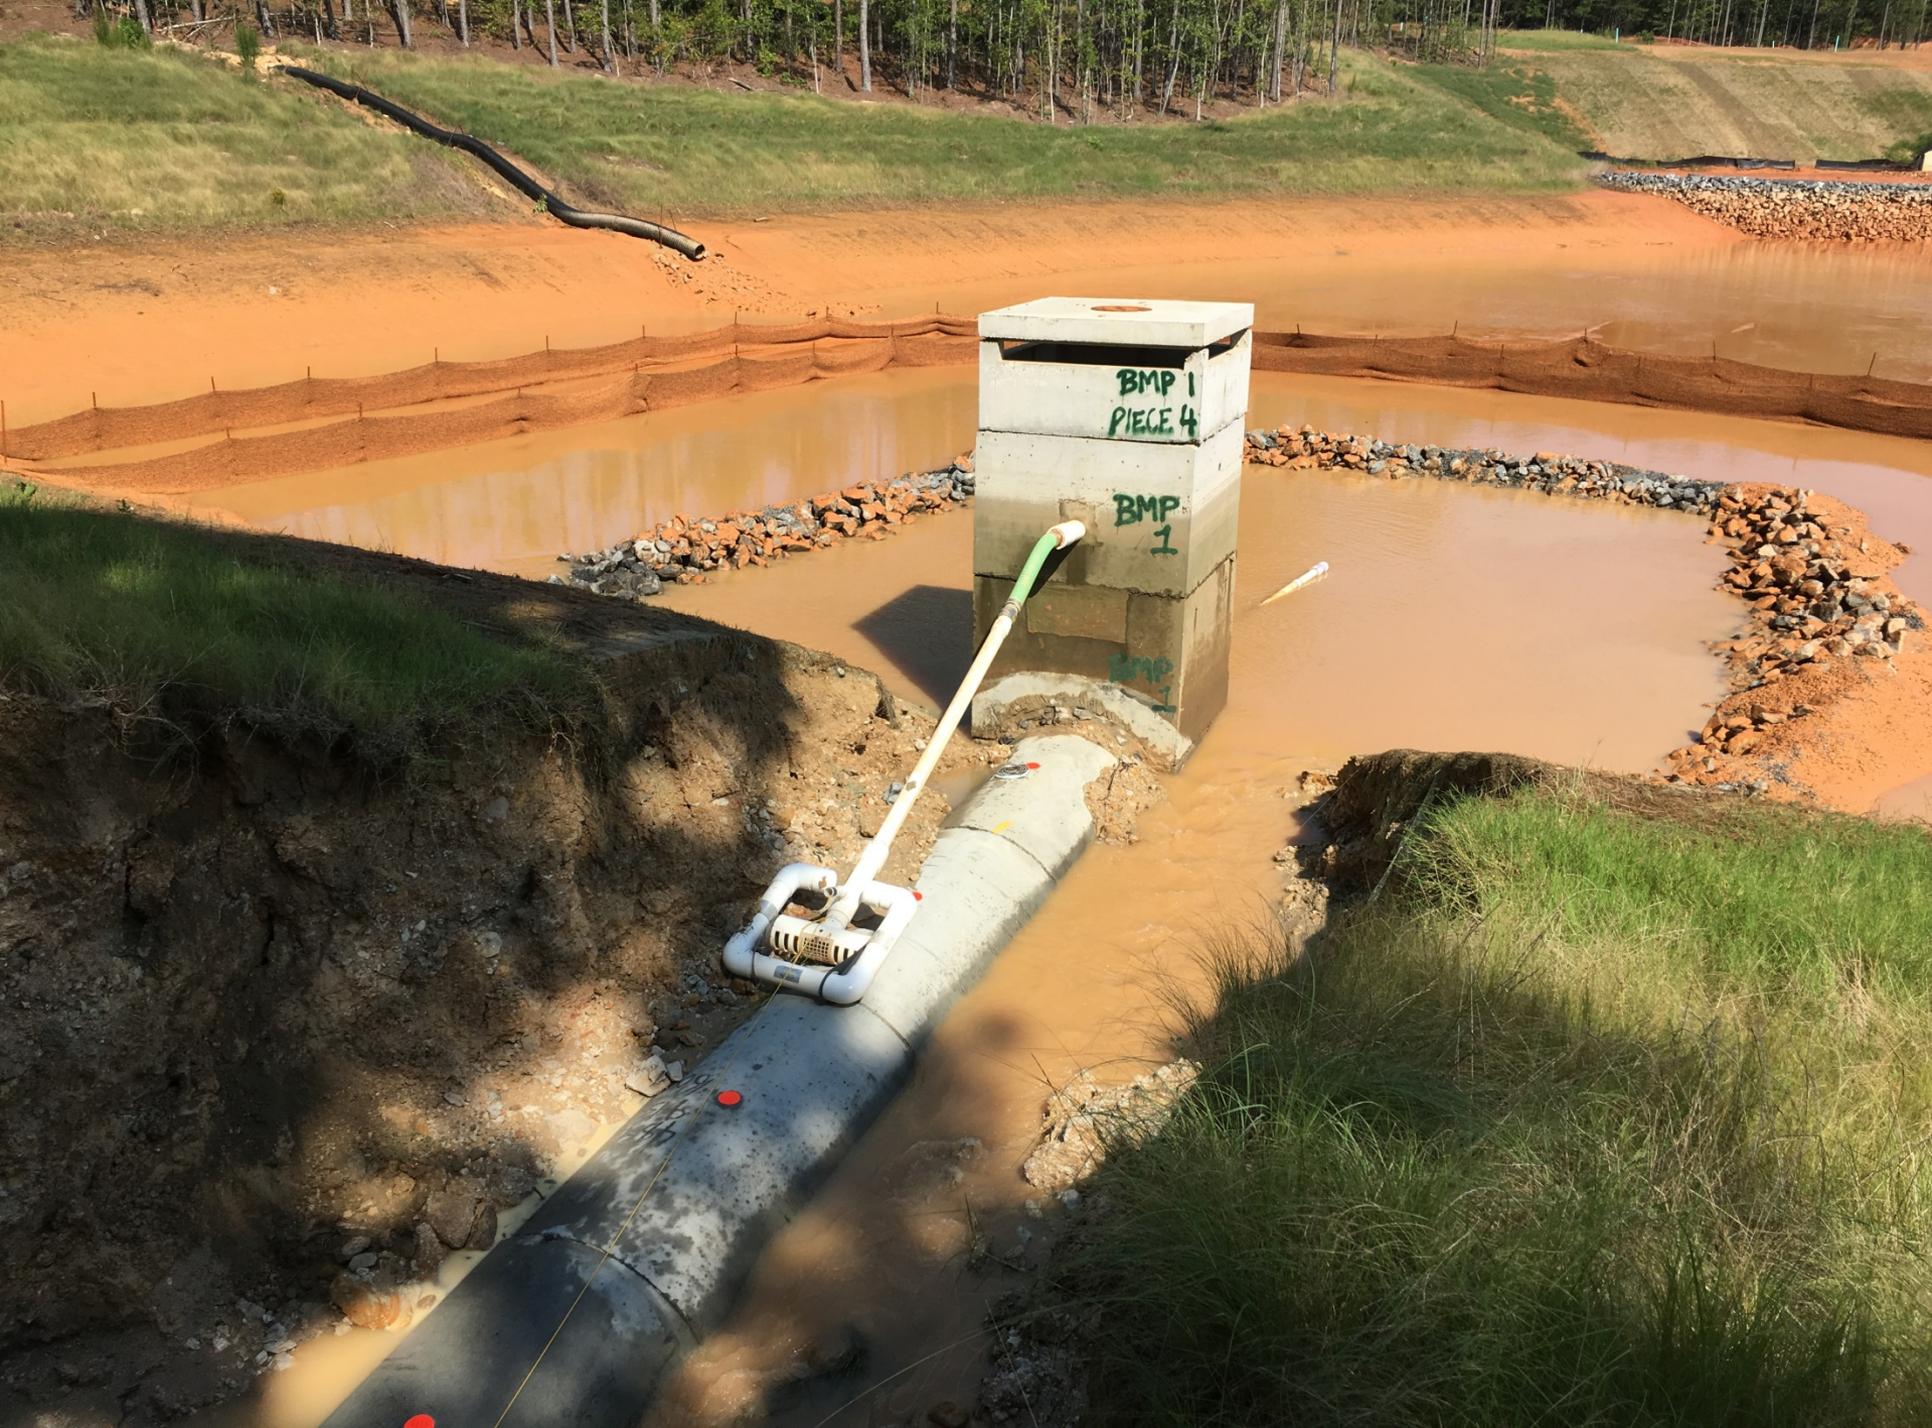
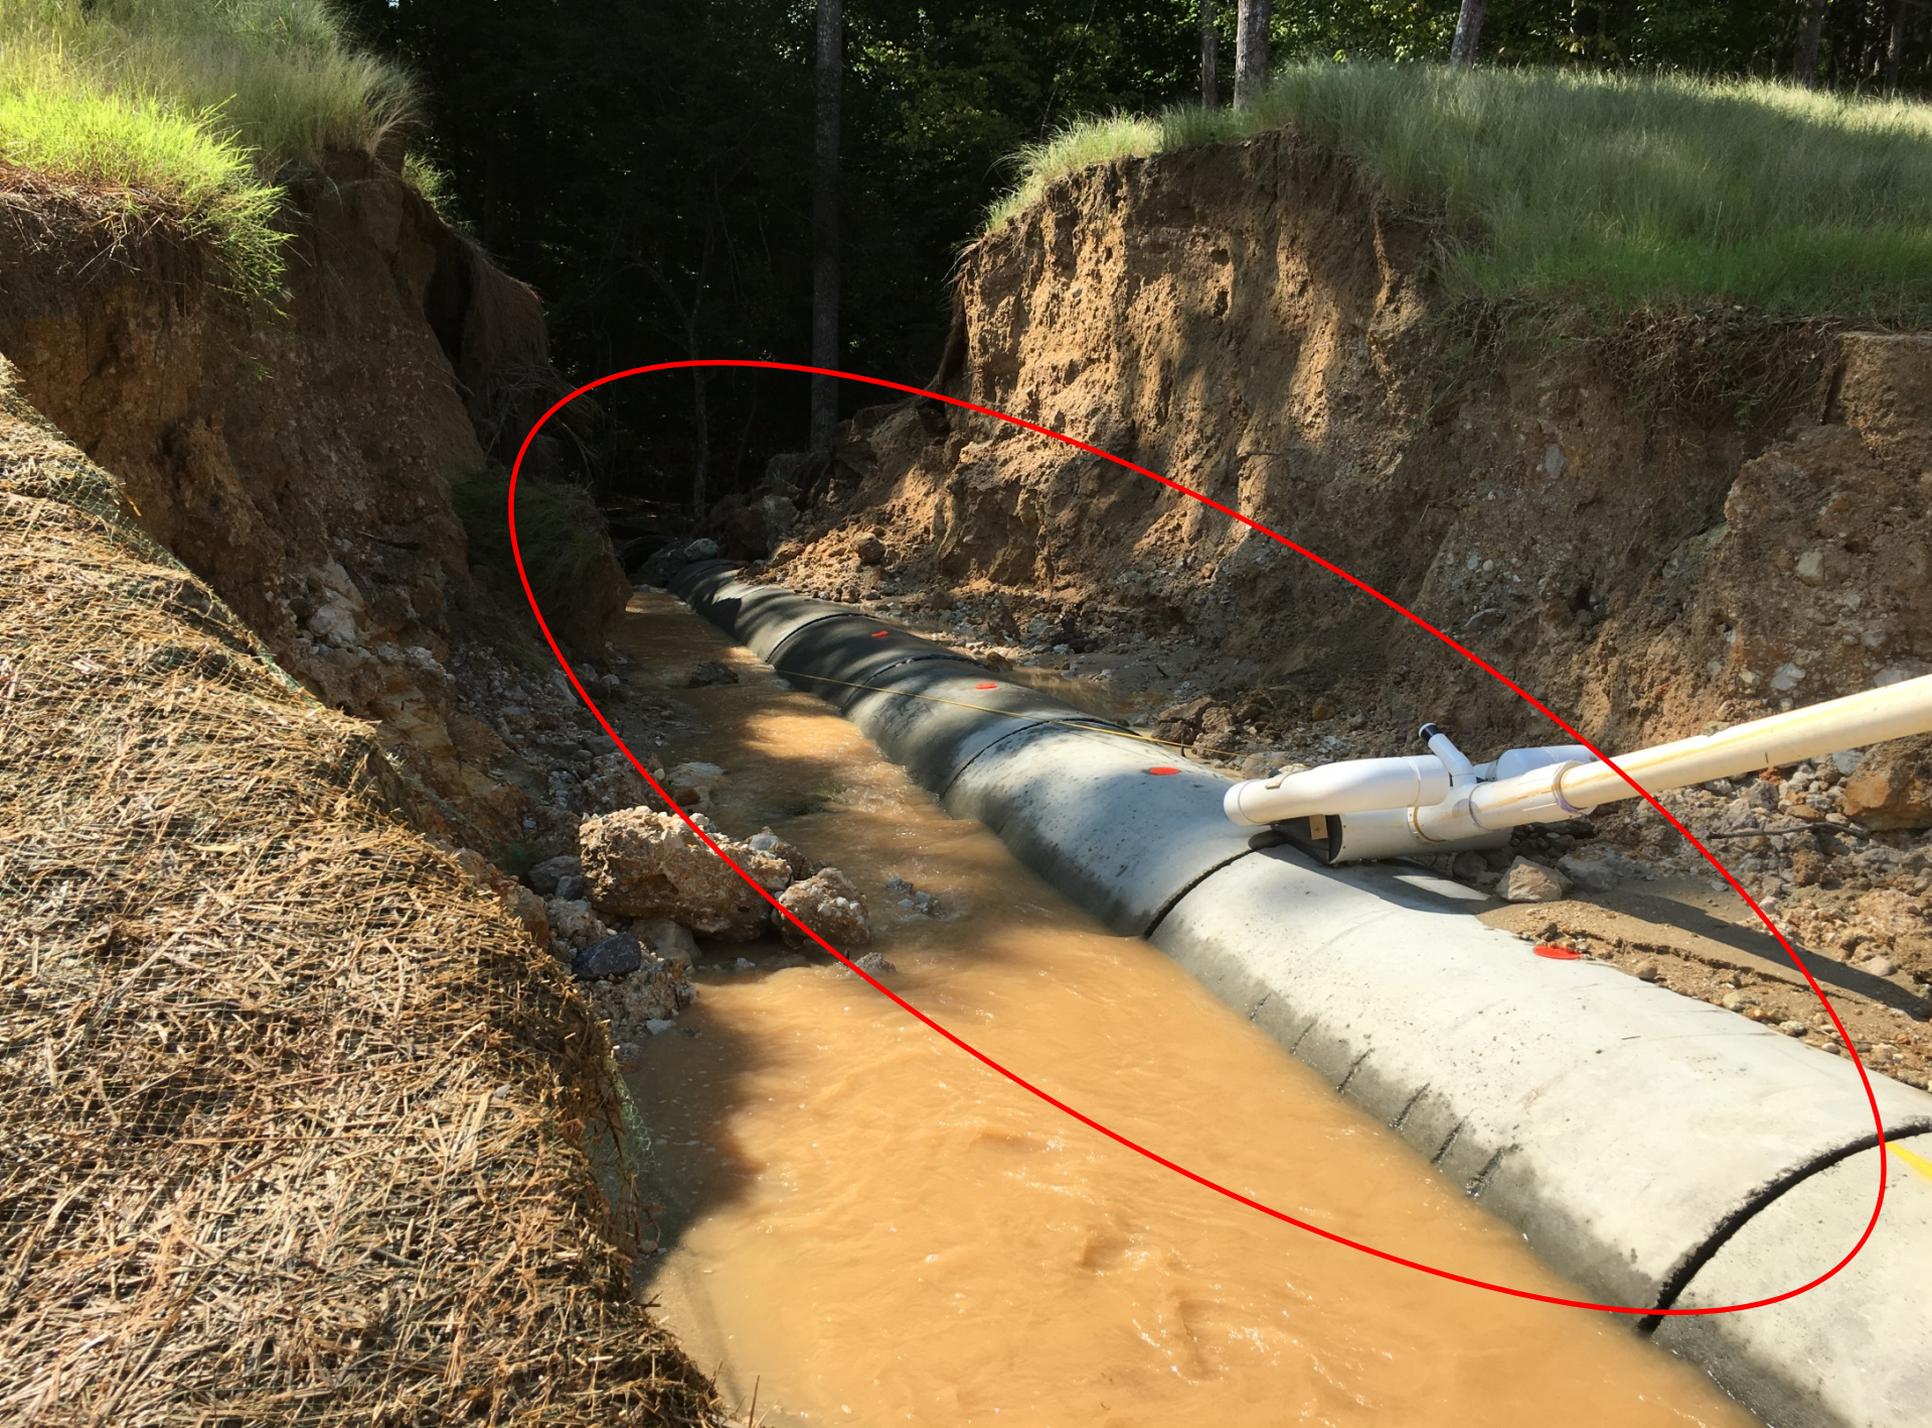
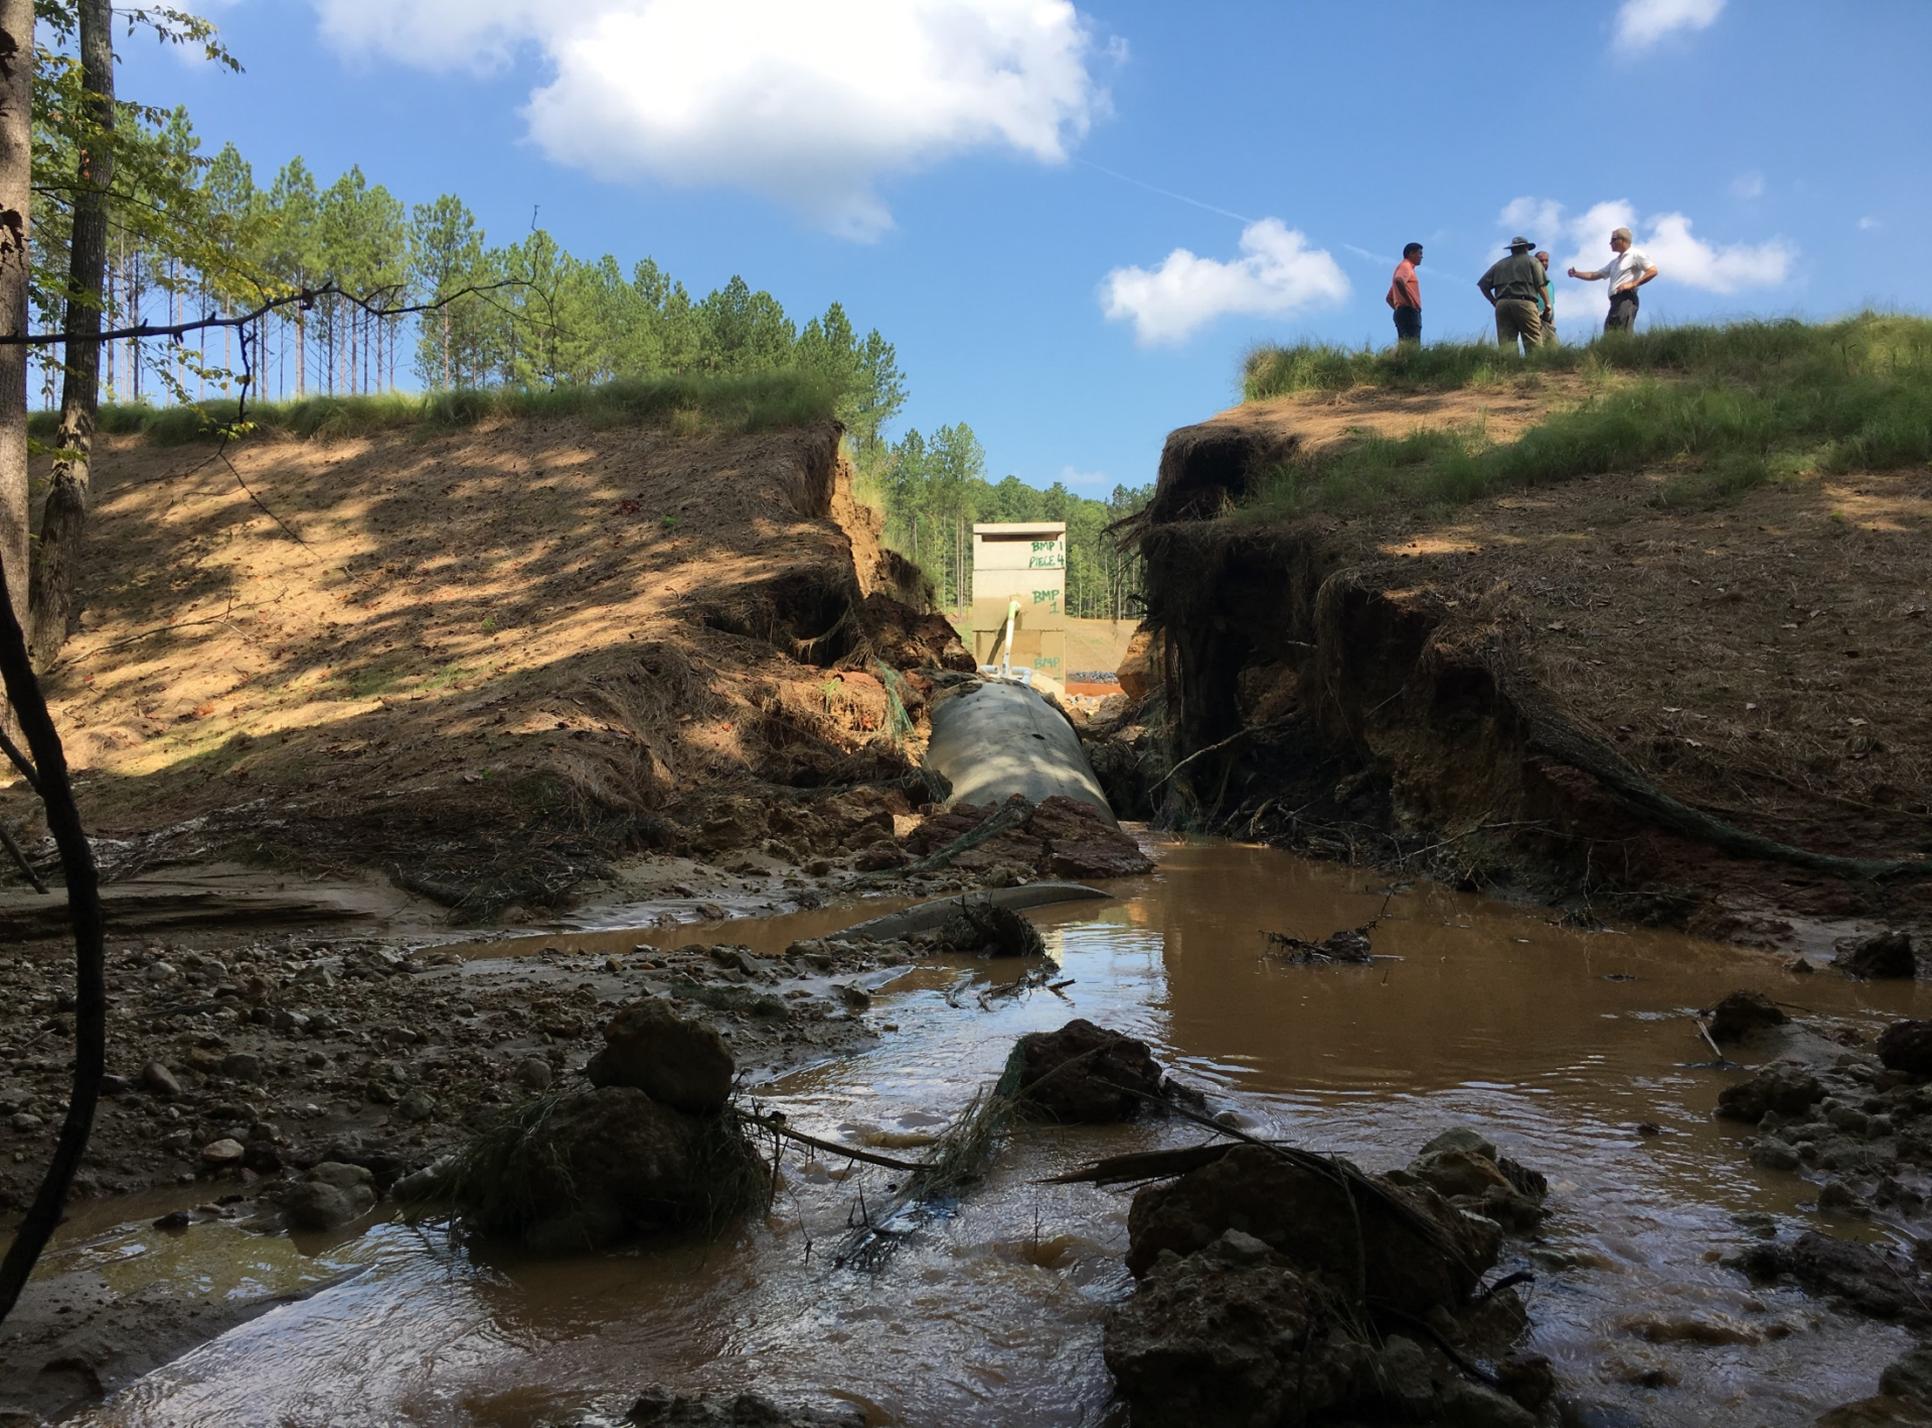
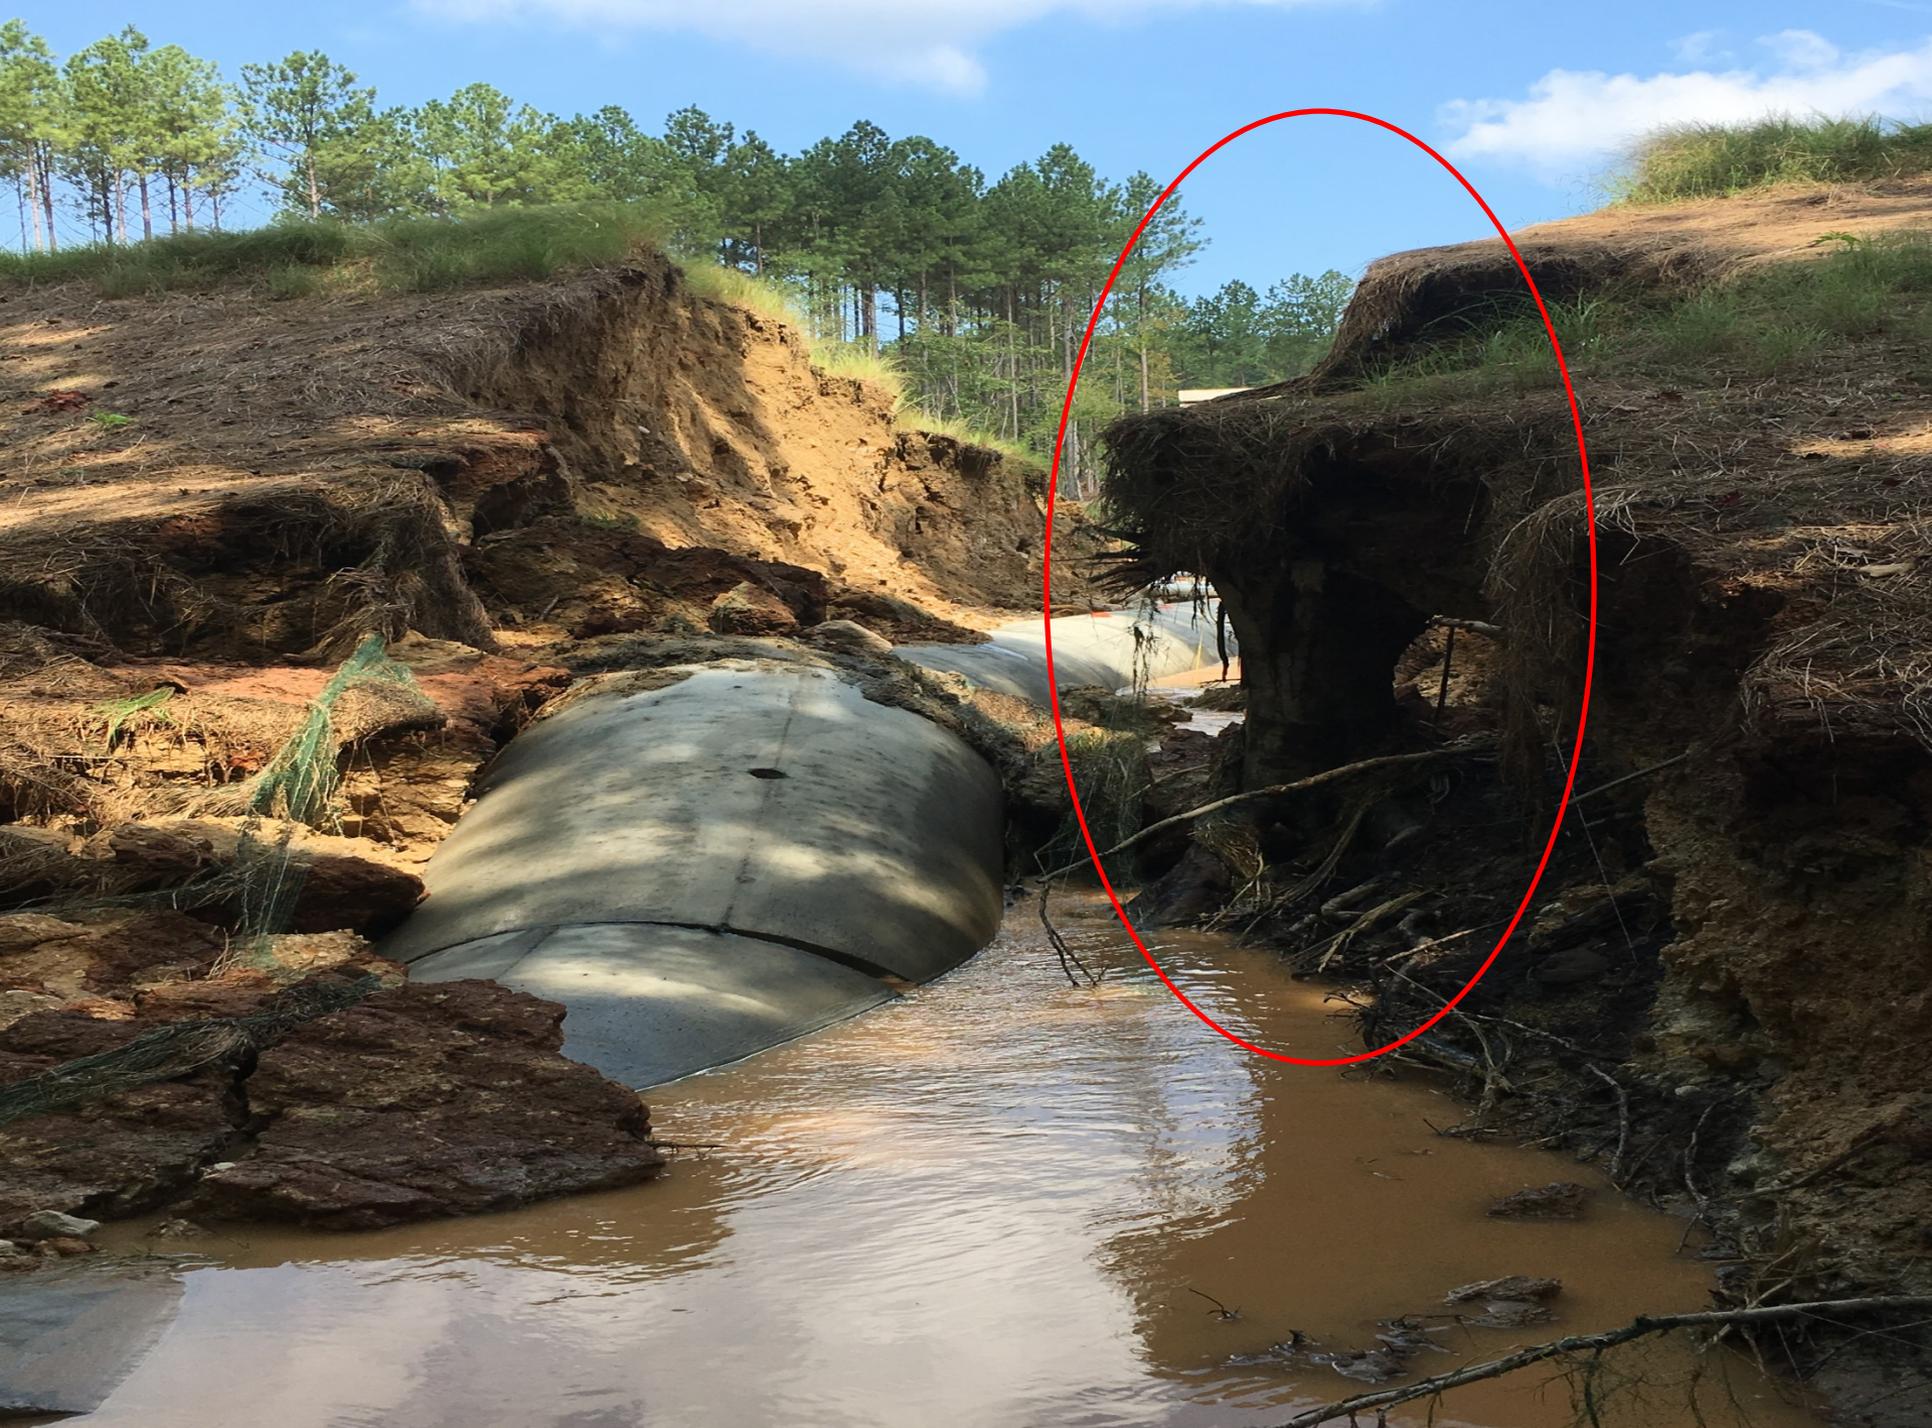
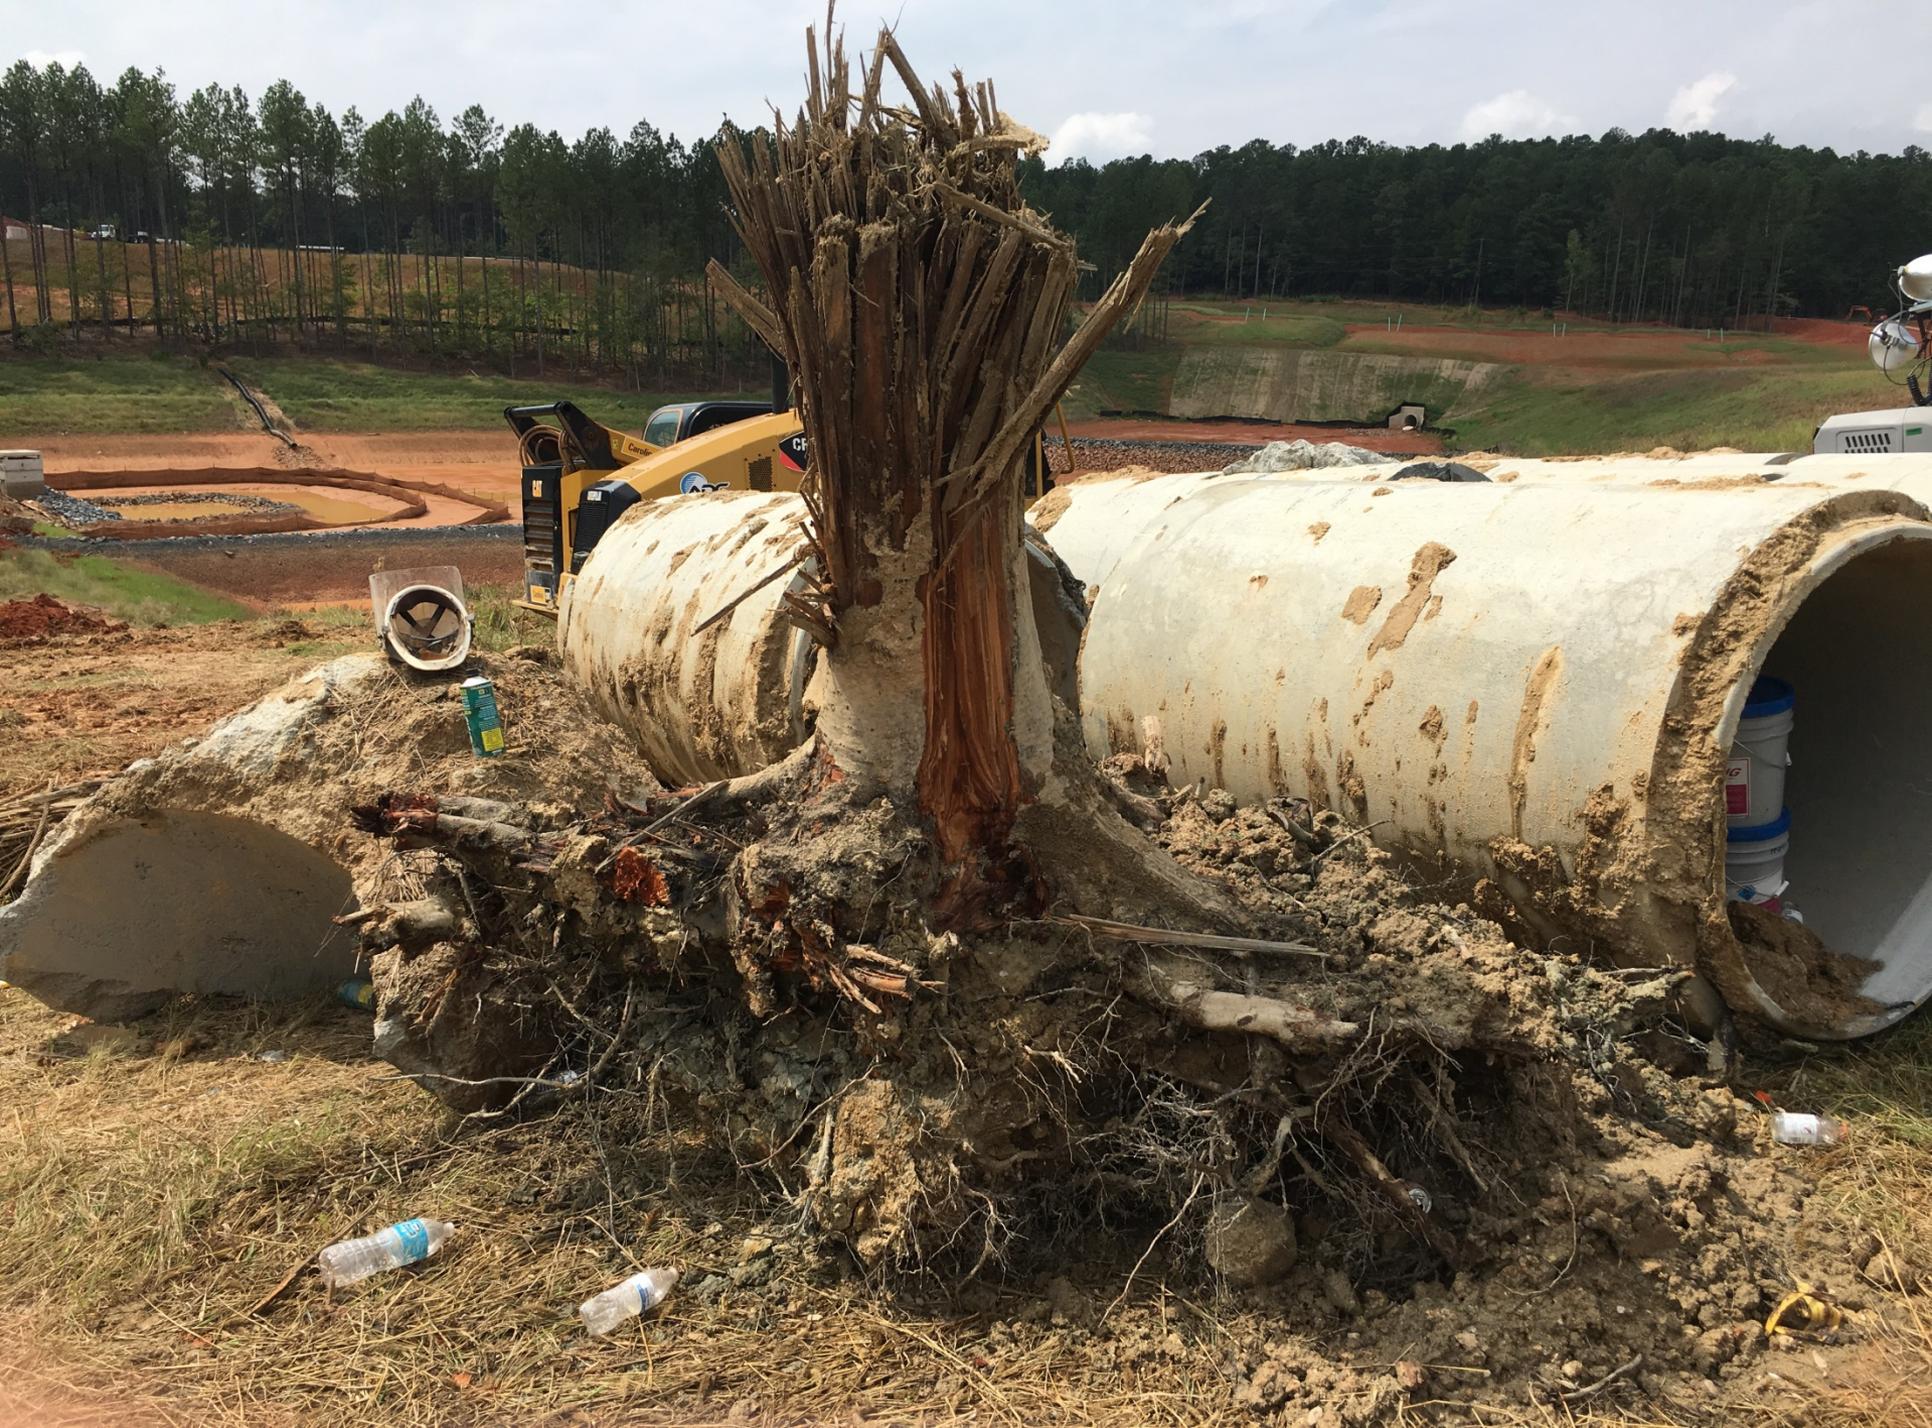
BMP 1  
PIECE 4

- Approximate 10' gap over barrel pipe at location of breach
- Pipe joints aligned but disrupted
- Grout seal between OCS riser and barrel pipe “rough”
- No visible external grout at pipe joints
- No anti-seep collar constructed
- Organic debris observed within embankment fill material
- Insufficient compaction
- Soil types not ideal (sandy Pacolet series)
