# BASIN FAILURE

## A Case Study on a Skimmer Basin Failure and Downstream Remediation

Jay Wilson, CPESC  
City of Charlotte

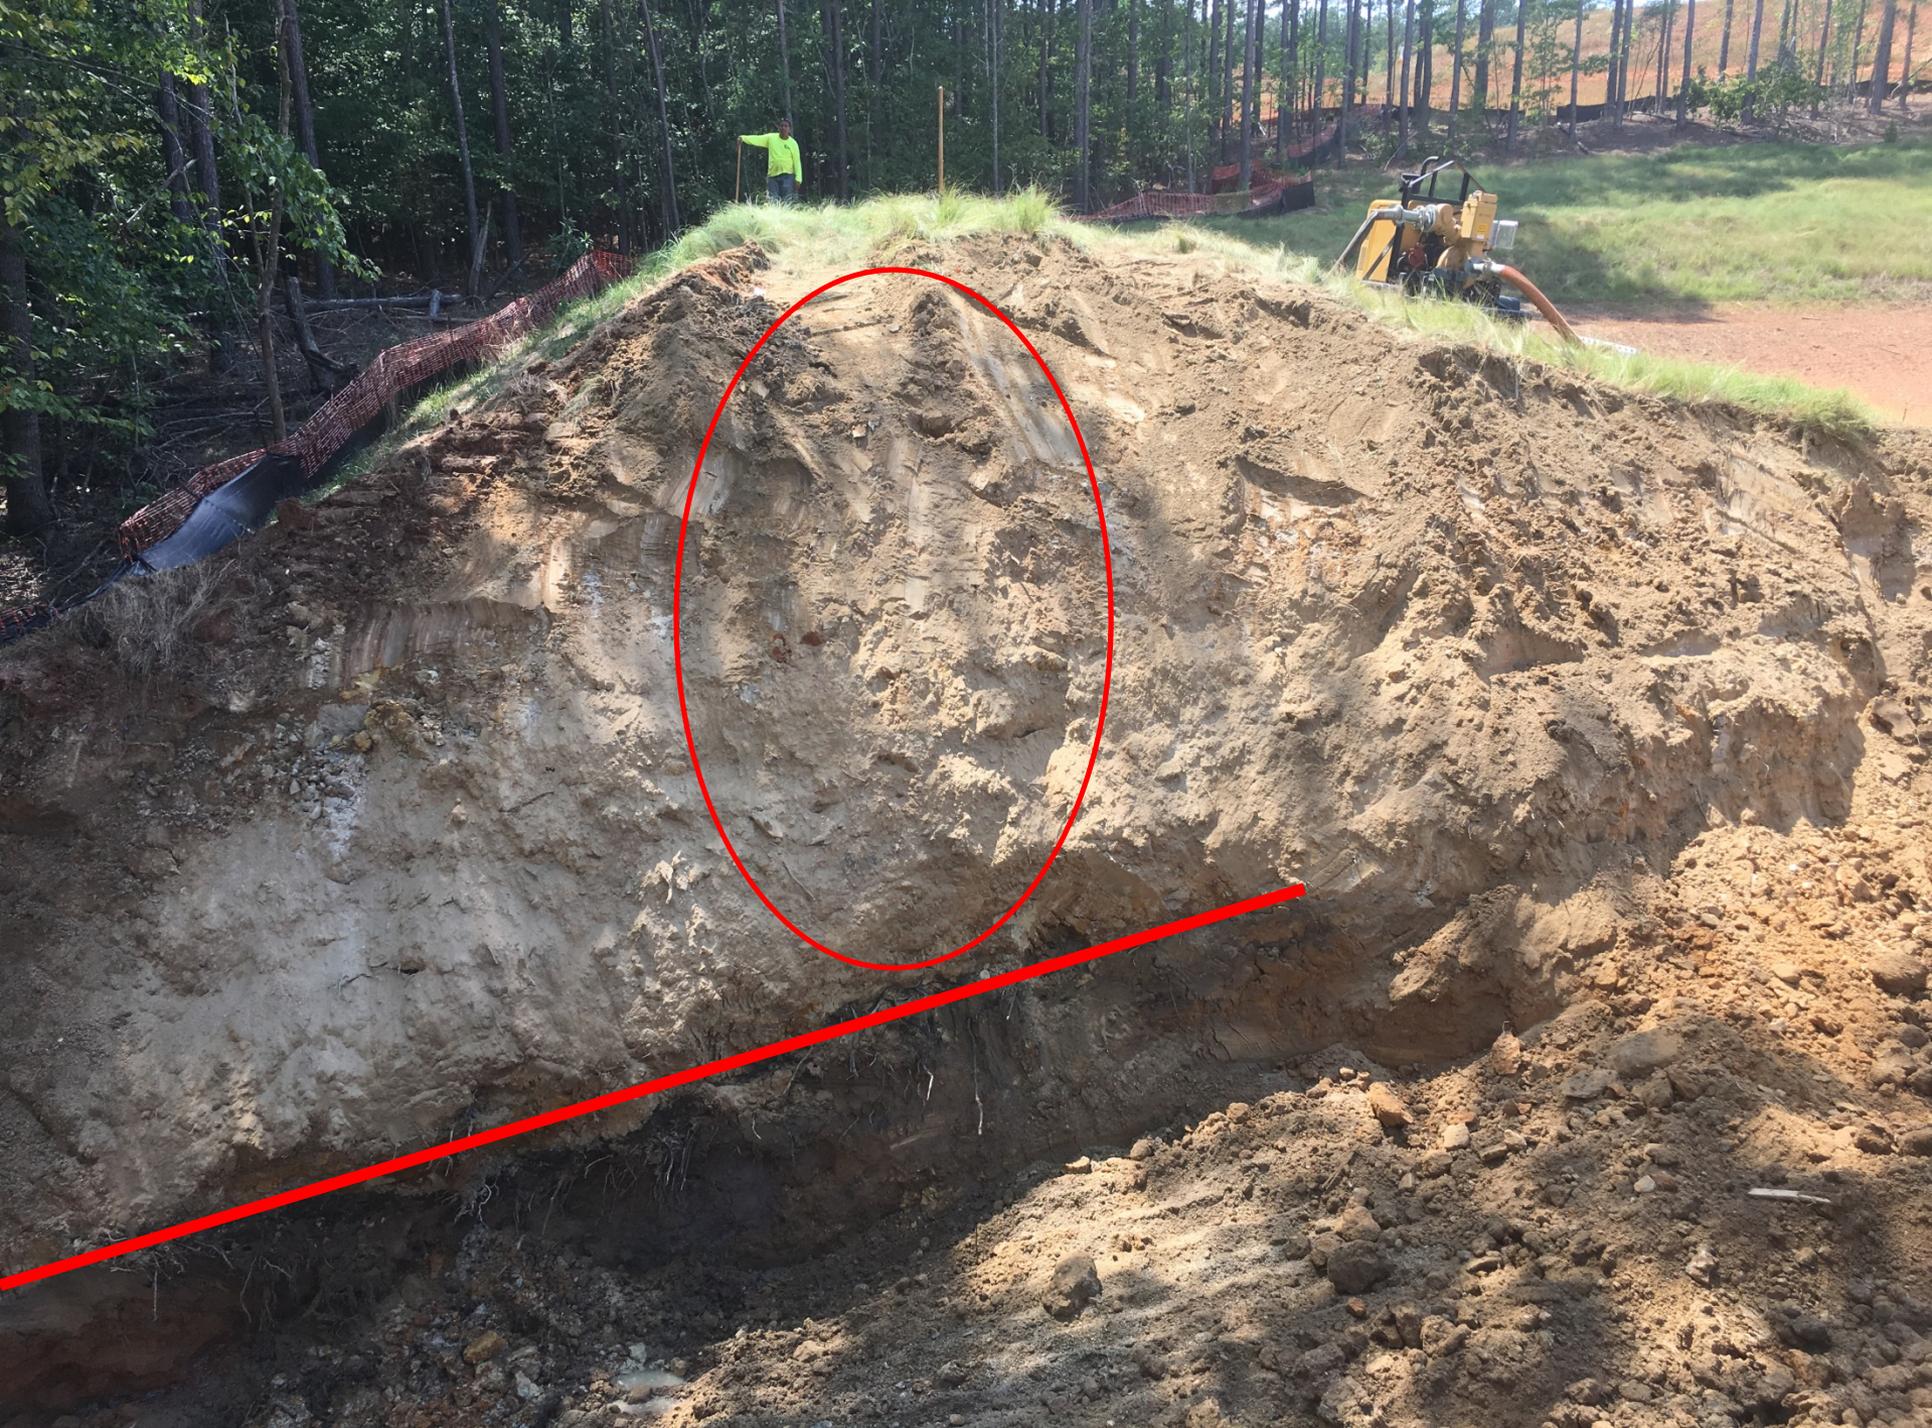
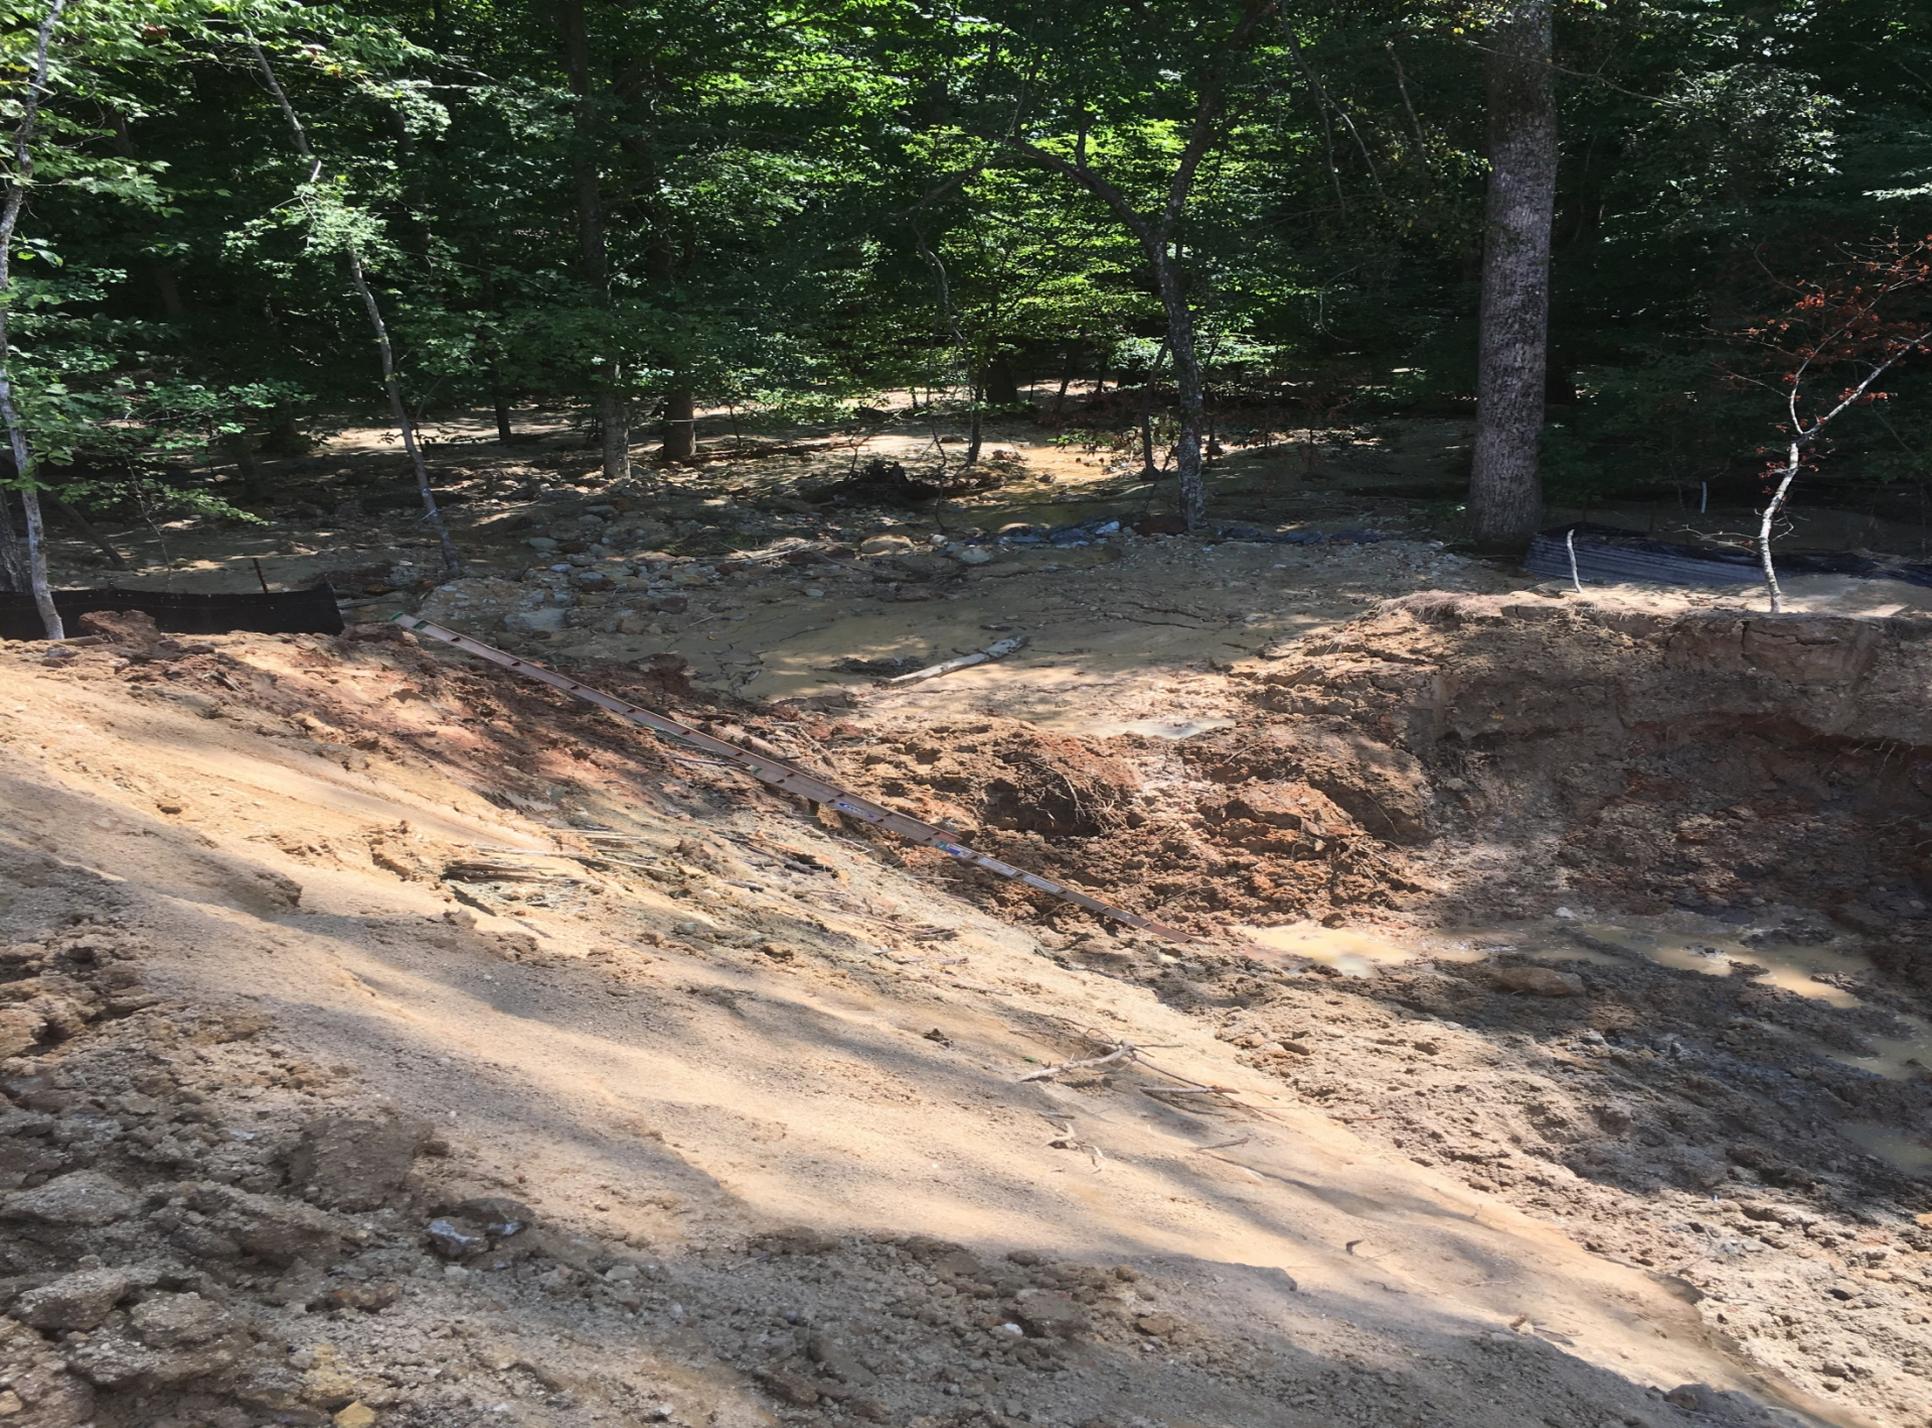
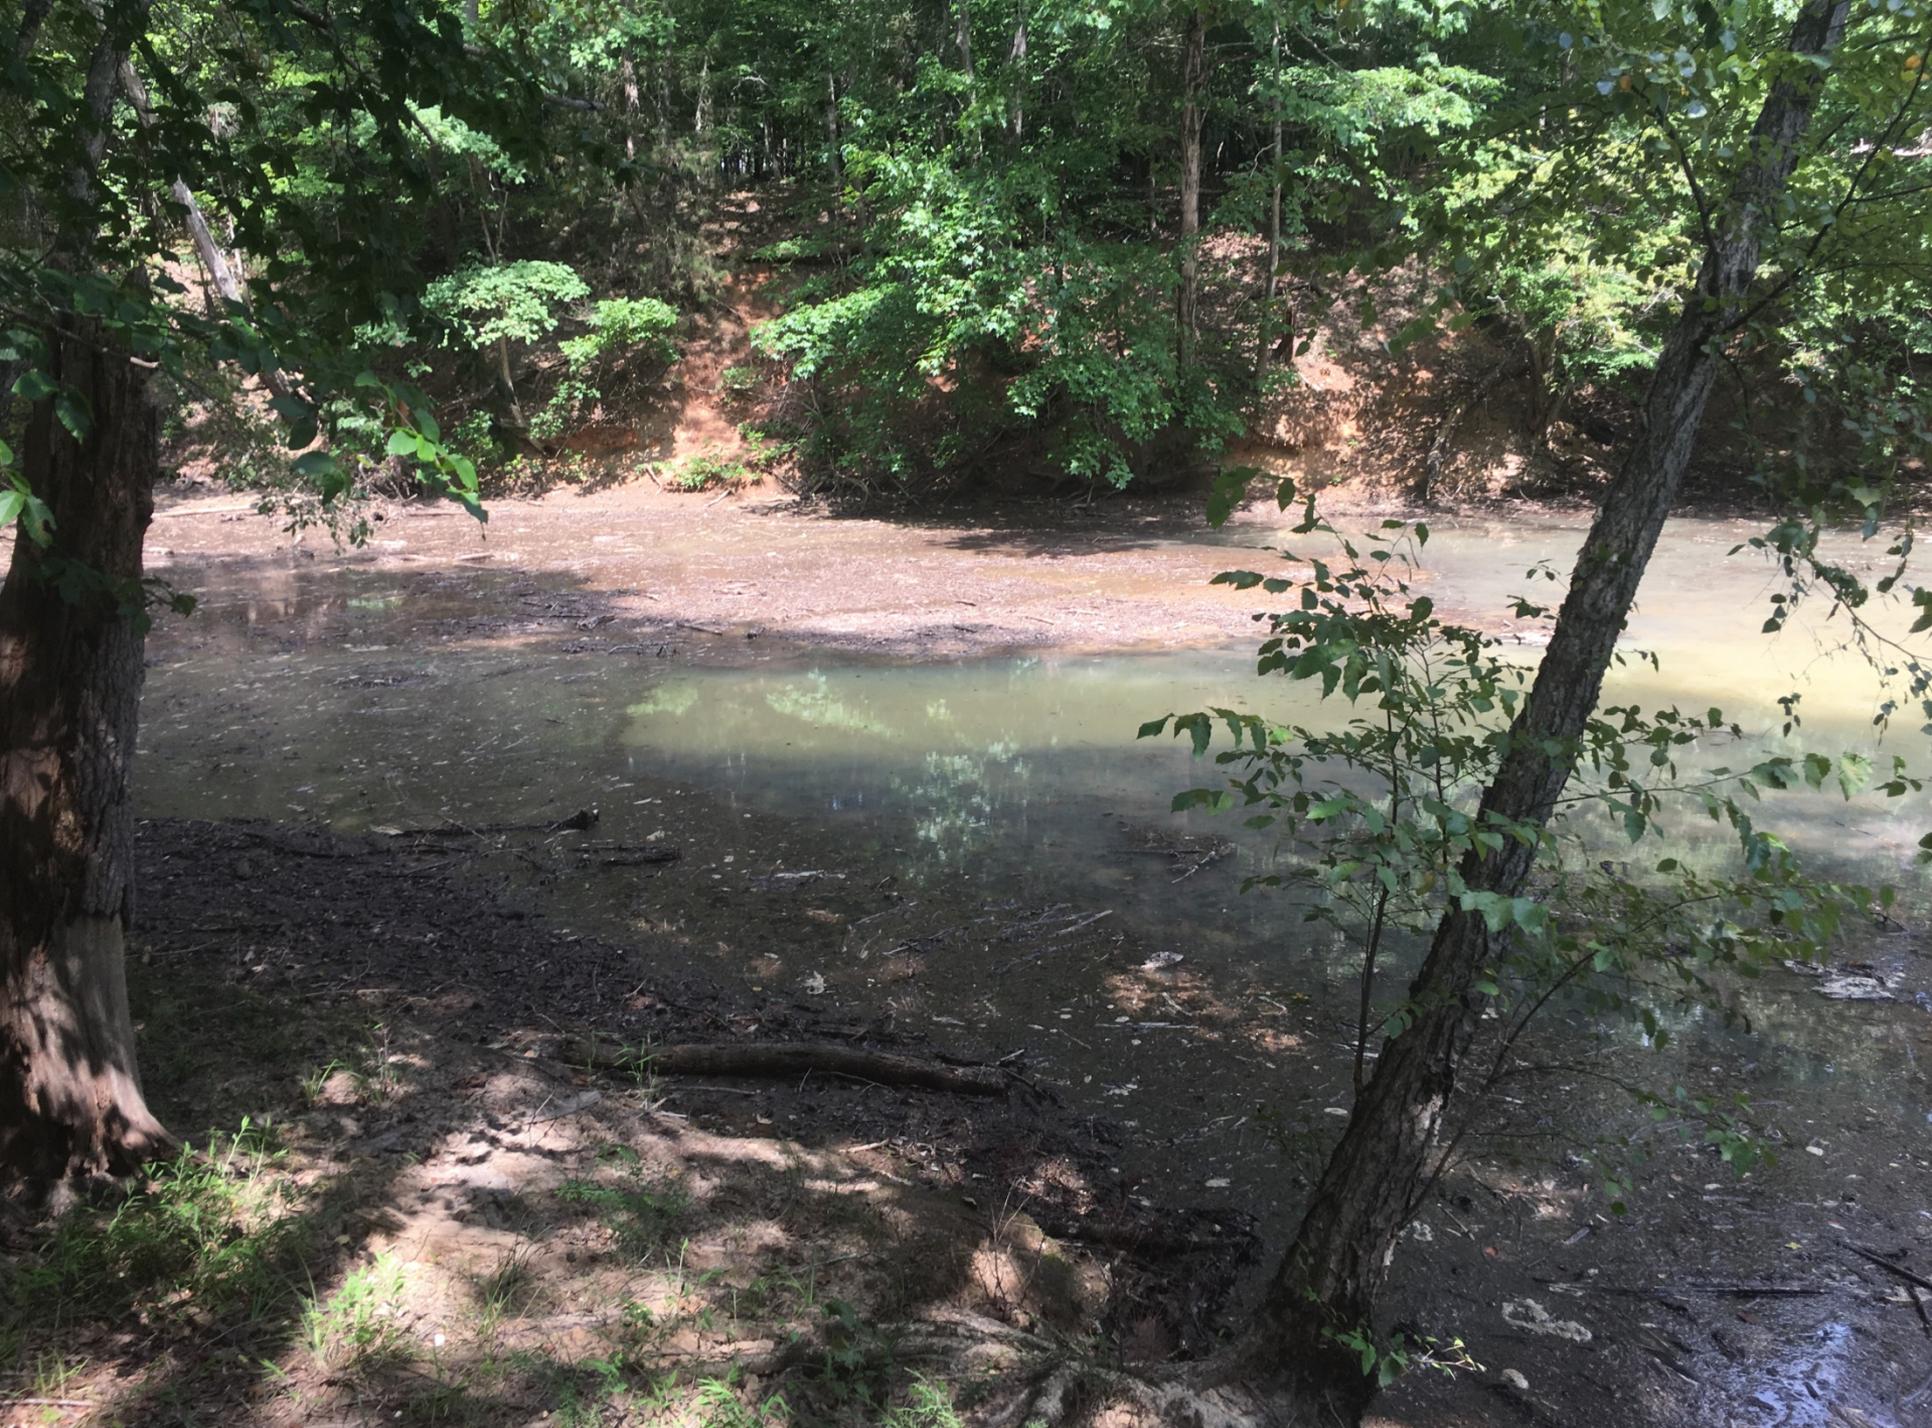
- Coordination between City of Charlotte, York County and Duke Energy Lake Management Officials
- Adjacent property owner disputed location of property line
- Would not allow anyone on their property to remove offsite sediment
