601 North II Stream Restoration Site

Annual Monitoring Report
NCDMS Project Number: 95025
Monitoring Contract Number: 003991
Monitoring Year 5 2017

**601 North II
Stream Restoration Site
2017 Monitoring Report (MY5)**

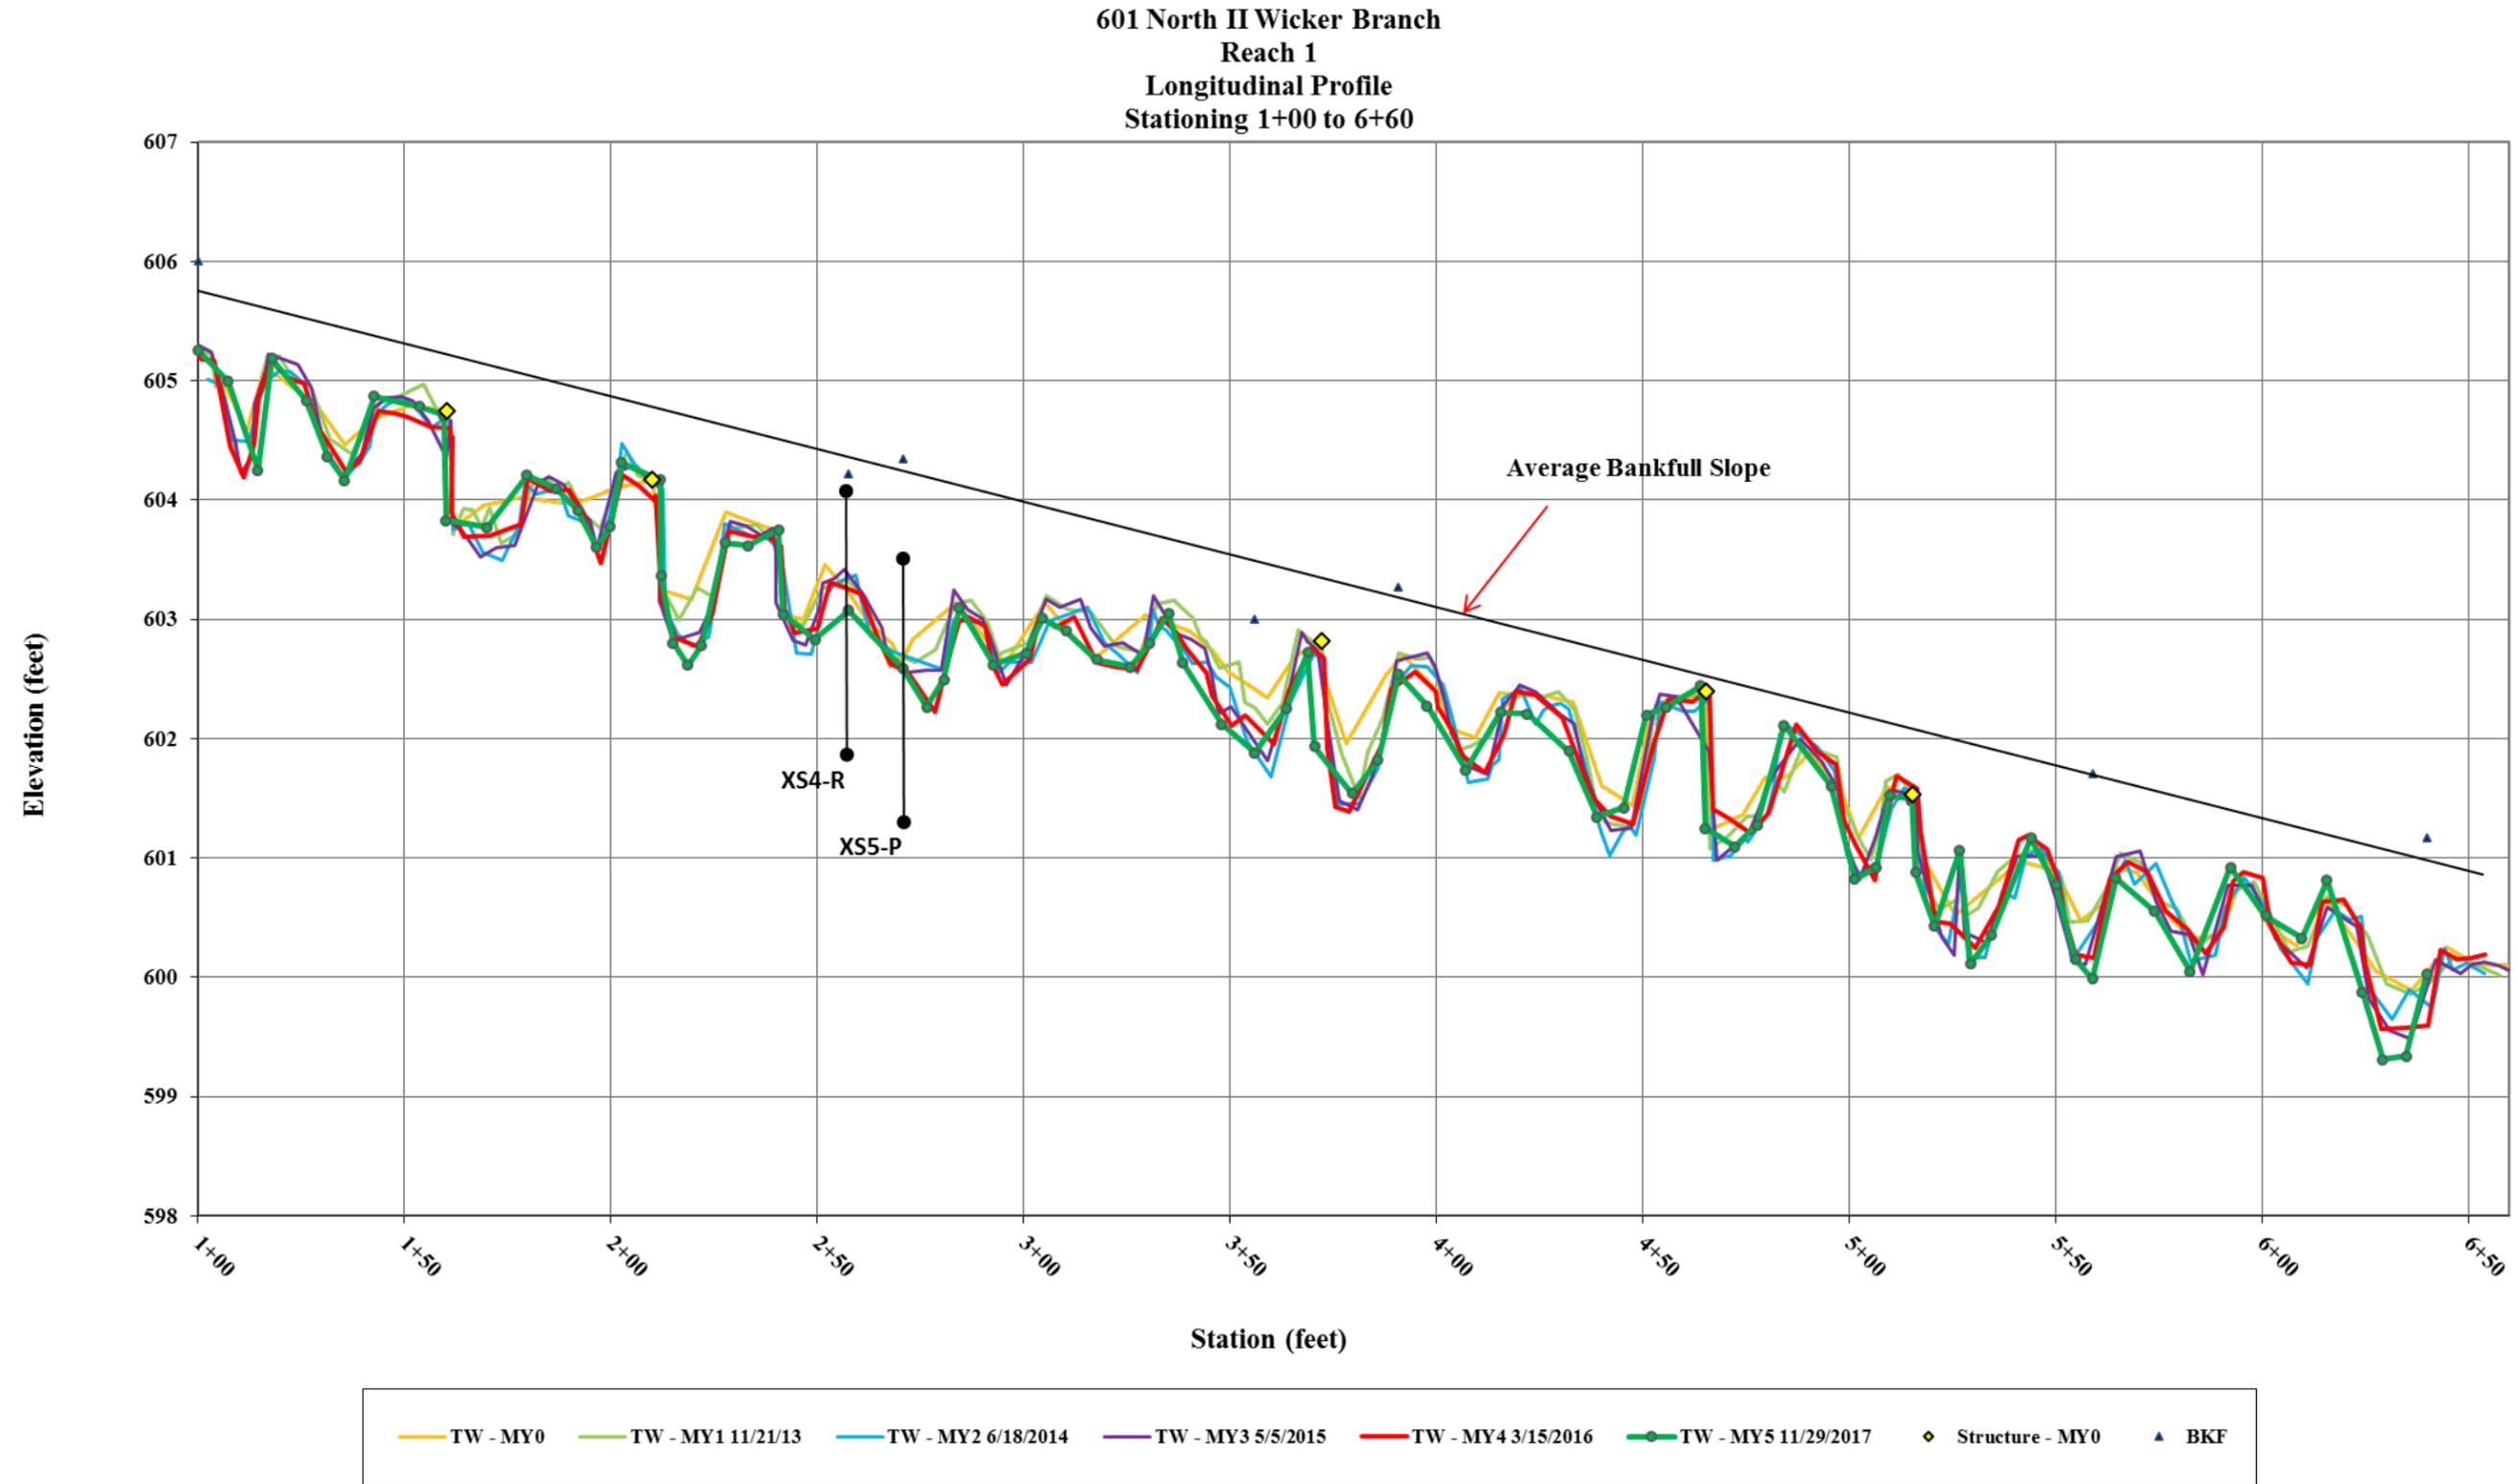
Figure 6. Longitudinal Profile with Annual Overlays

A field visit was conducted in the end of November 2017 to collect stream morphological data. Stream longitudinal profiles, in general, have remained stable from MY4 to MY5 (**Figure 6 and Table 11b**). MY5 cross-section data also showed little change between MY4 and MY5 (**Figure 5 and Table 11a**). BHR for MY5 riffle cross sections has been calculated using the bankfull elevation from baseline. This method was used because the dimension of the channels has not changed enough to alter the bankfull elevation. Pebble counts were conducted at all 10 cross-sections and continue to display removal of fine sediment in the channel, resulting in a larger, more coarse stream bed substrate (**Table 12; Figure 7**).
