**Paschal Golf Course (Richland Creek)  
Stream Restoration Site  
Final Baseline Monitoring Report Addendum  
Project # 276  
SCO# 02-05911-02A  
Wake County, North Carolina**

**Submitted: May 2016**

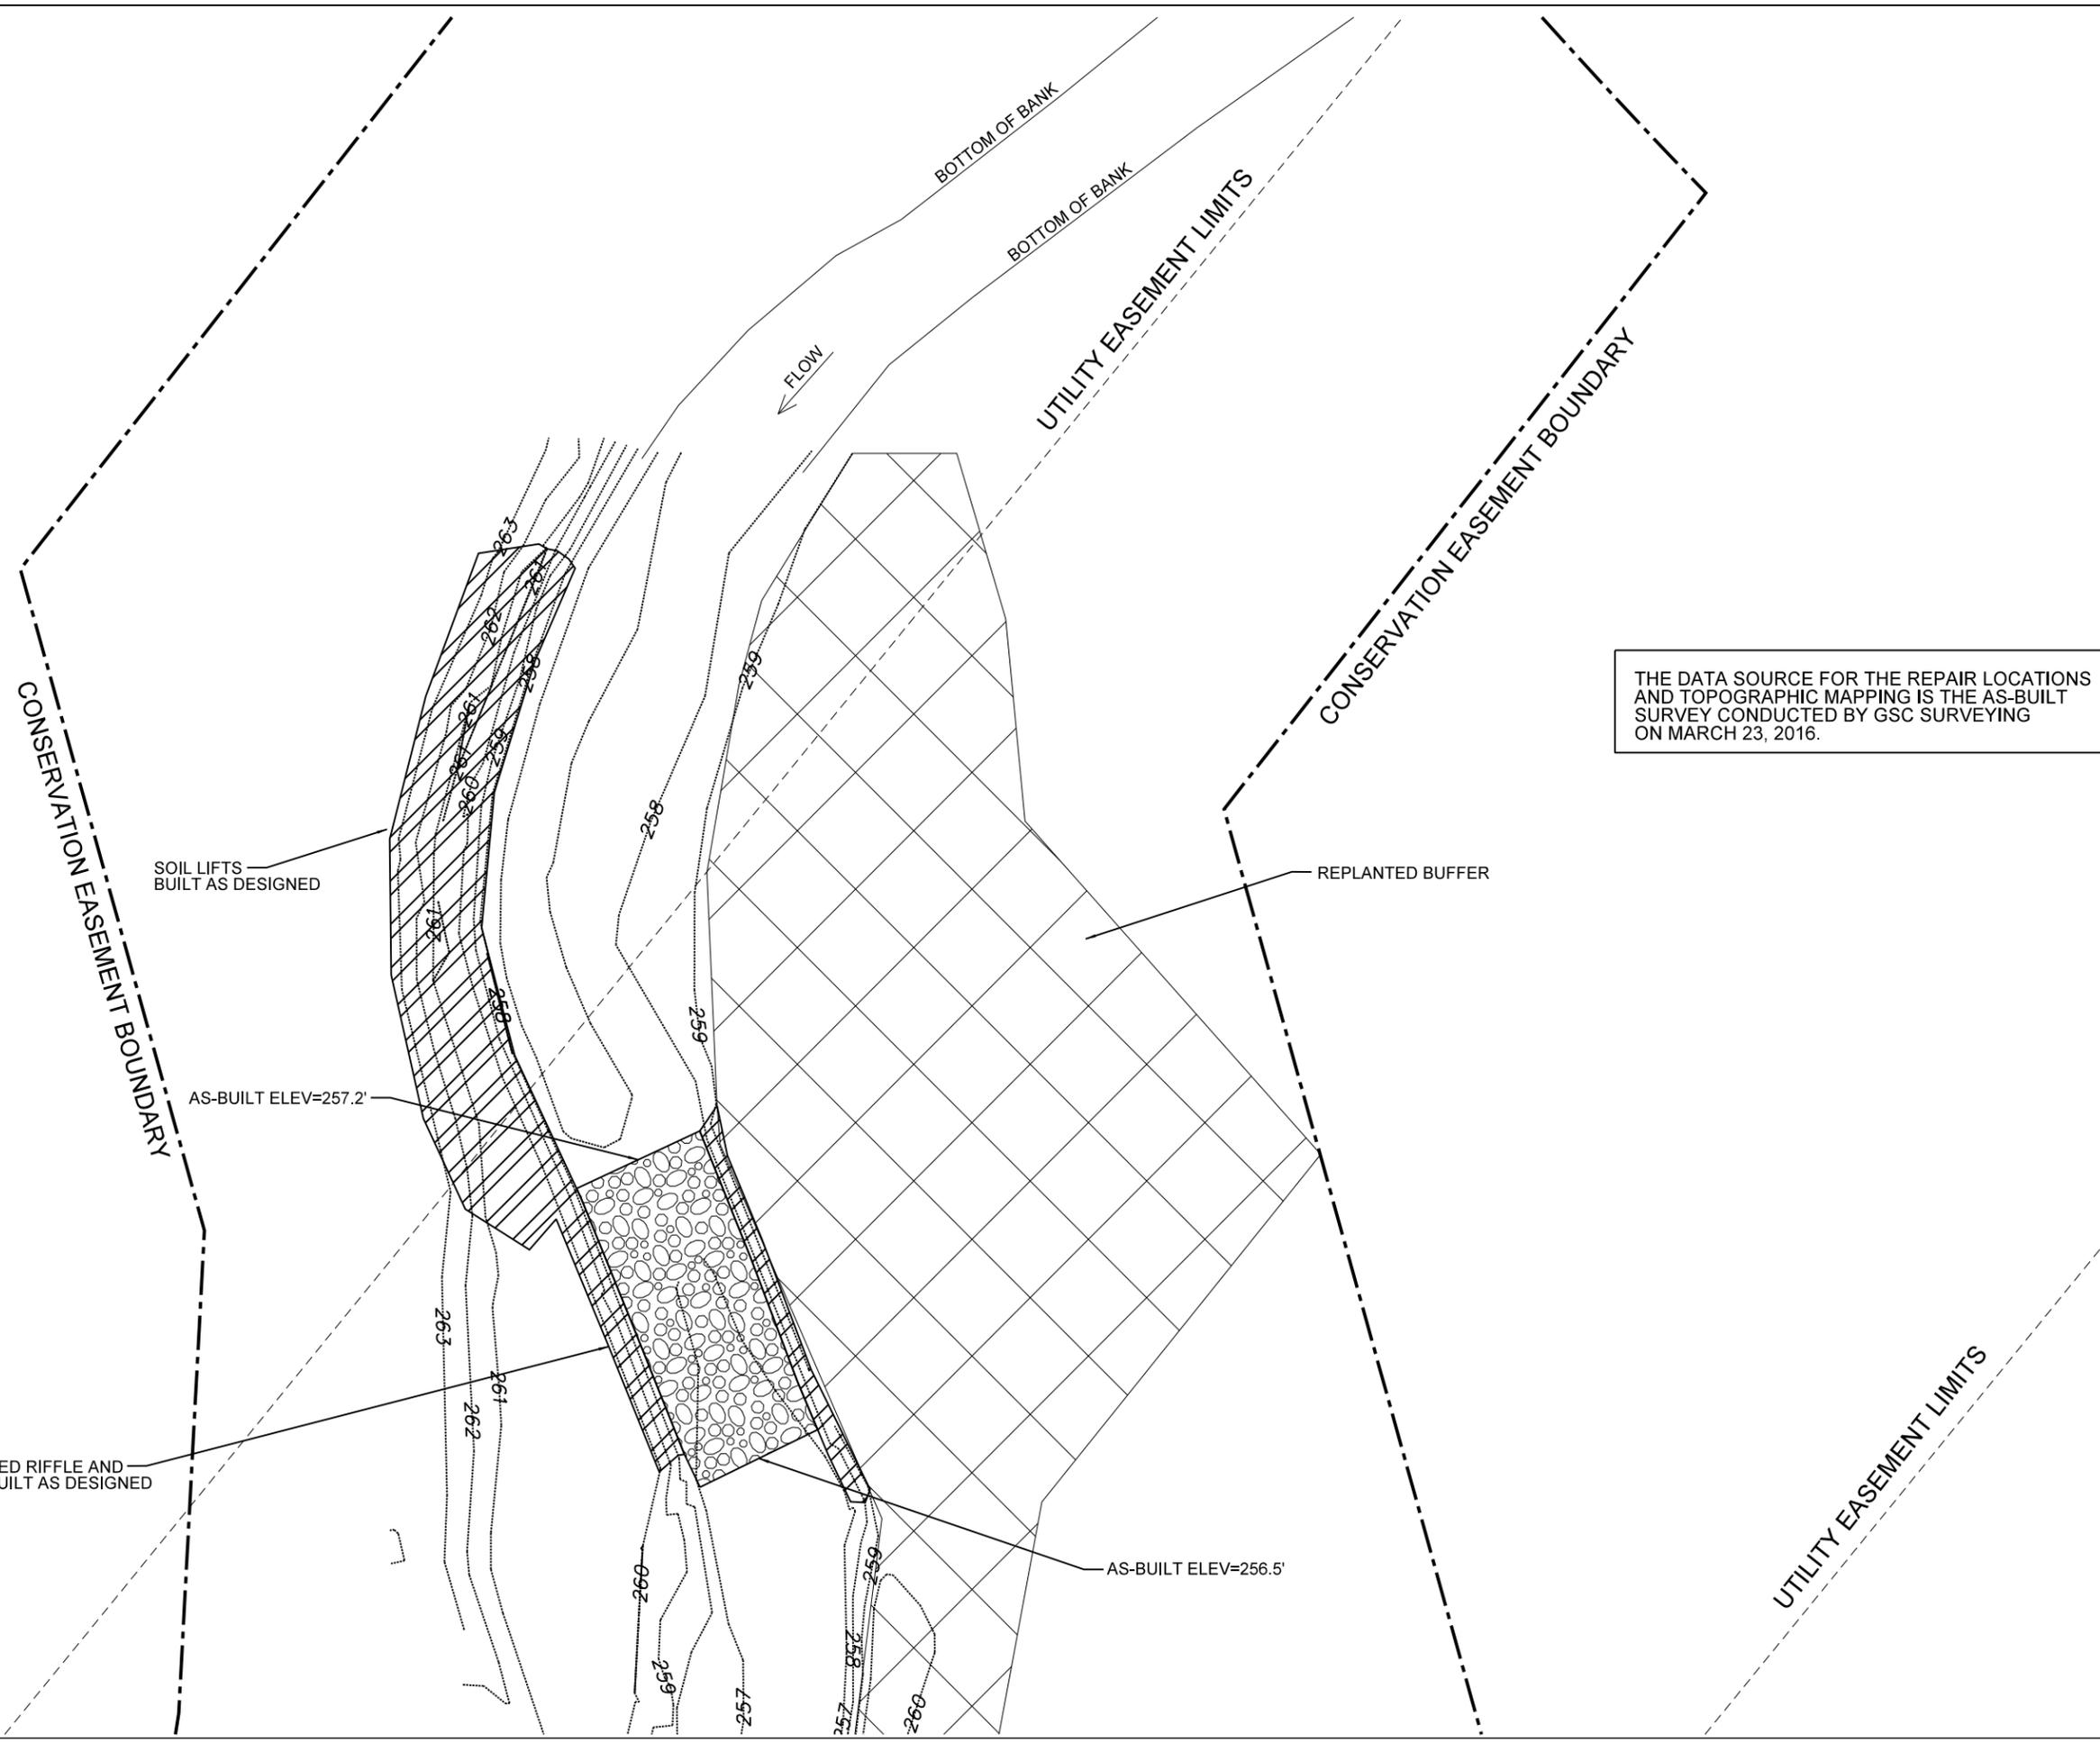
DATE: MAY 2016  
SCALE: GRAPHIC  
**RECORD DRAWINGS AREA 1**  
SHEET 2 OF 4

Area 1 consisted of an actively eroding outer bank. The bank had eroded through the bench and was eroding the terrace. Additionally, a mid-channel bar had formed in this location, which split the flow and caused additional erosion along the right bank of the downstream riffle. This was fixed by building vegetated soil lifts on a stone foundation along the outer bank, grading the inner bank back, and developing a new pool. The bank was built out towards the channel, but not as far as the original bank. This structure was tied to a downstream constructed riffle with adjacent soil lifts.

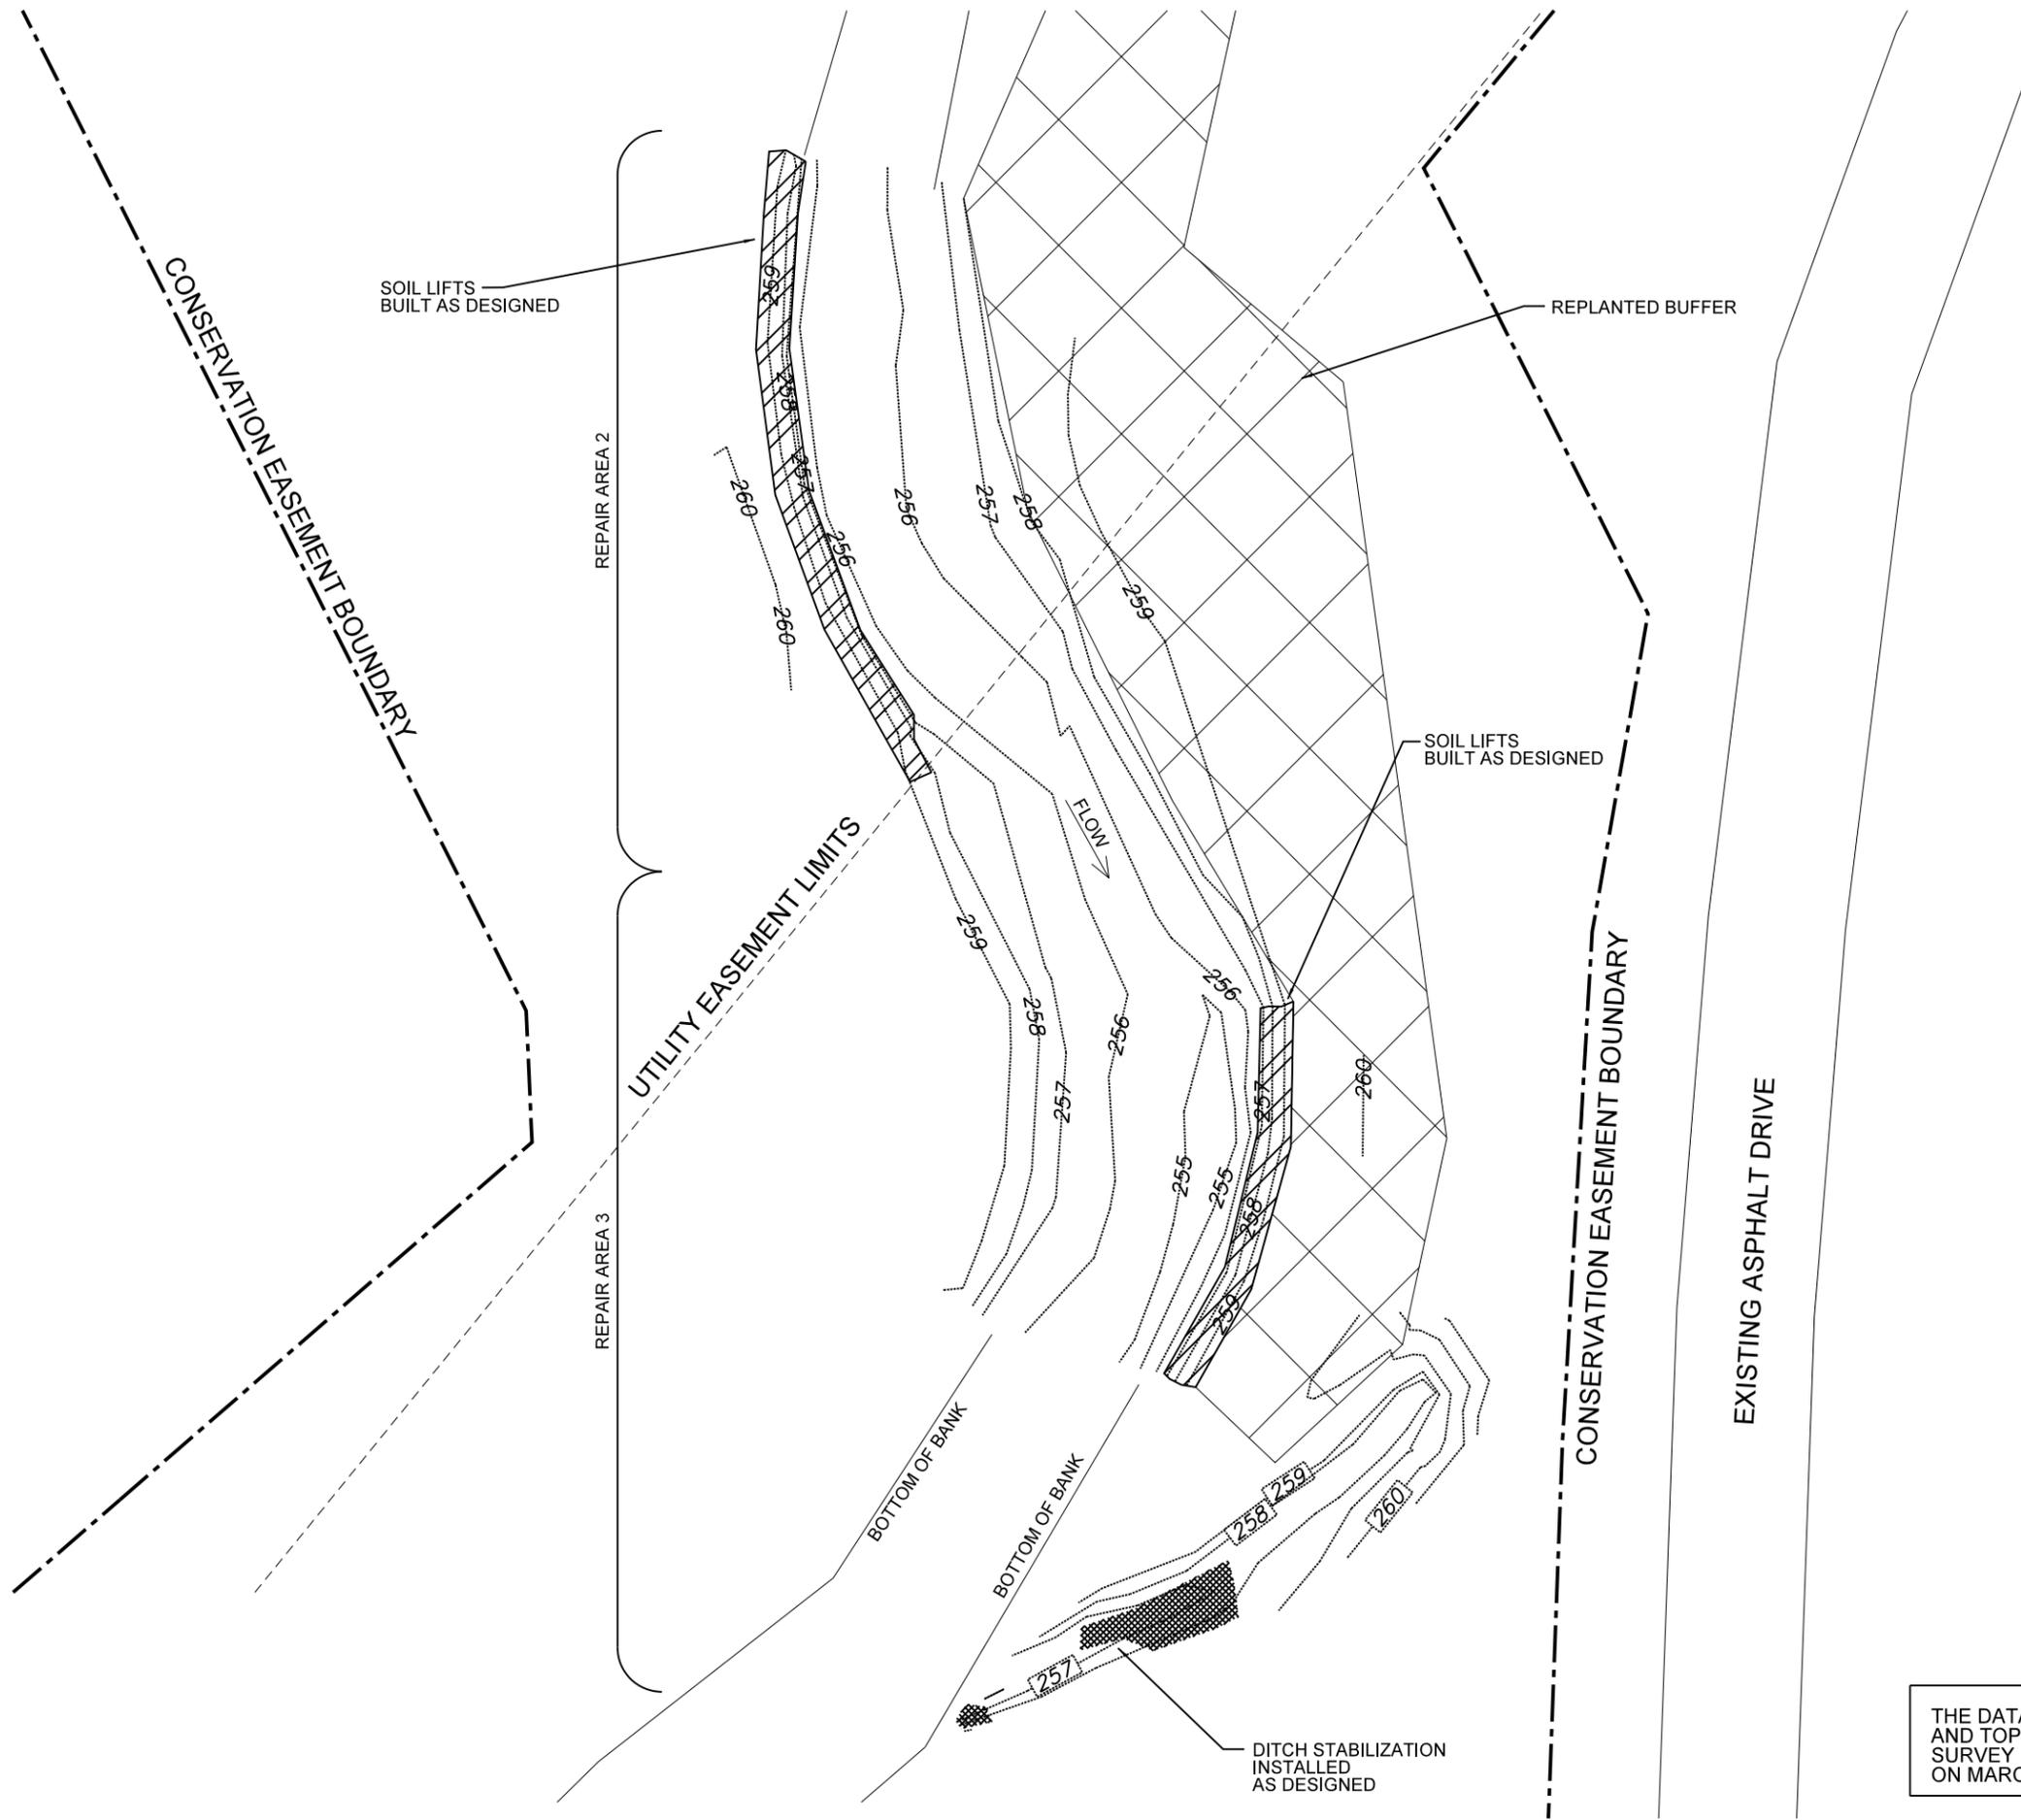
Area 2 also focused on an eroding outer bank. Unlike Repair Area 1, the erosion had not cut back to the terrace and there were no problems with deposition in this area. A vegetated soil lift with a stone foundation was installed in this location.

Area 3 consisted of an eroding outer bank, similar to Repair Area 2. The erosion stopped at a boulder single vane structure. Similar to the other repairs a vegetated soil lift with a stone foundation was installed in this location. The stones in the vane structure were removed up to where the vane tied into the bank, which was incorporated into the foundation for the lifts.

Additionally, Repair Area 3 has a side drain that comes from a small stormwater culvert just downstream of the bank to be repaired. This drain, which alternates between filling with sand and then washing back out, was stabilized with riprap at the confluence with the channel.

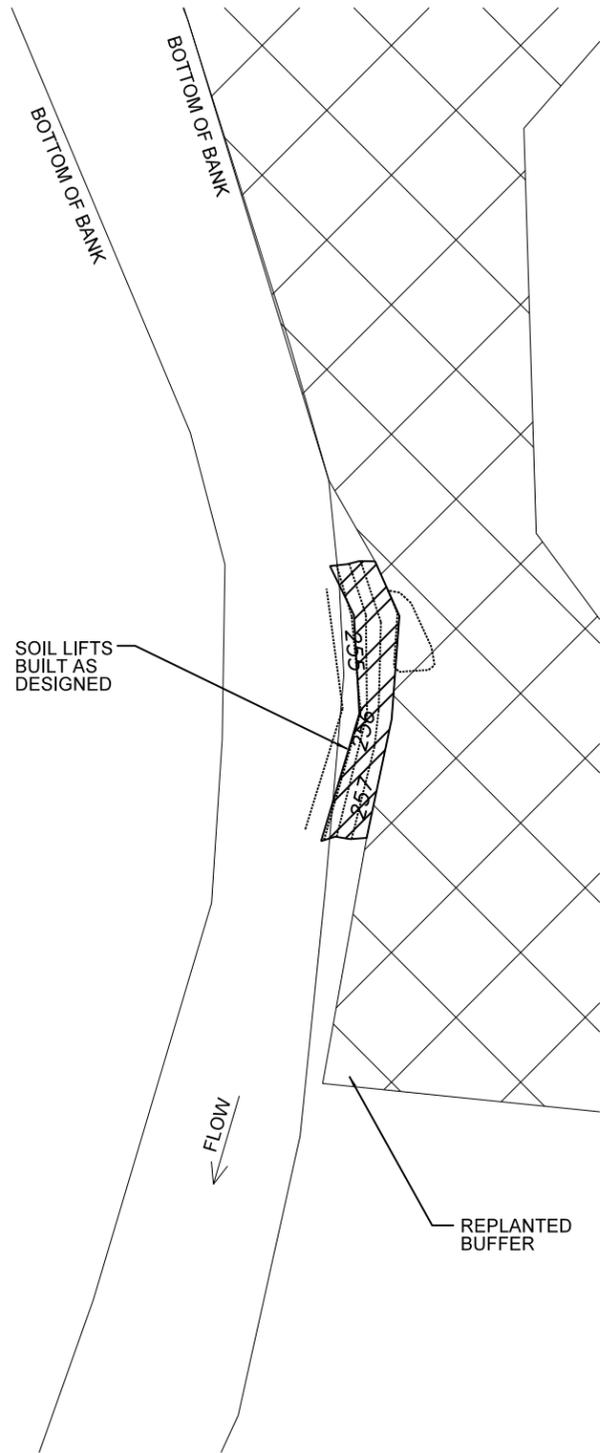
### REPAIR AREA #4

The most minor repair area was Repair Area 4, which consisted of an actively eroding outer bank. Similar to Repair Area 3, there is a boulder structure at the downstream end of the erosion that halted any further erosion. This structure has a better angle and was left in place. A vegetated soil lift with a stone foundation was installed in this location.

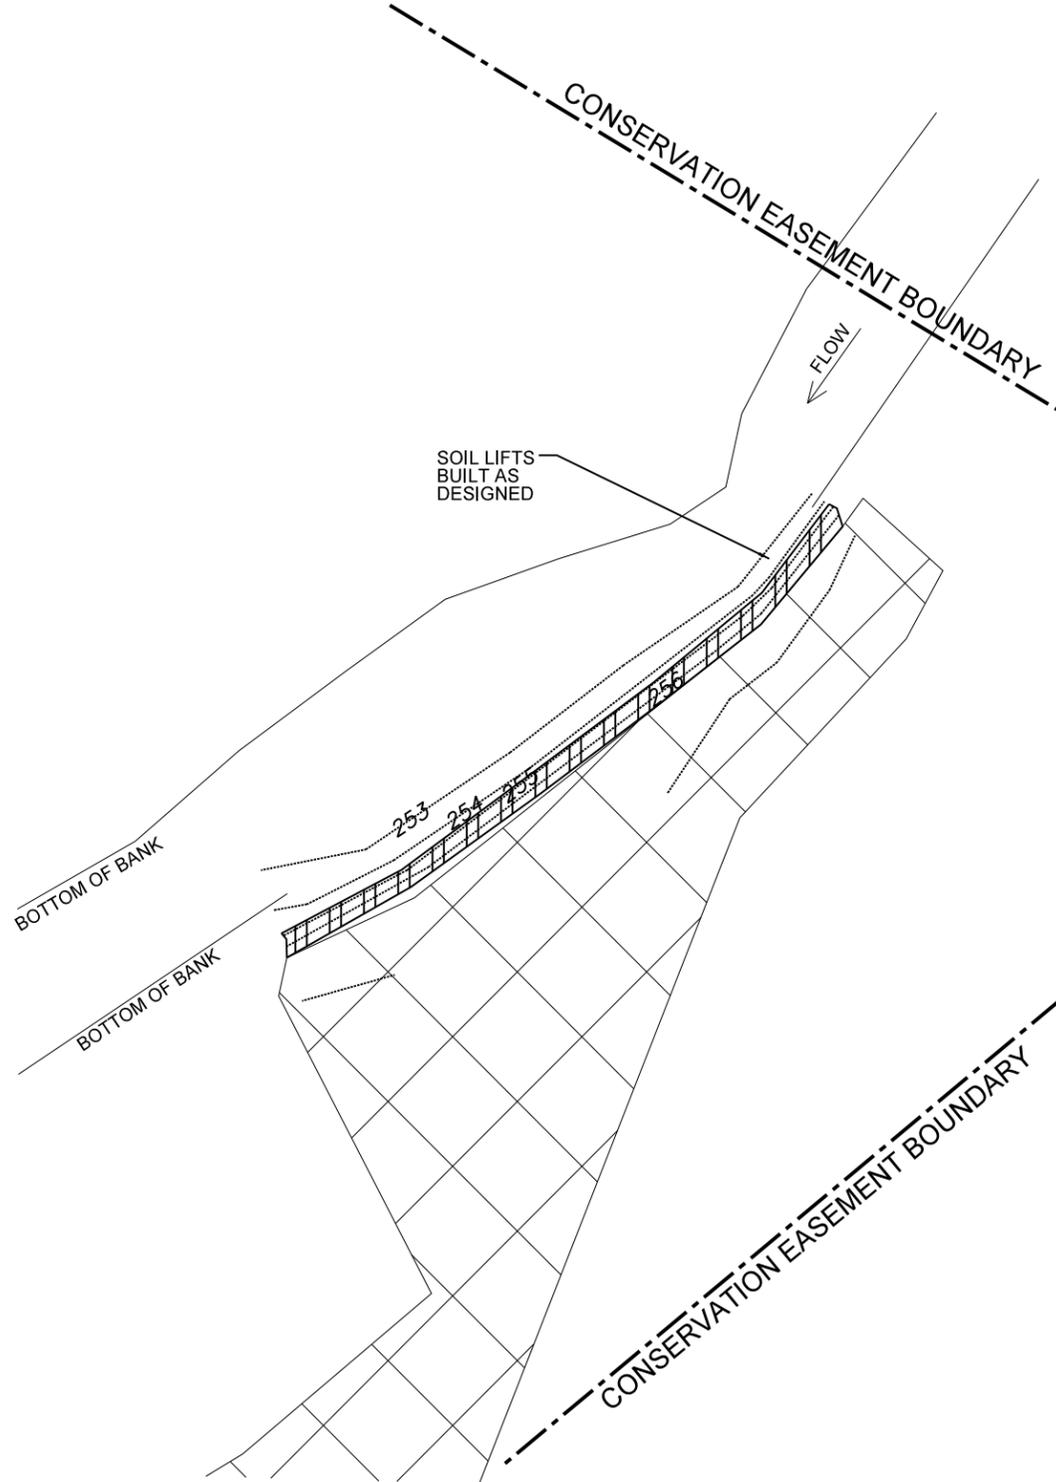
### REPAIR AREA #5

Area 5 consisted of an actively eroding outer bank downstream of the golf cart bridge. A 4" PVC drain pipe had been exposed and was hanging from this bank. A non-functioning single boulder vane was also located in the middle of this bank. A vegetated soil lift with a stone foundation was installed in this location. The PVC pipe is connected to an active drain line and was incorporated into the soil lifts. The vane arm was removed and the boulders were reused in the foundation.

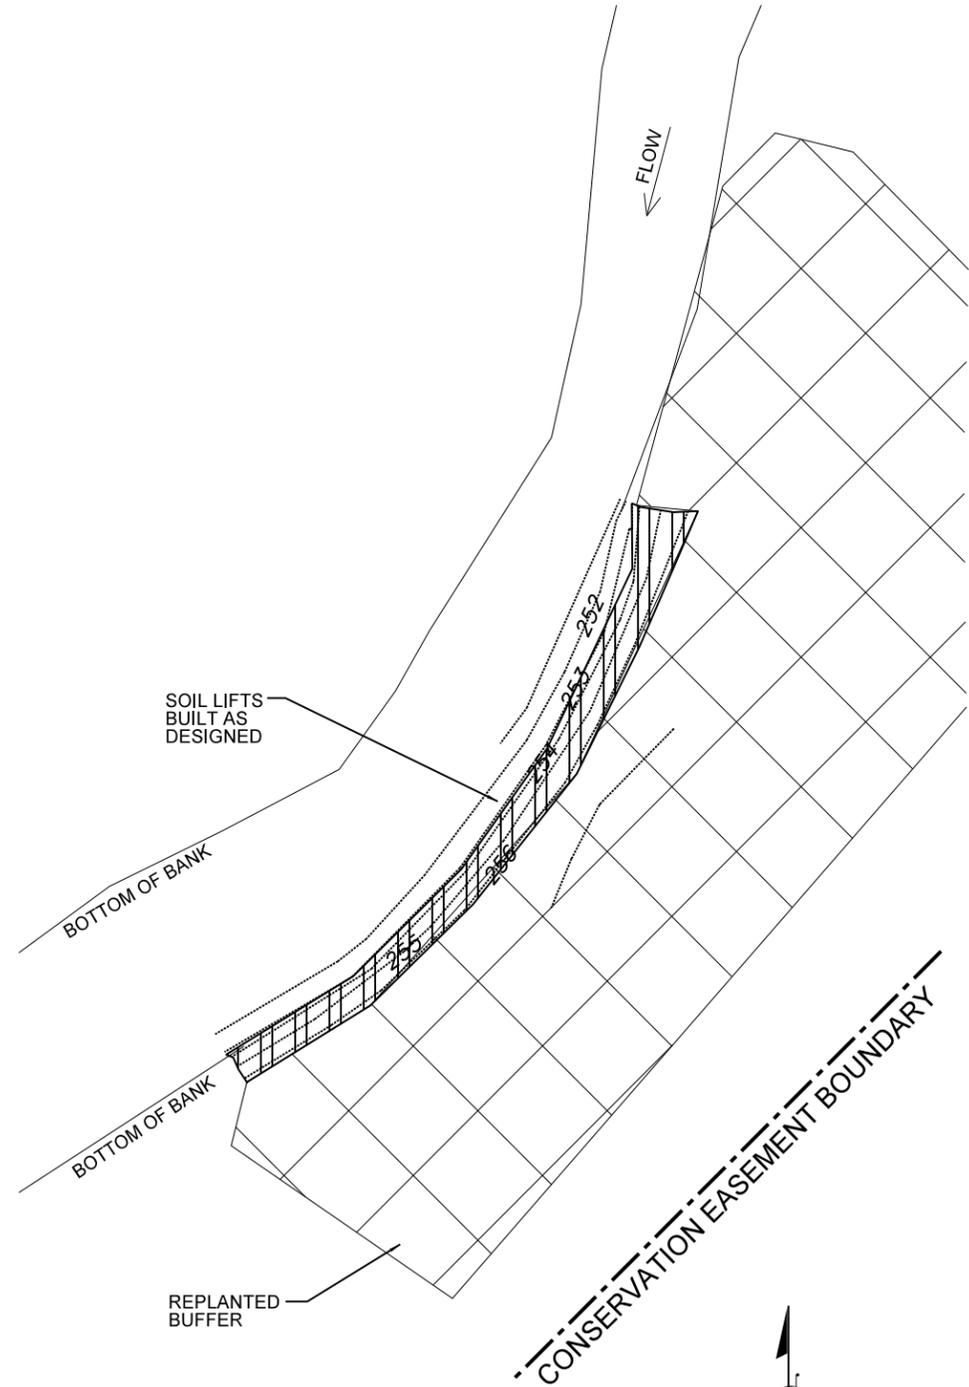
### REPAIR AREA #6

Area 6 was in the same state as Repair Area 3, with an eroding outer bank and non-functioning boulder vane. The repair approach was the same.
