**As-built report for the Bare Mitigation Site,
Unnamed Tributary to Peak Creek, Ashe County**

North Carolina Wildlife Resources Commission
Habitat Conservation Program

Joe Mickey and Staci Scott
Stream Mitigation Program

February 2002

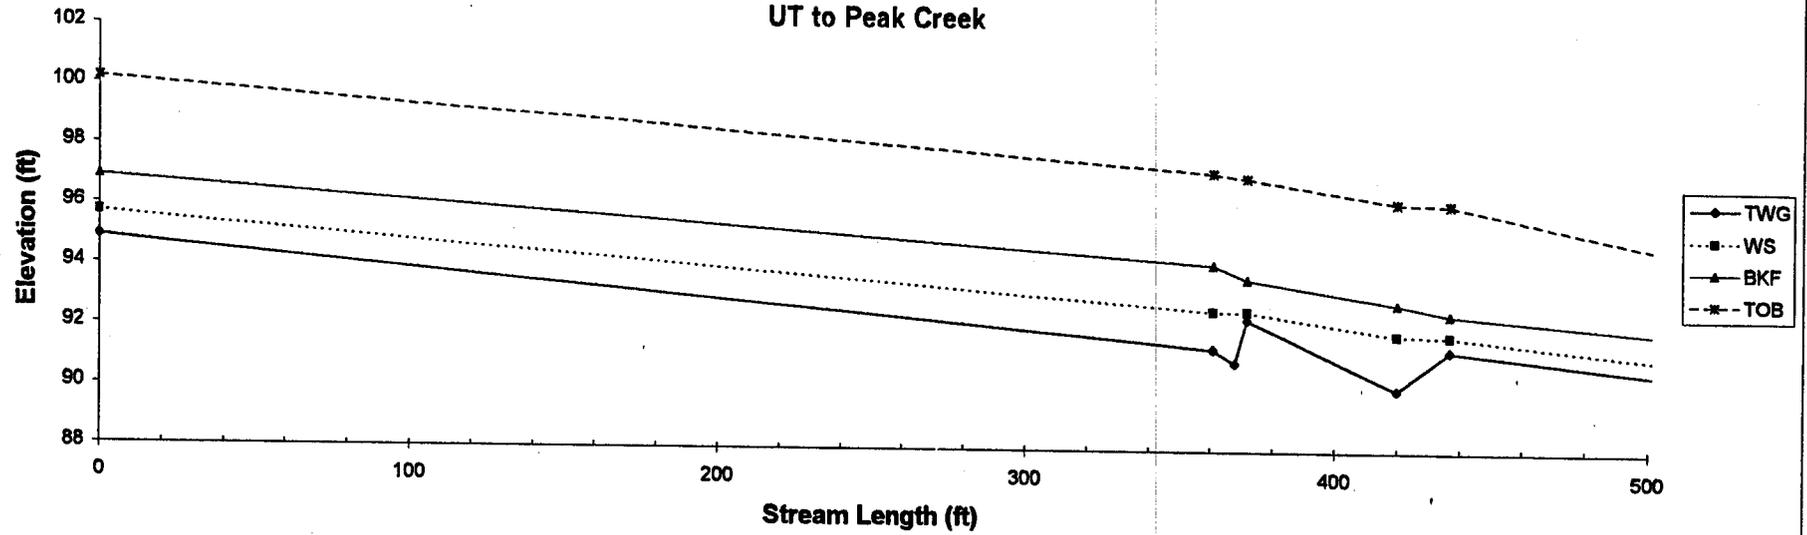
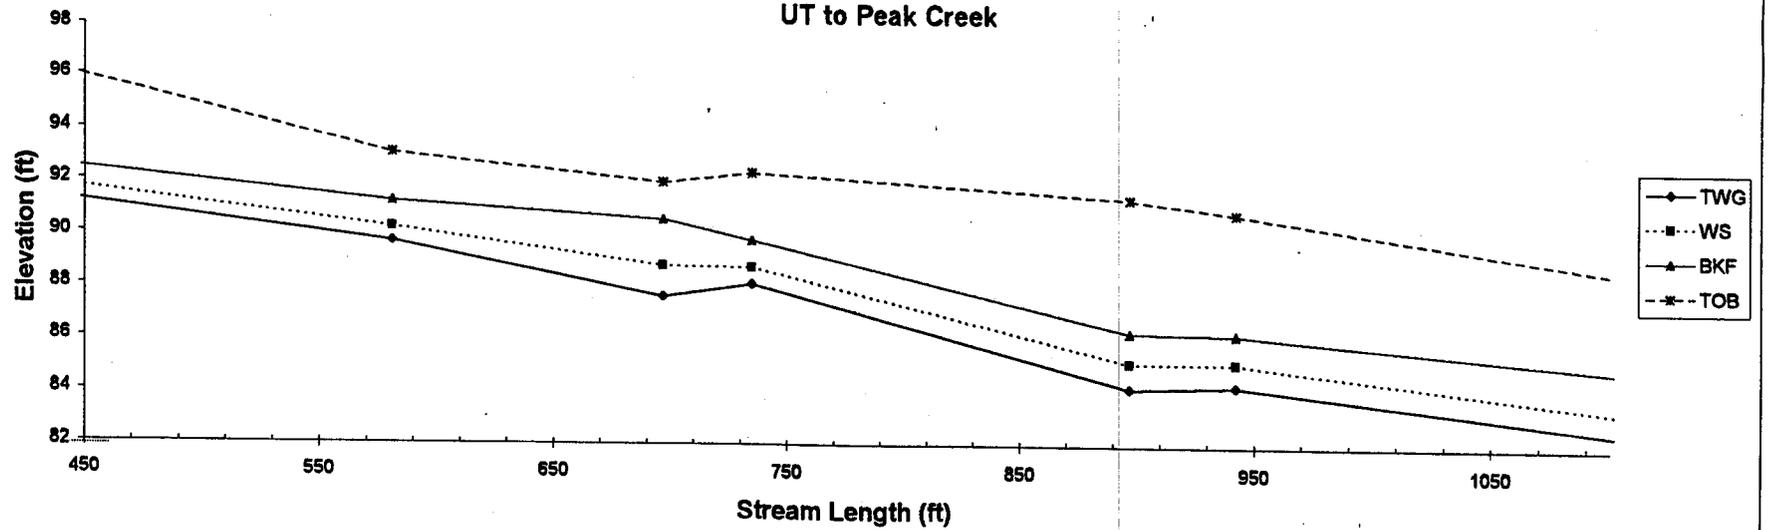
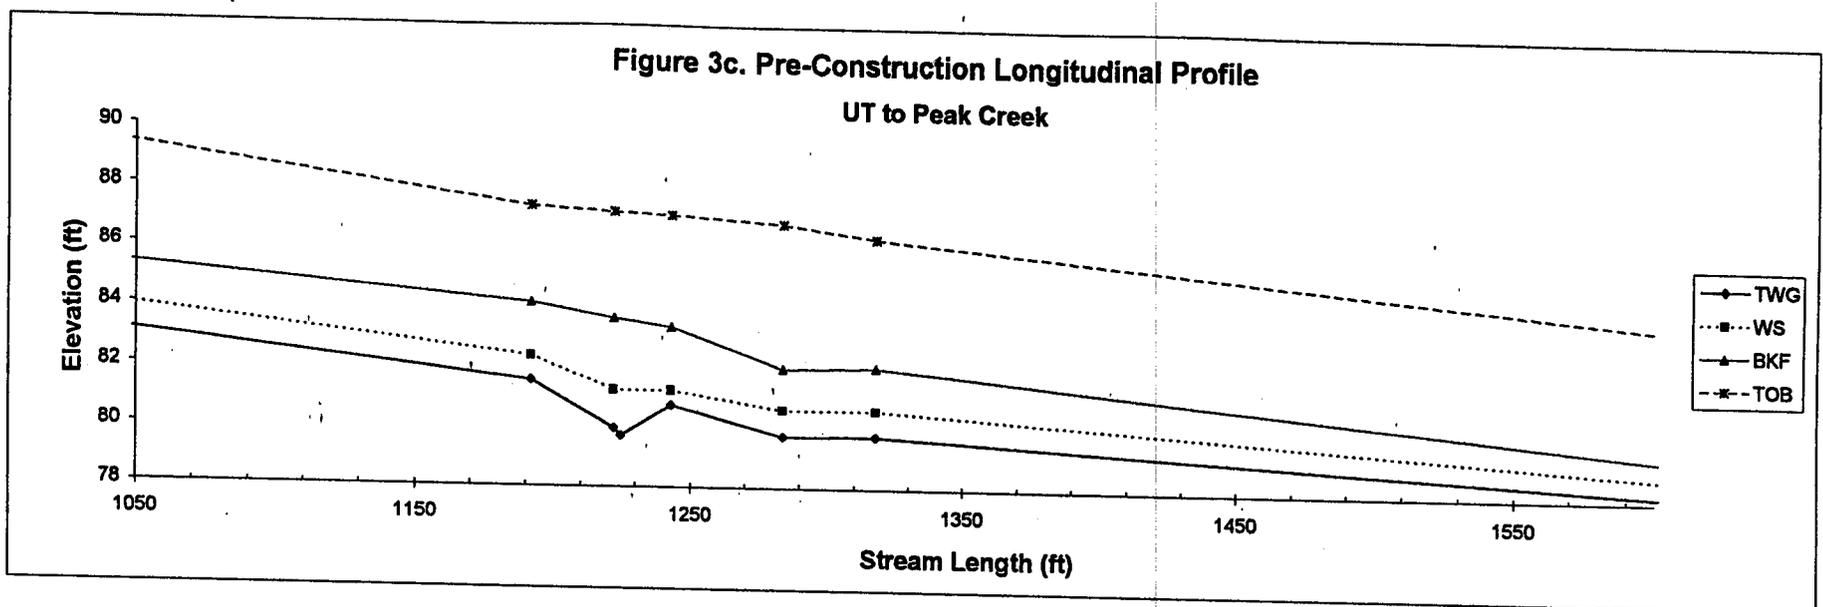
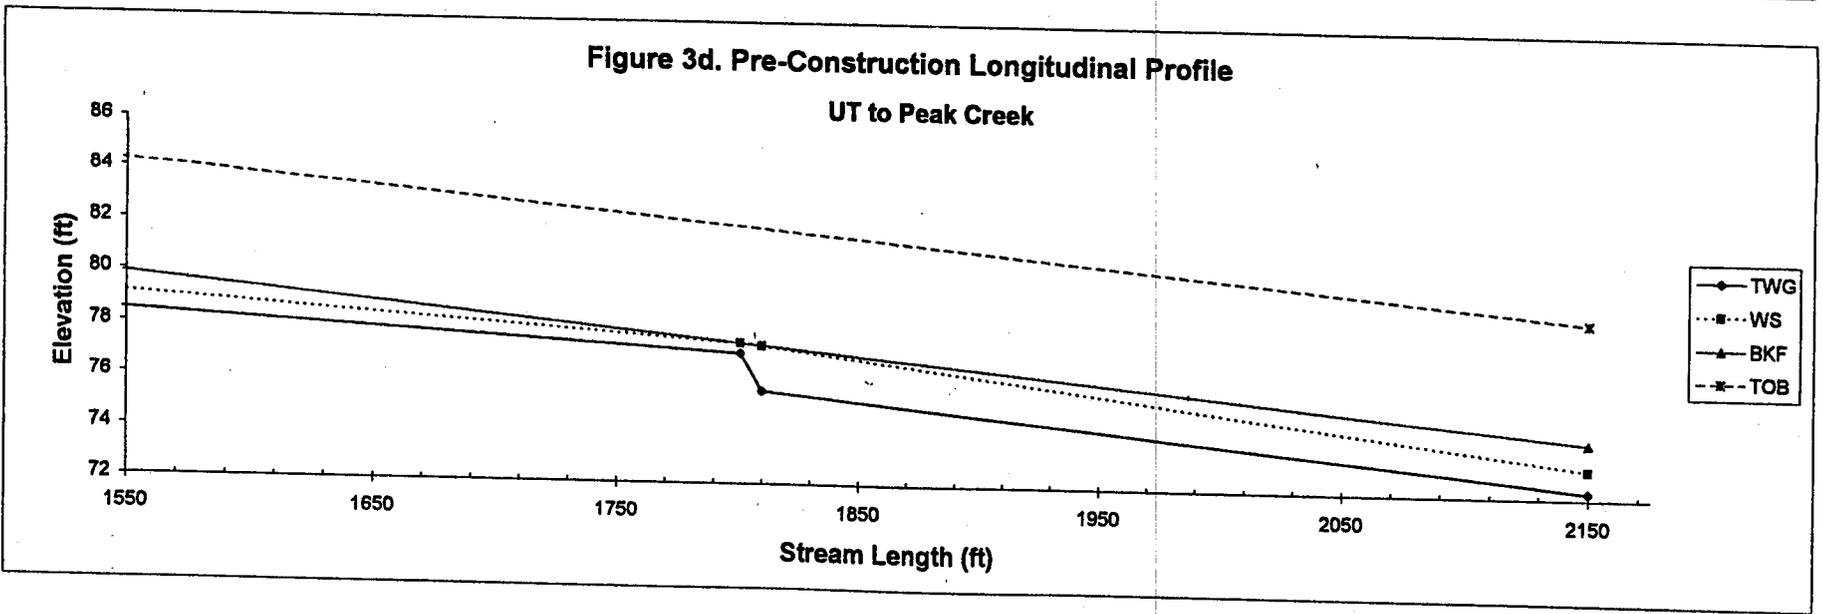
Figures 3a-d and Figures 4a-d show pre and post-construction longitudinal profiles. The post longitudinal profile (Figure 4a-d) shows how the project increased pool and deep-water habitat. Pool habitat was increased from 6.7 % to 47%. The scour action of root wads, rock weirs, and rock and log vanes can be observed from the as-built profile. These structures are creating the desired deep-water aquatic habitat and sorting bed material in a way that will provide needed fish spawning gravel.

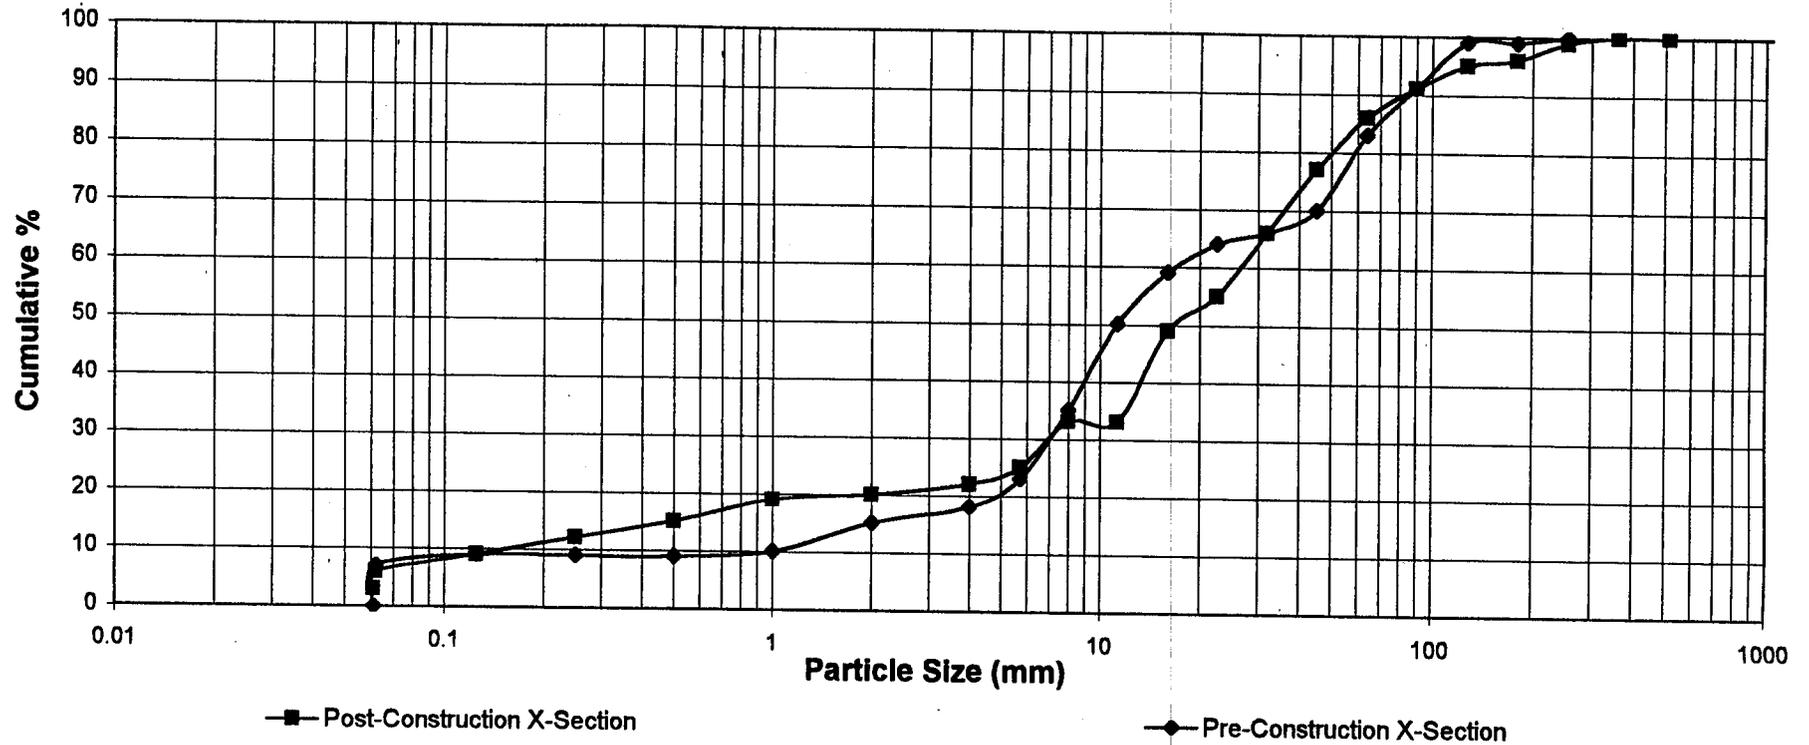
**Figure 5. Pre- and Post Construction Pebble Count Comparison
Bare Site**

Figure 5 summarizes pre and post-construction pebble count data. Pre and post construction pebble count data show no major differences. The D50 is small gravel, D84 is very coarse gravel, and D95 is small cobble.

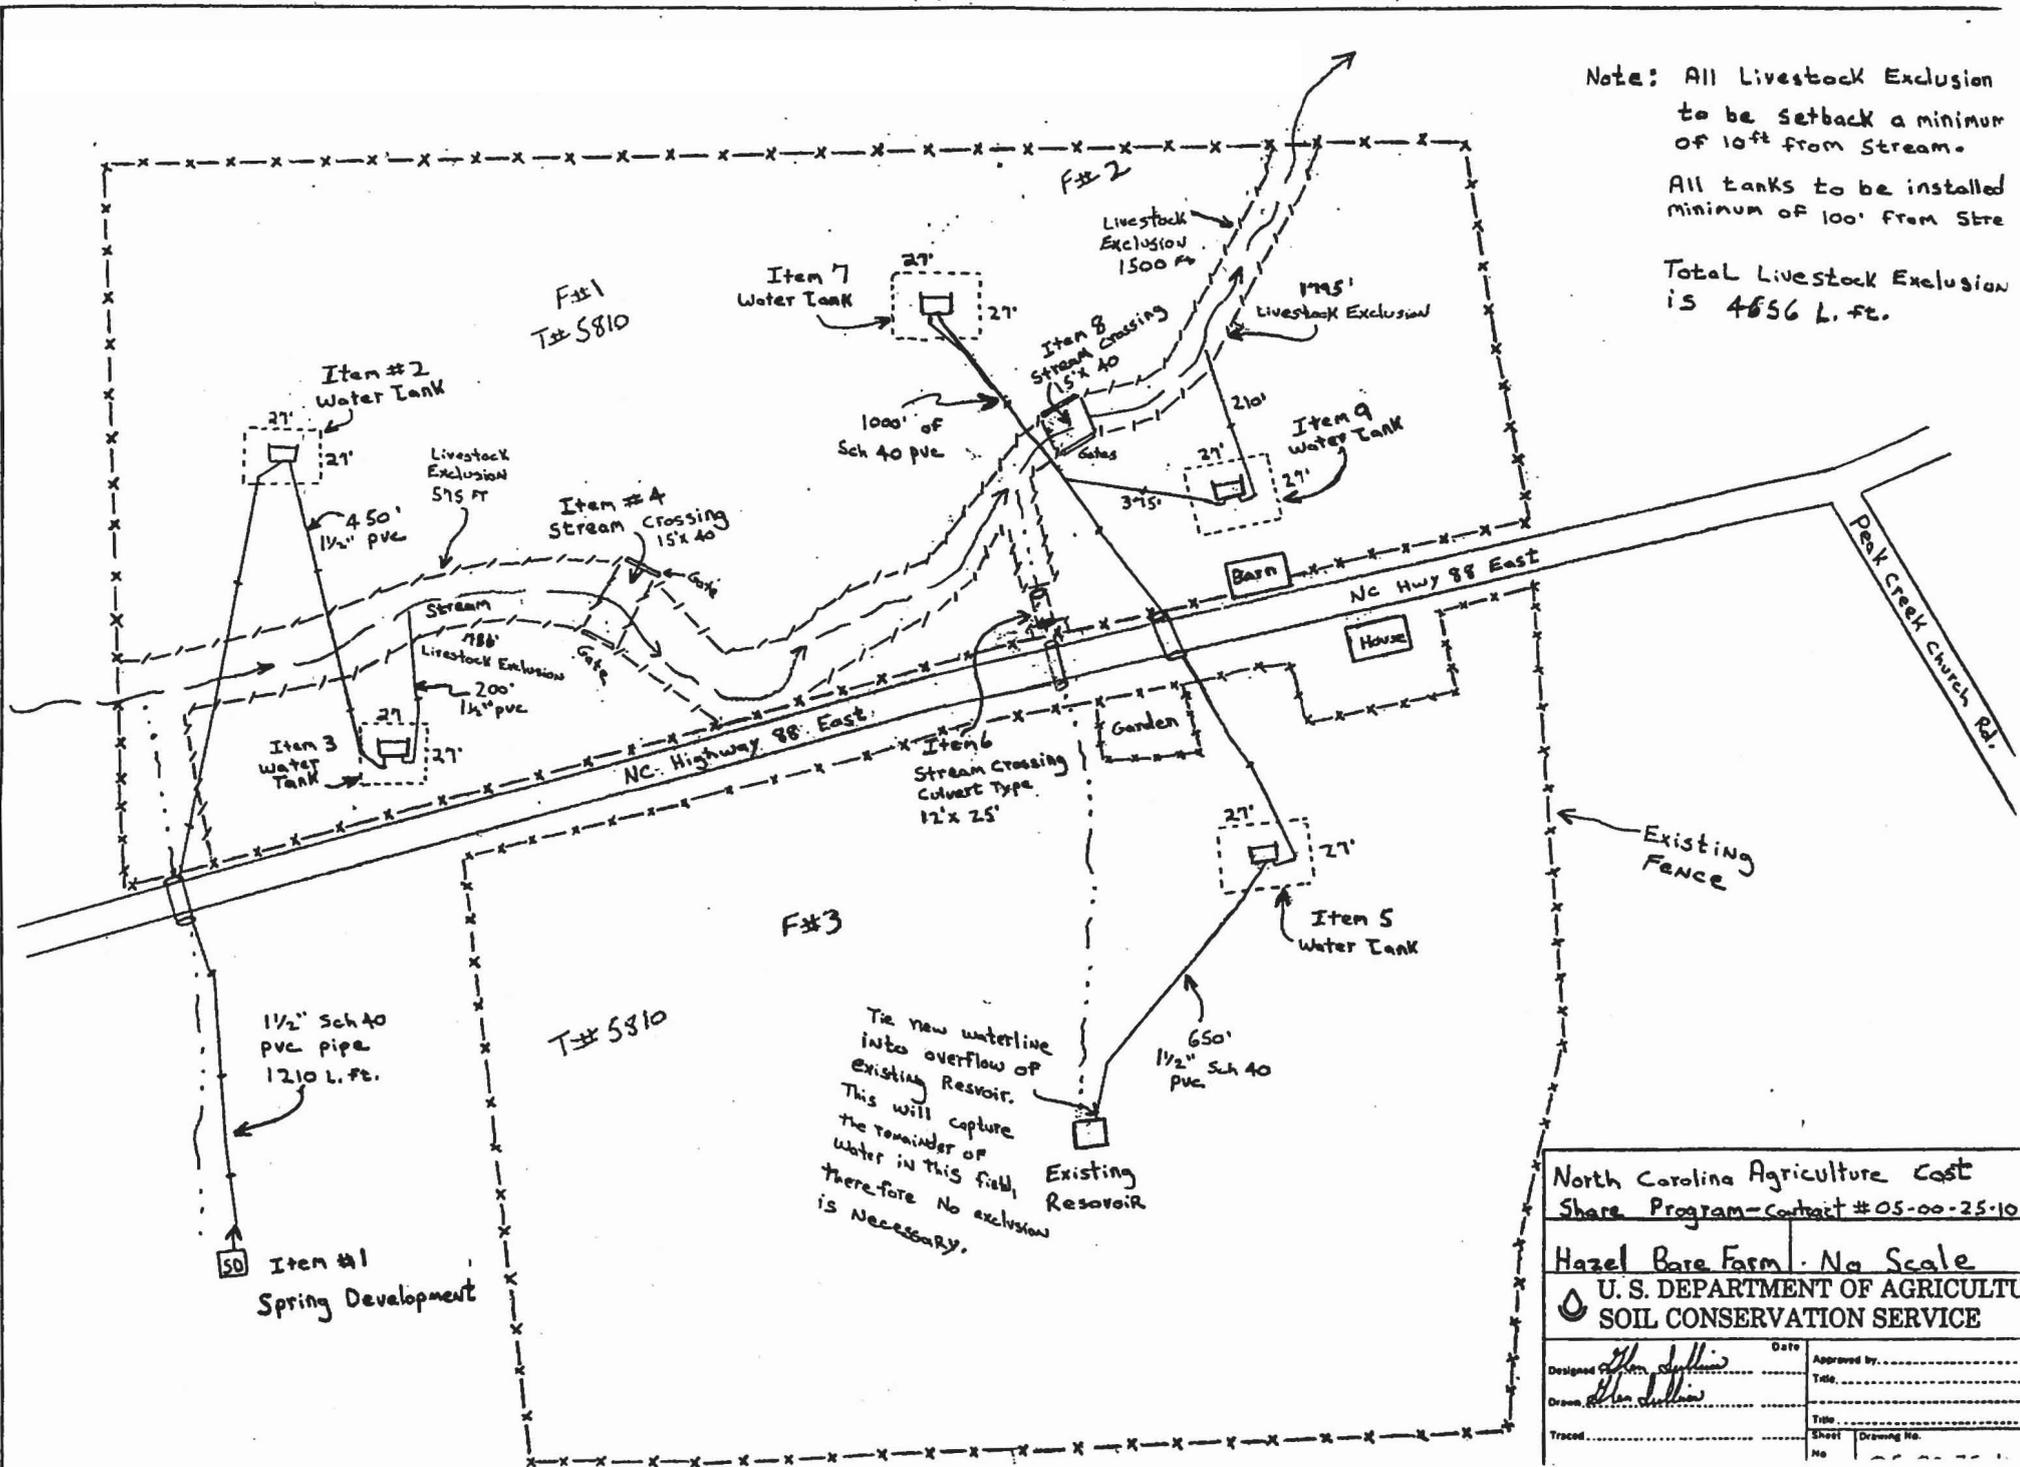
Figure 22

Mr. Glen Sullivan, Cost Share Technician, with the Ashe County Soil and Water Conservation District (ACSWCD) developed and supervised construction of the livestock exclusion plan for the site (Figure 22). In order for any stream restoration/enhancement project to be a success, livestock must be excluded from the recent construction and riparian zone and an alternate watering source other than the stream must be provided. This was accomplished by installation of one 500-gallon water reservoir, 5 watering tanks and associated lines, two stream crossings, and approximately 4,300 feet of conservation easement boundary fencing. Not included in the easement but also fenced from livestock were two small spring seeps totaling approximately 250 feet.
