**As-built report for the Barnhill  
Mitigation Site, Little Ivy Creek,  
Madison County**

**North Carolina Wildlife Resources Commission**

**November 1, 2000**

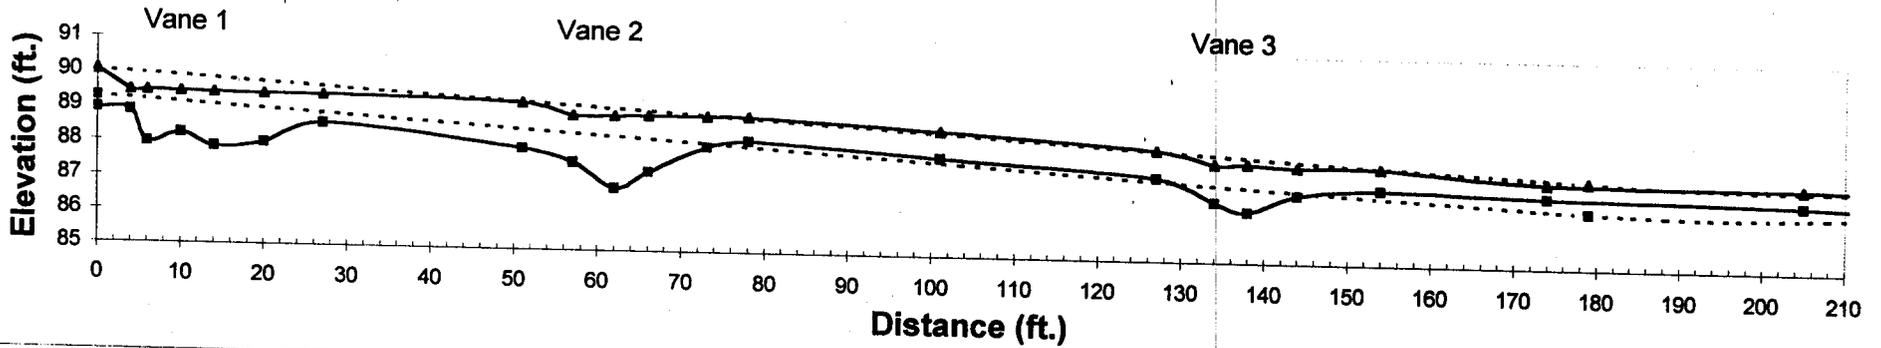
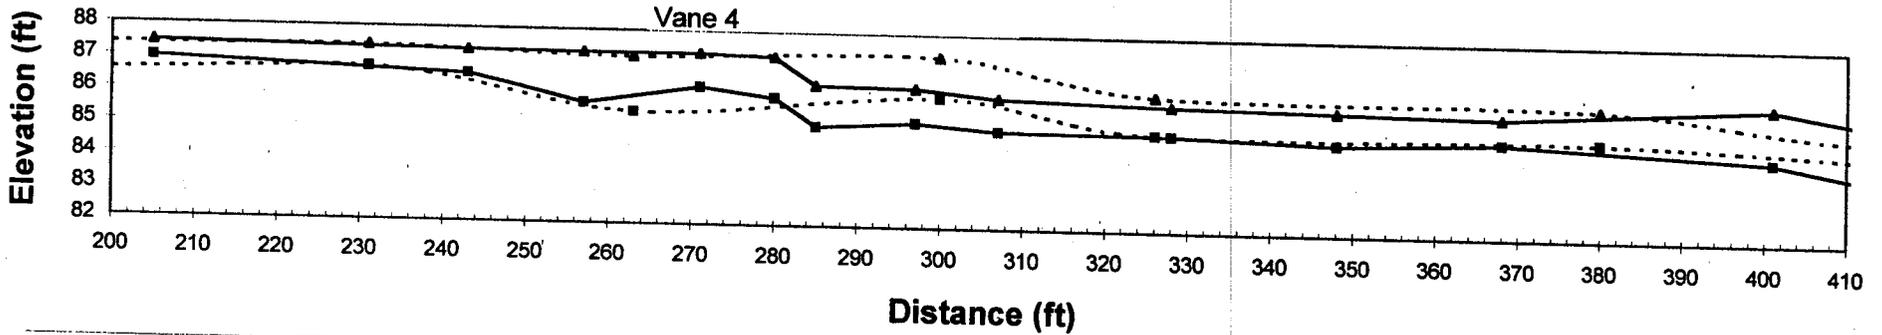
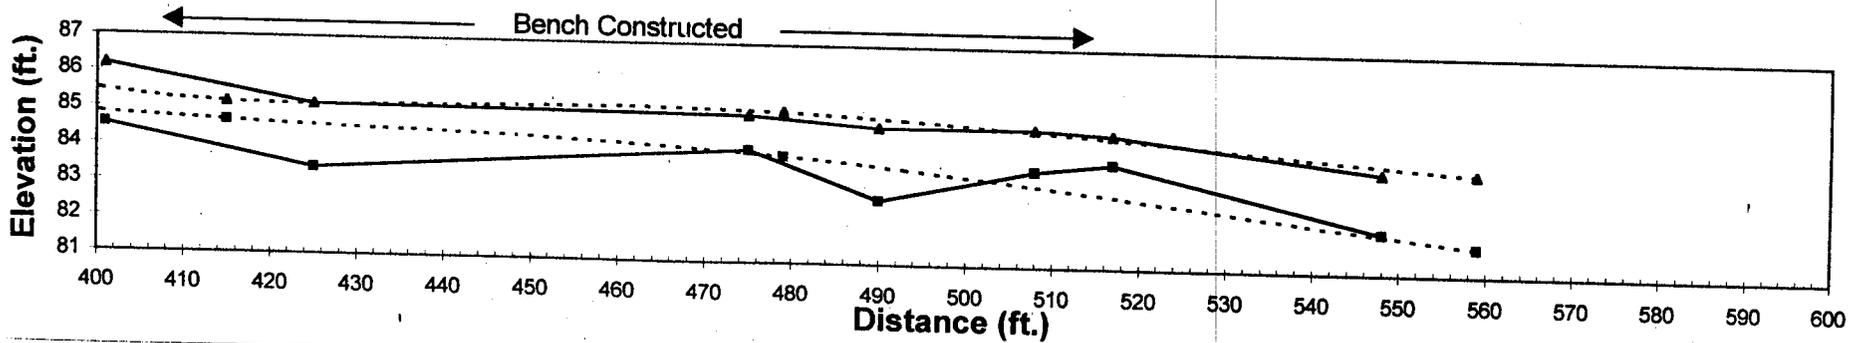
### Longitudinal Profile of Little Ivy Creek, Barnhill Site

- Thalweg Elevation
- Preconstruction Thalweg Elevation
- Bankfull Elevation
- Preconstruction Bankfull Elevation
