EEP Project Closeout Summary

Project ID and Status		Project Setting and Background			Project Timeline		
Project Name:	Ellerbe Creek	Basin:	Neuse		Restoration Plan:	March 2003	
EEP ID:	127	Physiographic Region:	Piedmont		Construction Complete:	March 2005	
County:	Durham	Ecoregion:	Triassic Basin		Monitoring Year 1:	Oct2005	
Project Type:	Stream	14-Digit HUC:	03020201050010		Monitoring Year 2:	Sept 2006	
Type:	Restoration	NCDWQ Sub-basin:	03-04-01		Monitoring Year 3:	Sept 2007	
Current Status:	5 years of monitoring complete	Thermal Regime:	Warm		Monitoring Year 4:	Sept 2008	
		Trout Water:	No		Monitoring Year 5:	July 2009	
		Designer:	Stantec Consulting				
		Monitoring:	Stantec Consulting Robert J. Goldstein & Associates

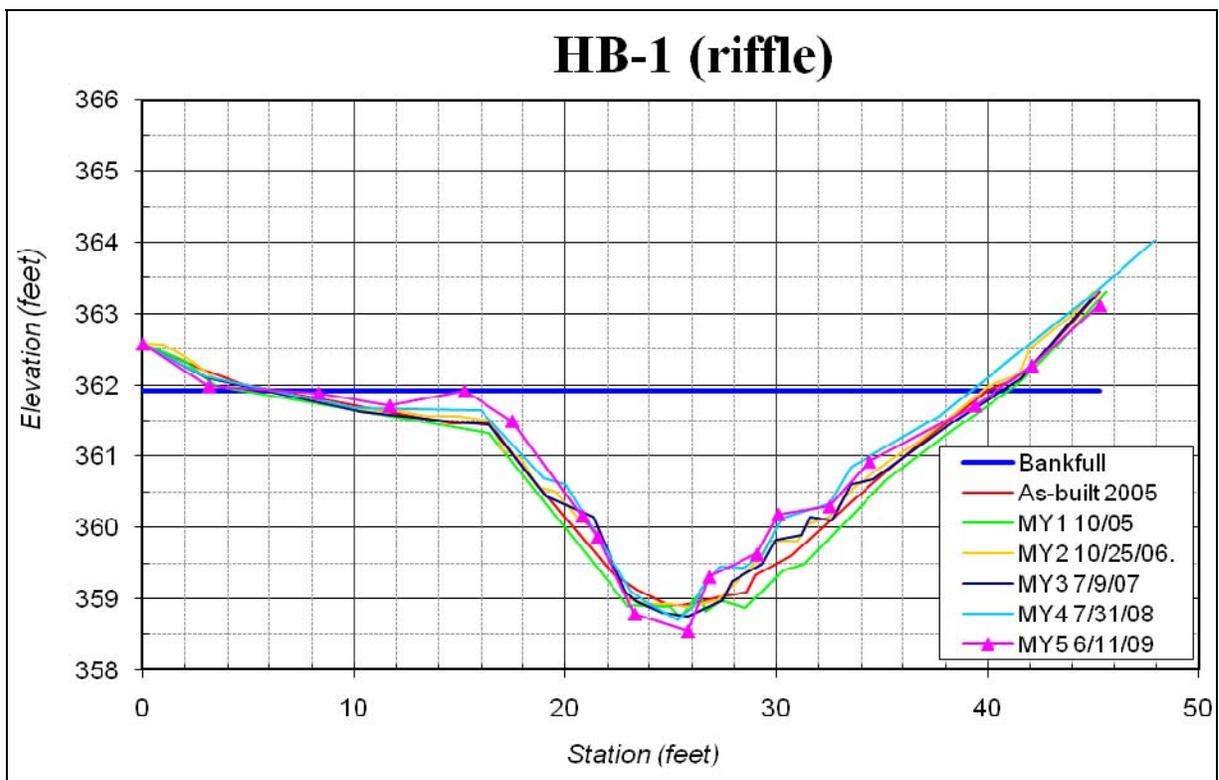
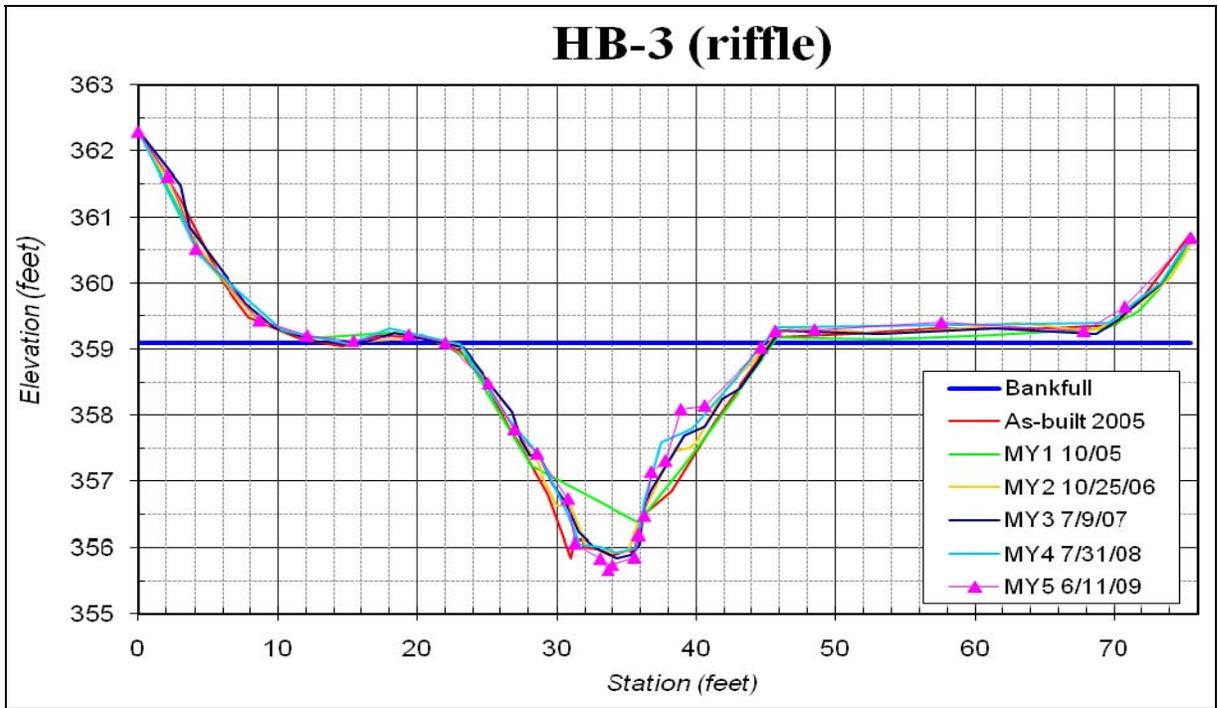
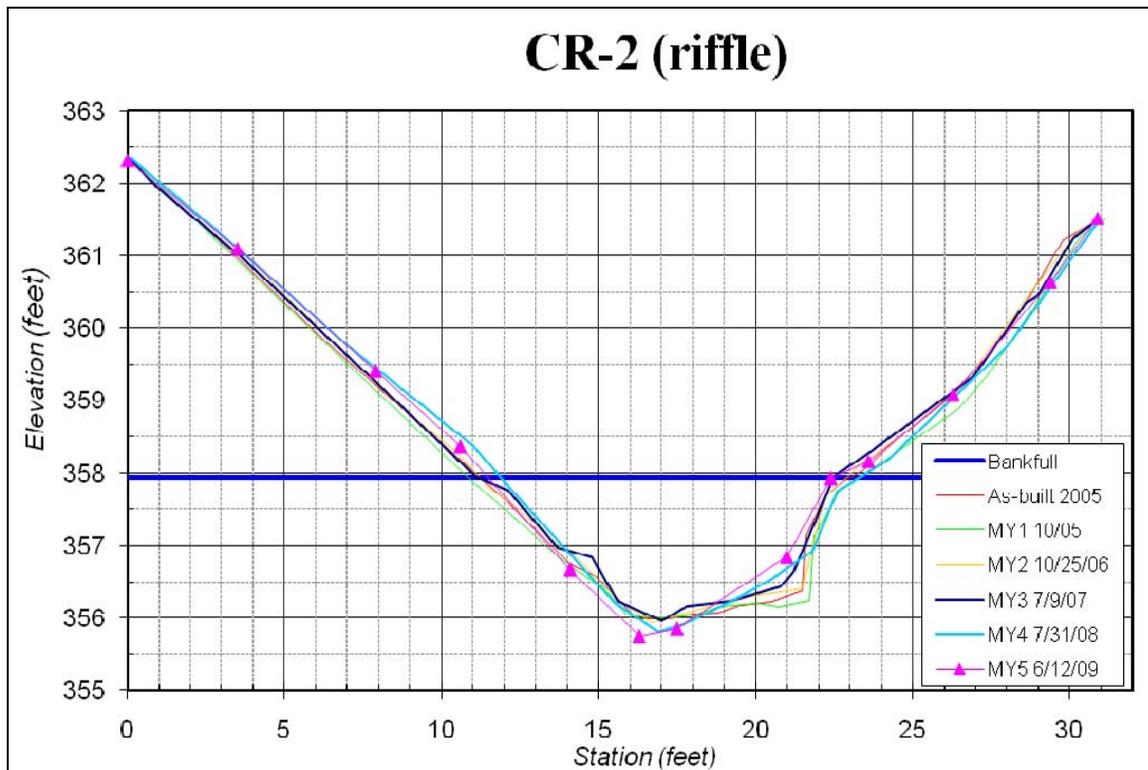
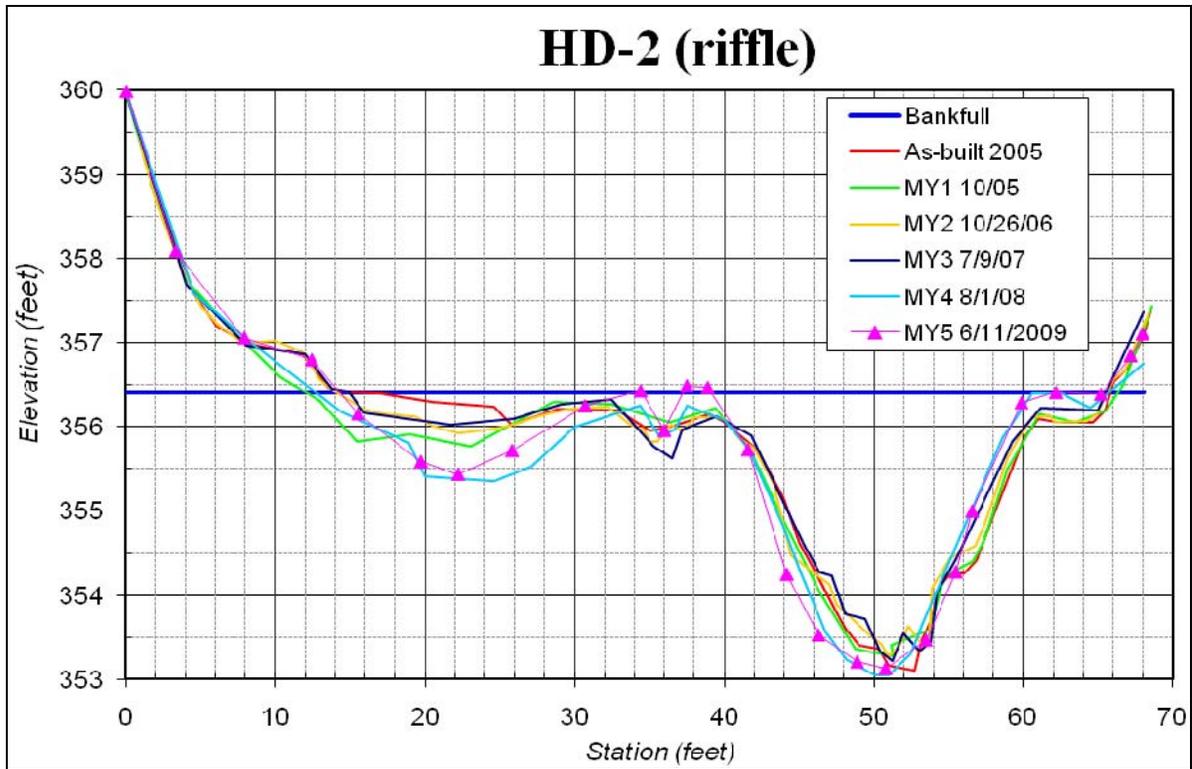
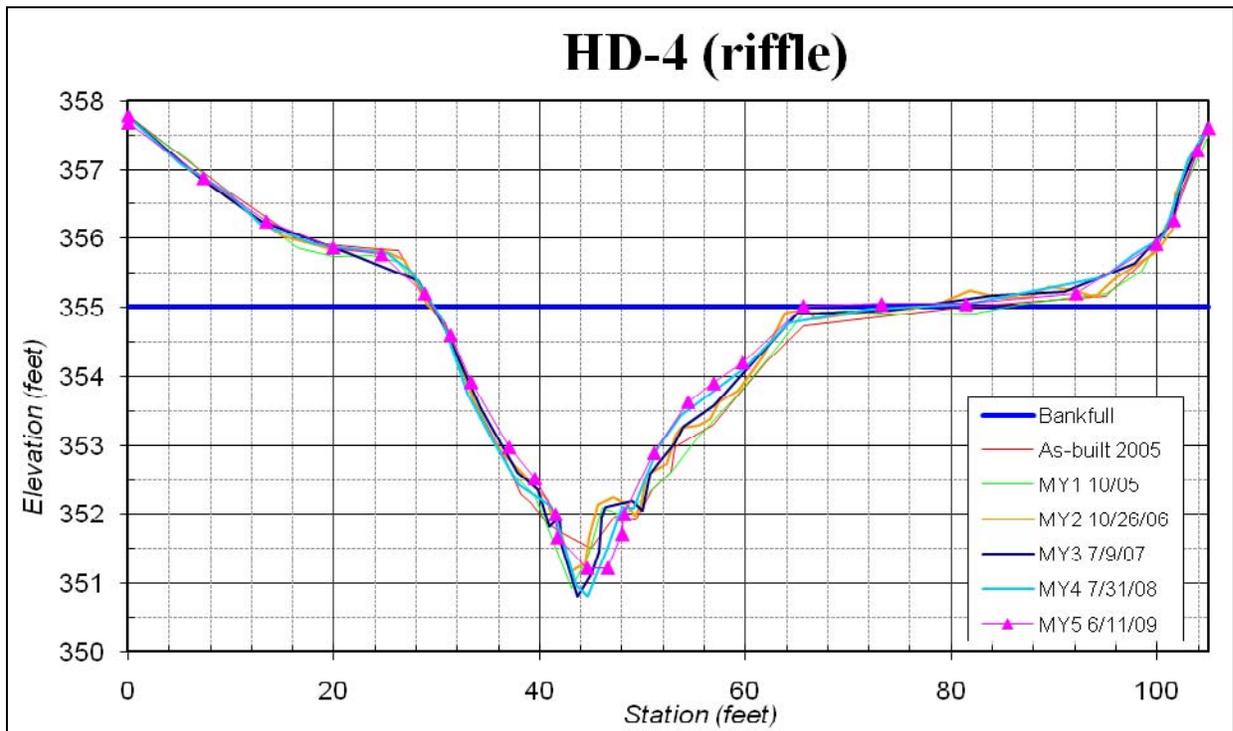
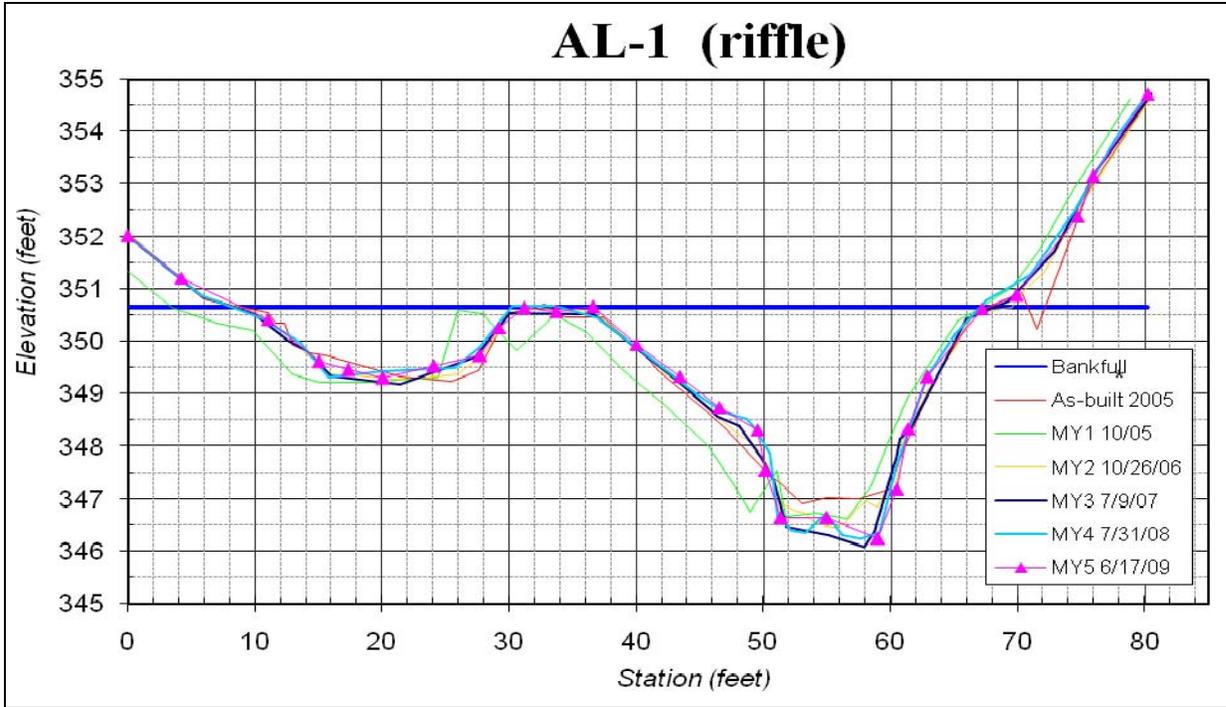
Figure 4. Annual Cross-Section Plots

Repeat X-section surveys indicate that the restored channels' dimensions were stable and changes were within expected parameters. Fourteen X-sections were installed on the site during the as-built survey and surveyed for all 5 monitoring years. The Hillsborough, Hillandale, and Albany reaches each contained 4 X-sections consisting of two paired riffle and pool X-sections. The Croasdaile Reach included two X-sections—one riffle and one pool. As might be expected, growth of stream bank vegetation caused the channels to decrease slightly in width and deposition slightly increased the bankfull elevation. Repeated beaver activity in the Hillsborough and Hillandale reaches appeared to have had little effect on overall channel dimension. All riffle X-section plots are depicted in Figure 4 below.

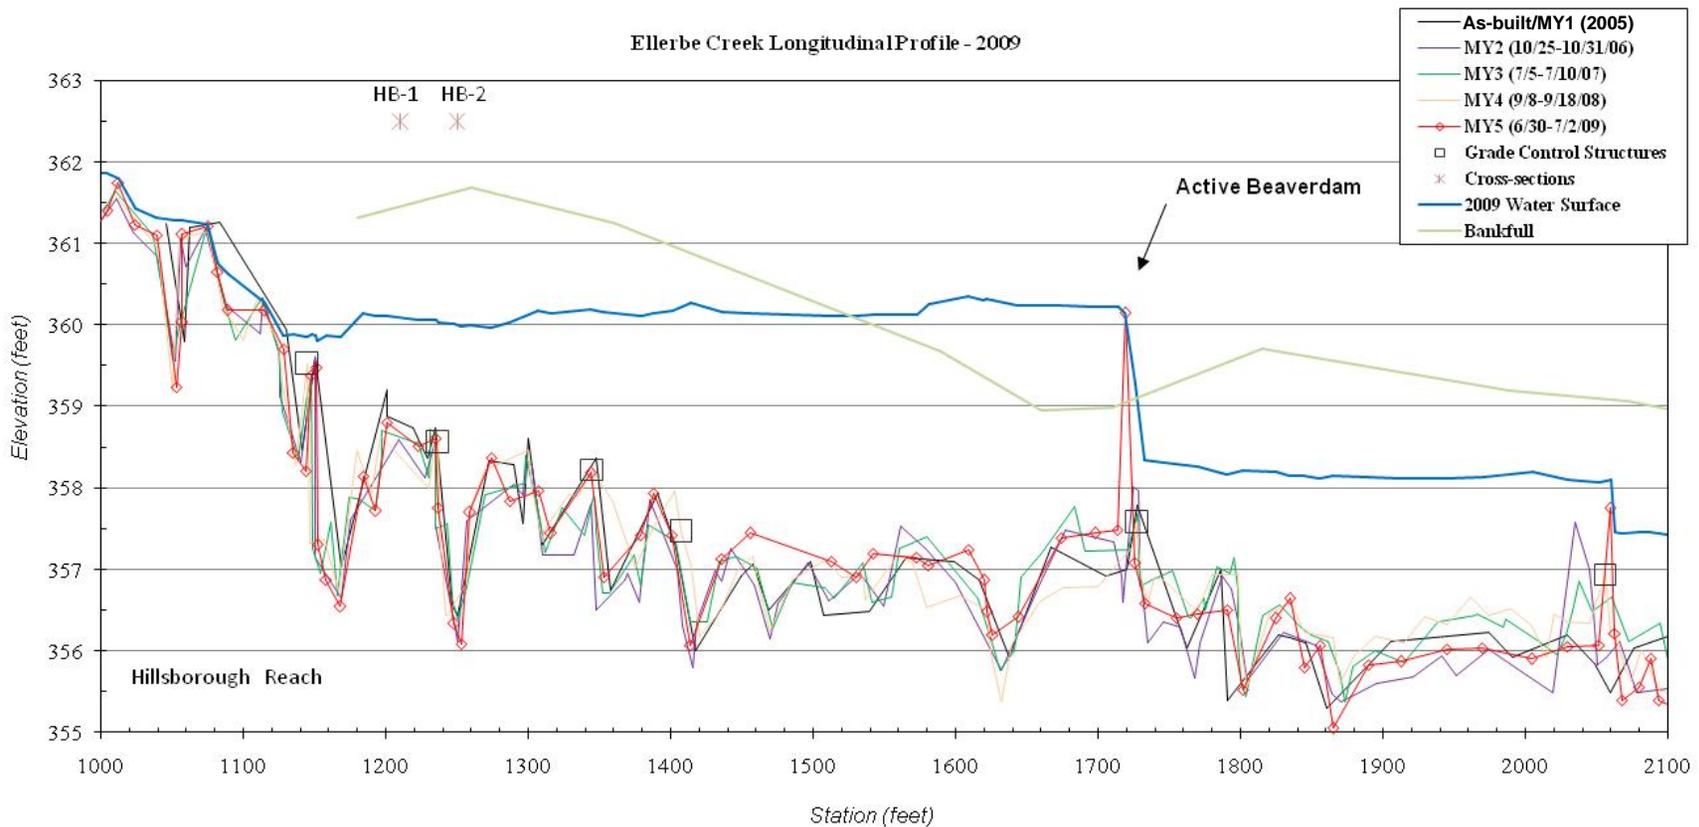
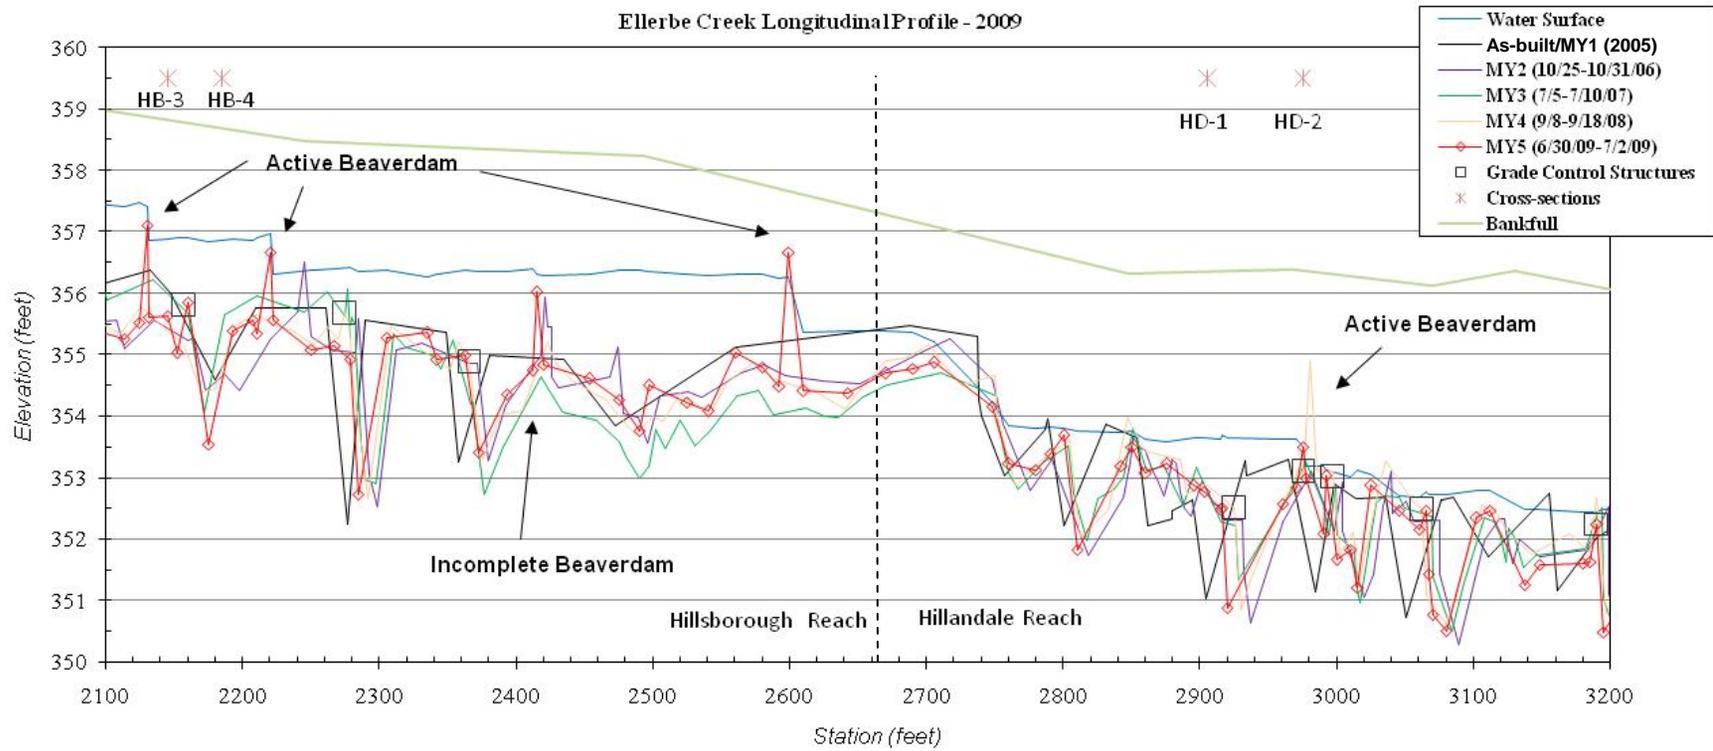
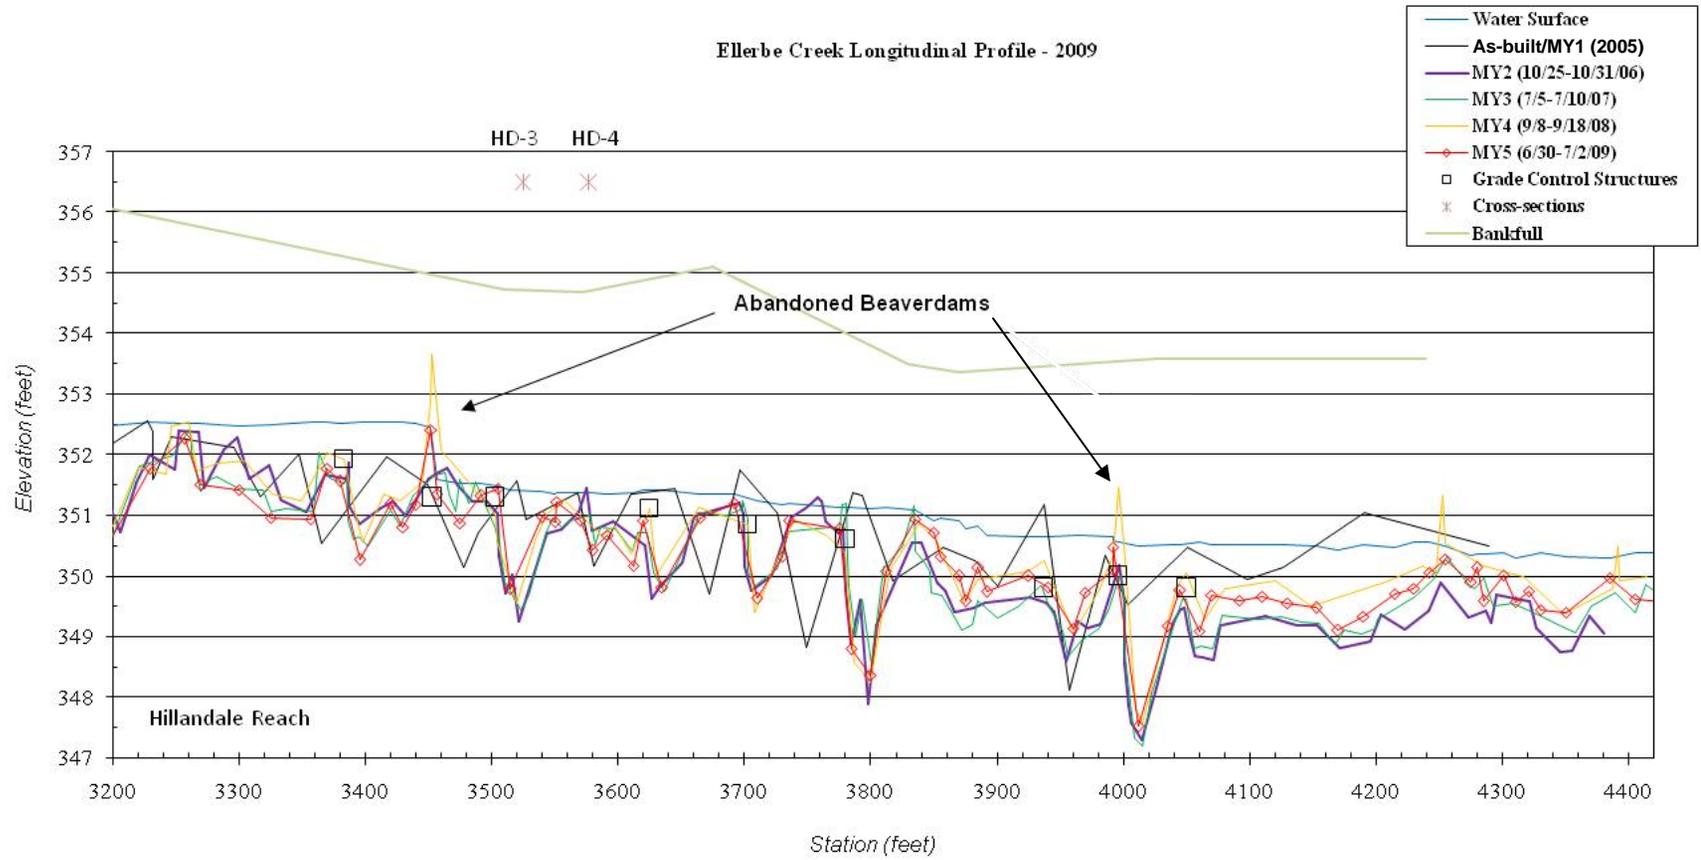
Figure 5. Annual Longitudinal Profile

Repeat longitudinal profile surveys indicate that riffle-pool morphology was maintained and in-stream structures and the project profile are stable. Project reaches experienced some bed degradation, but this stabilized as the site matured. Approximately 3,000 feet of the project was surveyed for all five monitoring years, including the entirety of the Hillsborough Reach and a portion of the Hillandale Reach. Longitudinal profile, channel beltwidth, and sinuosity data all indicated that the channel established a slightly longer and more sinuous pattern over the five year period. Beaver activity caused some isolated bed aggradation upstream of the dams, but this did not create project instability.
