**Kentwood Park (Bushy Branch)
Stream Restoration
Closeout Summary Report
EEP Project # 205
2010**

April 2010

Project ID & Status	
Project Name:	Kentwood Park (Bushy Branch)
EEP ID:	205
County:	Wake
Project Type:	Stream Restoration
Current Status:	5 Years of Monitoring Complete

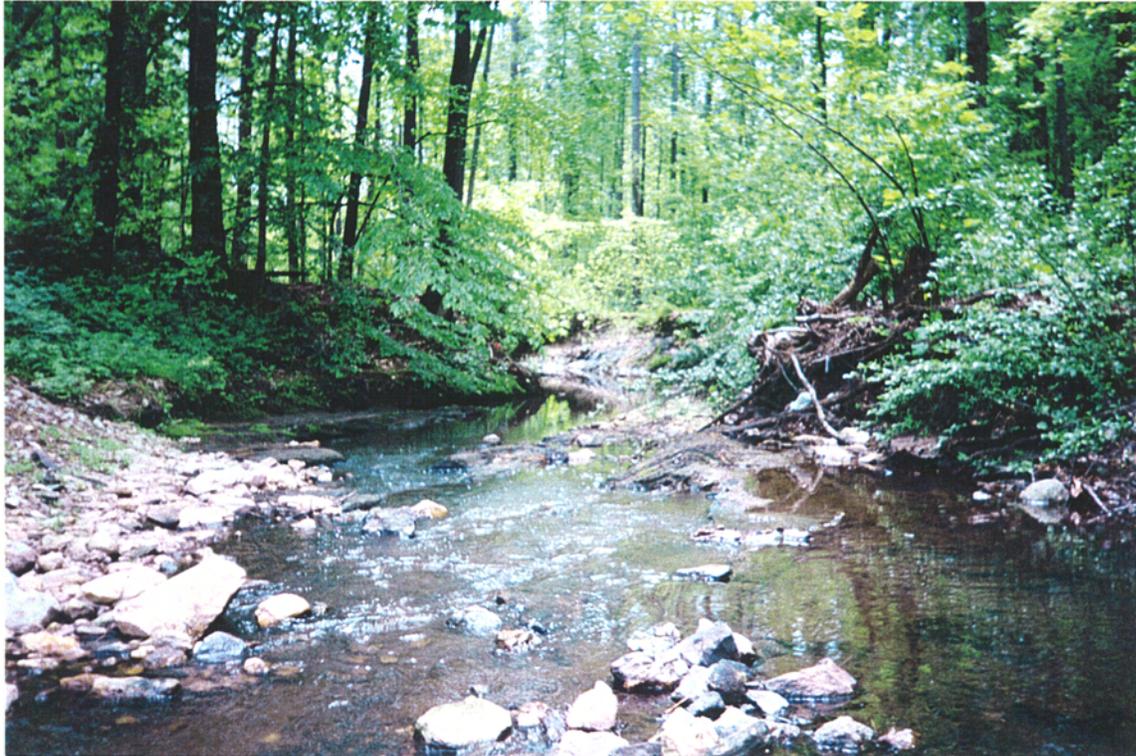
Photograph 8. Beginning of reference reach along Bushy Branch just downstream of Kentwood Park

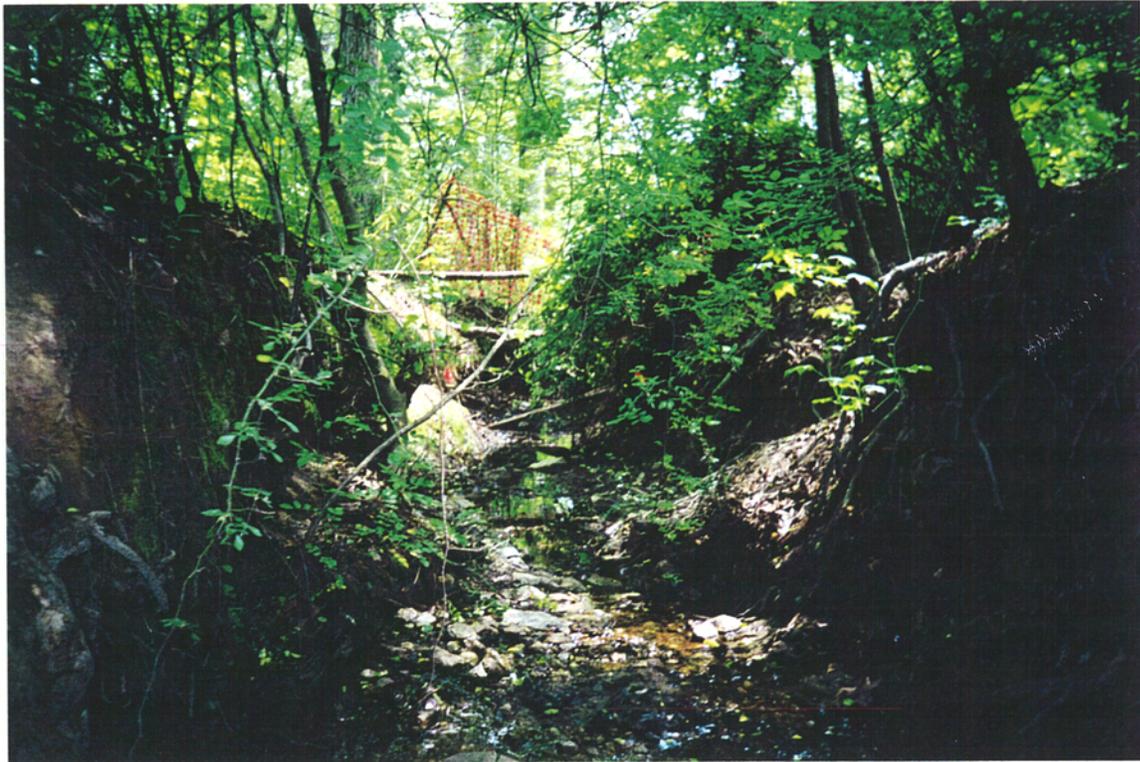
Photograph 11. Unnamed tributary of Bushy Branch looking upstream from just downstream of western Kentwood Park property line

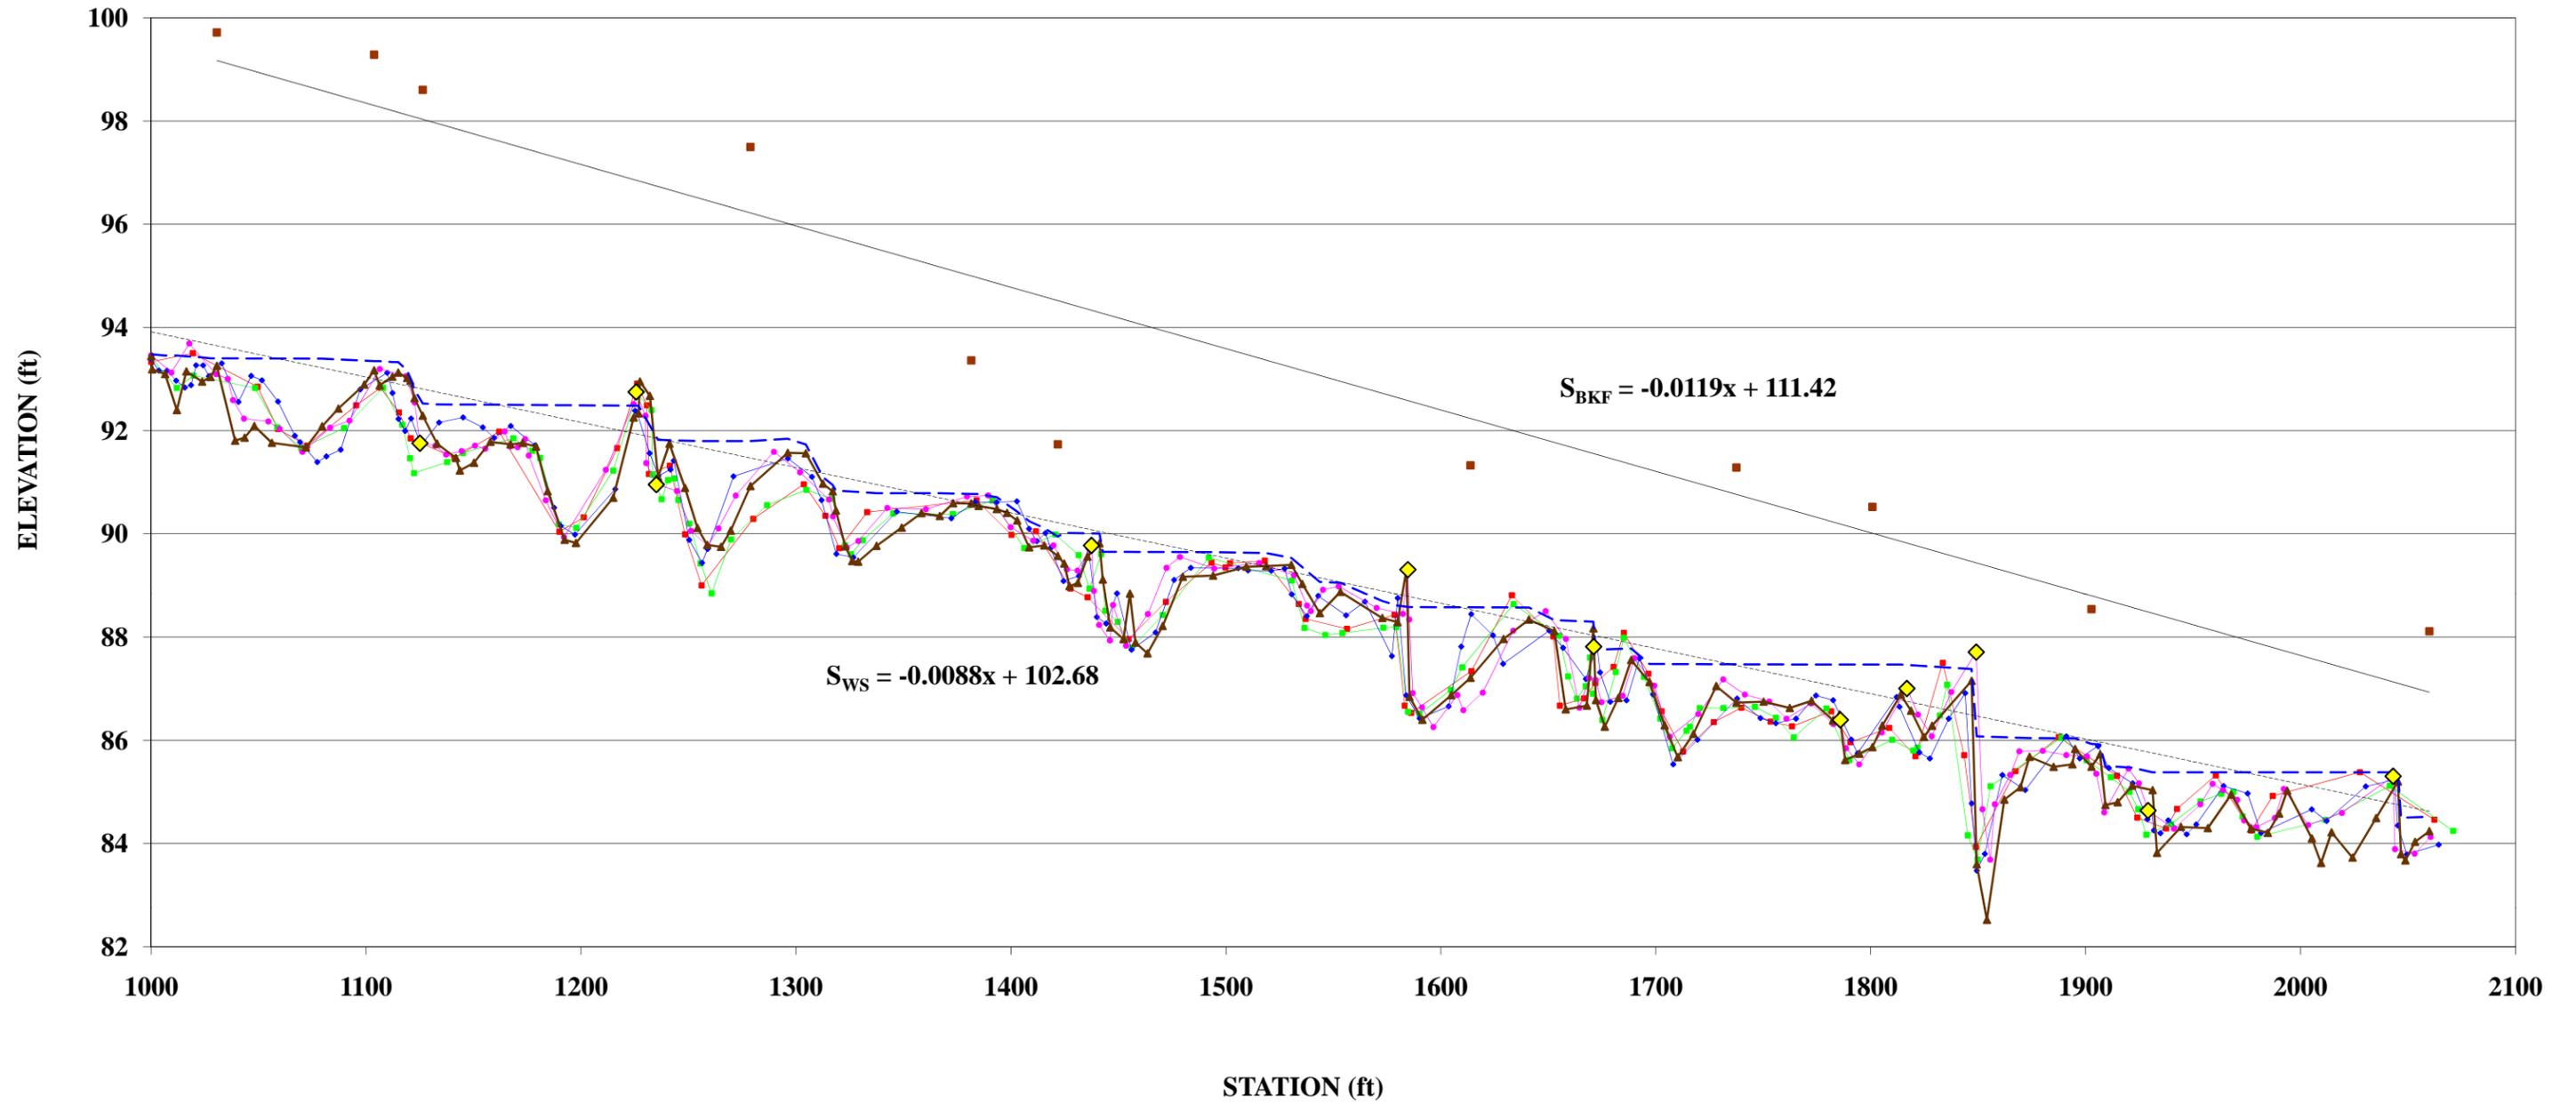
**Longitudinal Profile for Bushy Branch
Kentwood Park, Wake County
EEP Project Number 205 - MY05**

The profile has maintained its elevation and a consistent riffle-pool pattern over the past five years of monitoring. The as-built profile data could not be obtained from the designer in an electronic format that would facilitate overlay. The cross-sections, subsequent long profiles and field observations indicate a stable bed. The two riffle cross-sections surveyed in the reach also demonstrated bankfull areas and widths that matched the design targets well. The in-stream structures are holding grade and stable. Several structures that did exhibit some back arm scour at some point in the monitoring history represent remnant, localized areas of instability, which have advanced little or not at all in recent years. In addition, the majority of the project is surrounded by extremely dense woody vegetation and canopy, which is uncommon for an urban system. The associated stabilizing root mass from the buffer is extensive.
