**LYLE CREEK STREAM RESTORATION SITE**  
**AS-BUILT CONSTRUCTION REPORT**  
**CATAWBA COUNTY, NORTH CAROLINA**  
(SCO ID# 00-05378-01)

**ECOSCIENCE CORPORATION**  
**1101 Haynes Street, Suite 101**  
**Raleigh, NC 27604**  
**Tel (919) 828-3433 Fax (919) 828-3518**

**August 2002**

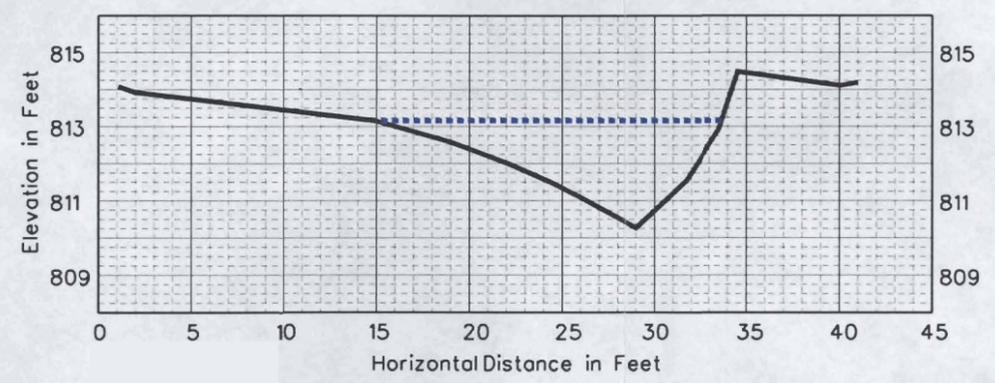
CROSS-SECTION 7  
Pool 41

Bankfull Width: 18.6'  
Bankfull Maximum Depth: 2.9'  
Bankfull Average Depth: 1.4  
Bankfull Cross-sectional Area: 25.3 sq. ft..

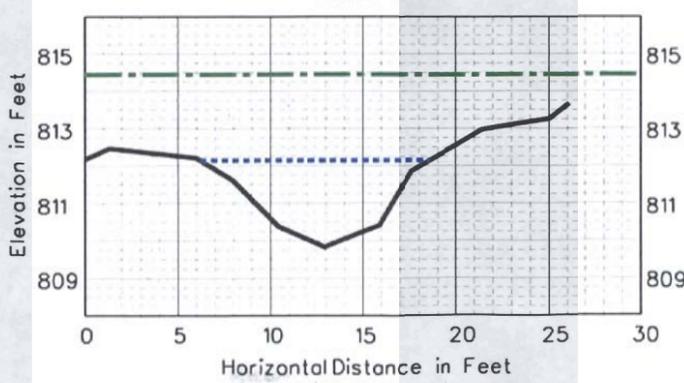
CROSS-SECTION 5  
Riffle 38

Bankfull Width: 12.4'  
Bankfull Maximum Depth: 2.3'  
Bankfull Average Depth: 1.3  
Bankfull Cross-sectional Area: 16.2 sq. ft..  
Width of Flood Prone Area: 154.0'

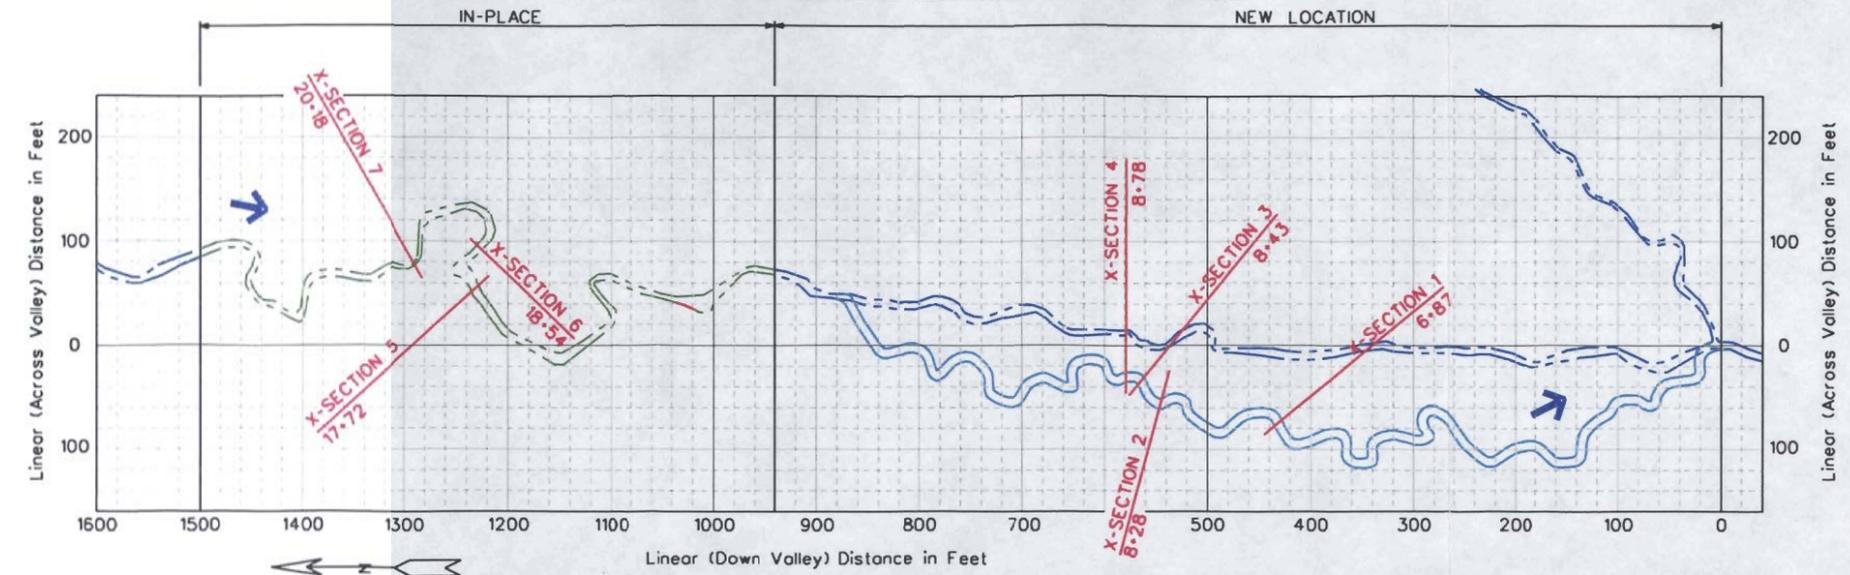
Title:  
**CHANNEL SLOPE ATTRIBUTES**

Channel slope and substrate attributes were obtained from profile measurements and pebble count data (Figure 2). The water surface slope averaged 0.0075 (rise/run) relative to a valley slope of approximately 0.012 (rise/run). The median riffle and pool slopes were 0.0147 and 0.0024, respectively. Compared to proposed conditions, the ranges of riffle and pool slopes were slightly extended. Several conditions may explain this discrepancy including the formation of small drops and scour holes immediately downstream of cross-vane weirs resulting in shortened riffles with steep individual facet slopes.

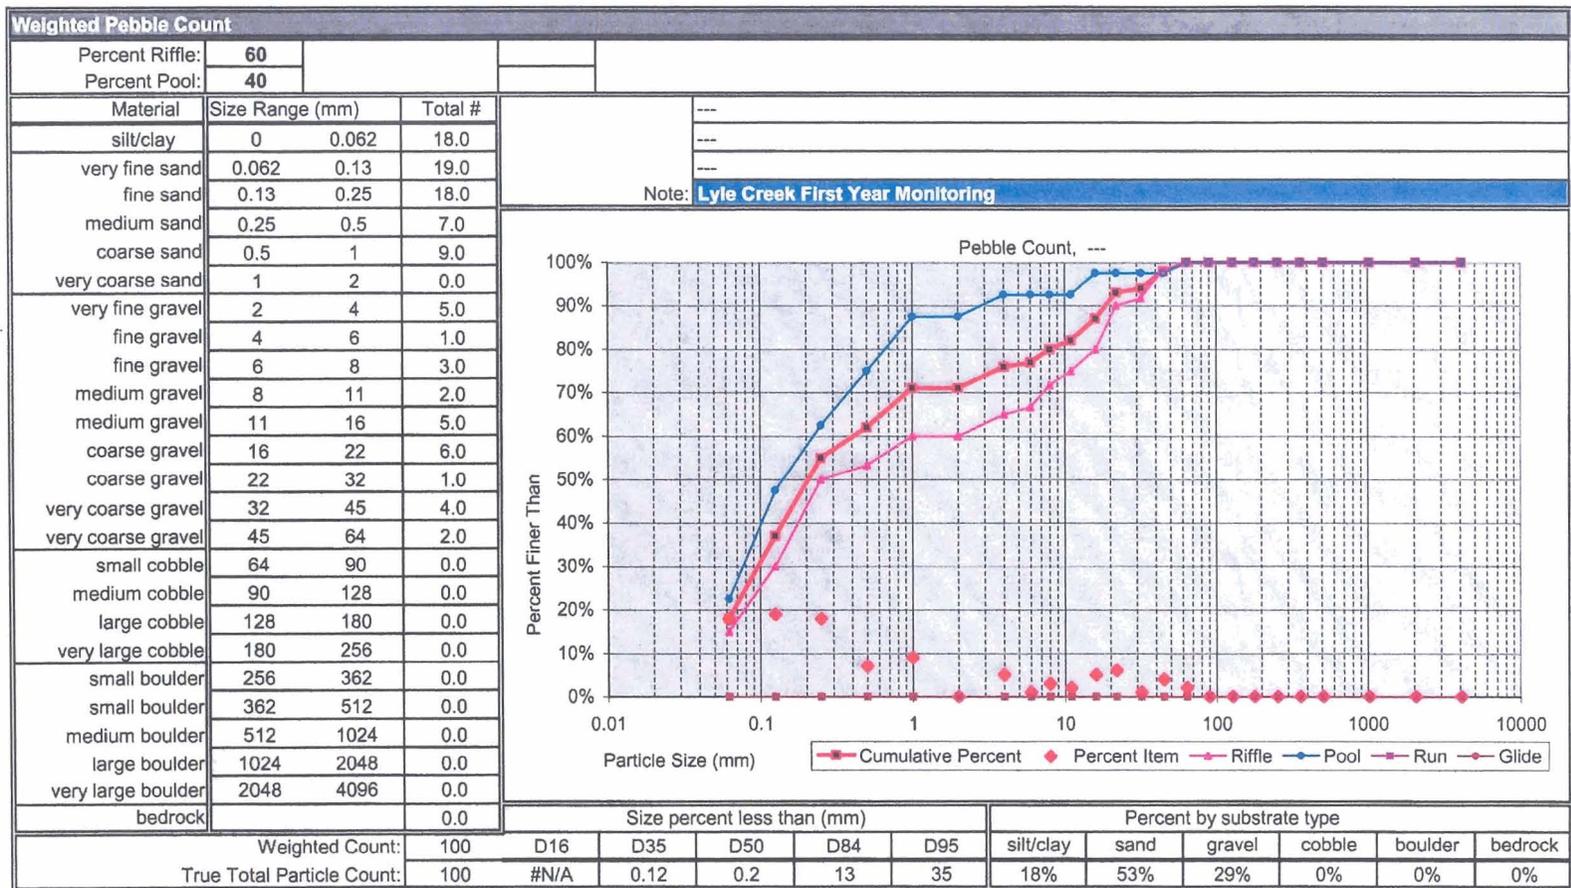
### Graph A

cutoffs. Profile comparisons of as-built versus year one water surface slopes (average water surface slope [0.0076 vs. 0.0075], riffle slopes [0.0141 vs. 0.0147], and pool slopes [0.0022 vs. 0.0024]) do not indicate significant changes. Based on dimension, pattern, and profile measurements, current monitoring indicates that the restored channel appears stable upon completion of year one monitoring.

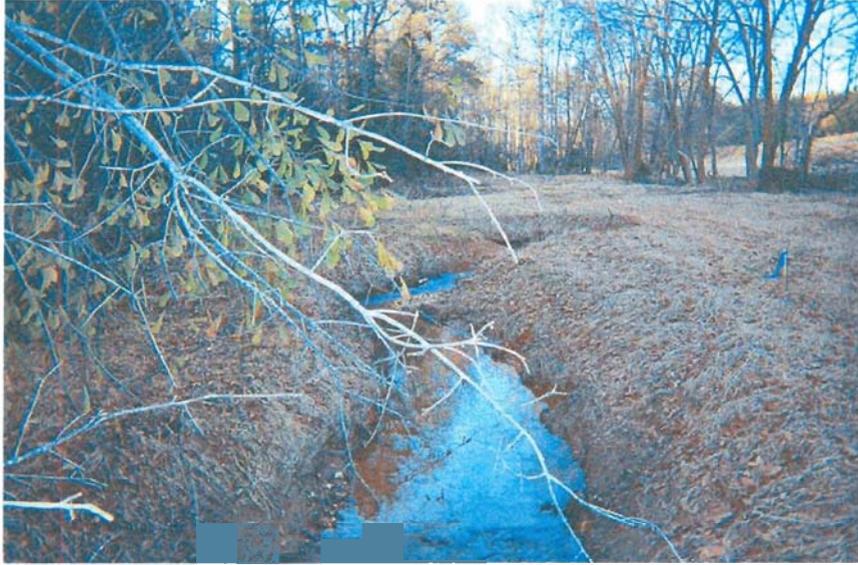
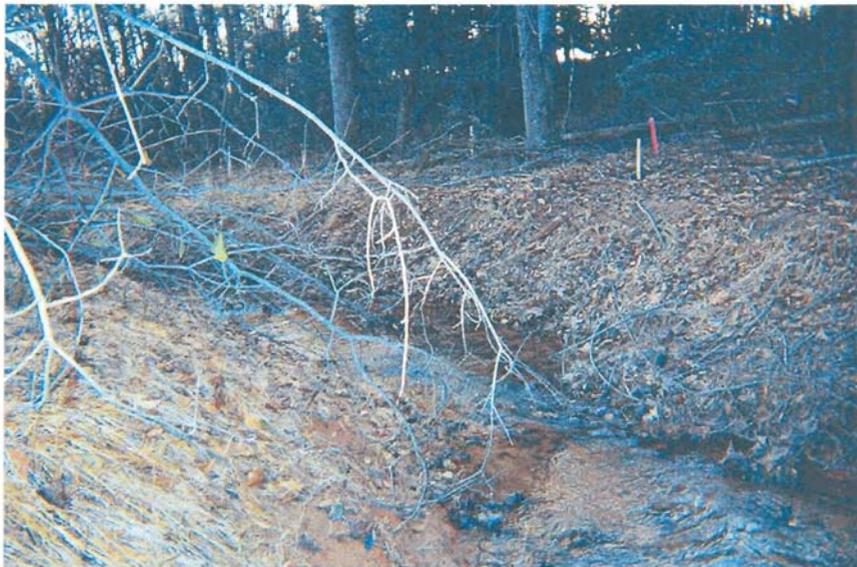
## PHOTO PLOT 8

(tree branches in foreground of pictures are the result of an ice-storm)
