<u>Project ID & Status</u>	<u>Project Setting & Background</u>	<u>Project Timeline</u>																
Project Name/Number: Lyle Creek EEP ID: 423 County: Catawba Project Type: Stream Restoration Current Status: 5 Years of Monitoring complete	Basin: Catawba Physiographic Region: Piedmont Drainage Area: 0.47 Impervious cover: <10% USGS Hydro Unit: 03050101 NCDWQ Subbasin: 03-08-32 Thermal Regime: Warm Trout Water: No Designer: Ecoscience

Project Background and Summary

Figure 1. Project Location and Watershed Map
Lyle Creek Stream Restoration
Catawba County, NC
Monitoring Report Year 4 of 5

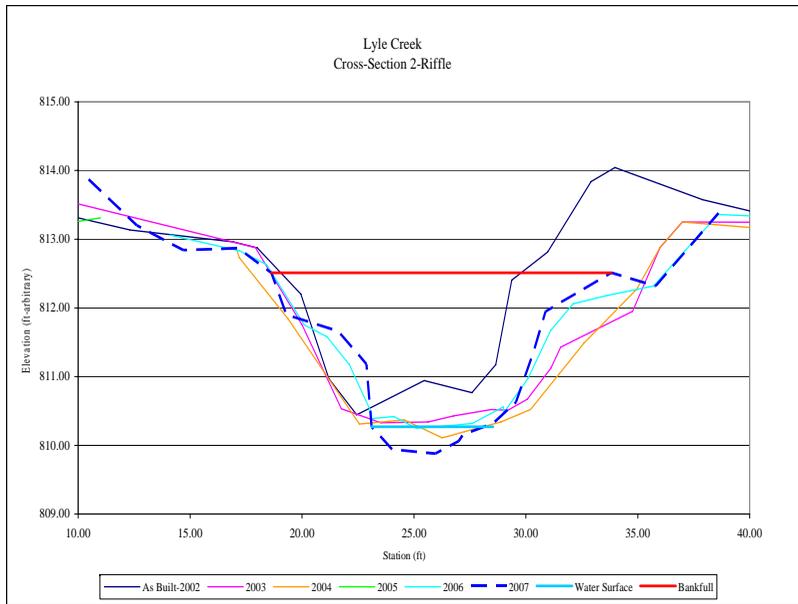
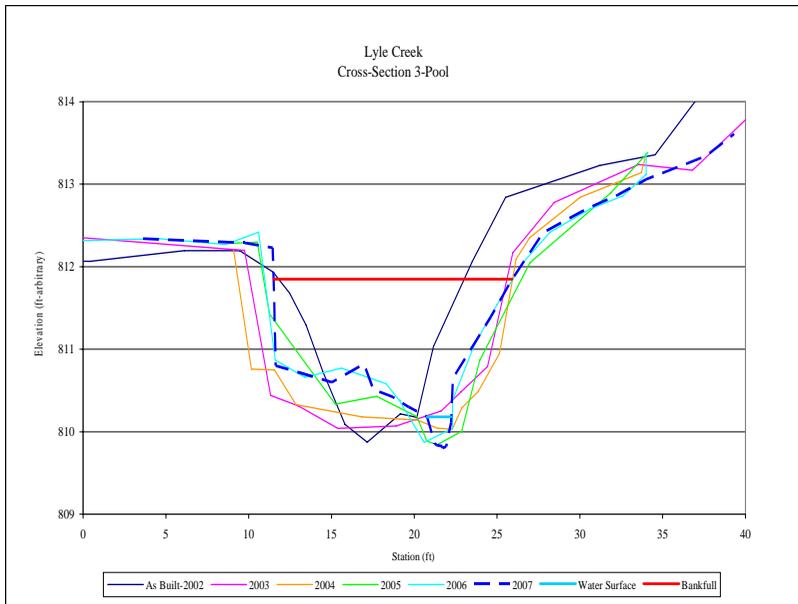
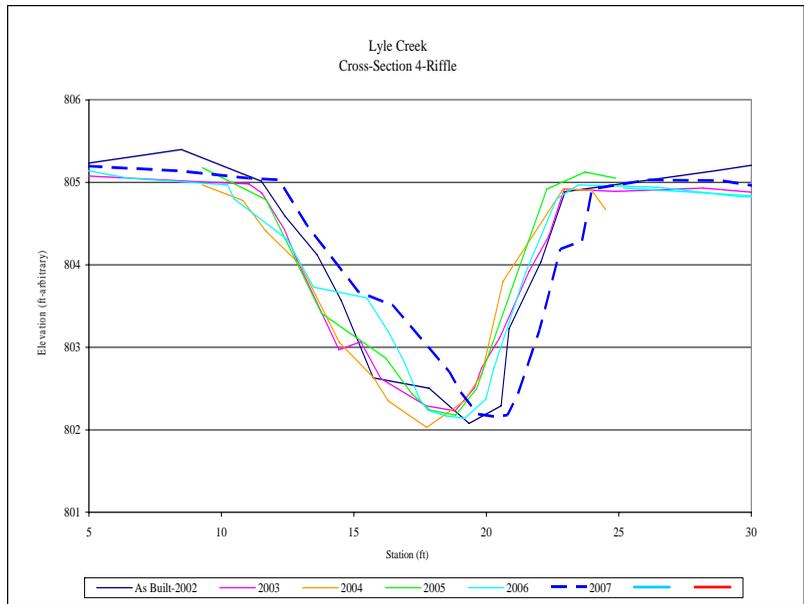
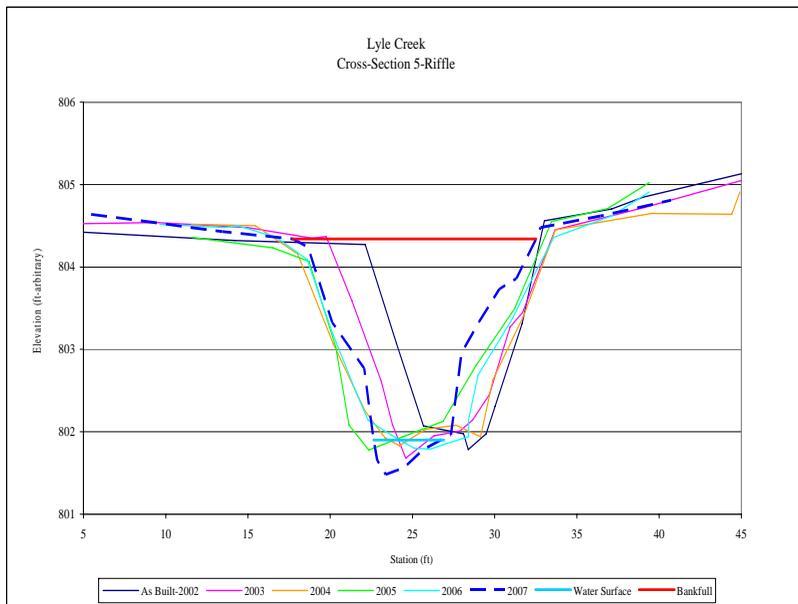
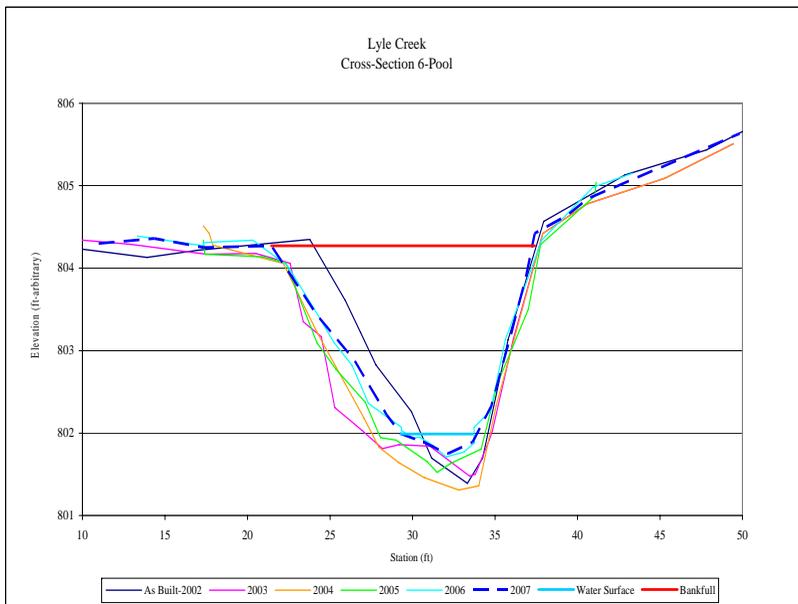
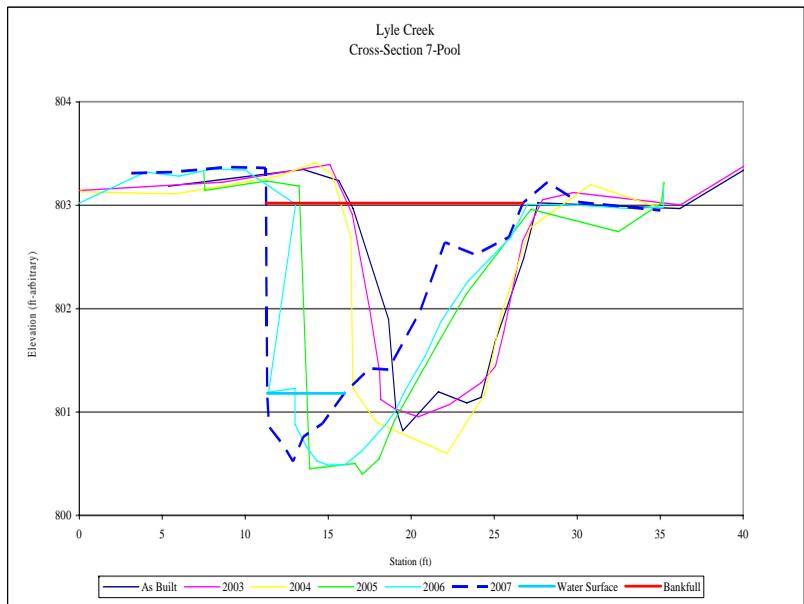
The lower reach was subjected to more stress than the upper reach in that there was more bank erosion, especially the lower 200 feet. The highly sinuous nature of this reach and the valley slope applied pressure on this reach, which exhibited some longitudinal bed migration, where riffles were being pushed downstream and the meander below would experience some erosion (~ 16% of the reach), but this appears to have slowed and arrested. The riffles in this reach exhibited some widening in 2004 ad 2005, but have exhibited narrowing below the top of bank in 2006 and 2007with the advancement of vegetation (See Figure below). This reach was also subjected to a headcut, which brought the channel bed down ~0.5 feet. These areas of instability have not changed appreciably in the last 3 years and it is believed that the mature trees that were maintained on the site and incorporated into design, where possible have achieved an equilibrium with the tight curvatures and the tighter E channel cross-section.
