**EEP Project Closeout Summary**

<b>Project ID &amp; Status</b>	
Project Name:	Trout Cove Branch and Tributary
EEP ID:	388
County:	Clay
Project Type:	Stream Restoration
Current Status:	5 years of monitoring complete

<p>Trout Cove Branch &amp; Tributary Restoration Closeout Clay County, North Carolina</p> <p>NCEEP # 388</p> <p>Date September 2010</p>	<ul style="list-style-type: none"> <li>

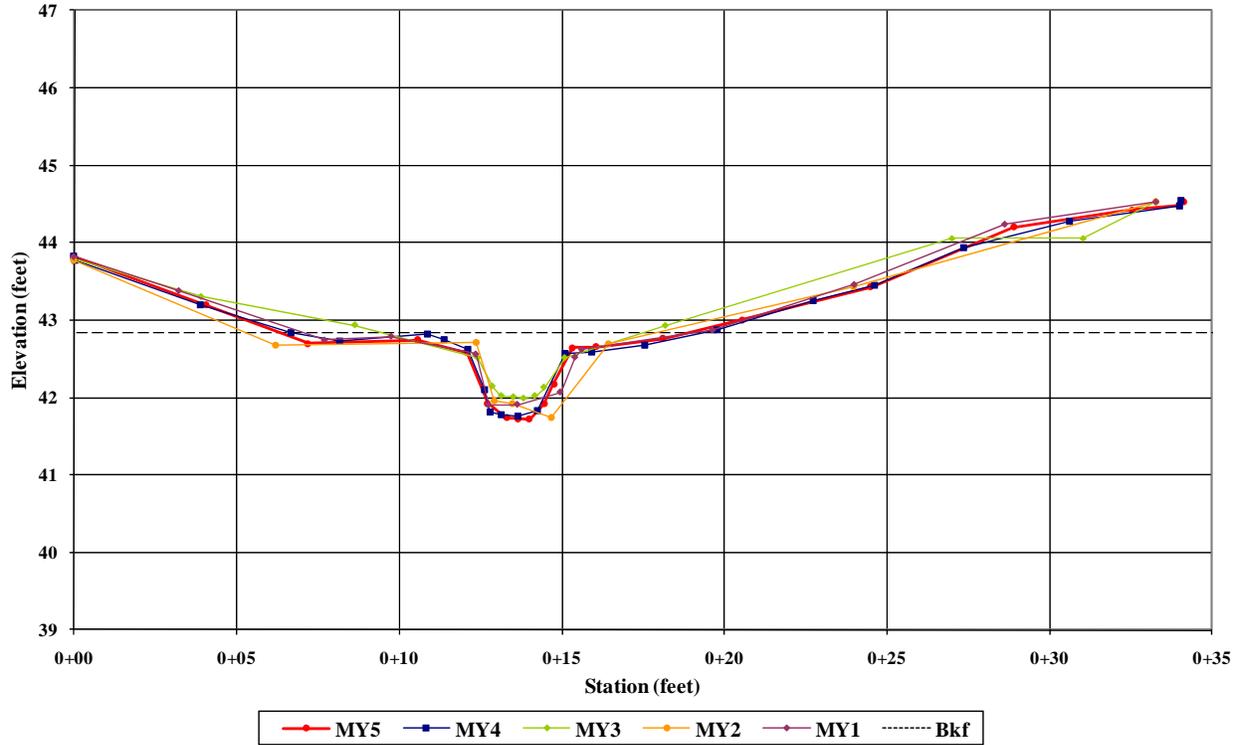
**Trout Cove Branch  
Cross-Section #3 - Riffle  
April 8, 2009**

<b>Riffle Cross-Sections</b>	<b>MY 1</b>	<b>MY 2</b>	<b>MY 3</b>	<b>MY 4</b>	<b>MY 5</b>
Cross-Section 3	3.5	4.2	2.7	3.6	3.9
Cross-Section 4	3.2	4.1	5.2	4.2	4.4
Cross-Section 5	1.8	4.0	3.3	3.9	2.7
