**INDEPENDENT CONSULTANT INSPECTION  
MAIN COOLING LAKE DAM,  
WEST ASH POND DAM AND AFTERBAY DAM  
ROXBORO ELECTRIC PLANT  
PERSON COUNTY, NORTH CAROLINA**

**PROGRESS ENERGY CAROLINAS**  
Raleigh, North Carolina

**MACTEC ENGINEERING AND CONSULTING, INC.**  
Raleigh, North Carolina

December 29, 2008

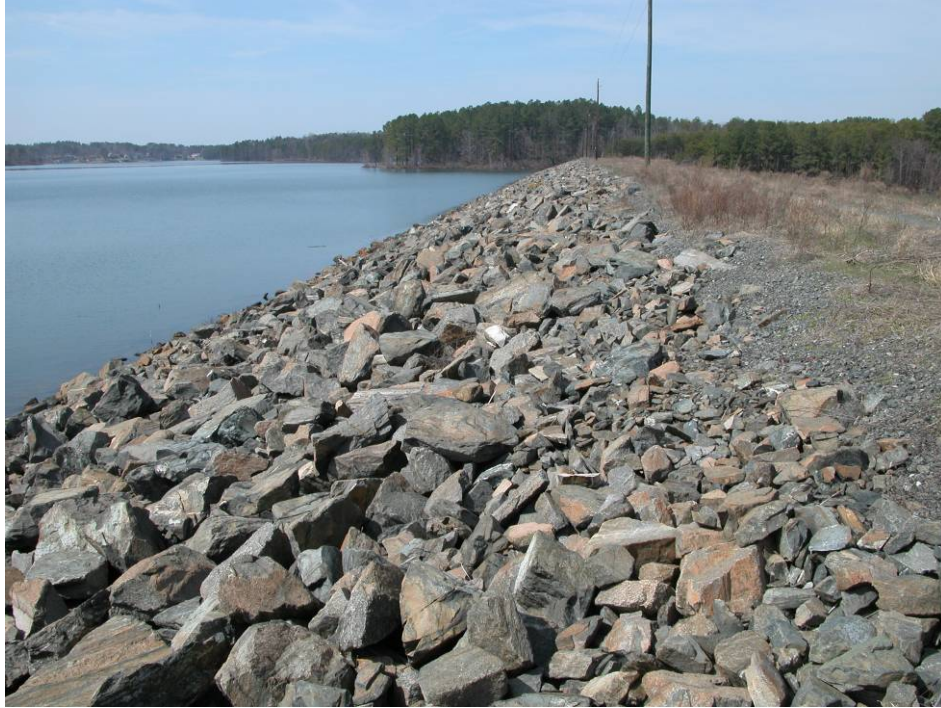
1. Main Dam – Crest and upstream slope looking west.

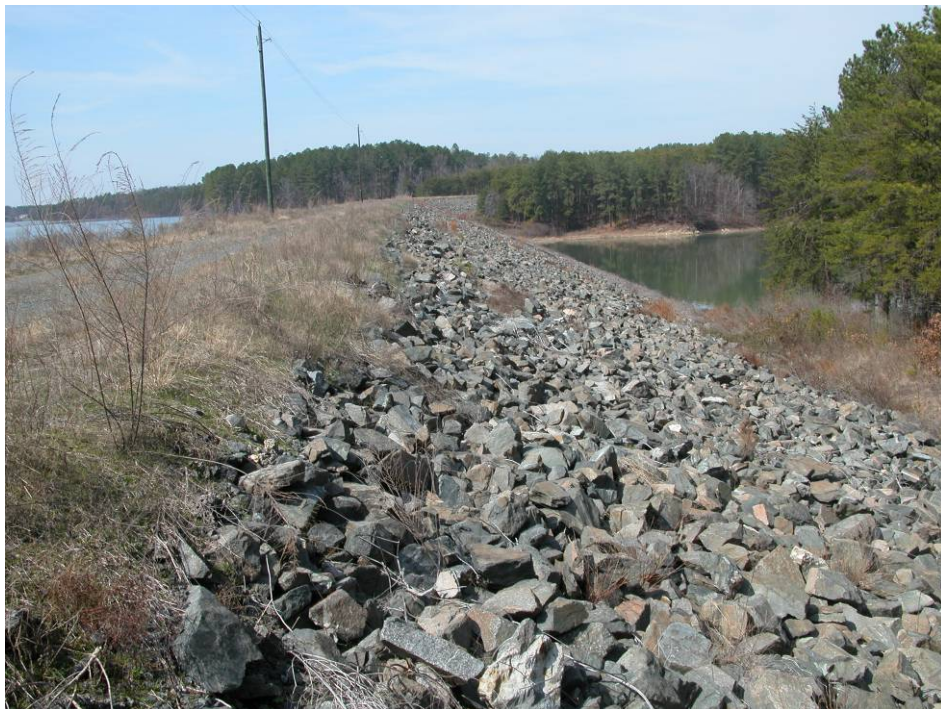
2. Main Dam – Crest and downstream slope looking west.

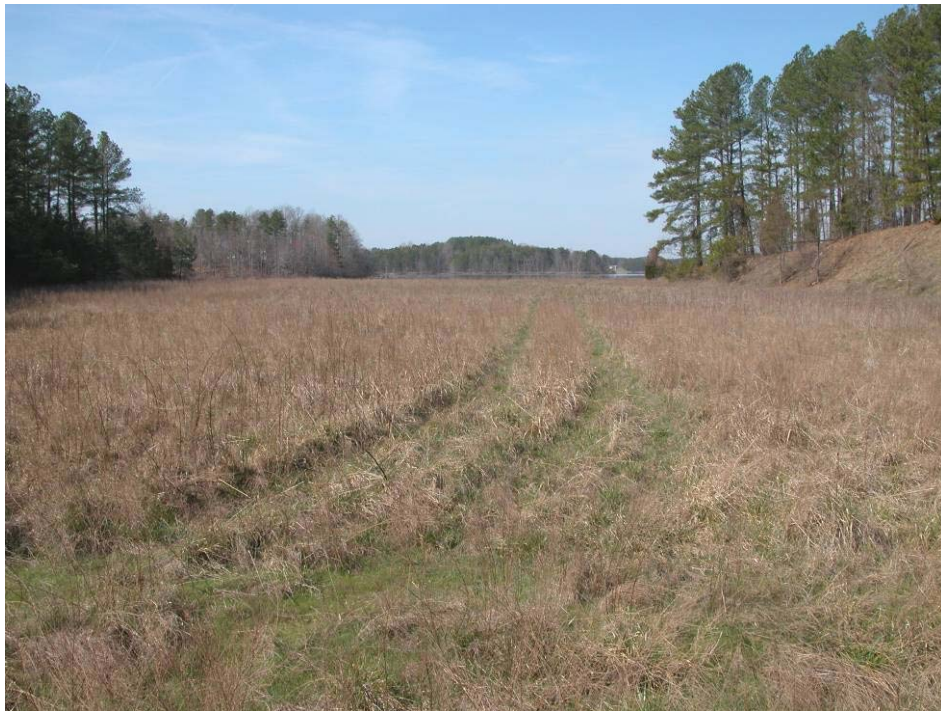
6. Main Dam – Emergency spillway looking toward lake.

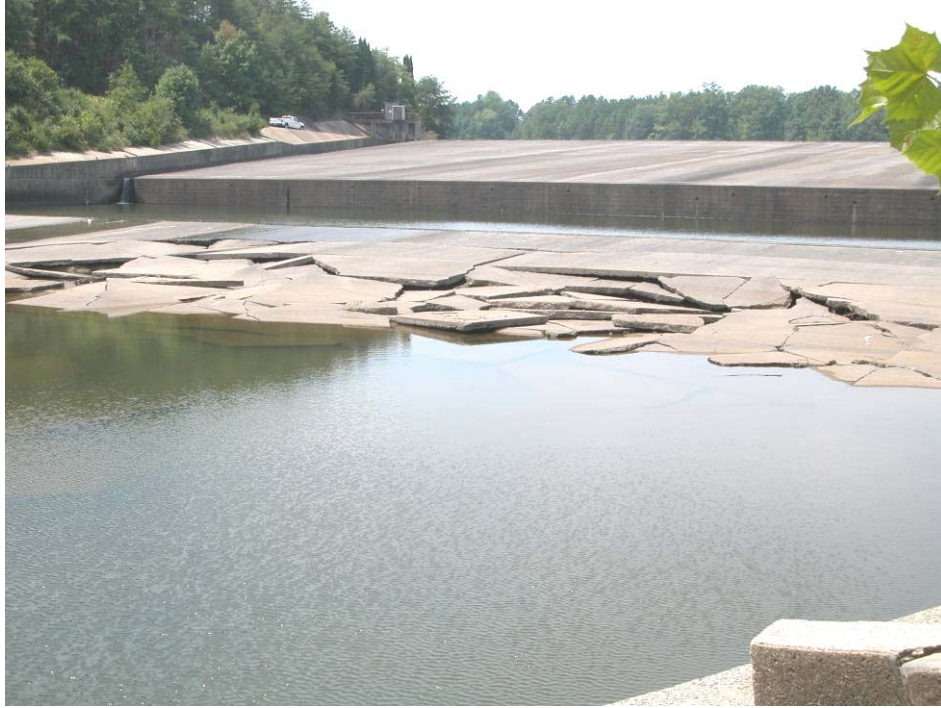
9. Main Dam – Lower spillway (August 5, 2008).

Overall, the main dam and the associated spillways are in good condition. Except for maintenance items, no repairs are needed at this time; however, a plan to implement general caulk refurbishment and sealing for the joints at the primary spillway is recommended for implementation within the next 5 years.

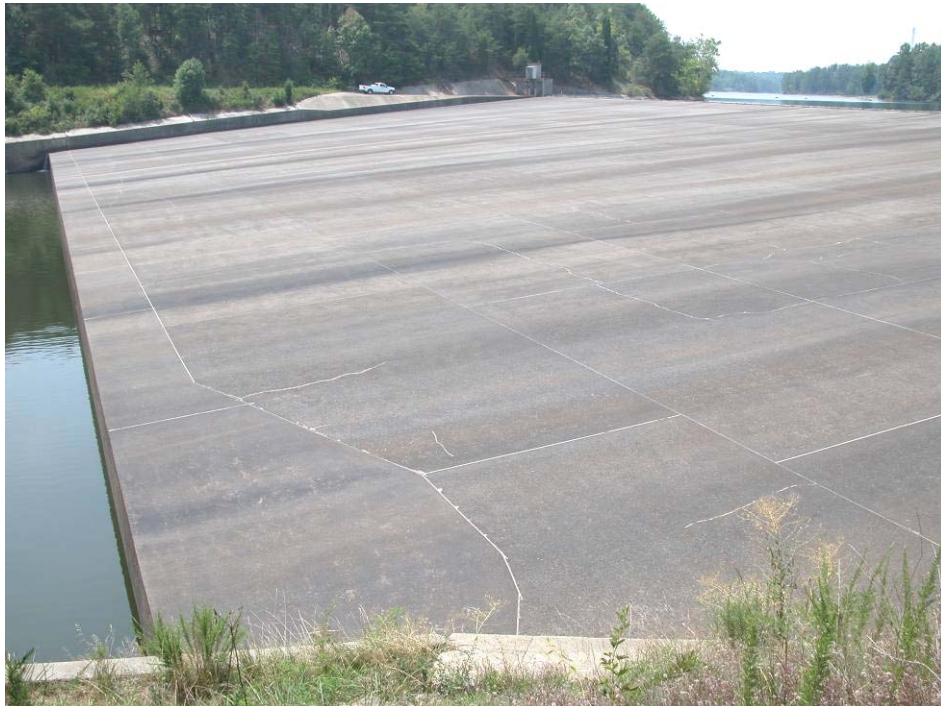
10. Main Dam – Lower spillway from left wall (August 5, 2008).

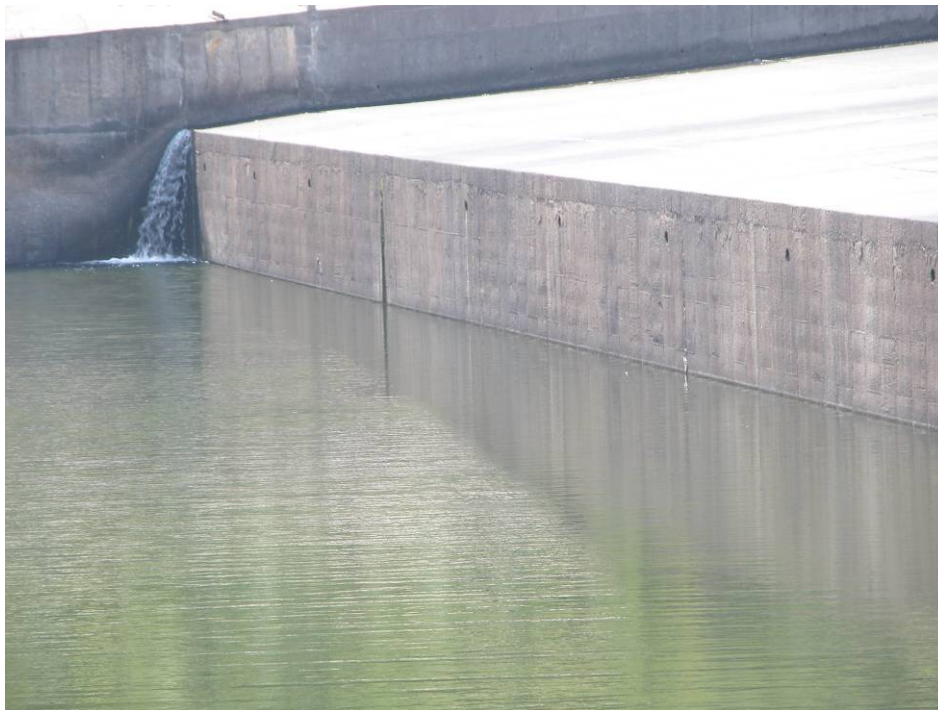
11. Main Dam – Drop wall (August 5, 2008).

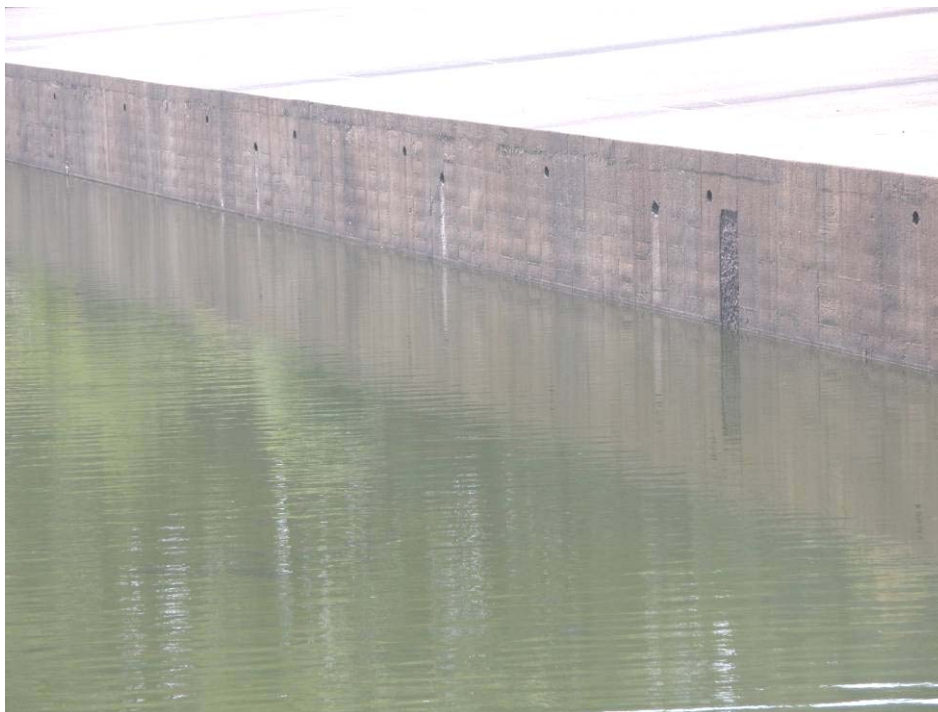
12. Main Dam – Drop wall (August 5, 2008).

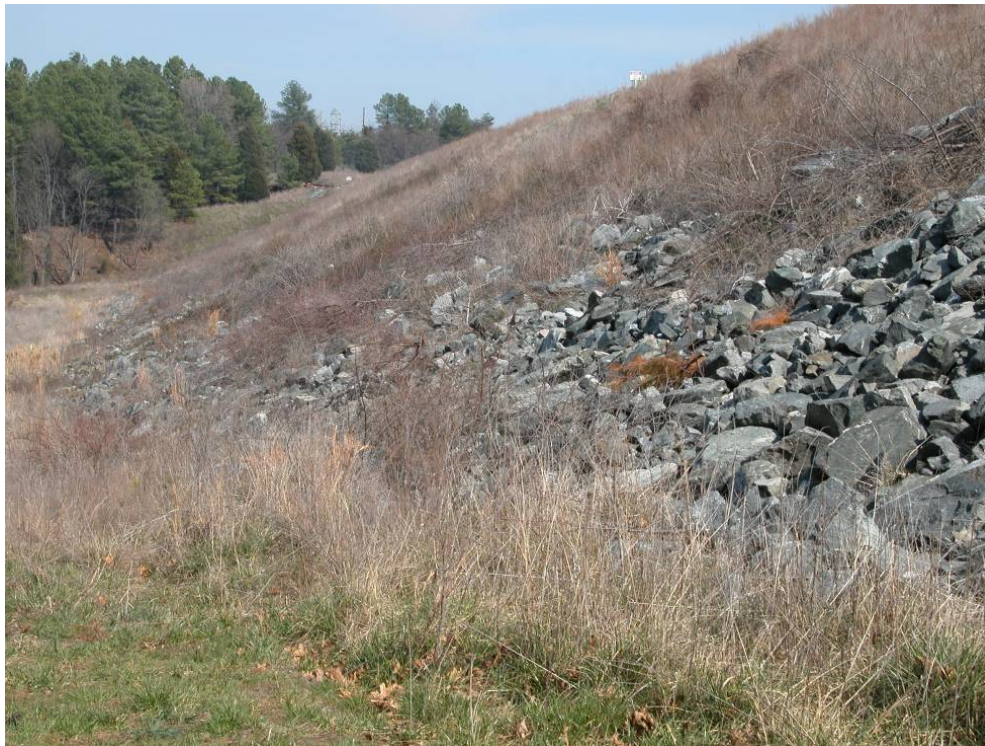
28. West Ash Pond Dam – Downstream slope and toe.

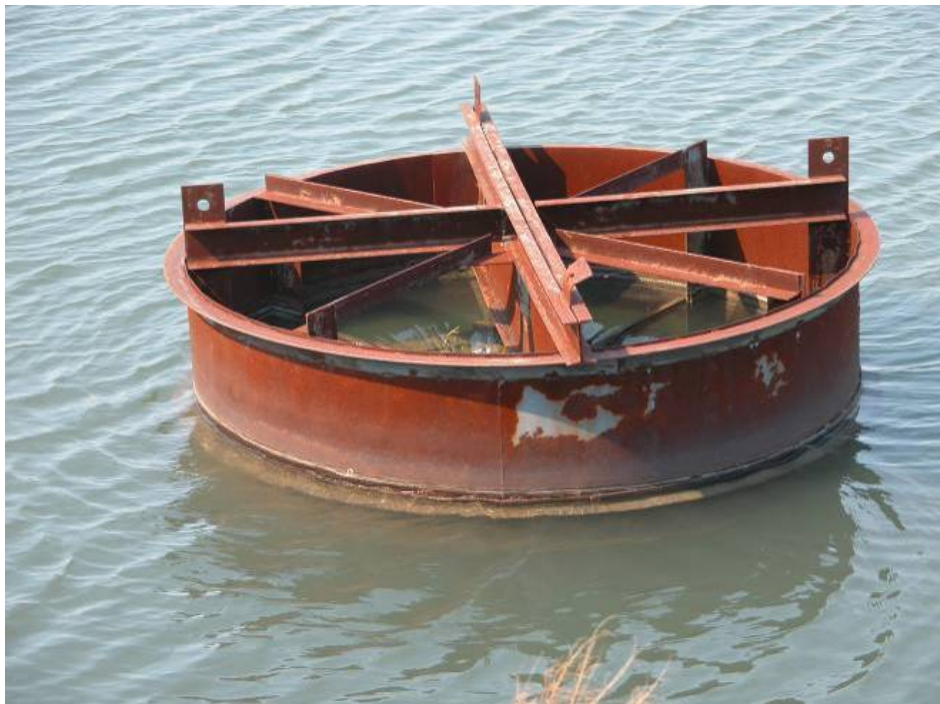
34. West Ash Pond Dike No. 1 – West skimmer.

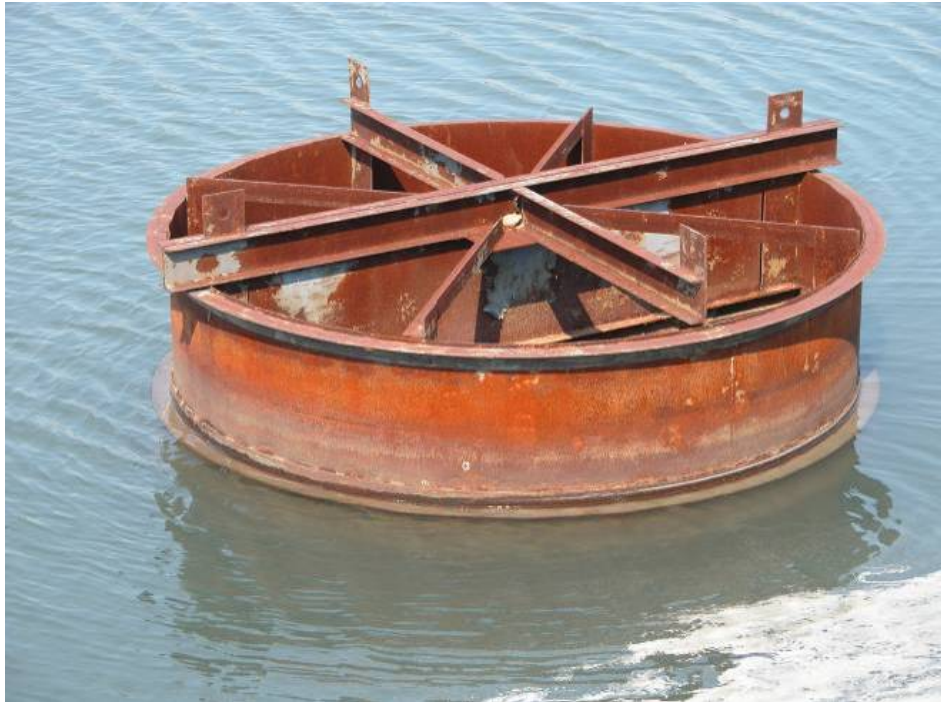
35. West Ash Pond Dike No. 1 – East skimmer.

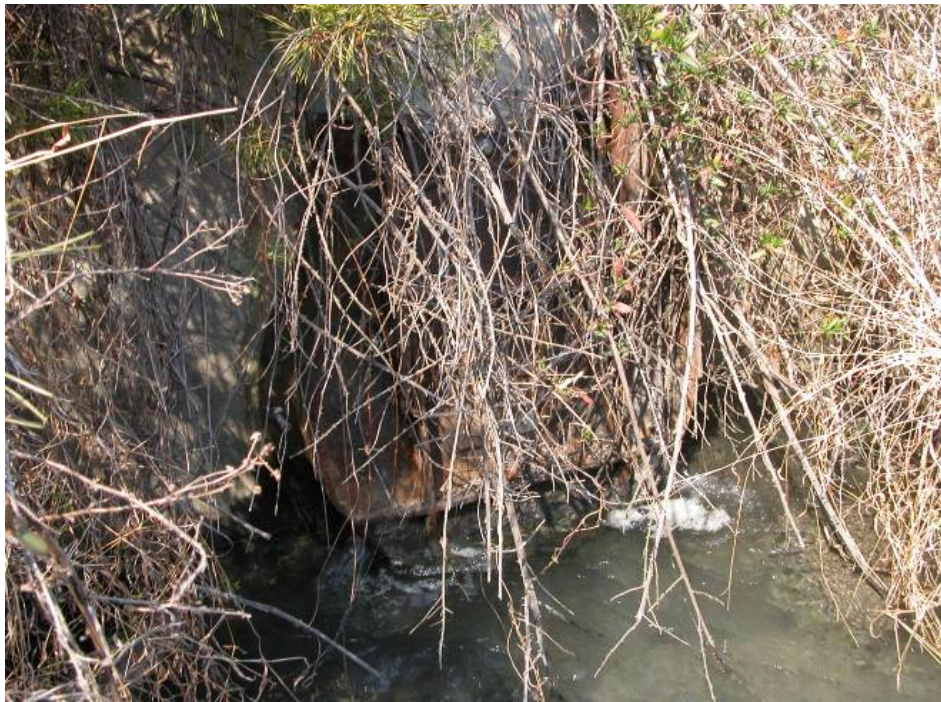
36. West Ash Pond Dike No. 1 – West flap gate.

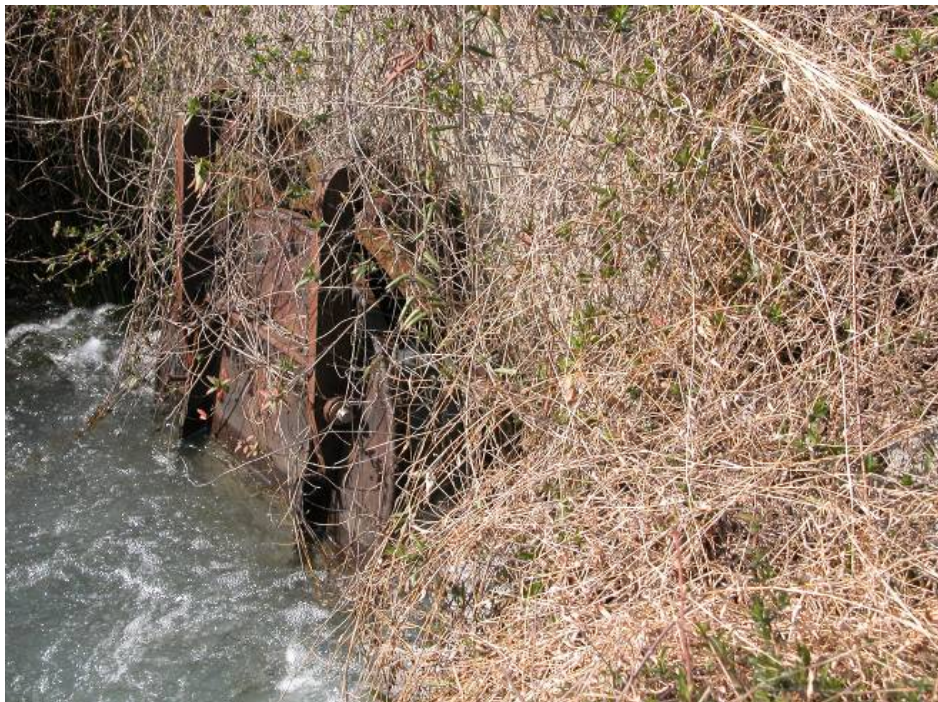
37. West Ash Pond Dike No. 1 – East flap gate.

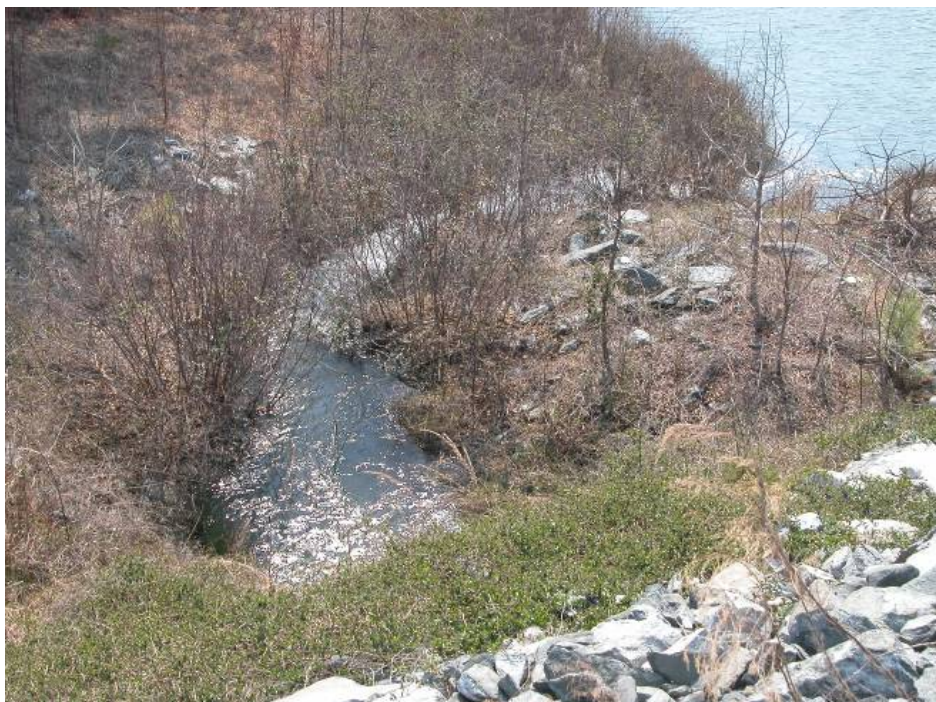
38. West Ash Pond Dike No. 1 – West outflow channel.

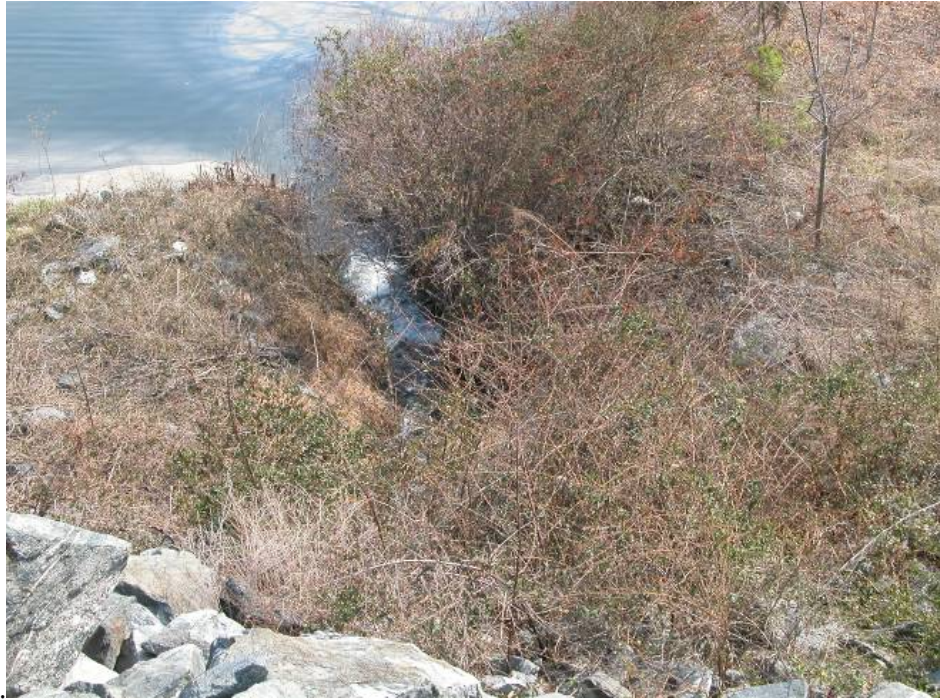
39. West Ash Pond Dike No. 1 – East outflow channel.

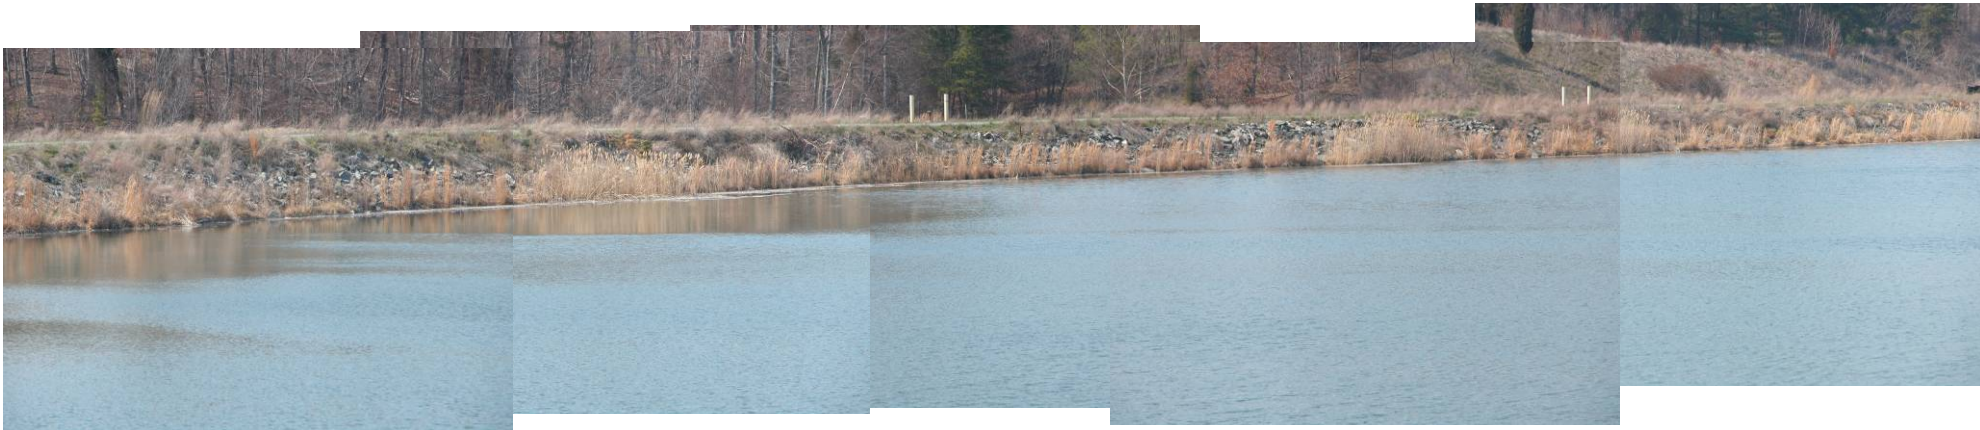
40. West Ash Pond Dike No. 4 –Interior slope.

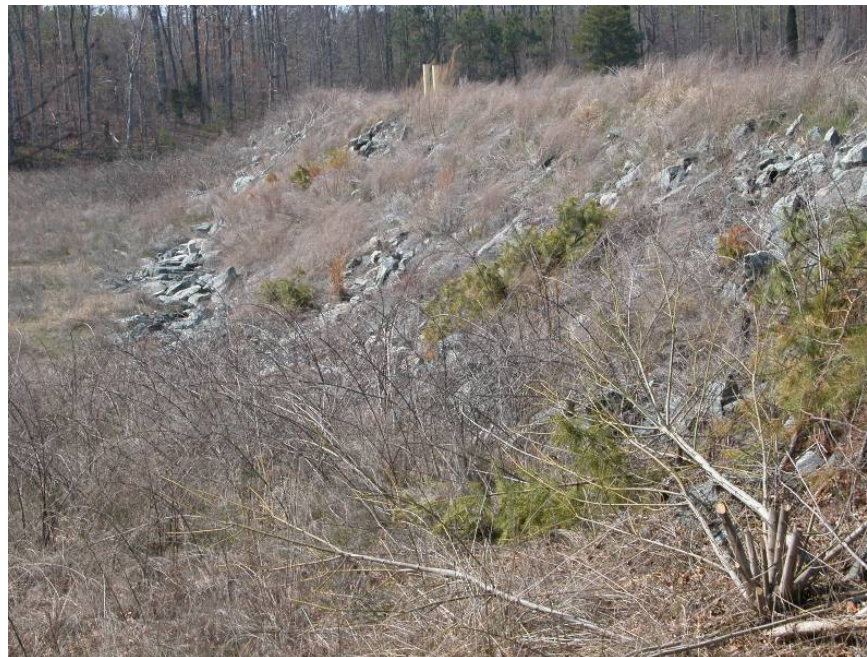
41. West Ash Pond Dike No. 4 – Exterior slope.

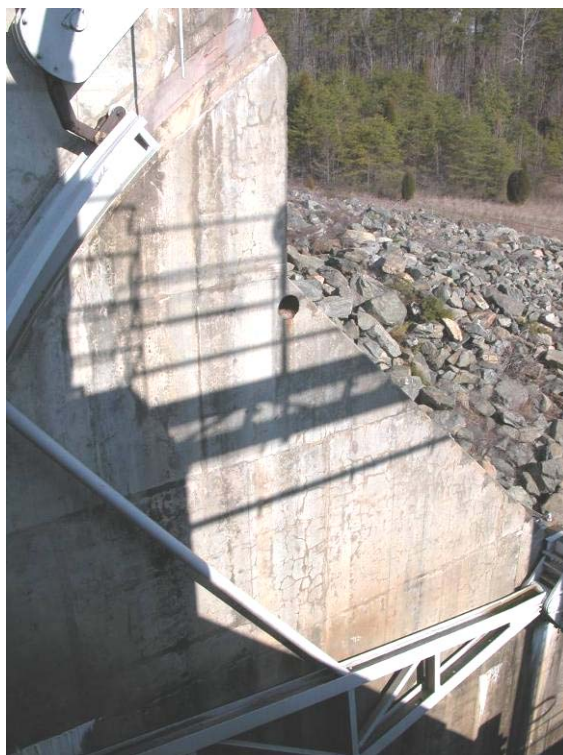
43. Afterbay Dam – West side Pier 1.

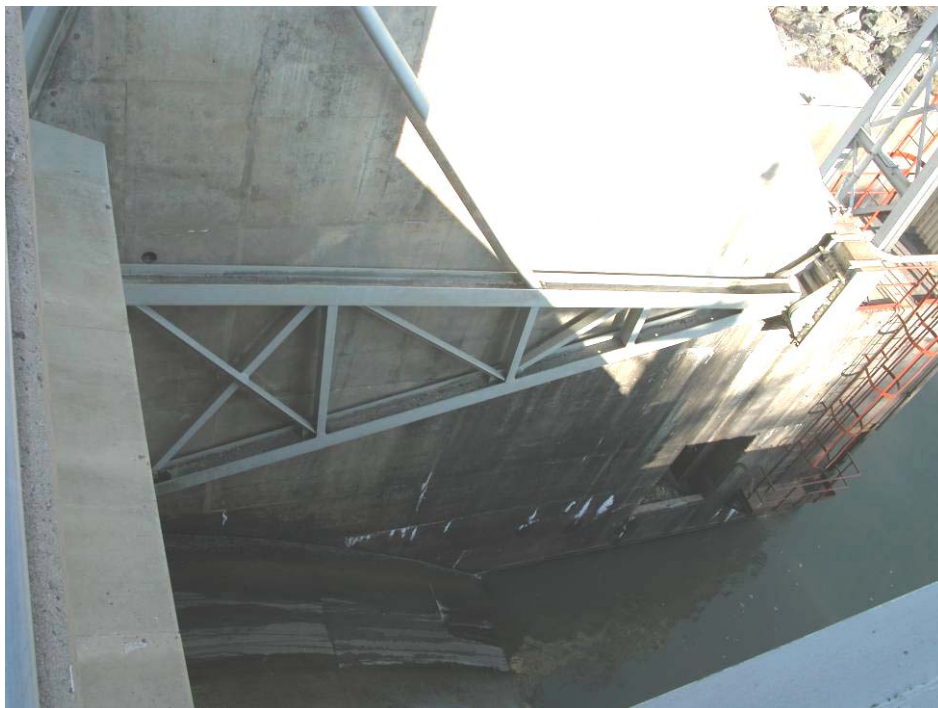
45. Afterbay Dam – West side Pier 2.

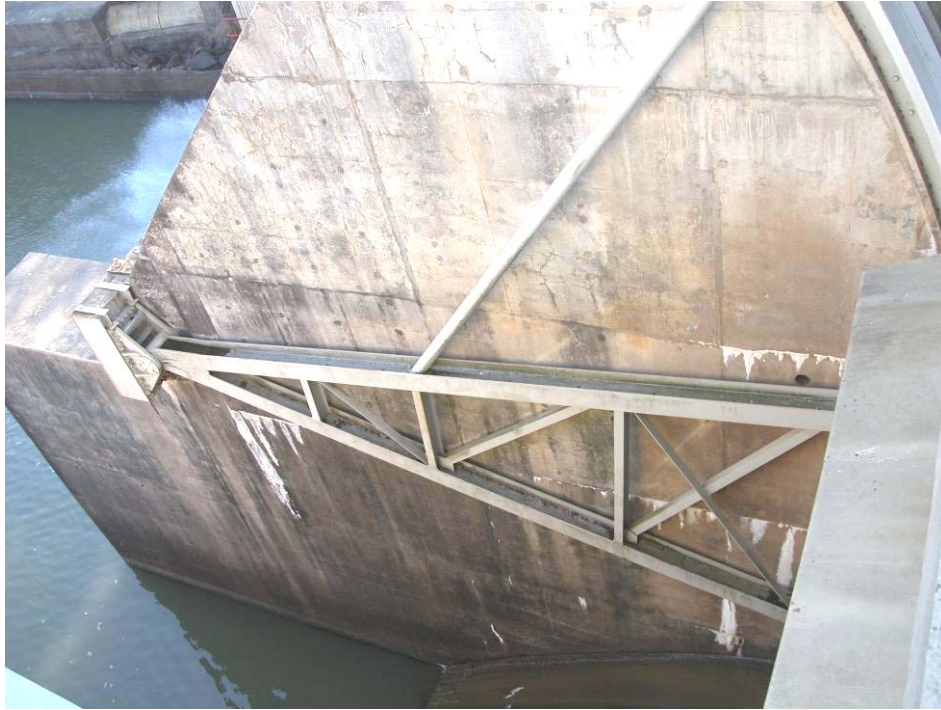
46. Afterbay Dam – East side Pier 3.

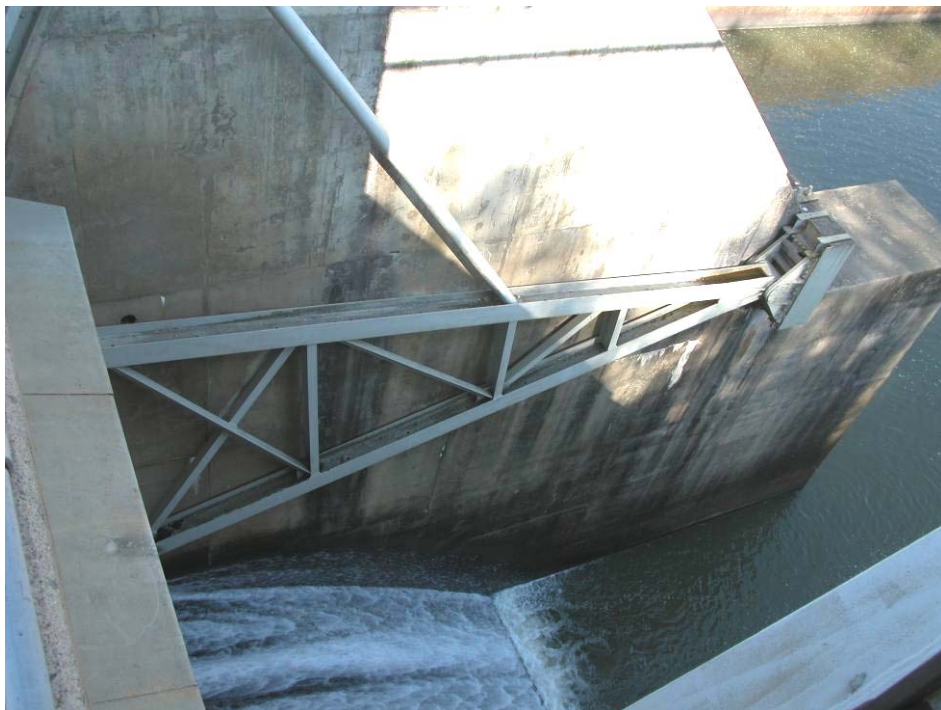
47. Afterbay Dam – West side Pier 3.

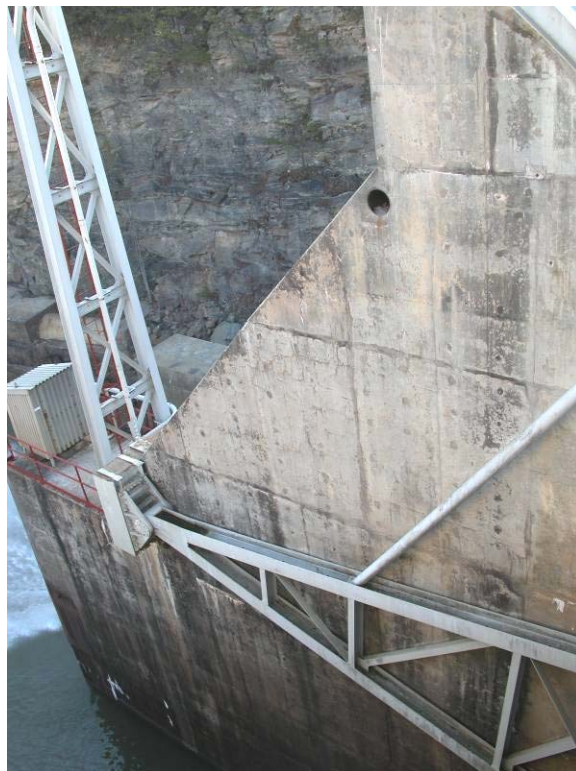
48. Afterbay Dam – East side Pier 4.

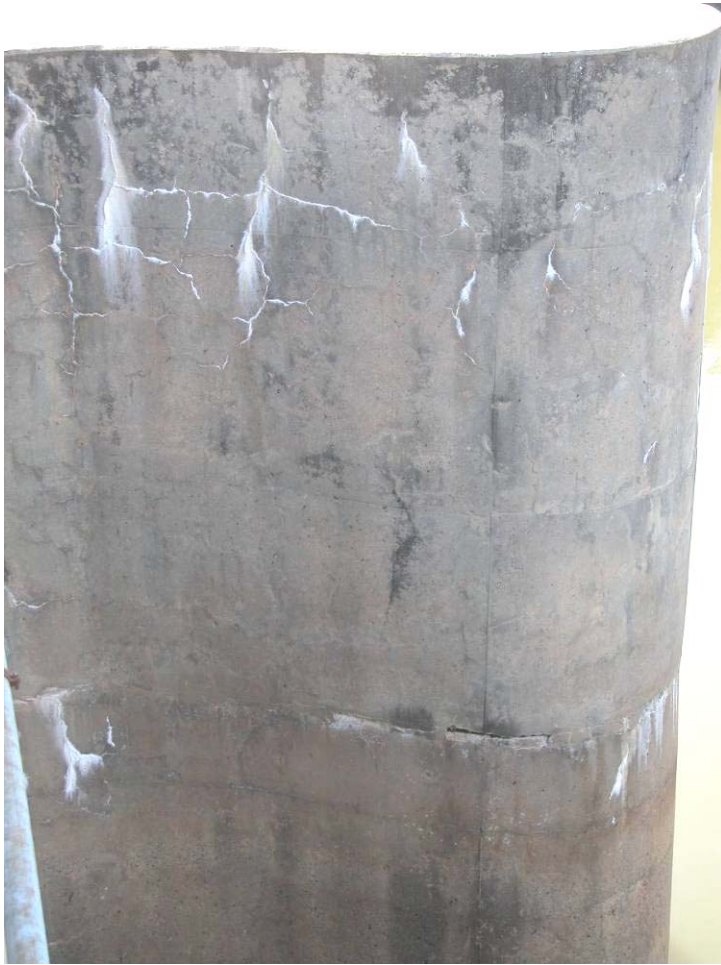
52. Afterbay Dam – East side Pier 1, upstream.

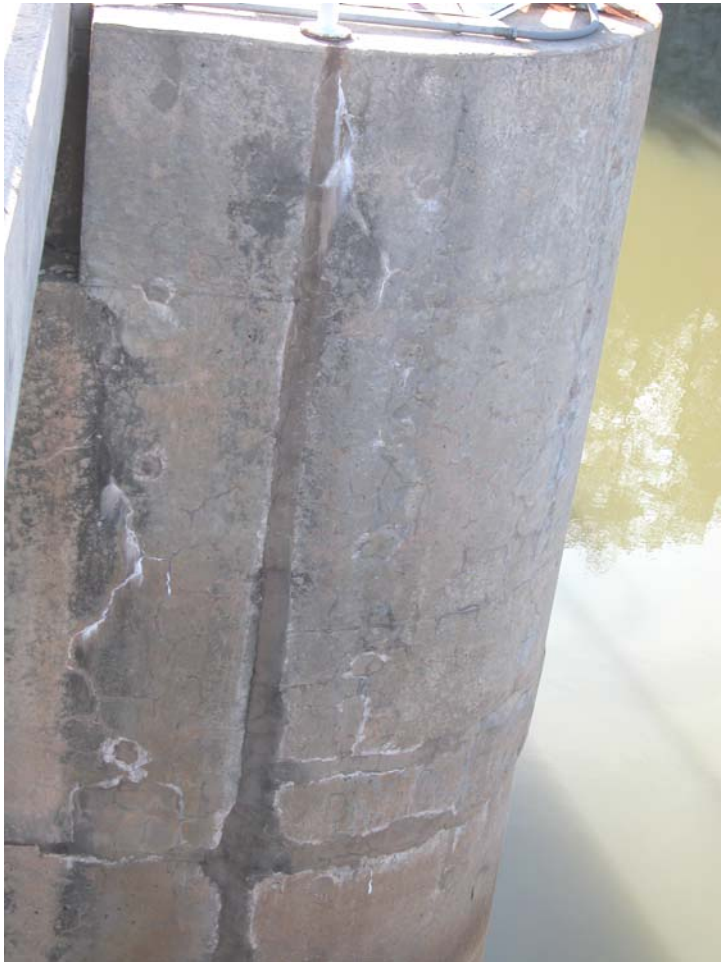
54. Afterbay Dam – East side Pier 2, upstream.

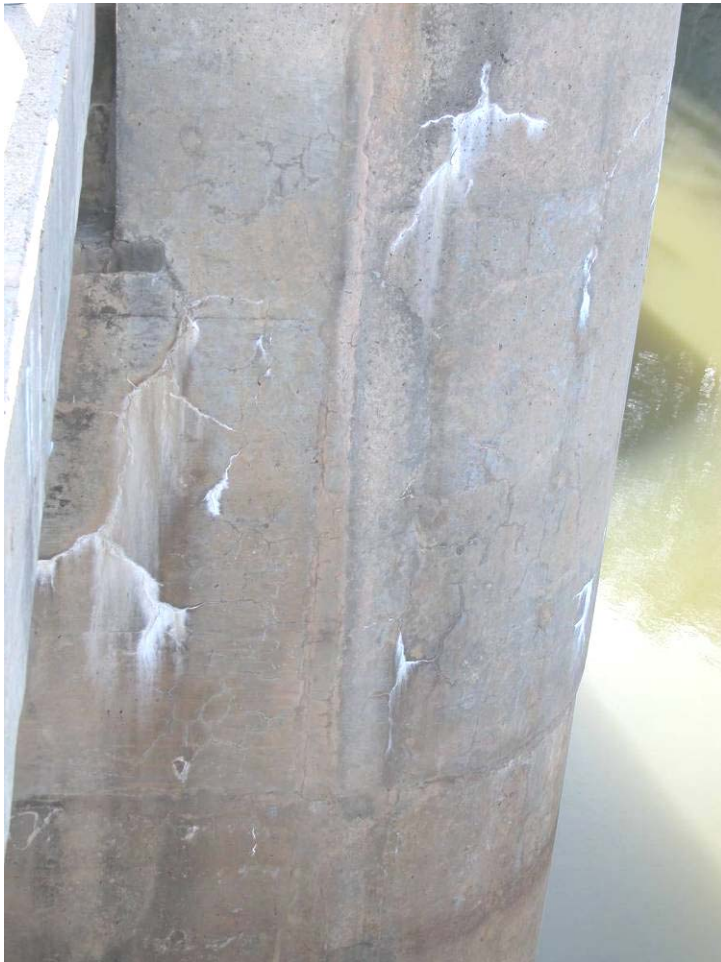
56. Afterbay Dam – East side Pier 3, upstream.

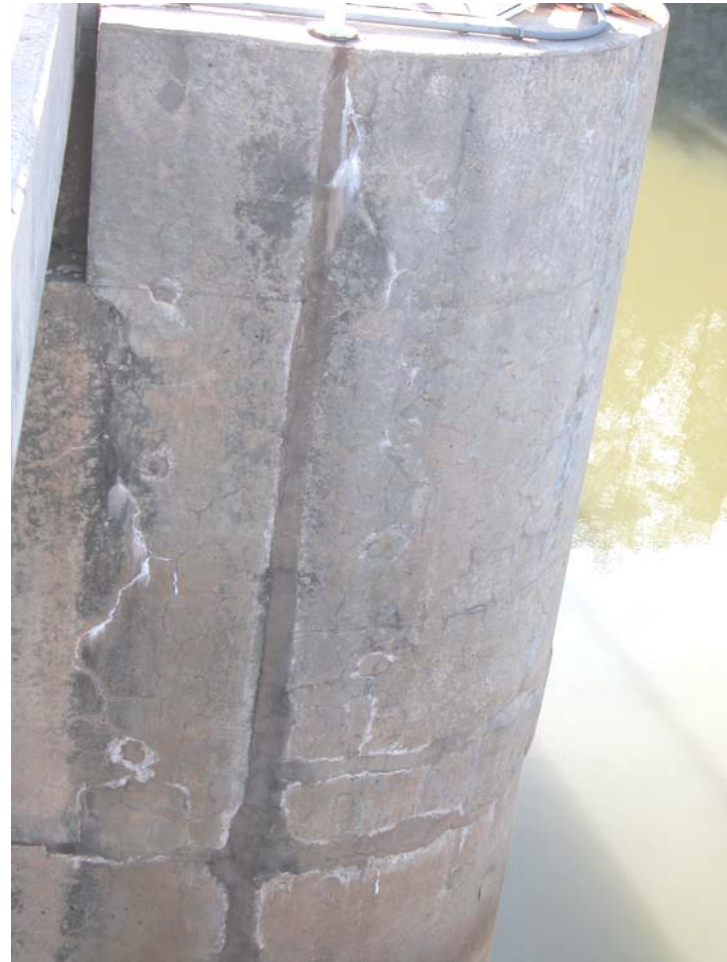
57. Afterbay Dam – West side Pier 3, upstream.

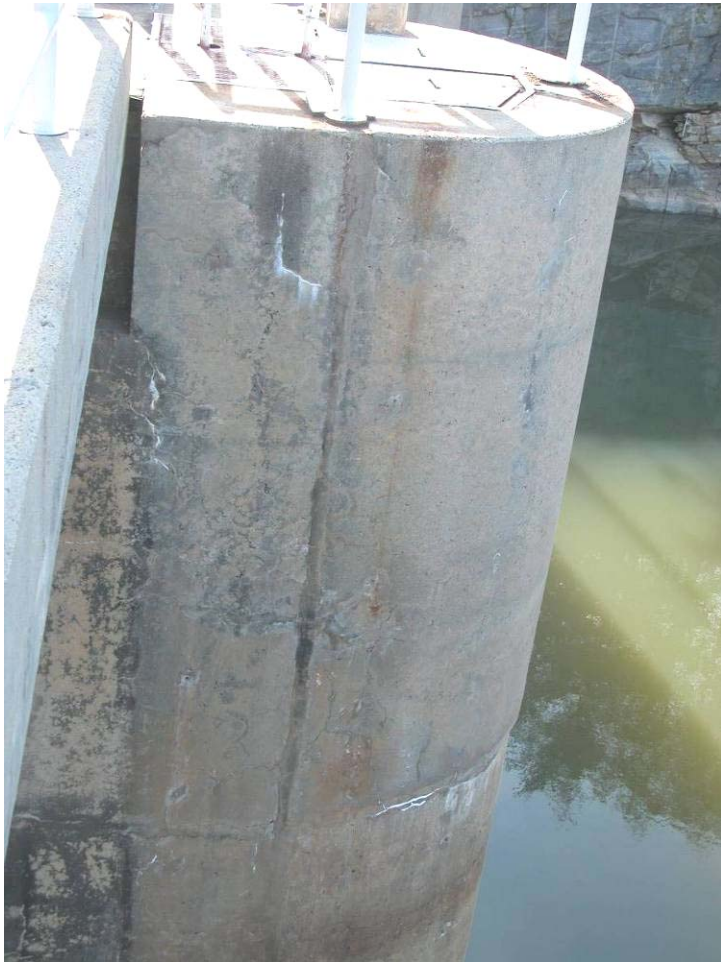
58. Afterbay Dam – East side Pier 4, upstream.

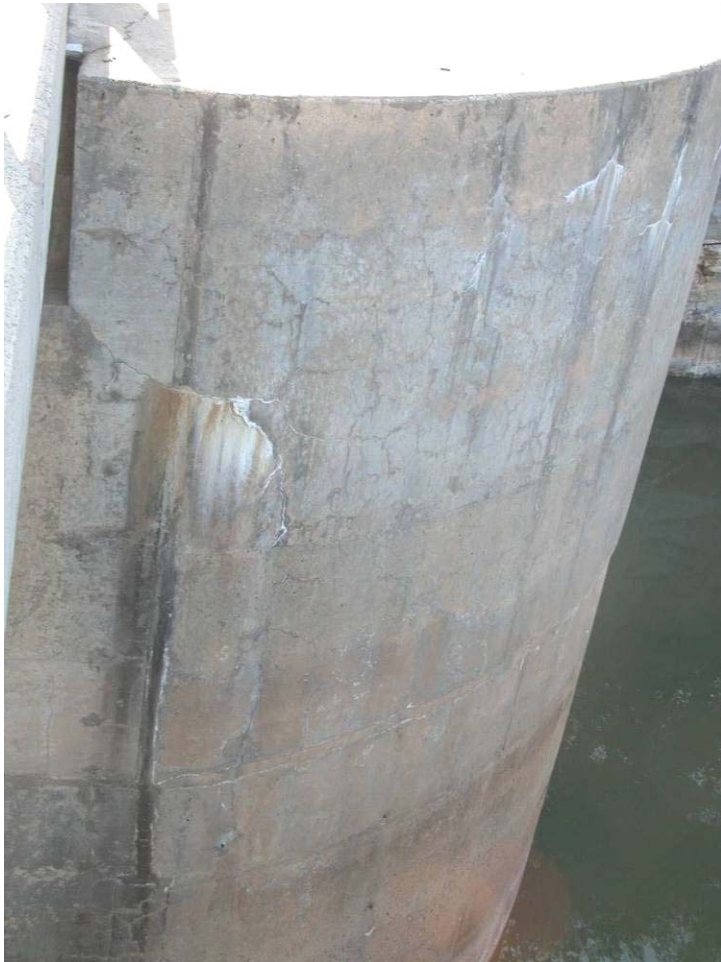
60. Afterbay Dam – East side Pier 5, upstream.

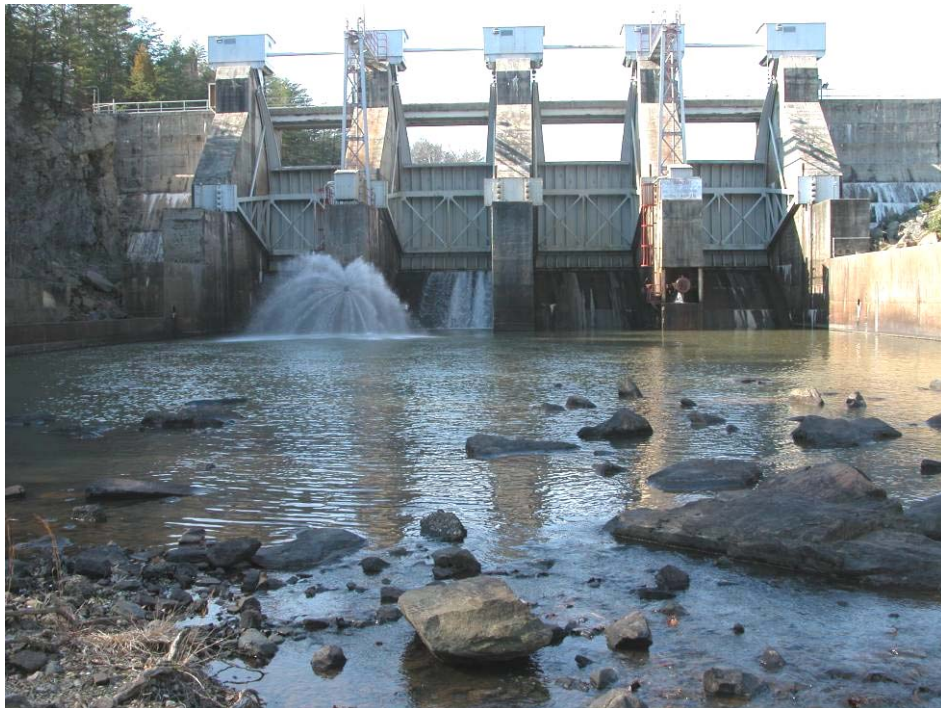
67. Afterbay Dam – General view of downstream concrete section.

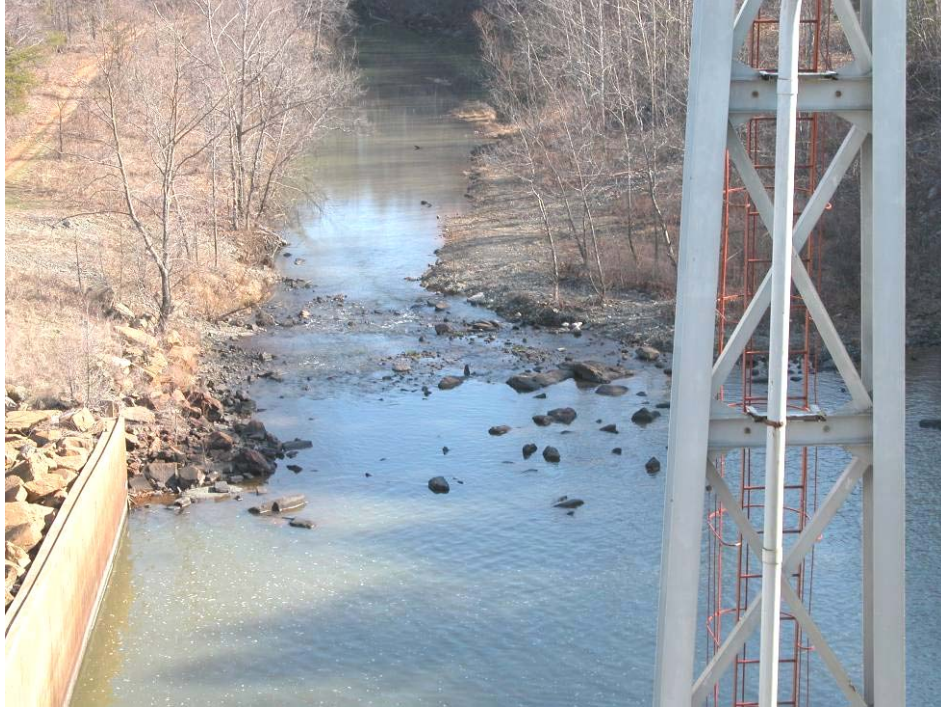
68. Afterbay Dam – View of downstream channel, no major obstructions.

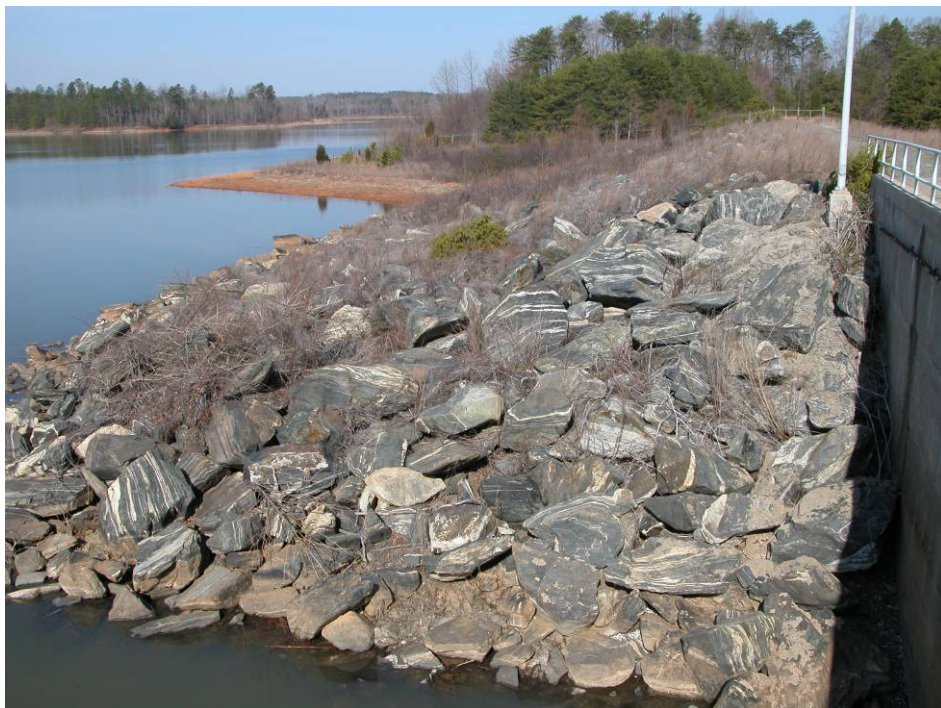
69. Afterbay Dam – View of upstream slope earth embankment section.
