**SEVENTH
FIVE-YEAR INDEPENDENT CONSULTANT
INSPECTION REPORT
(PER THE NORTH CAROLINA UTILITIES COMMISSION)**

**DUKE ENERGY
ALLEN STEAM STATION
253 Plant Allen Road
Belmont, North Carolina 28012
S&ME PROJECT NO. 1411-07-152**

Reference: **Five-year Independent Consultant Inspection Report**
Ash Basin Dikes, Allen Steam Station
Belmont, North Carolina
S&ME Project No. 1411-07-152

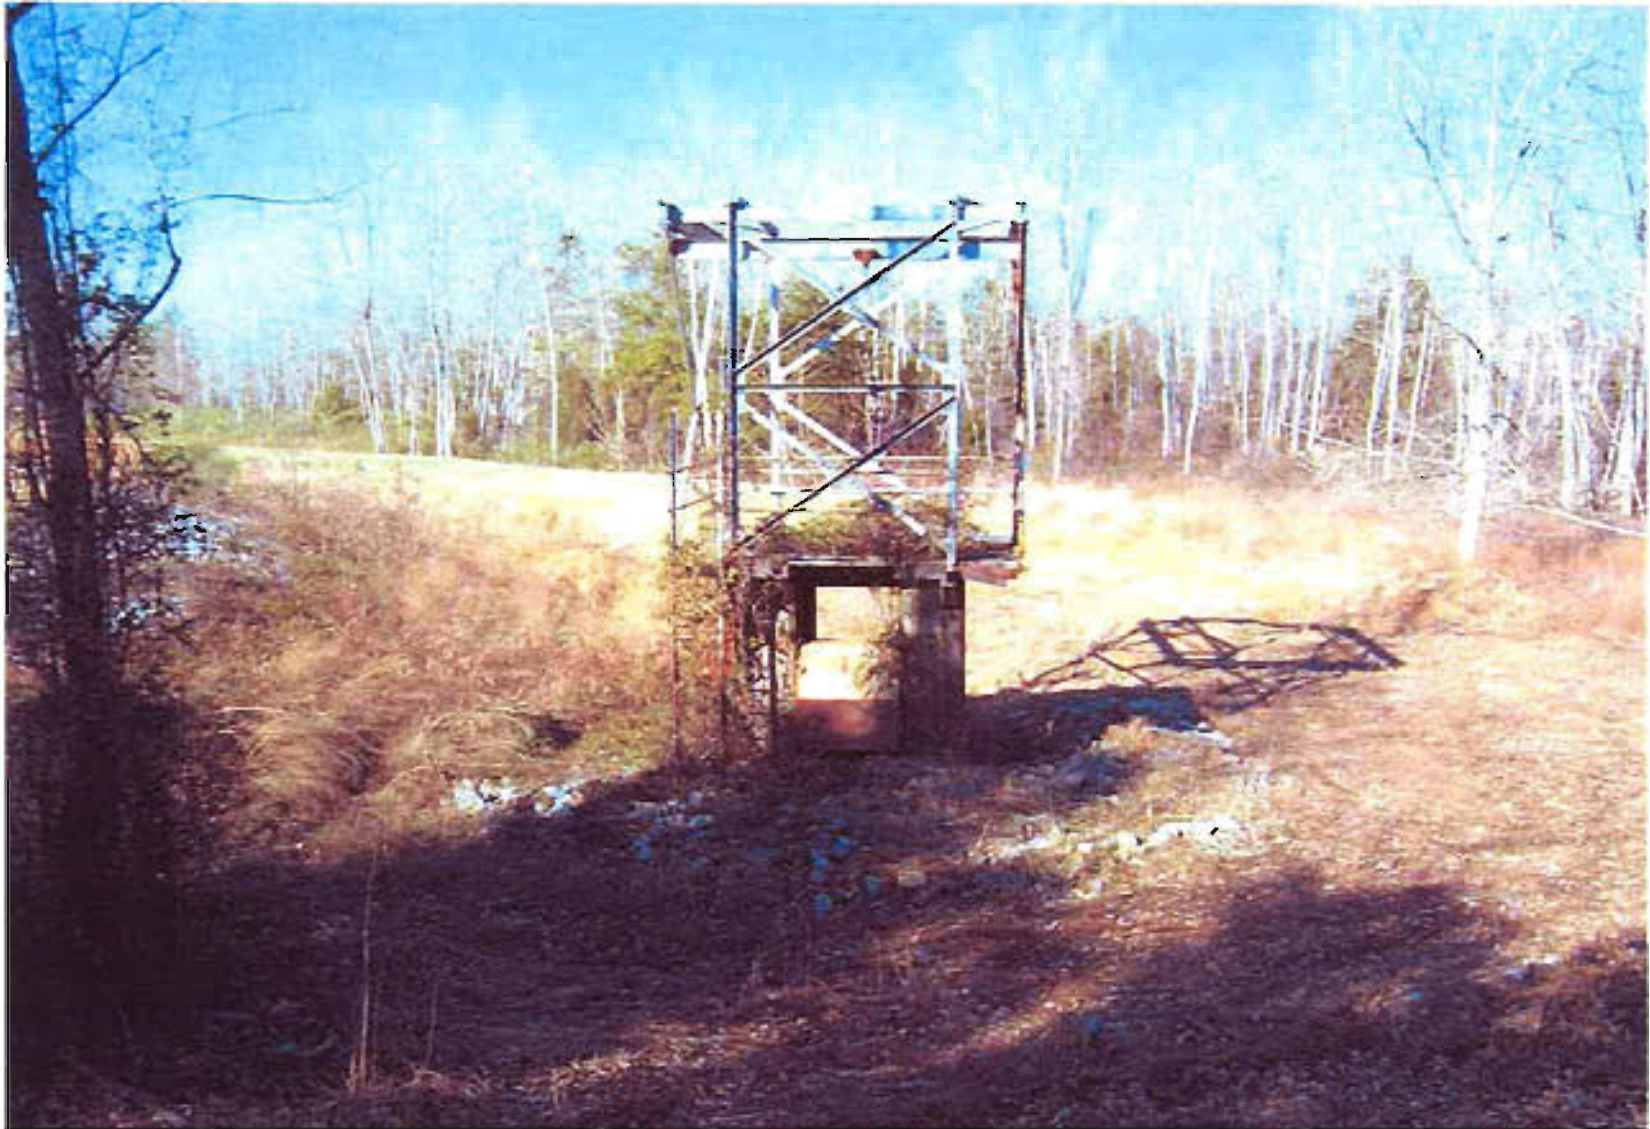
Location: North Dike
Description: Retired Ash Basin outlet structure

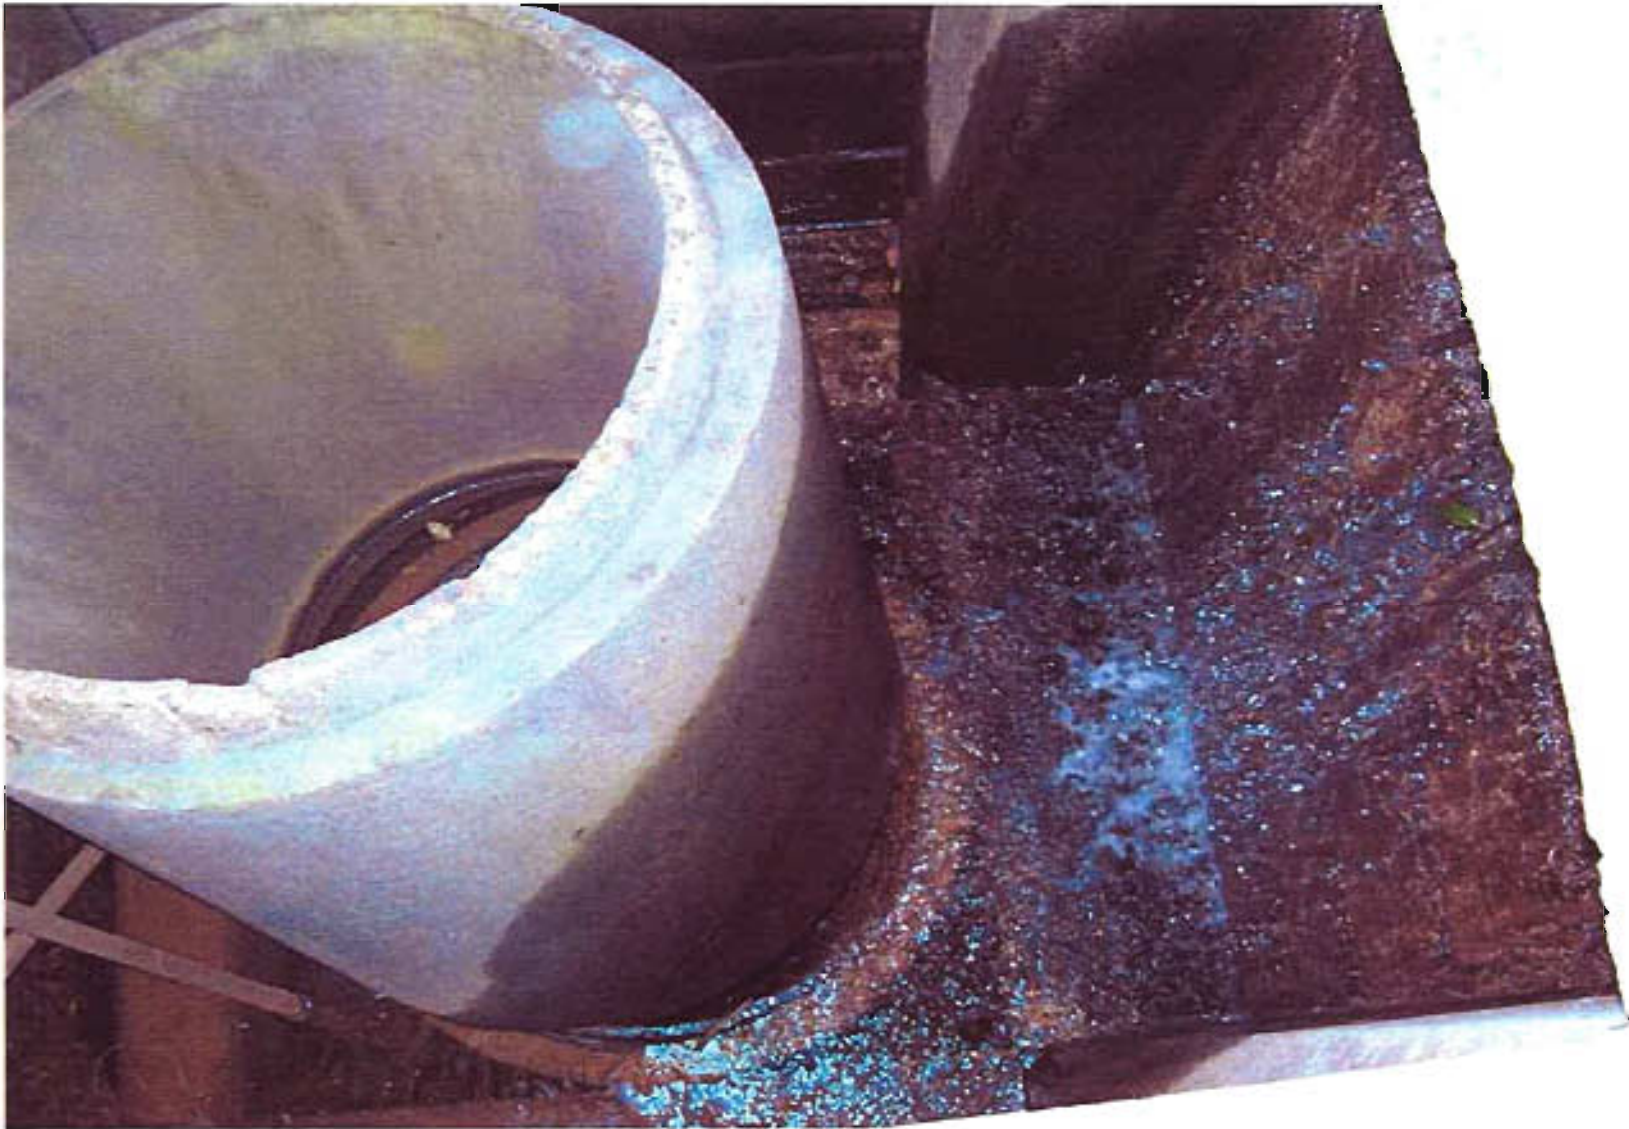
Site drainage from the Retired Ash Basin and associated upslope areas are controlled in a channel that runs along the downstream toe of the North Dike. The outlet structure is similar in design to the Active Ash Basin outlet structure (Figure 9). Only one weir on the structure was activating at the time of our site visit, and the interior vertical intake conduit has been displaced (Figure 10). No hydrologic or hydraulic calculations were reviewed for this structure. We understand that issues related to the Retired Ash Basin overflow structure will be addressed with future development of a proposed landfill within the area of the Retired Ash Basin.

Location: North Dike
Description: Retired Ash Basin outlet structure - interior

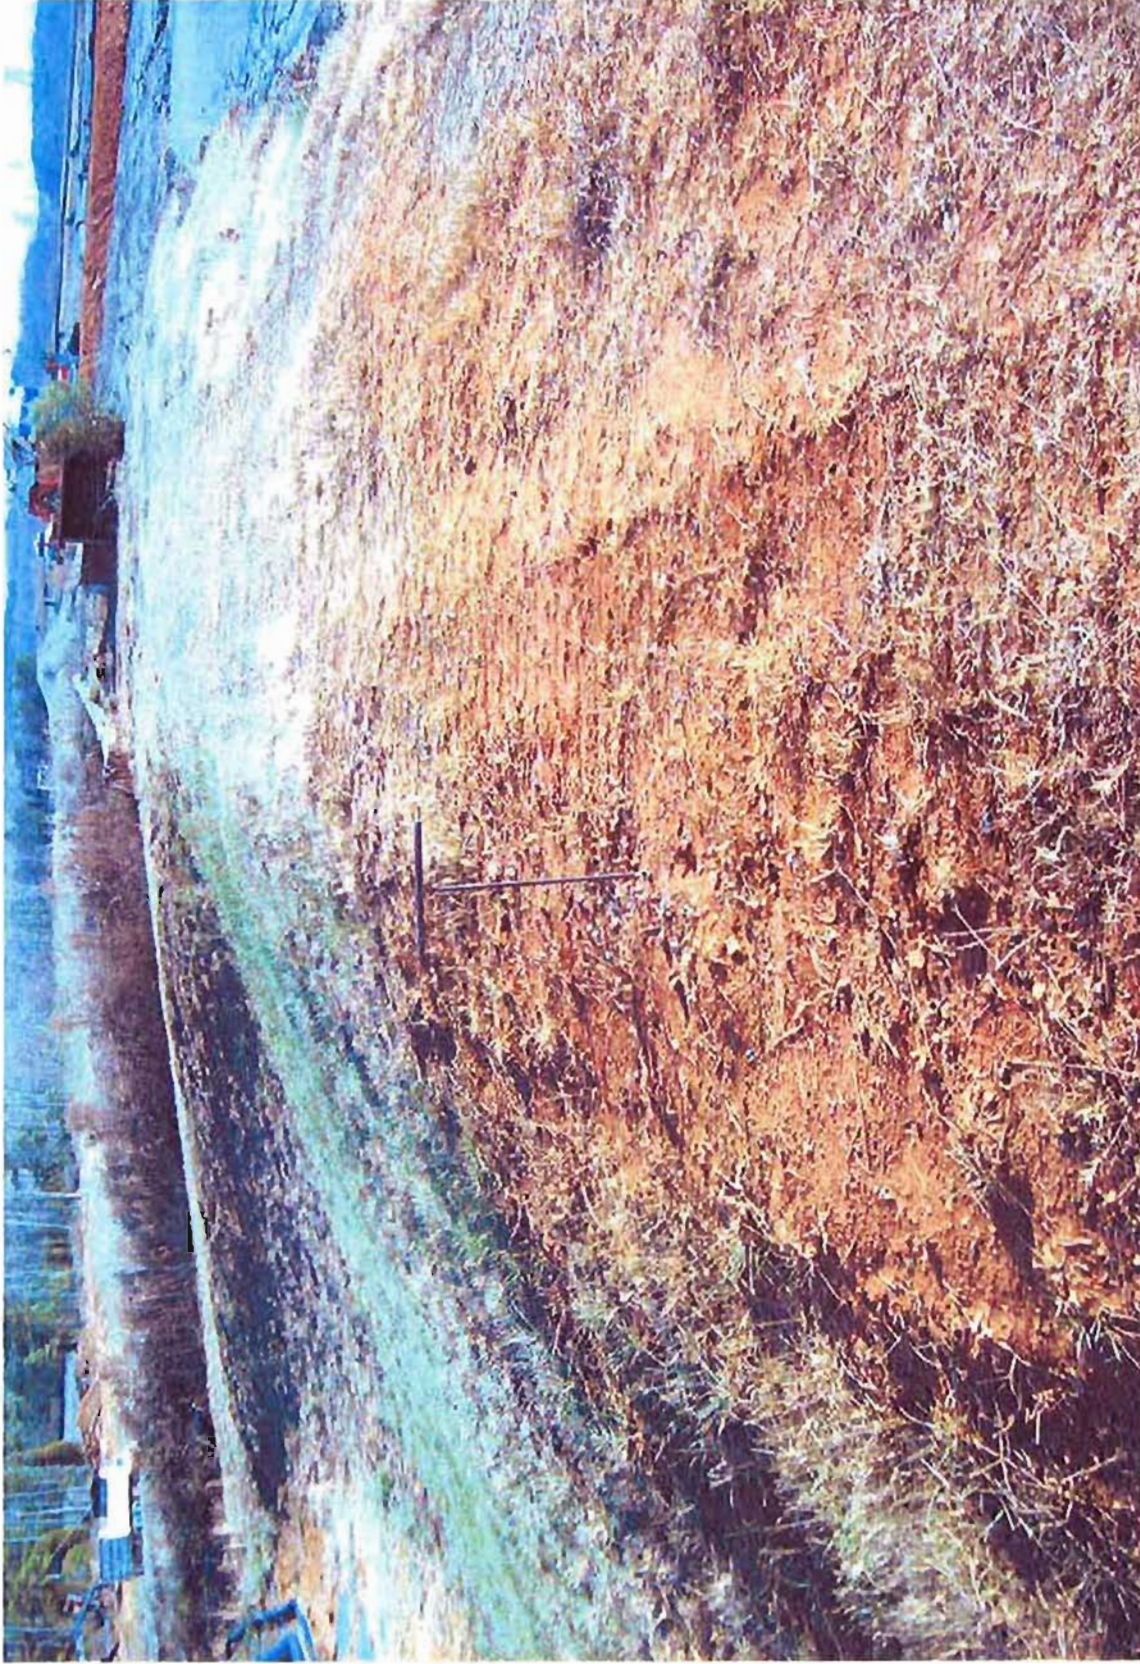
SCALE: NTS CHECKED BY: DRAWN BY: JFG DATE: 5/15/2008		Location: North Dike Crest - looking east from axis bend to access road Description: Area of sparse vegetation		Active Ash Basin Dikes Five-year Indep. Consultant Inspection ALLEN STEAM STATION JOB NO. 1411-07-152		FIGURE NO. <h1>15</h1>
---	--	--	--	--	--	----------------------------------

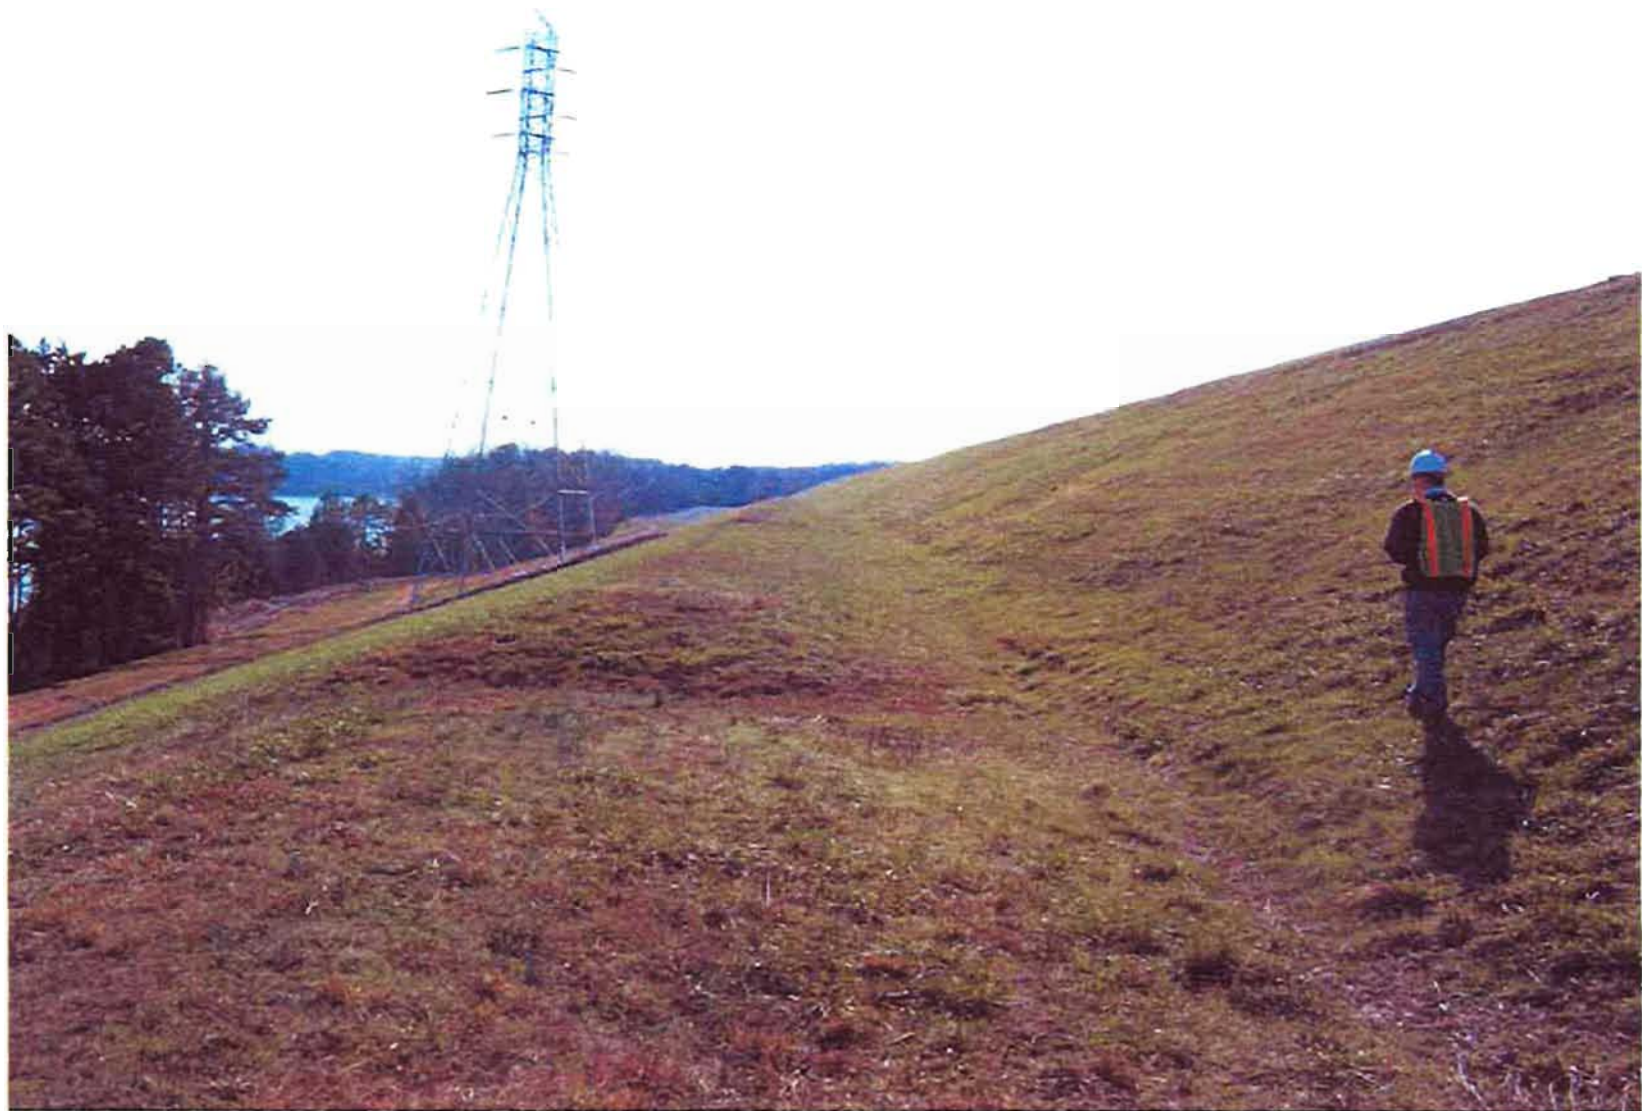
Location: East Dike downstream embankment looking south

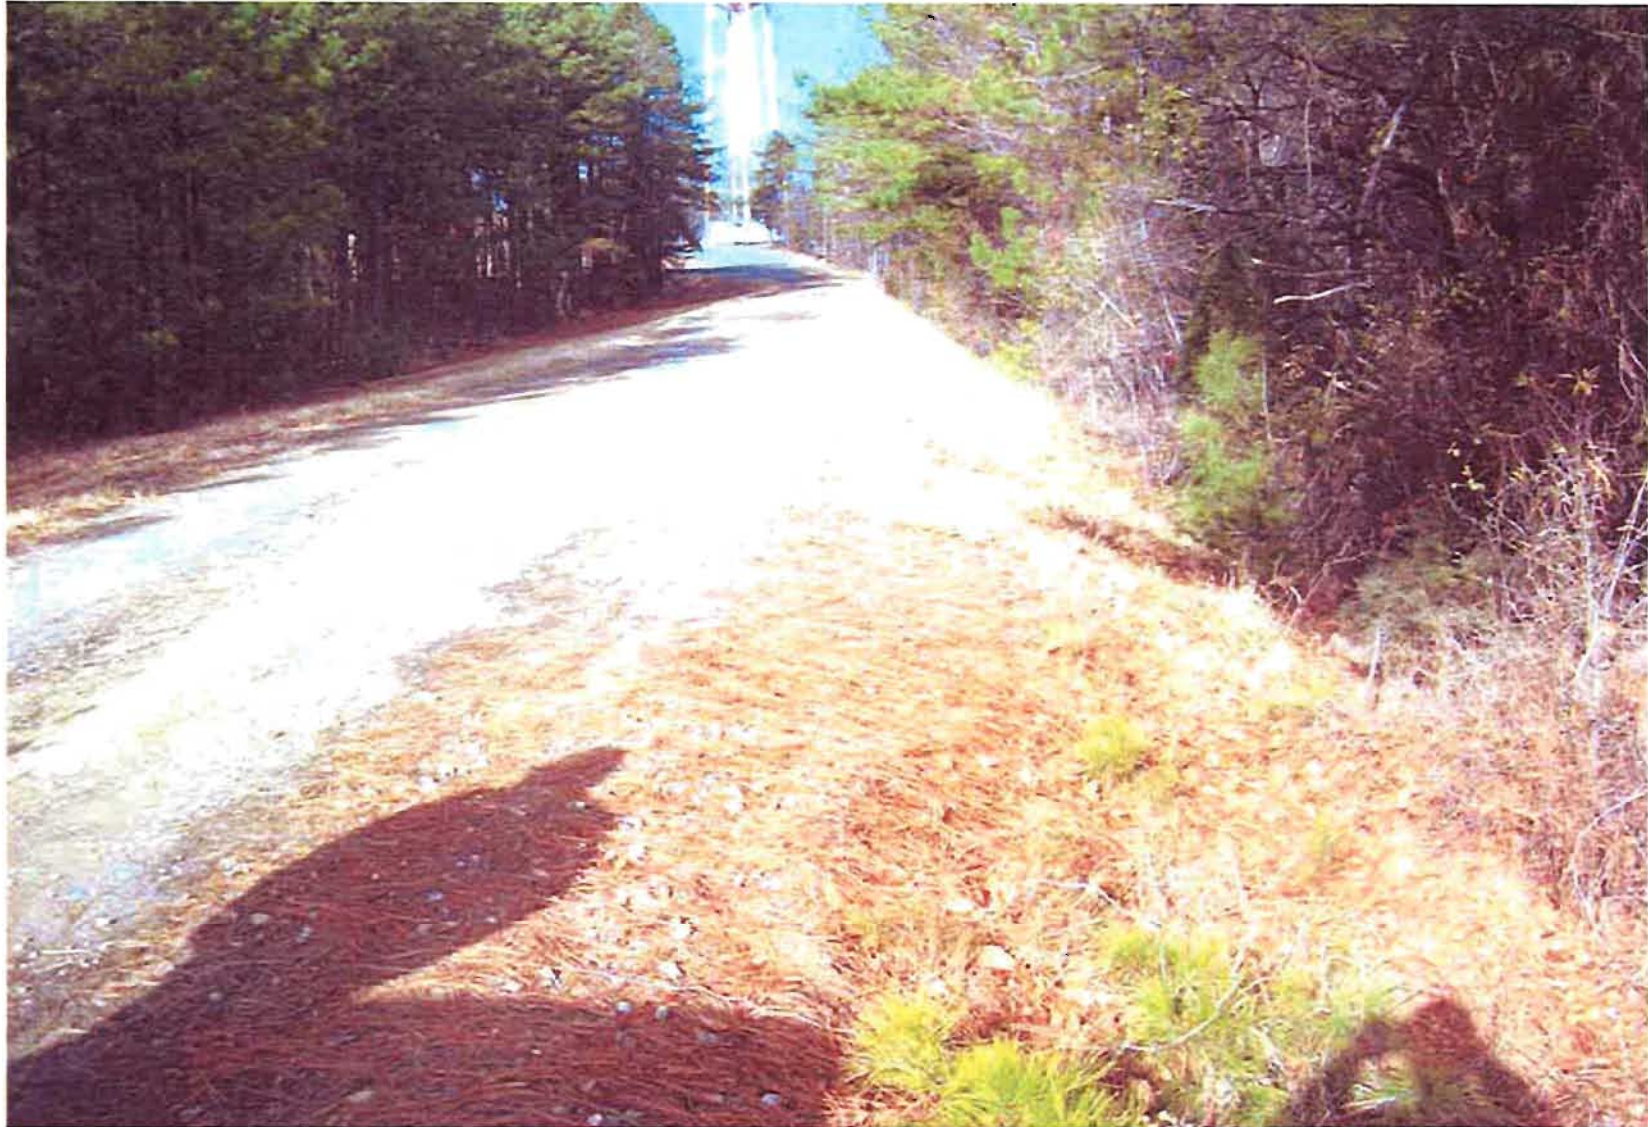
Existing dikes at a lower crest elevation form the perimeter of the Retired Ash Basin, which lies just north of the Active Ash Basin. The Retired Ash Basin dikes are covered with mature pine trees on both the upstream and downstream slopes (Figure 35). The outlet structure tower requires some maintenance for any use beyond maintaining surface water at a low elevation (Figure 9). The outlet conduit discharges surface water flows to Lake Wylie. We observed no signs of seepage around the pipe or joint deterioration (Figure 36).

Location: Retired Ash Basin Dike
Description: Typical embankment cover
