**BACK CREEK SITE  
DETAILED STREAM AND WETLAND MITIGATION PLAN  
MECKLENBURG COUNTY, NORTH CAROLINA**

**North Carolina Department of Transportation  
Raleigh, North Carolina**

**EcoScience Corporation  
1101 Haynes Street, Suite 101  
Raleigh, North Carolina 27604**

**January 2003**

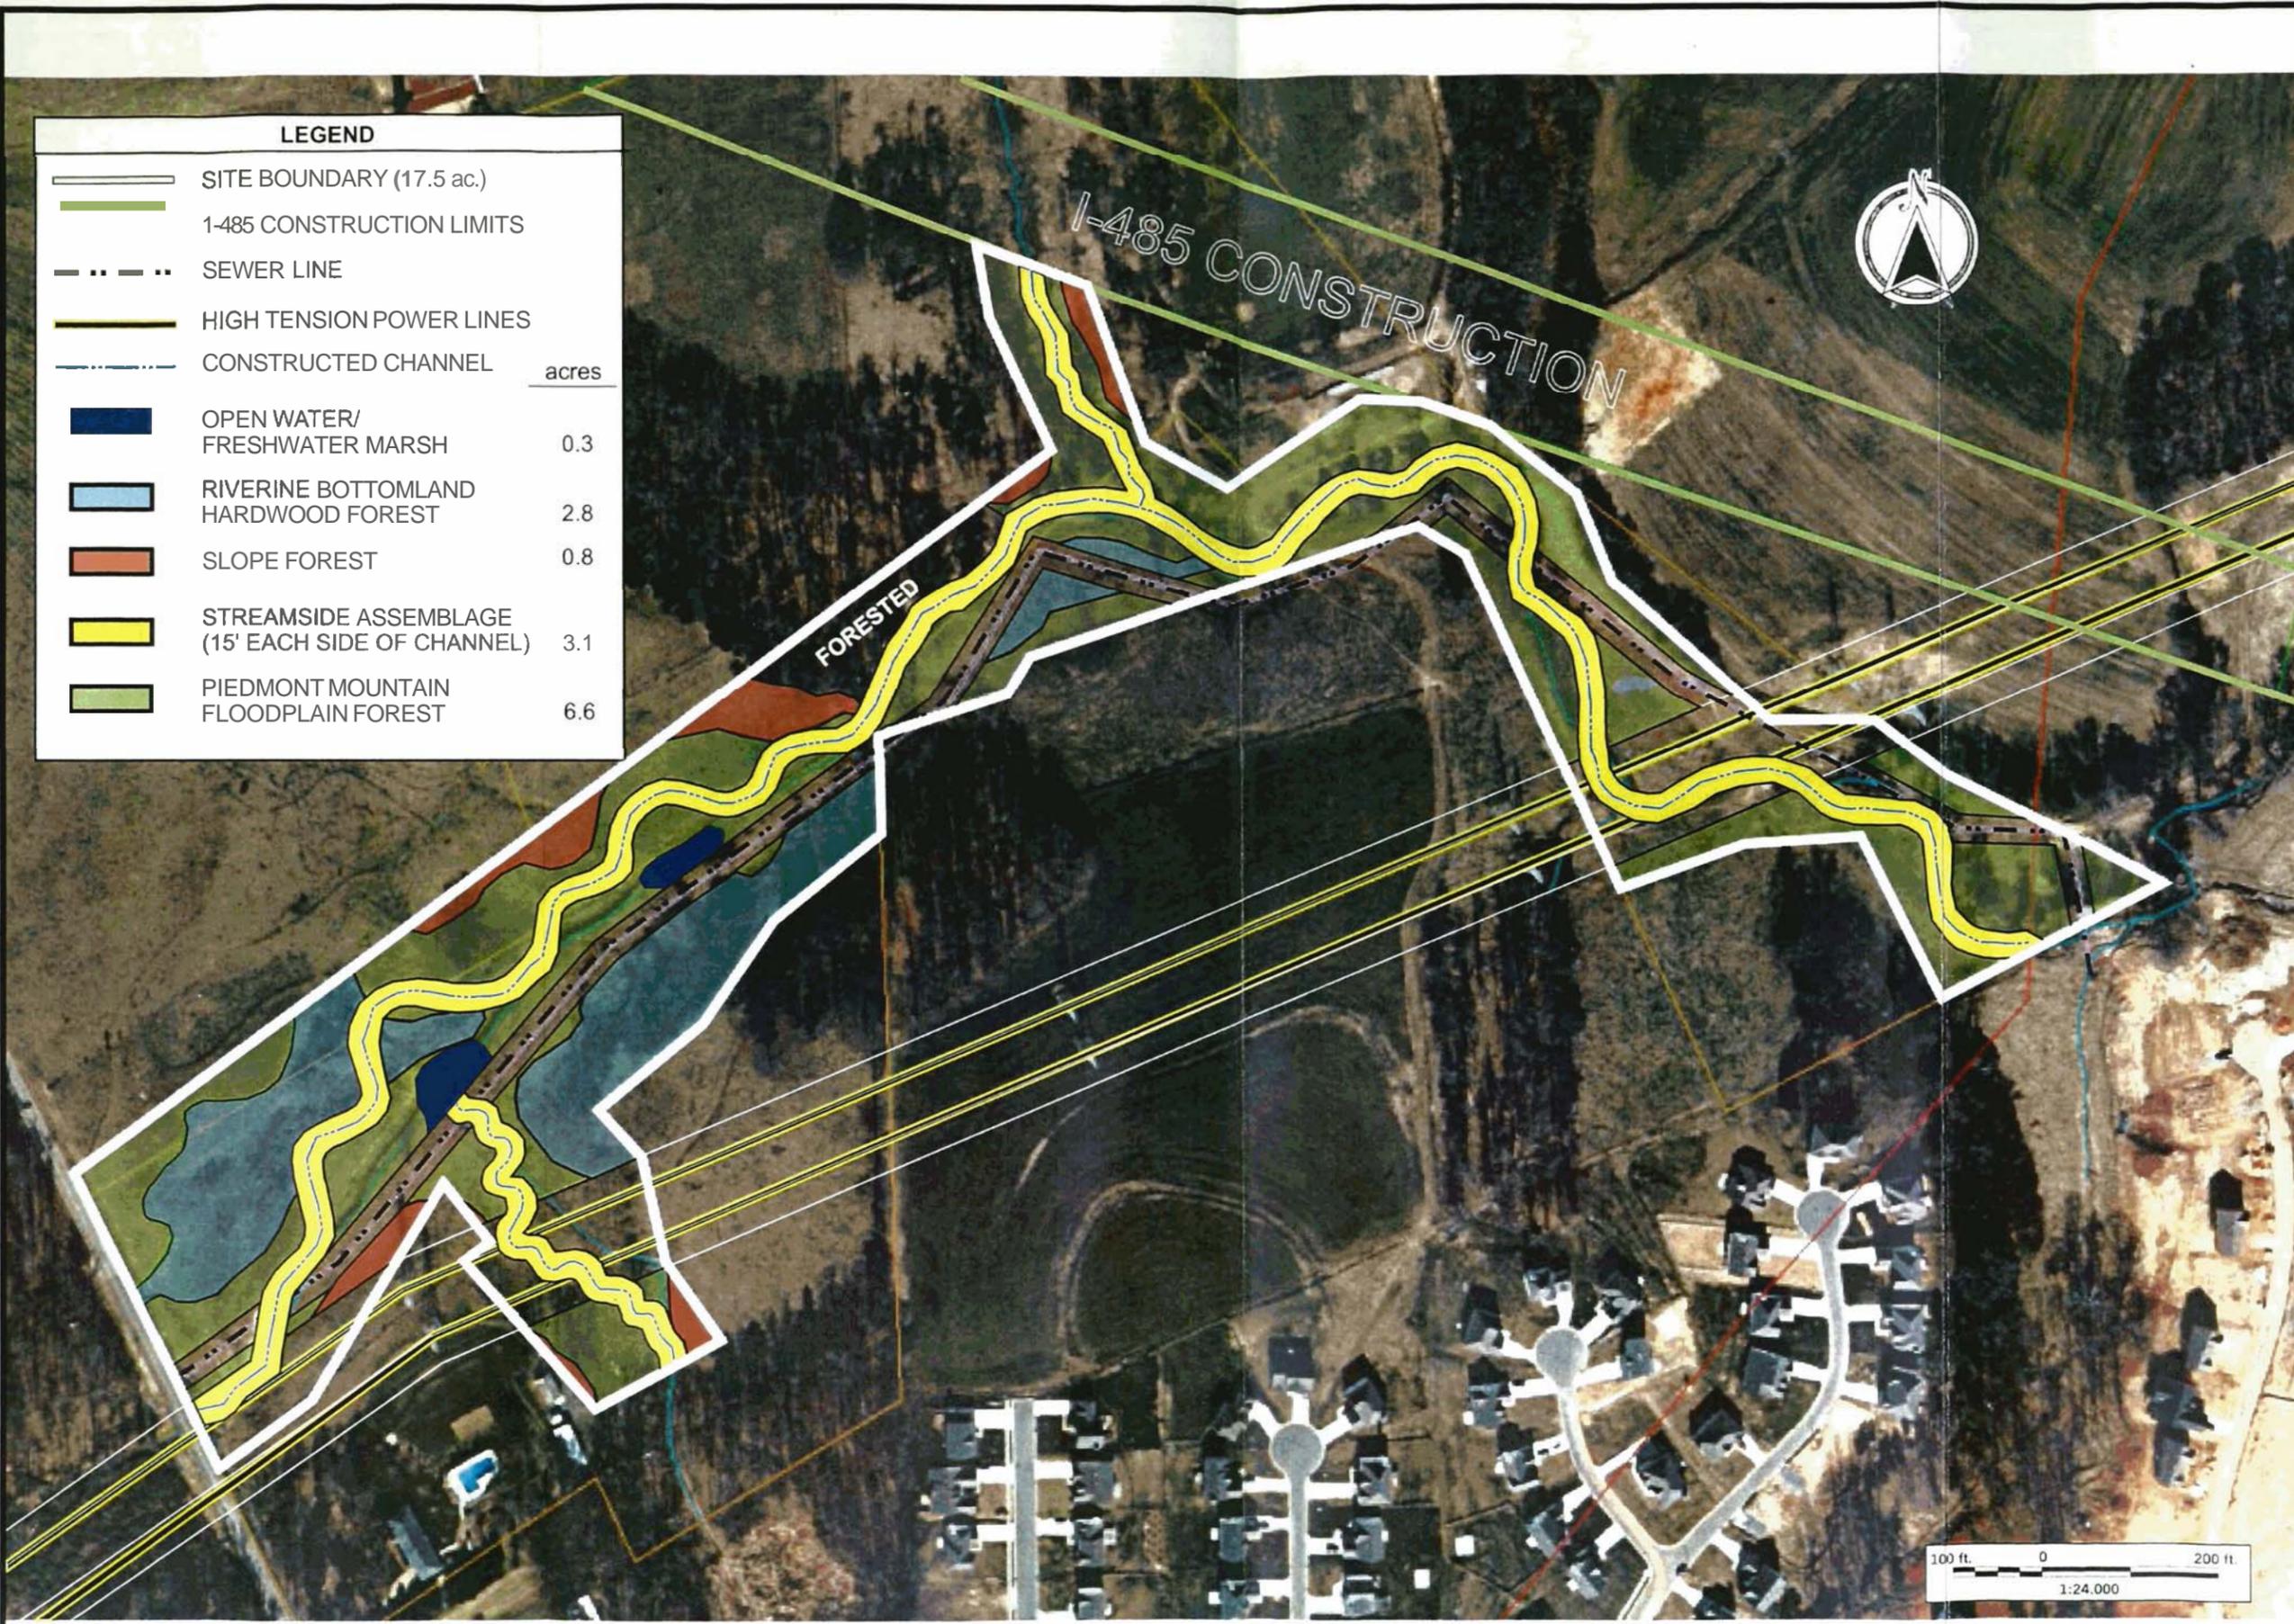
LEGEND		
	SITE BOUNDARY (17.5 ac.)	
	1-485 CONSTRUCTION LIMITS	
	SEWER LINE	
	HIGH TENSION POWER LINES	
	CONSTRUCTED CHANNEL	
	OPEN WATER/ FRESHWATER MARSH	0.3
	RIVERINE BOTTOMLAND HARDWOOD FOREST	2.8
	SLOPE FOREST	0.8
	STREAMSIDE ASSEMBLAGE (15' EACH SIDE OF CHANNEL)	3.1
	PIEDMONT MOUNTAIN FLOODPLAIN FOREST	6.6
